Ida Lee Willis Memorial Foundation Historic Preservation Awards Program

Name Louisville Water Company Pump Station 1 - Exterior Restoration

This narrative is to consider The Louisville Water Company Pump Station 1 for the 2011 Ida Lee Willis Memorial Foundation Historic Preservation Awards Program for the Preservation Project Award.

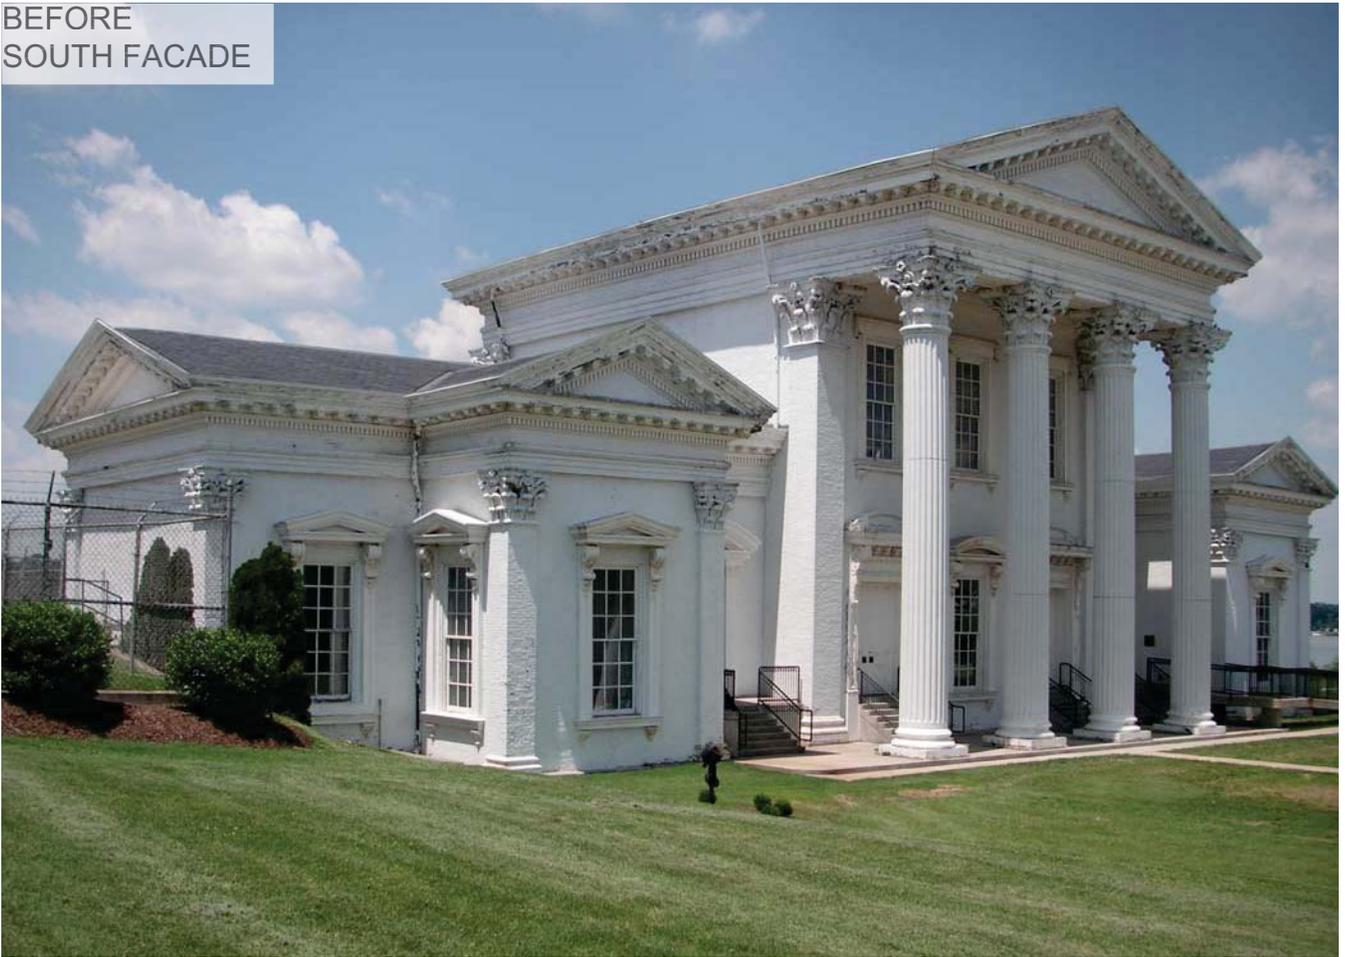
BEFORE
SOUTH FACADE

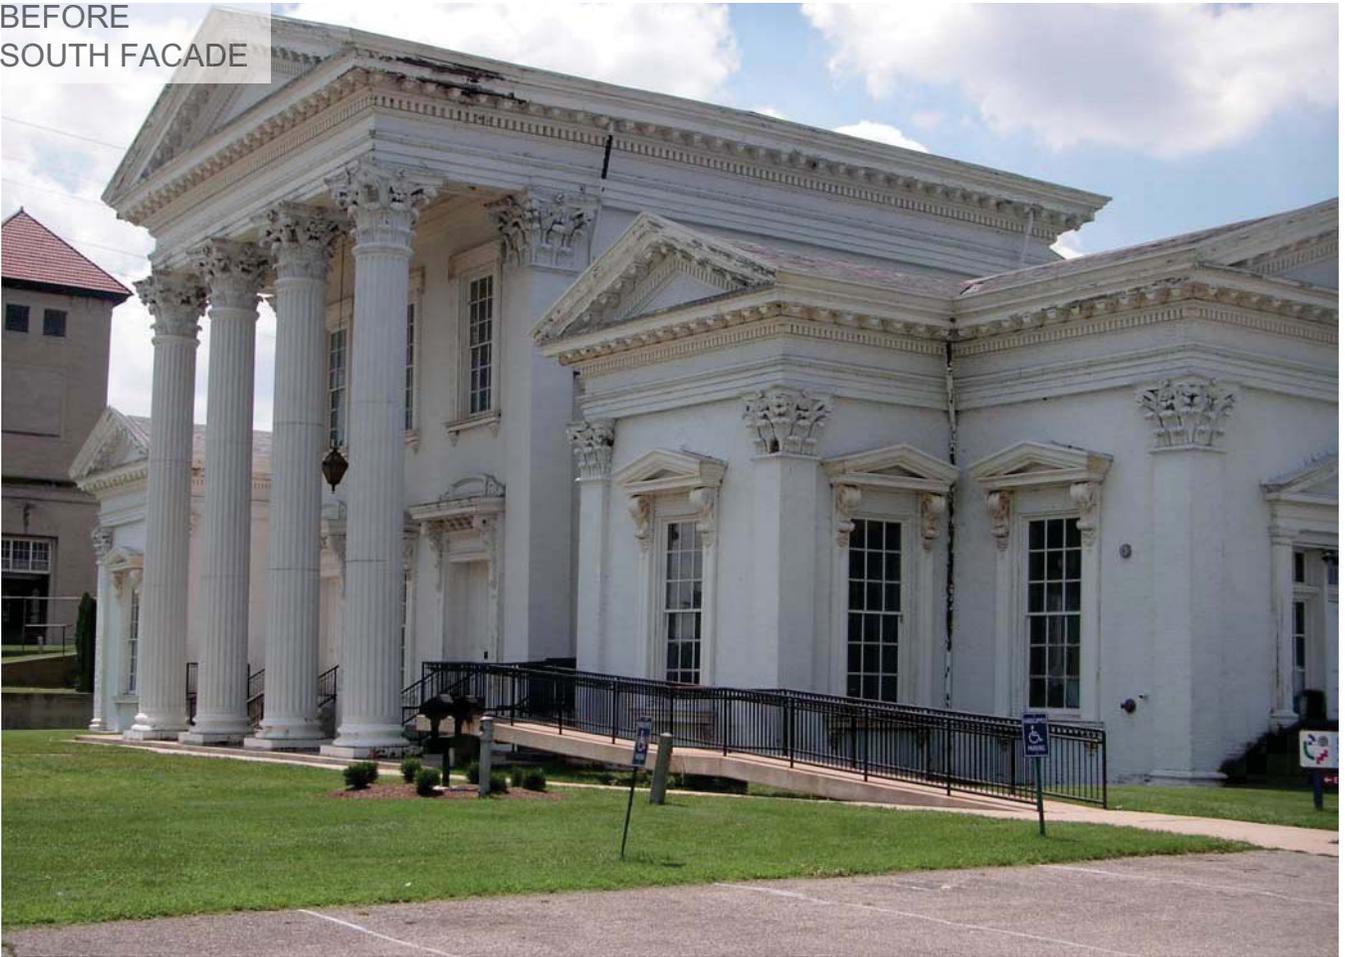
BEFORE
SOUTH FACADE

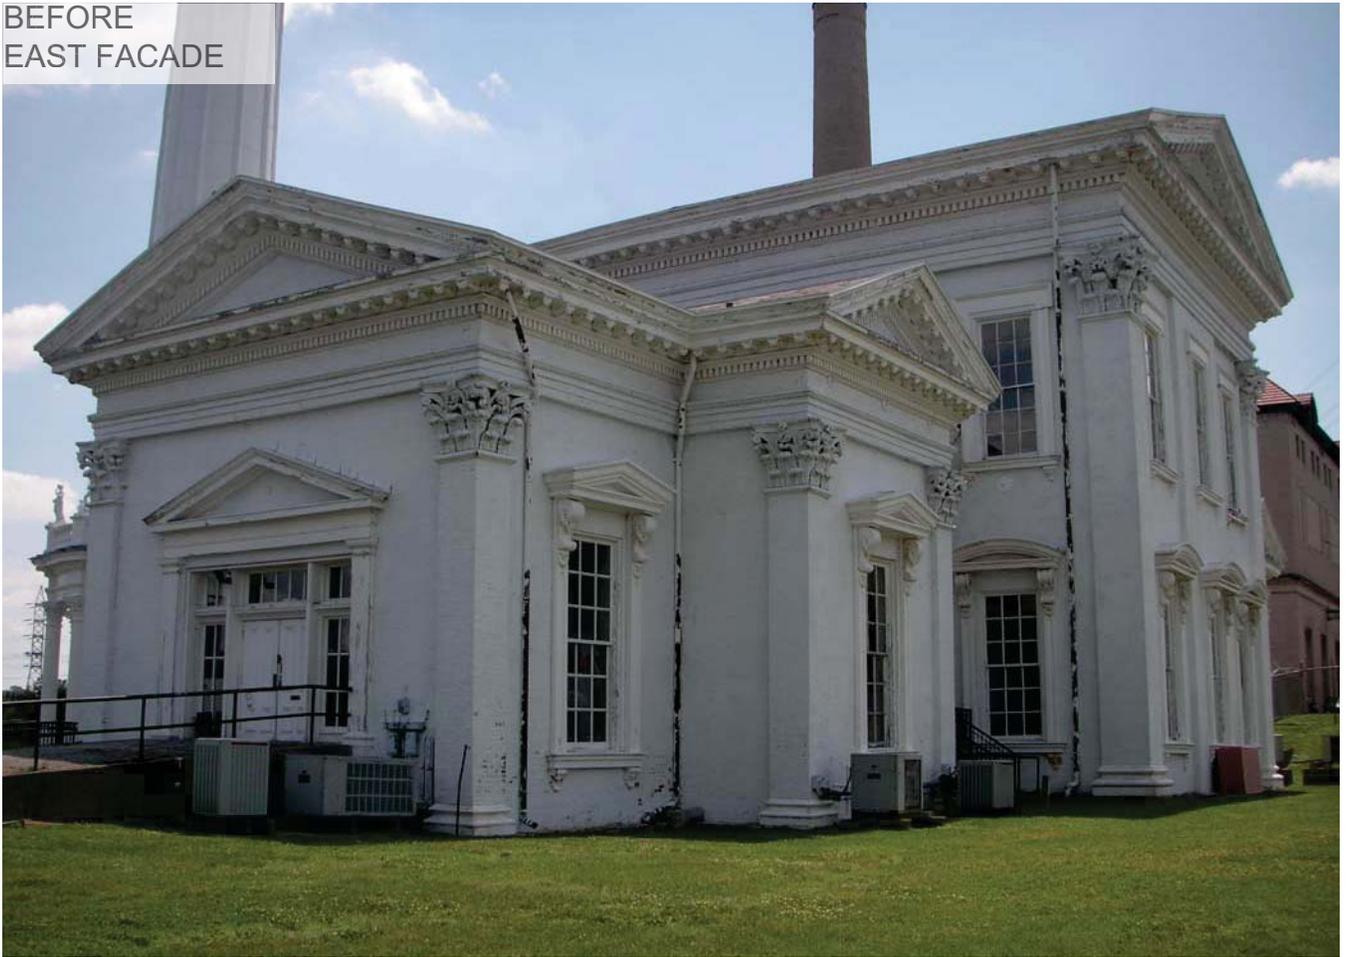
BEFORE
EAST FACADE

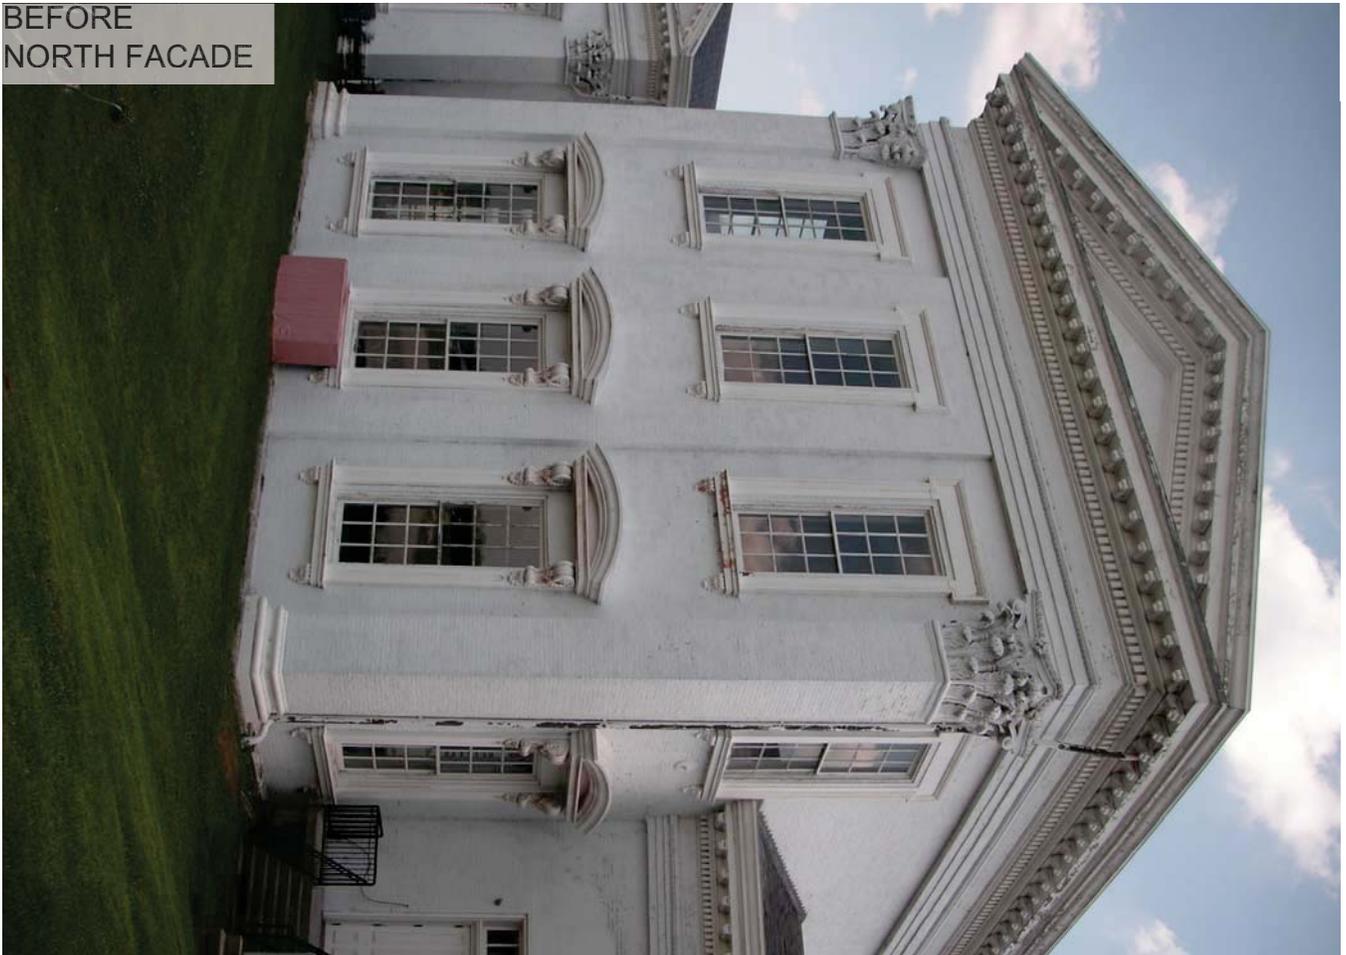
BEFORE
NORTH FACADE

- Replication of the north door pediments and pilasters were created out of gypsum fiberglass reinforced concrete matching the original drawings in scale, detail, and finish.

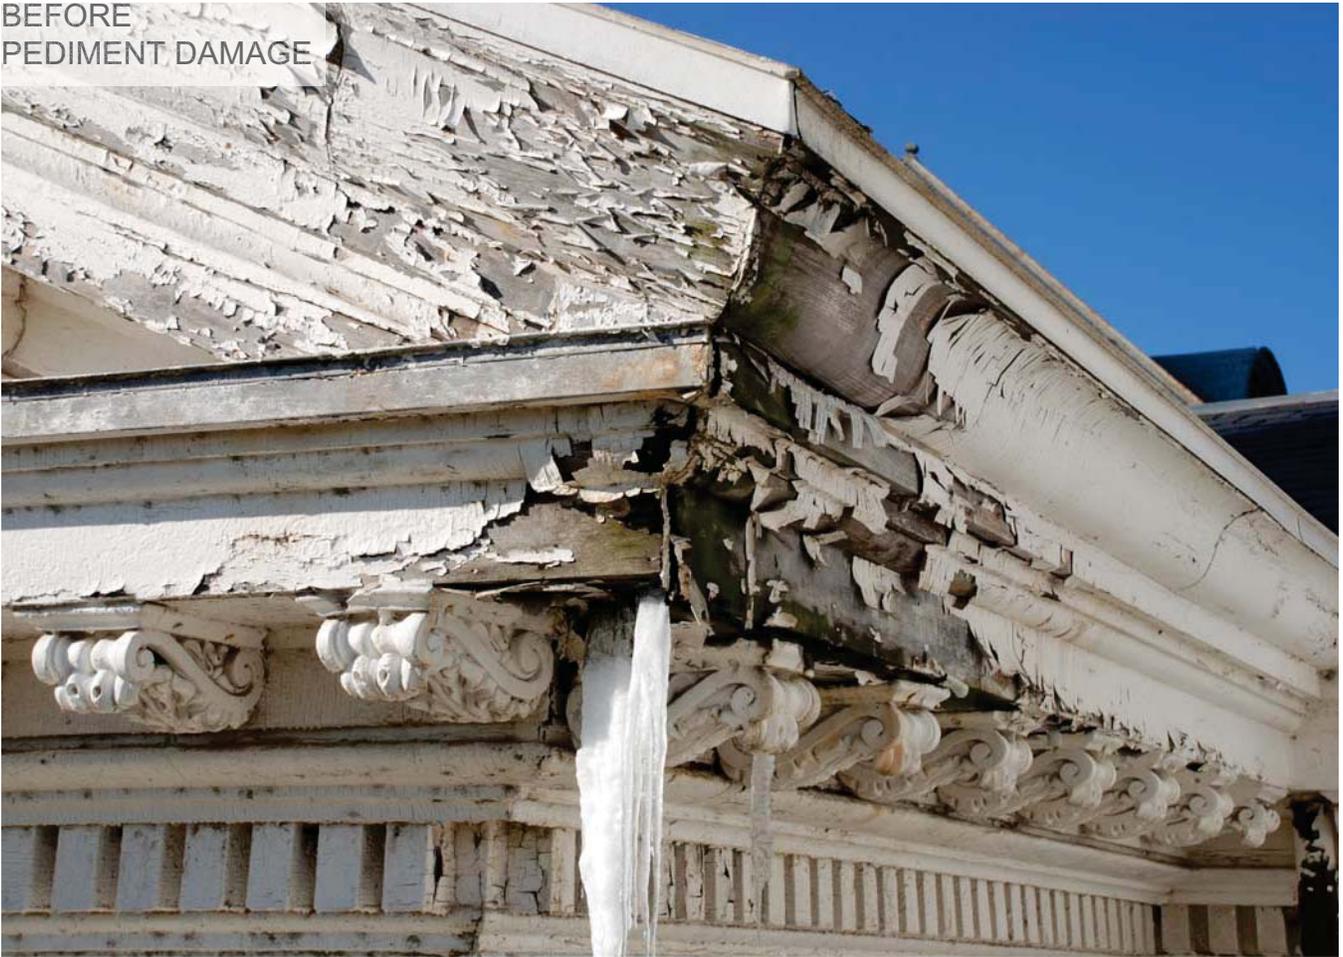
BEFORE
PEDIMENT DAMAGE

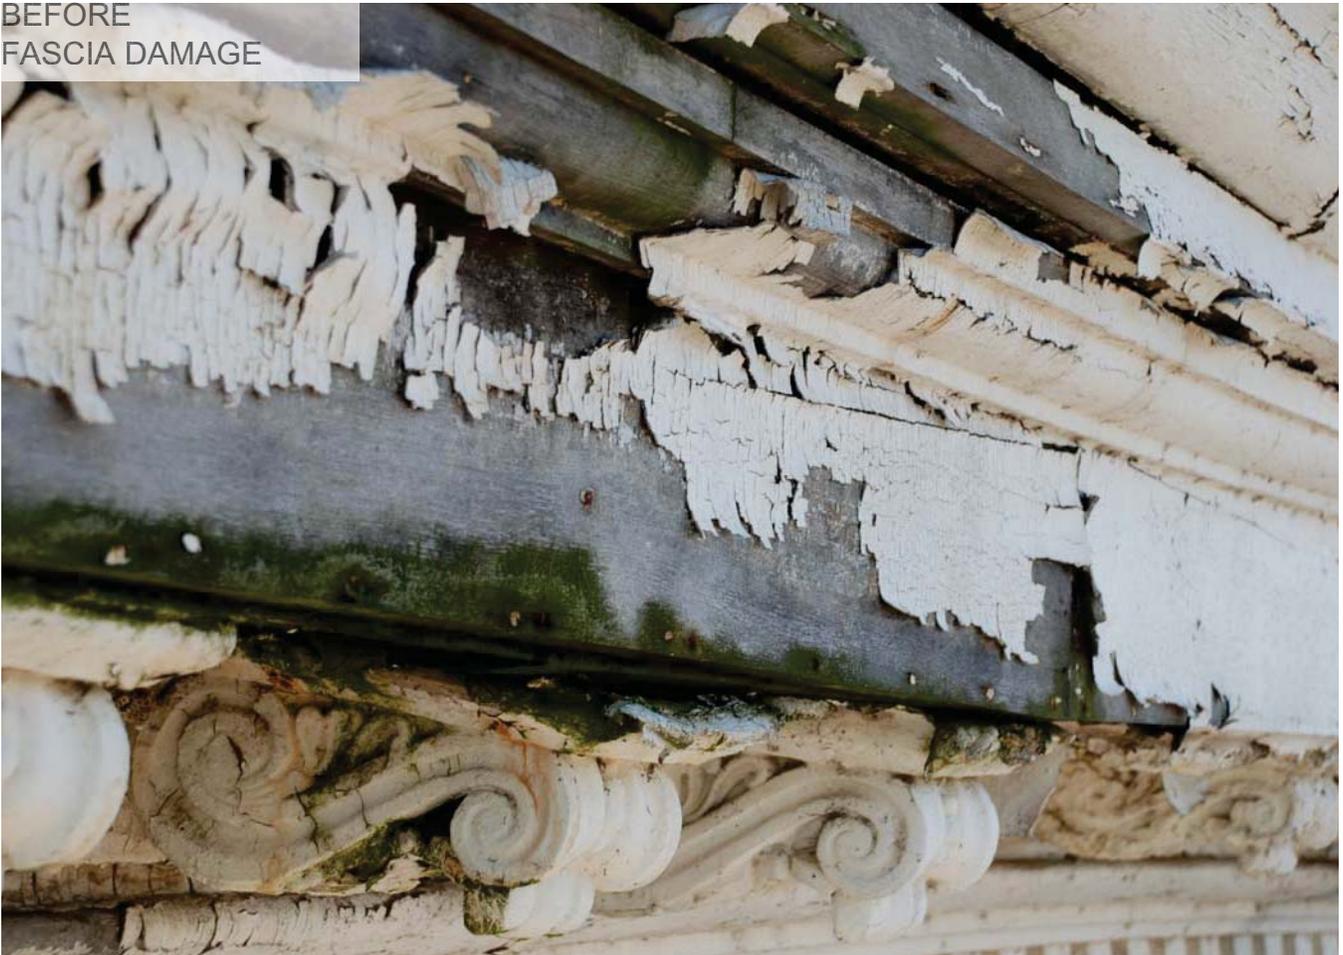
BEFORE
FASCIA DAMAGE

- The damaged eaves and built-in gutters were disassembled, rotted wood was replaced, the eaves and built-in gutters were reconstructed, and items were painted.

- Two-thirds of the paint on the wood trim and eaves was removed, the wood repaired or replaced, the surfaces prepped and primed, and the wood was painted.

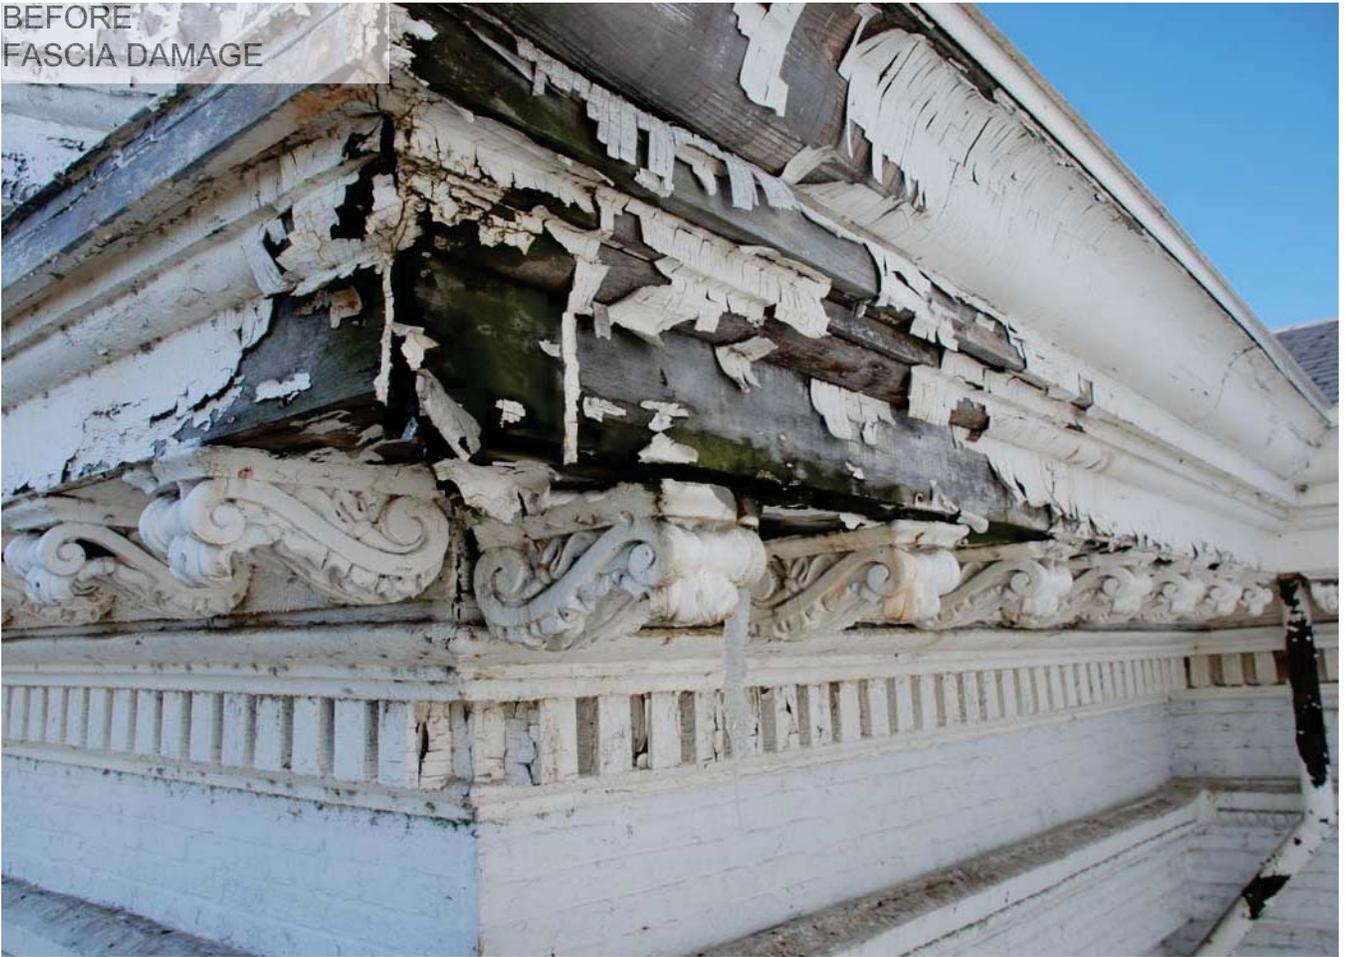
BEFORE
FASCIA DAMAGE

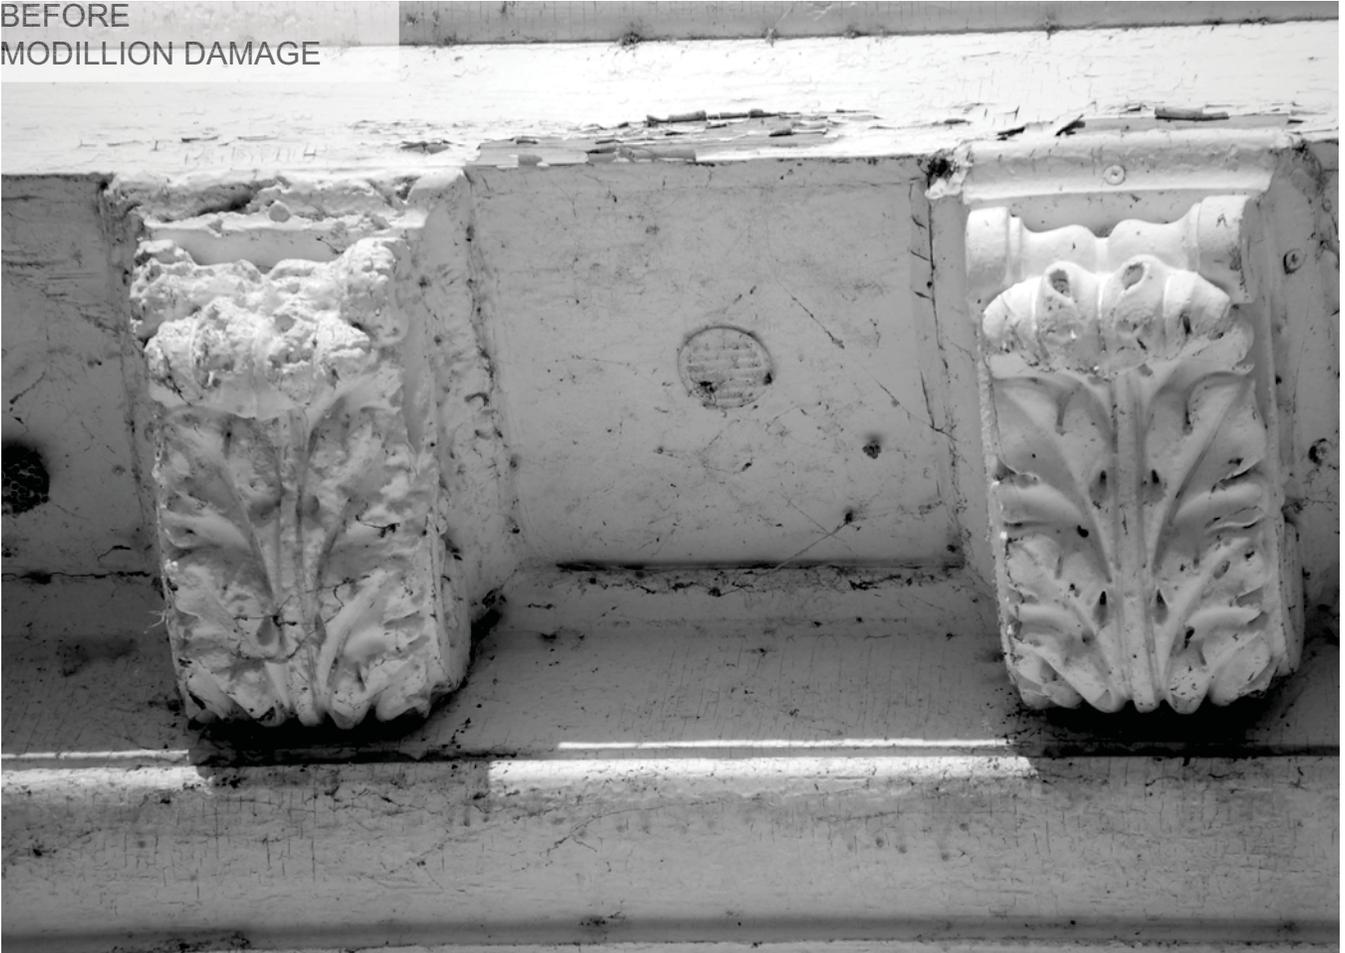
BEFORE
MODILLION DAMAGE

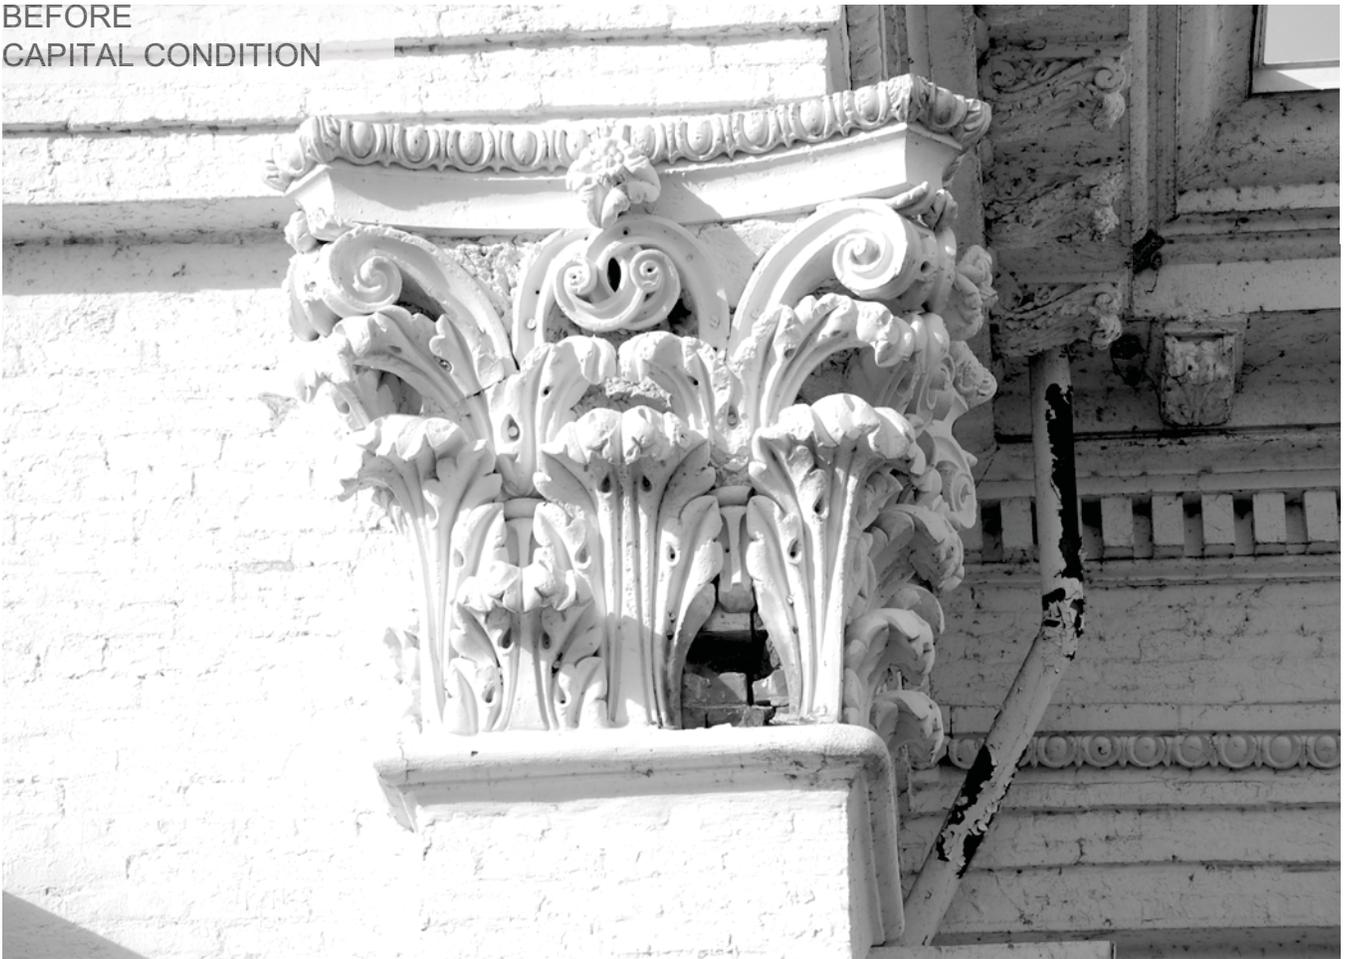
BEFORE
CAPITAL CONDITION

- The terra cotta elements were all documented, broken pieces were either repaired in place or replaced with replicated elements in terra cotta. Missing terra cotta elements were recreated in terra cotta and installed.

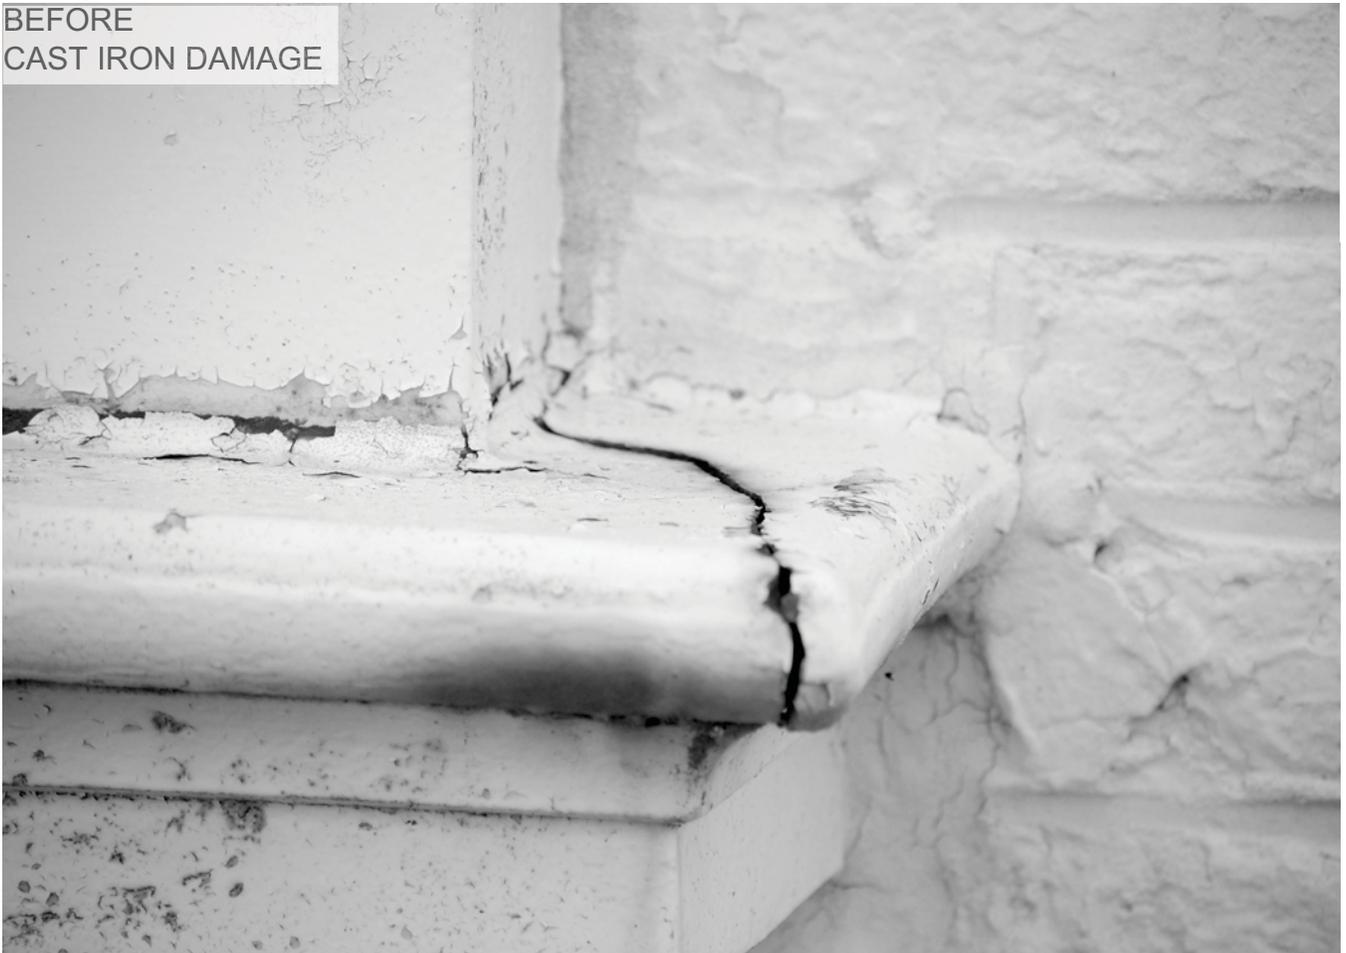
BEFORE
CAST IRON DAMAGE

- The cast iron was repaired in place and painted.
- The wood doors and windows were all removed, refurbished, reinstalled, and painted. All the door hardware was replaced with the exception of some historic pulls. Window panes which were replaced in the 1970's that were failing were replaced with new insulated panes. Historic single pane glass which was broken was replaced with historic single pane glass.

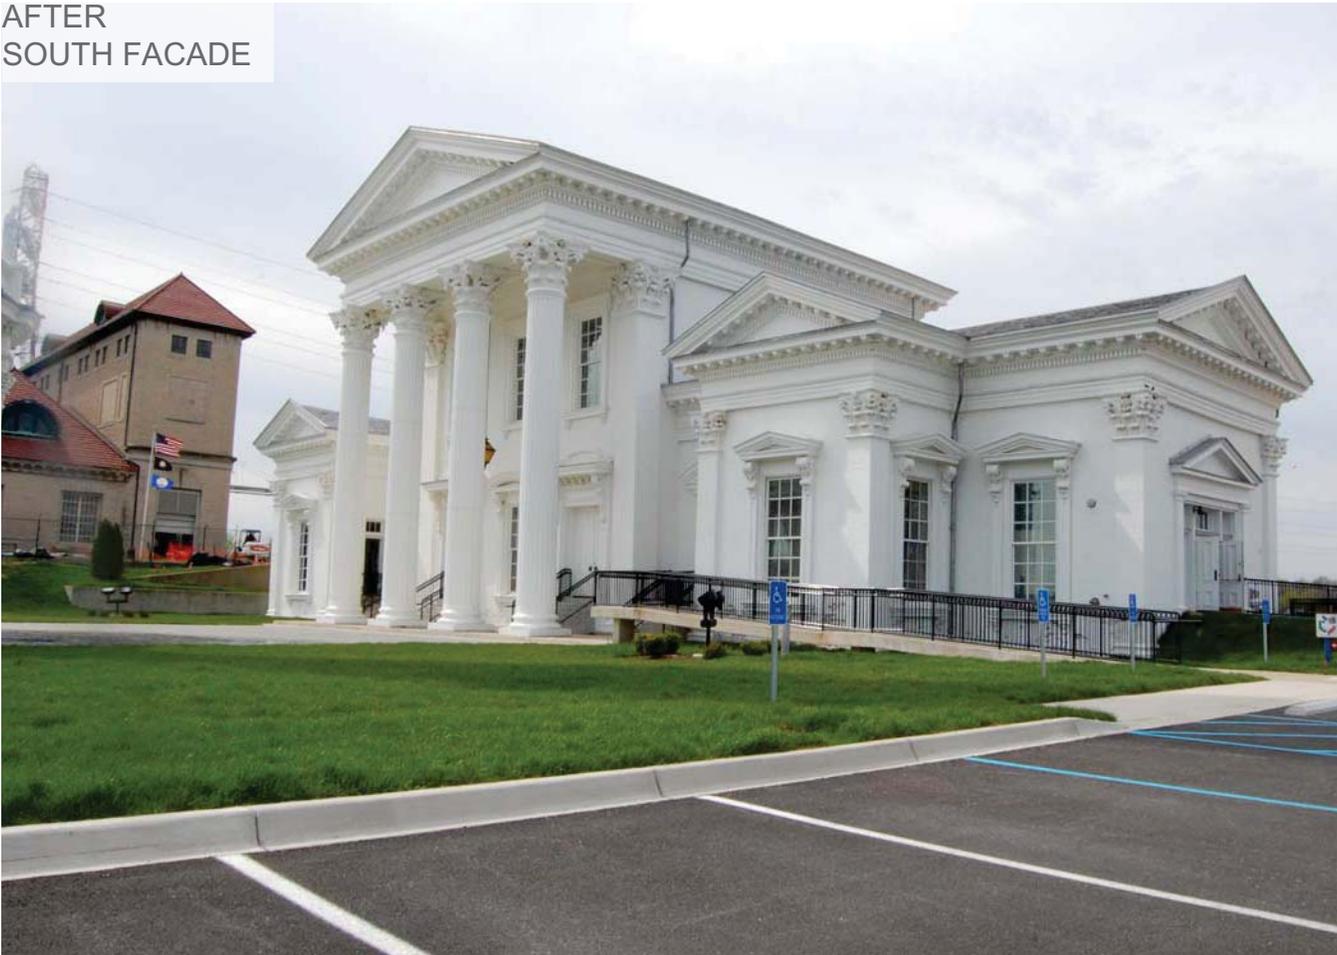
AFTER
SOUTH FACADE

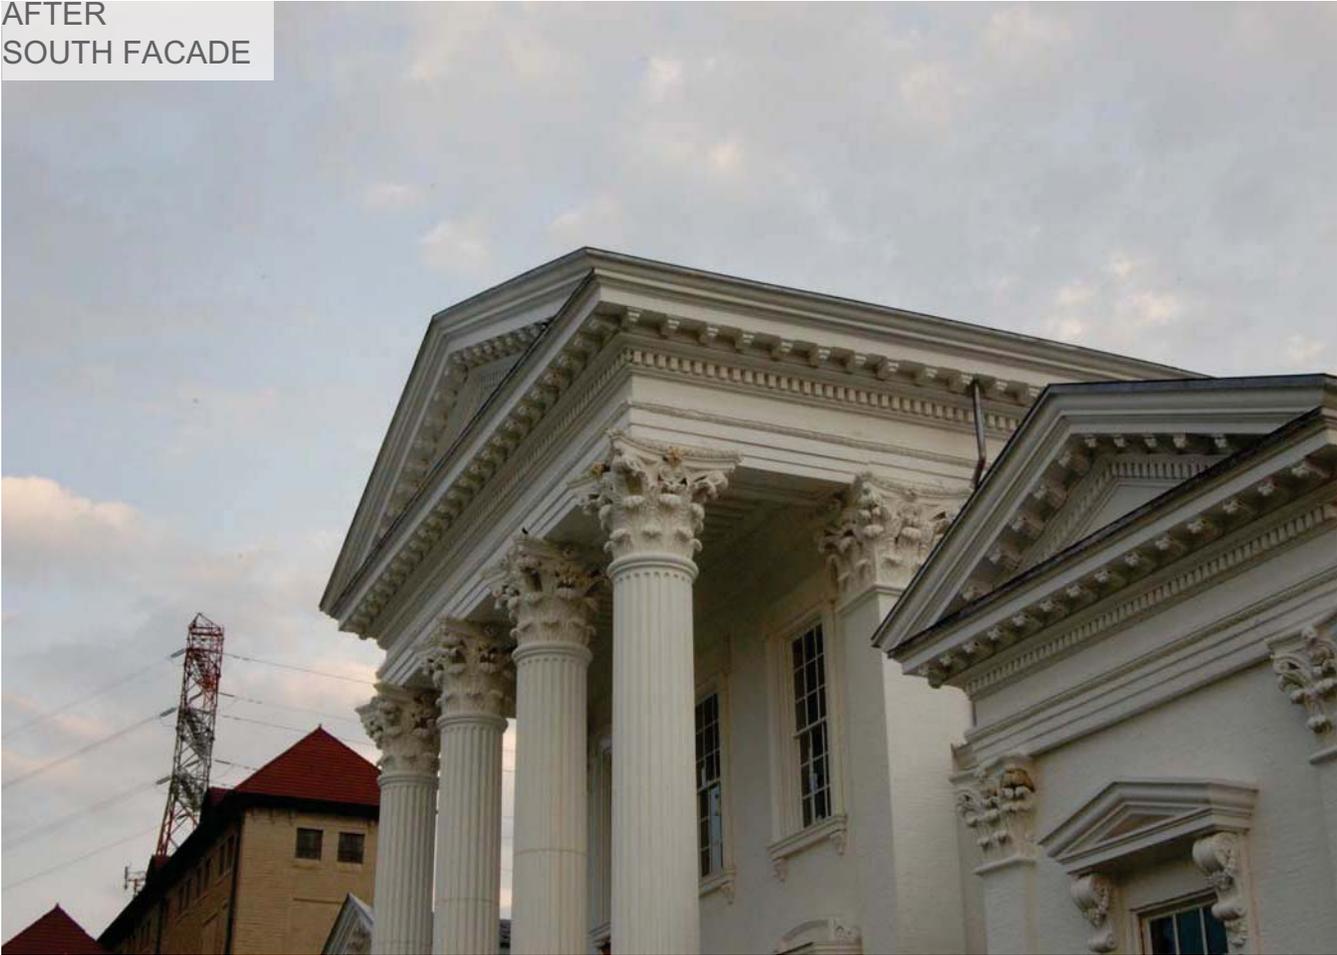
AFTER
SOUTH FACADE

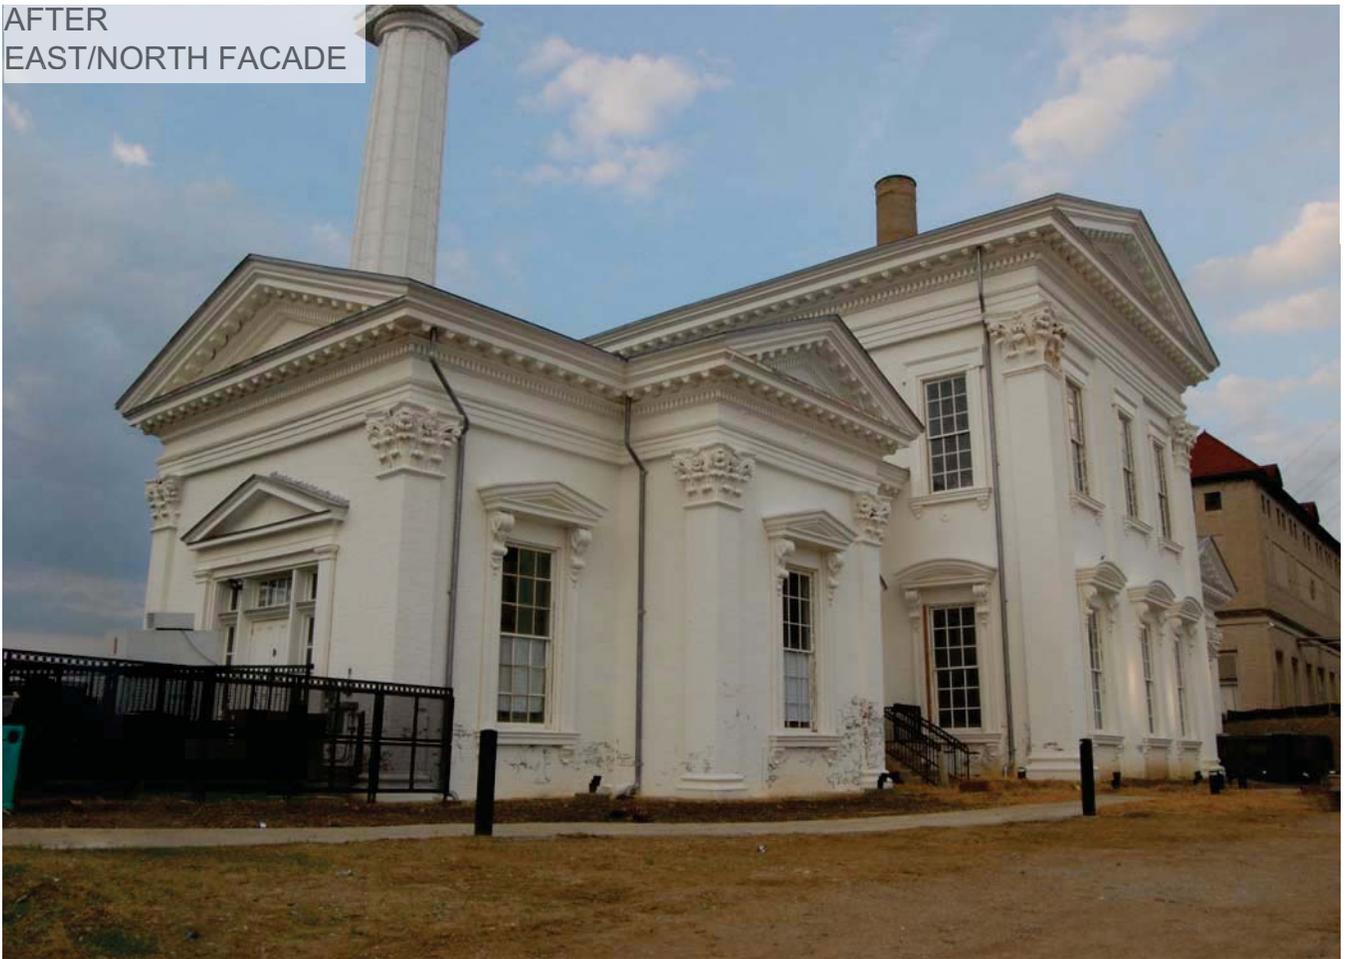
AFTER
EAST/NORTH FACADE

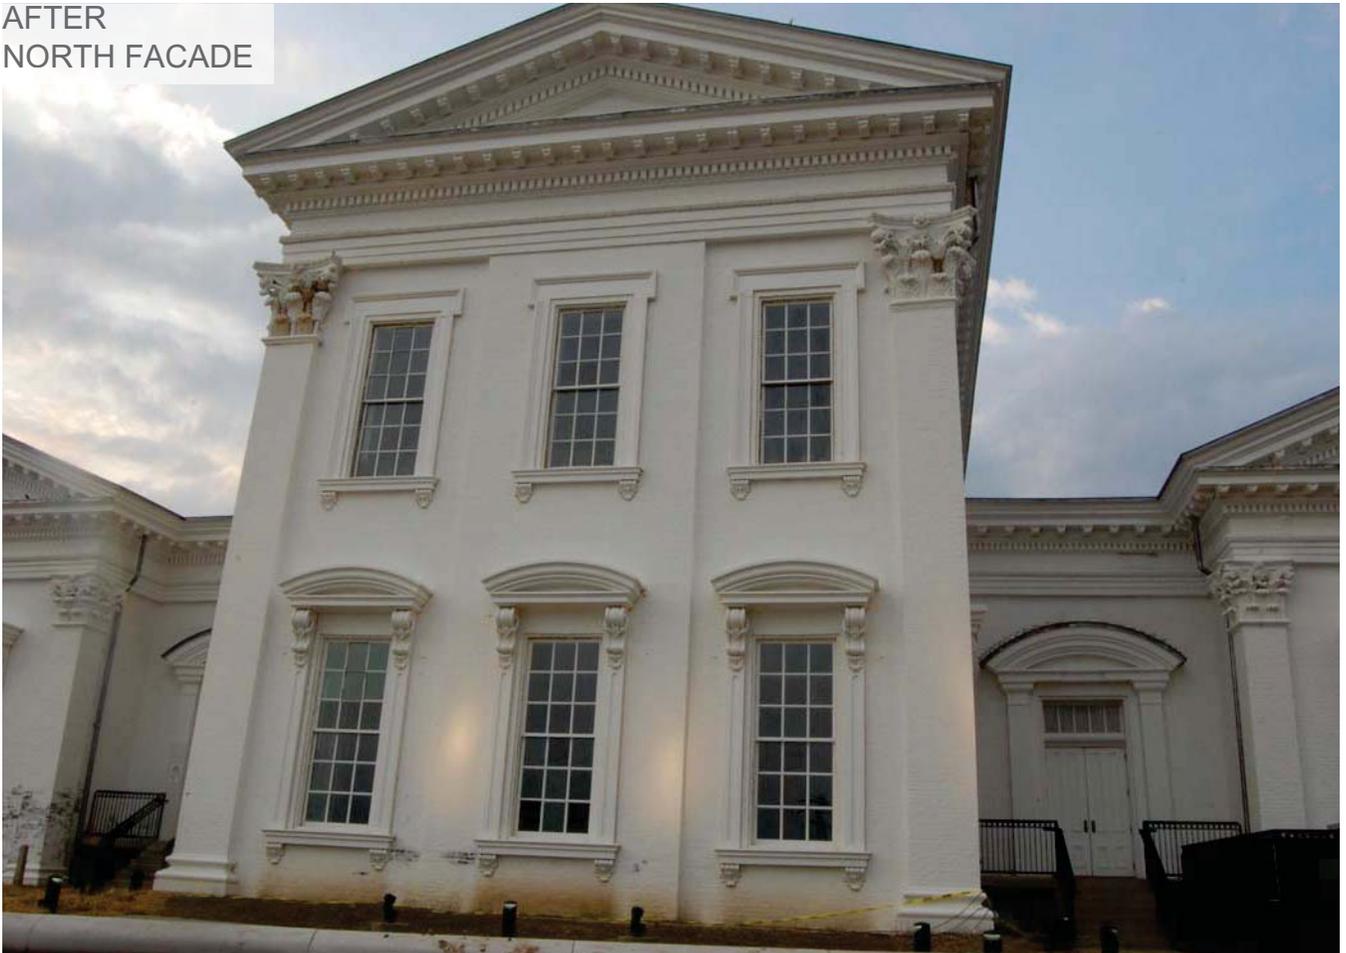
AFTER
NORTH FACADE

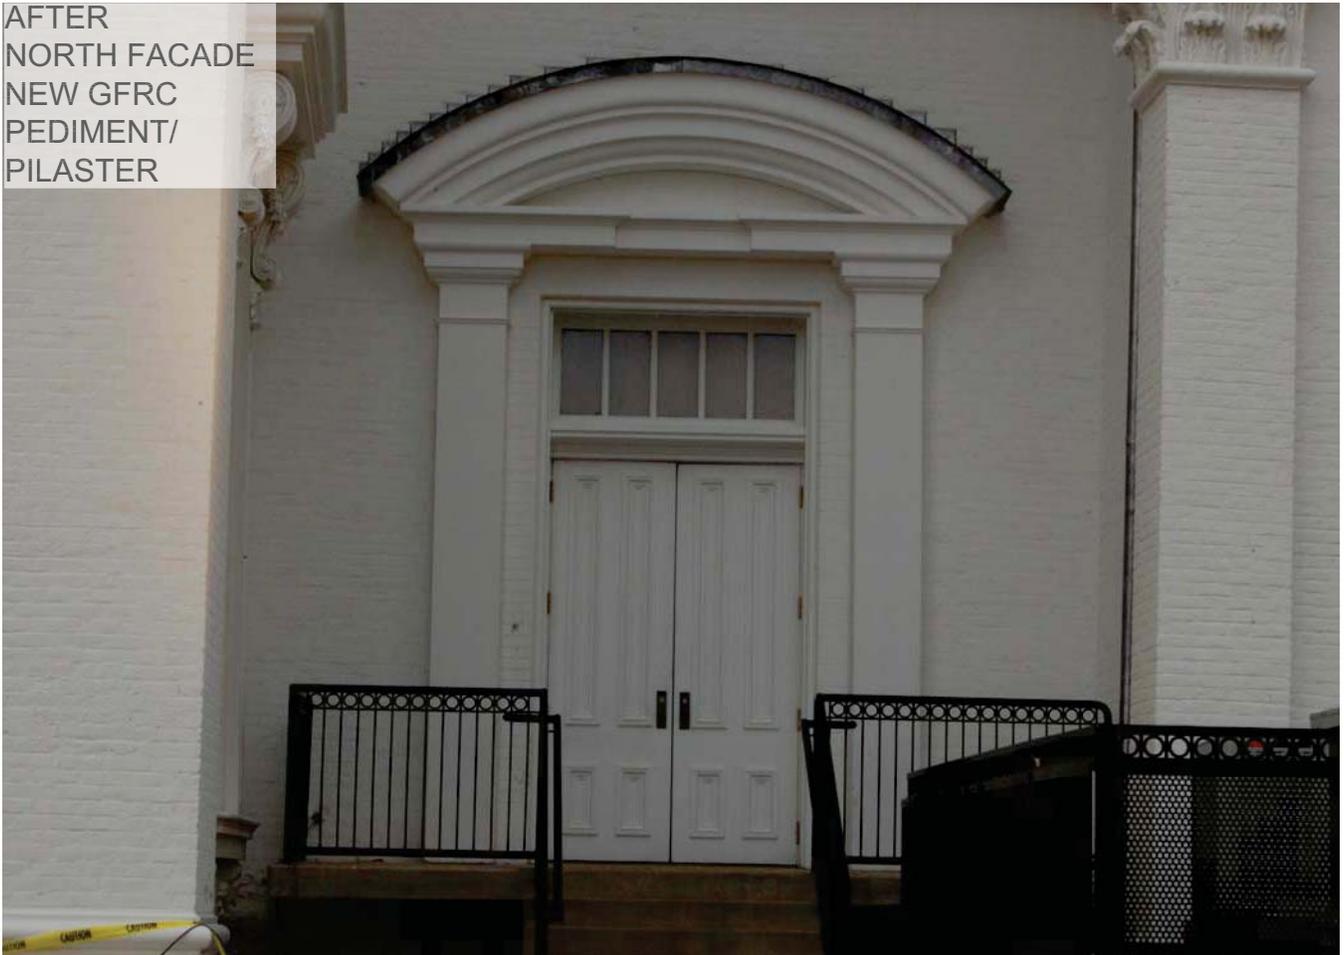
AFTER
NORTH FACADE
NEW GFRC
PEDIMENT/
PILASTER

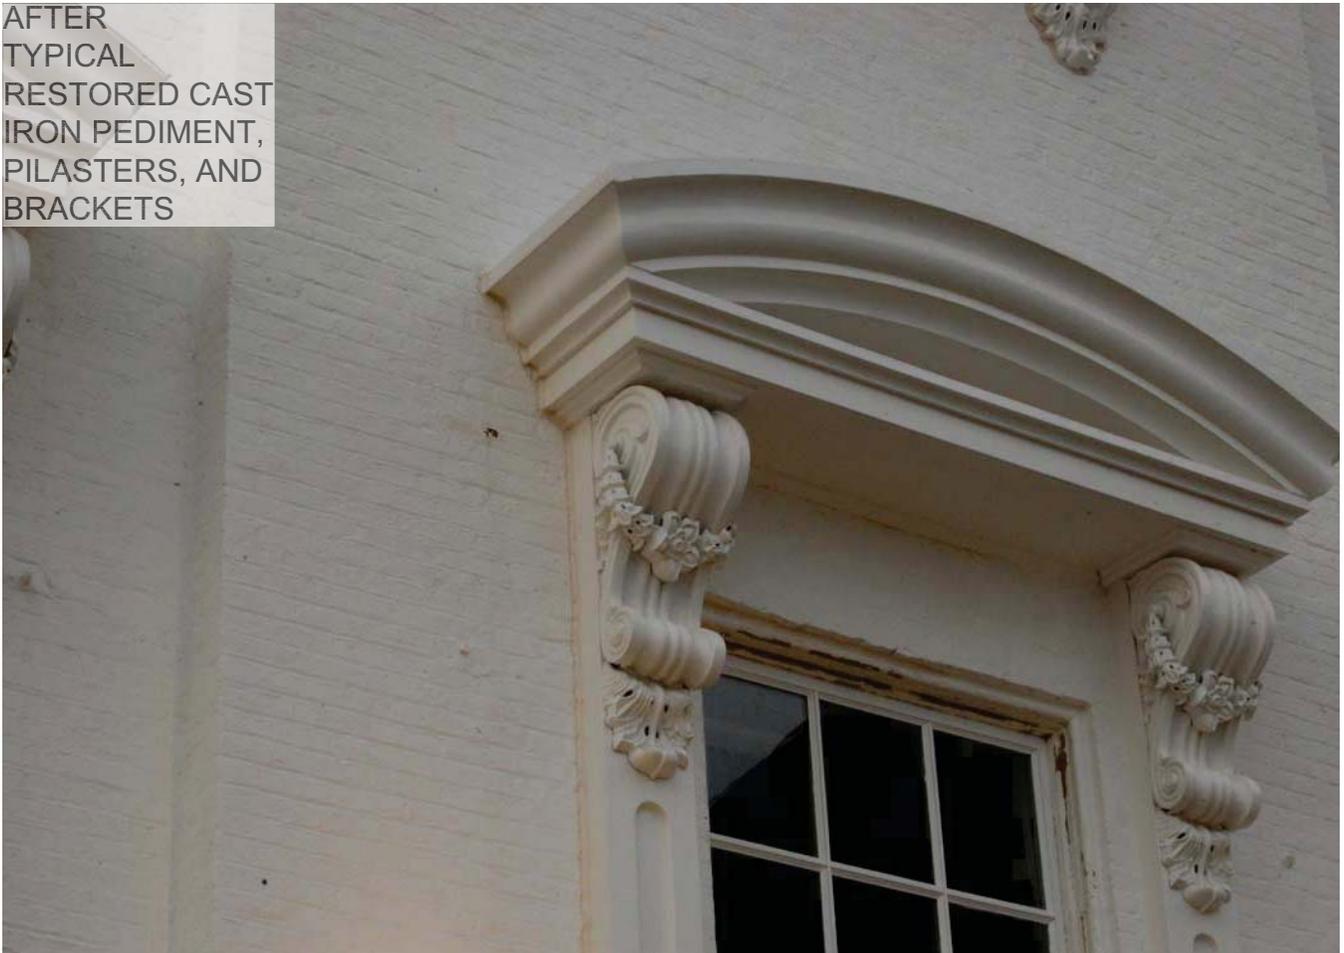
AFTER
TYPICAL
RESTORED CAST
IRON PEDIMENT,
PILASTERS, AND
BRACKETS

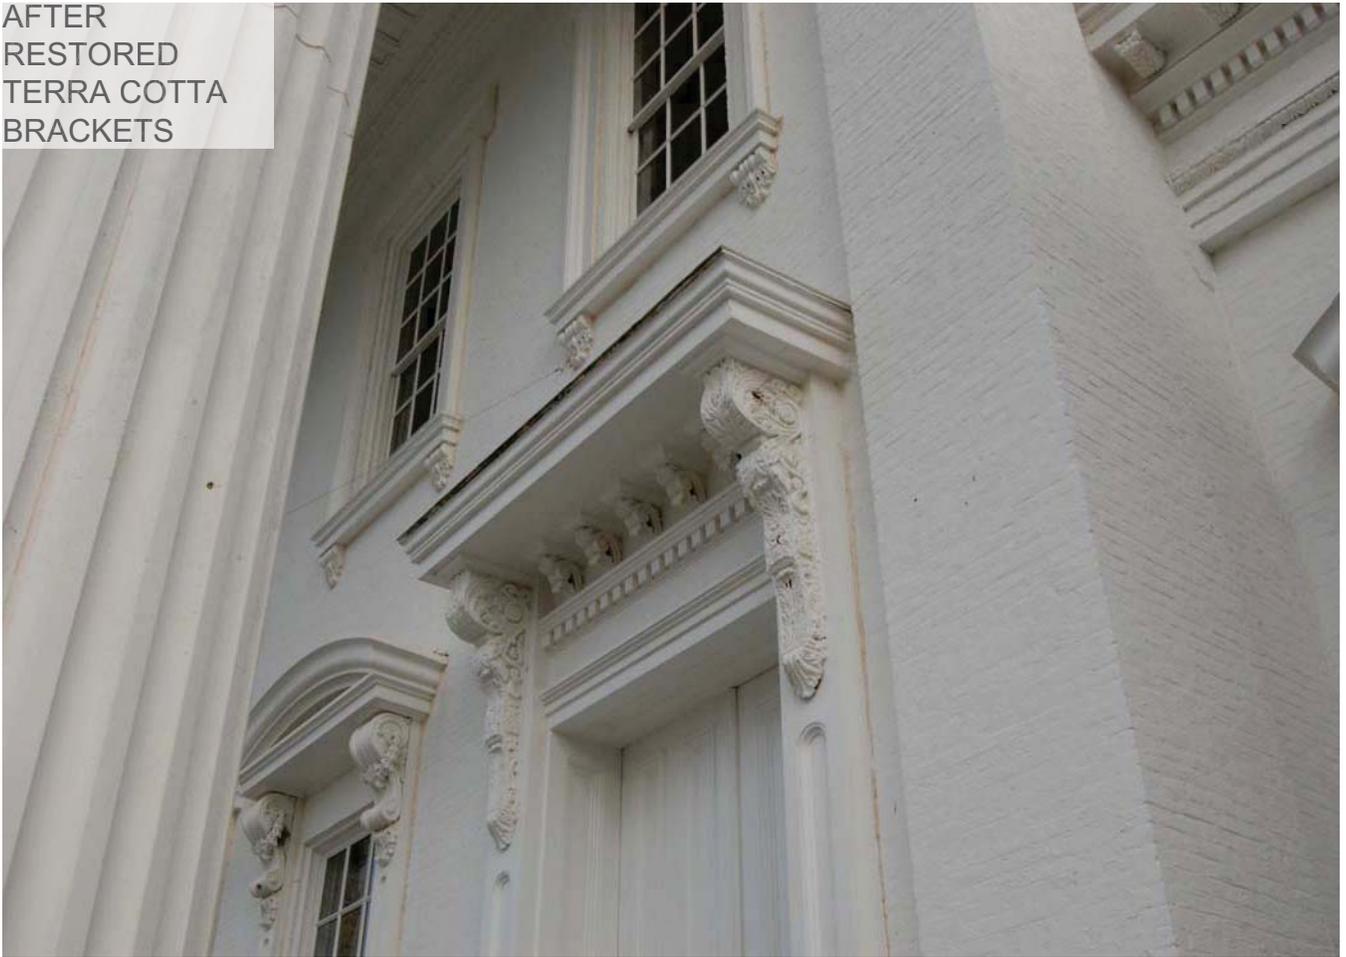
AFTER
RESTORED
TERRA COTTA
BRACKETS
