Ida Lee Willis Memorial Foundation Historic Preservation Awards Program

Name Louisville Water Company Pump Station 1 - Exterior Restoration

This narrative is to consider The Louisville Water Company Pump Station 1 for the 2011 Ida Lee Willis Memorial Foundation Historic Preservation Awards Program for the Preservation Project Award.

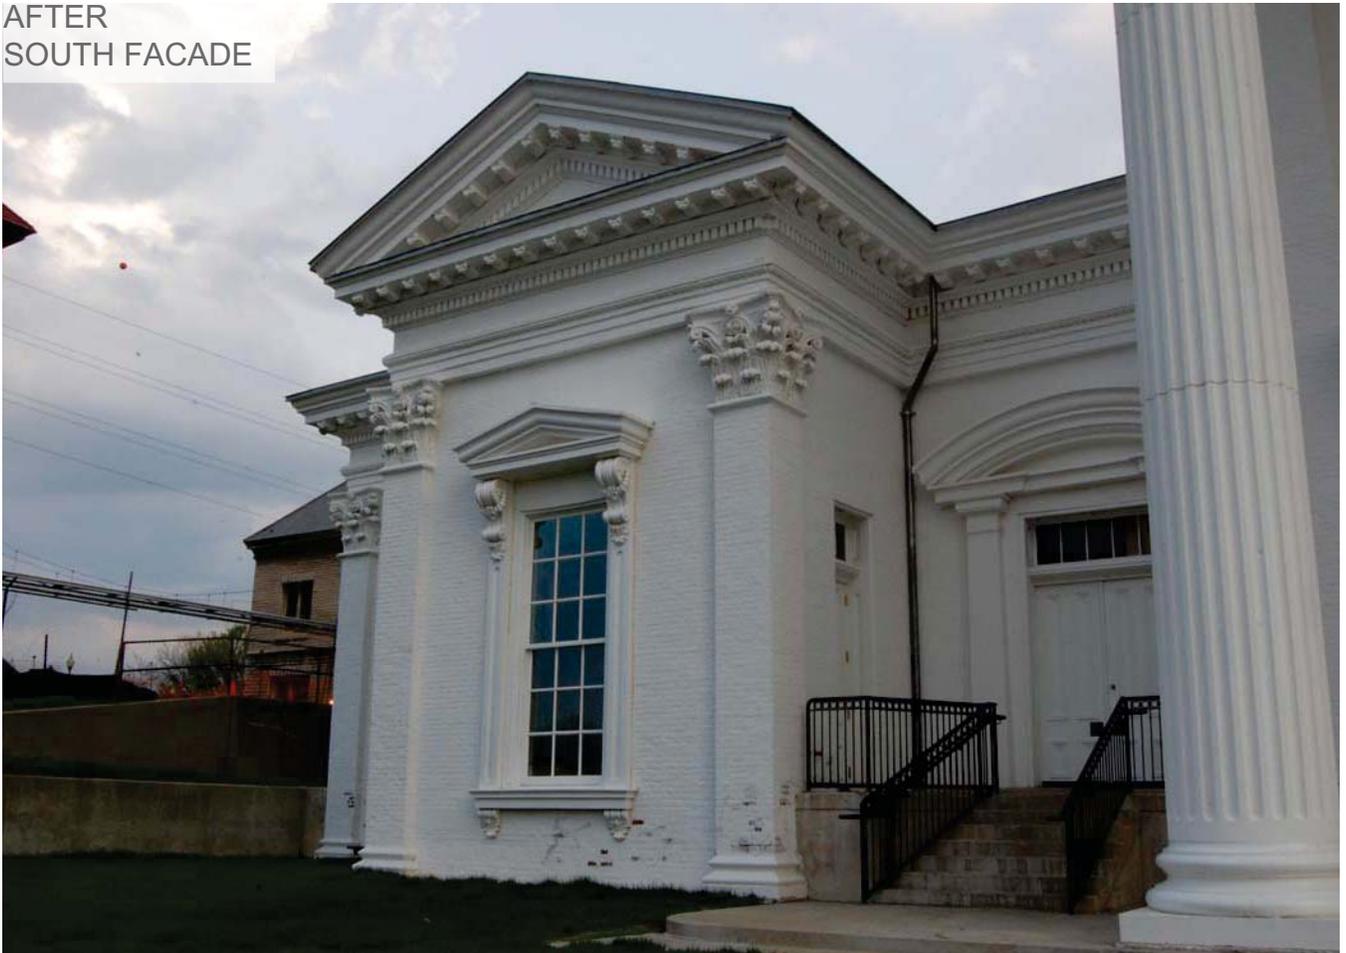
AFTER
SOUTH FACADE

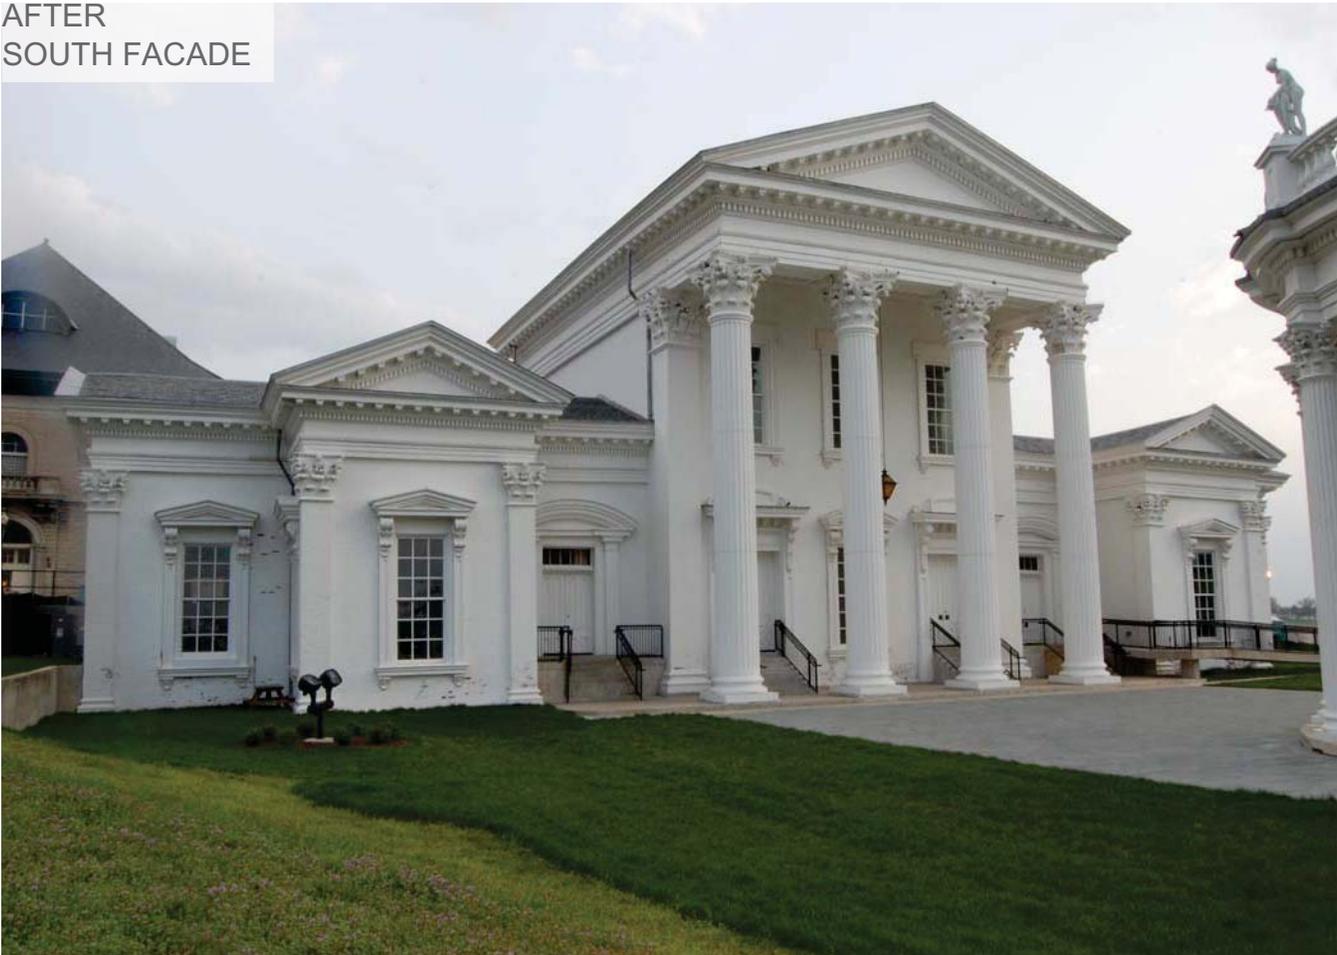
AFTER
SOUTH FACADE
