**The Restoration of Burton's Store
Perryville, KY**

May 1, 2010 to February 1, 2011

**Report Prepared by Bill Faulconer
Photos by Linda Faulconer, Timothy Wilkinson and Vicki Goode**

**Chaplin Hills
Timberwrights**

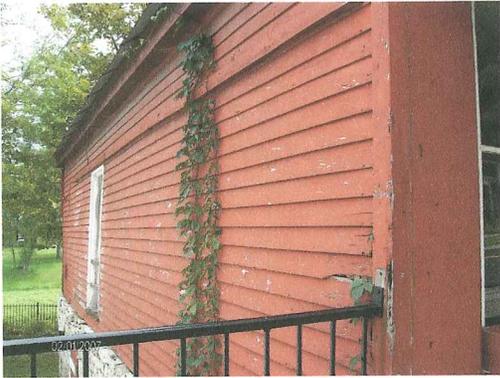
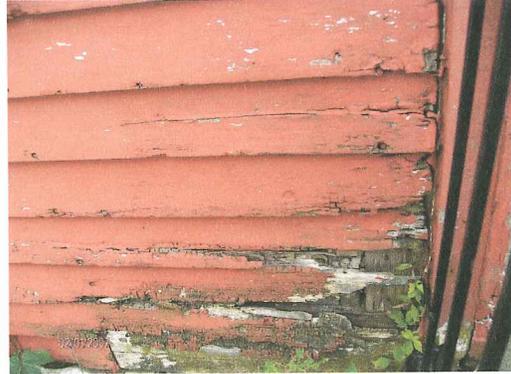
Burton's store, 334 South Buell Street, Perryville is a 20'x 34' single story structure constructed about 1850. The west gable end of the building faces Buell Street while the east gable backs up to the Chaplin River.

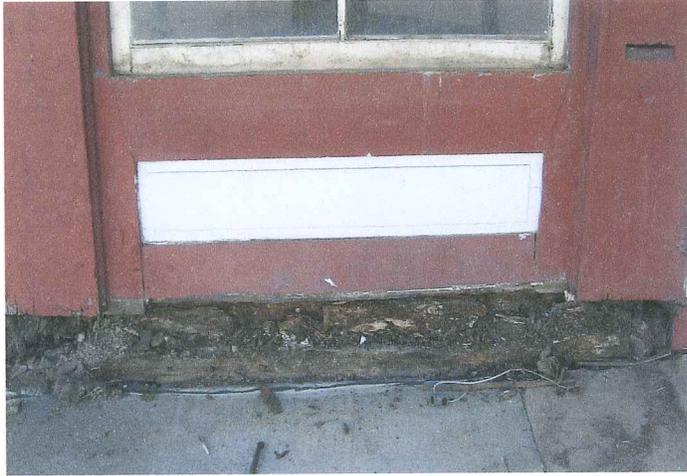
decades of settling, and to hold the weight of the building while repairs were made to the stone foundation. A lift of over 5 inches was to be required. We exposed the sill plates by removing a small amount of exterior siding on all four sides. Inspection revealed the total failure of the front sill plate due to decay. The damage extended around the corners on both sides to include the joinery and the first two feet of both long sills. The rear sill was okay, but was actually two pieces, having

been originally separated by a stone fireplace and chimney. The long sill on the north side had serious decay immediately below the doorway.

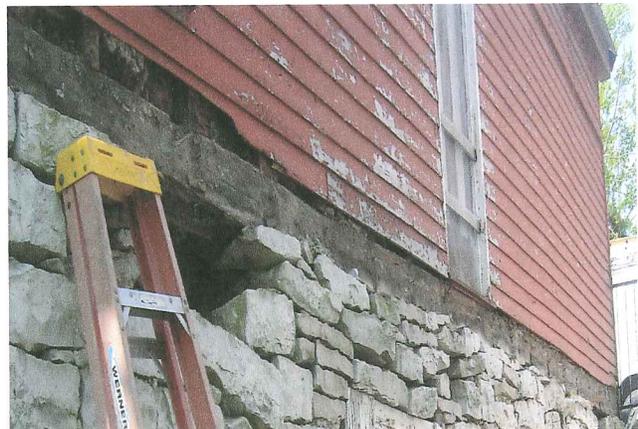
Exposing the sill plate in front also revealed further decay in the southwest corner post. Exposing the corner post indicated extensive rot in the tie beam above. By pursuing the rot, we ultimately removed the entire front façade. Both diagonal braces in front had been

removed when the façade we see today was added in the latter 19th century. The new, much larger windows did not leave room for the diagonal braces so they were simply removed. This loss of structural support, plus the decay and failure of other structural parts resulted in severe sagging in the front of the store and a 4 inch out-of-plumb lean toward the adjacent building to the south.

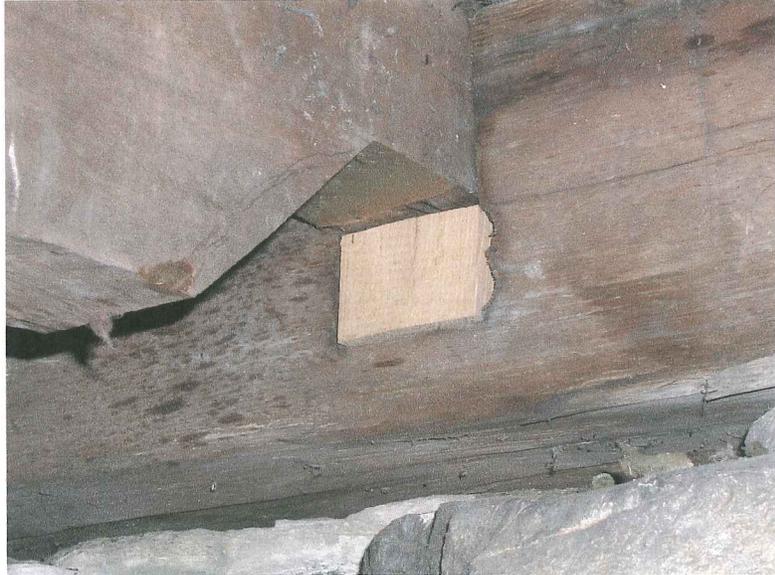
Although we had leveled the building at this point, we still had not leveled the floor. For some unexplained reason in the past, the floor was lowered progressively from back to front, by deepening the joist pockets from nothing at the back, to over 2 inches at the front. It was at this time that the center tie beam was removed, because it could not be lowered like the joists without a lot of effort. Interestingly, the descending floor made the sill plates appear to gradually rise out of the floor as you look from back to front. These four inch projections from the wall were trimmed in an awkward fashion and detracted immensely from the interior appearance. We raised all of the joists back to level with the sill plates and filled in the gaps at the bottom of the joist pockets with custom sized spacer blocks.

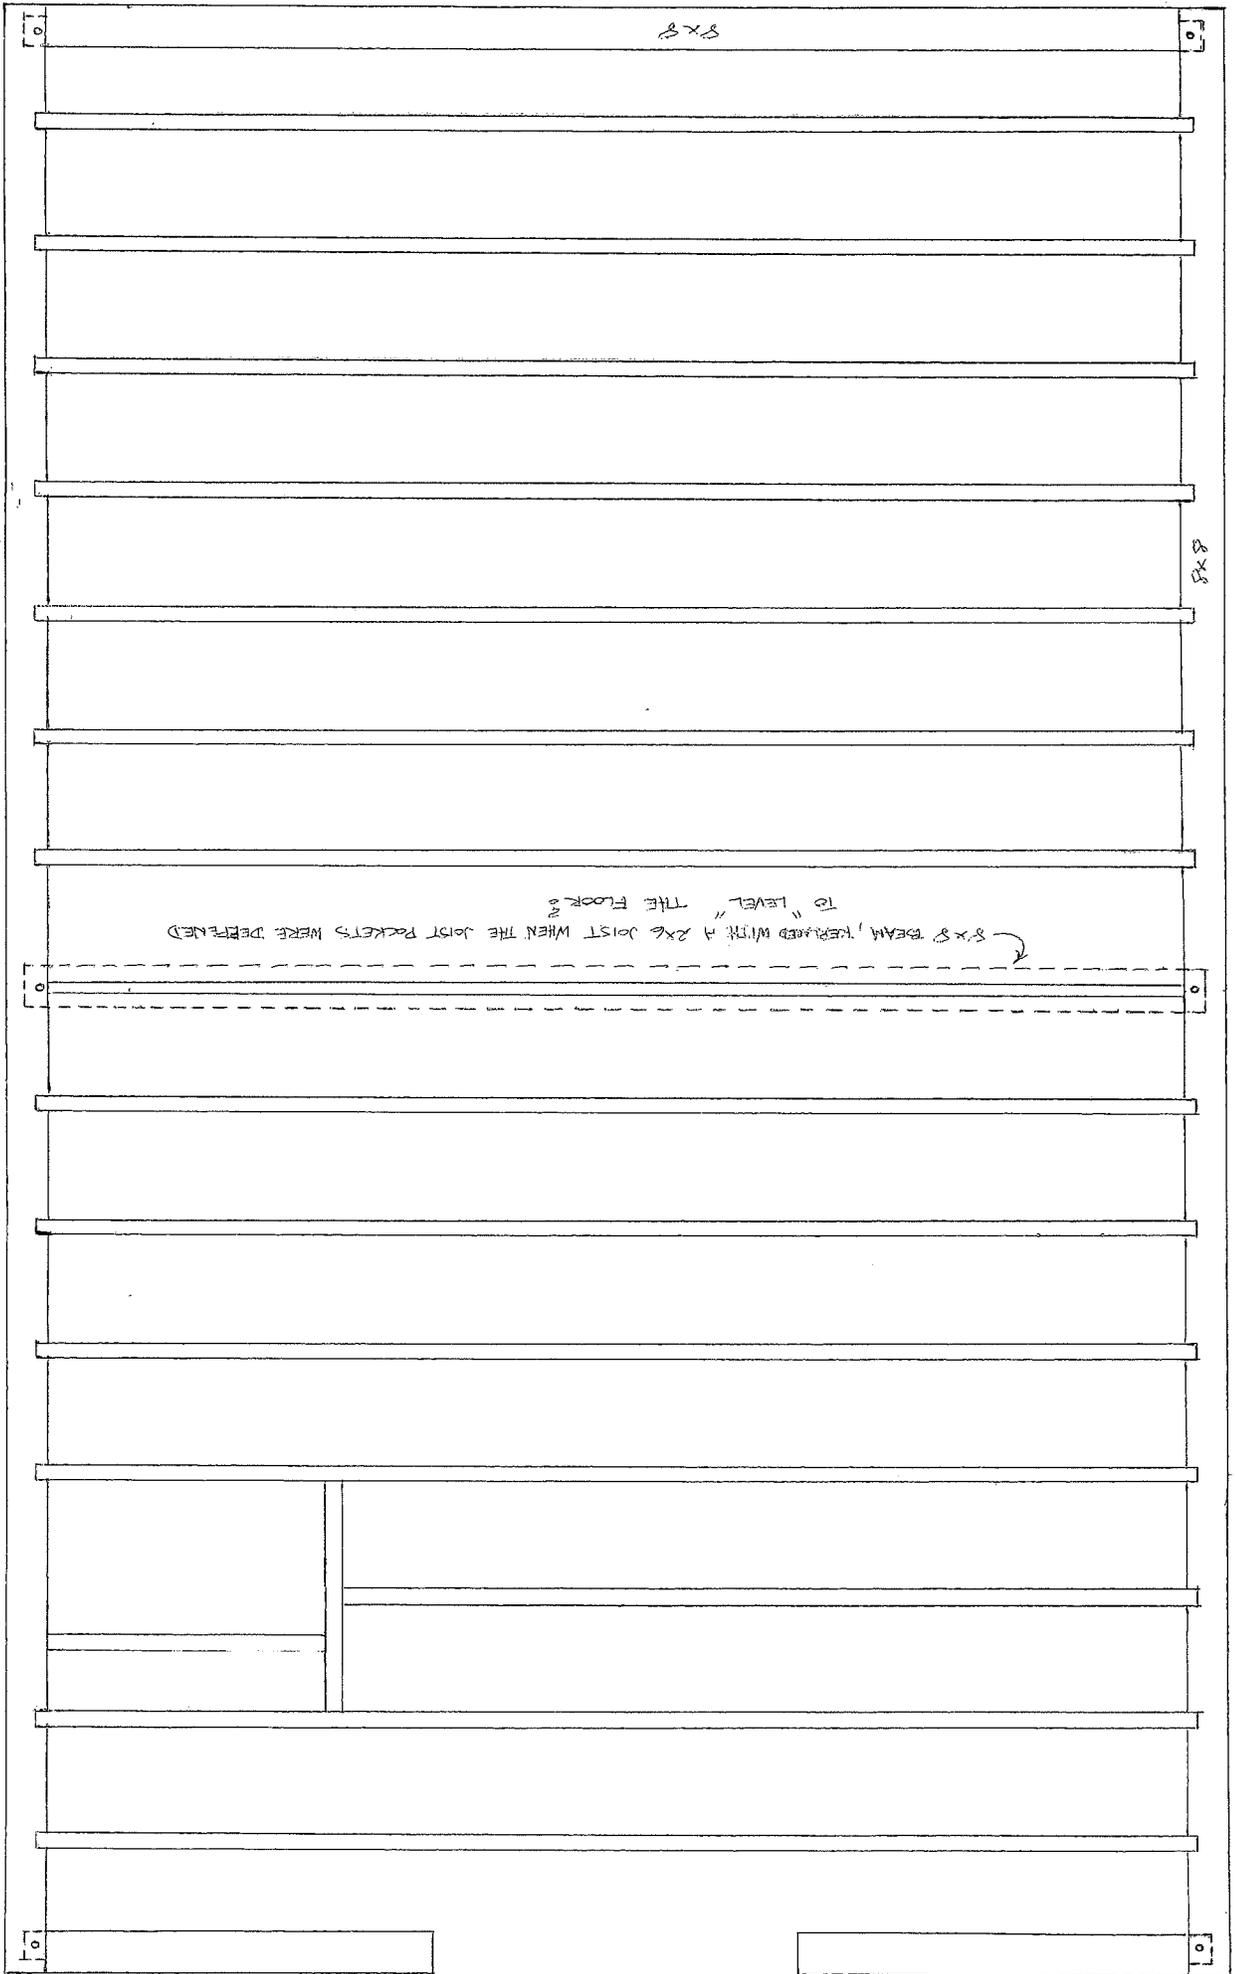
FLOOR PLAN BURTON'S STORE

8x8 BEAM, TURNED WITH A 2x6 JOIST WHEN THE JOIST RACKETS WERE DELETED TO "LEVEL" THE FLOOR.
