A Survey of the Rural Resources of Crittenden and Livingston Counties, Kentucky

**Kentucky Archaeological Survey
Jointly Administered By:
The University of Kentucky
The Kentucky Heritage Council
Report No. 214**

KAS Report No. 214

February 2012

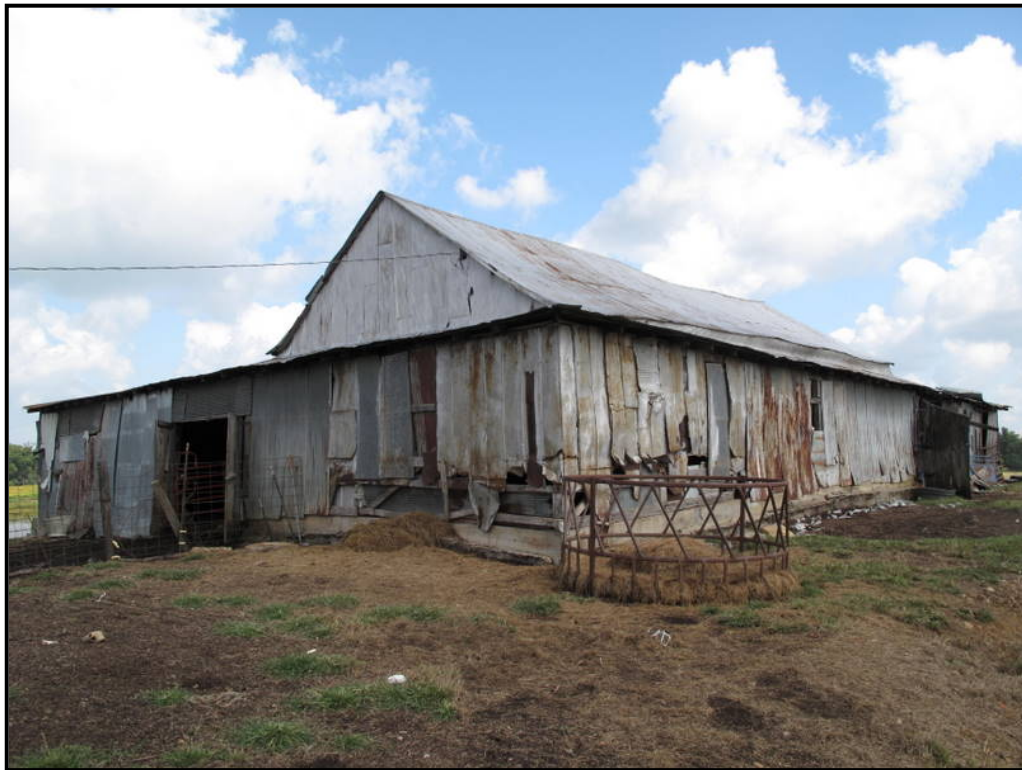
Figure 3. 9 *West and south elevations of the Tedford Barn, CN-63, in Crittenden County.*

The log barn at the Tedford Farm (CN-63) in Crittenden County was the largest and most complex log barn in the survey (Figures 3.9 and 3.10). The log cribs on the interior are obscured by the transverse frame barn superstructure enveloping them; which is further distorted by shed roof additions three sides of the barn. It is comprised of a two cribs side-by-side (on the east side of the barn, Figure 3.11) perpendicular to the ridgeline of the surrounding frame superstructure (used for grain storage), and then across an aisle (west side of barn), set perpendicular to those cribs (parallel to the ridgeline), are six log stalls. The cribs feature half-dovetail notching (Figure 3.13).

It is likely that the log cribs were constructed between 1865 and 1880. The logs are hewn, and rest on stone piers. A frame crib was added to the end of the grain cribs; the name and date scratched into one of the circular sawn vertical boards reads “Homer Bennett, April 19, 1891.”

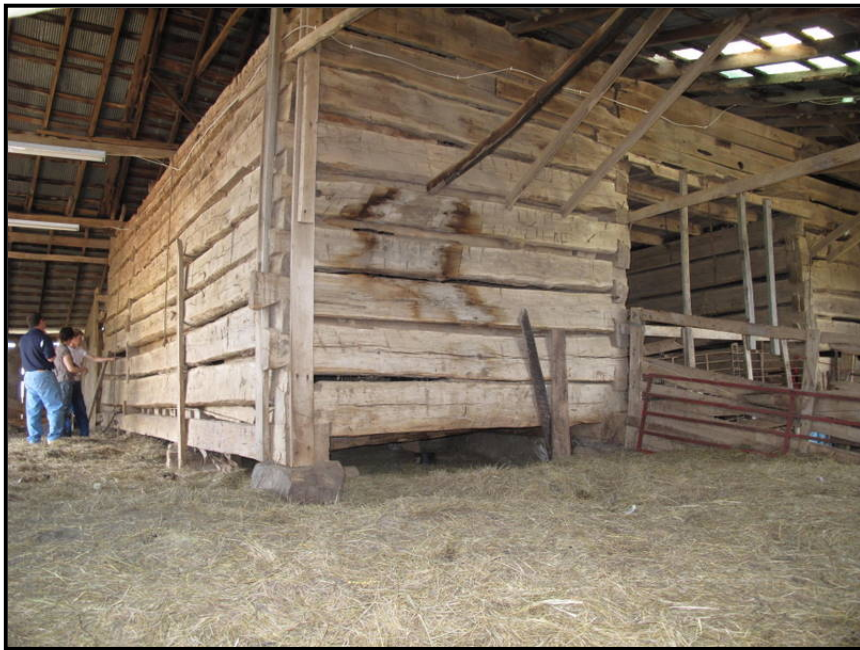
Figure 3. 11 *East side cribs used for grain storage, CN-63.*

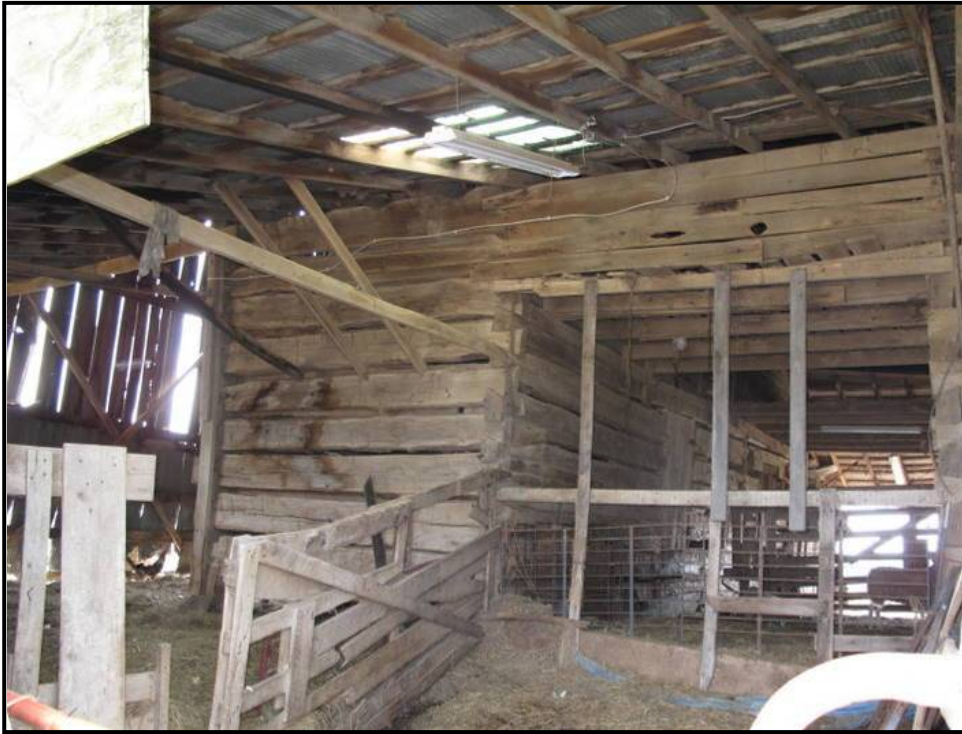
Figure 3. 12 *View of two cribs on the east side of the barn, CN-63.*

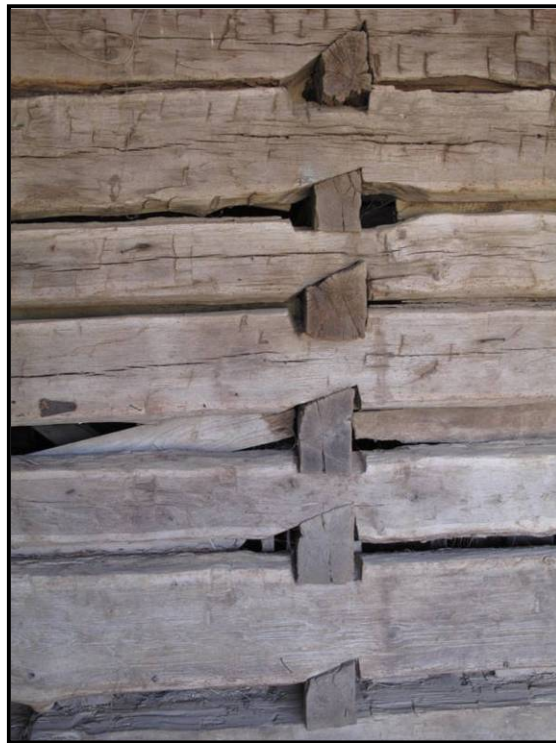
Figure 3. 13 *Detail of notching on log crib, CN-63.*

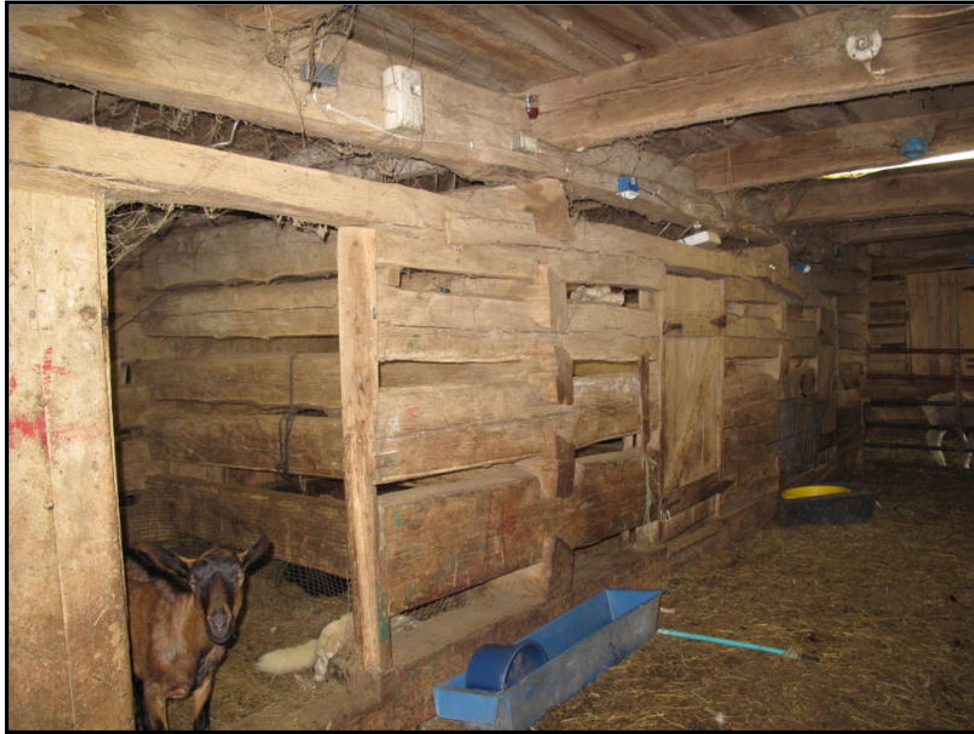
Figure 3. 14 *Log stalls on the west side of the barn, CN-63.*

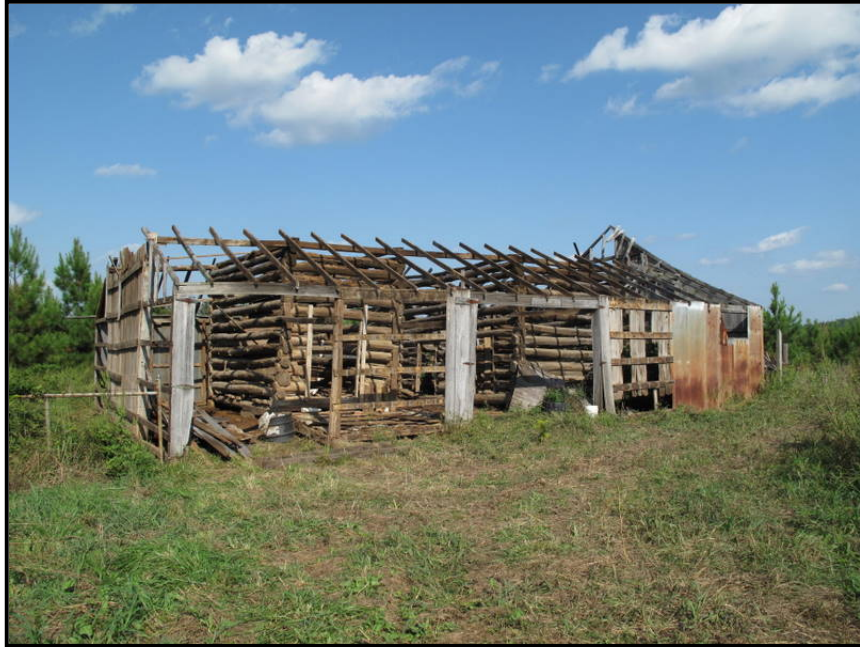
The remainder of the log barns in the survey date from the twentieth century. Two were in severe disrepair during the project; the barn on Route 91 (CN-70, Figures 3.14 and 3.15) was in the process of being dismantled and is now completely gone. This barn and one on the old Dean Farm (CN-26, Figures 3.16 and 3.17) on the Ford's Ferry Road have logs with a lesser degree of finish than their 19th century counterparts. The logs are left rounded and are fitted together less precisely than older examples.

Figure 3. 15 *Log barn (CN-70), now demolished, on Route 91 in Crittenden County.*

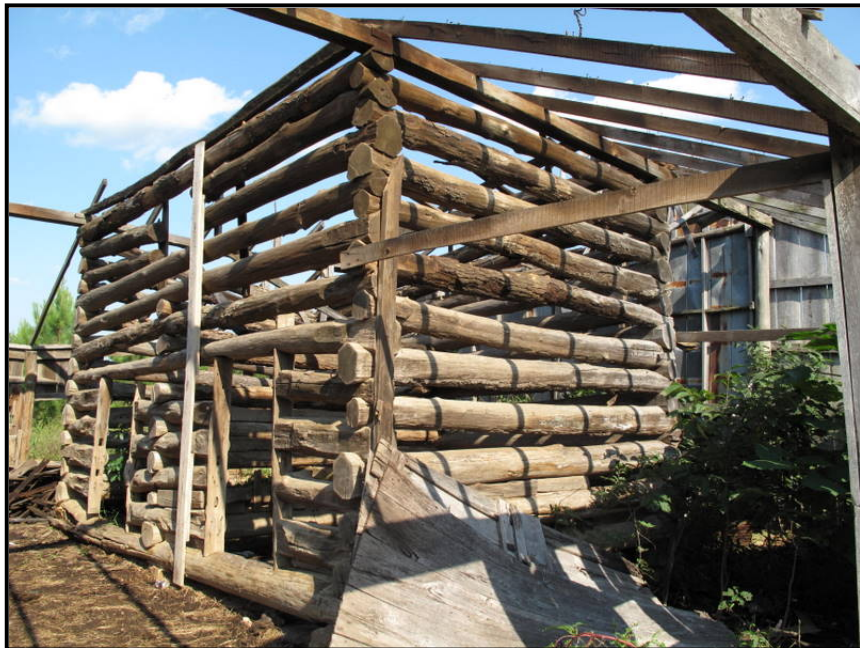
Figure 3. 16 *Detail of one of the cribs at CN-70.*

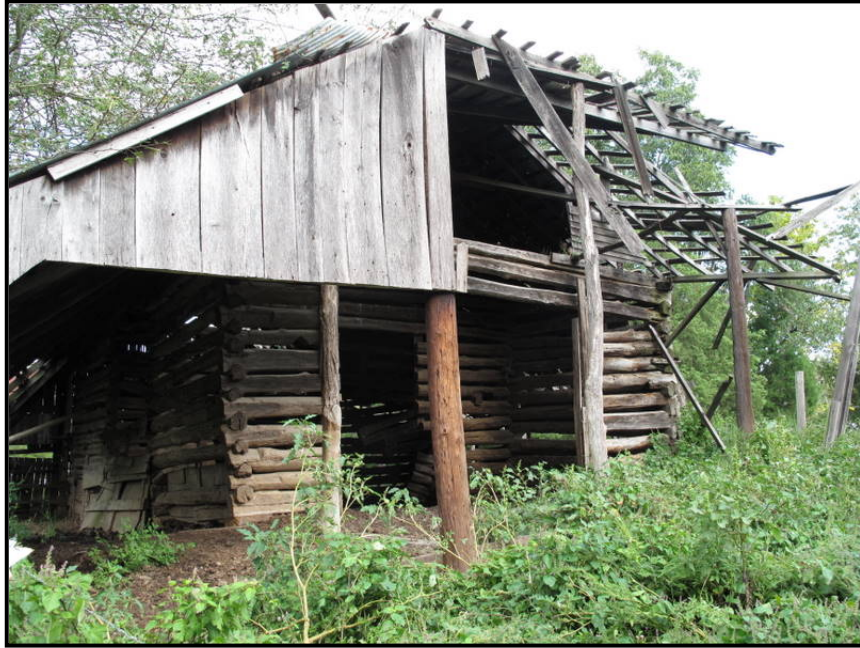
Figure 3. 17 Log barn on Ford Ferry Road in Crittenden County, CN-26.

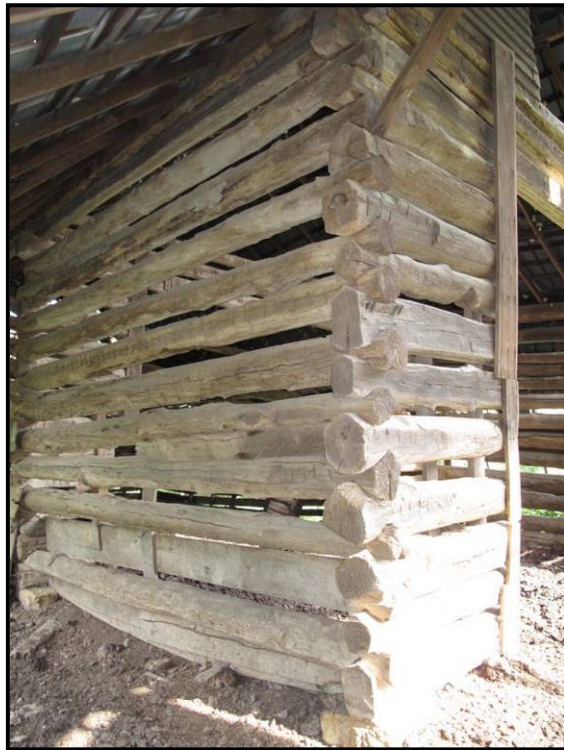
Figure 3. 18 Detail of notching on CN-26.

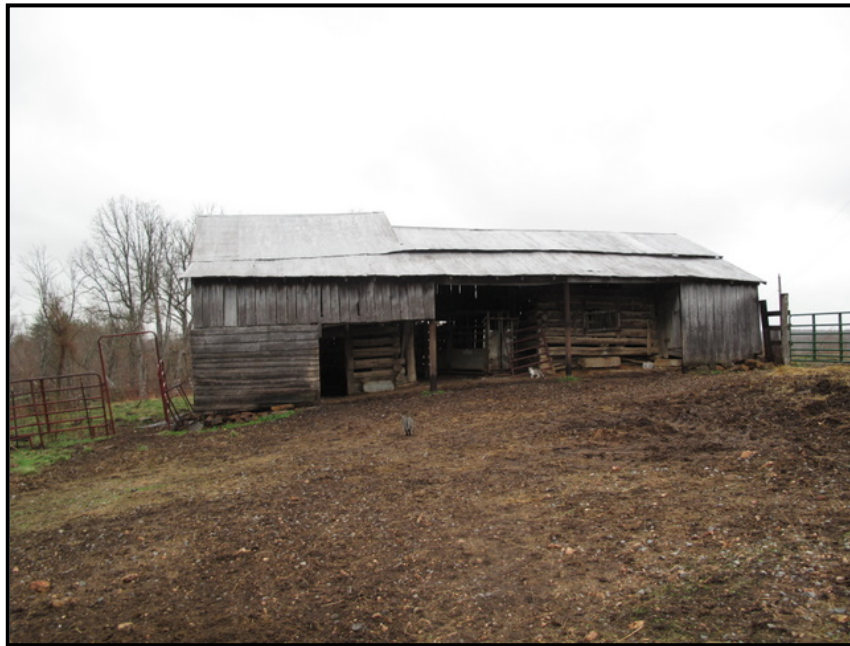
The log barn at the Underdown Farm (CN-67) in Crittenden County also dates from the 20th century. According to Brenda Underdown, the barn was built in 1927 by two brothers, Jackson and Jeff Winders. The two cribs appear to have been built at different times; the frame enclosures around the cribs have different roof lines. The crib at the far left in Figure 3.18 has a cantilevered left above it, and appears to have been used as a stall for livestock. The crib on the right hand side is elevated off of the ground, and could have been used for grain storage.

Figure 3. 19 *Log barn (CN-67) at the Underdown Farm in Crittenden County.*

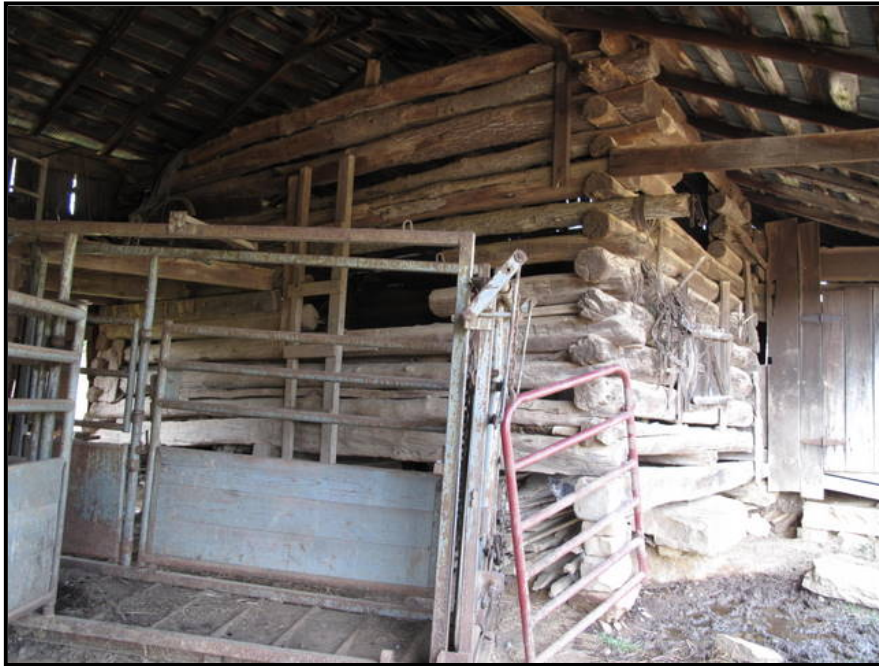
Figure 3. 20 *Detail of the right hand side crib at CN-67.*

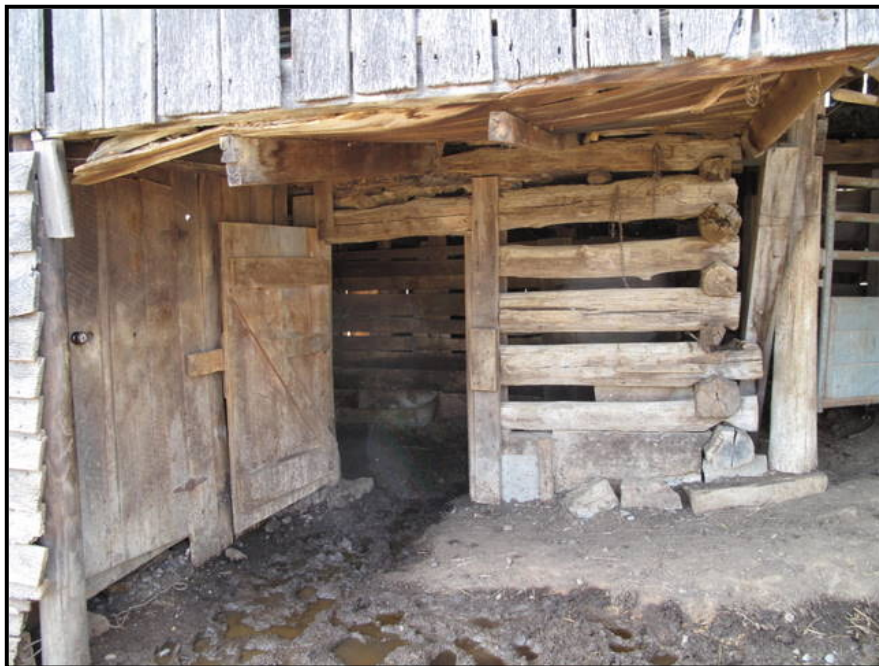
Figure 3. 21 *Left hand side crib at CN-67.*

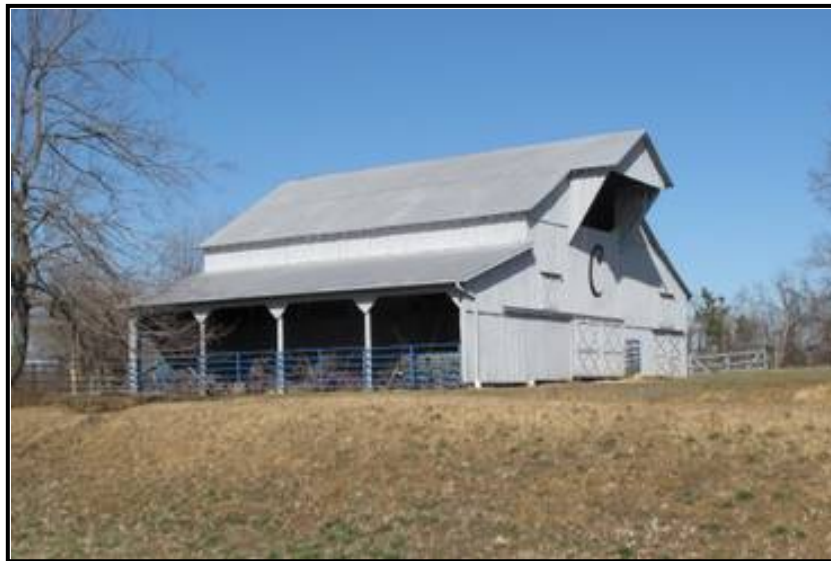
Surveyed stock barns typically had a room at one end with a raised floor intended as a corn crib, and another space with a raised floor used as a tack room. Stalls that opened onto the main aisle would have built-in mangers and troughs. Additional side aisles on a barn might contain built-in hay racks for feeding cattle or space to house equipment (like the side aisle at the Cothron Barn, LV-43, pictured below.)

Figure 3. 23 Barn at the Cothron Farm in Livingston County, LV-43.

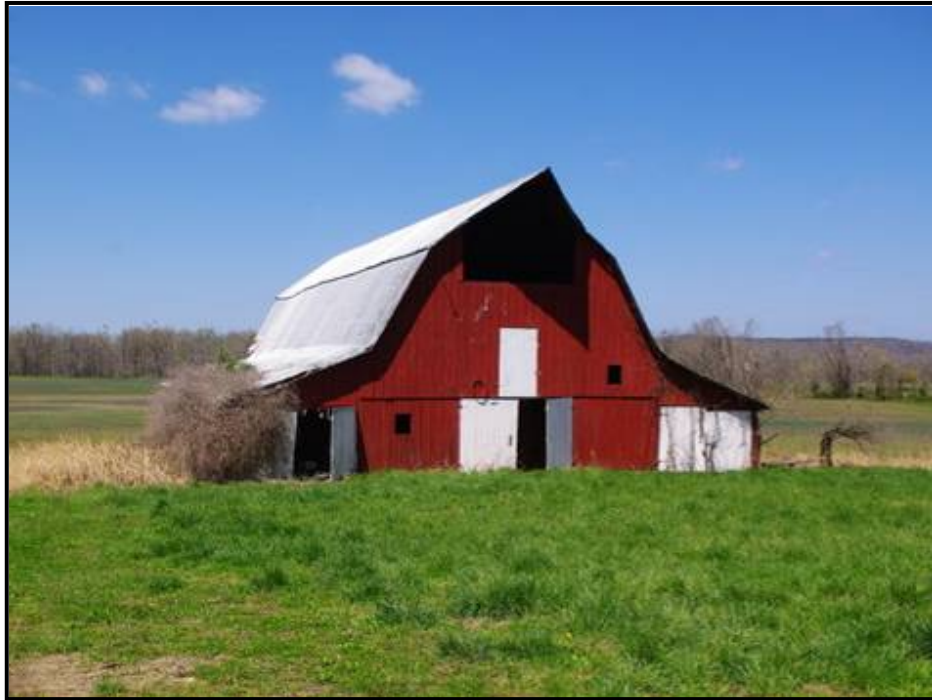
Figure 3. 25 *LV-26, a multi-purpose barn on River Road in Livingston County.*

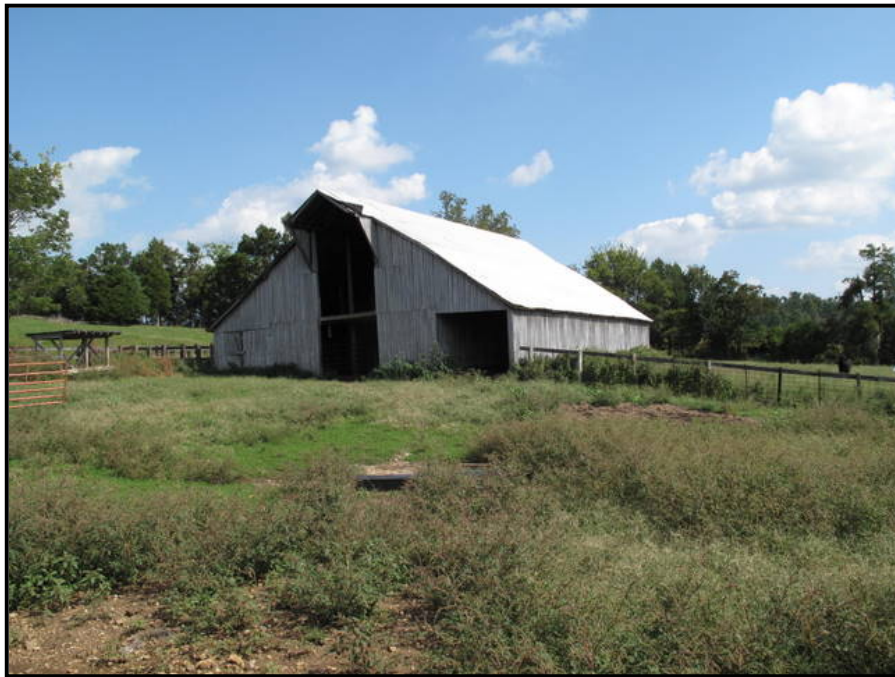
Figure 3. 26 *Barn at the John Boyd Farm, CN-66, in Crittenden County.*

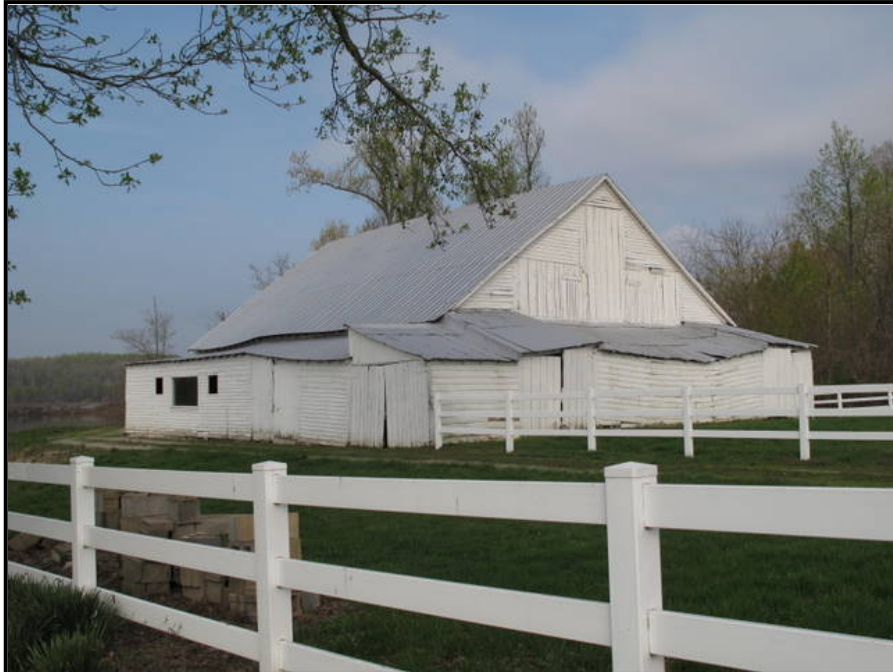
Figure 3. 27 Barn with multiple shed additions, LV-69, Kathleen Chipps Farm in Bayou, Livingston County.

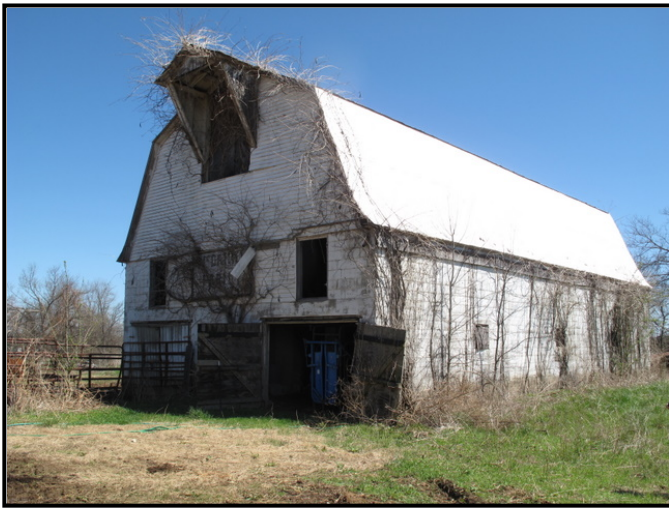
The concrete block barn on the O.B. McDaniels Farm (CN-32) in Crittenden County was the only historic barn surveyed to utilize concrete block not only as a support member (interior concrete block piers hold up the loft floor, Figure 3.30), but also as the wall material. The square piers seen in Figure 3.29 were the only such concrete support piers documented in the survey area. The first floor of the barn is concrete block, while the full loft has frame (now vinyl siding) on the gable ends.

Figure 3. 29 *O.B. McDaniels Barn, CN-32, Crittenden County*

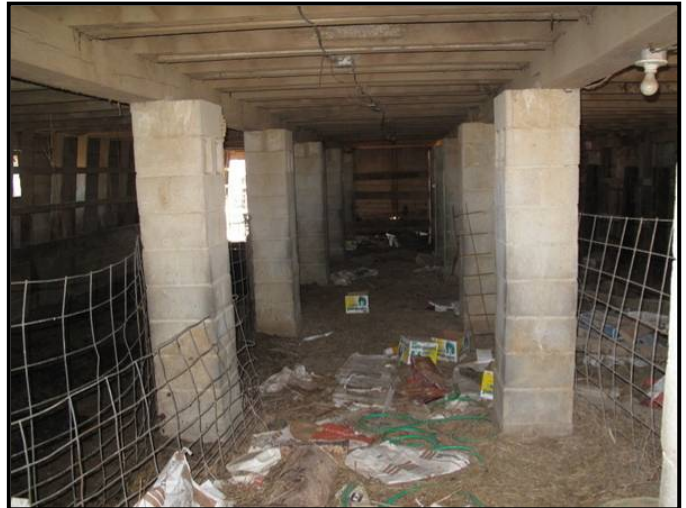
Figure 3. 30 *Interior of the concrete block barn, CN-32, at the O.B. McDaniels Farm.*

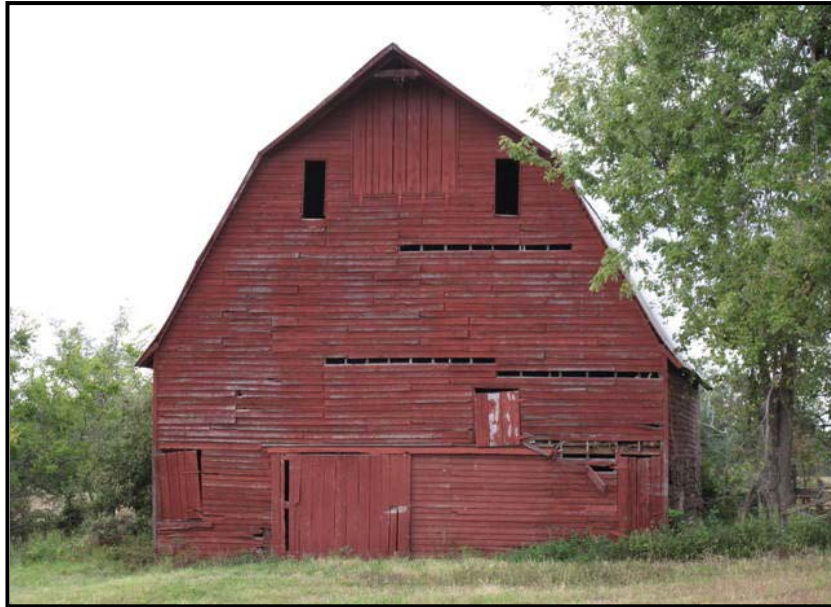
Due to changes in building technology and material, the majority of the barns surveyed in Crittenden and Livingston County made the most of the available space. Lofts were present in most barns, either a full loft in a transverse frame barn, or a loft over the three central aisles in a barn with additional side aisles. Several barns retained their hay rake mechanisms in the loft. It is not known the standard loft size and how much baled or loose hay a typical barn loft could hold, but the historic barn on the James May Farm (LV-83, Figures 3.31 and 3.32) near Hampton had one of the largest lofts documented in the two counties.

Figure 3. 31 *Barn on the James May Farm (LV-83) near Hampton, Livingston County.*

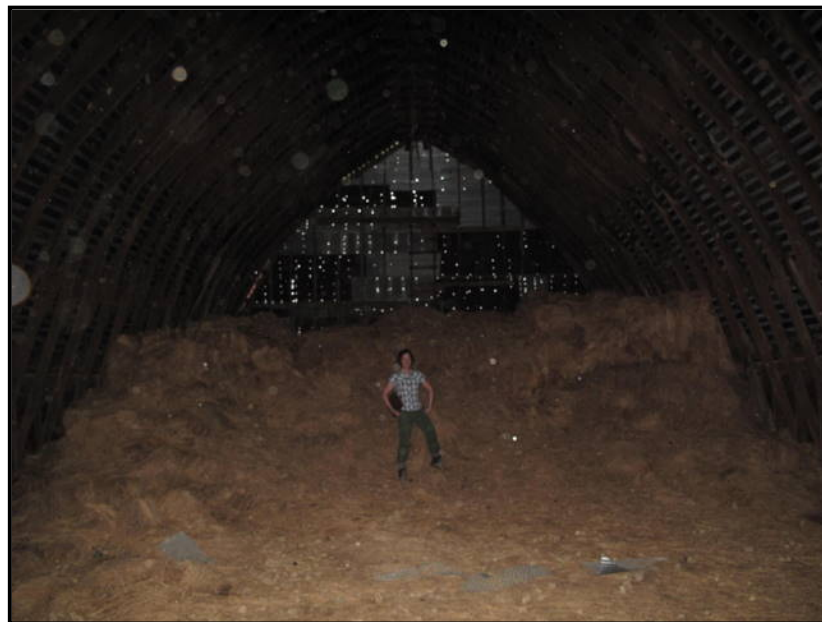
Figure 3. 32 *Interior of loft in the James May barn (LV-83); author included to show scale of loft.*

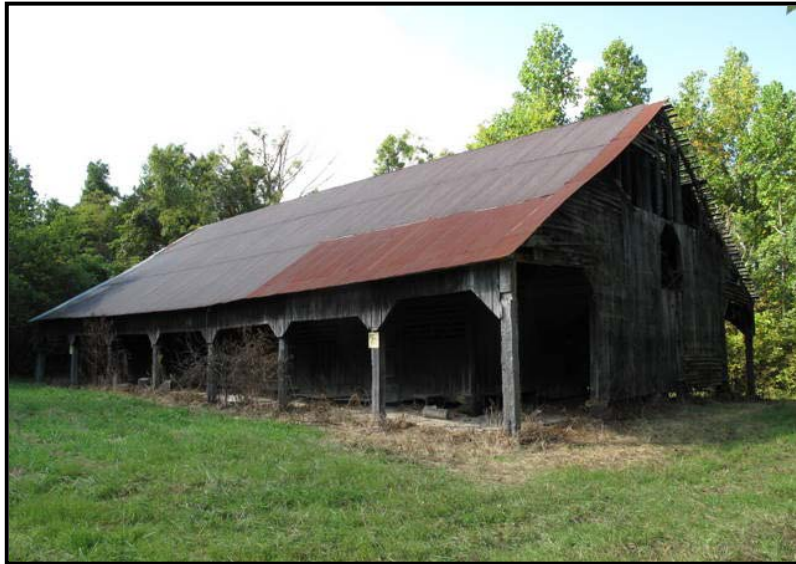
Some of the surveyed barns were built for a more specific purpose, and their design reflects both the function of the structure, as well as the background and knowledge of the farmer. The Darby Hughes Barn (CN-81) in Crittenden County is a unique structure that does not fit any known barn plans. Its stable and loft arrangement either housed mules or horses, as well as grain (ear corn) and hay. Stalls are arranged on either side of a raised walkway that holds built-in troughs. The stalls open directly onto an open shed.

Figure 3. 33 *Darby Hughes Barn (CN-81) on Cotton Patch Road, Crittenden County.*

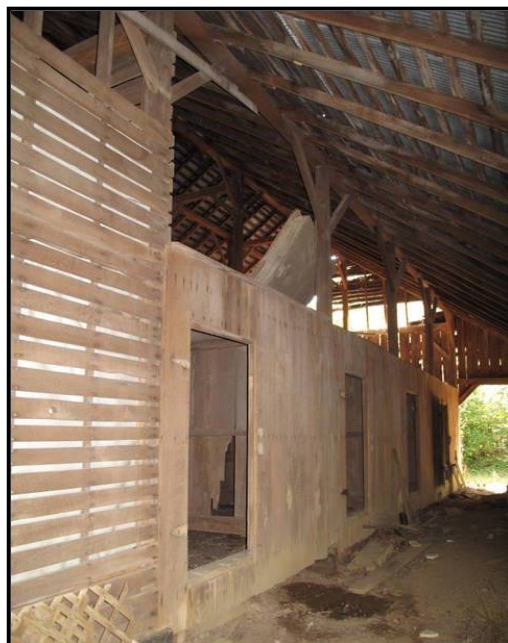
Figure 3. 34 *Interior of Hughes barn (CN-81).*

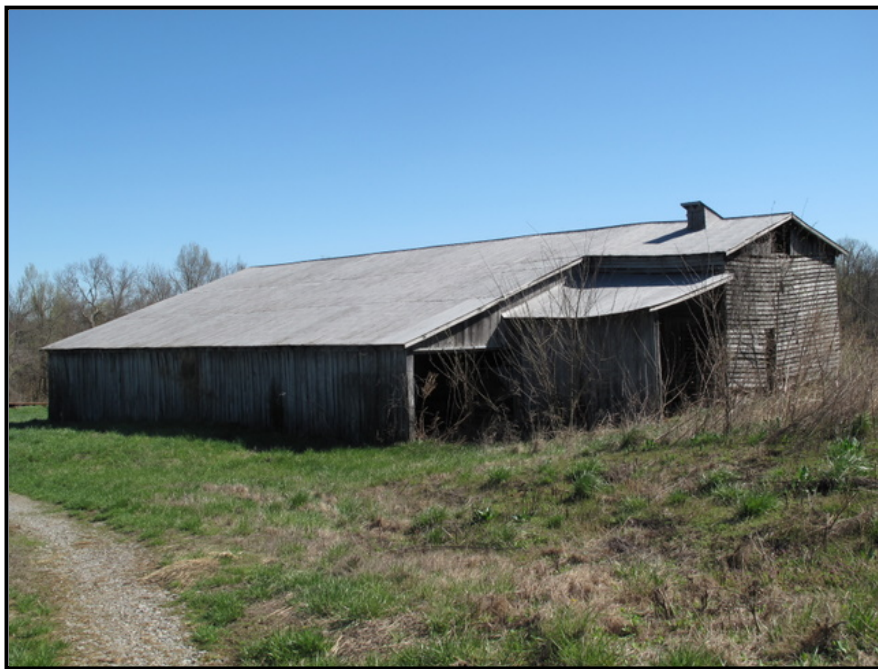
As silage increased in importance in the first half of the twentieth century, farmers across Kentucky began to adapt existing structures and their agricultural operations to accommodate a silo and the feeding of silage to cattle. Free standing silos are discussed separately in this report, but the silage barn at the Gregory-Guggenheim Farm (CN-31, Figure 3.35) in Crittenden County illustrates one way farmers fed silage to their cattle. While existing barns could be retrofitted with elevated feedways that connected to an exterior gable end silo, CN-31 appears to be a Midwest-three portal barn constructed specifically for the feeding of silage. The five aisle barn is accessed through the north gable end.

Figure 3. 35 *Silage/stock barn, showing exterior corn crib, CN-31, Crittenden County.*

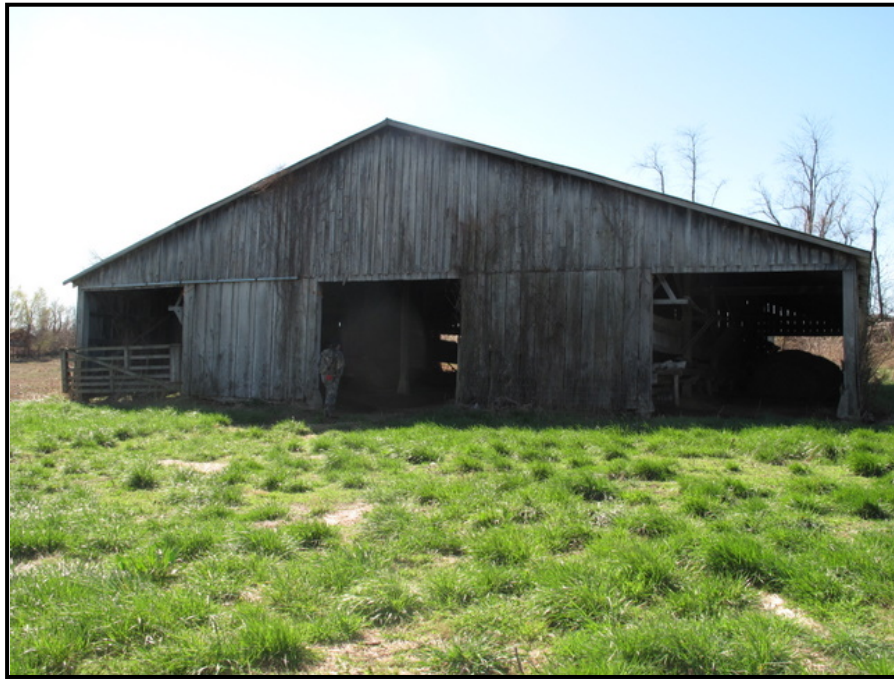
An exterior corncrib is located on the south gable end. A shed roof cupola, built to accommodate a portable grain elevator (for ear corn), is located on the downslope of the roof. An open shed is located on the west side of the corncrib. Though the corncrib location is somewhat unusual, the vertically-boxed barn does not appear that different from the exterior. The interior, however, reveals a layout designed to feed silage to cattle efficiently and out of the weather (Figure 3.37). An interior wooden silo is situated against the south gable wall, the same wall as the corncrib (Figure 3.38). Rather than a centrally-located feedway located parallel to the ridgeline, an elevated track runs in a “U” shape in the central aisle of the barn. The silage cart still rests on the track (Figure 3.39). Troughs were located on the outside of the track, near the two outside aisles. Cattle would come in these outer aisles to feed. In addition to the trough for silage, hay racks were mounted above the trough.

Figure 3. 36 North elevation of the silage/stock barn at CN-31.

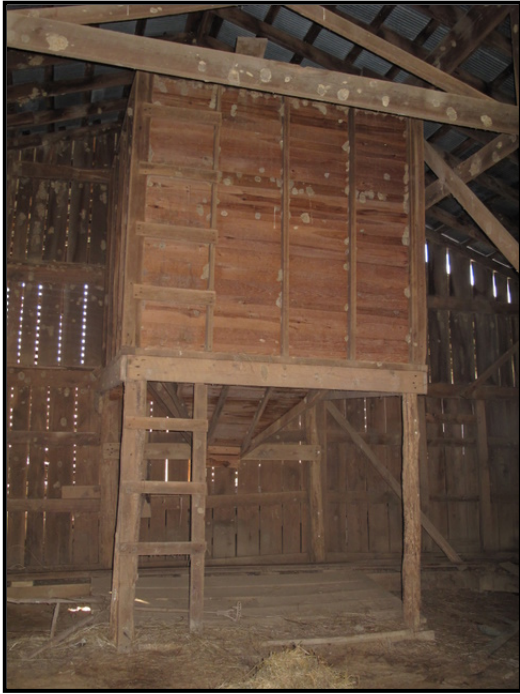
Figure 3. 38 Interior silo, CN-31.

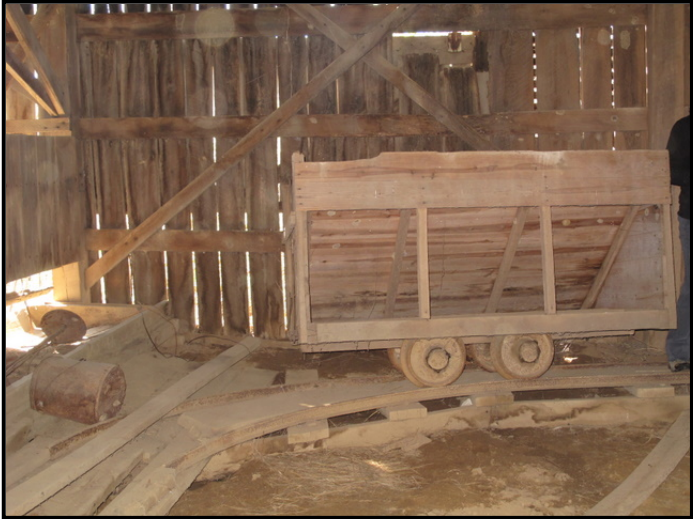
Figure 3. 39 Silage cart and track, CN-31.

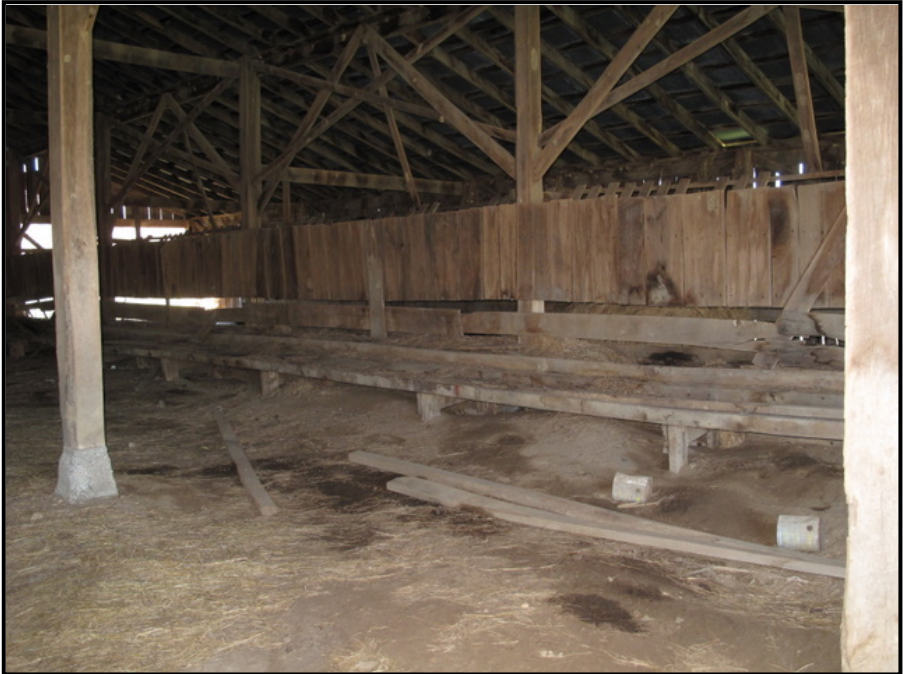
Figure 3. 40 The silage track at CN-31 ran around the barn to this trough, which has hay racks mounted on the other side.

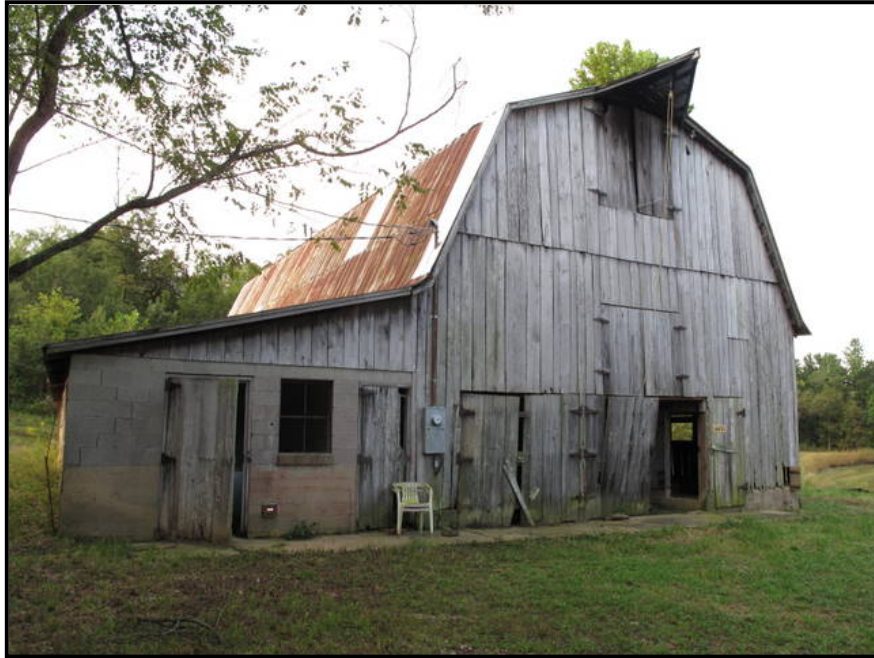
Pat Rogers built the barn in the 1950s as part of his 600-acre farming operation in south central part Livingston County. According to his daughter, Nancy Lloyd, he had about 20 milk cows.²² Three could be milked at one time in the milking parlor. The milking parlor is somewhat unusual, with a poured concrete ramp in a “L” configuration on which the cows were milked (Figure 3.48). The cows entered a chute on the south gable end, which led onto the ramp. A separate room on the north gable end held the milk.

Figure 3. 46 Pat Rogers Barn (LV-76) on the Gillum Road in Livingston County. The milking parlor is on the left in photo.

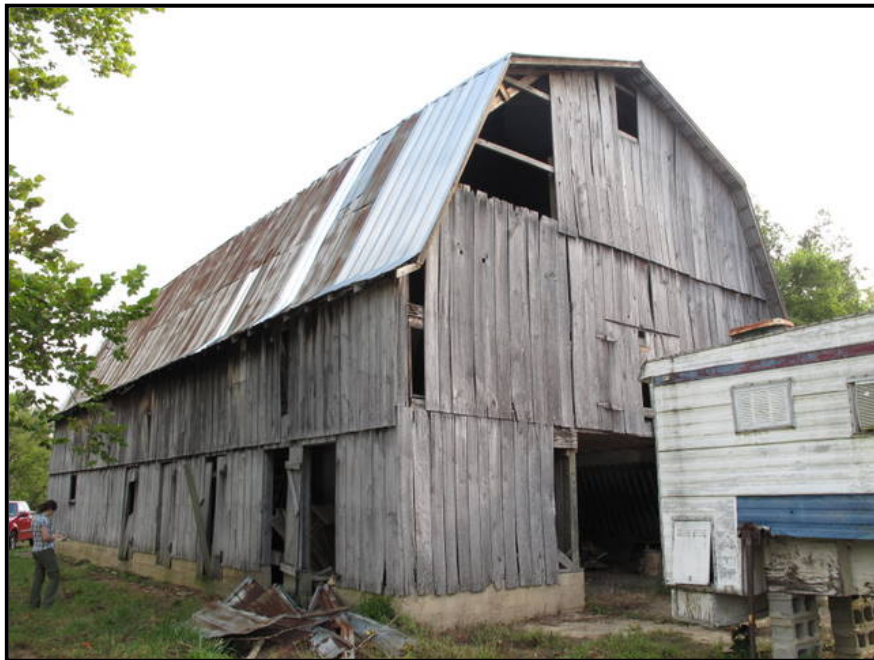
Figure 3. 47 Rear of the Rogers dairy barn (LV-76). A silo used to sit at the location of trailer (far right in photo).

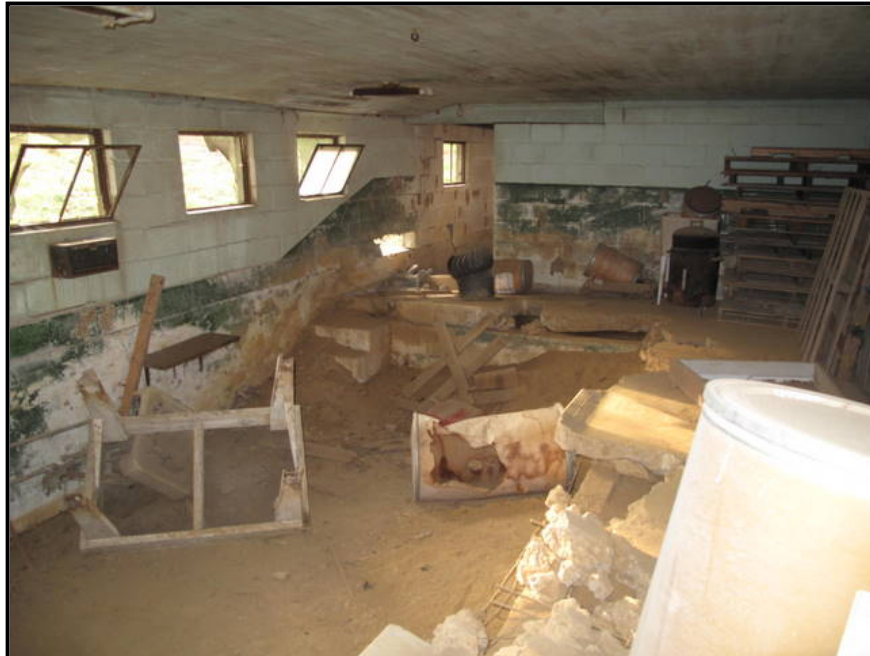
Figure 3. 48 Interior of milking parlor at LV-76, showing ramp (entrance to ramp is in center rear of photo)

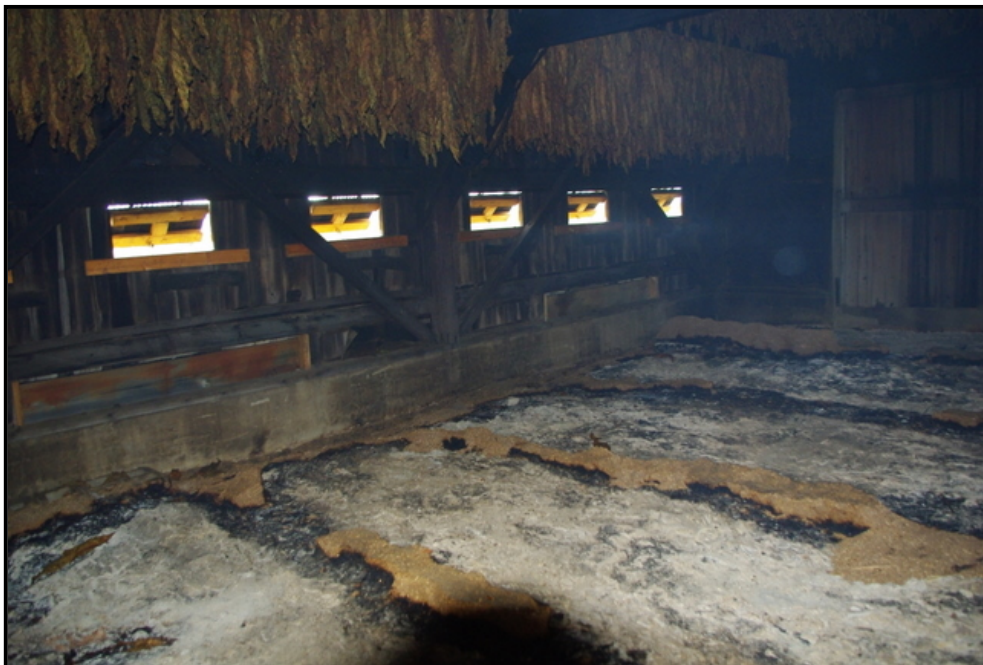
The counties in the western part of Kentucky continued to produce dark tobacco after the Civil War in part because of the “type of soil, the abundance of hardwood for firing and the mild climate of the region.”²³ Though the growing season of dark tobacco differs little from that of burley, the resulting two months of curing after the tobacco is housed bears no resemblance to air-cured tobacco. Once the tobacco is spiked or tied onto the tobacco stick and hung in the barn, the firing process begins. Rows or “runs” of lumber are laid out along the floor and covered with sawdust. The fire is started either before or after the sawdust applied, and is kept smoldering, producing the smoke that cures the tobacco leaf to its desired level of color and texture (Figure 3.49).

Figure 3. 49 Interior of the fire-cured tobacco barn at the UK Research Farm in Princeton.

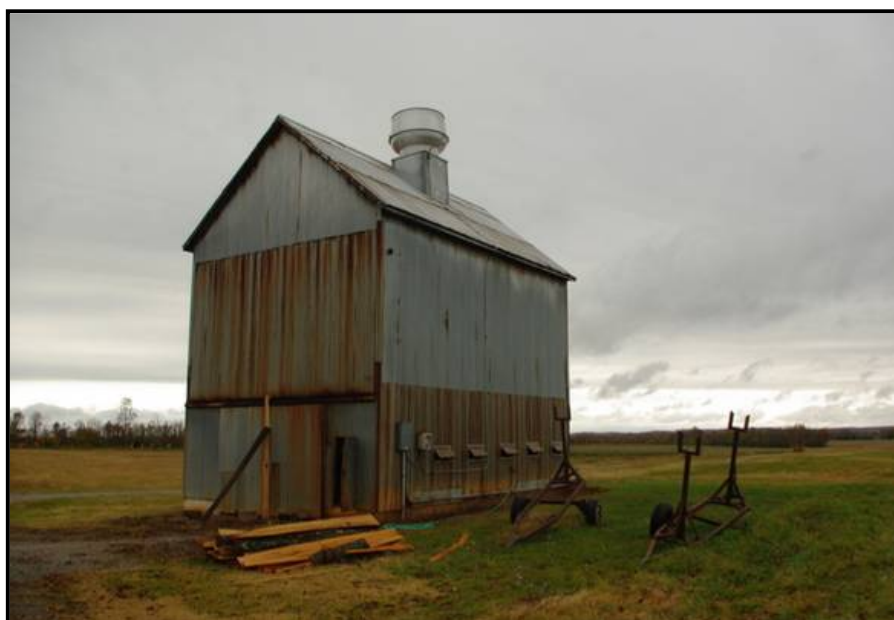
Three fire-cured tobacco barns were surveyed in Crittenden County, and a visit to the University of Kentucky Research Farm in Caldwell County allowed a glimpse of a firing in process. One barn at the Research Farm (pictured below, Figure 3.50) dates from 1926 and is remarkable similar to a plan produced by the College of Agriculture in May 1926 (see Figure 3.51). Likely built as a “two-acre” tobacco barn, the barn now holds one-acre of tobacco, due the plant being topped higher now and taking up more room.

Figure 3. 50 *Historic fire-cured tobacco barn at the UK Research Farm.*

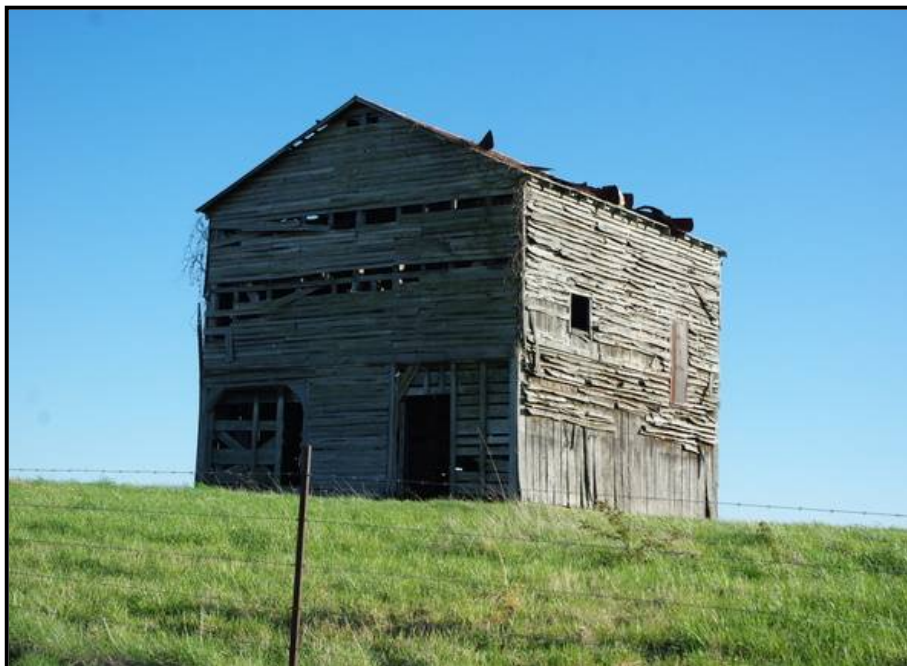
Figure 3. 52 CN-43, a dark fire-cured tobacco barn in Crittenden County, facing northeast.

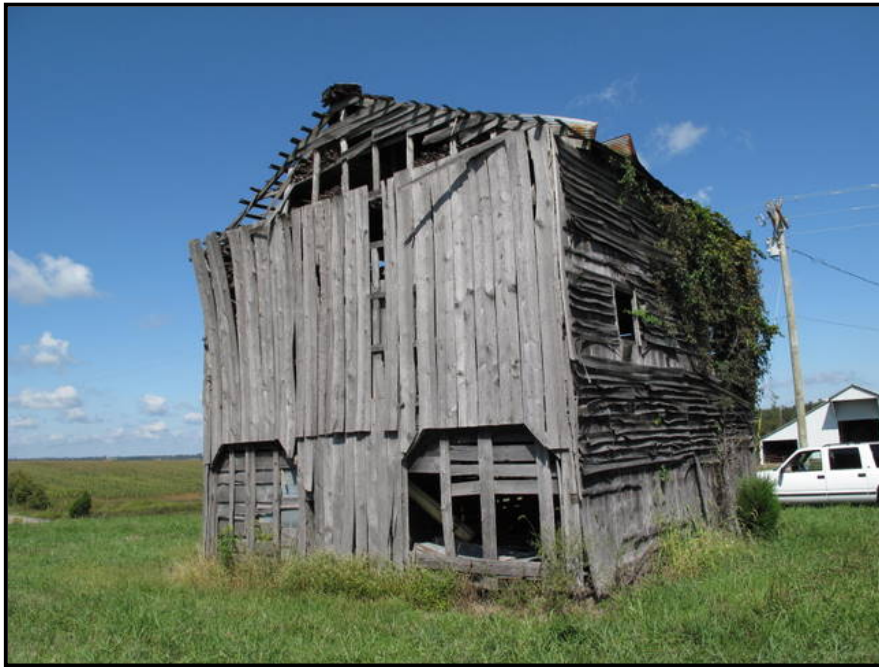
Figure 3. 53 *CN-43, south and east elevations.*

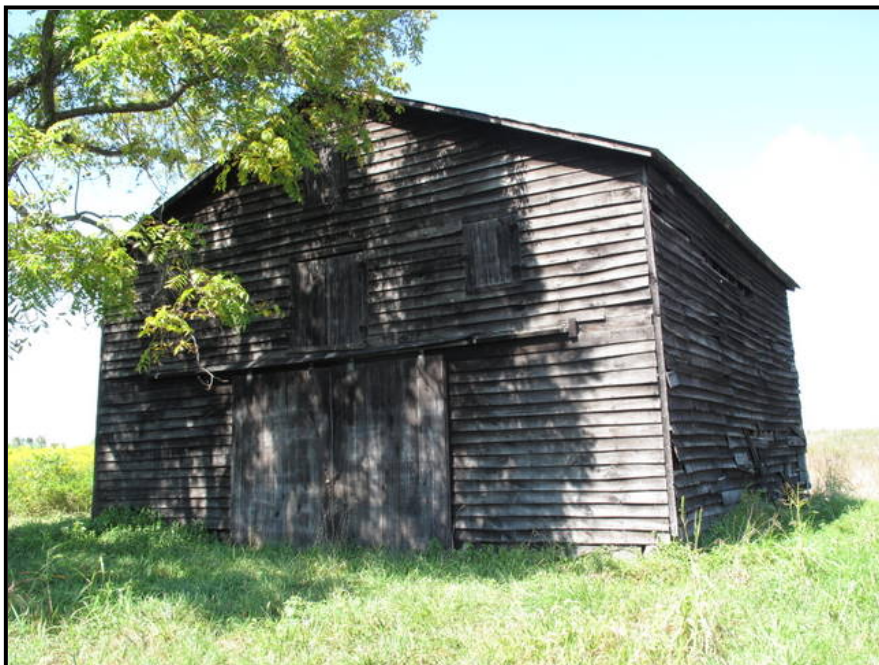
Figure 3. 54 *CN-45, a two-acre dark fire-cured tobacco barn, facing northwest.*

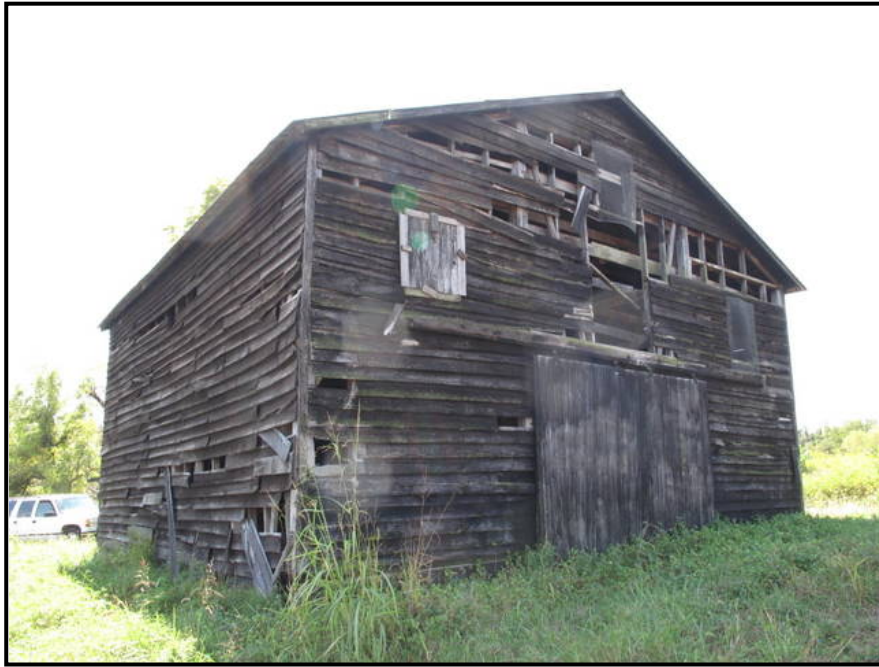
Figure 3. 55 *East and north elevations of CN-45.*

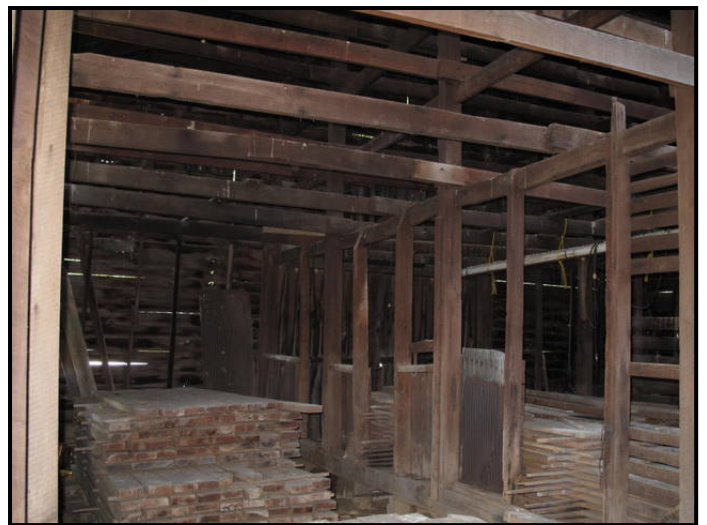
Figure 3. 57 *Interior of CN-45.*
