A Survey of the Rural Resources of Crittenden and Livingston Counties, Kentucky

**Kentucky Archaeological Survey
Jointly Administered By:
The University of Kentucky
The Kentucky Heritage Council
Report No. 214**

KAS Report No. 214

February 2012

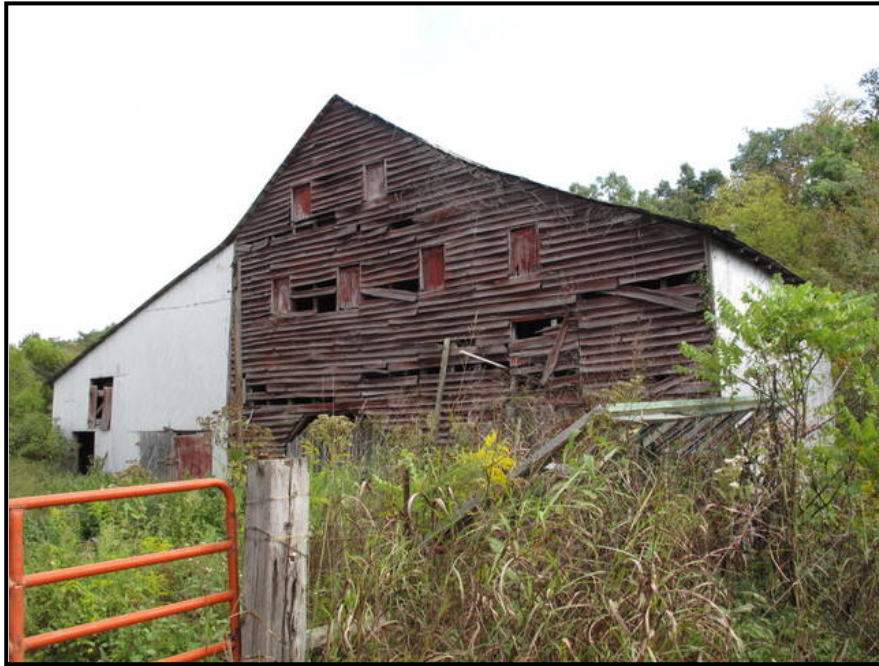
Figure 3. 58 *South elevation of a dark fire-cured tobacco barn, CN-72.*

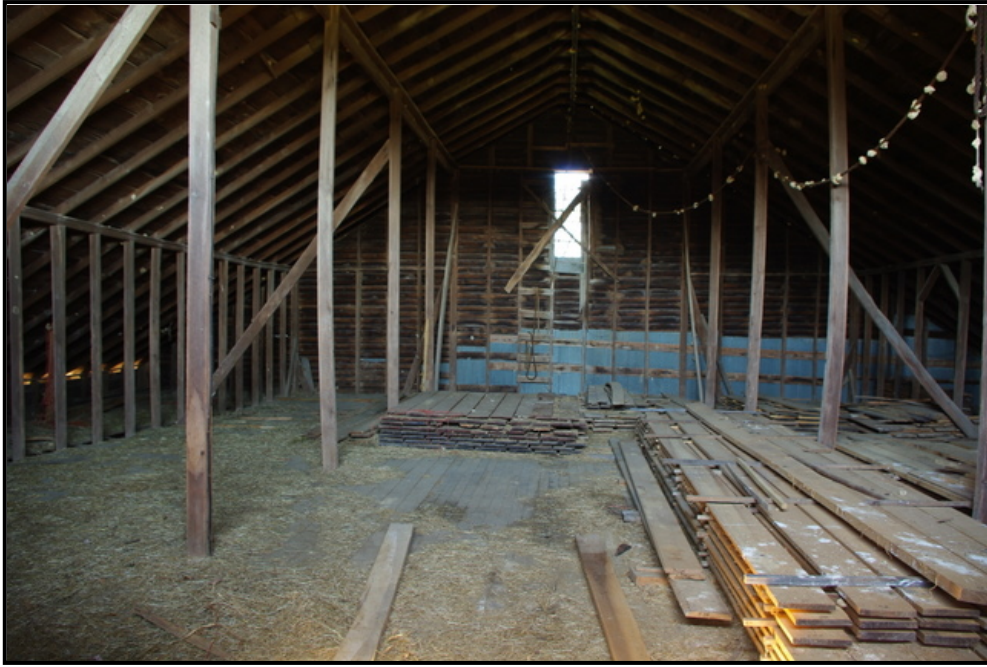
Figure 3. 65 Interior of loft at CN-41.

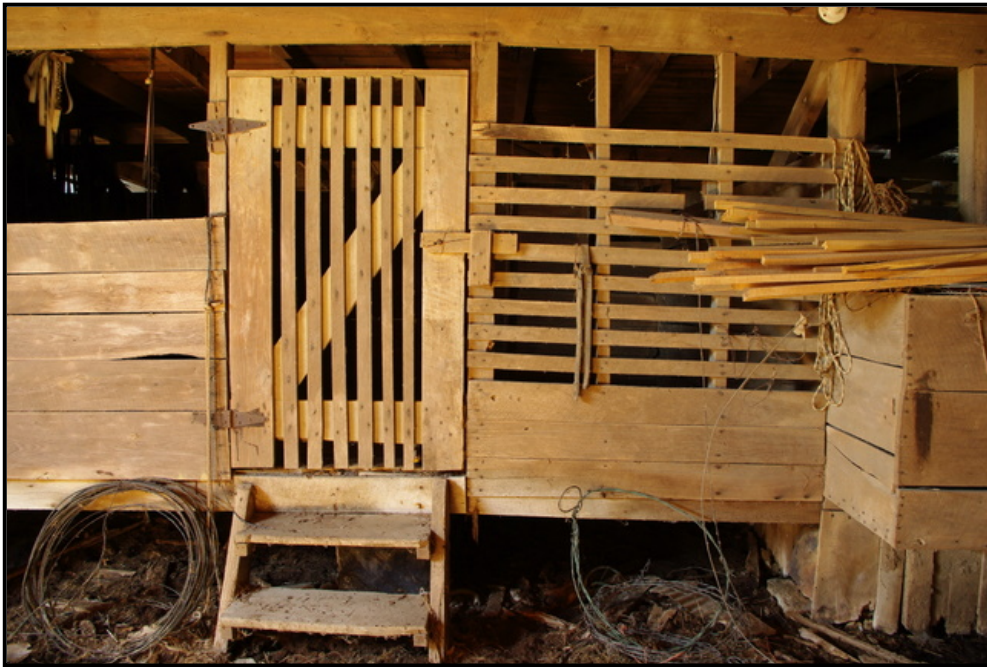
Figure 3. 66 Tack room at CN-41. Steps in tack room lead to loft.

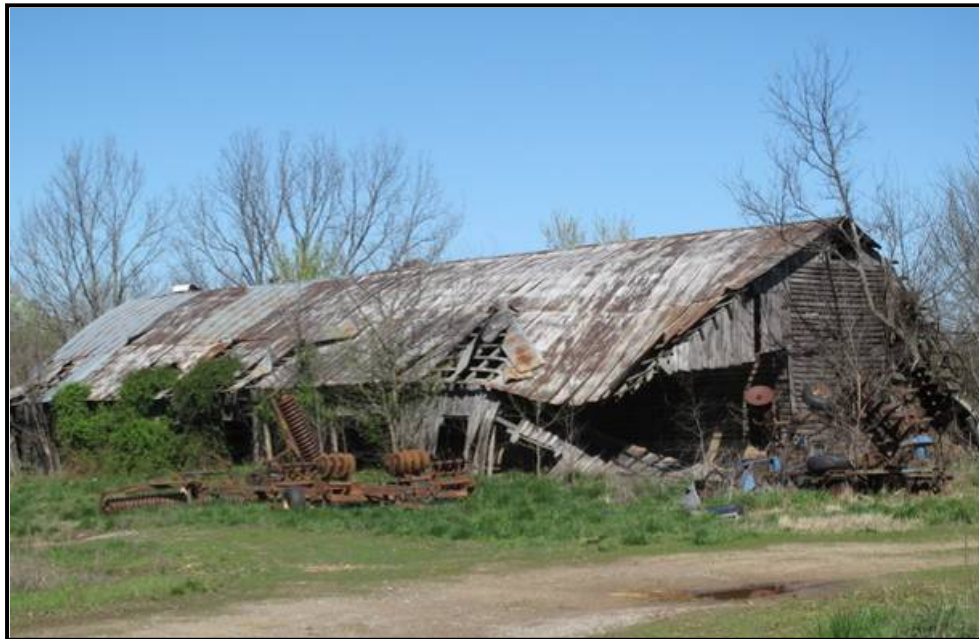
Figure 3. 67 *South side of the corncrib at CN-32.*

Increased corn production in the 1930s through the 1960s led to a growth in both the number and size of corncribs across Kentucky. Standard dimensions of historic corncribs in the survey area were not calculated, the largest corncrib by far was located on the O.B. McDaniels Farm (CN-32) in Crittenden County. This corncrib, built during the Great Depression, consists of four separate cribs, resting on heavy sills on field stones, clad in wood slats measuring six to eight inches high.

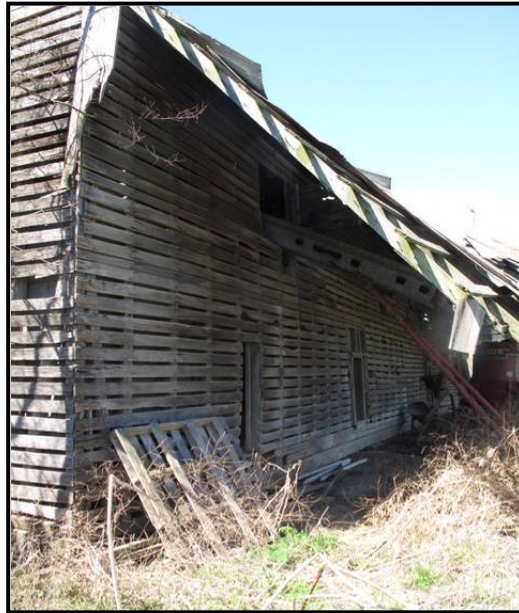
Figure 3. 68 *North side of CN-32, showing cribs.*

The crib is slightly tapered at its base, and wider at the top. A human-sized door is located in each crib, while a hinged window is located at the top of the wall of each crib for loading the corn (Figure 3.68). An open shed is located on the north side of the crib, while the shed on the south side of the crib has been enclosed. This side of the crib was divided into stalls for mules or horses.

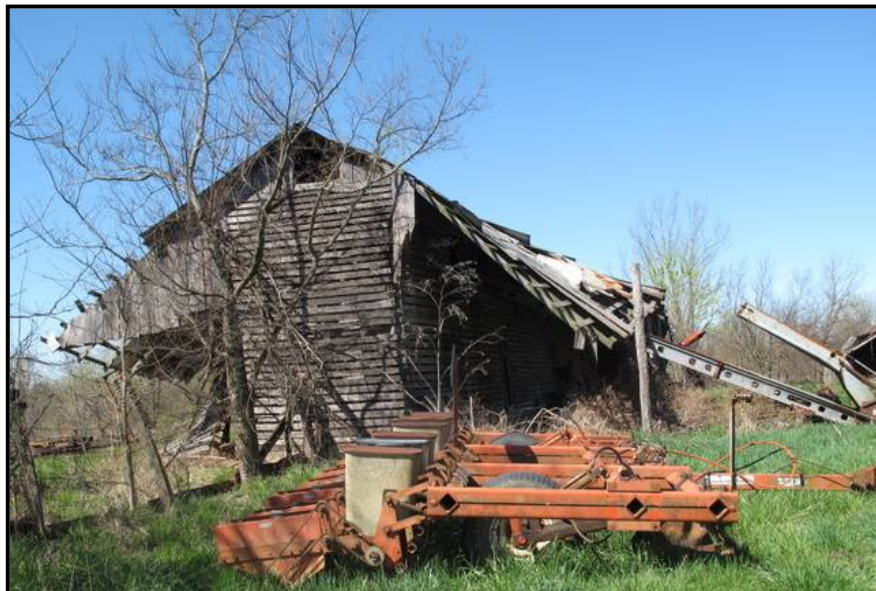
Figure 3. 69 *East gable end of CN-32 corncrib, showing open north shed.*

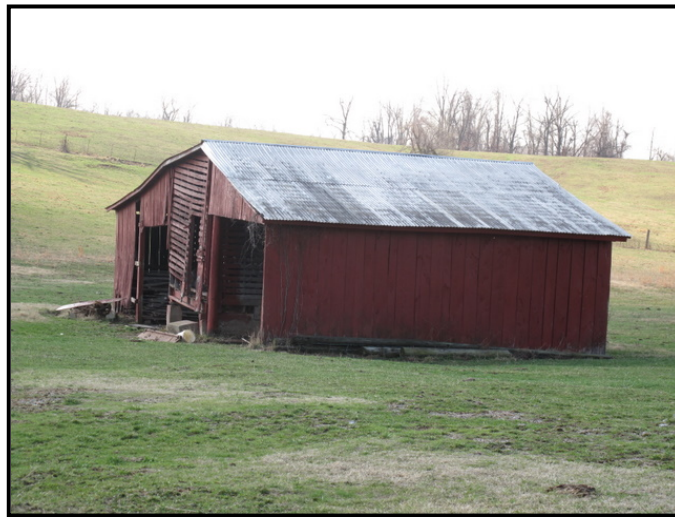
Figure 3. 70 *Corncrib with side shed additions at LV-77.*

The O.B. McDaniels corncrib is an extreme example of a freestanding corncrib with side sheds. The corncrib at LV-77 is a smaller version, with two sheds on either side of the crib, which rests on piers (Figure 3.70).

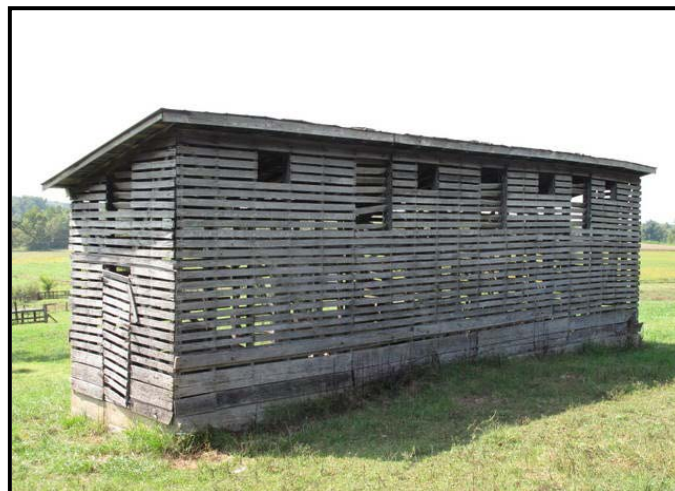
Figure 3. 71 *John Boyd corncrib, CN-66.*

Built in 1948 or 1949, the crib rests on a poured concrete foundation, and has a human-sized entry door on the gable end. It is very similar to the corncrib included in the College of Agriculture's 1940 *Plans for Dwellings and Farm Buildings in Kentucky* (Figure 3.72).

A more typical freestanding (and single purpose) corncrib is the one at the John Boyd Farm (CN-66) in Crittenden County (Figure 3.71).

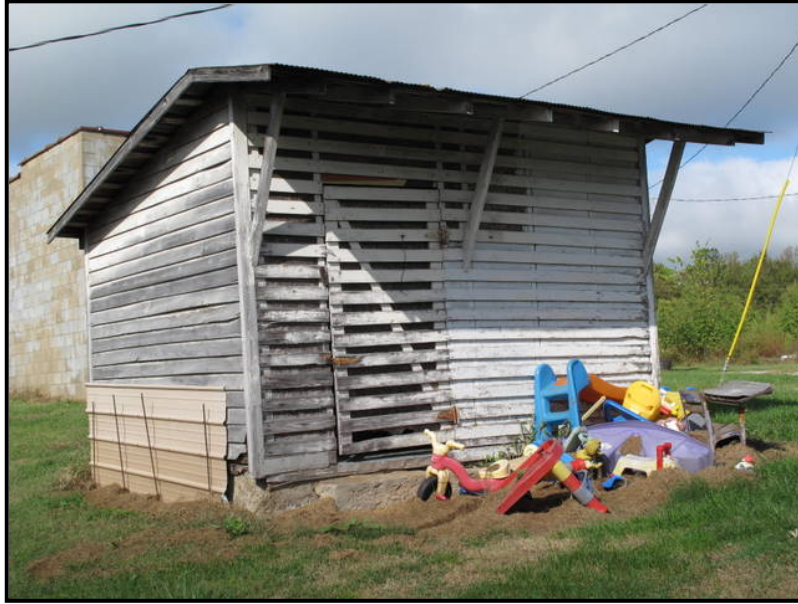
Figure 3. 73 Corncrib at the Virgil Alexander Farm, CN-71.

Only one other dedicated corn only freestanding corncrib was identified in the survey area. The corncrib at the Virgil Alexander Farm (CN-71, Figure 3.73) is a smaller version of the type promoted by the College of Agriculture.

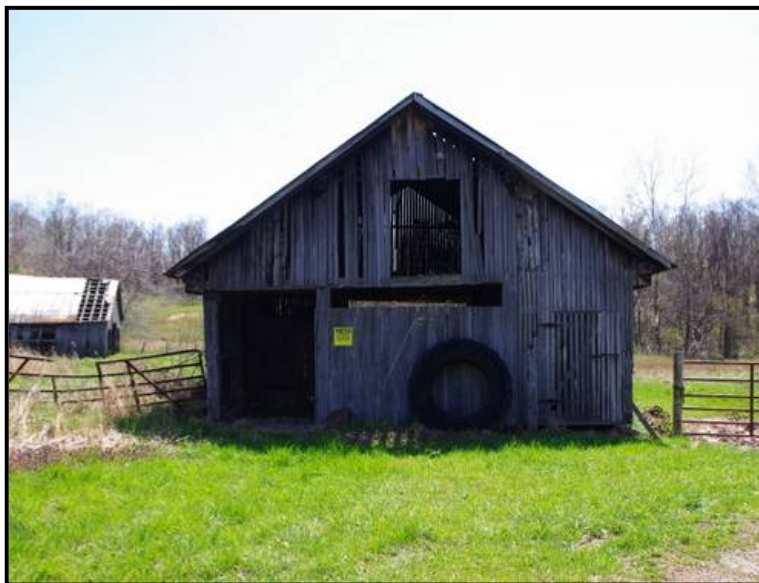
Figure 3. 74 Corncrib and stable, LV-25.

Like barns, many historic corncribs in the survey area accommodate more than the storage of ear corn. While interior corncribs (located inside of barns) will not be covered in this section, there are smaller, barnlike structures designed for the storage of corn, hay, equipment, and perhaps room for a horse or two. The combination corncrib and stable at LV-25 (Figure 3.74) on River Road is one example.

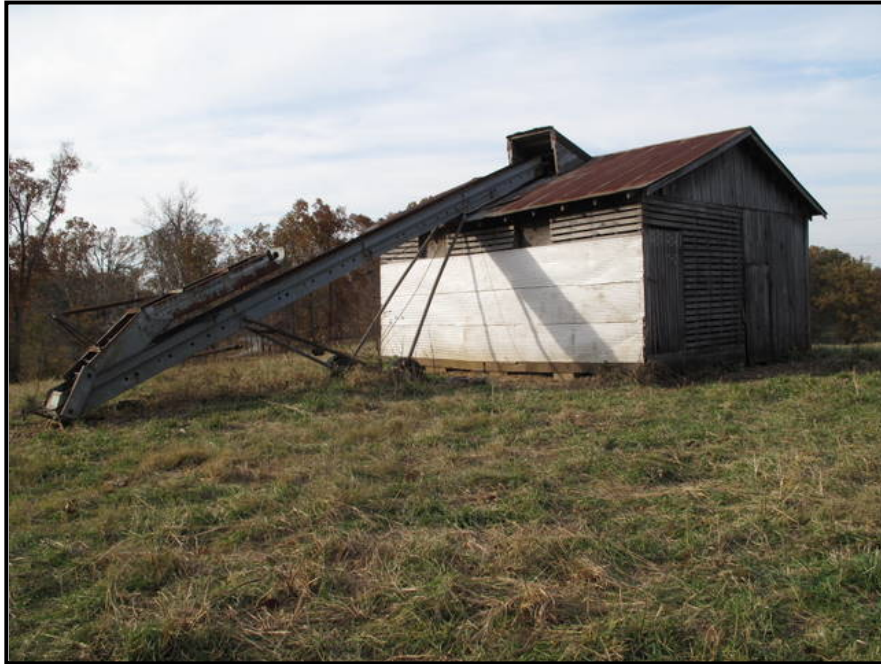
Figure 3. 75 *Corncrib with elevator, CN-85.*

Another type of corncrib is the one at CN-85, complete with elevator hooked up the cupola on the roof (Figure 3.75). Cupolas for loading corn (and protecting the head of the elevator) come in all shapes and sizes, but the shed roof projection is perhaps easiest to build.

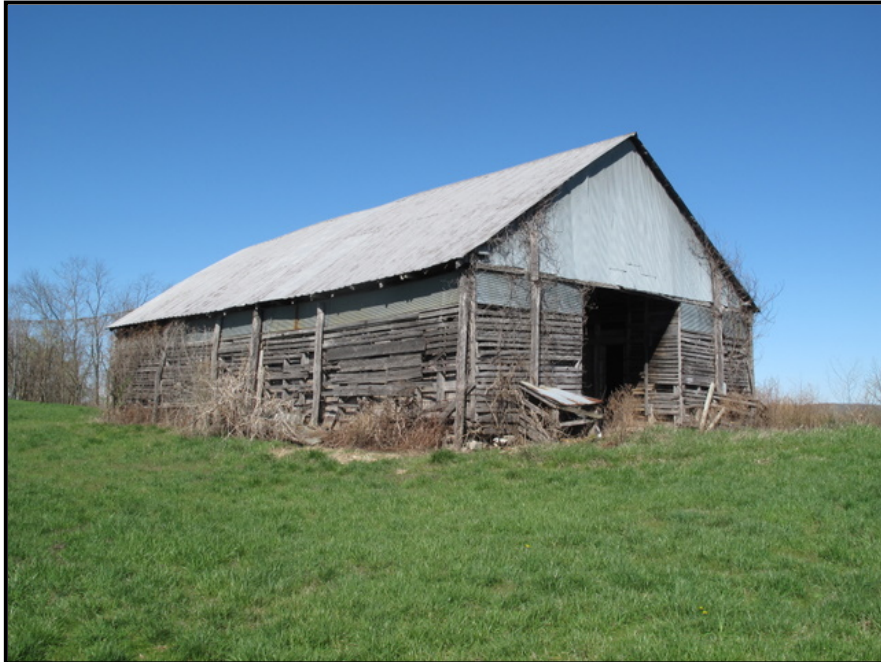
Figure 3. 76 *Corncrib at CN-31, south and east elevations.*

The Gregory-Guggenheim Farm (CN-31) in Crittenden County has a corncrib that may have originally been a drive-through, though one gable end is enclosed now. Two long cribs flank an open central aisle, under a front-gable facing metal roof. Despite the overall differences in form, this corncrib is very similar to the one right down the road at the O.B. McDaniels Farm (CN-32).

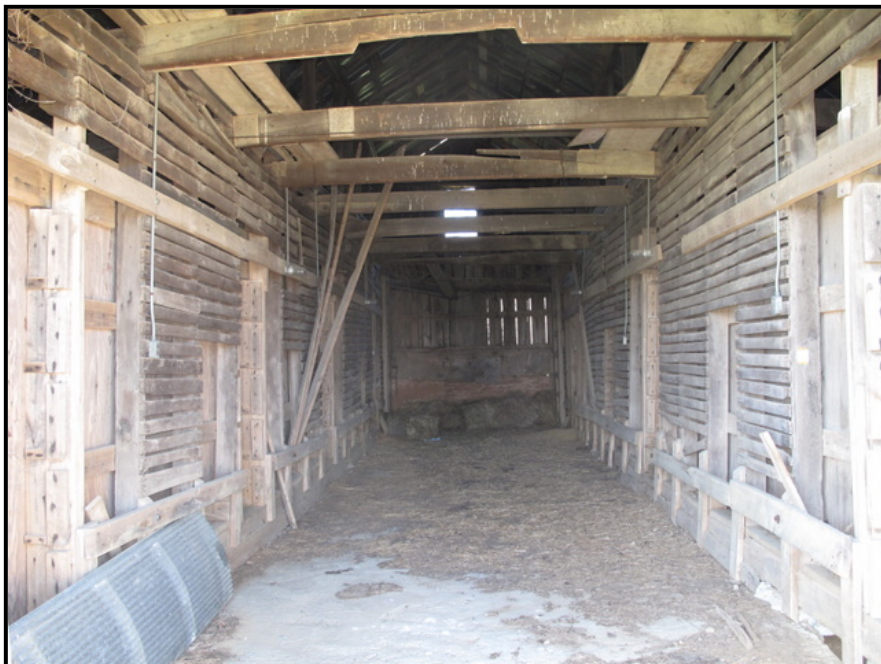
Figure 3. 77 *Interior of corncrib at CN-31.*

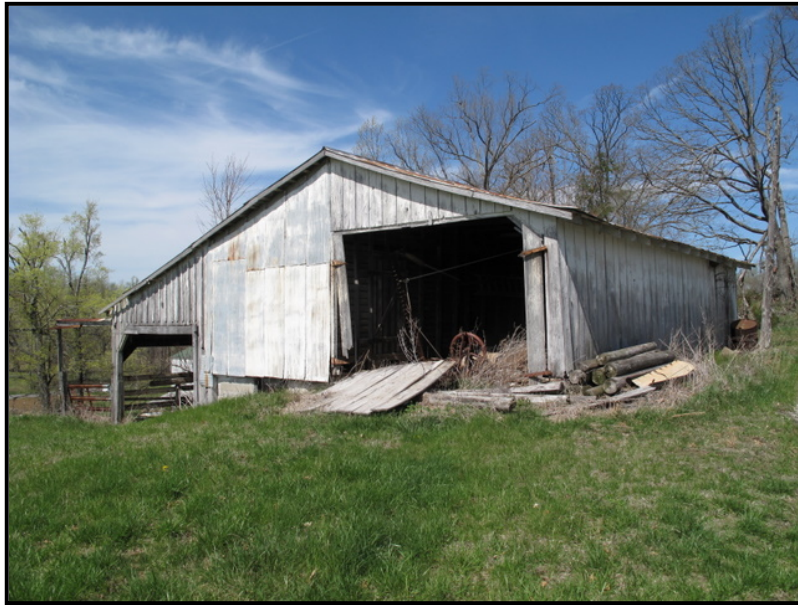
Figure 3. 78 Corncrib at the Old Smith Farm, LV-54.

Although the majority of the corncribs in the two counties were designed to hold ear corn and accommodate animals or equipment in a shed addition, the corncrib at the Old Smith Farm (LV-54) between Salem and Lola also processed corn (Figure 3.78). The crib is built into the side of a hill, with a drive-in shed beside it (Figure 3.79), and on the lower level, another drive-through aisle, with built-in troughs, bins and equipment possibly used to grind or crush corn for feed (Figure 3.80).

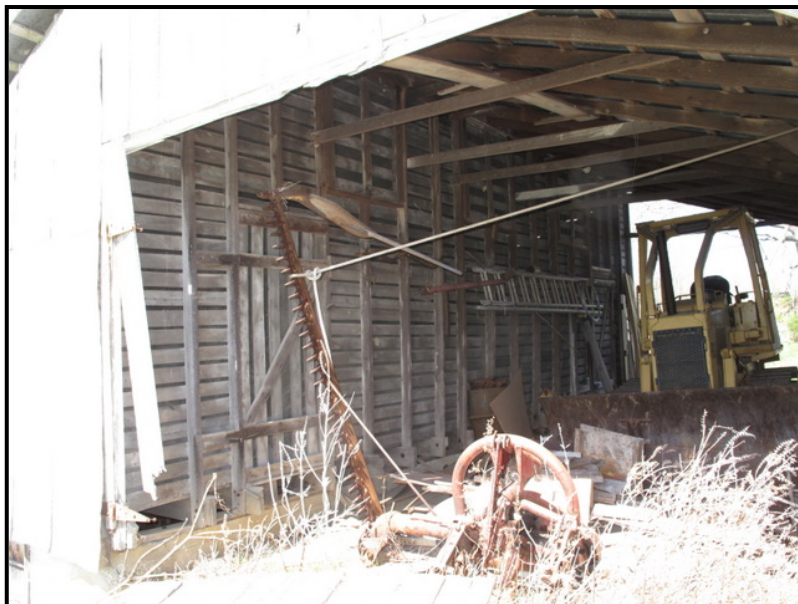
Figure 3. 79 Corncrib at LV-54, upper level.

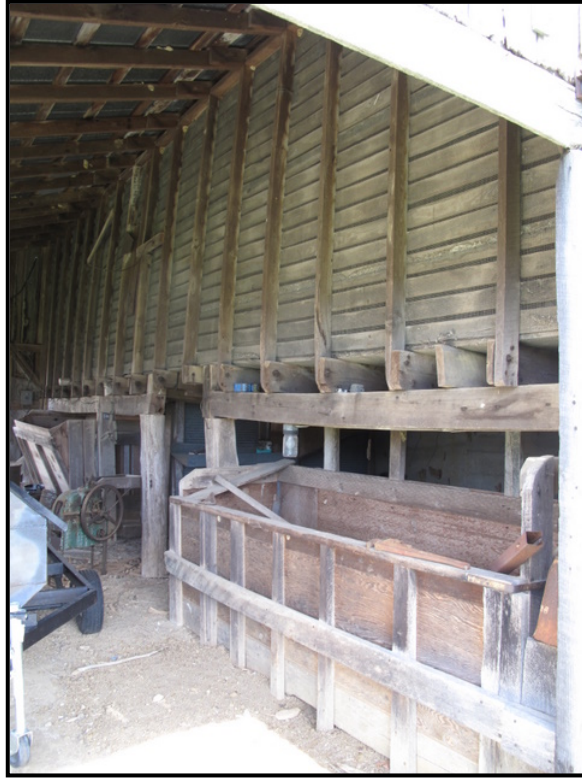
Figure 3. 80 *Lower level of LV-54 corncrib.*

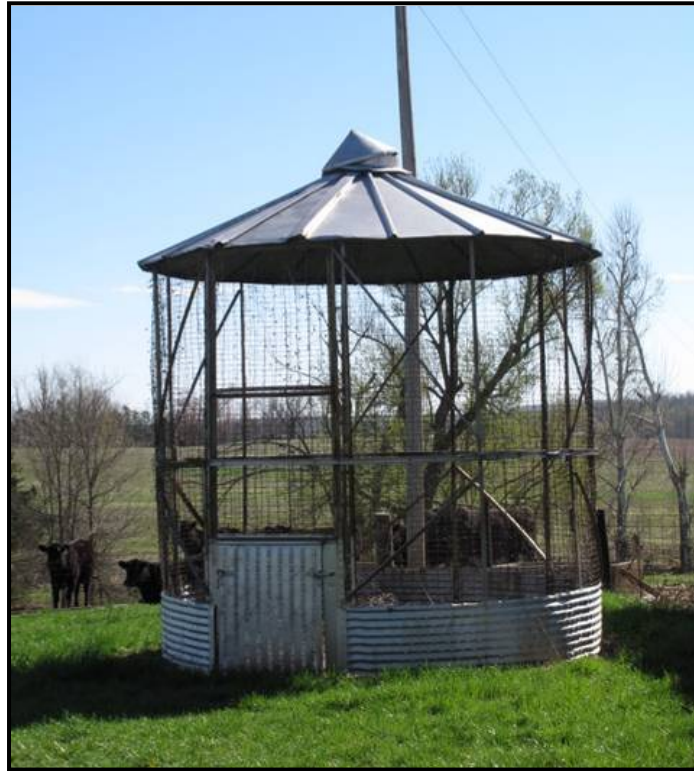
Figure 3. 81 *Circa 1950s wire mesh corncrib at LV-51.*

Easy to fill mechanically with corn, and equally easy to empty, metal cribs keep their shape well, are low-maintenance and typically held more than a small wooden corncrib. Wire-mesh cribs, like the one at the Workman Farm (LV-51, Figure 3.81) were also popular. This particular crib dates from the 1950s.

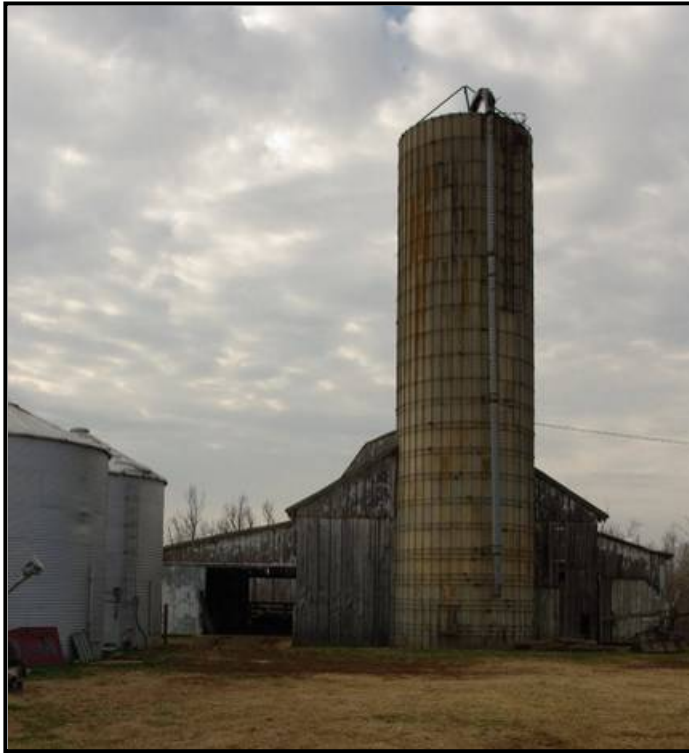
Figure 3. 85 *Cement stave silo, with grain bins to the left at the Robert and Ada White Farm, CN-29.*

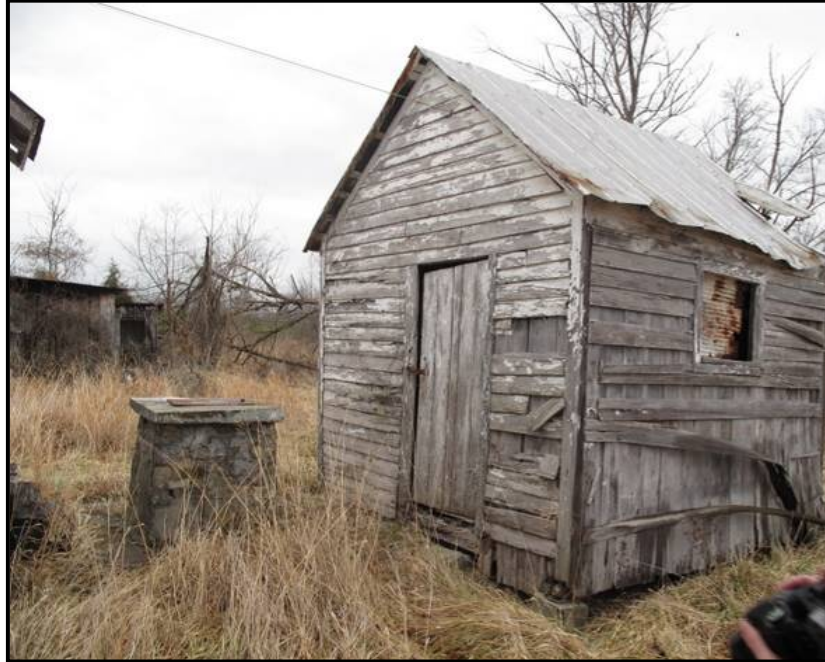
Figure 4. 2 Meathouse at CN-24. Note the horizontal weatherboards over the vertical board boxing. A raised cistern is located at left in photo.

The simplest of meathouses, for example, are one-bay wide frame structures, with a door centered in the gable end. These resemble the example below from the University of Kentucky College of Agriculture's 1940 *Plans for Dwellings and Farm Buildings in Kentucky* (Figure 4.1). This example is actually a smokehouse, with a fire pit detached from the smokehouse (on right side of the front gable structure). This eliminated much of the fire hazard associated with frame smokehouses.² The roof is typically clad in corrugated metal, and the structure rests on piers of some type, either wood, stone, brick or concrete. Meathouses of this type include Figures 4.2 through 4.4.

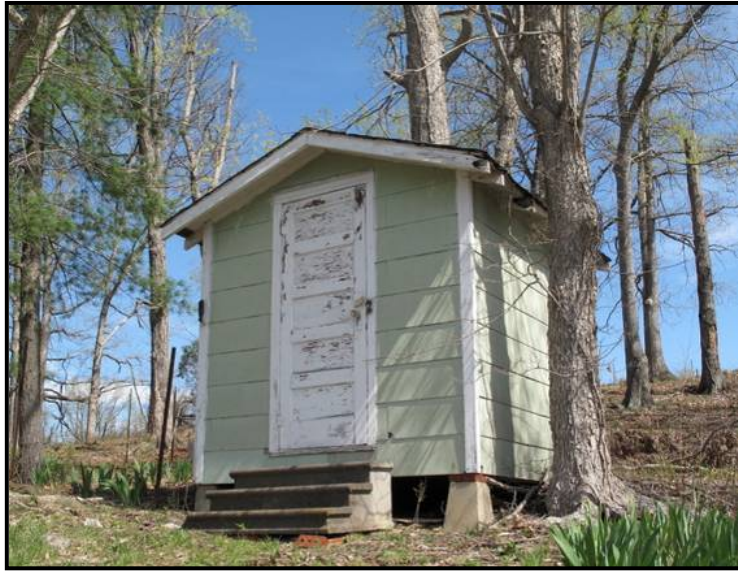
Figure 4. 4 *Meathouse on concrete piers, LV-54.*

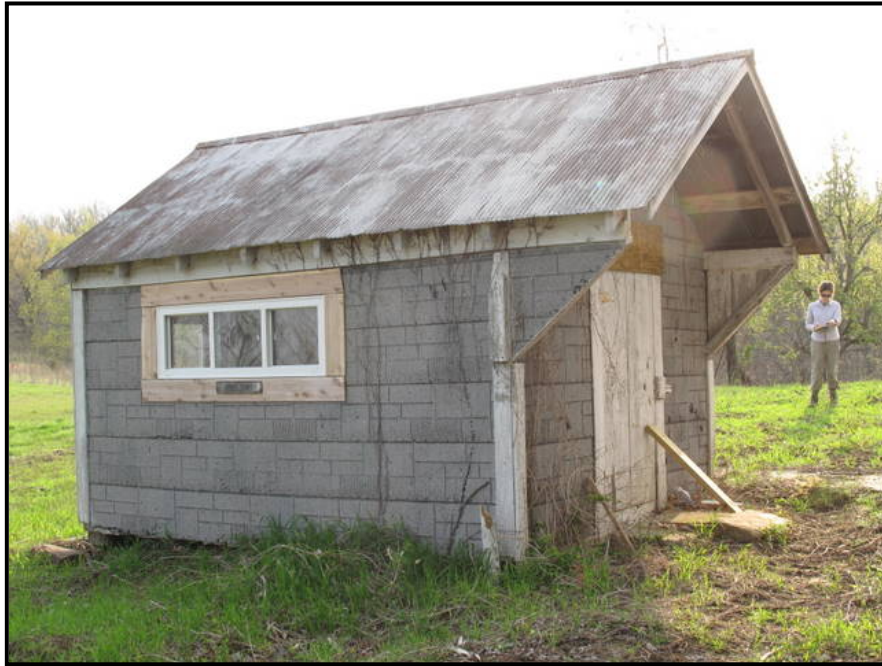
Figure 4. 6 *Cantilevered front-gable meathouse at the Rudell Ford Farm, LV-62.
The window on the side is a later addition.*

Front-gable meathouses with a braced cantilevered overhang over the central entry are another common type. This overhang provided some shelter from the weather both for the people going in and out of the meathouse, as well as some protection for the building. Some overhangs are supported by diagonal, boxed-in bracing, like the mid-twentieth century meathouse at the White Farm (CN-29, Figure 4.5) and the meathouse at the Rudell Ford Farm (LV-62, Figure 4.6). The meathouse at the Trimble Farm (LV-25), however, cantilevers out over the loft opening and the door with no support (Figure 4.7).

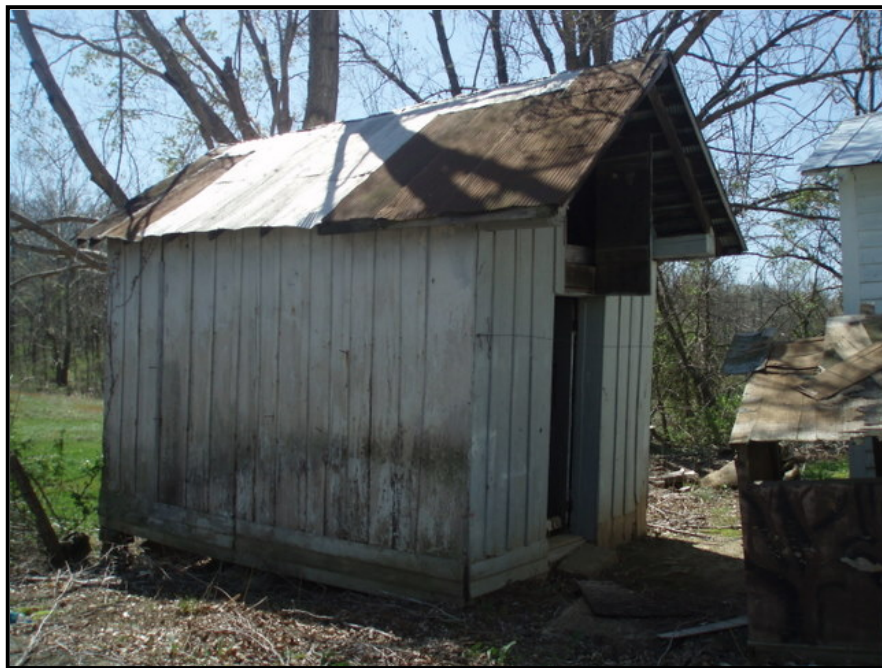
Figure 4. 7 *Meathouse at the Trimble Farm on River Road, LV-25.*

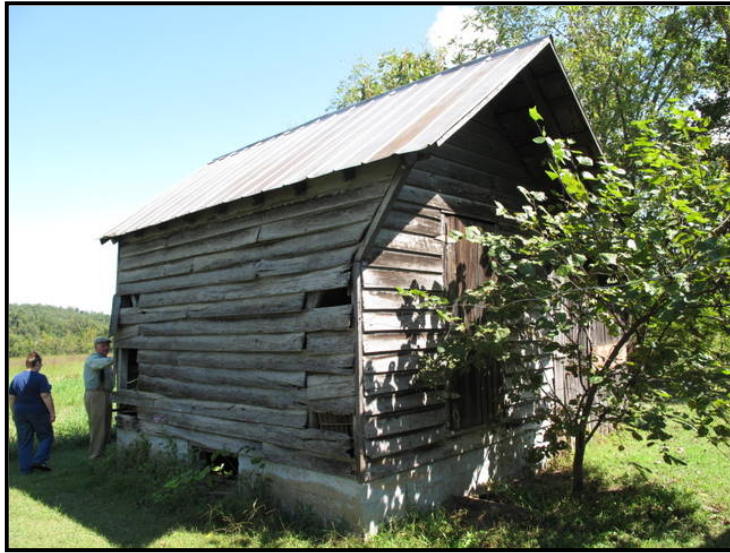
Figure 4. 8 *Meathouse/cellar/wash house combination at CN-77.*

Like most agricultural outbuildings, meathouses often served double duty, either with a shed addition to the side or the rear of the main structure. Meathouses located over root cellars is a common combination in Kentucky; the meathouse at CN-77 is an example of a meathouse over a cellar, with a side shed addition (Figure 4.8). The addition has a small brick flue that vented the stove; the space was likely used as a wash house and canning room (Figure 4.9).

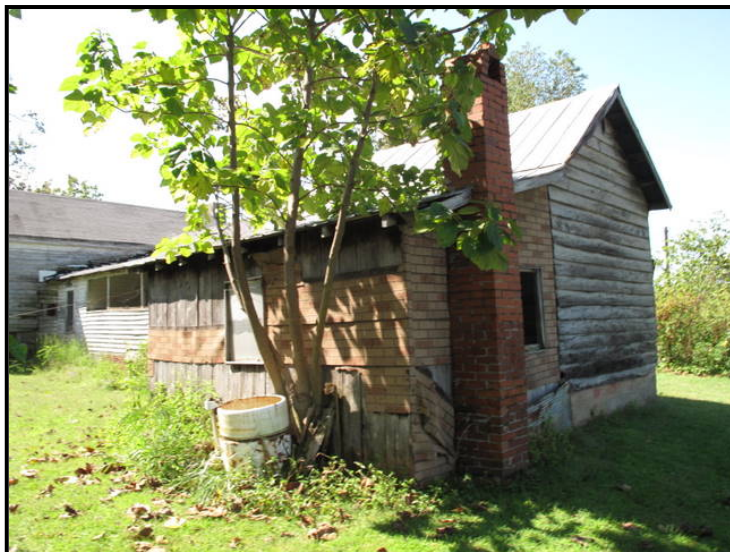
Figure 4. 9 *Rear of the meathouse at CN-77, showing brick flue on addition.*

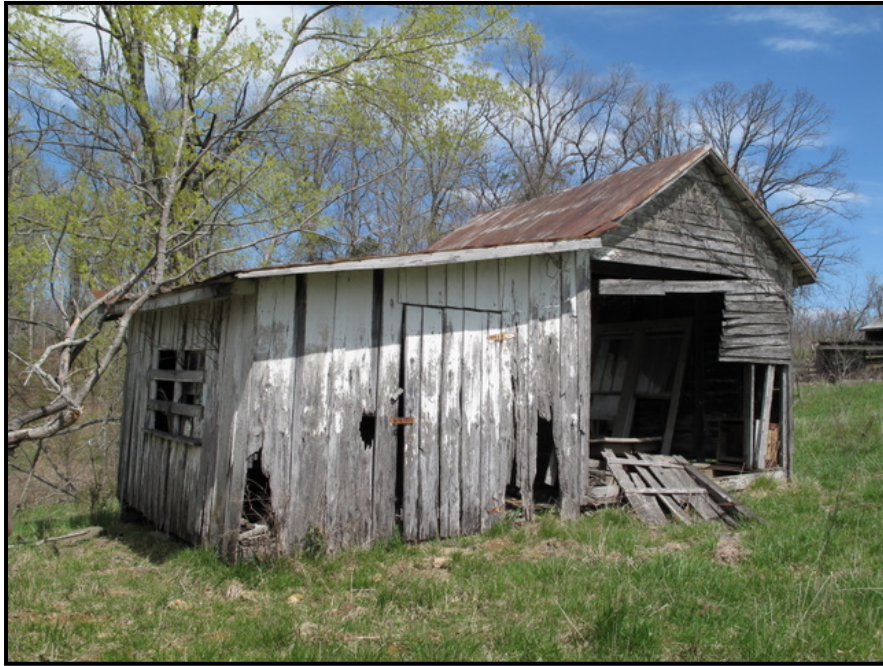
Figure 4. 10 *Dilapidated meathouse with side shed addition at LV-54.*

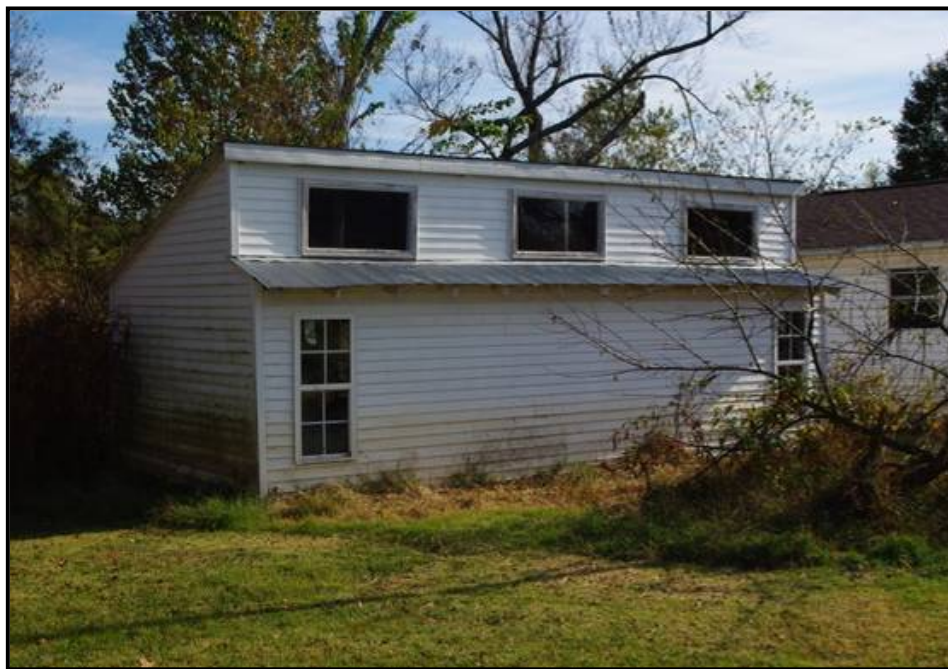
Figure 4. 18 *Remodeled chicken house at LV-97 on River Road.*

Two chicken houses, LV-97 and LV-87, in Livingston County appear to be “half-monitor” chicken houses (Figures 4.18 and 4.19). The step-back form allowed more light and air into the chicken house, but at a good distance from the roosting chickens. Chickens typically entered from the rear of the house, and eggs were collected from the front. These plans started being promoted in the 1920s (Figure 4.20).

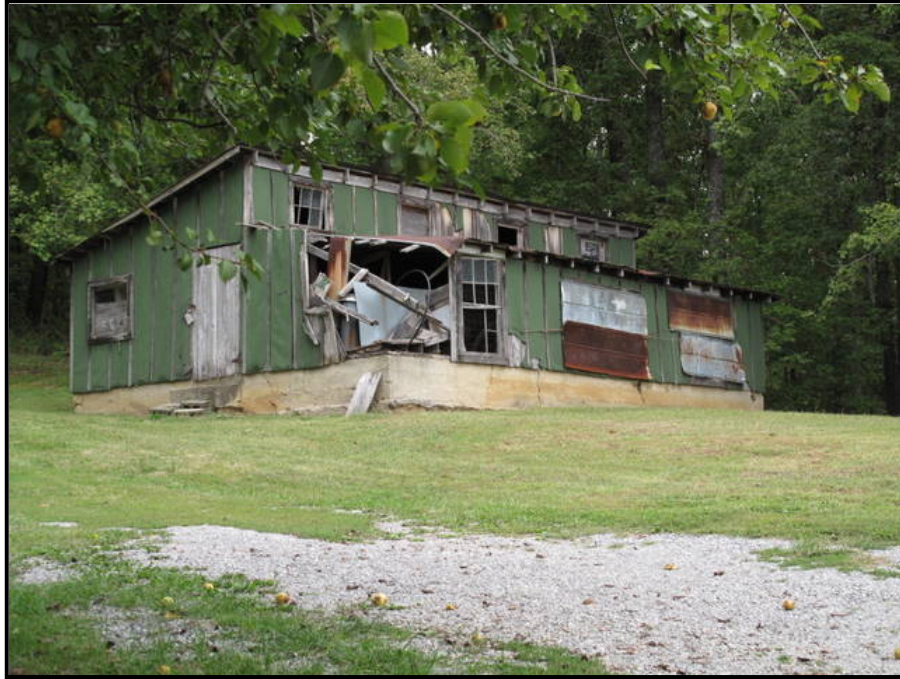
Figure 4. 19 Half-monitor chicken house at LV-87. This type of house was more expensive to construct than a simple shed roof version. Widely touted by agricultural colleges in the 1920s and 1930s, the plan typically ranged from 20 feet wide to 18 feet long.

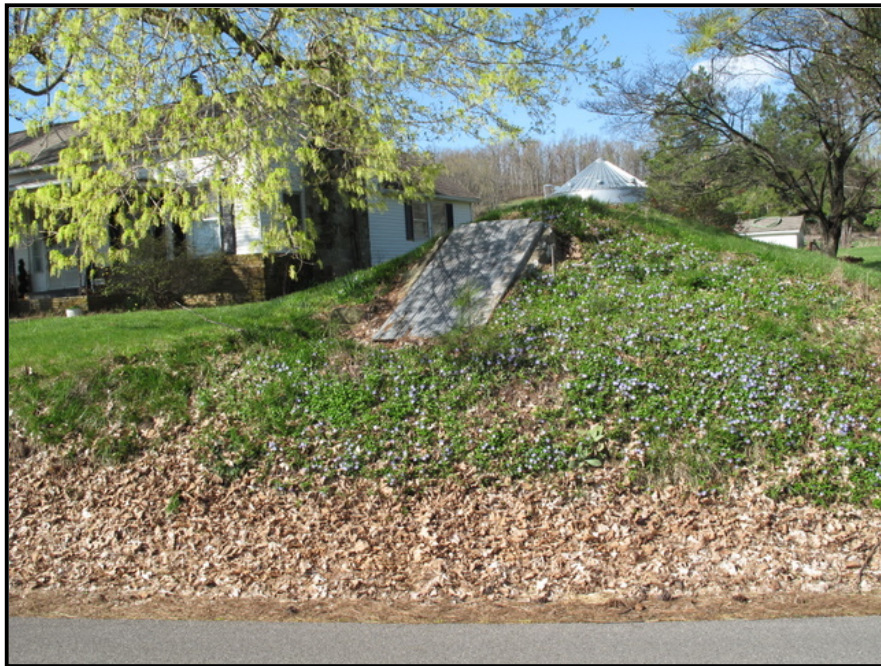
Figure 4. 21 *Root cellar at LV-51.*

Root cellars can simply be dug out of the side of hill (LV-51, Figure 4.21, is one such example), and are identified by an earthen covered arched dome. In this case, a bulkhead-type door opens directly onto the steps descending in to the cellar. The interior of the hillside root cellar typically has masonry or concrete walls and ceiling and a dirt floor.

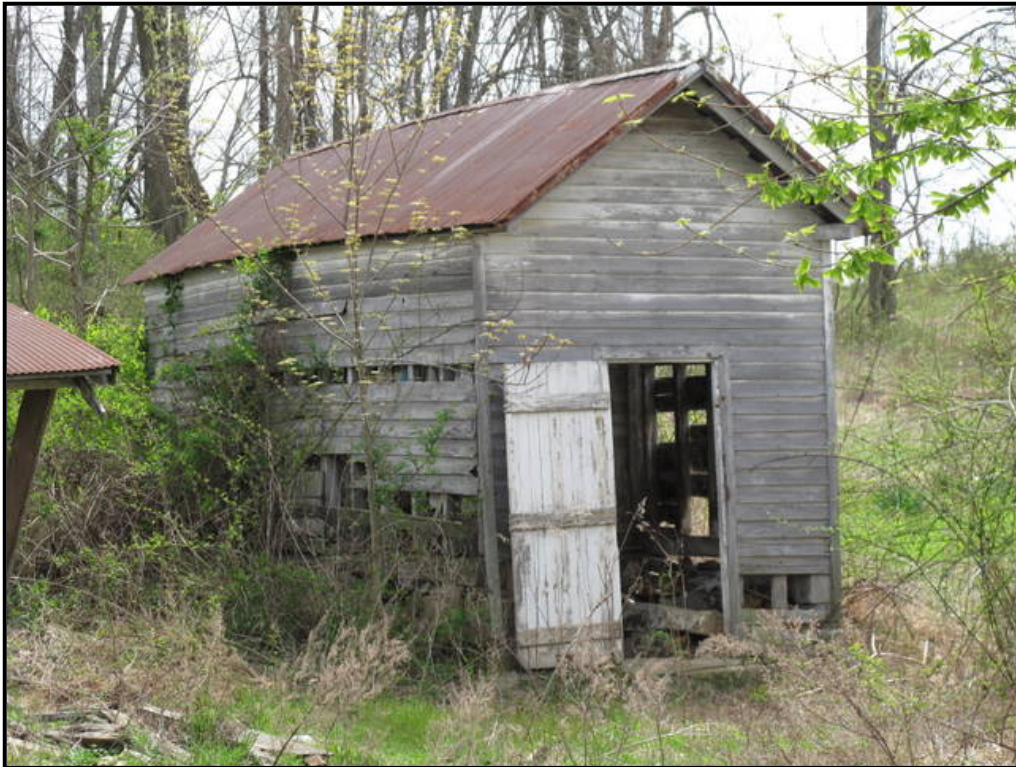
Figure 4. 22 *Root cellar at the Edmonds Farm, LV-68.*

The root cellar at the Edmonds Farm (LV-68, Figure 4.22) is a good example of this type of cellar. The stone root cellar is sheltered by a one-bay wide balloon frame structure resting on heavy, hand-hewn sills. The door opens onto stone steps leading into the cellar. Located over the cellar, and accessed from a door narrowly situated to the side and rear of the steps, is another room, where the current owner's father slept as a teenager.³

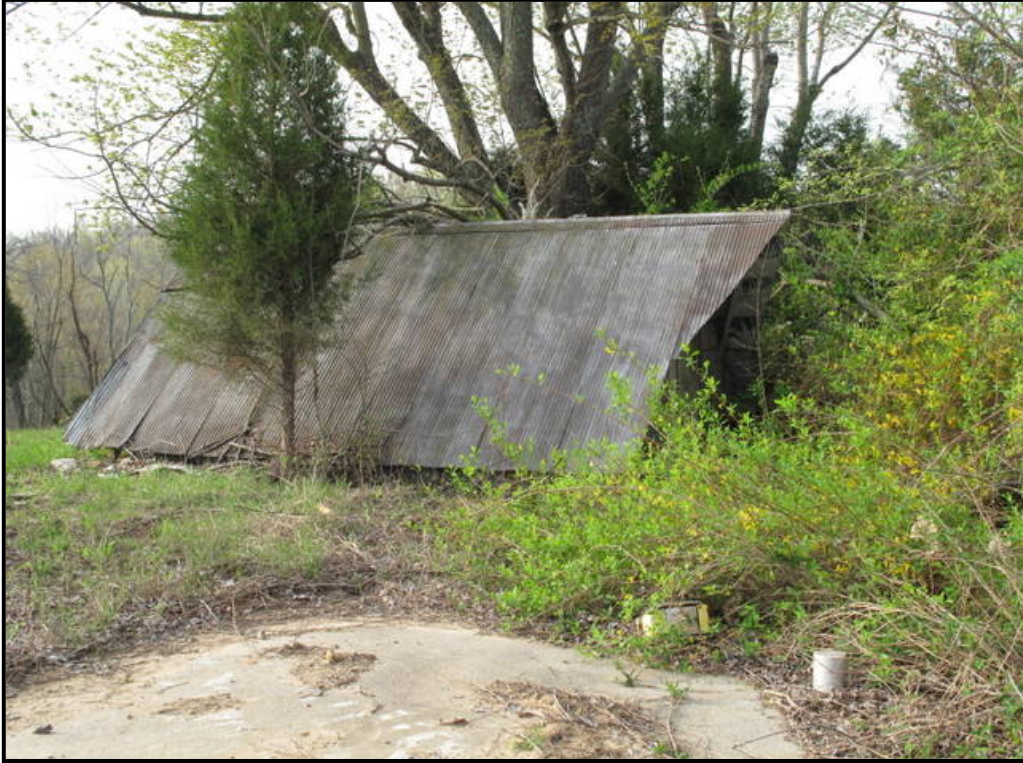
Figure 4. 24 *Root cellar at the Rudell Ford Farm, LV-62.*

The root cellar at LV-62 (Figure 4.24) is a variation on the front-gable super structure, and closely resembles the hog houses located on the farm (and could well be adapted from one of those structures). The low-pitched, one-bay wide front gable structure has a hatch door in the floor leading to the cellar beneath. This type of arrangement provides more storage space on the floored level than the typical open stair arrangement.

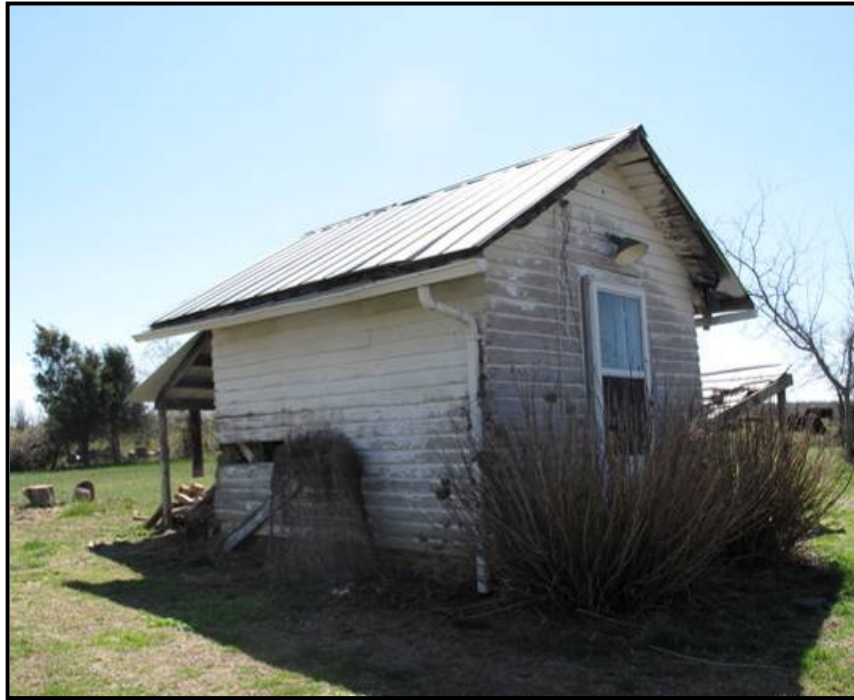
Figure 4. 25 *Root cellar at CN-36.*

Most, though not all, root cellars with the superstructure were part of a combination structure, either with another room on the rear or to the side of the cellar entrance. A common combination is root cellar and meathouse. The root cellar at CN-36 has a small open shed at the rear for storage (Figure 4.25). The root cellar at the Lucas Farm in Livingston County (LV-64) is a front-gable building with two doors on the gable end (Figure 4.26). The door on the right leads down to the root cellar, while the other door was used for storage.

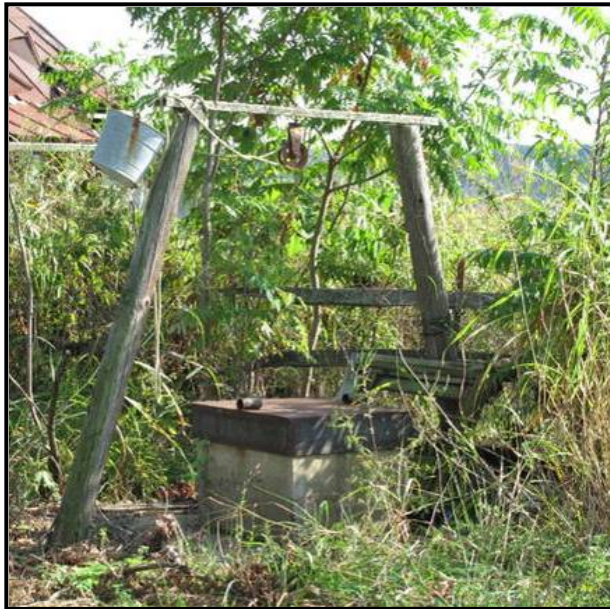
Figure 4. 28 *Well at CN-26.*

Sites within the survey area had pumps, cisterns and wells, sometimes one of each. Wells were hand dug during the nineteenth century, and lined with brick or stone. Sometimes a hand pump (sometimes simply the pump apparatus, sometimes encased inside a decorative metal cover) would be placed over the well covering, but water could also be hauled up with a rope and bucket. The well at CN-26 (Figure 4.28) illustrates this type of well; with a twentieth century concrete block and wood covering over the well opening. The stone well with a concrete cap at the Peter Paul Paris Farm (CN-41, Figure 4.29) is another example.

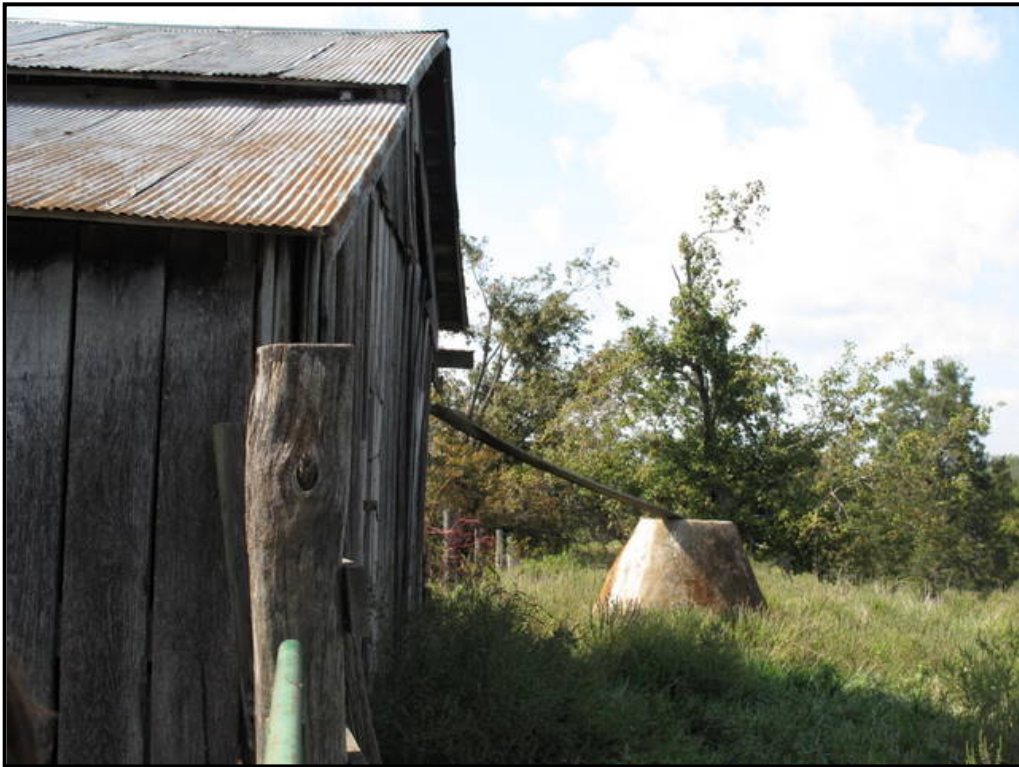
Raised conical cisterns, often brick covered with a veneer of poured concrete, were identified at several sites in the two counties. These cisterns collected water from gutters (CN-67, Figure 4.30) collects water off of the barn roof) on houses and outbuildings. The water then flowed through an underground pipe, either by gravity or through a pump, to its desired location. Farms might have multiple cisterns to collect and store water, and complicated system of piping and pumping to deliver the water. The most efficient way to deliver the water from the cistern was a pump at the cistern itself, since it is easier to push rather than pull water to its desired location.

Figure 4. 30 *Raised cistern in barn lot at CN-67.*

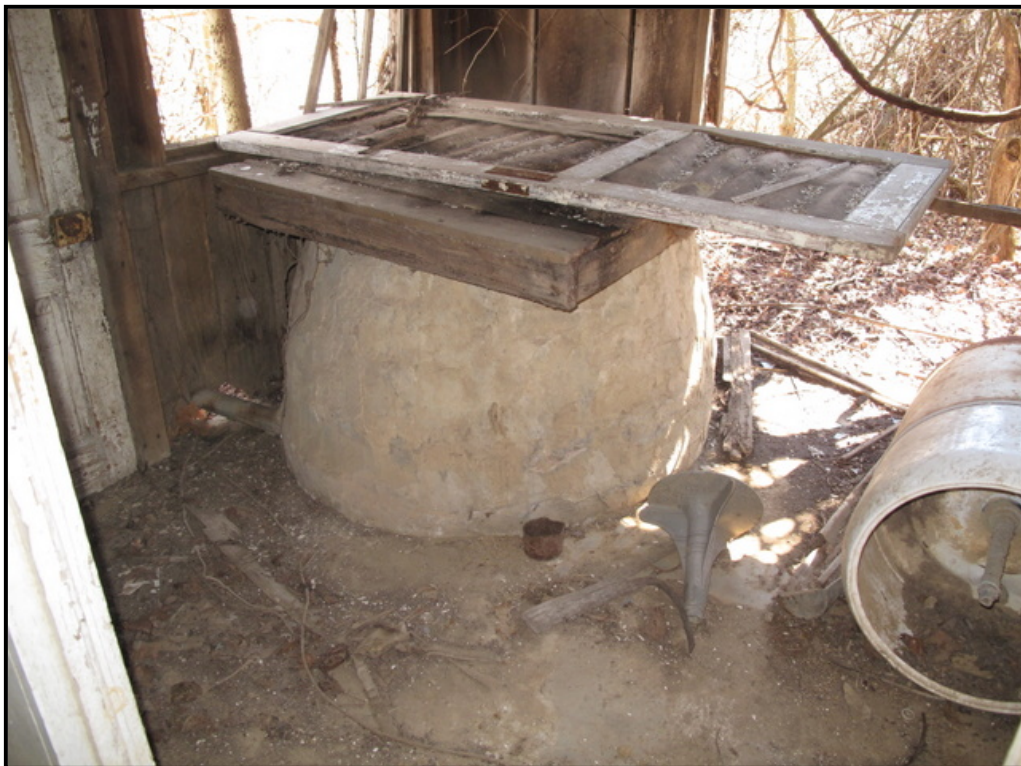
Exterior cisterns are a common sight on farmsteads, but another type observed is the cistern included on an enclosed porch of the main house. Several sites had these cisterns or wells, including CN-31 (Figure 4.31), a box-frame tenant house from the early twentieth century. Figures 4.32 and 4.33 show other types of water collection found within dwellings, usually on enclosed porches.

Figure 4. 31 *Cistern on enclosed porch at CN-31.*

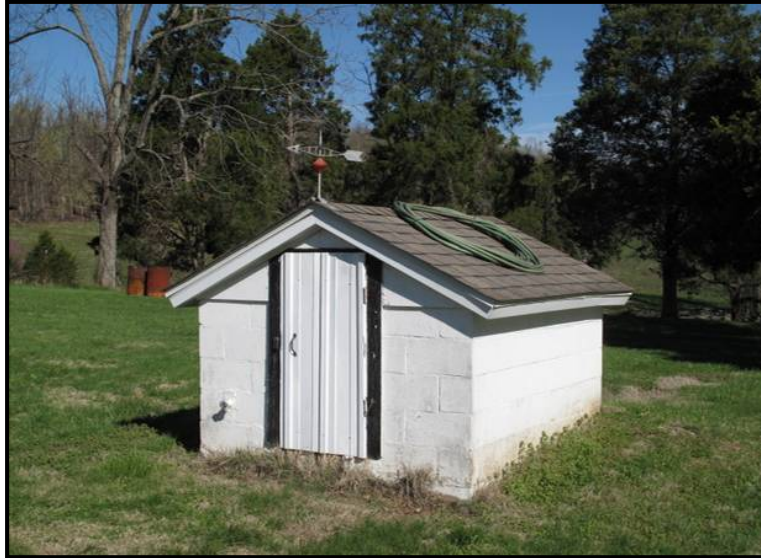
Figure 4. 34 Concrete block pump house at LV-51.

Pump houses, most dating from 1930-1960, were a common site on farms in the survey area. Pumps moved the water up from a well or cistern. Constructed to hold pump machinery, these small structures are square or rectangular, and built of frame, poured concrete or concrete block. They typically have a front gable or shed roof, and one human-sized opening on the front. Many have steps leading down to the pump equipment – the below-grade location helped insulate the pipes from freezing.

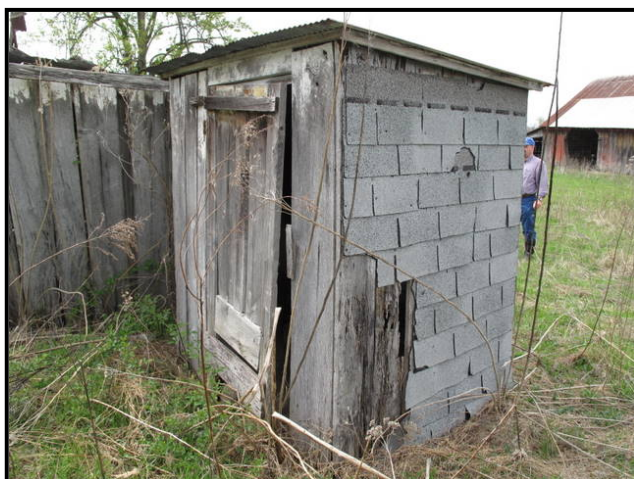
Figure 4. 38 Privy at LV-68.

Only a handful of privies were documented in the survey area. They were frame, shed roof, one-bay wide structures, either clad in vertical board, weatherboards or rolled asphalt siding. These privies are likely earth vault or dry earth privies. The former rested over an open pit in the ground, and the structure would be moved once the pit reached capacity. Dry earth privies had a water-tight galvanized box mounted underneath the toilet seat. A hinged door at the rear of the privy allowed the box to be removed and emptied (Figure 4.39).
