A Survey of the Rural Resources of Crittenden and Livingston Counties, Kentucky

**Kentucky Archaeological Survey
Jointly Administered By:
The University of Kentucky
The Kentucky Heritage Council
Report No. 214**

KAS Report No. 214

February 2012

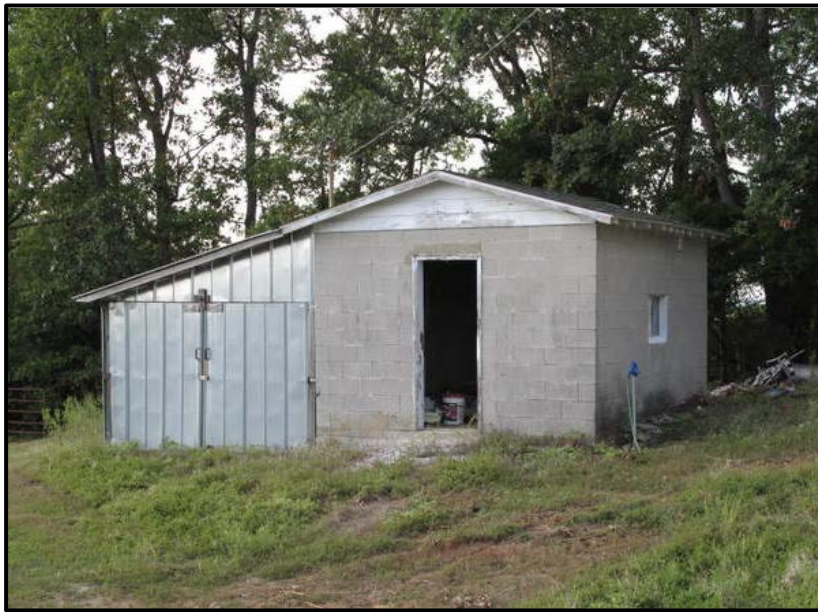
Figure 5. 15 Former polling station in Crittenden County, CN-26.

Other scattered examples of commercial and civic life in the crossroads communities across Crittenden and Livingston County include a former polling place (CN-26) in Crittenden County (Figure 5.15, below). The utilitarian concrete block structure is located near an abandoned farmstead in north central Crittenden County, on Route 91.

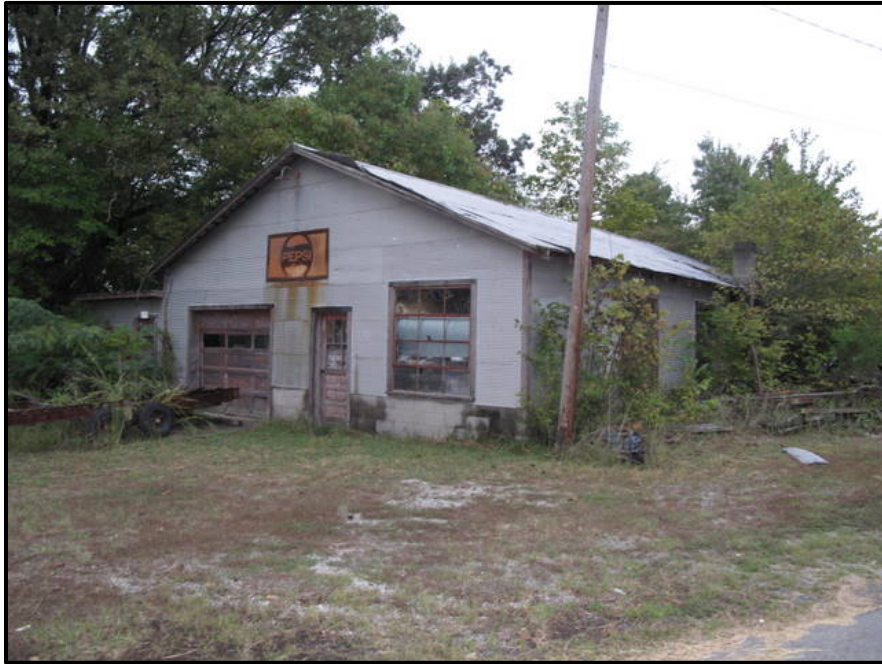
Figure 5. 16 *Garage in Frances (CN-56).*

Automotive garages are another resource found in the hamlets of the survey area. Like the stores, none of them appeared to be in business, or at least not servicing vehicles. Both of the surveyed garages are concrete block structures dating from the mid-twentieth century. The garage in Frances (CN-56) is a one-story, front-gable building with a three-bay wide façade (Figure 5.16). The entry door is flanked by a rolling vehicular bay and a steel casement window.

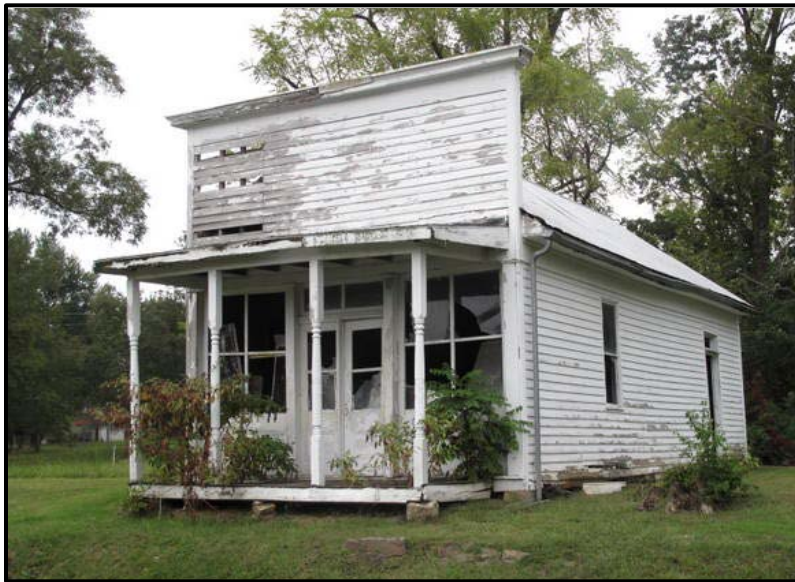
Figure 5. 18 *Dr. Davenport's office, LV-91, in Hampton, Livingston County.*

In addition to stores and post offices, the community of Hampton retains one structure built as a physician's office. Dr. Davenport's office (LV-91) looks very similar to the front gable stores documented in the survey, complete with parapet wall, double entry doors and large fixed light display windows (Figure 5.18). A shed roof porch with turned and chamfered supports extends across the façade. No other known offices were documented as part of this project, but it is highly likely that they existed at one time.

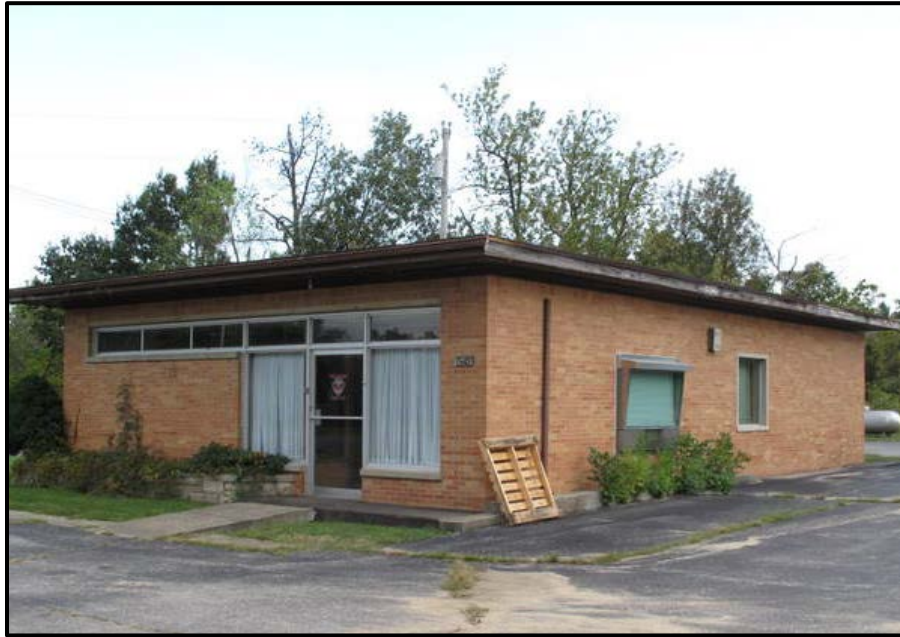
The former Bank of Livingston remains in the community of Tiline. The twentieth century Modernist structure has a flat roof, clearstory windows on the façade and a drive-through teller window on the west side (Figure 5.19). The mid-twentieth century structure was built on the foundation of an older bank building, and holds the dubious distinction of being robbed several times in the second half of the twentieth century.

Figure 5. 19 *Former bank building (LV-93) in Tiline.*

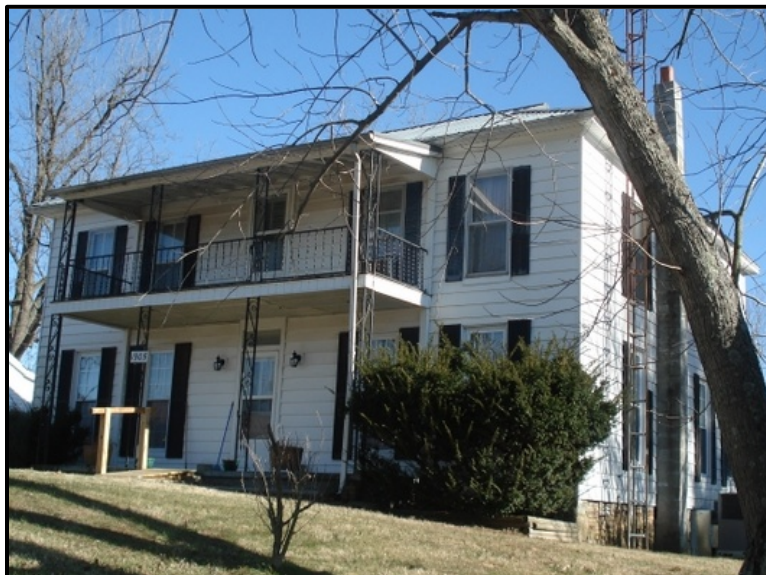
Figure 5. 20 *Former Carrsville City Hospital (LV-114).
Photo by Kathleen Guess.*

In the early twentieth century, a hospital operated in Carrsville. Perhaps more accurately classified as a “surgery,” the practice was housed in an extant two-story white frame house on Main Street. Dr. W. T. Gardner apparently lived and practiced in the house. The Carrsville Hospital (LV-114) is now a single-family dwelling.

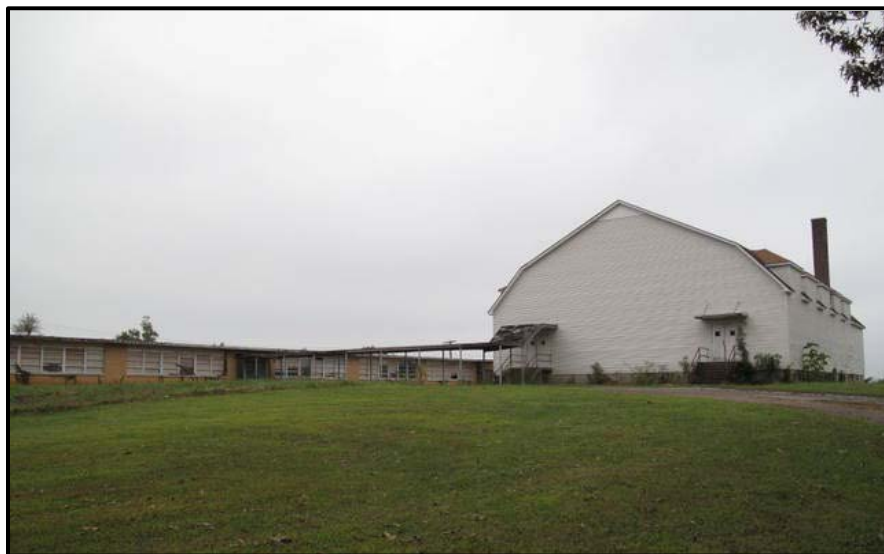
Figure 5. 25 *CN-58, the Frances Elementary School at left, and CN-1, the Frances WPA Gymnasium, at right in photo.*

The WPA assisted in the construction of a gymnasium at Frances in 1938. This structure (CN-1, Figure 5.25) still stands and is one of three NRHP-listed sites in the entire county. The Frances gym is adjacent to the 1960s Frances Elementary School (CN-58) which closed in 1998 and consolidated with the Crittenden County Elementary School.

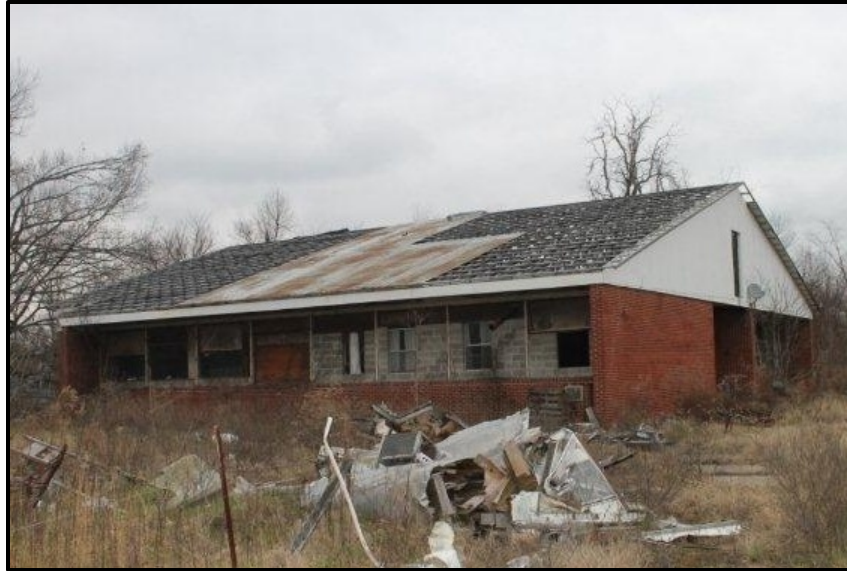
Figure 5. 28 *Tiline School (LV-113). Photo by Darrell Jones.*

Another 1950s era school is the 1956 Tiline Elementary School (LV-113) in Livingston County. Only a portion of the abandoned school building still stands (Figure 5.28).

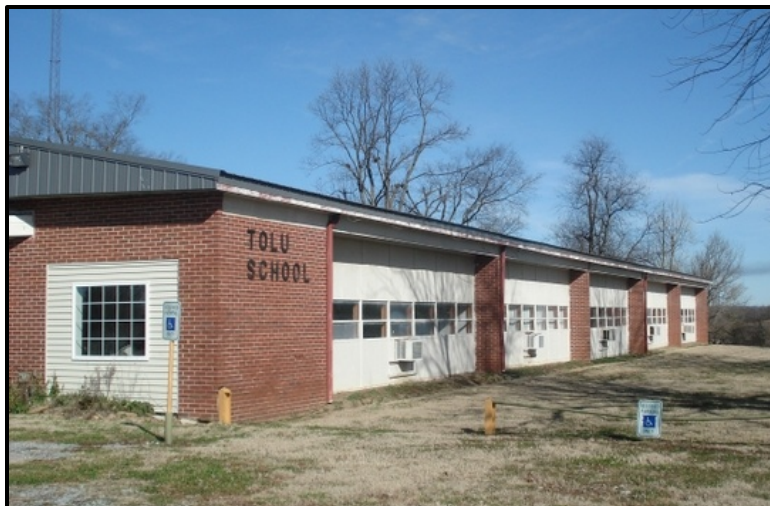
Figure 5. 29 *Part of the façade and south elevation of Tolu School (CN-88). Photo by Kathleen Guess.*

Tolu Elementary School (CN-88, Figure 5.29) in Crittenden County dates from the same period. Like the Frances and Tiline Schools, the one-story is low brick veneer building is low and horizontal, with banks of ribbon windows on the sides. Tolu School closed in 1998 and consolidated with Marion.

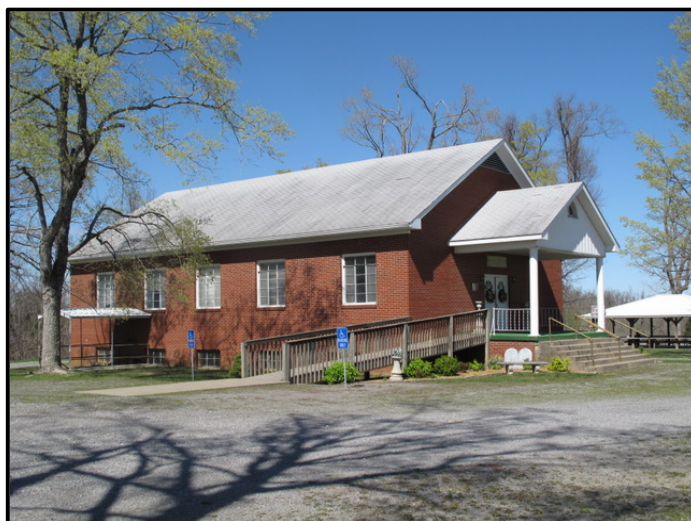
Figure 5. 30 *Current church at Piney Fork Presbyterian (CN-39).*

Piney Fork Presbyterian Church (CN-39), organized in 1812, is considered the first Cumberland Presbyterian Church in Kentucky.¹² Annual camp meetings started on the grounds that same year, and continued well into the twentieth century. The shed, similar to the one at Hurricane Camp, was built in 1886 and demolished in 1970. The first log church was replaced in 1843; the third church on the site, constructed of bricks, went up in 1867. The present brick-veneered building was built in 1957 (Figure 5.30).

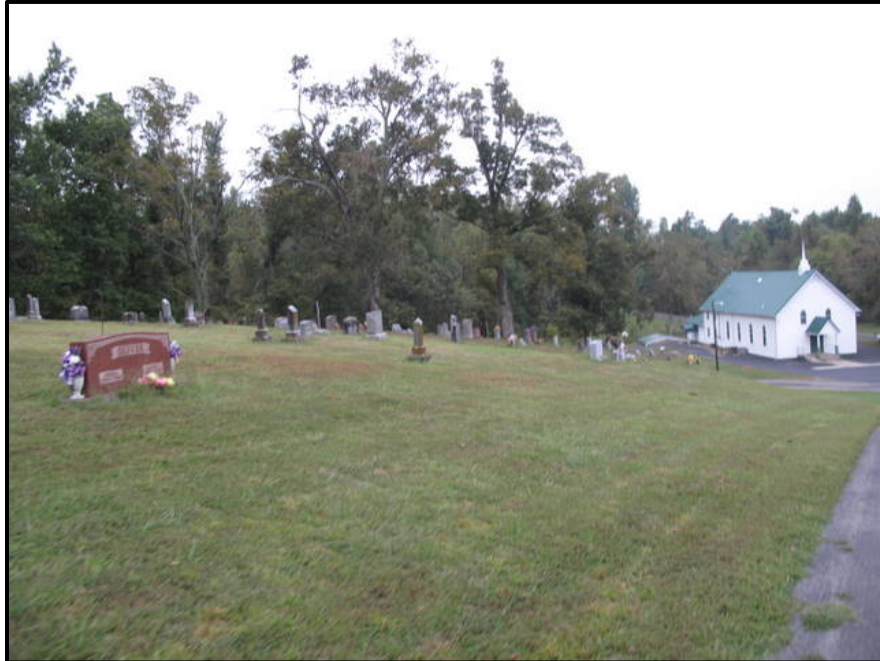
Figure 5. 31 *Caldwell Springs Cemetery looking toward church (CN-51).*

Caldwell Springs Missionary Baptist Church (CN-51, Figure 5.31) was organized in 1844. It sits alongside a natural spring, and a large cemetery is located on a hill opposite the church (Figure 5.30). Rather than having windows on either side of the entry door, the frame, front gable church has pointed arch windows above and to either side of the entryway.

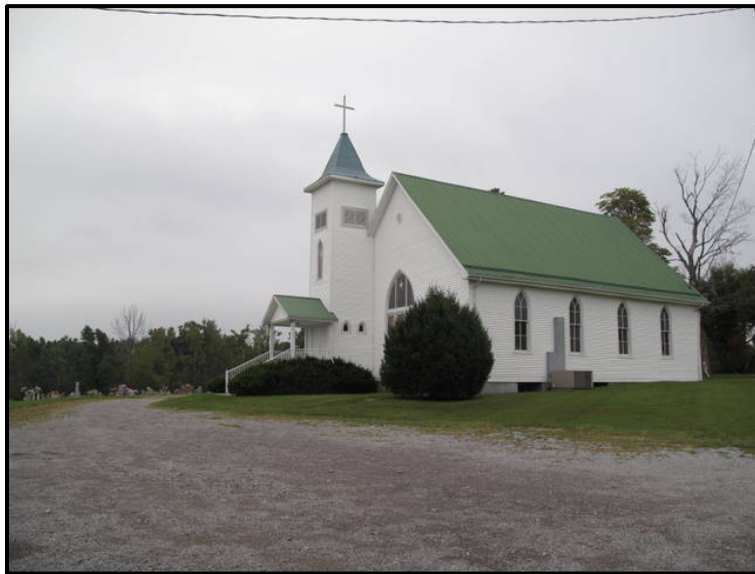
Figure 5. 32 *Frances Presbyterian Church (CN-52) and cemetery.*

The Frances Presbyterian Church (CN-52) has an off-center belltower and entryway, and a canted apse on the rear gable elevation of the church (Figure 5.32). The congregation organized in 1909 with 35 members. George L. Whitt donated land for the church and cemetery; he current church building was dedicated in 1910.¹³

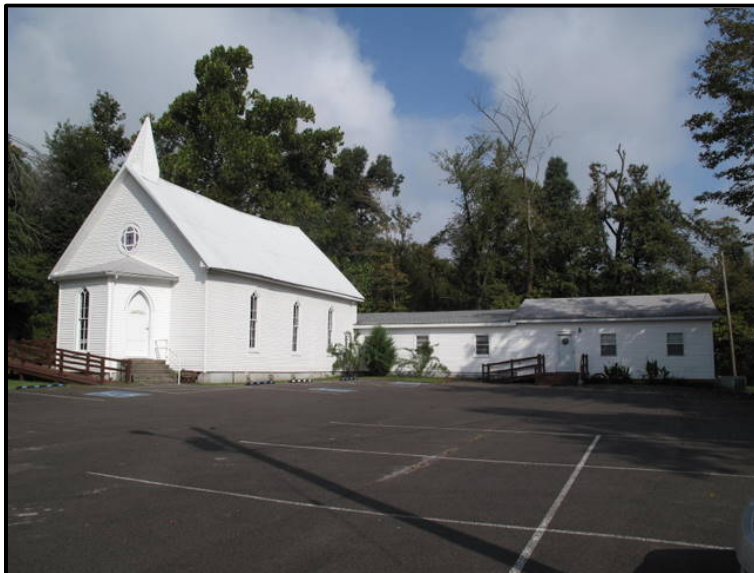
Figure 5. 33 *Sulphur Springs Baptist Church (CN-60). Sunday School rooms extend laterally at the rear.*

Sulphur Springs Baptist Church (another church located near the site of a spring, so important during the settlement period) is a variation on the massing of the Frances Presbyterian Church. Sulphur Springs (CN-60) has a canted apse like projection on its front gable, serving as entryway to the sanctuary (Figure 5.33).

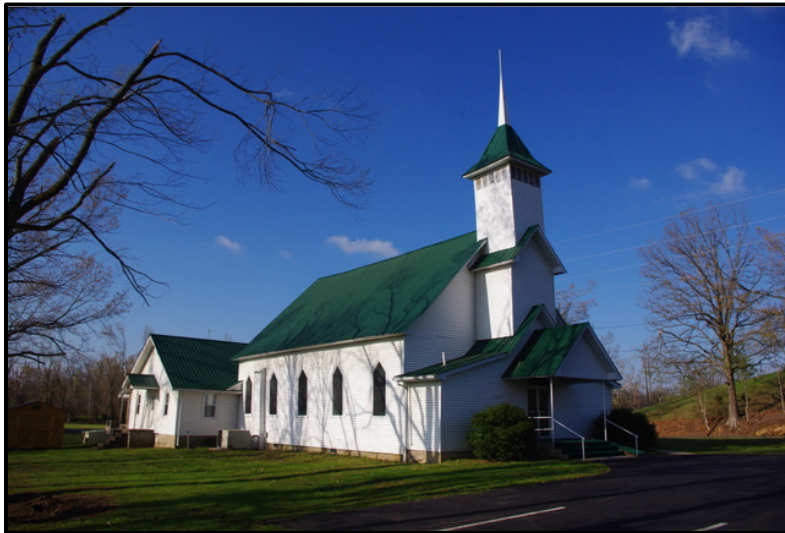
Iuka Baptist Church (LV-30), organized in 1914, is a frame front gable church with an unusual three-part bell tower (Figure 5.34). Despite its date of construction, the church borrows heavily from the Gothic Revival style of architecture, with pointed arch windows piercing the sides of the buildings. Most late-nineteenth and twentieth century rural churches favor the Gothic Revival style. Sunday School rooms were added at the rear of the sanctuary in 1957, and a fellowship room added in 1988.

Figure 5. 34 *Iuka Baptist Church (LV-30).*

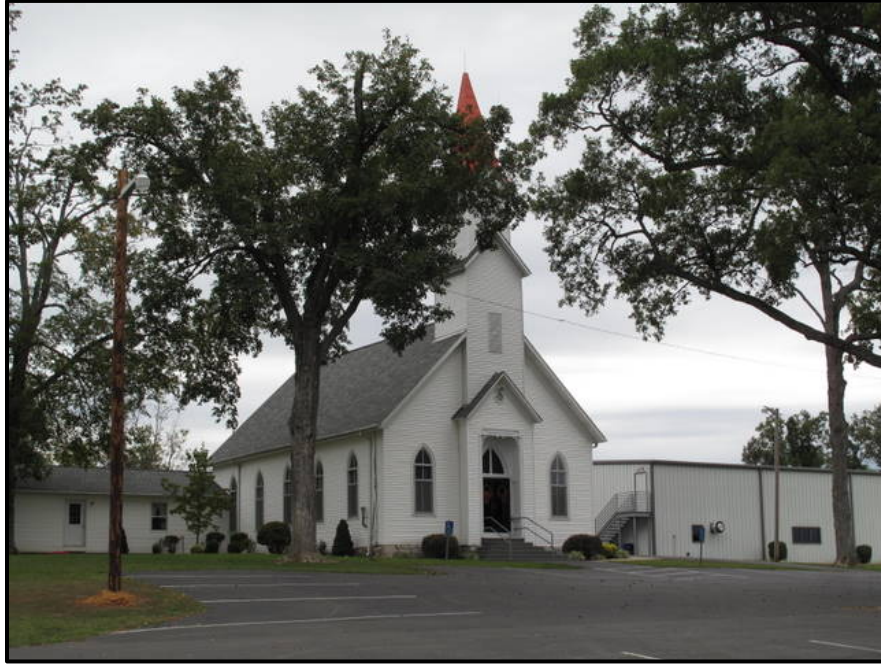
Figure 5. 35 *Pinckneyville Baptist Church (LV-84).*

Pinckneyville Baptist Church (LV-84) in Livingston County was organized in 1852. T. C. and Mary Elizabeth Guess donated four acres of land and \$50.00 worth of lumber for the current church building in 1886. The total cost of construction was \$1,646.10.¹⁴ The frame, front gable church rests on a stone foundation and has a three bay wide façade, with pointed arch windows flanking double entry doors (Figure 5.35).

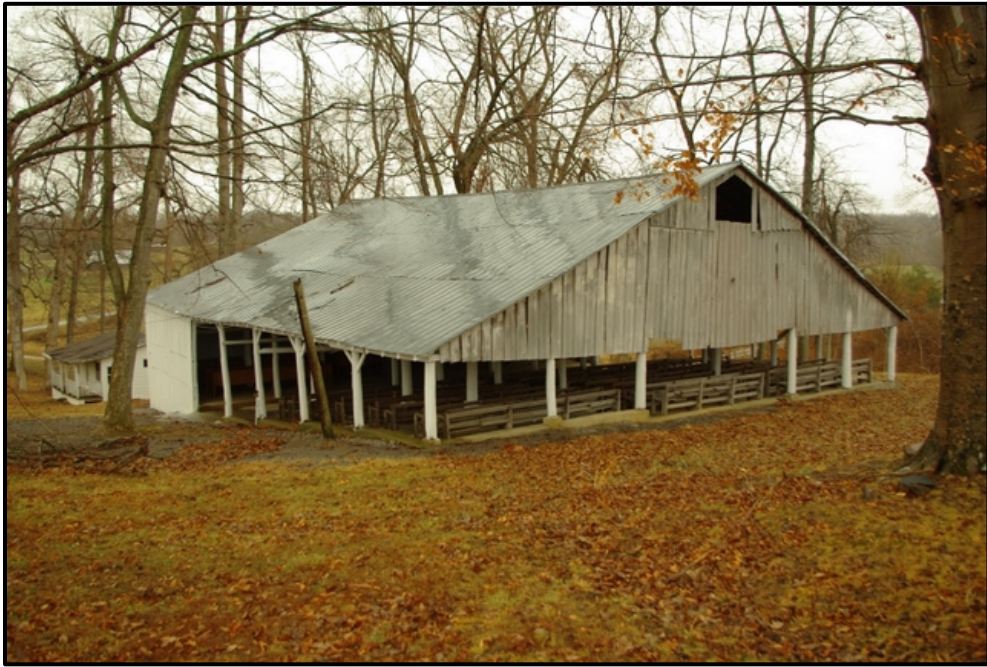
Figure 5. 39 *Circa 1920 open –air shed at Hurricane Camp (CN-25).*

Hurricane Camp, organized in 1889, is located in northern Crittenden County near Tolu. Though the meeting dates to the late-nineteenth century, Hurricane Church was established in 1843. The meeting grounds are extensive (Figure 5.38). The camp, still operating each summer, has a very large shed (Figures 5.39 and 5.40) and church (Figure 5.41) both of which date to around 1920, built to replace earlier structures that burned. Frame and concrete block cabins (Figure 5.42) for camp attendees, a dining hall and a large cemetery complete the site.

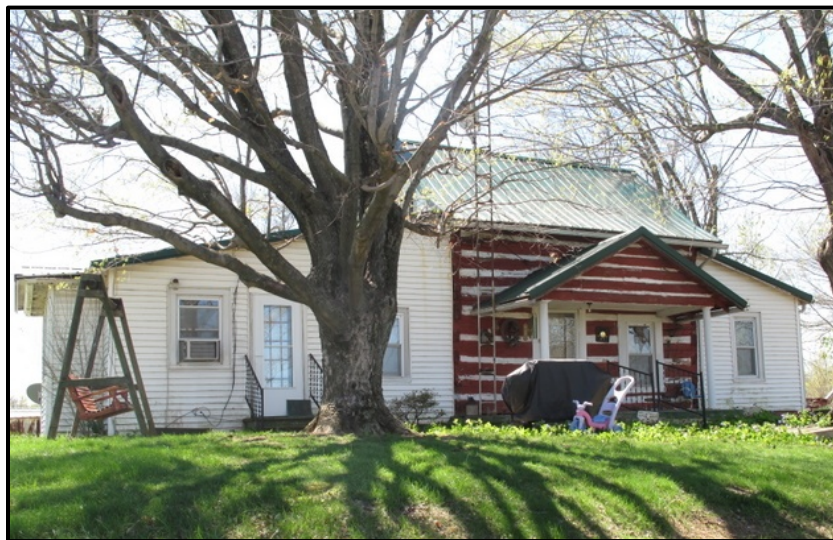
Figure 6. 1 *CN-33, a single pen log house with side frame additions.*

A single pen log house (CN-33) with exposed logs can be seen in Figure 6.1 It is not known how old this house is, but the smooth chinking between the logs (both logs and chinking have been painted) indicates that the logs were intended to be exposed. If the builder intended to cover the log house with frame siding after construction, the chinking would often be left somewhat rough and unfinished-looking.

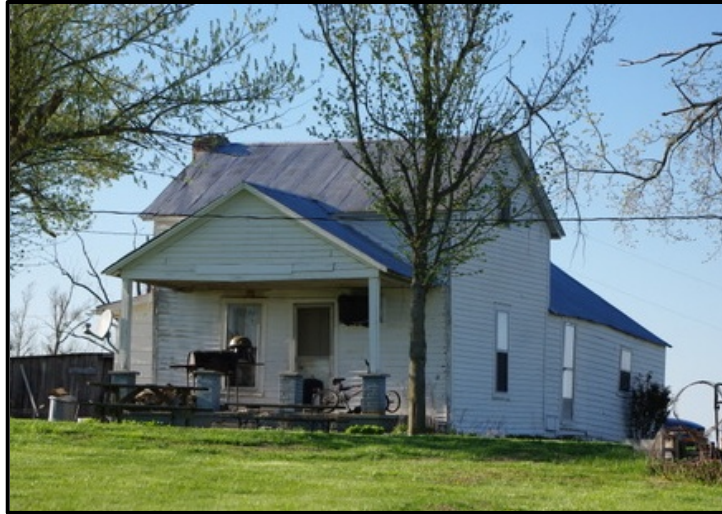
Figure 6. 2 *CN-44, a log pen with siding.*

Another one-and-one-half story log house (CN-44), this one clad in siding, was surveyed in southeastern Crittenden County near the Caldwell County line. This example also has a two-bay wide façade like CN-33 and a front gable porch. The additions, however, extend to the rear of the main house, forming an “ell” shaped arrangement.

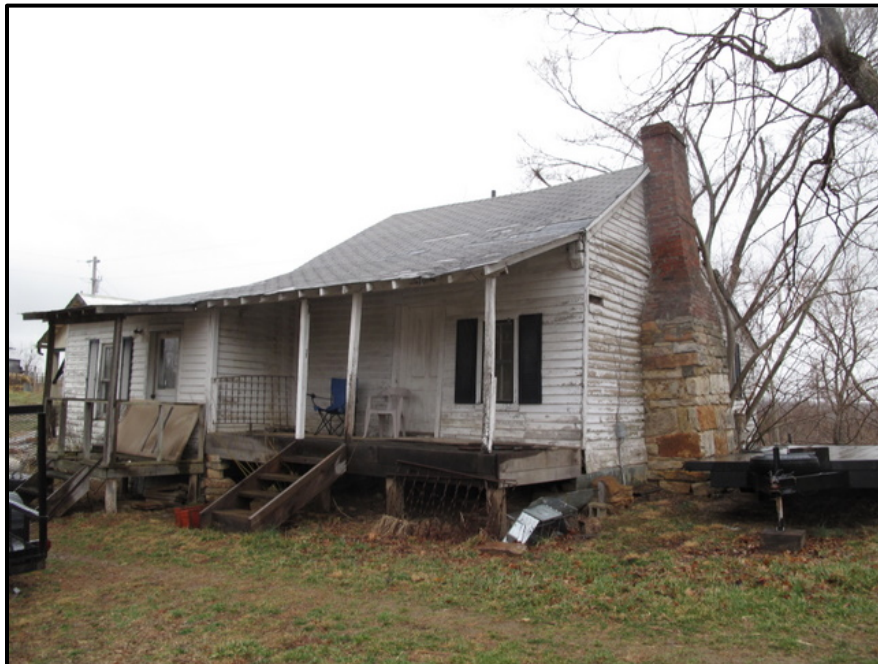
Figure 6. 3 *The log house at the Underdown Farm in Crittenden County, CN-67.*

The Underdown log house (CN-67) illustrates the single log pen with siding and with its shouldered gable end chimney, here handsomely executed from sandstone and brick (Figure 6.3). According to Brenda Underdown, the house was built in the 1830s or 1840s. One clue to its log construction is the projecting end wall plate visible on the top right hand side of the façade of the house. The façade of the log pen is two bays wide, a door and window, like the other examples. A frame addition extends out from the log pen on the northwest side; the porch on that frame addition has been enclosed.

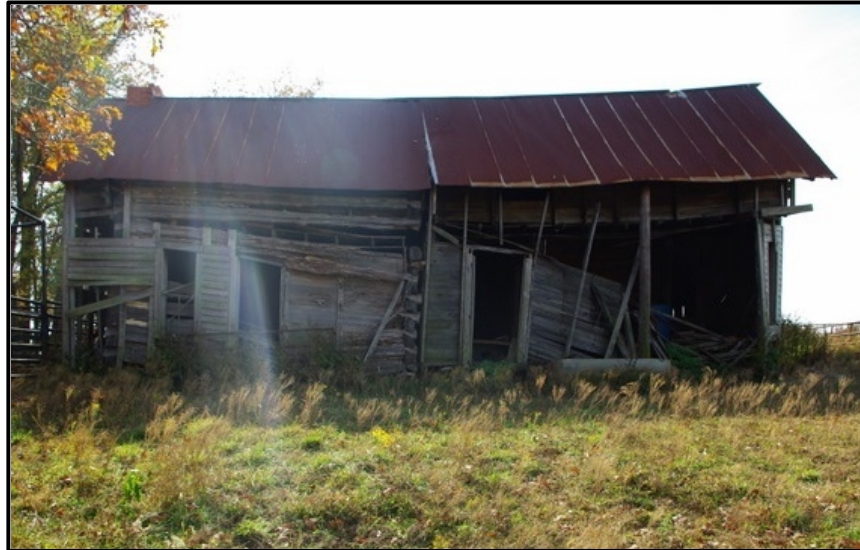
Figure 6. 4 North elevation of LV-65; log pen is on left in the photo.

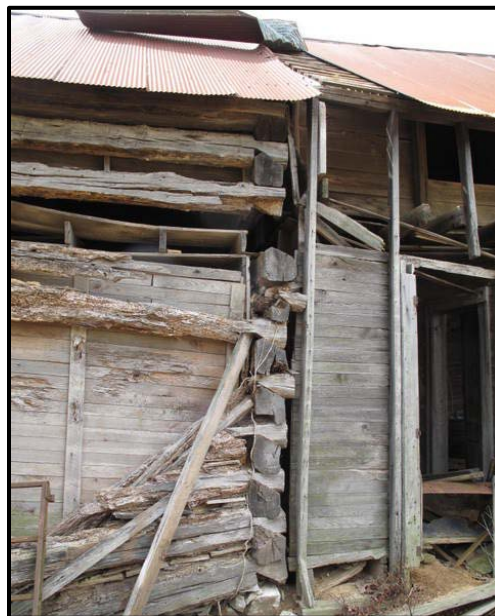
Figure 6. 5 Intersection between the log and frame pens, LV-65.

Another example of single log pen with frame additions was documented at the Jones Farm in Livingston County (LV-65, Figure 6.4). This single pen log house dates to the late-nineteenth century, possibly the 1880s. The house is sadly quite deteriorated, but the deconstructed state makes it possible to track the evolution of additions and changes to the original log pen. The log pen, with V-notched logs, is on the east side and faces north (Figure 6.5). The frame section, added between 1897 and 1912, extends to the west, and is divided into a stair hall and one room. The west gable end of the frame addition consists of canted bay with two windows (Figure 6.6).

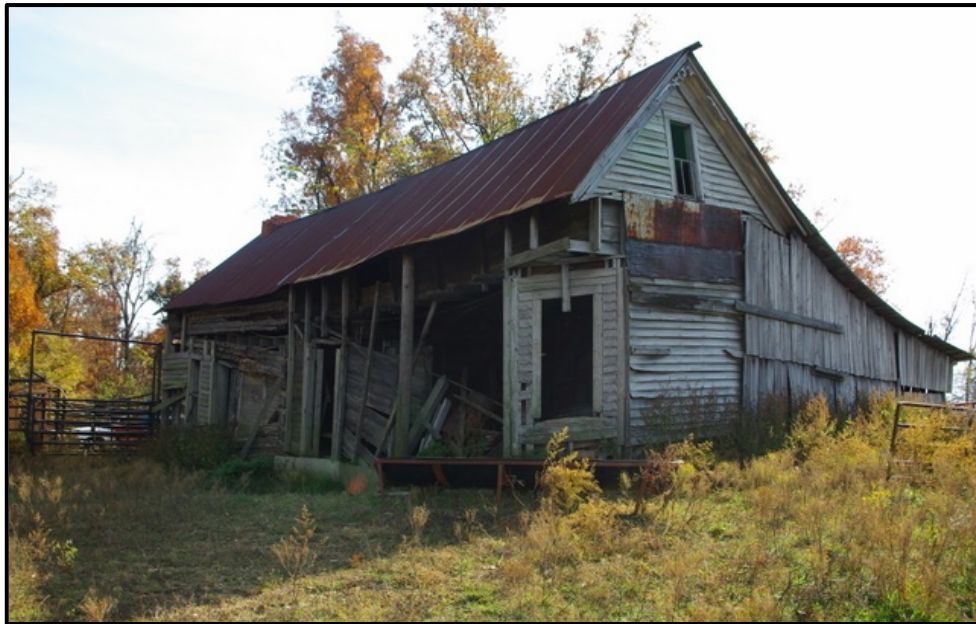
Figure 6. 7 *LV-65, looking at the frame pen in the foreground.*

Interestingly, the exterior gable end brick chimney on the log pen sits inside a balloon-framed exterior wall, which obscures most of the stack (Figure 6.7) This might have been done to camouflage the exterior stack at a period when interior stacks were more fashionable, or done to create additional storage space. The space on the south side of the stack was accessed from a door in the rear shed addition; it does not appear that the space on the north side of the stack was accessible.

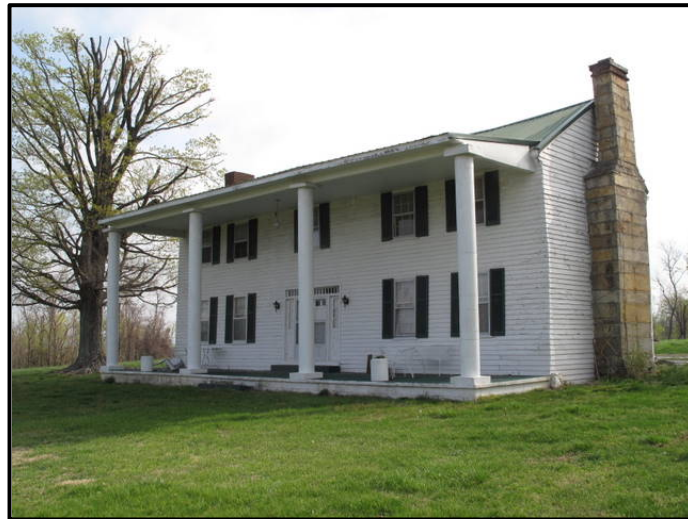
Figure 6. 9 *The W.E. Chipps House (LV-73).*

Larger-scale log houses also expanded via frame additions, such as the Chipps House (LV-73) in Bayou (Figure 6.9). This home began as a two-story single pen, but from all outward

appearances, looks like a two-story, five bay wide frame central passage or “I” house. The central doorway on the five-bay wide façade features double four panel Greek Revival doors with a glass occupying the top two panels. It is not known whether this was original or alter modification. An 18-light transom stretches across the top of the door surround, while three sidelights above an inset panel flank either side (Figure 6.9). First floor windows are six-over-nine double-hung sash, and the second story are six-over-six double hung sash. The two-story portico dates from the 1950s.

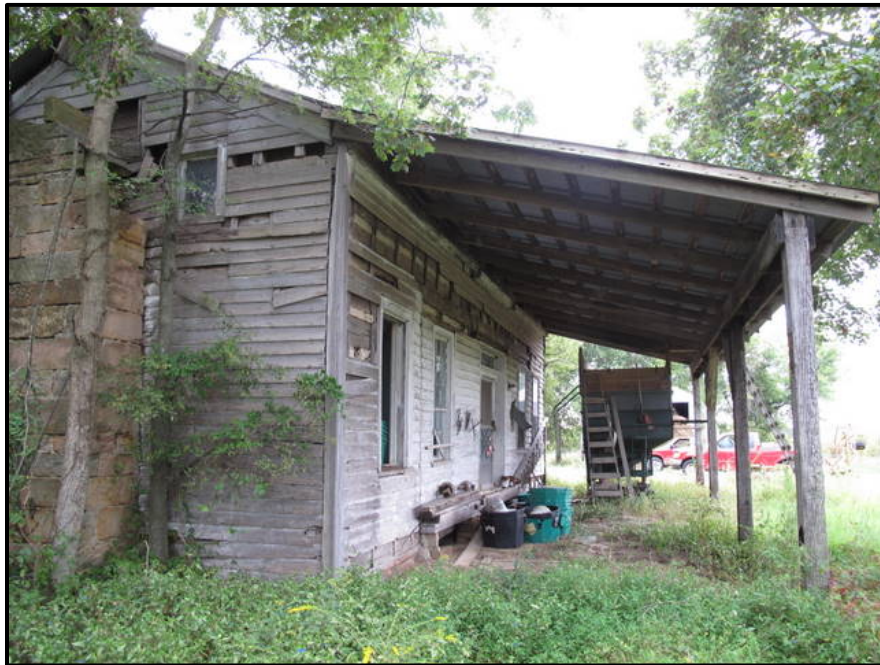
The dogtrot of this resource has been framed in and functions as a central passage., though The façade of the house is not easily visible, since a shed roof overhang has been added to the west elevation to provide shelter for farm equipment (Figure 6.11). Stone gable end chimneys are located on either end of the dwelling. The one-and-one-half story house, clad in weatherboards, is a smaller version of the Chipps House. Windows on the five-bay wide façade are nine-over-six double-hung sash.

Figure 6. 11 *The north gable end and façade of the Duley House, LV-81.*

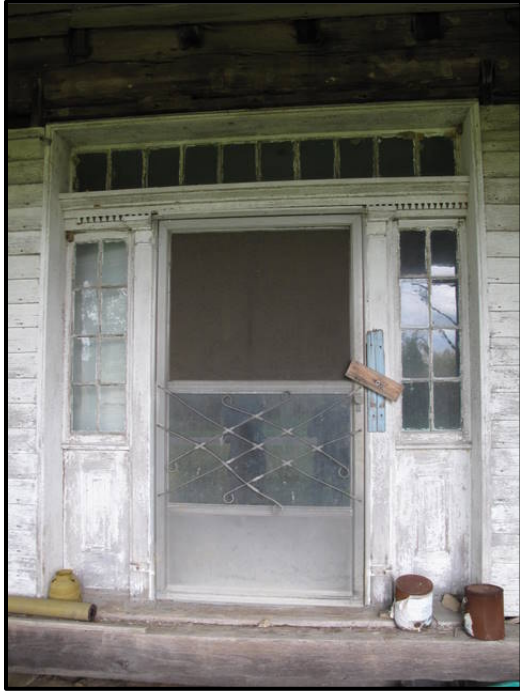
The central entry door, a five-panel Greek Revival style door, features an inset door surround with a ten-light transom and eight-light sidelights above an inset panel (Figures 6.12 and 6.13). Pilasters flank the door. A curious detail is the denticulation above the sidelights, which appears interrupted by the sidelights and does not continue all the way to the jamb on the left-hand side.

Figure 6. 12 *Detail of central entryway, LV-81.*

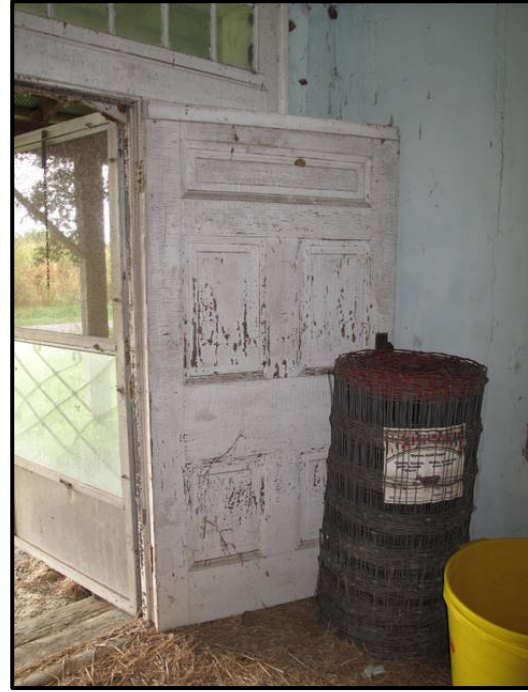
Figure 6. 13 *Detail of five-panel door, LV-81.*

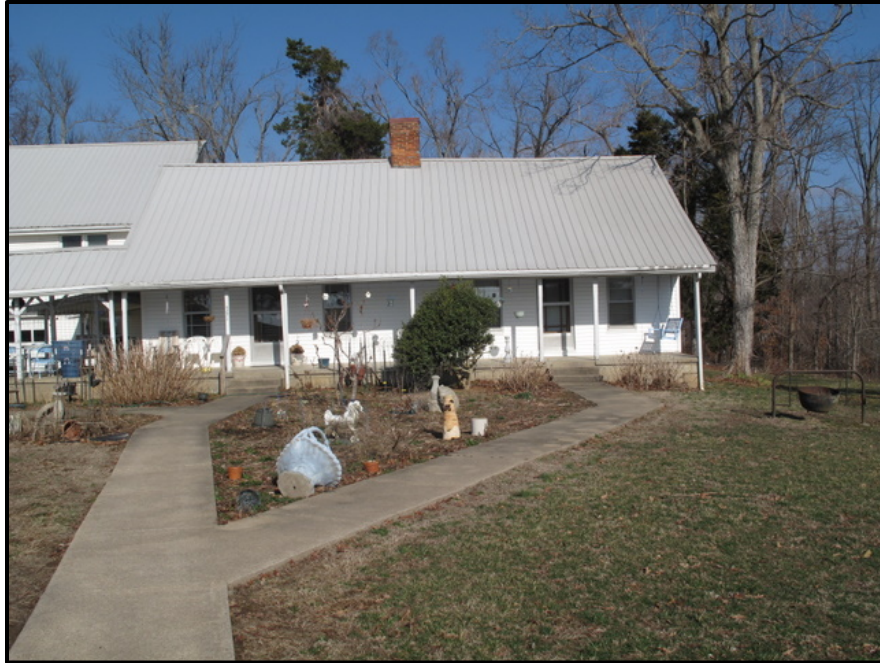
A saddlebag house consists of two log pens on either side of a central chimney. One example of a saddlebag house in the survey area is the house at the former Margaret Jones Farm (LV-42, the log barn at this site was discussed in Chapter 3). The six-bay wide, one-and-one-half story dwelling is clad in vinyl siding (Figure 6.14). It has an interesting fenestration pattern that was observed on later frame, two-room plans, such as CN-30 (see Figure 6.27, page 226). The façade has a window/door/window/window/door/window pattern.

According to Mrs. Jones, there was originally no communication between the two rooms, and the winder stair now located beside of the chimney stack in the left-hand room was added to replace a stair located on the exterior porch. She also stated that pieces of a newspaper from 1835 were found on the wall in the loft portion of the house. A modern, two-story addition with a two-car garage on the first floor extends to the west of the original log dwelling. A frame ell addition extends to the north.

Figure 6. 14 *Saddlebag dwelling at the Margaret Jones Farm (LV-42).*

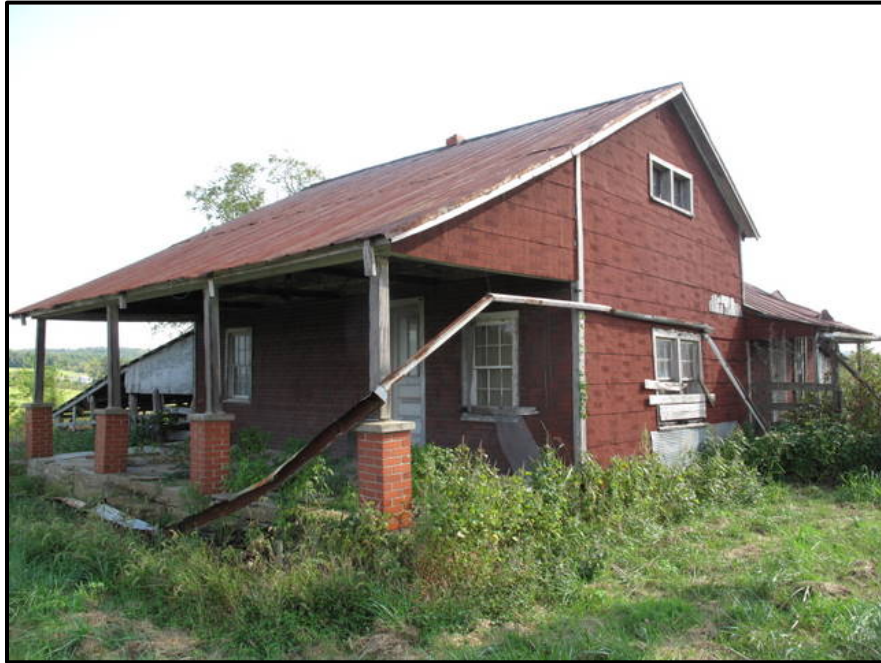
While log construction was supplanted by timber frame construction in the more populous and urban parts of Kentucky by the 1840s, in rural, heavily-wooded areas, such as Livingston and Crittenden counties, it could persist into the late-nineteenth and even early twentieth century. Some of the surveyed log houses in the survey could date from the early twentieth century; Mr. Wm. Ralph Paris remarked that when he was young “three-quarters of the houses were log. People wanted to build little boxy houses that were easy to heat.” The double pen log house on the Flannery Farm (CN-26) has been reused as a barn, but appears to date from the late-nineteenth or early twentieth century (Figure 6.15). No discernible evidence of a large chimney exists, only a flue for a stove, which indicates at the least a post-Civil War construction date. The finish of the logs and the milled lumber also indicate a later period of building.

Figure 6. 15 *Late log house, CN-26, in Crittenden County.*

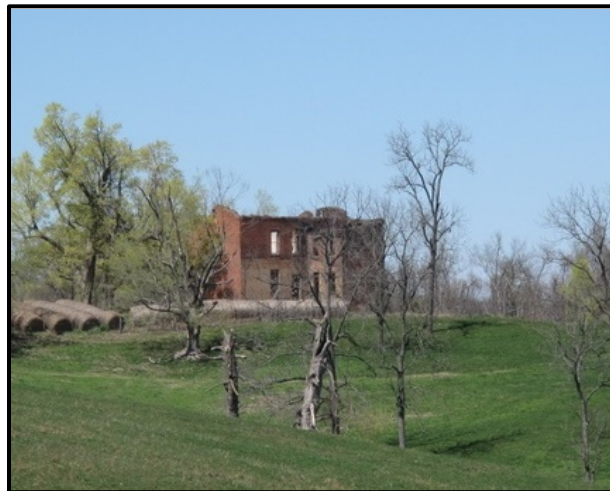
Only one masonry building was recorded in Crittenden County; the old Harris Place (CN-34) is located on Route 135 and is perhaps more accurately described as a ruin than an extant resource (Figure 6.16). Historically known as “Westwood,” the two-and-one-half story brick house was built by the Wallace family. Given the deteriorated condition, it is hard to surmise much about its original condition; a painting of the house in better days is on page 218.

Figure 6. 16 *Harris House in Crittenden County (CN-34).*

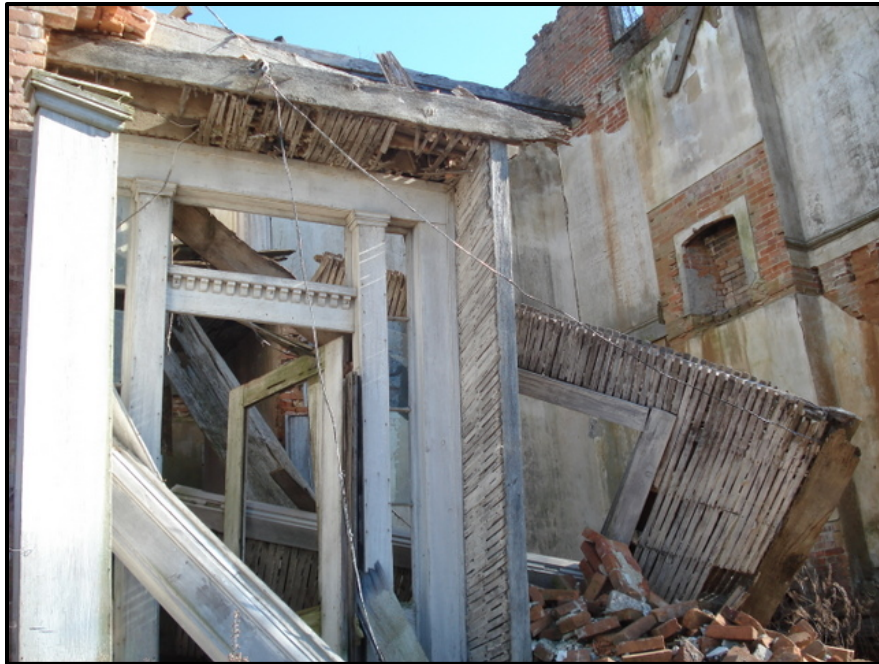
Figure 6. 17 *Remains of an entryway at Westwood, CN-34.
Photo by Kathleen Guess.*

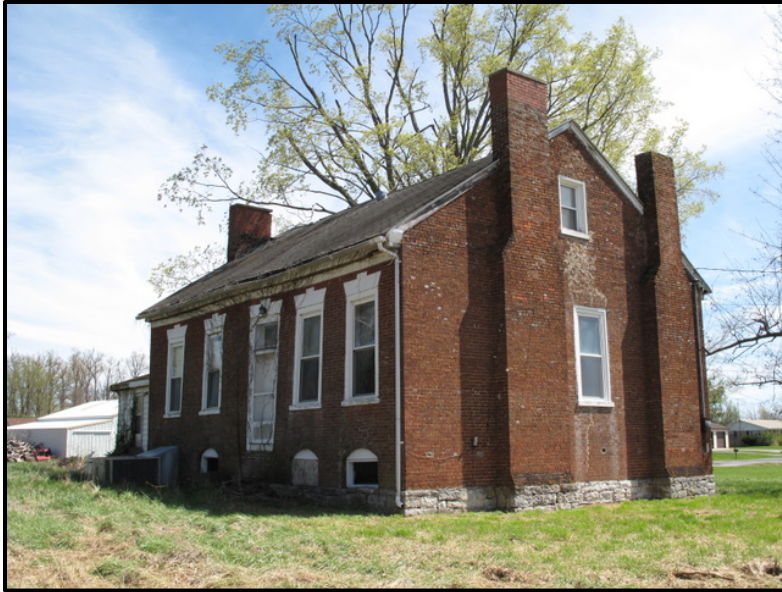
The treatment of the five-bay wide façade is much more elaborate, with keystone lintels above the windows and segmental arched basement lights (Figure 6.20). Cove moldings highlight the windows and doors, and the sills are dressed stone. Local history recounts that the house was built in 1824 by Richard Caldwell, “almost on the same architectural design as the Old Kentucky Home...”¹² Federal Hill (NEB-1), known as “My Old Kentucky Home” is a Federal-era house in Bardstown, Kentucky. The resemblance appears to be superficial - both houses date from the Federal period, are double-pile and are laid in Flemish bond. Federal Hill stands two stories high, has a central passage plan and the façade is seven bays wide.

Figure 6. 21 *West and north (original façade) elevations of the Alvis House (LV-55).*

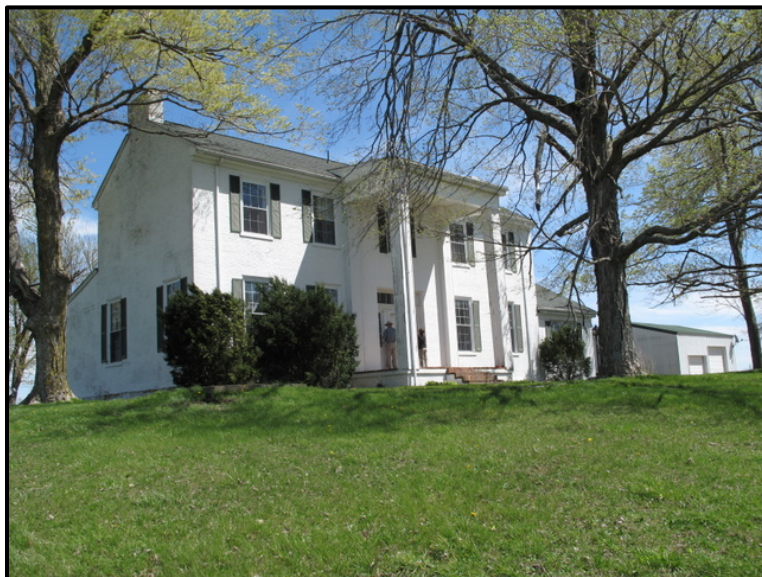
The Richard Miles House (LV-56), a two-story, central passage brick house, dates to the 1830s (Figure 6.22). The five-bay wide house with a two-story portico, has interior gable end brick chimneys and Greek Revival detailing (Figure 6.23).

Figure 6. 22 *Richard Miles house, LV-56.*

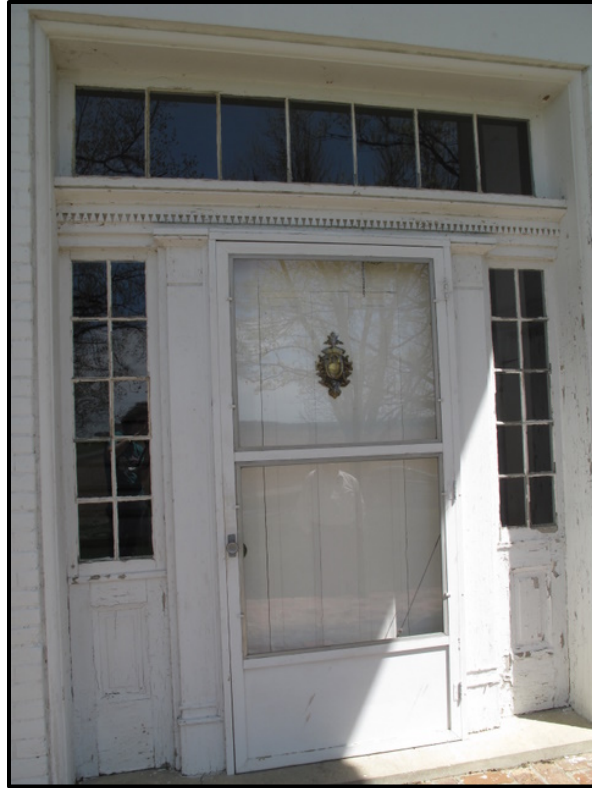
Figure 6. 23 *Central entryway, LV-56. The use of transom, sidelights, inset panels and denticulation is common of the vernacular Greek Revival expression in Livingston County.*

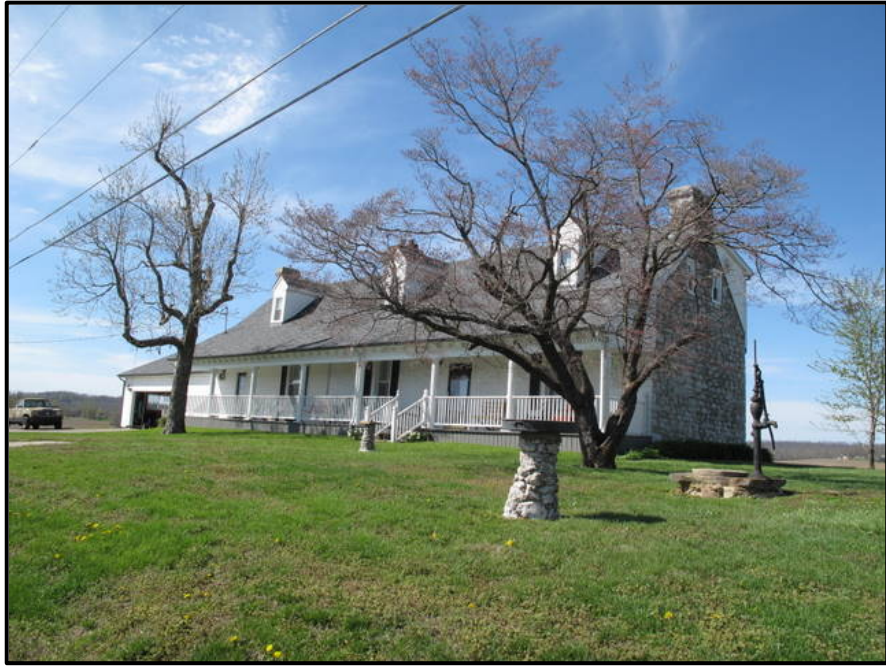
Only one stone resource was included in the survey, the Butler House (LV-60). The dwelling, originally a hall-parlor plan, has been modified several times over the years, and modern modifications almost obscure the historic house (Figure 6.24). The walls are approximately three and one-half feet thick, and it was once the center of a very large farm, though it is now on a one-acre parcel. The interior does retain a few batten doors.

Figure 6. 24 *The Butler House (LV-60) in Salem.*

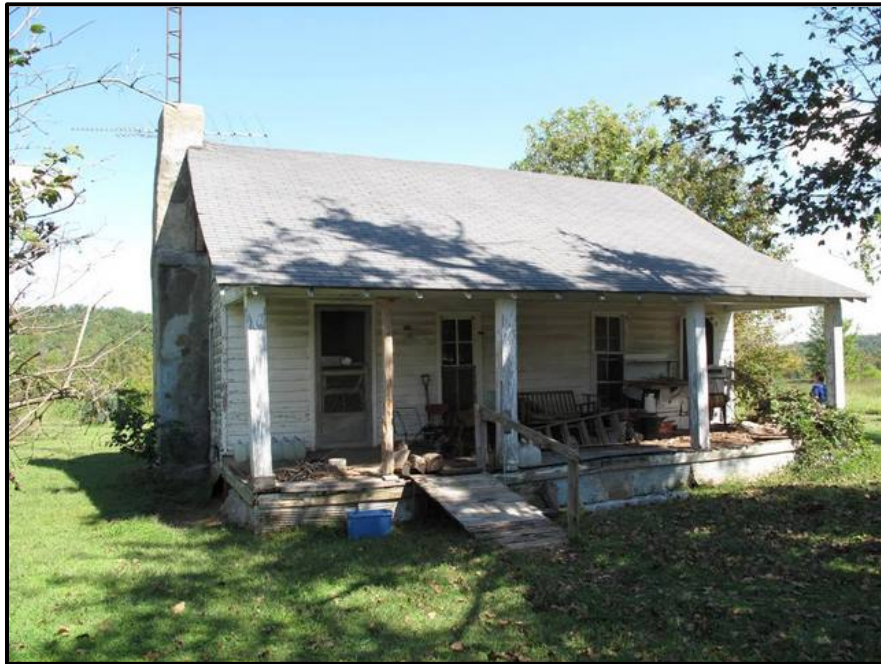
The majority of buildings documented in the survey were frame, most of them built with milled, sawn lumber with cut or wire nails. There were 210 frame buildings surveyed in the two counties. Most were either balloon frame, with stud wall construction (or platform frame), or box framing (no studs, with the wall itself – vertical boards – forming the structure). Figure 6.32 on page 229 illustrates a typical balloon frame structure. Some of the surveyed barns utilized mortise and tenon construction, together with nailed or bolted lumber, but only one house in the project area was identified as timber frame (CN-77, Figures 6.25 and 6.26). The one-story weatherboarded dwelling is four bays wide, with four-over-four double-hung sash windows. An exterior stone gable end chimney is located on the west gable end.

Figure 6. 25 *Two-room timber-frame house (could be log and frame), CN-77.*

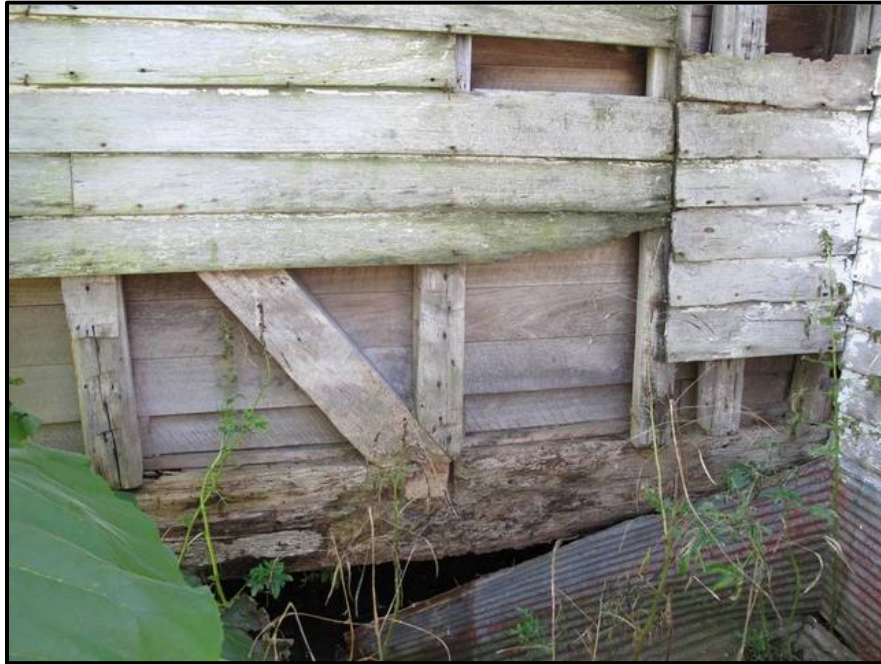
Figure 6. 26 *Detail of framing of CN-77 on rear elevation.*

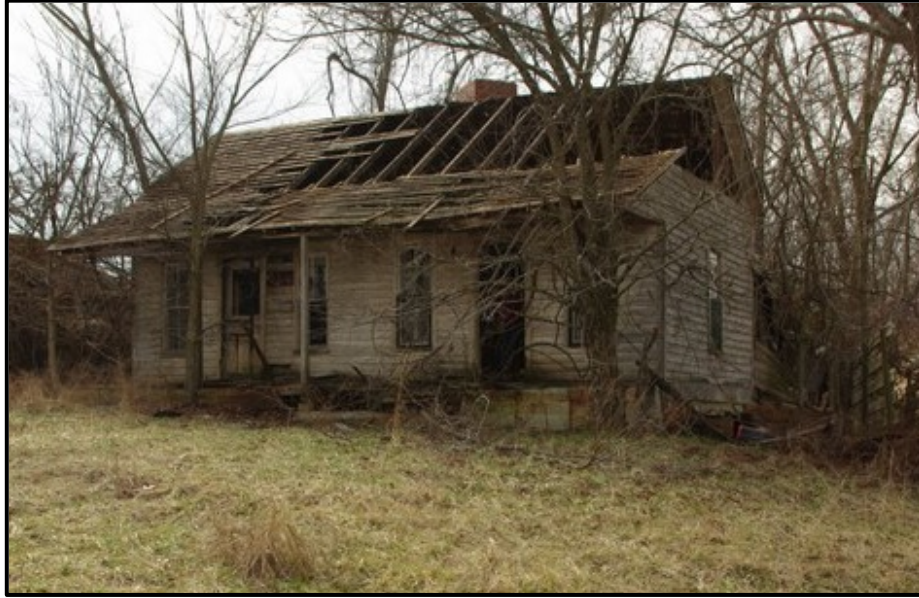
The late nineteenth century saw an increase in frame construction, largely due to the introduction of balloon framing. There were 32 frame houses surveyed in Livingston County and 18 in Crittenden County. The ease and affordability of this construction method allowed standard rectangular and square forms to be modified. Older house plans, such as a two-room house and central passages, also were constructed in frame. The two-room frame house pictured below (CN-30, Figure 6.25) has an unusual diagonal brick chimneystack that supports three fireplaces (Figure 6.26). Though the window/door/window/window/door/window façade fenestration of the house suggests a Cumberland House plan (see page 235), this resource adheres more to a two-room plan.

Figure 6. 27 *Façade of CN-30, a two-room house with diagonal brick stack.*
