A Survey of the Rural Resources of Crittenden and Livingston Counties, Kentucky

**Kentucky Archaeological Survey
Jointly Administered By:
The University of Kentucky
The Kentucky Heritage Council
Report No. 214**

KAS Report No. 214

February 2012

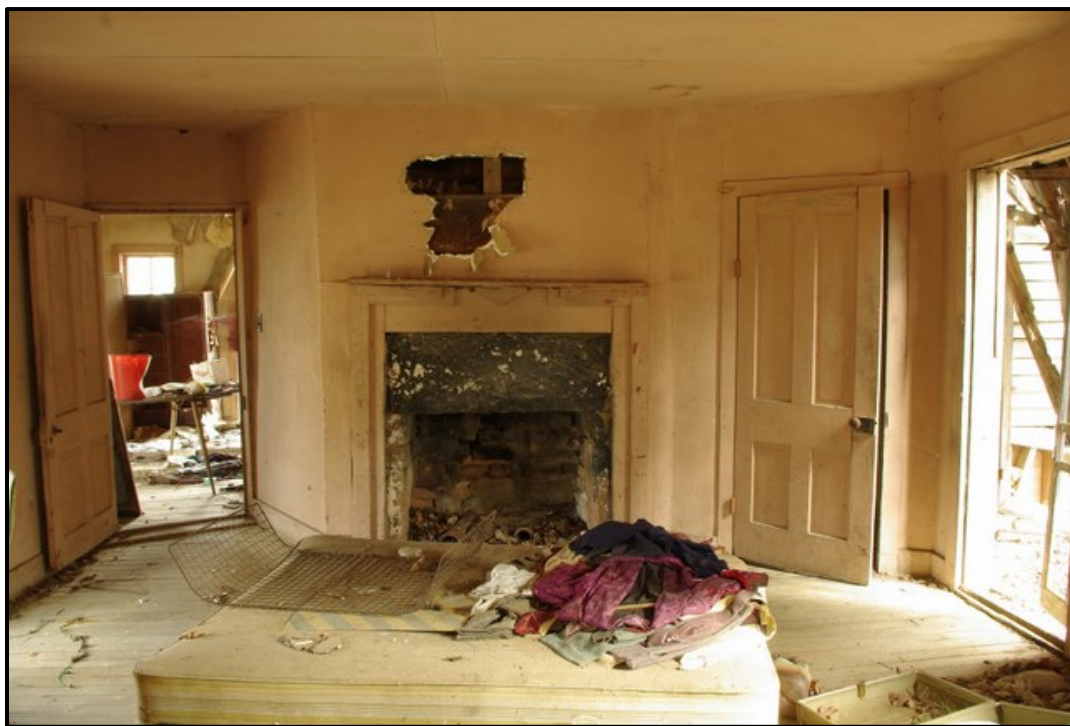
Figure 6. 28 *Interior of CN-30, right-hand side room, showing diagonal firebox.*

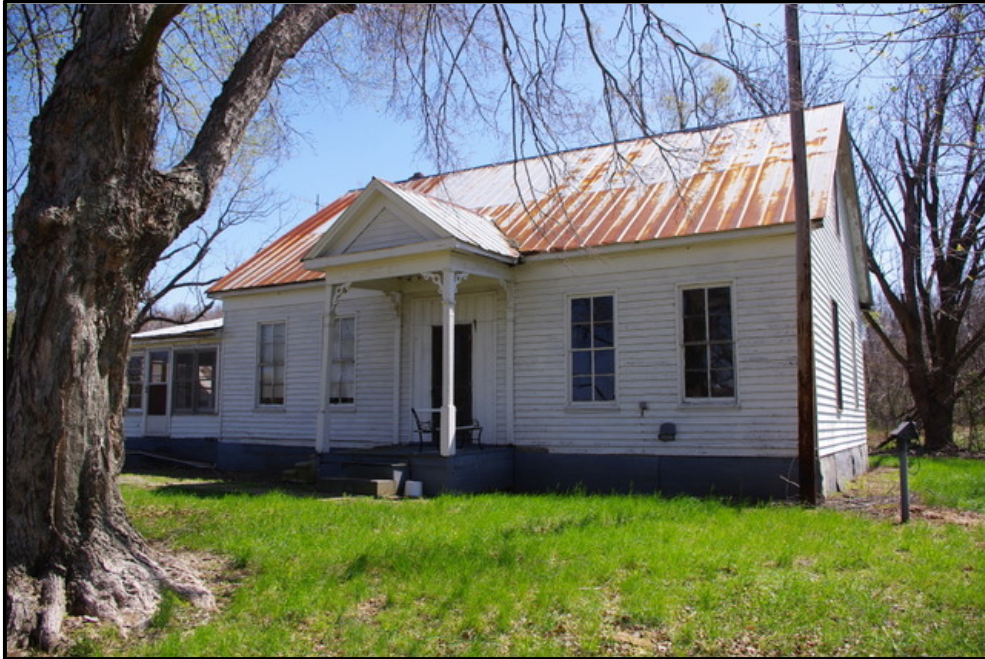
The Trimble House (LV-25) is a late-nineteenth century frame dwelling on River Road in Livingston County. It is likely a central passage plan, with a five bay wide façade (Figure 6.29). It appears that at one time the central entryway featured a transom and sidelights that have been covered over with siding. The front-gable portico has chamfered supports and delicate brackets.

Figure 6. 29 *Trimble House on River Road (LV-25).*

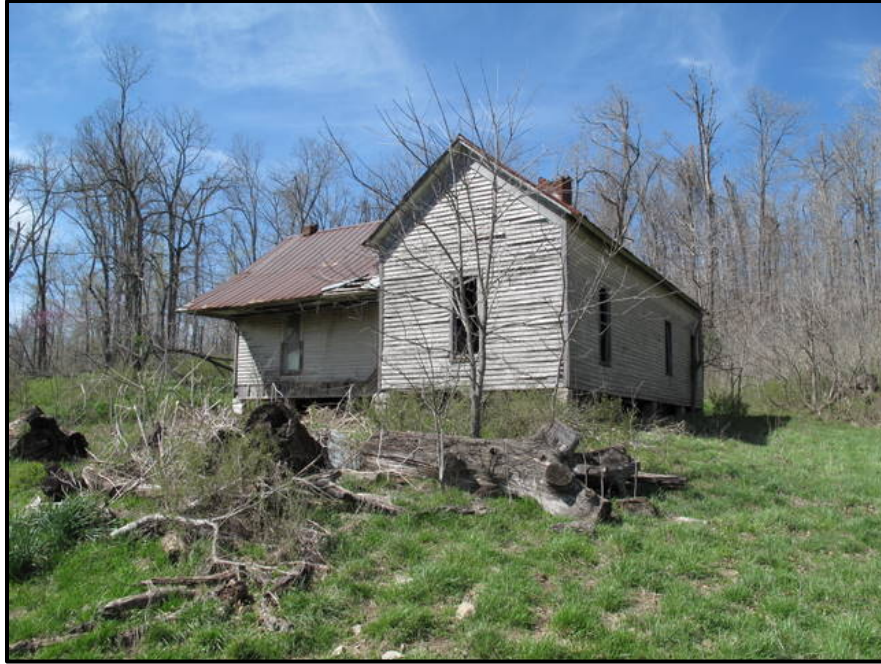
With the new framing techniques, T-plans and cross-plan houses became common, as did the addition of porches and decorative elements on a common house forms. The T-plan is a variation on the I-house – one of the rooms located along the central hall was moved forward, resulting in an irregular facade. This allowed the rooms in the ell to be accessed by the central passage. There were four T-plans surveyed in Livingston County, and only one T-plan surveyed in Crittenden County.

Figure 6. 30 *One-story T-plan dwelling on Bennett Road, Livingston County (LV-58).*

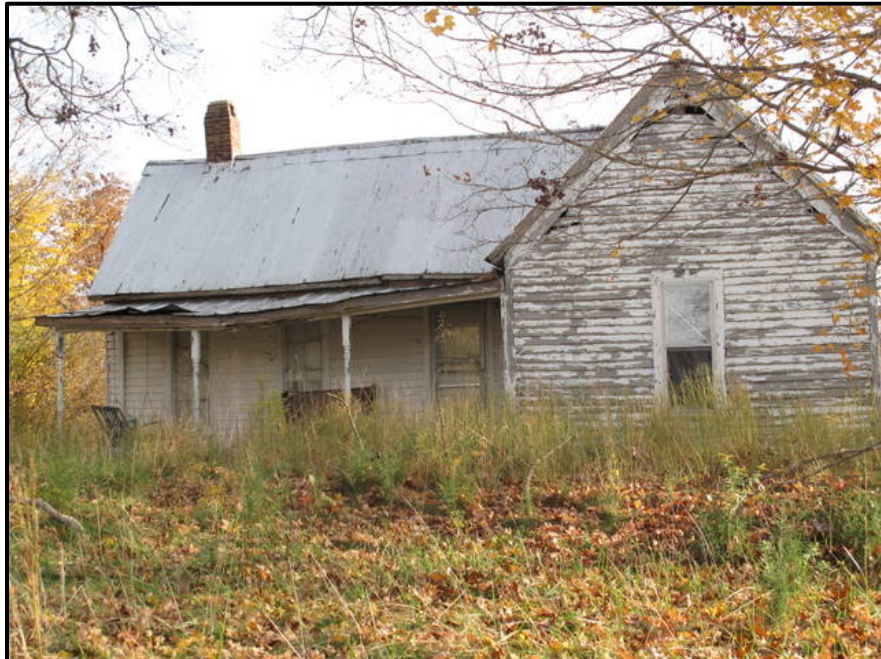
Figure 6. 31 *One-story T-plan dwelling near Sheridan, Crittenden County (CN-24).*

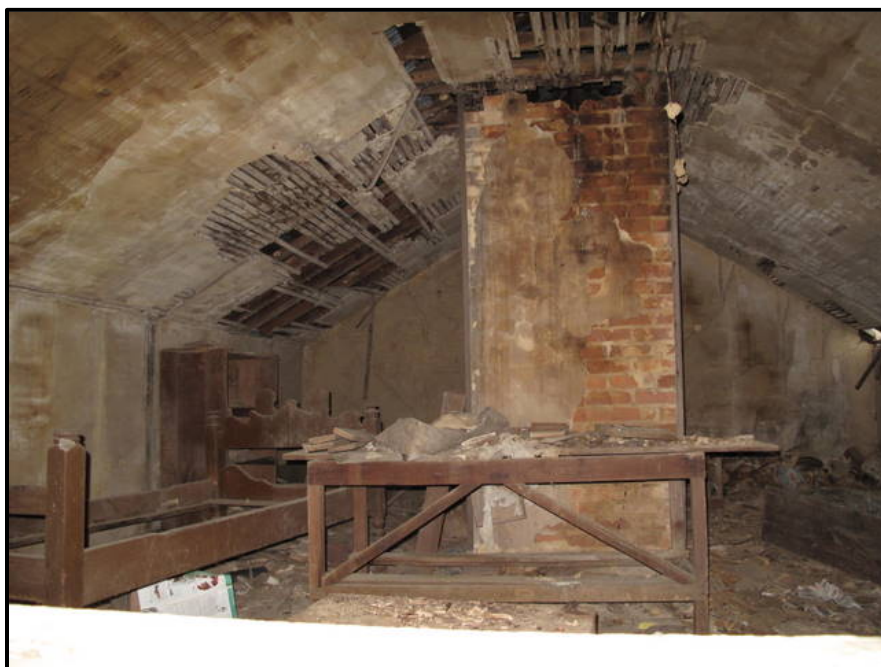
Figure 6. 33 *Interior stack on upper story of LV-83, east side of house.*

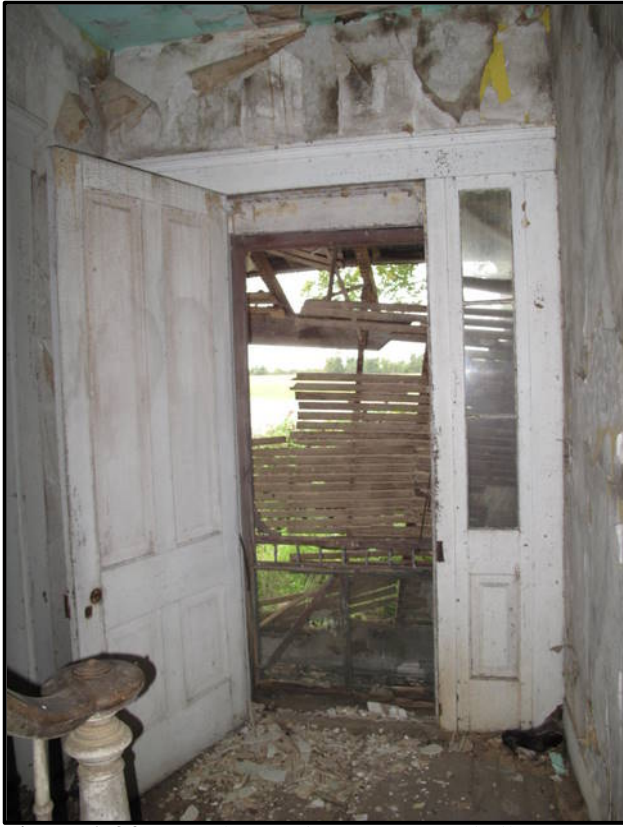
Though vacant and abandoned, the house is a fairly high-style representation of the way architectural trends, including Greek Revival and Italianate, were interpreted in rural areas. The wide gable ends feature cornice returns and a wide cornice board. The three-bay wide façade, sheltered by a centrally placed hipped roof porch (now obscuring much of the façade) has a panel entry door flanked by three-light sidelights set above inset panels (Figure 6.34). The woodwork is not elaborate, but ranges from entablature window surrounds to Greek Ear detailing (Figure 6.35). All of the four-over-four double-hung sash windows are set above inset panels.

Figure 6. 34 *Central entry door, seen from hall (LV-83).*

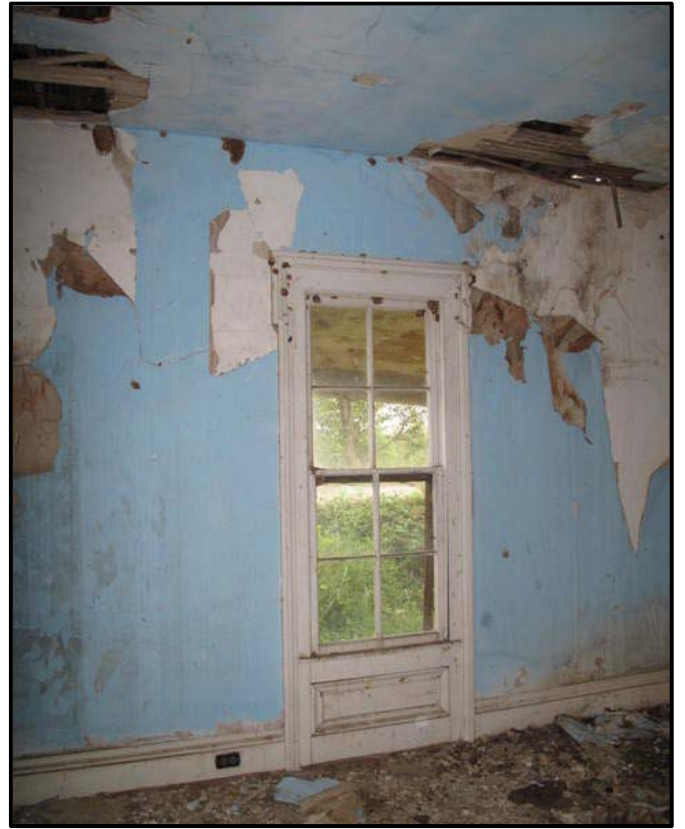
Figure 6. 35 *Window with Greek Ear trim (LV-83).*

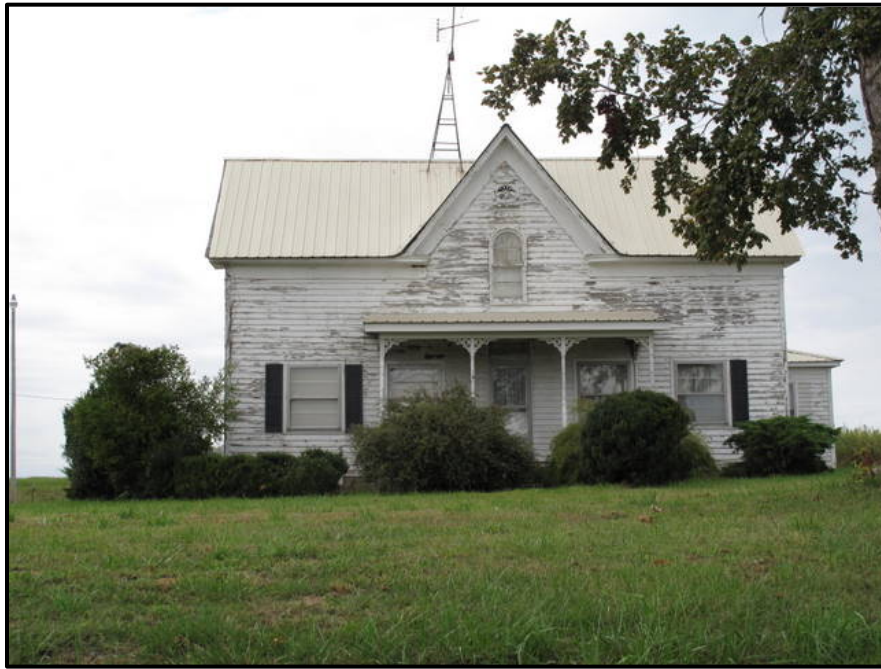
The Gothic Revival, along with the Italianate, was another style echoed in vernacular dwellings in the survey area. Many Gothic Revival houses in Kentucky do no more to echo the style with steeply-peaked cross gables on the façade. The plan of the house can be very basic, “one to two stories tall, a single room deep, and two or more rooms wide with one, two or three steeply-peaked cross gables or dormers. More often than not, the main part of the house is augmented with shed or ell appendages stretching behind them. Minus the front gables they have the same basic forms as many of the non-Gothic contemporary examples nearby, whatever their style might be.”¹⁴

Figure 6. 37 *Bradford Bussey House, LV-80, a vernacular Gothic Revival dwelling.*

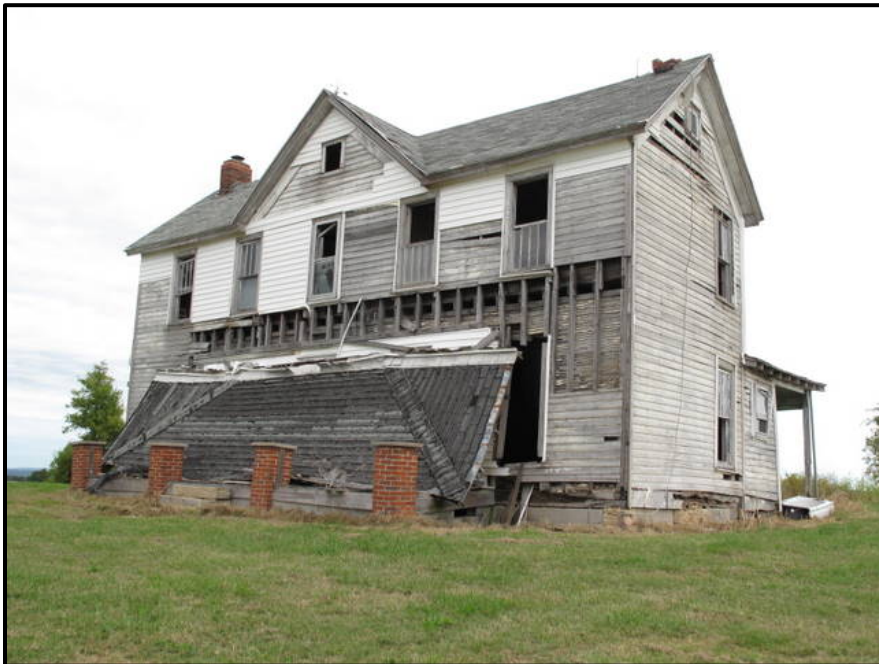
Figure 6. 39 *Ray House, LV-79, a two-story central cross gable Gothic Revival.*

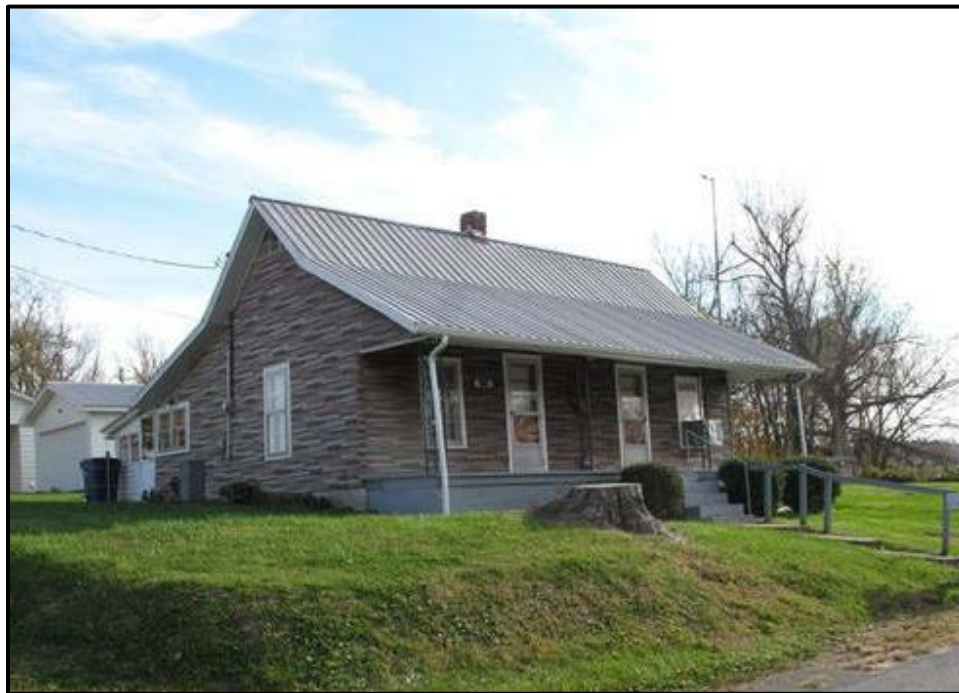
Figure 6. 41 *One of the Cumberland houses surveyed in Livingston County. The Martin Van Buren Fisher House (LV-108), in Lola, was built around 1900.*

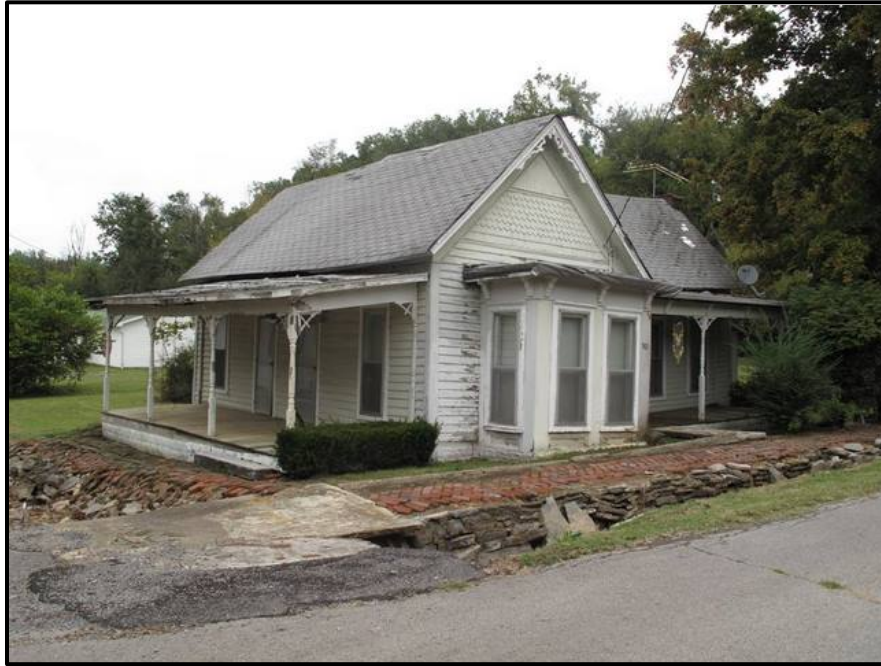
Figure 6. 42 Late-nineteenth century Cumberland in Dycusburg (CN-74).
The dwelling has Italianate and Queen Anne stylistic details.

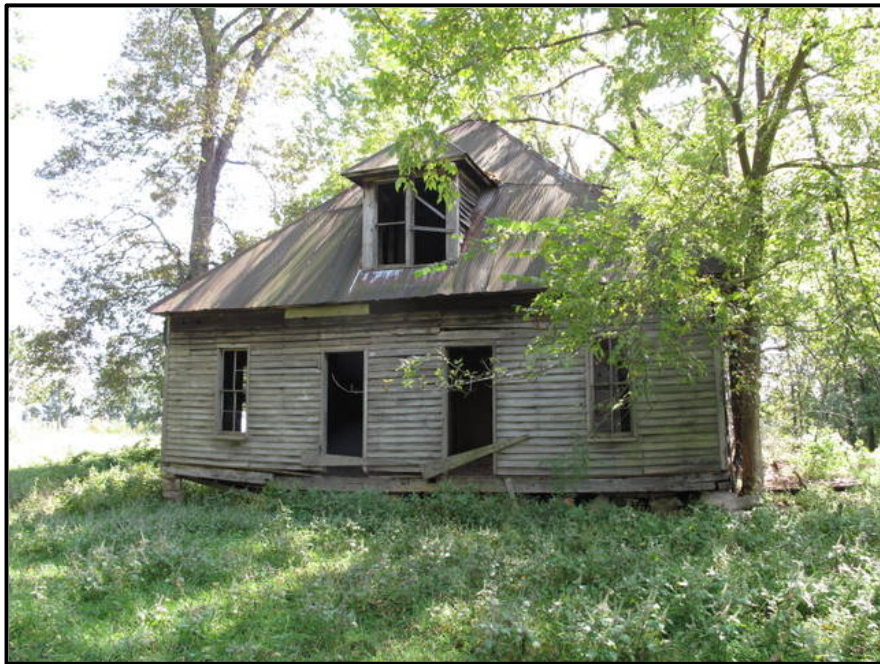
While many Cumberland houses lack stylistic details, (CN-74 is the exception to the rule), the two-front door house could be interpreted not only in the Craftsman style, as noted earlier, but in a number of ways. The pyramidal-roofed two-front door house surveyed on the John Boyd Farm (CN-66) in Crittenden County was utilized as a tenant house during Mr. Boyd's childhood. Resting on stone piers, the one-and-one-half story frame dwelling likely dates from between 1890 and 1920. Clad in weatherboards, the house has some hewn and mortise and tenon support members (sills). Given its deteriorated condition, access to the interior was not possible. Dormers light the upper story, and the windows are four-over-four double-hung sash (Figure 6.44).

Figure 6. 44 *CN-66, a two-front-door house in Crittenden County.*

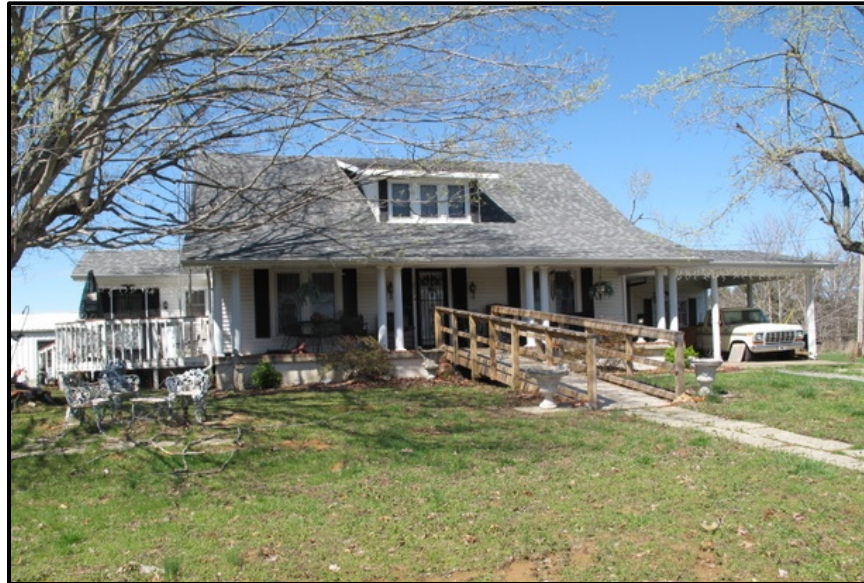
Henry Wigginton, the barn builder discussed in Chapter 3, is credited with building several bungalows on the farms where he also constructed barns. His own home, which he could have built, is a classic example of a rural bungalow (CNB-37, Figure 6.46). Another home in the Piney Fork area thought to be built by Wigginton is CN-35 (Figure 6.47).

Figure 6. 46 *Henry Wigginton House, a side-gable bungalow (CN-37) with additions.*

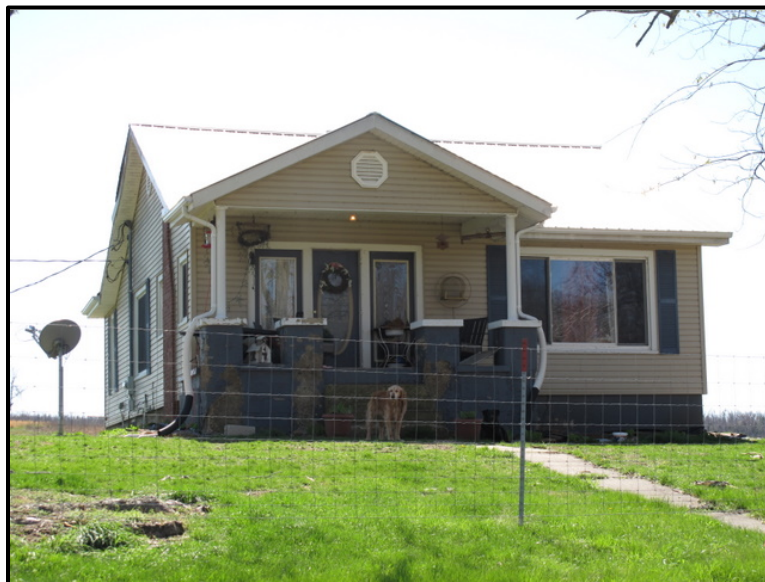
Figure 6. 47 *CN-35, a possible Wigginton-built bungalow in Crittenden County.*

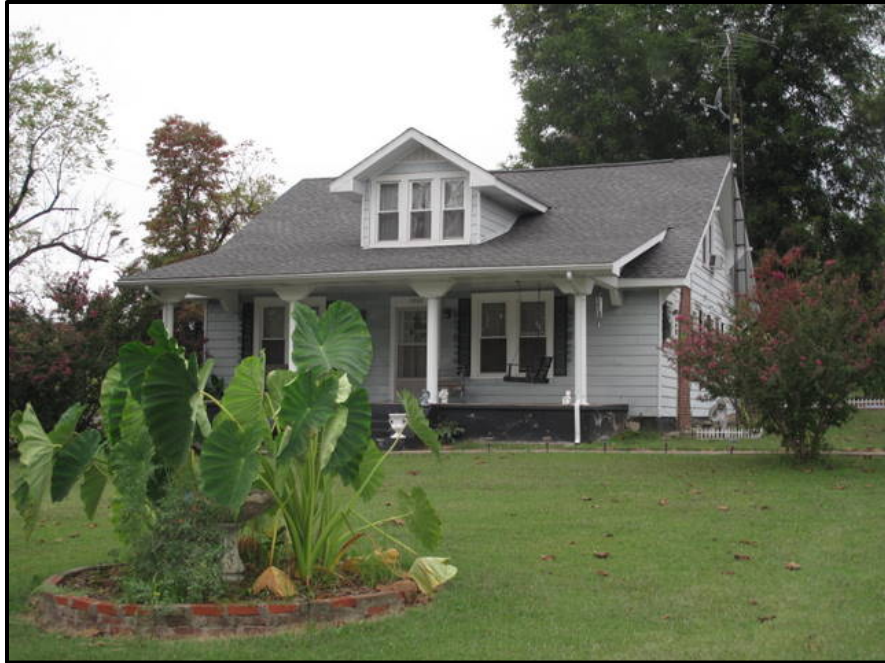
Figure 6. 48 *Bungalow in Frances (CN-57).*

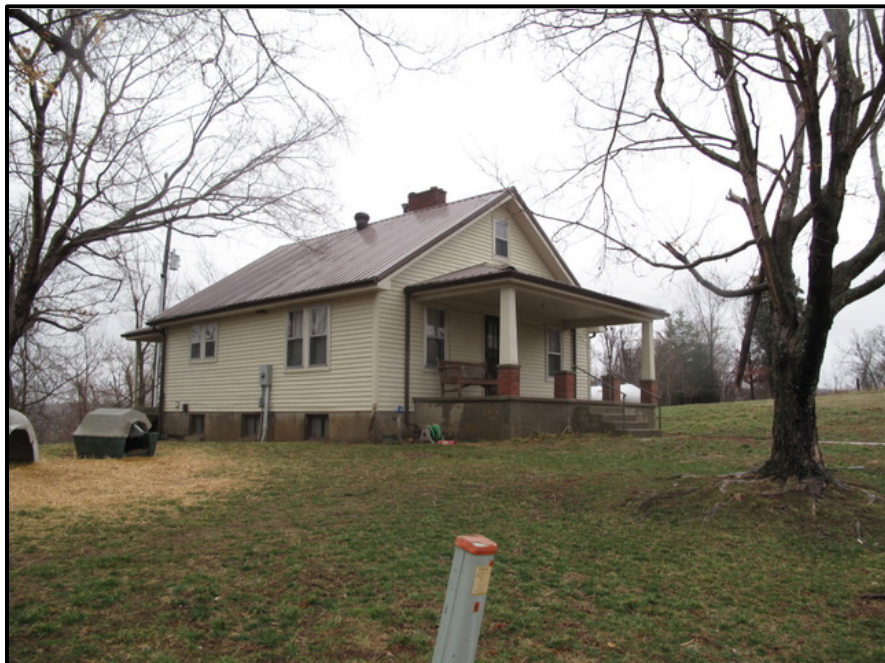
Figure 6. 49 *Southern-bungalow in Crittenden County, CN-67.*

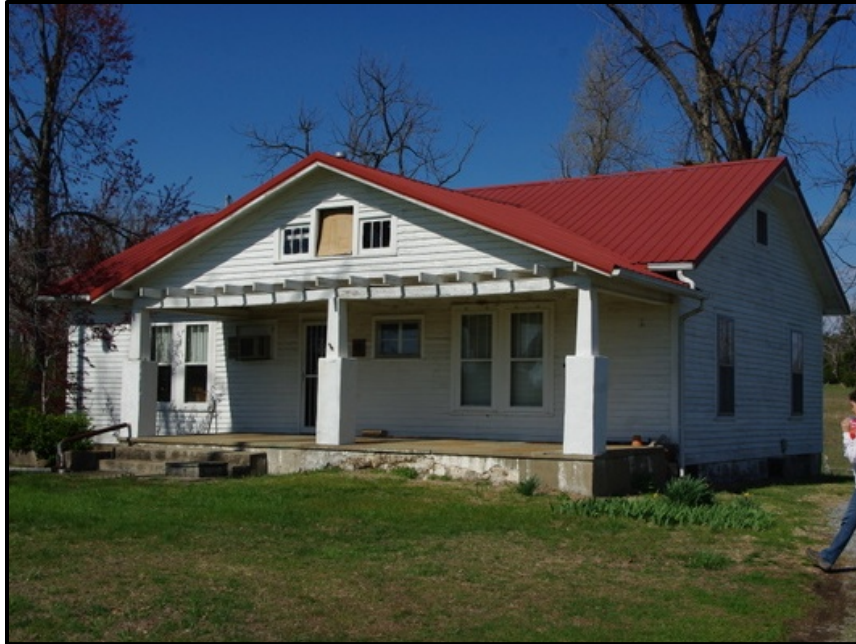
Figure 6. 50 *The Peter Paul Paris House (CN-41), a bungalow with distinctive Craftsman styling, was built on the foundation of an earlier house that burned in 1930.*

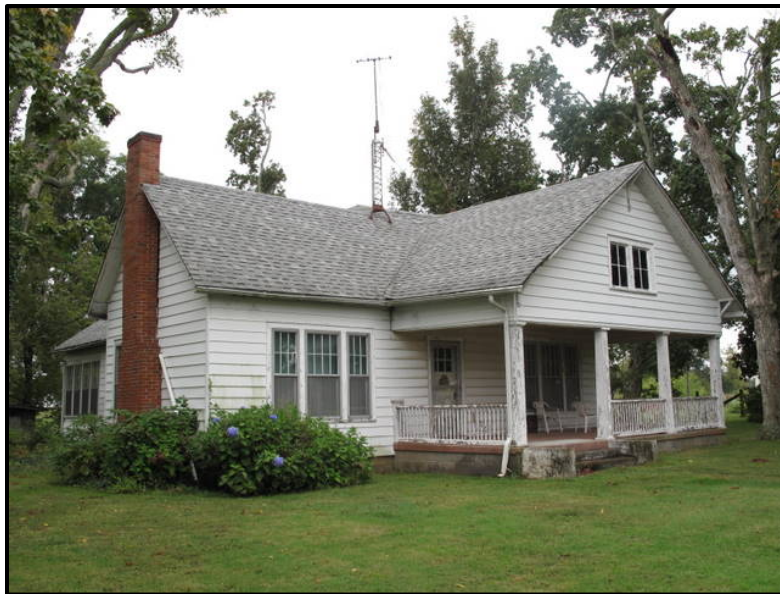
Sometimes houses in the survey area were remodeled with Craftsman-style windows and doors, or porches were added to give the house a “bungalow look.” Though not much background information was available on the Edward Davenport House (LV-90)in Hampton, it appears to be an earlier house that received Craftsman updates (figure 6.51).

Figure 6. 51 *Edward Davenport House (LV-90) in Hampton.*

The Edward Davenport house (LV-90) has many characteristics of the Craftsman style; in fact, from an brief glimpse at the façade only, it would certainly appear to be bungalow from the 1920s or 1930s. The large front-gable porch with brackets and three-part the multi-light over single light double-hung sash windows suggest the influence of the popular national style. The main house, though, is only one-room deep, though with an ell addition to the rear. A four-over-four double-hung sash window is located beside the chimney on the northeast gable end. It appears likely that the Edward Davenport House dates from the turn of the twentieth century and was a one-room deep, central passage or two-room plan that was updated in the 1930s or 1940s.

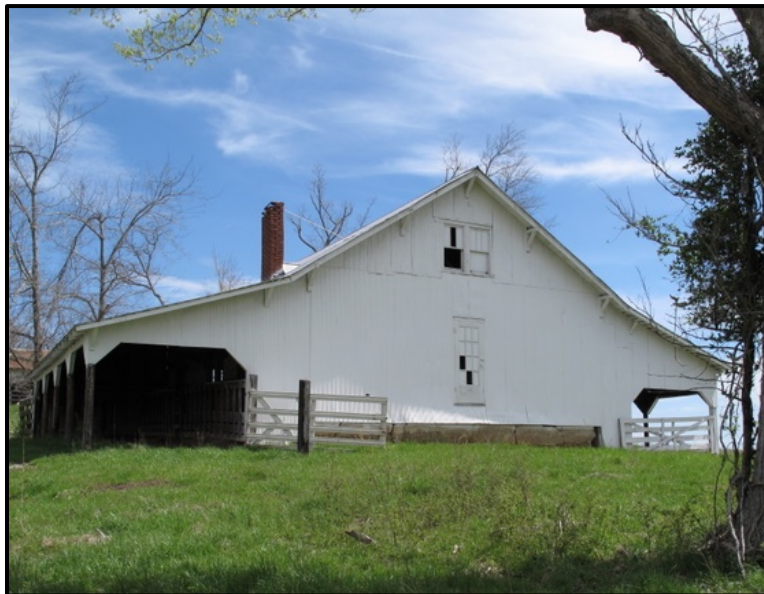
One of the more curious bungalows surveyed was LV-54, a frame, front-gable bungalow that has been adaptively reused into a barn (Figure 6.52). Though the fenestration (among many other things) has been altered, elements of the Craftsman style still visible include the multi-light front door, brackets at the gable on the façade, the brick chimney, and on the interior, the open, originally two-room wide plan.

Figure 6. 52 *Former dwelling on the Smith Farm, now used for farm purposes (LV-54).*
