# National Register of Historic Places Registration Form

Historic name: Magnus Metal Company Building

Other names/site number: KEL 105

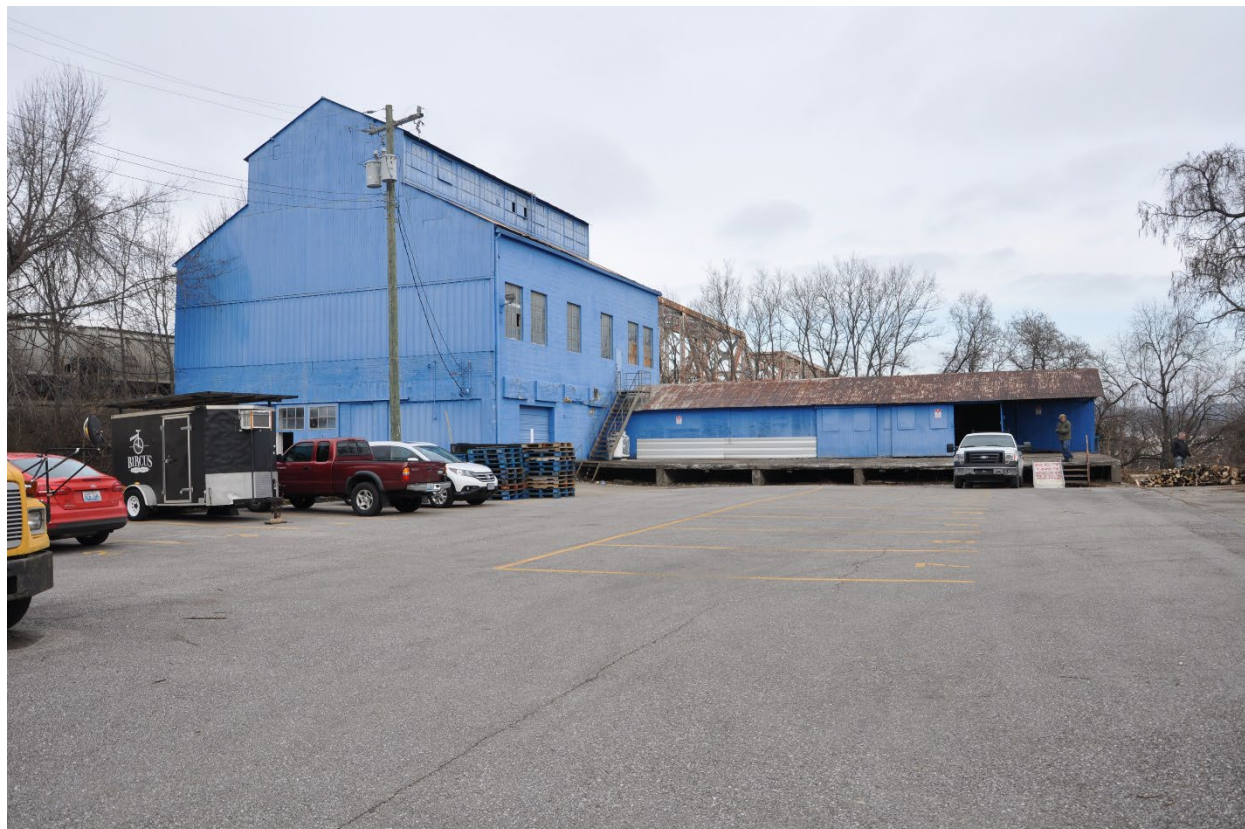
Figure 2: Façade (southwest) elevation of the Magnus Metal Company Building, looking north-northeast.

A long, rectangular addition constructed between 1933 and 1949 extends from the southeast elevation (see Figure 2). The addition rests on a concrete deck supported by concrete piers. It is clad in corrugated metal panels and sheltered by a side-gable roof covered with metal panels. The southwest (façade) elevation of the addition displays a single-leaf entry filled with a hinged, unglazed, metal panel door and two single-leaf entries displaying sliding metal doors on a horizontal metal tracks. The doors each display two solid metal panels which may cover original

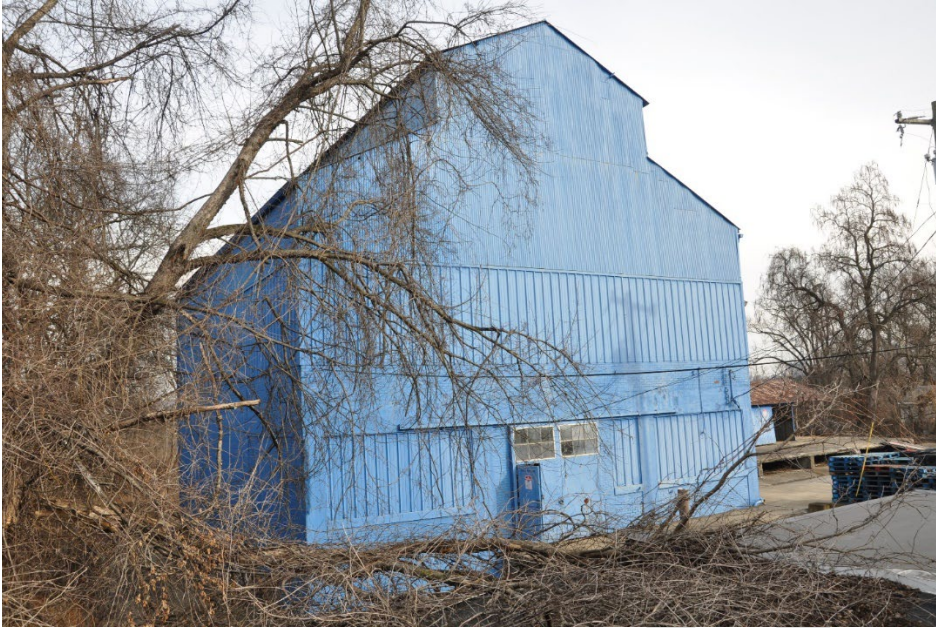
Figure 5: Façade (southwest) and northwest elevations of the main block of the Magnus Metal Company Building, looking southeast.

The northwest elevation displays a parged concrete foundation pierced by two louvered metal vents (see Figure 5). The elevation features brick along the first story, which is pierced by three large window bays filled in with concrete blocks. The southeastern bay is flanked with two sections of brick and features a metal sill. The two northwestern bays display concrete sills and rest over sections of brick. A full-width concrete belt is located over the filled windows, and concrete pilasters extend between the window bays to the parged foundation, framing the first-story fenestration. Above the concrete belt, a narrow section of brick cladding sheathes the elevation. The second story features a full-width section of metal panels covering the location of the original windows. Above, the elevation is clad in corrugated metal panels. The section of elevation located between the lower and upper portions of the monitor roof display a continuous ribbon of metal windows similar to the configuration on the southeast elevation.

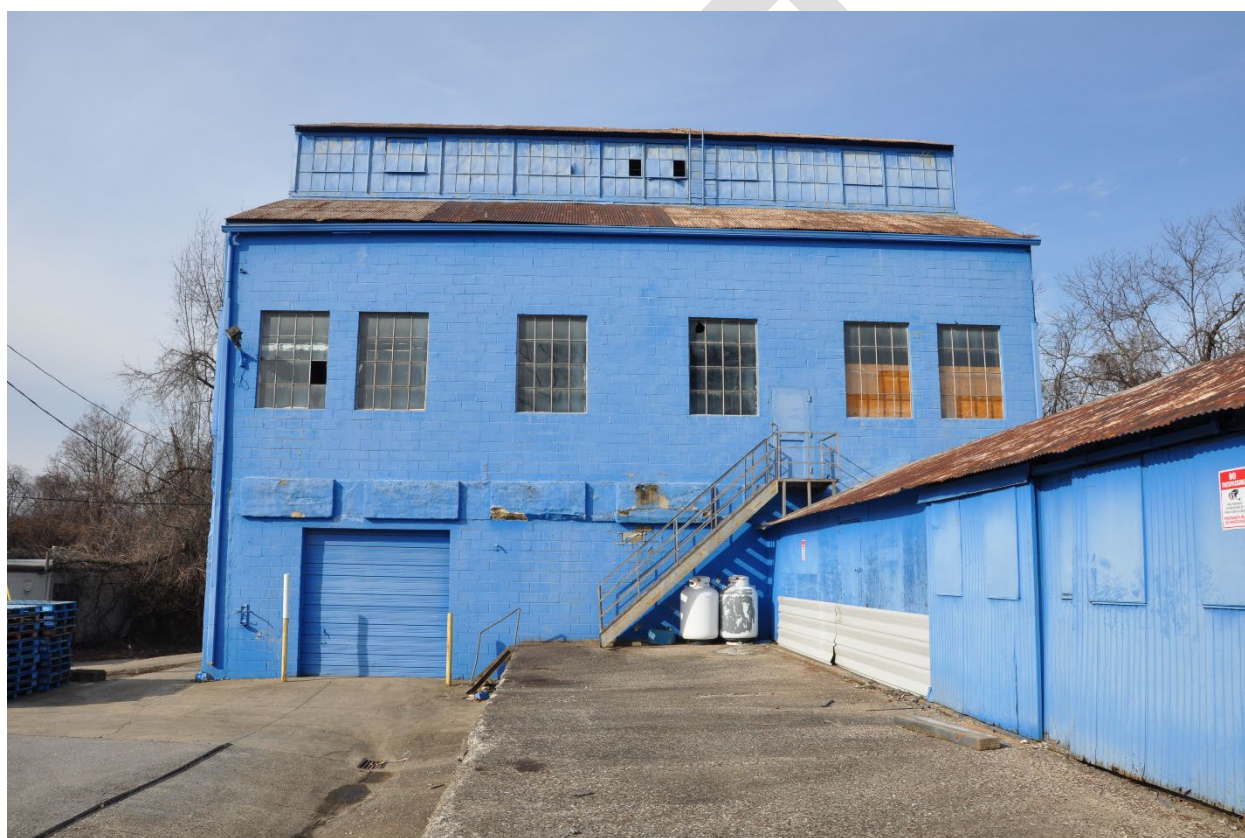
Figure 7: Southeast elevation of the main block of the Magnus Metal Company Building, and partial view of the southwest elevation of the addition, looking west-northwest.

The southeast elevation is fully constructed of concrete blocks (see Figure 7). The first floor is pierced by a vehicular entry filled with a metal, unglazed overhead door. A belt of concrete

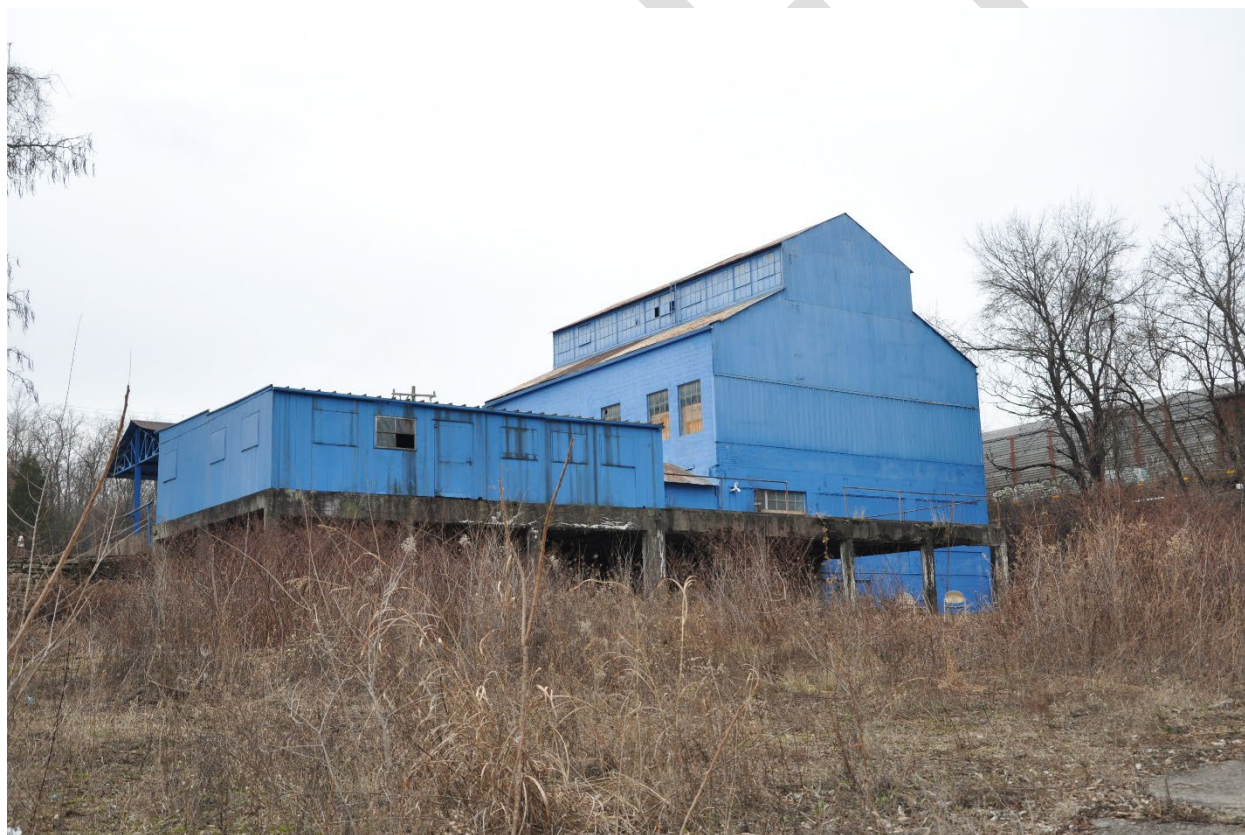
Figure 8: Southeast and northeast (rear) elevations of the addition of the Magnus Metal Company Building, and northeast (rear) elevation of the main block, looking southwest.

A flat-roof addition was constructed on the northeast elevation of the primary addition between 1949 and 1954 (see Figure 8). Three window openings covered with solid metal panels pierce the southeast elevation of the addition. A single-leaf entry filled with an unglazed, metal door and five window openings covered with metal panels punctuate the northeast (rear) elevation. Only one window opening is uncovered and features original glazing, displaying a four-light metal sash with a missing pane of glass. The northwest elevation displays a single-leaf entry filled with a sliding, unglazed, metal panel door on a horizontal metal track. The entry is flanked by two window openings covered with solid metal panels.

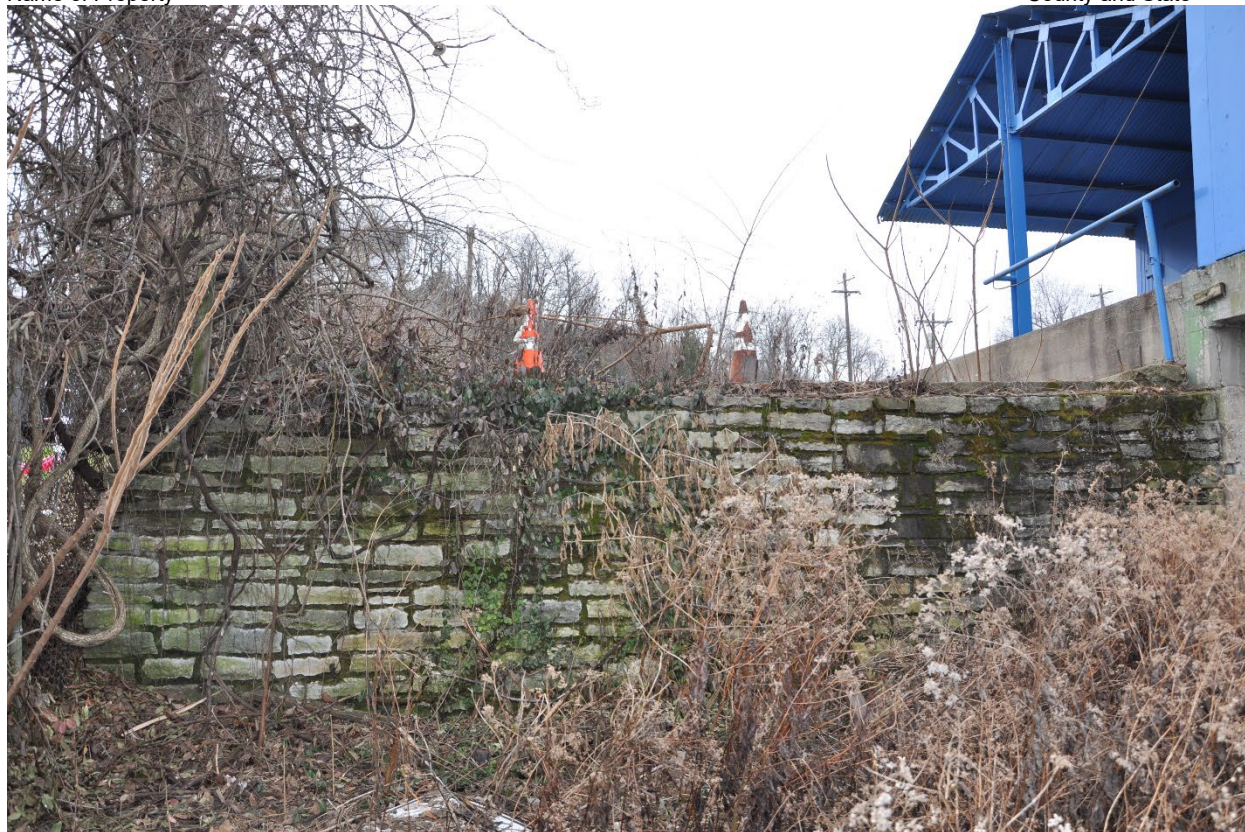
Figure 9: View of the quarried stone and mortar retaining wall, looking south-southwest.

glazing. Between the doors, the façade features two solid metal panels which cover original glazing. A partial-width integral porch spans the southeast portion of the façade elevation. The southeast portion of the integral porch is supported by a metal post, and the apex of the gable is supported by a metal truss. The northeast (rear) elevation displays a single-leaf entry filled with a hinged, metal door and a section of brick cladding which may infill an original window or door opening (see Figure 8). A quarried stone and mortar retaining wall intersects with the basement foundation of the southeast elevation and stands approximately ten feet in height (see Figure 9).

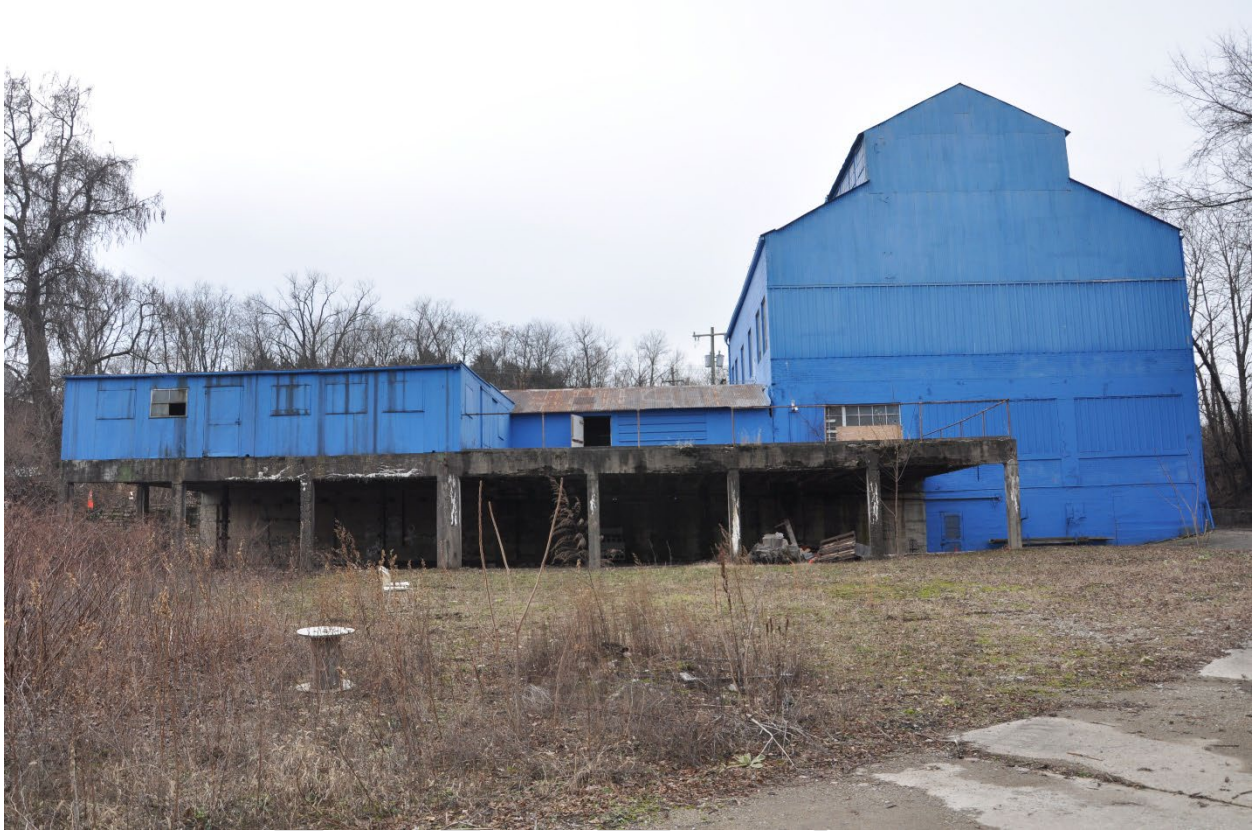
Figure 10: Northeast (rear) elevation of the Magnus Metal Company Building, looking south-southwest.

The northeast (rear) elevation of the main block displays a parged concrete basement foundation, a first story clad in brick, and a second story clad in metal panels (see Figure 10). A single-leaf entry filled with a metal door with a metal screen pierces the basement foundation. A poured concrete belt divides the concrete foundation and brick on the first story. Above the belt, three window bays pierce the first story and display concrete sills. The bay piercing the southeastern end of the elevation is filled with a fixed, multi-light metal sash partially covered by metal panels. The two remaining window bays are covered with metal panels. Above the window bays, a concrete belt runs across the elevation. Concrete pilasters cover the sections of the first-story elevation between the bays and on the ends of the outermost bays, extending to the concrete belt between the first story and basement foundation and framing the first story fenestration. Exterior brick is located between the first story and the original second-story, full-width window fenestration, which is currently covered with metal panels. The second story is clad in corrugated metal panels.

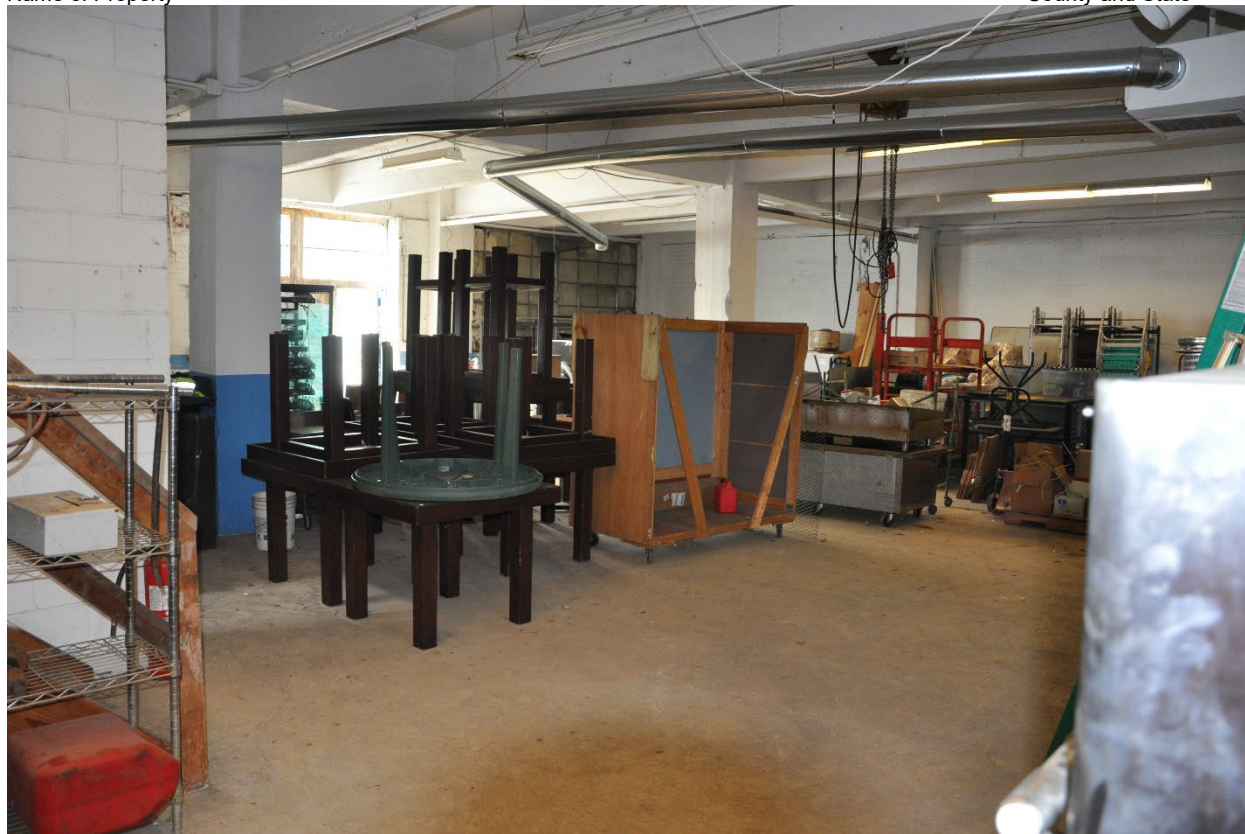
Figure 11: Interior view of the first story of the main block of the Magnus Metal Company Building, looking southwest.

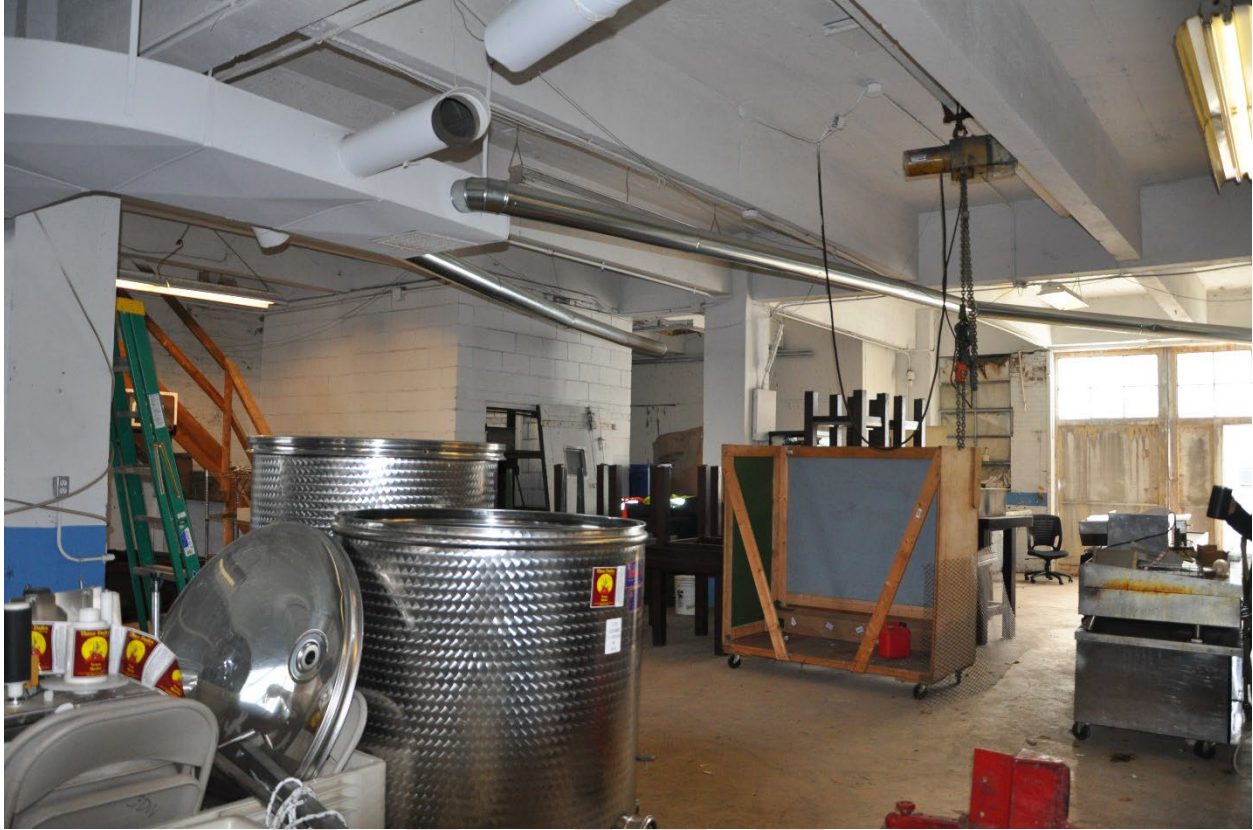
Figure 12: Interior view of the first story of the main block of the Magnus Metal Company Building, including the elevator shaft, looking southeast.

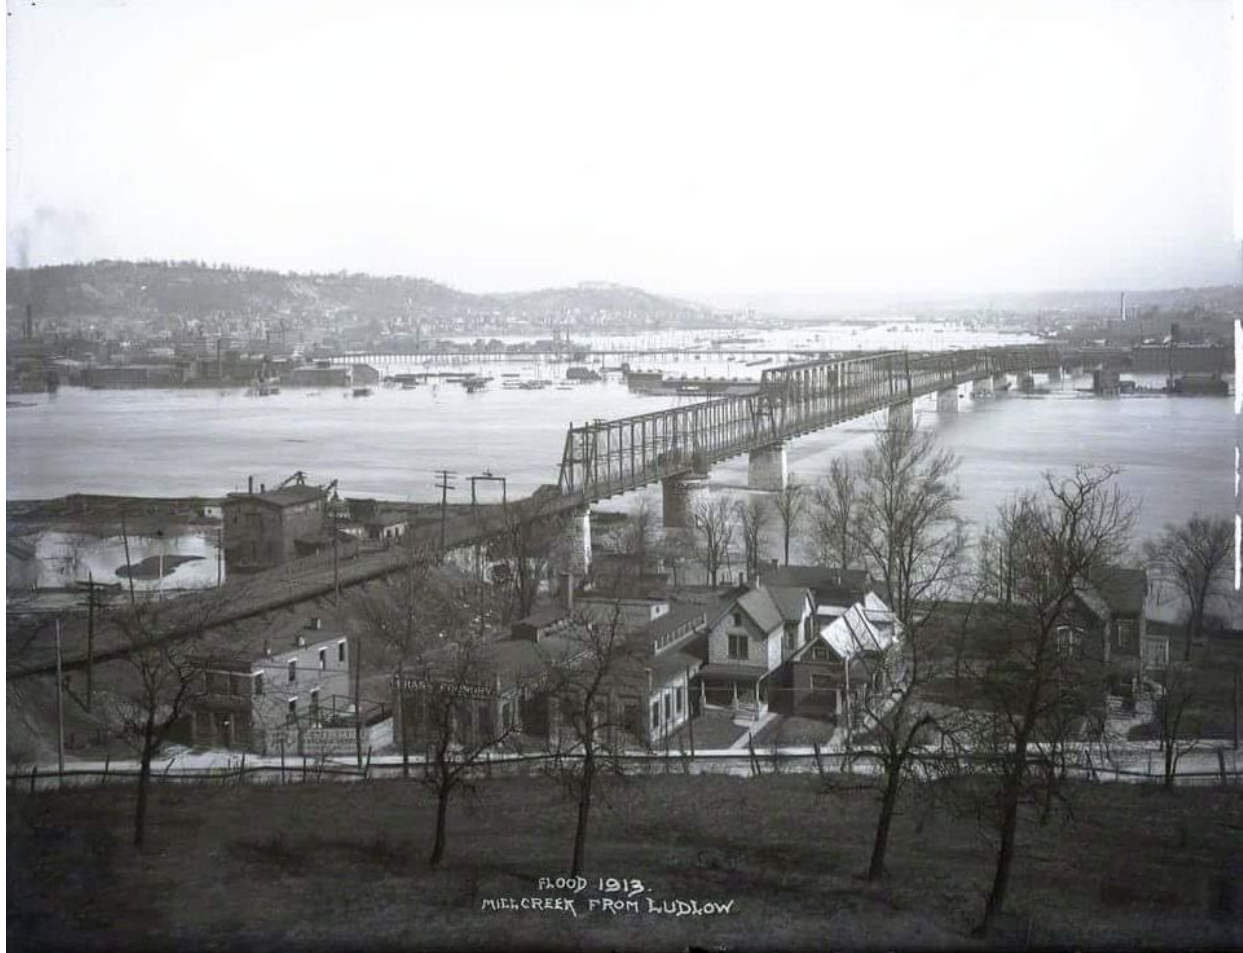
Figure 13: Historic photo of the site circa 1913

The Magnus Metal Company building, built between circa 1913 and 1933, is first depicted on a photograph of the Magnus Metal Company site,<sup>1</sup> though it is absent from a 1913 photograph of the site (Figure 13, page 19, below).<sup>2</sup> The 1909–1949 Sanborn Fire Insurance Map of Covington,

In 1909, the parcel on which the foundry operated consisted of six structures on a lot slightly larger than the current parcel, which currently consists of 1.77 acres.<sup>54</sup> The foundry was comprised of a one story, brick commercial structure housing an office and an industrial floor with four large brass furnaces. A dwelling with two supporting domestic structures faced northeast to river road. A smaller dwelling, located in the southeast corner of the lot, faced Ludlow Highway (present-day Highway Avenue). Northwest of the foundry, a small saloon also faced Ludlow Highway (see Figure 13).

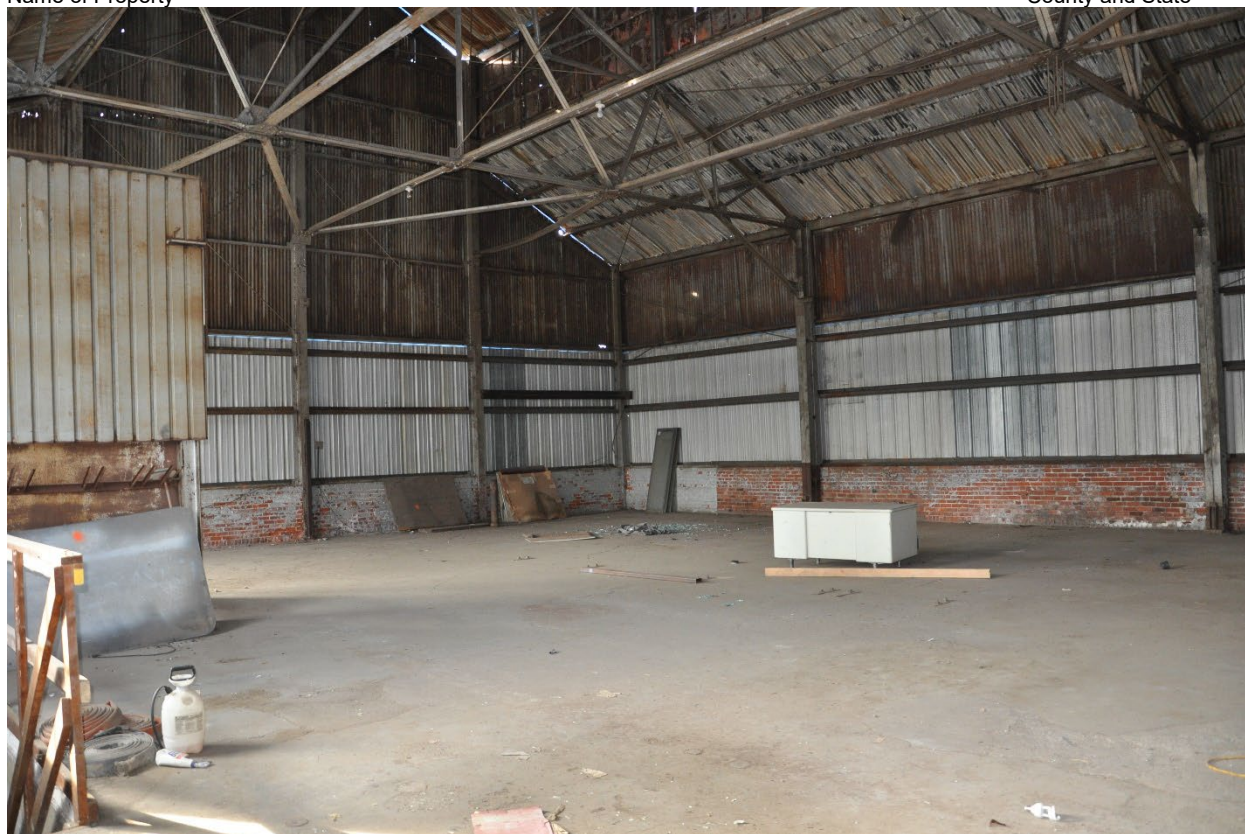
Figure 15: Interior view of the second story of the main block of the Magnus Metal Company Building, looking southwest.

The second story displays fewer alterations than the first as the building retains its open floorplan. Continuous poured concrete floors extend to each wall (see Figure 15). A concrete block wall pierced by windows forms the southeast wall and the ribbon of brick is fully visible on the remaining elevations (see Figure 16). A Fink Truss system supports the second story walls and the monitor roof (see Figure 17).

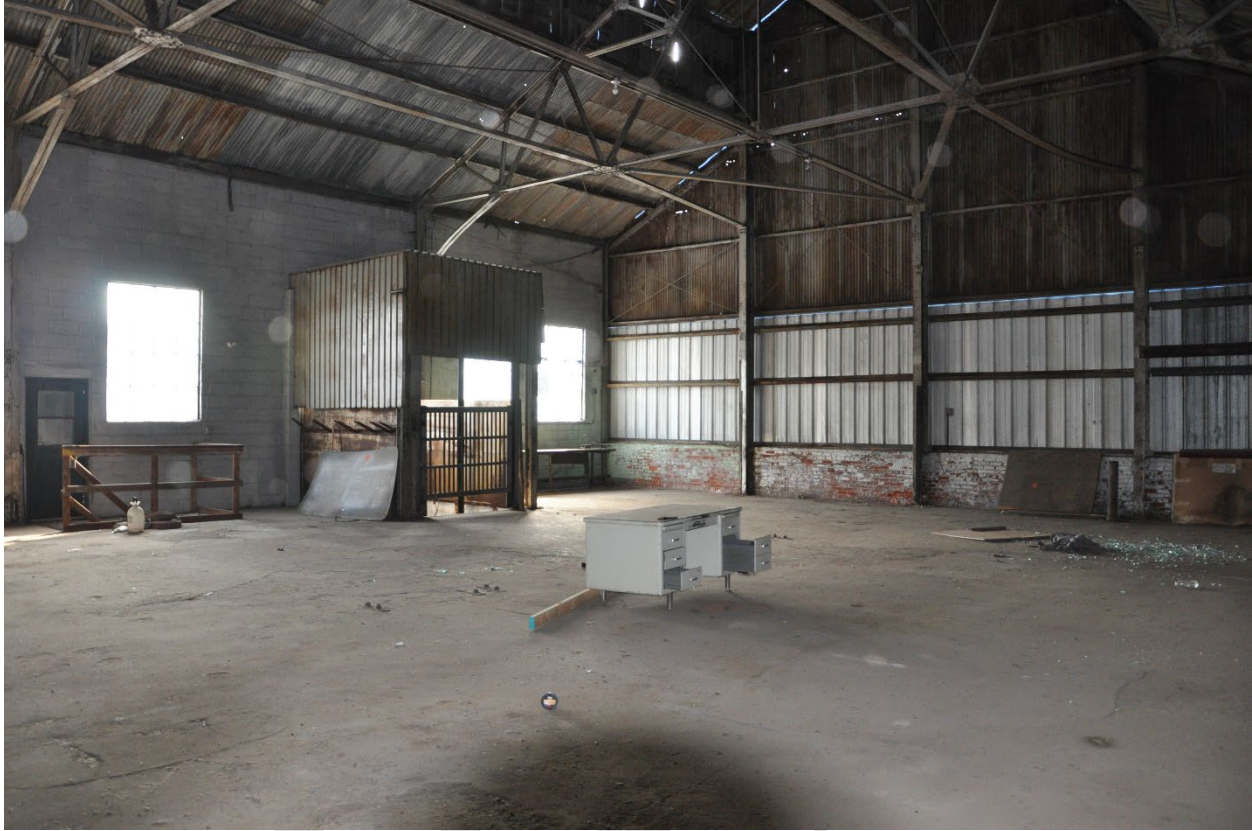
Figure 16: Interior view of the second story of the main block of the Magnus Metal Company Building, including the elevator shaft, looking southeast.

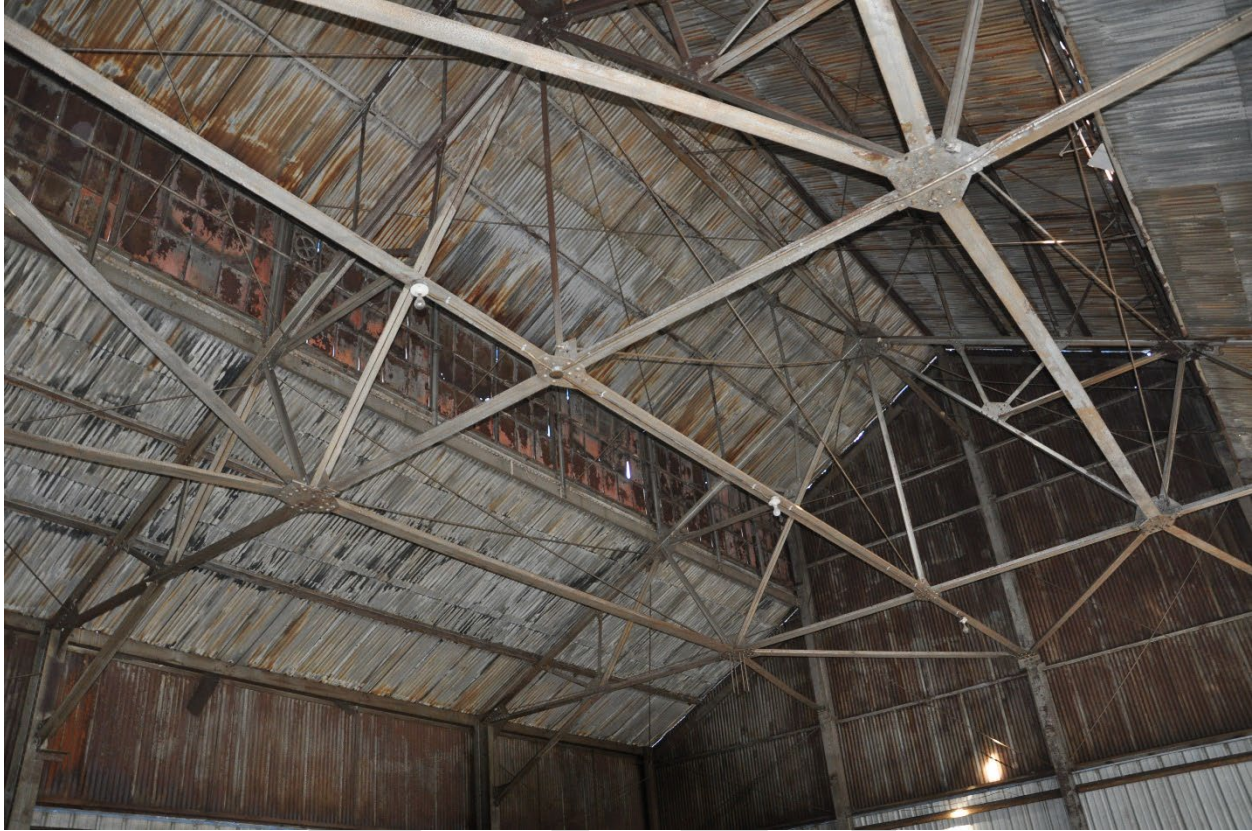
Figure 17: Detail of the Fox Fink steel truss system supporting the roof of the main block of the Magnus Metal Company Building.

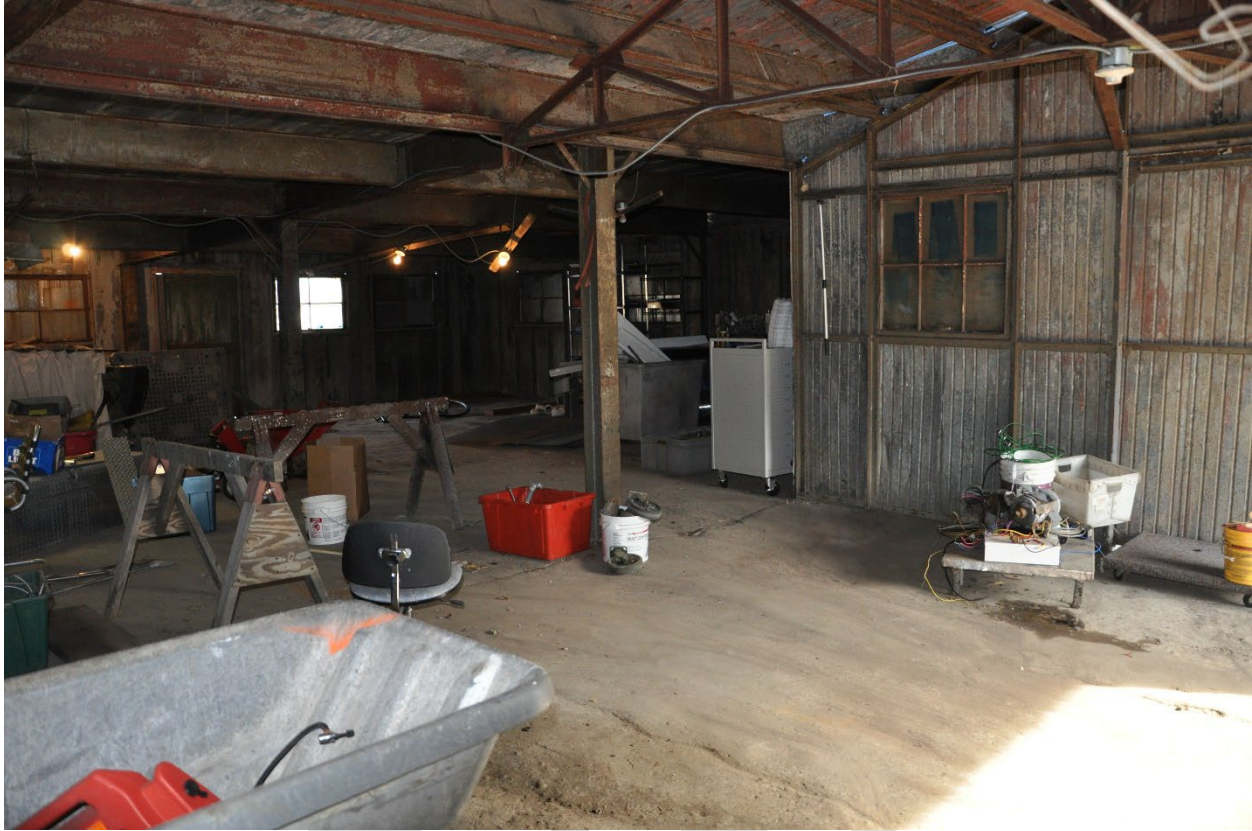
Figure 18: Interior view of the first story of the first and second additions of the Magnus Metal Company Building, looking northeast.

Photo 13. Interior view of the first story of the first and second additions of the Magnus Metal Company Building, looking northeast.

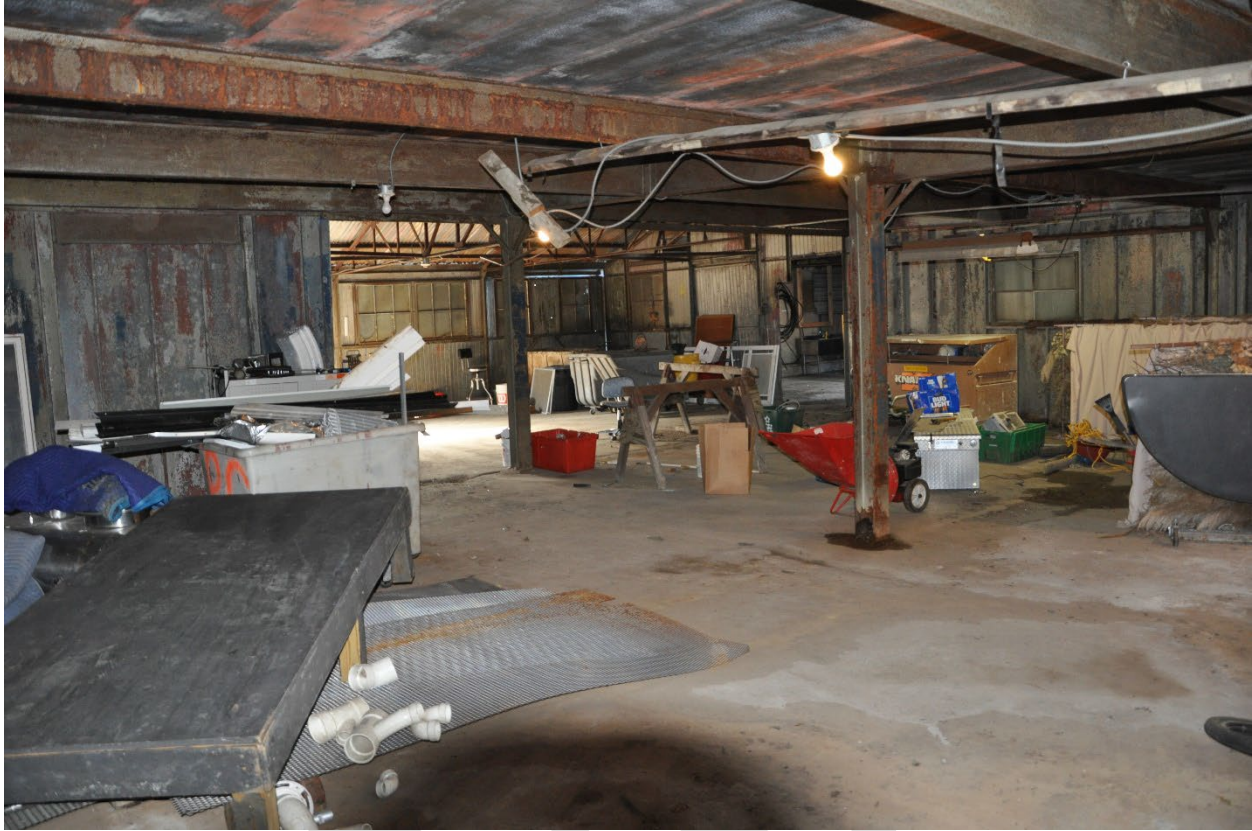
Figure 19: Interior view of the first story of the first and second additions of the Magnus Metal Company Building, looking southwest.

Photo 14. Interior view of the first story of the first and second additions of the Magnus Metal Company Building, looking southwest.

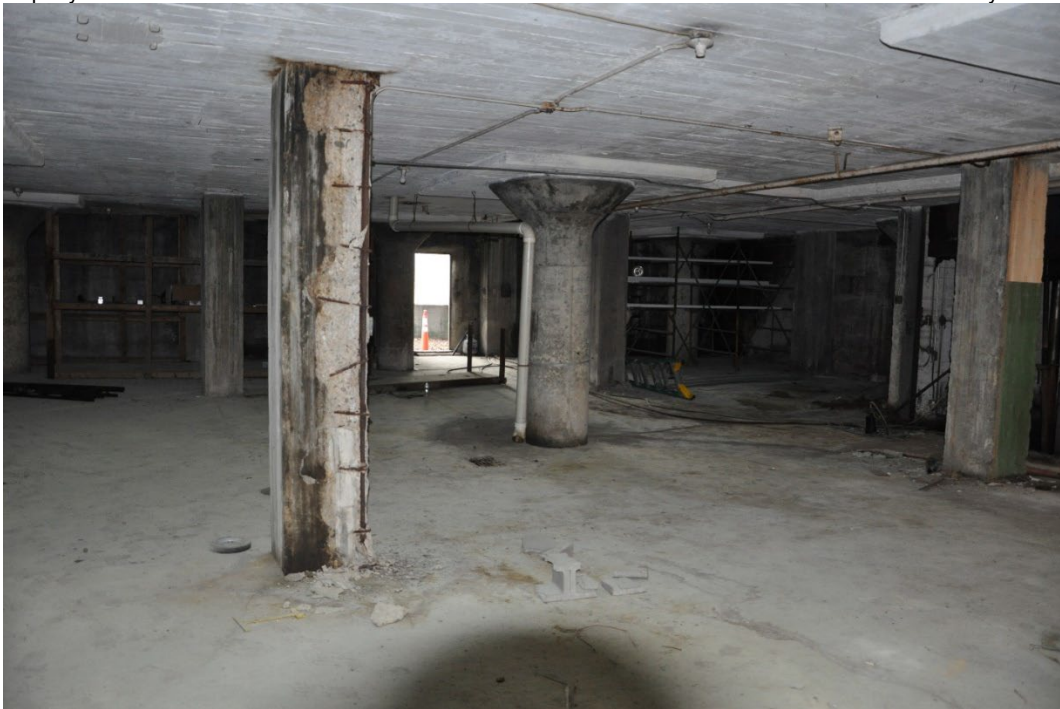
Figure 20: Interior view of the basement of the main block of the Magnus Metal Company Building, looking northeast.

A continuous poured concrete floor, concrete pillars with a large circumference, and exposed foundational concrete walls define the basement level (see Figure 15). The ceiling is concrete and is divided by a network of pipes. The uninterrupted space houses the elevator shaft and a sink (see Figure 16).

Photo 15. Interior view of the basement of the main block of the Magnus Metal Company Building, looking northeast.

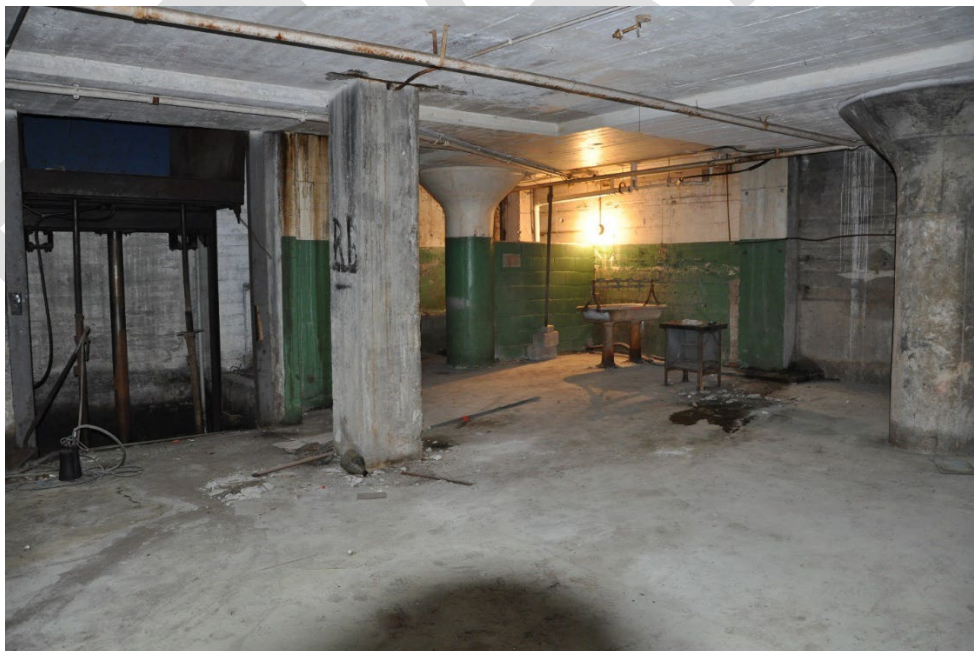
Figure 21: Interior view of the basement of the main block of the Magnus Metal Company Building, including the elevator shaft and the sink, looking southeast.

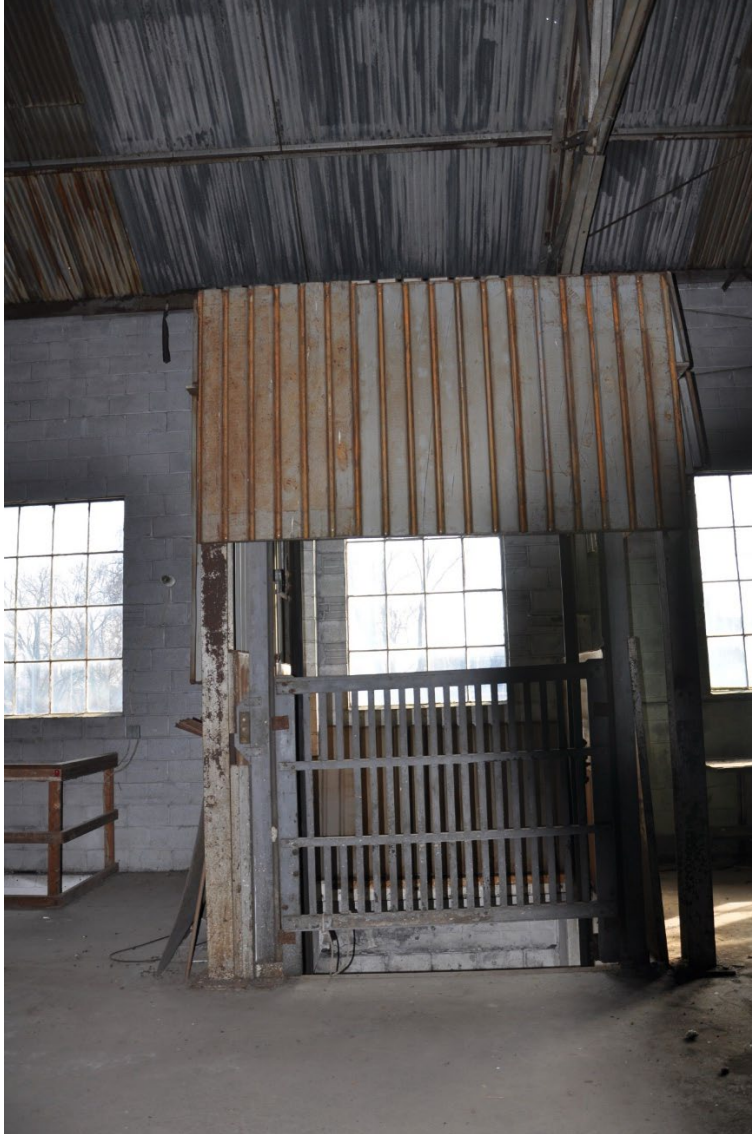
Figure 22: Detail of the elevator shaft on the second story of the original block of the Magnus Metal Company Building.

The Magnus Metal Company Building has undergone various changes since the period of significance, though many of the original materials remain. Perhaps the most significant alteration is the removal of the second story windows and the removal of some of the first story windows. Interior alterations are limited to the partitioning of the first story to incorporate storage and office space and the addition of an interior stair. Major industrial equipment has been removed from the site, but traces of equipment during the period of significance, such as a work table and the elevator, remain (see Figure 22).
