507 W 12th St

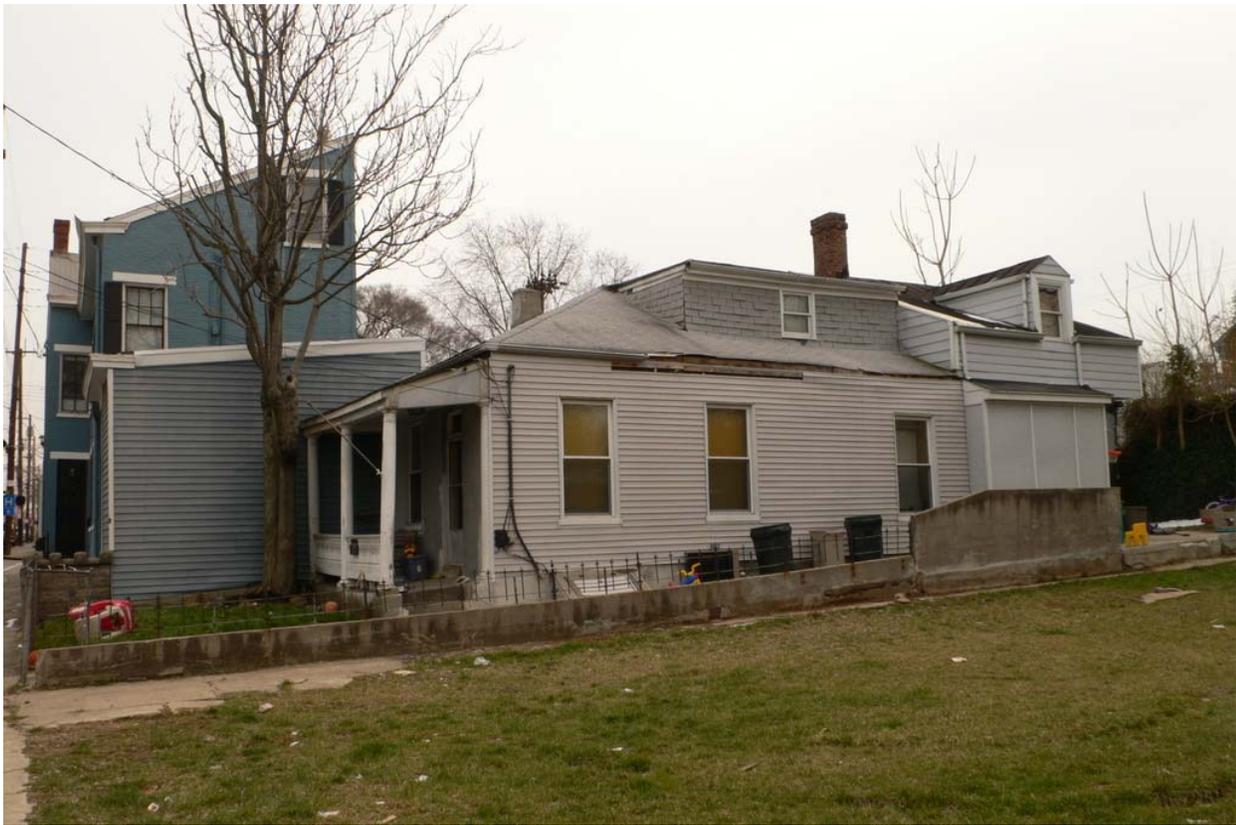
Figure 1: 507 West 12th St from NW, 1201 Main St is the blue structure at left.

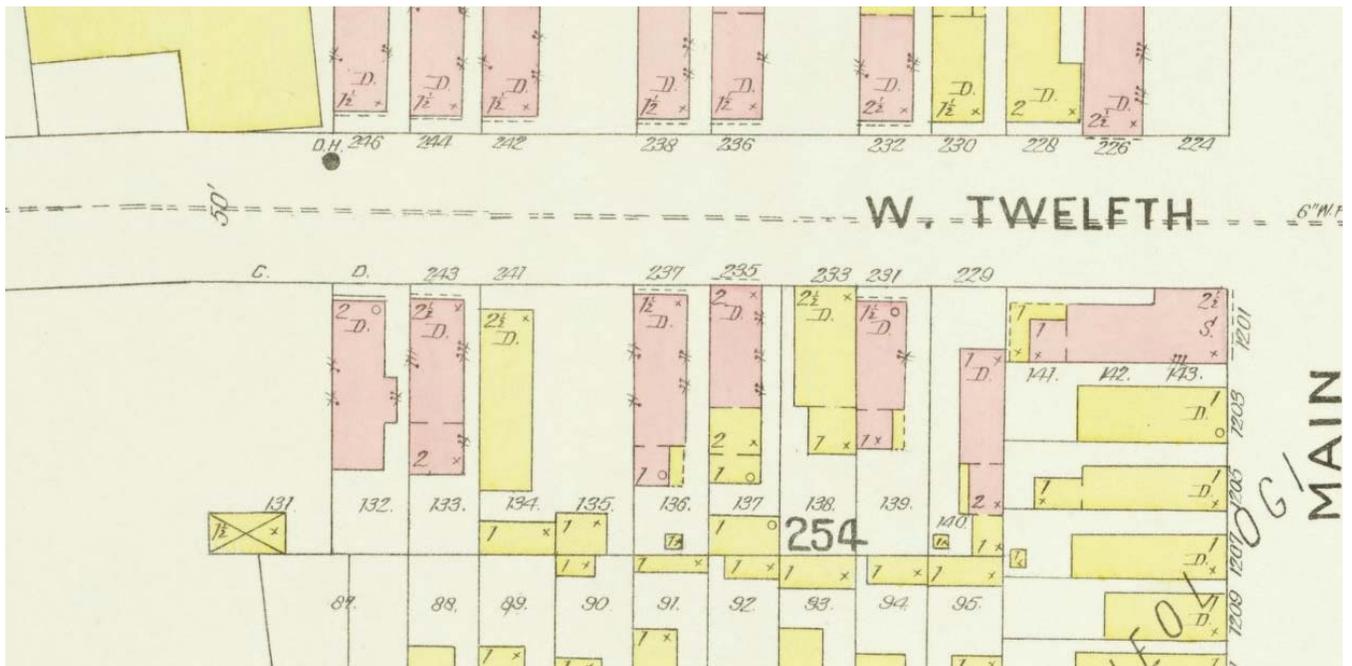
Although it was previously reported as frame, as it appeared to be with its vinyl siding, it was readily apparent upstairs that at least the east, hearth wall was brick, and further, the house is colored in as brick on Sanborn maps (Figure 4, with frame elements indicated at the back that adjoin the main structure to an outbuilding on the lot behind). The house was apparently built before 1877, when a building with similar footprint appears at that location in the Hopkins *Atlas* (Figure 2). The house had an interesting roof configuration: a hipped shed, or half-gable rather than a full gable, which offered an interesting counterpoint to the flounder configuration of the adjacent ell of 1201 Main St (Figure 1). The long shed roof dormer that expanded the attic space may have been original, or an early expansion upward. A later dormer above the bathroom addition at the back (a privy is indicated on the 1894 map) expanded the upstairs still further.

Figure 4: 507 West 12th St is located at # 229 in the 1894 Sanborn map, and color coded as a masonry construction.

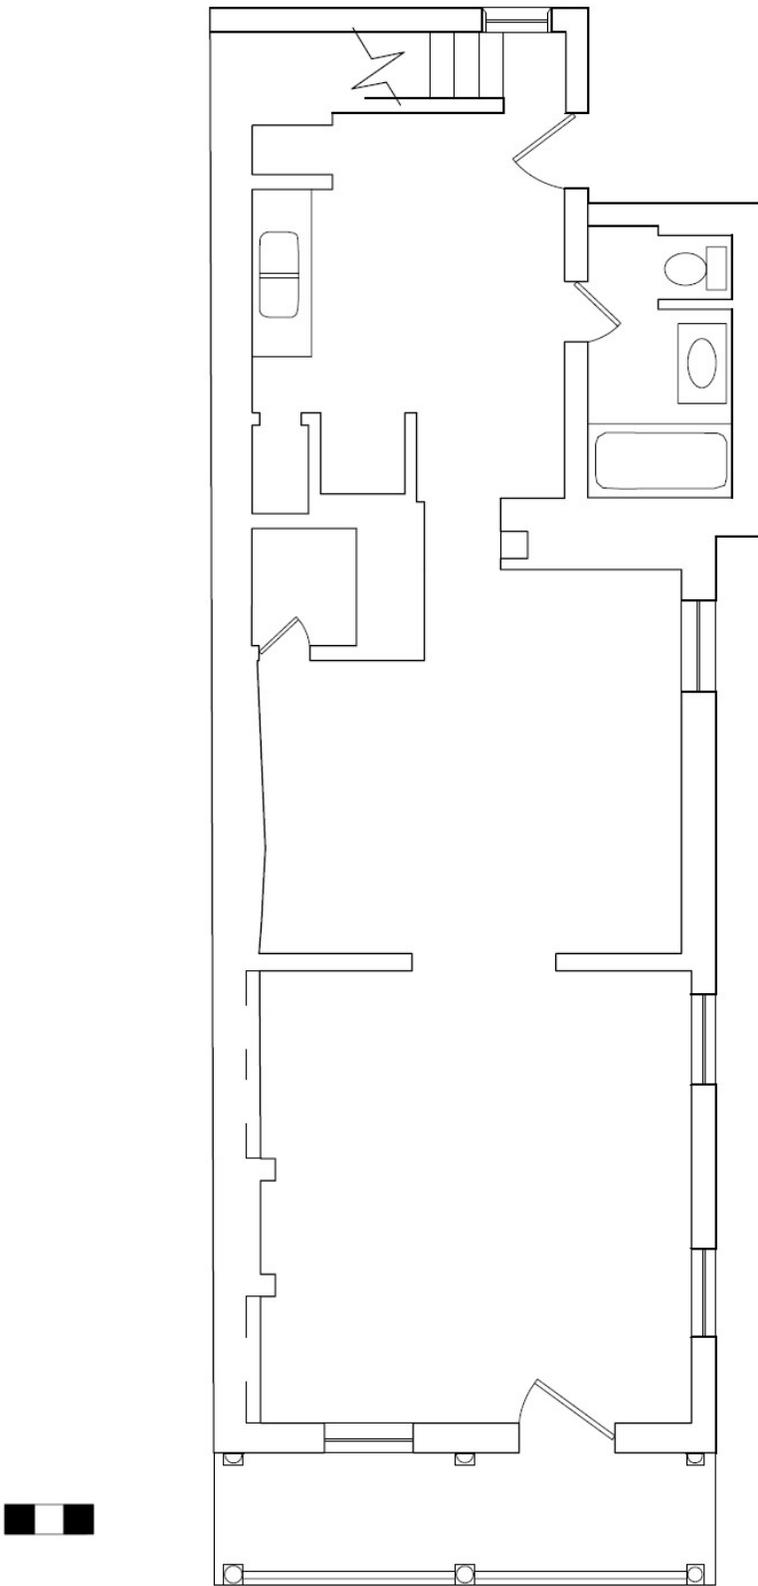
A shed roof porch ran all the way across the front of the house, supported by three turned neoclassical columns joined by a spindled baluster (Figure 6). The main body of the house had three rooms north to south: the front room, second room, and the kitchen (Figure 5). Adjoining the kitchen was a small bathroom that had been added to the house in a frame addition.

Figure 5: 507 West 12th St, Main floor plan, Drawn by Bill Macintire and Danielle Jamieson, scale in feet.

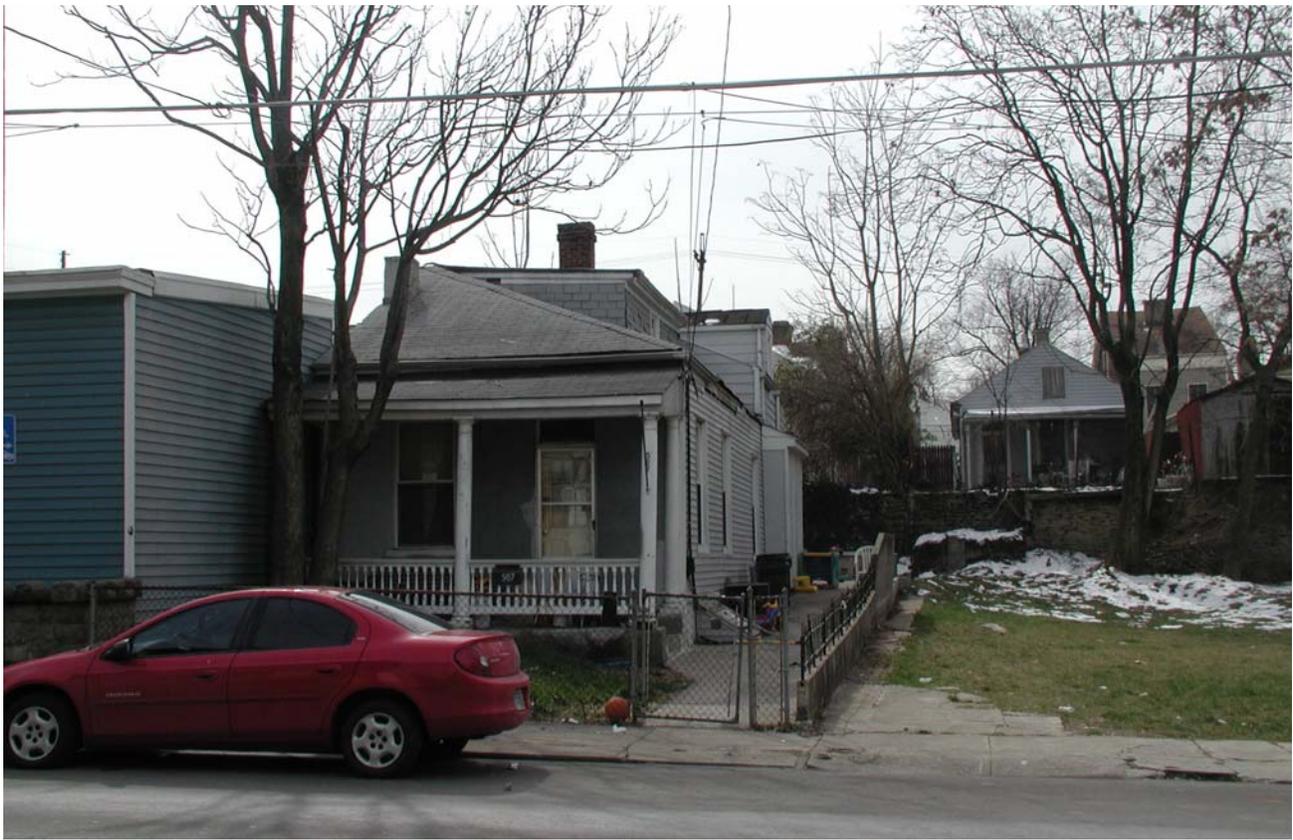
Figure 6: 507 West 12th St from North

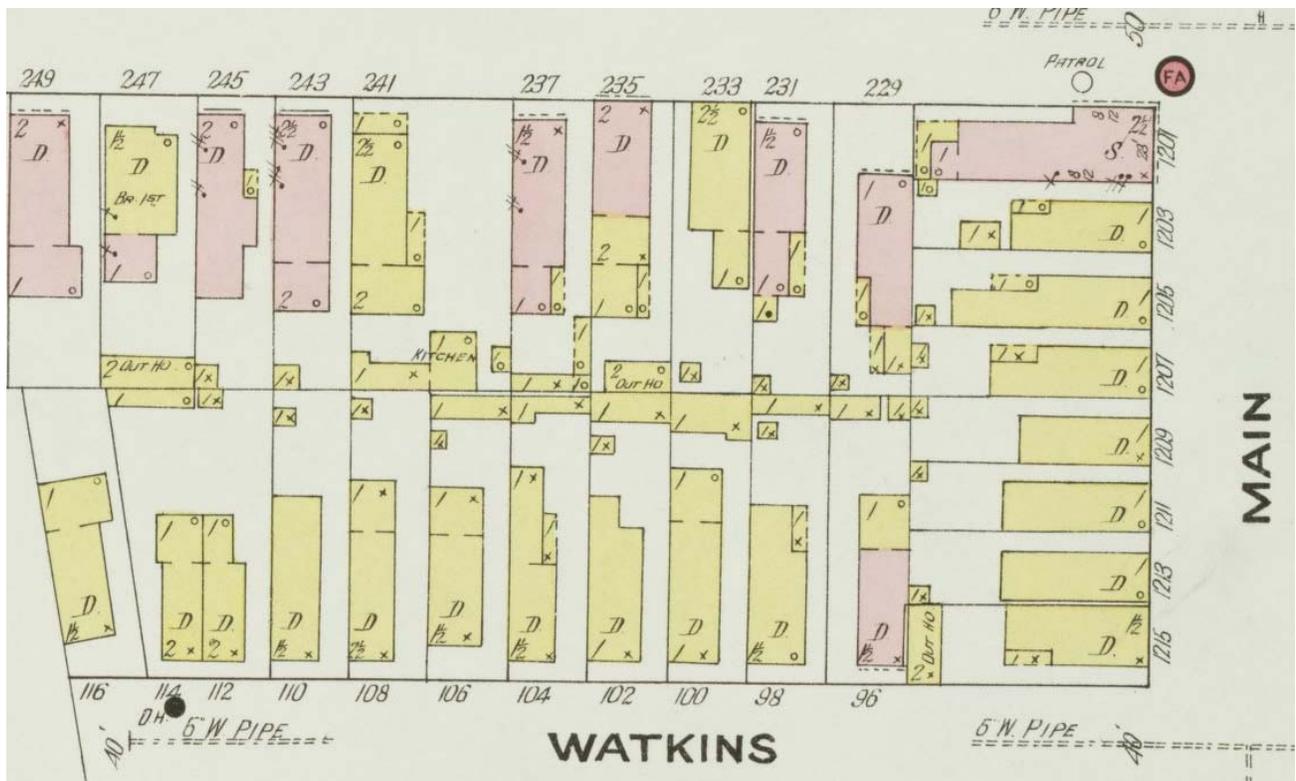
Figure 7: 500 Block of West 12th from the 1906 Sanborn map. 507 West 12th St is located at # 229. Since the depiction in the 1894 Sanborn map, some reconfiguring of the back additions appears to have taken place.

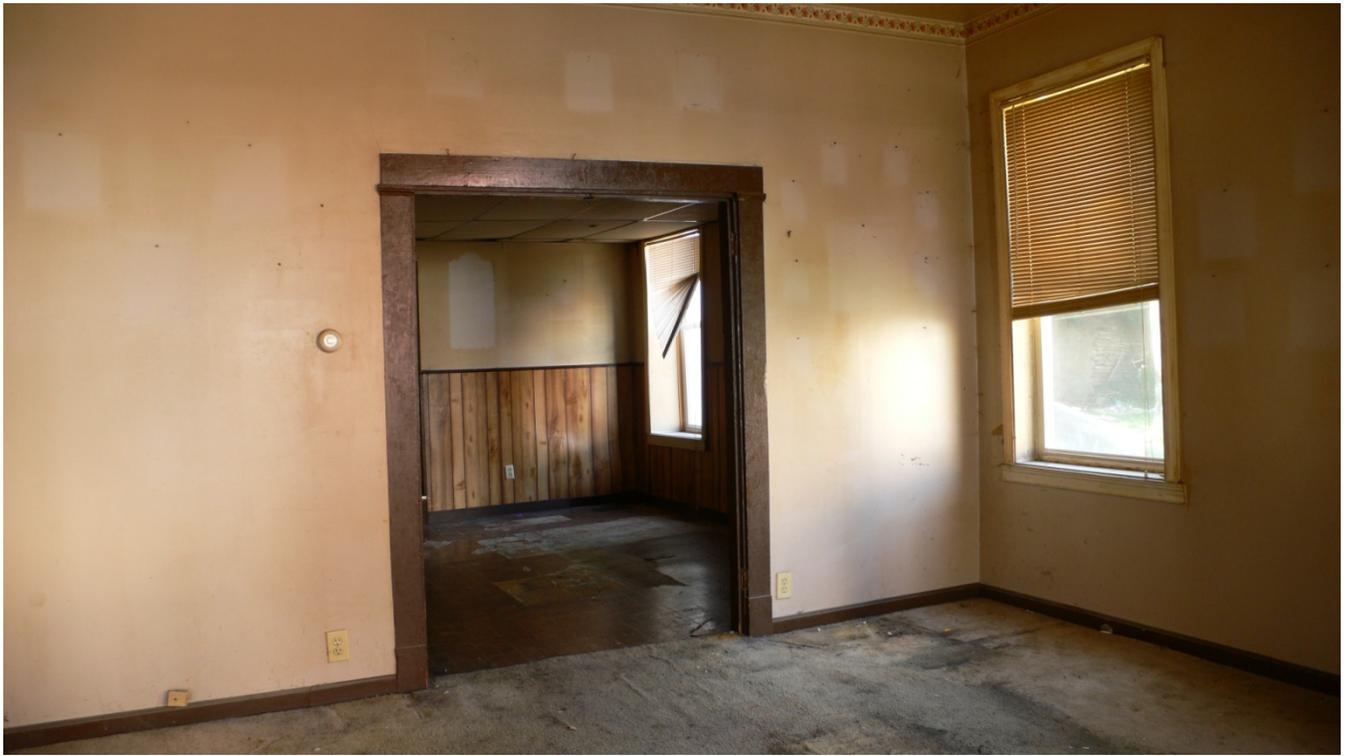
The front room appeared to be a living room, the second may have served as a bedroom or dining area, probably serving multiple purposes, the last room was clearly marked as a kitchen by the installed services (Figure 12, Figure 13). The west walls of all three rooms had been built out with drywall in a somewhat awkward manner, probably to create space for electrical lines or other services. (Figure 9) The mantle in the front room, though, appeared to be original and reflected a late Greek Revival/Neoclassical style. At the back of the front room, a large opening surrounded by stained arts-and-crafts style trim led to the second room (Figure 8). Possibly, this opening had been enlarged from an earlier single doorway.

Figure 8: 507 West 12th St, front room looking into the second room.

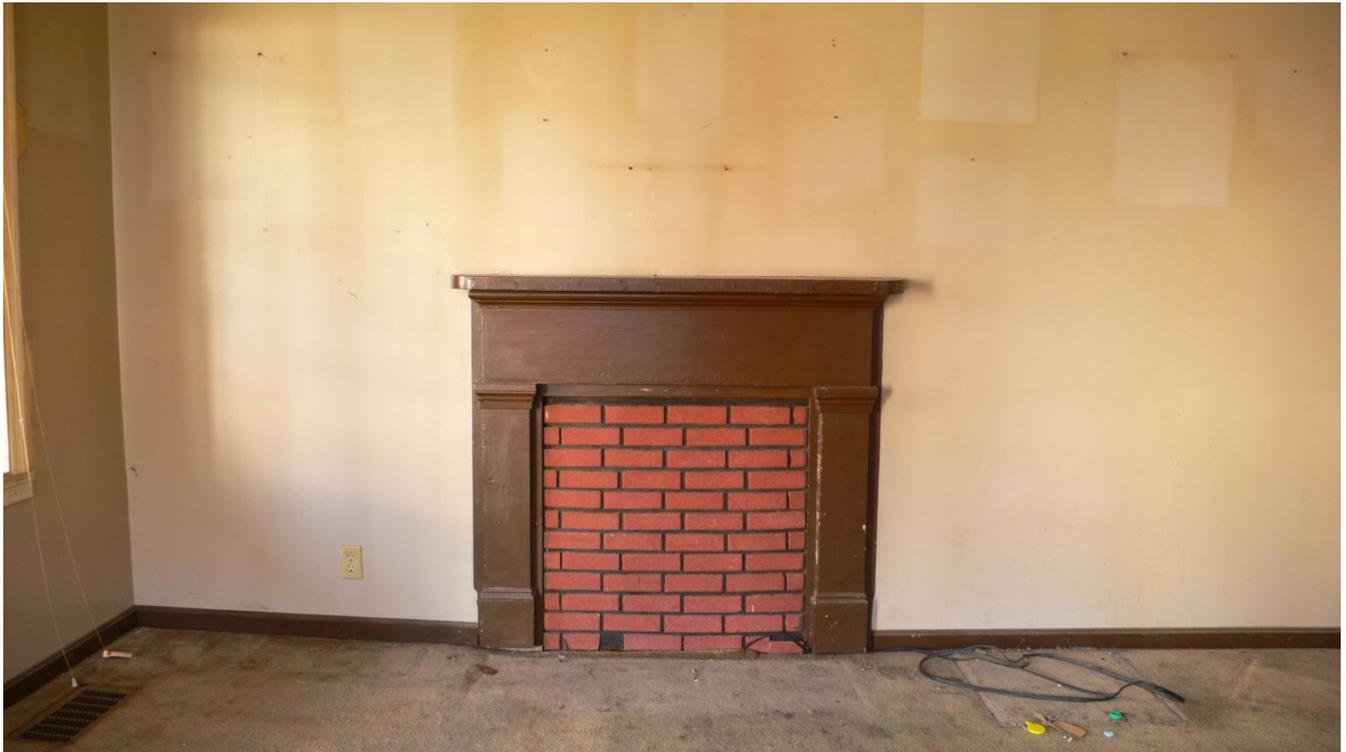
Figure 9: 507 West 12th St, mantle on East wall of front room.

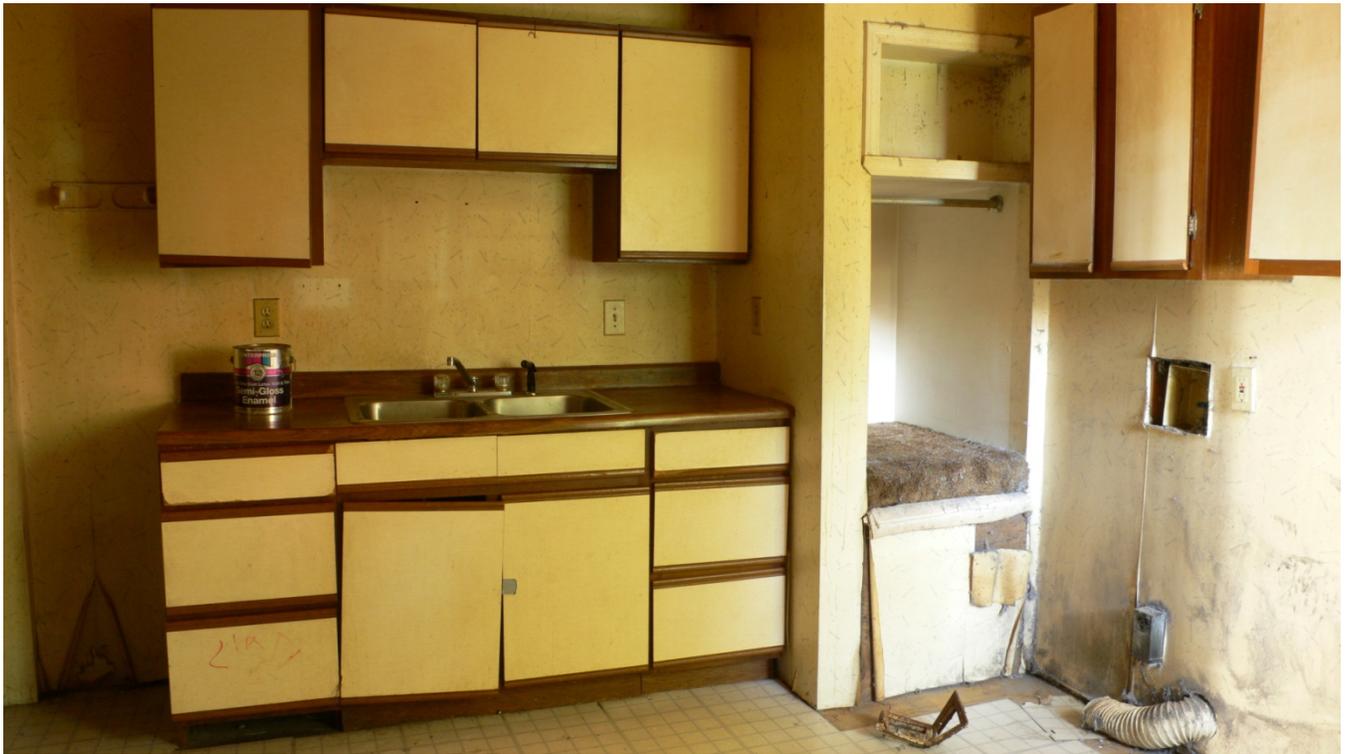
The second room was fairly non-descript with late 20th century wall and trim treatments and a closet built into the south east corner of the space. The kitchen had late 20th century cabinets (Figure 12) but seemed to have elements of an earlier kitchen design such as the stove bay next to a closet (Figure 13). At the back of the kitchen was the back door to the house, and the stair to the second floor (Figure 15). The west wall of the kitchen had a door leading to a bathroom with a tub, sink, and toilet (Figure 14).

Figure 12: 507 West 12th St, east wall of kitchen with sink, cabinets, and closet. The raised floor level in the closet might be to accommodate headroom to a cellar stair below, but this is not confirmed.

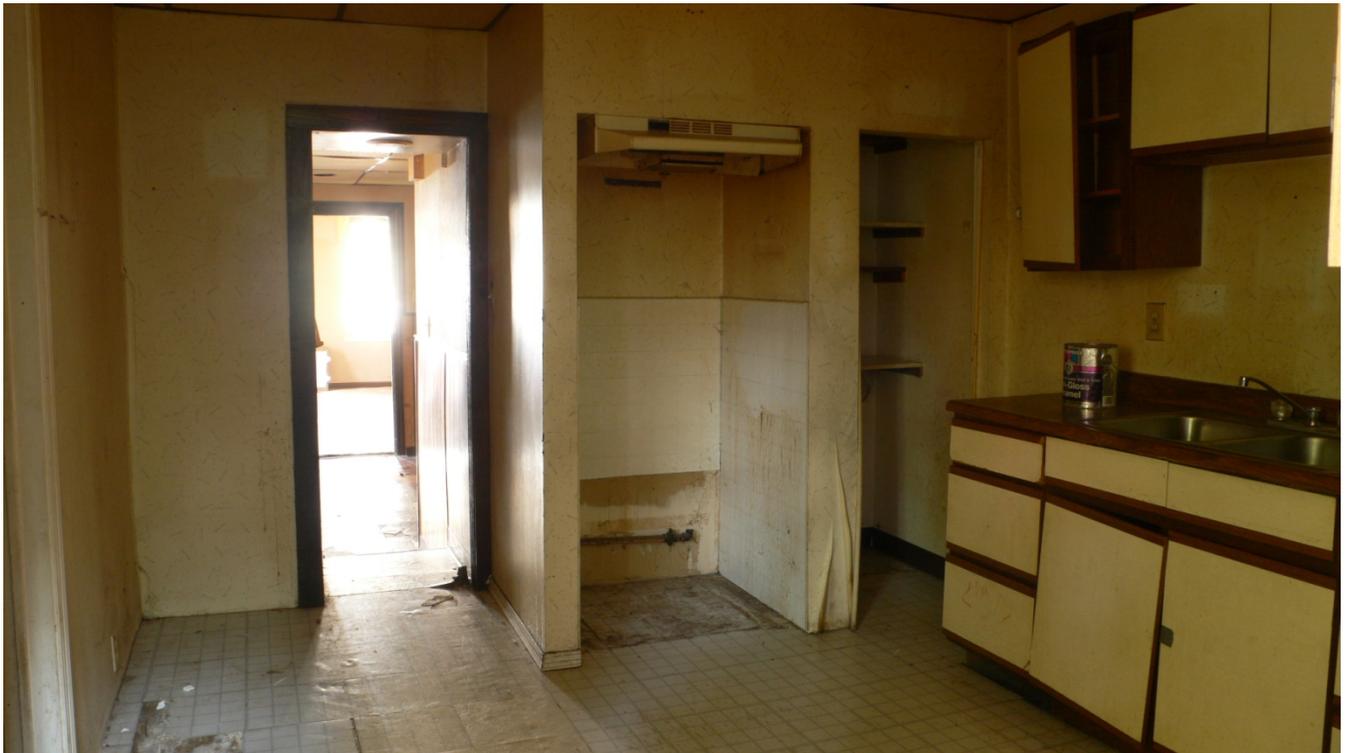
Figure 13: 507 West 12th St, kitchen looking north into second room, showing stove bay and closet, bathroom entry is to the left.

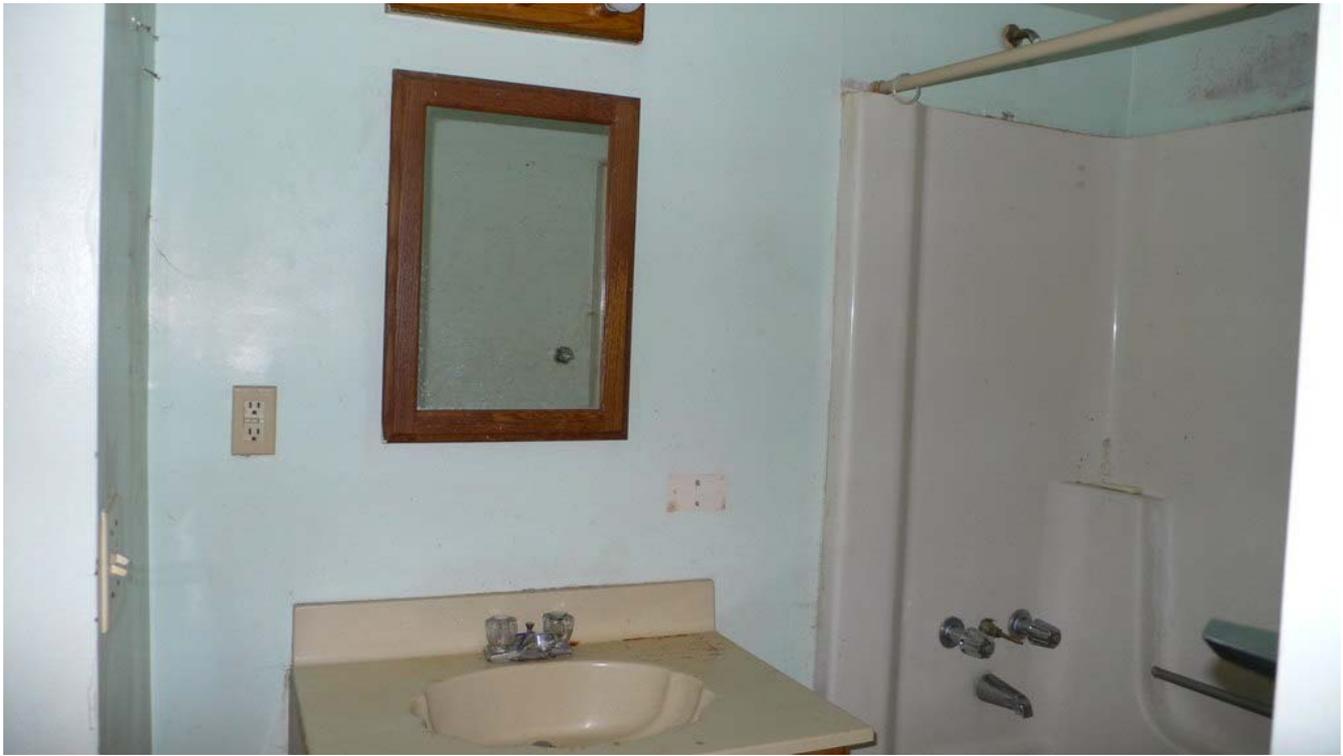
Figure 14: 507 West 12th St, bathroom interior.

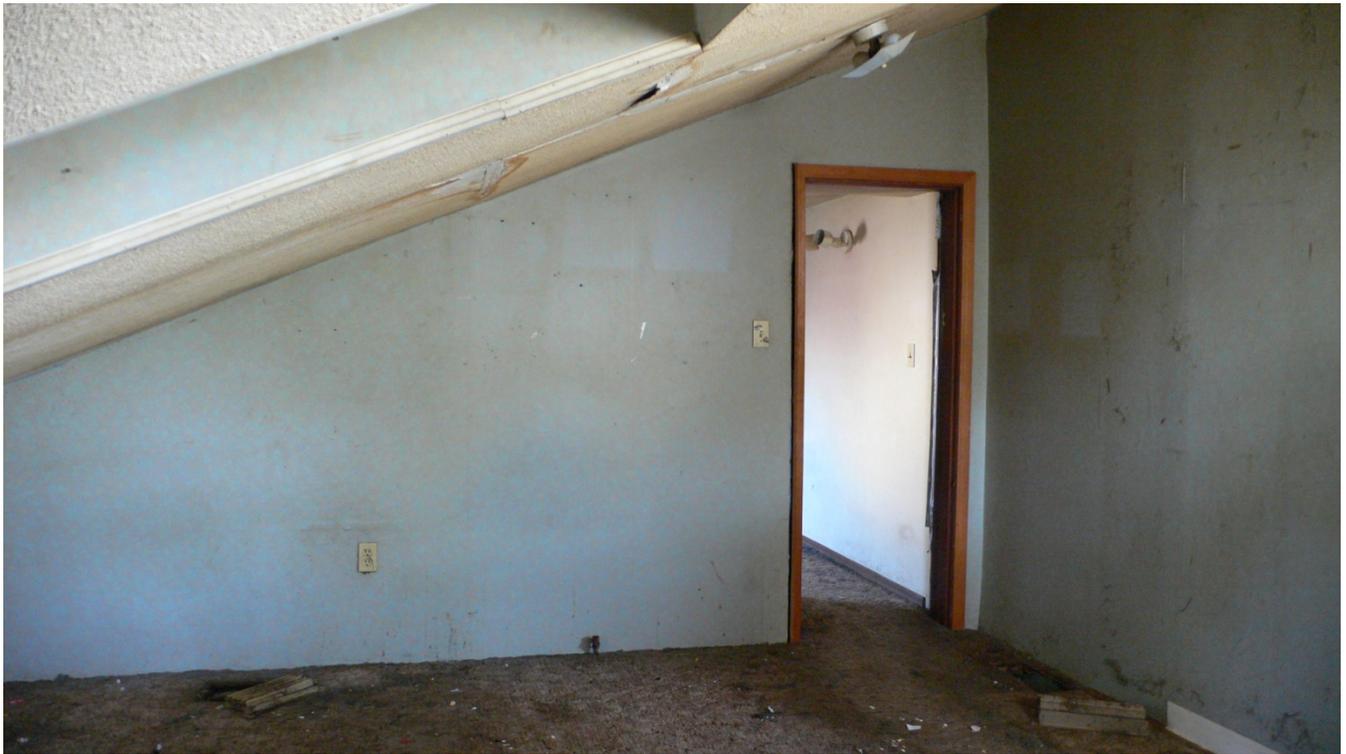
Upstairs there were two chambers, one above the kitchen reached directly from the stair (Figure 16) and beyond that, a second room above the center room of the house. Both of these rooms were under the long shed dormer, the back one was larger thanks to the extended dormer above the bathroom addition. At the front was an unfinished garret with a low steeped roof under the hip at the front of the house (Figure 17, Figure 18, and Figure 19).

Figure 16: 507 West 12th St, back room of second floor (first room reached by the stair).

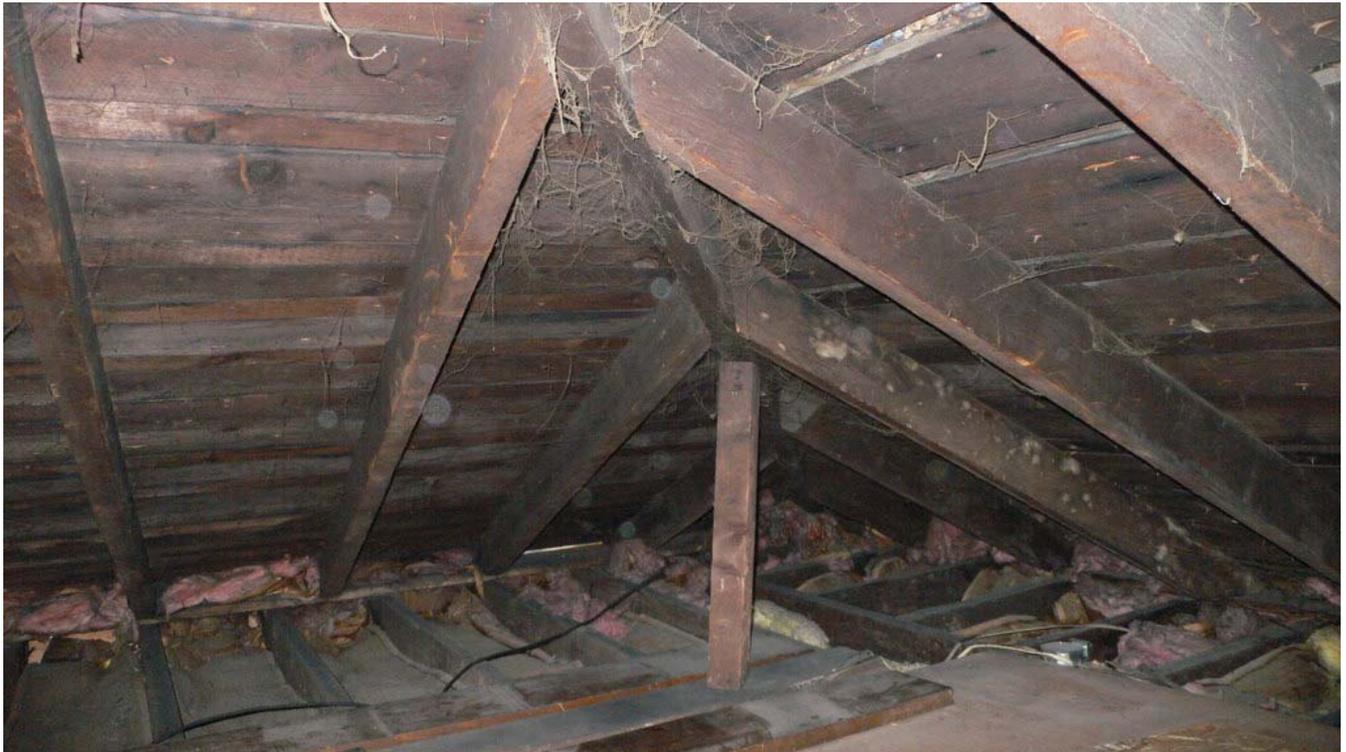
Figure 17: 507 West 12th St, garret in NW corner, corner roof framing, rafters rest on a false plate at the bottom and meet a ridgeboard at the top.

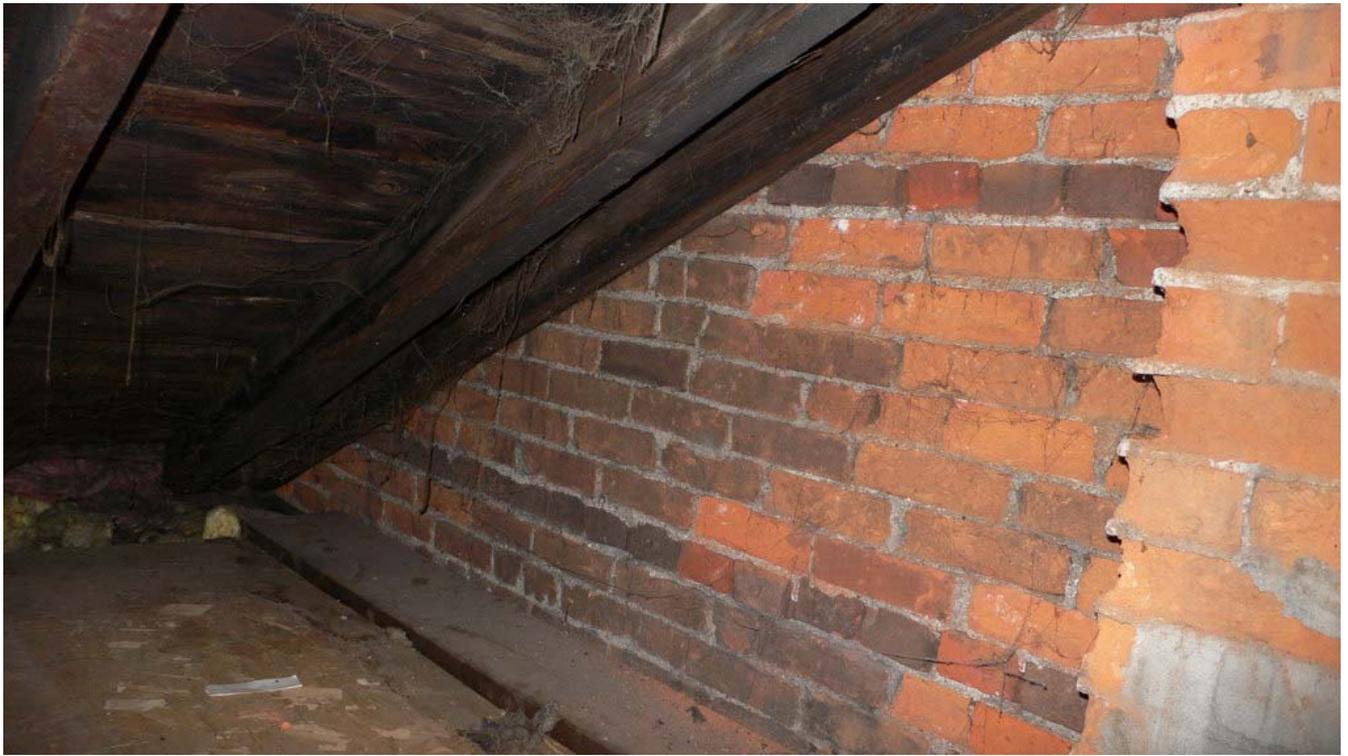
Figure 18: 507 West 12th St, garret in NE corner showing brick hearth wall, note brick spalling on chimney at right.

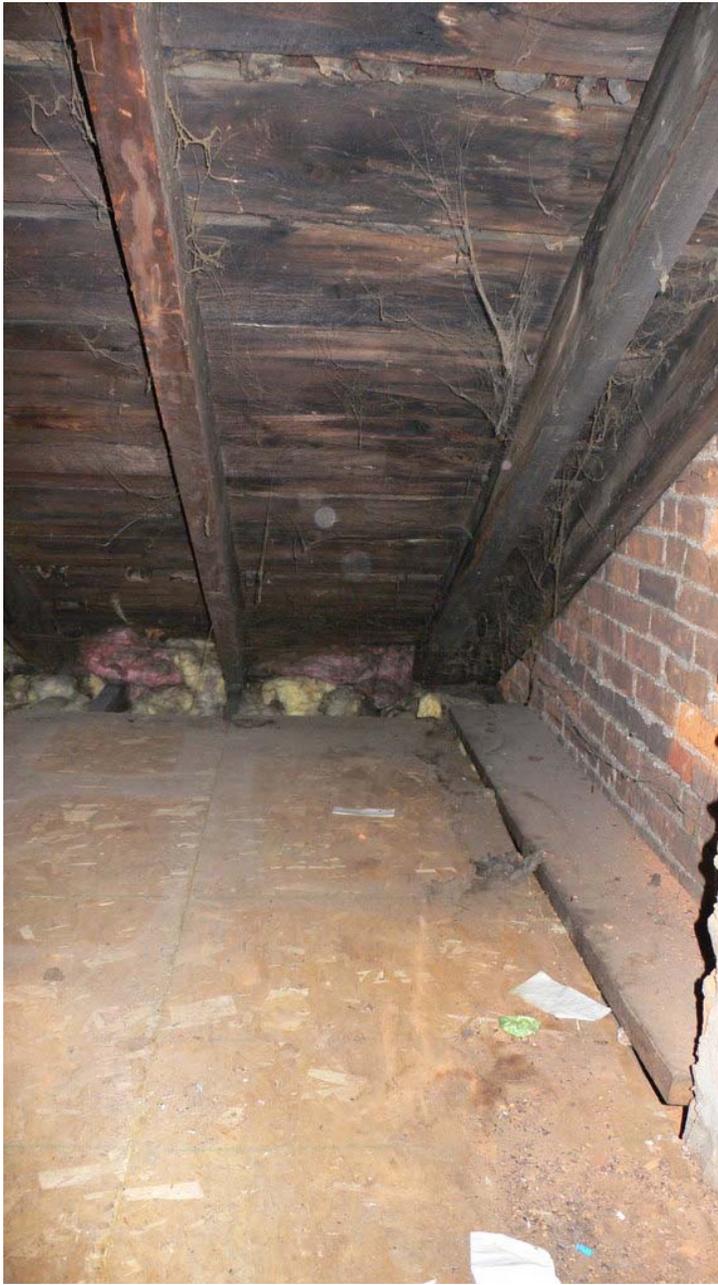
Figure 19: 507 West 12th St, garret at front of house looking north, east (hearth) wall at right.
