### *15 – 17 East 12<sup>th</sup> Street, KECL 1063 (formerly 29-31 East 12<sup>th</sup> Street)*

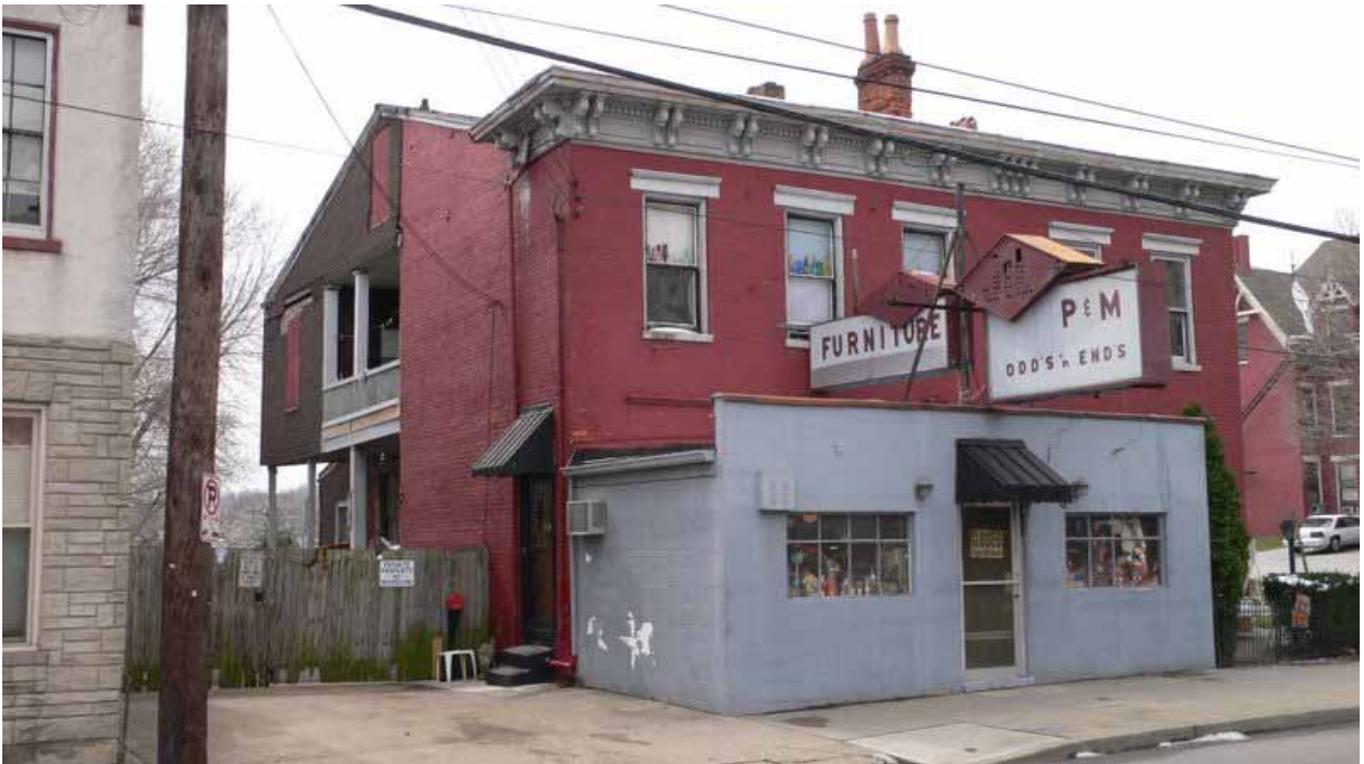
**Figure 1:** 15-17 East 12<sup>th</sup> Street, from northeast.

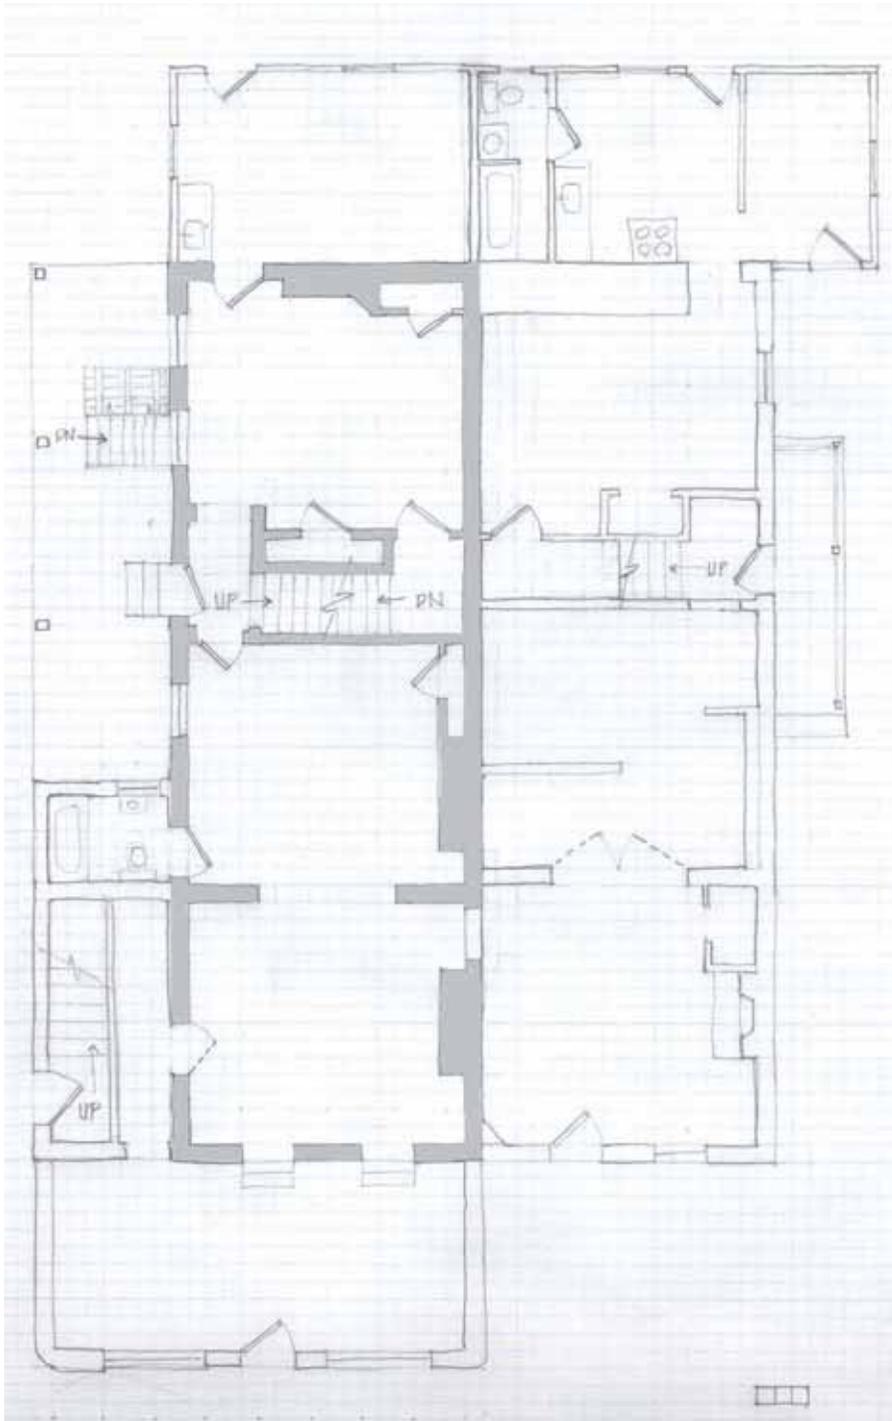
The original structure was likely constructed in the 1850s – 1860s, and had modest Greek Revival trim. The original house was two bays wide and three rooms deep, a typical Northern Kentucky Townhouse type: each main floor had two rooms at the front divided by a lateral stair hall from a single room at the back (see floor plan in Figure 2). Each room had its own fireplace. The second floor plan mirrored the first: on both floors, the two rooms in front of the back stair had a higher level of architectural finish than the single room behind the back stair (see Figure 17, Figure 18, Figure 20, Figure 22, Figure 23, and Figure 24). The two front rooms on each floor were also *en suite*, with a wide opening between them. The rooms behind the back stair on both floors were heated, but comparatively plainer. The structure had a cellar underneath, accessed by a bulkhead entry to the left of the side entry.

**Figure 2:** Plan of 15-17 East 12<sup>th</sup> Street. The original house is shaded.

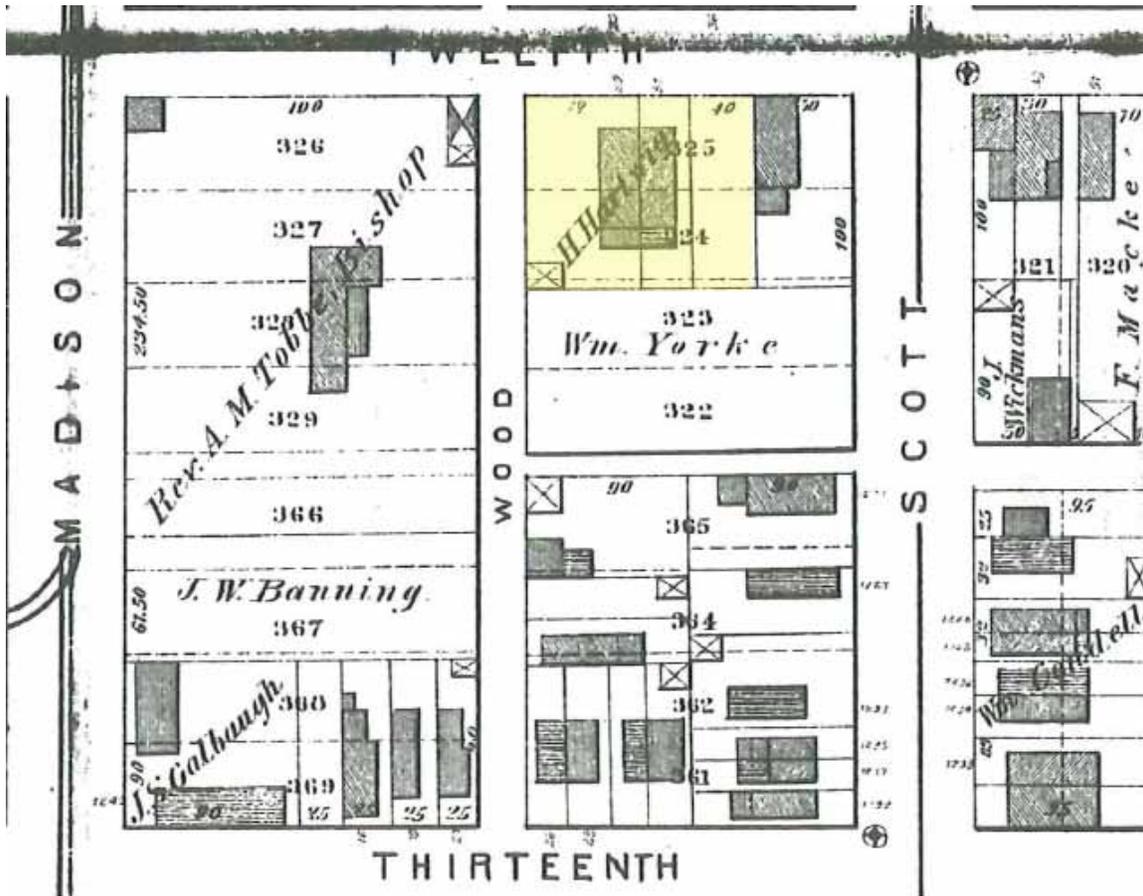
By 1877, the dwelling at # 15 had been added to the west side of # 17, and shed additions appear to be present at the back of the structure (Figure 3). The dwelling at # 15 had a similar layout to # 17, but the circulation patterns were not entirely clear at the time of documentation. Later alterations to this side

Figure 3: Detail of 1877 C. M. Hopkins City Atlas of Covington, with the 15-17 East 12<sup>th</sup> street property highlighted.

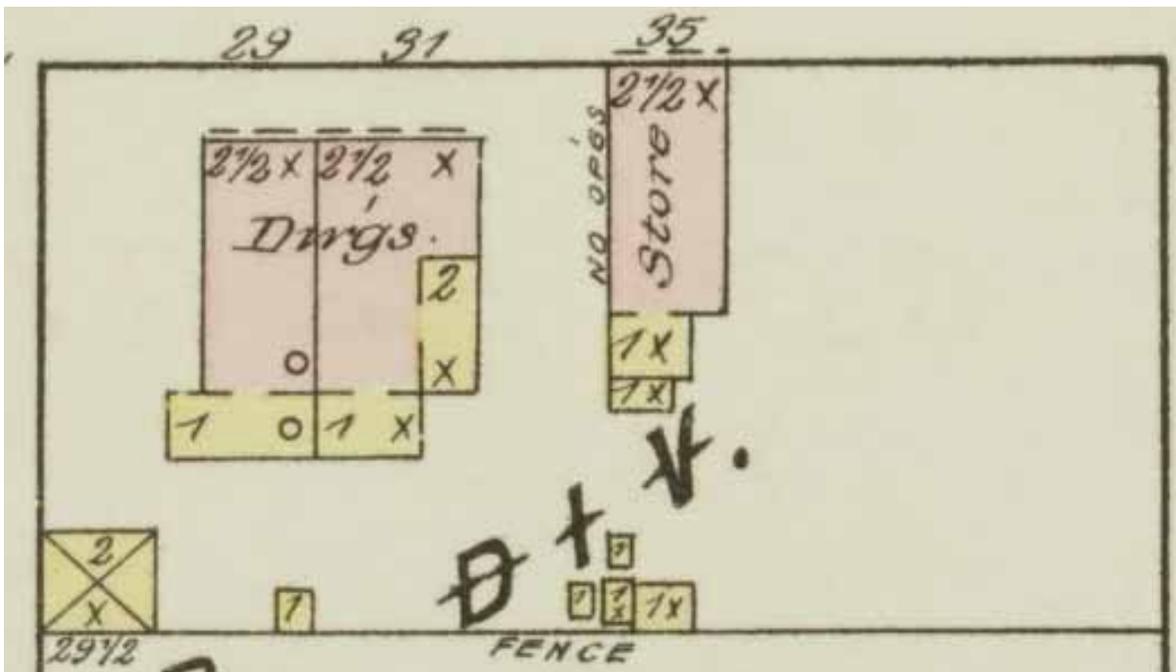
Figure 4: Detail of the 1884 Sanborn Insurance map showing 15-17 East 12<sup>th</sup> Street on the left.

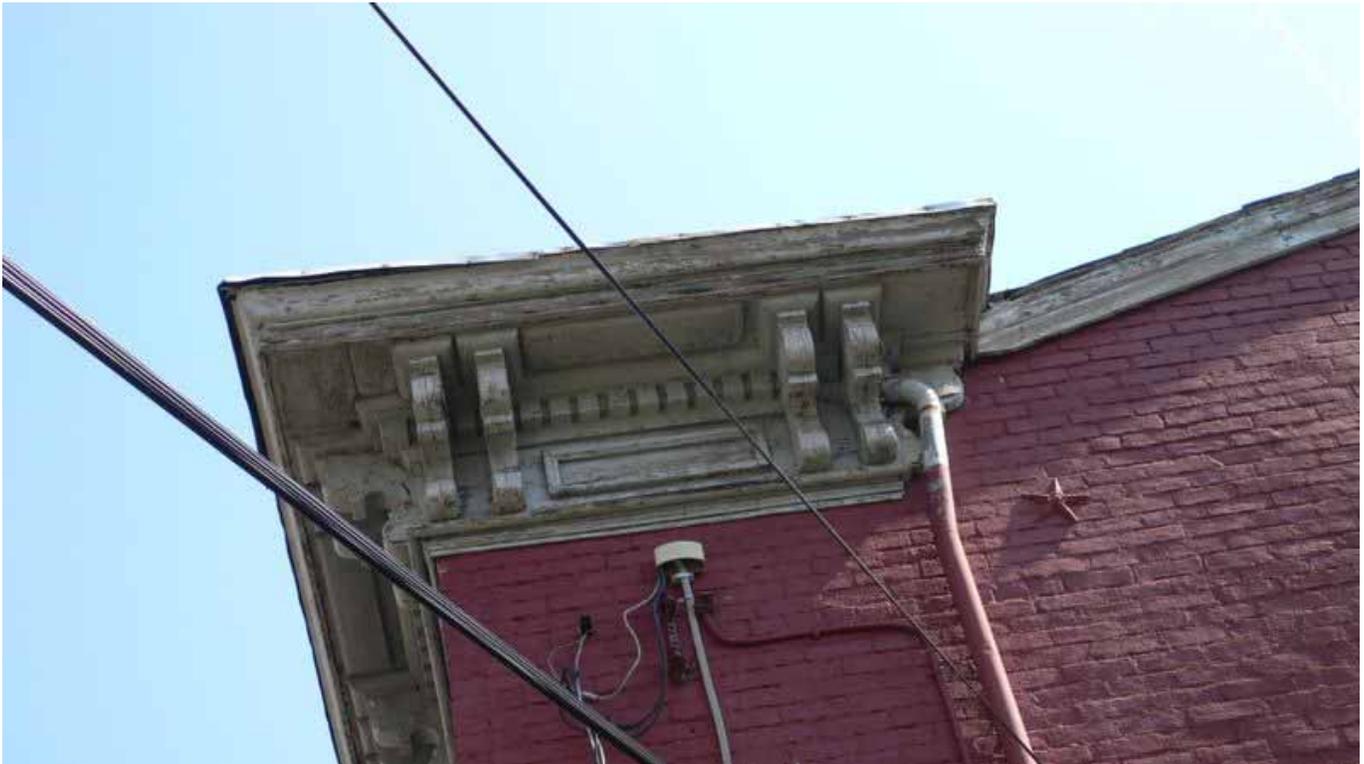
This property was an especially intact and interesting example of combined commercial and domestic spaces, so it was decided to document it pretty thoroughly, including a floor plan of the ground floor. At the latest stages of its existence, 15 – 17 East 12<sup>th</sup> Street was a large brick duplex with a projecting storefront at # 17 (Figure 1). The basic outline of the building's evolution became clear on inspection: it began as a single townhouse dwelling at # 17, on the left hand side of the building: by 1877 when it appears in the Hopkins *City Atlas* (Figure 3), the building had doubled in size: it became a duplex with the addition of a two bay wide dwelling on the west side at #15. That # 17 came first was clear by the way that # 15 adjoined the party wall and blocked a window opening next to the hearth at # 17 (see floor plan, Figure 2). The sheds at the back and the storefront were clearly additions, but what about the front stair hall and side porch on # 17? Those appeared to be original to # 17 on inspection, but the depiction of the property in the 1877 Hopkins *Atlas* as it compares with the rendering in the 1884 Sanborn map (Figure 4) strongly suggests that the side passage stair and the open side porch was constructed in the interim, and thus well after the enlargement of the house into a duplex. The brick front of the building was heavily coated with paint and difficult to read, but a seam for the stair hall addition was not readily visible. It is possible that when the stair hall was added, the whole front of the building was reworked, adding the handsome parapet wall and Italianate cornice (Figure 6).

**Figure 6:** 15-17 East 12<sup>th</sup> Street, detail of cornice.

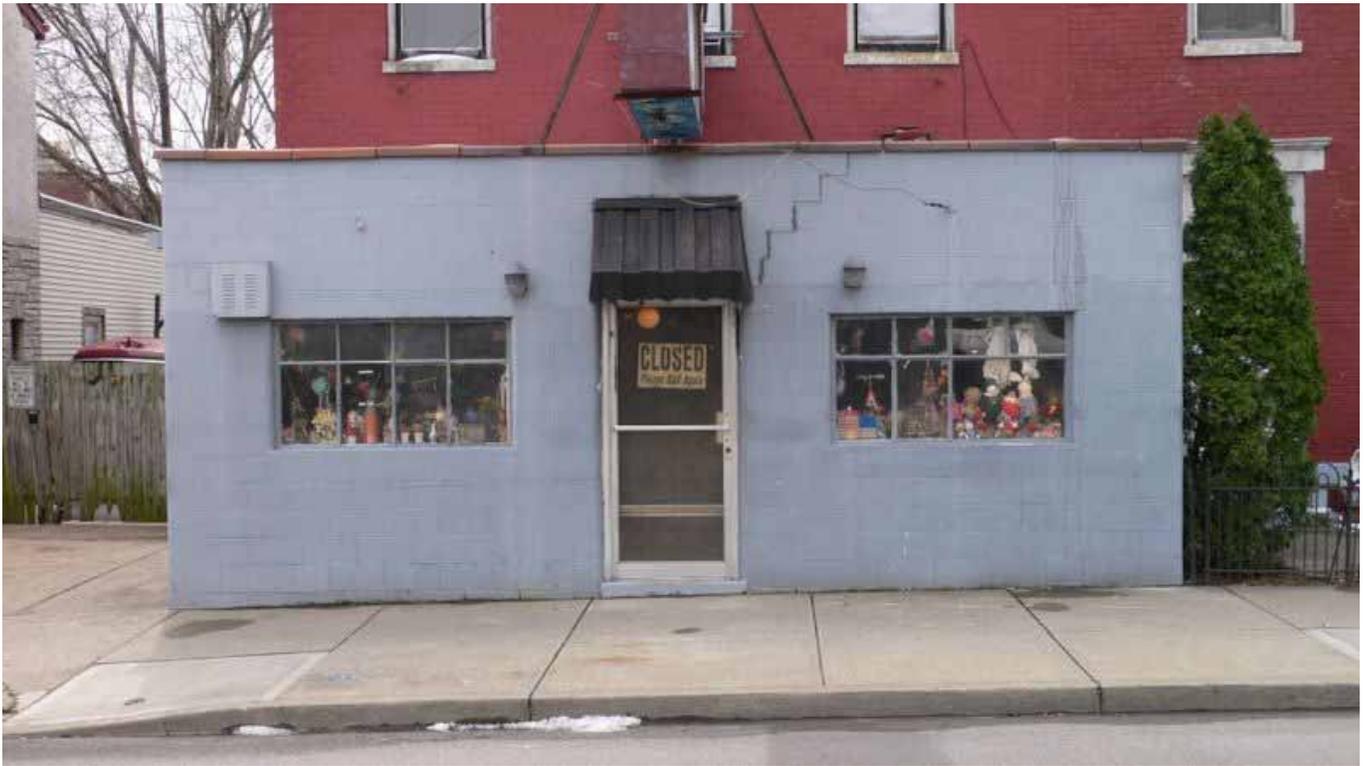
Sometime in the mid 20<sup>th</sup> century, a concrete block store front was added to the front of # 17 (Figure 7). Its rounded corners hint at a moderne style. Inside was a small show room with glass counters and shelves (Figure 16). The two ground floor rooms behind this space were also given over to the commercial interest, a furniture and odds and ends store as indicated by its mid-century box signage (Figure 1, Figure 8, and Figure 9). The rather large light fixture found in the second room of # 17 may also relate to this commercial renovation (Figure 19).

**Figure 7:** Store front at 17 East 12<sup>th</sup> Street.

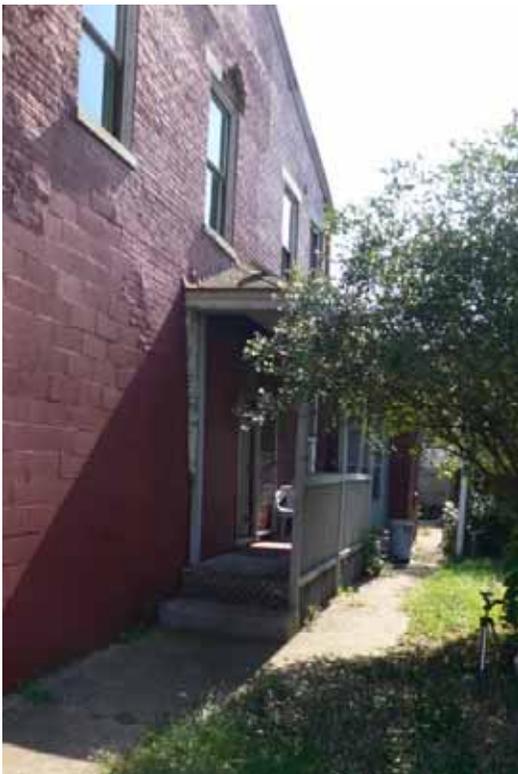
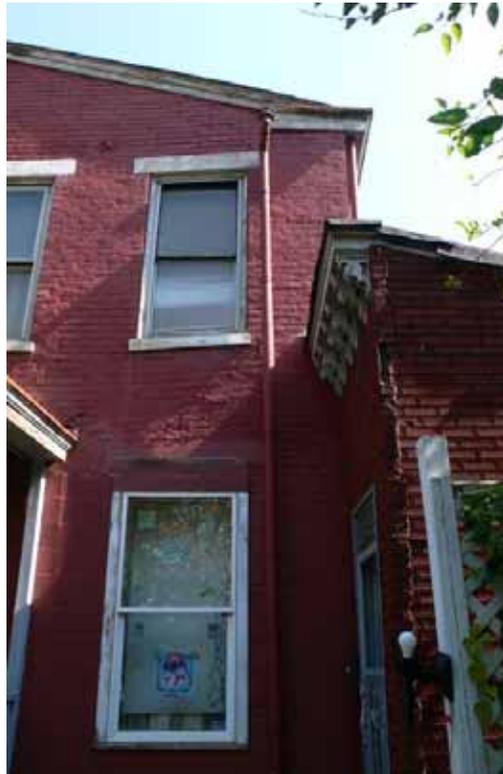
**Figure 10:** Details of 15 East 12<sup>th</sup> Street. Left: Side entry porch. Right: detail of back corner of the building, note the cornice on the shed addition.

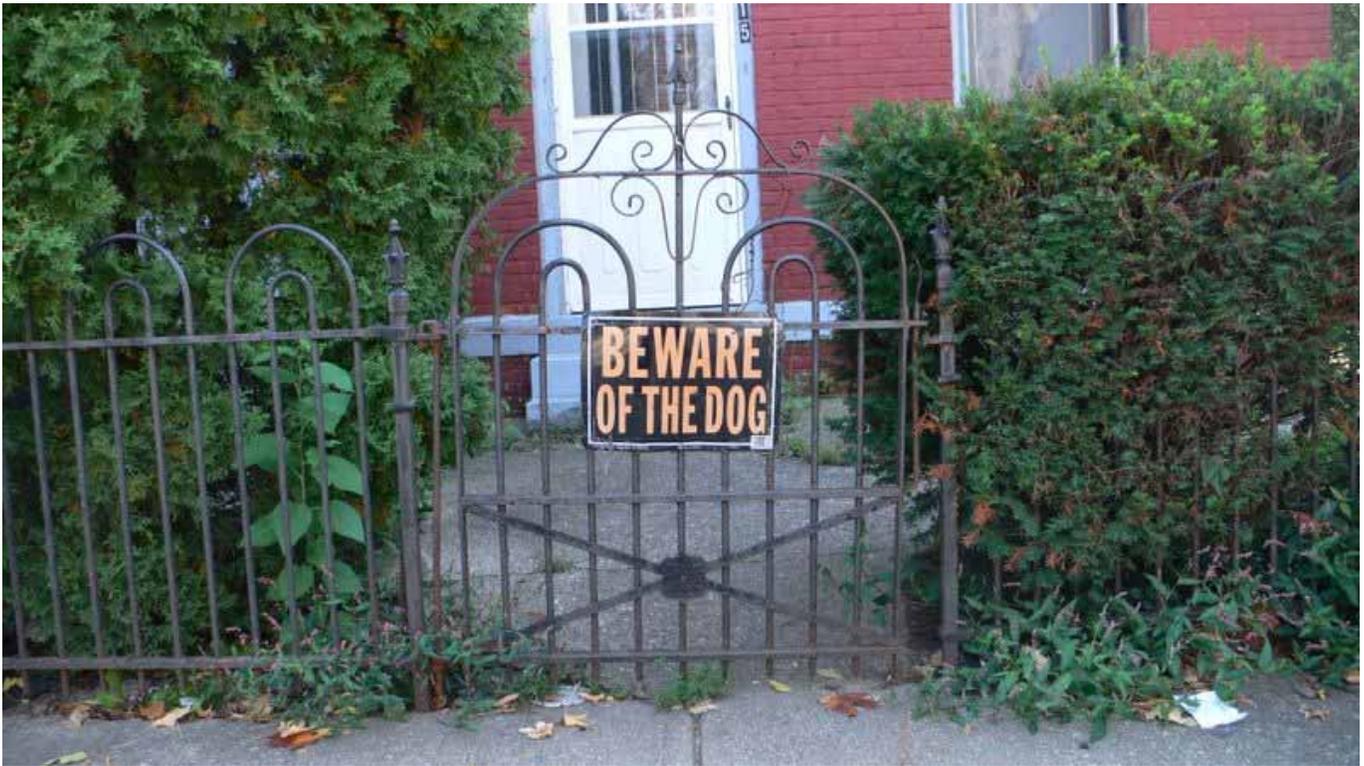
Other notable features documented at 15-17 East 12<sup>th</sup> Street include the wrought iron fence surrounding the yard at # 15 (Figure 11 and Figure 12), and the Art Deco "Magic Queen" kitchen faucet in the back shed kitchen of # 17 (Figure 21). Both dwellings had unheated attic spaces that served most recently as bedrooms, but may have had other purposes such as storage in the past (Figure 28).

**Figure 11:** *Iron fence at 15 East 12<sup>th</sup> Street.*

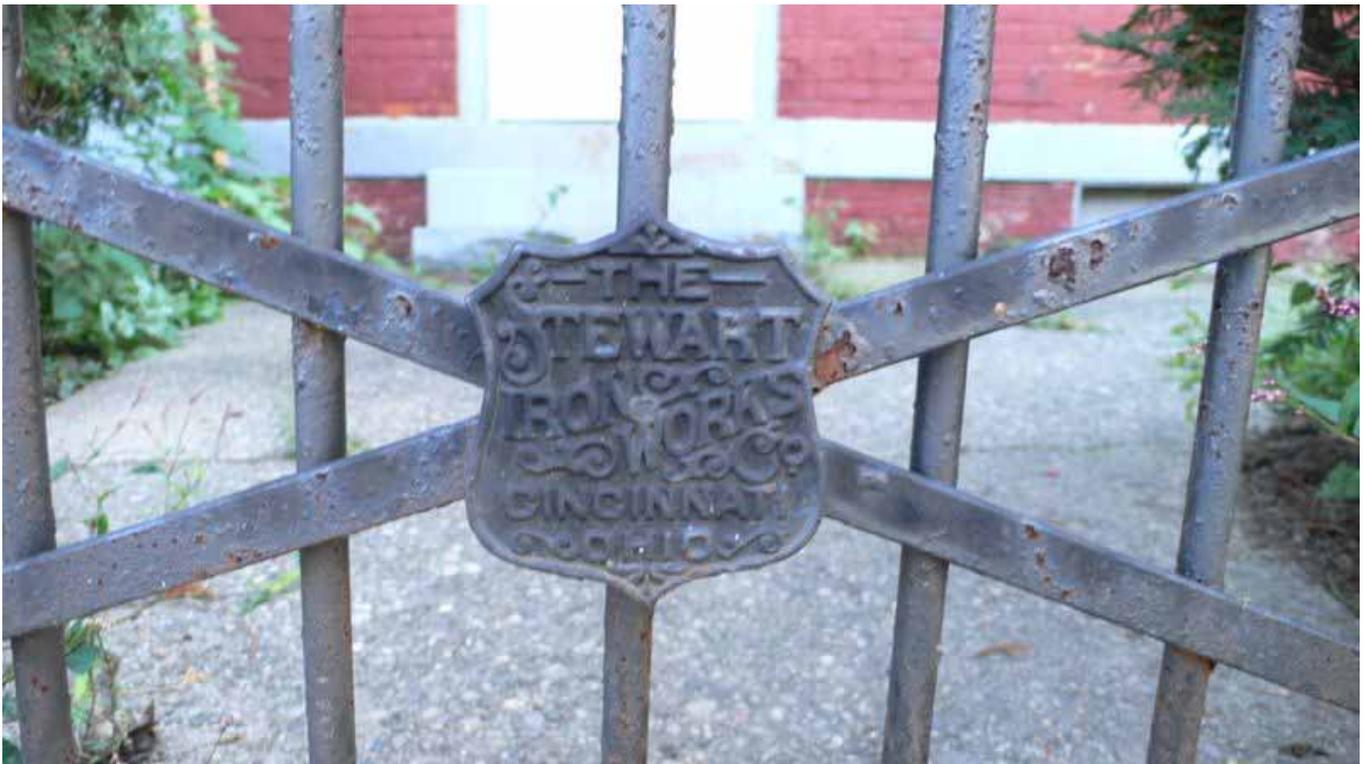
**Figure 12:** *Detail of Iron Fence at 15 East 12<sup>th</sup> Street.*

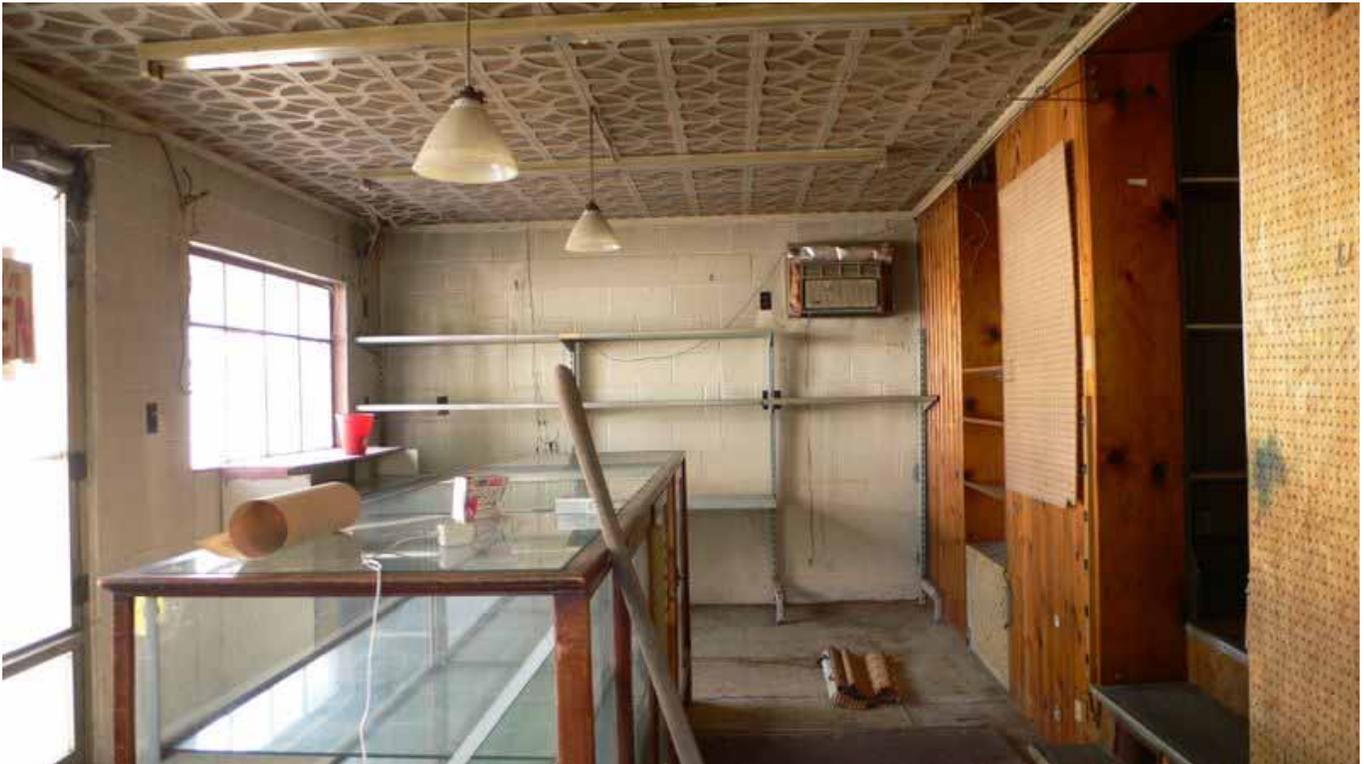
**Figure 16:** Interior of the concrete block storefront at 17 East 12<sup>th</sup> Street.

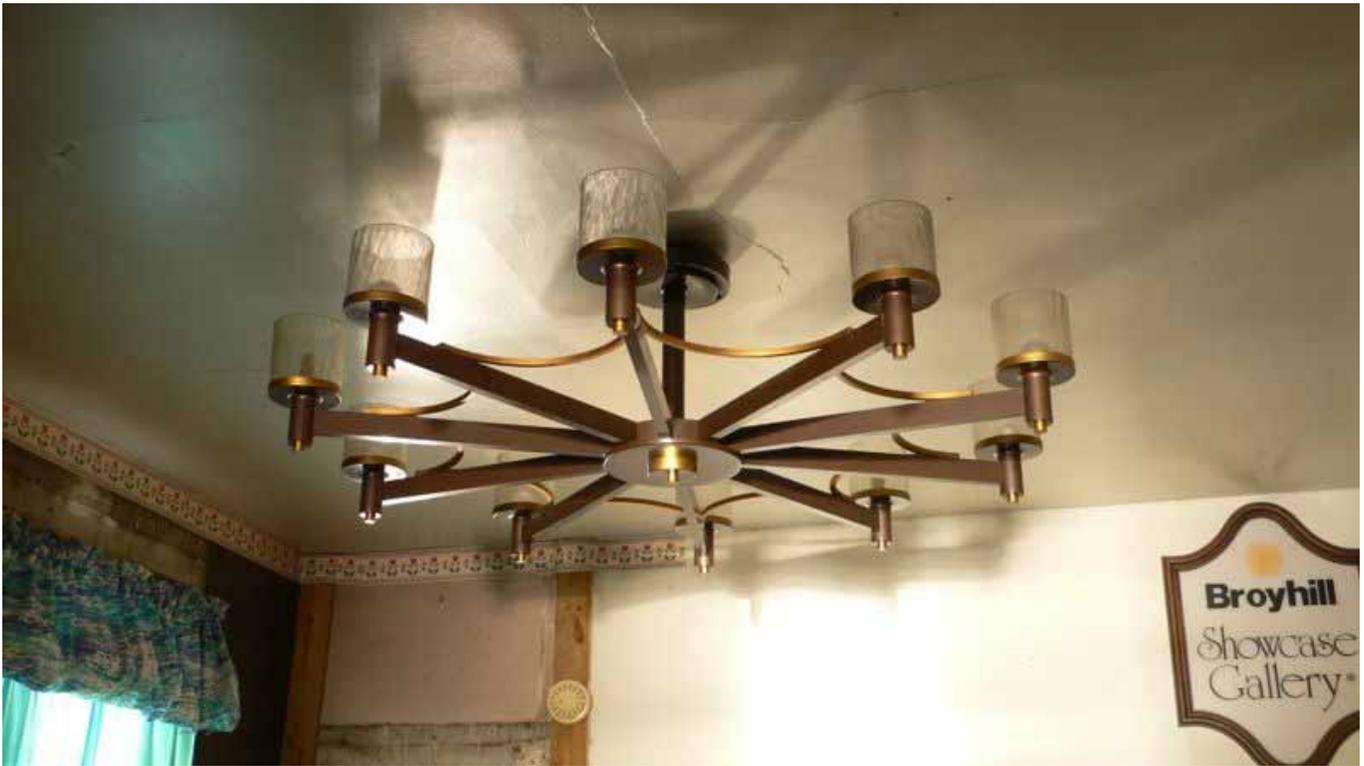
**Figure 19:** *Detail of light fixture in second ground floor room of 17 East 12<sup>th</sup> St.*

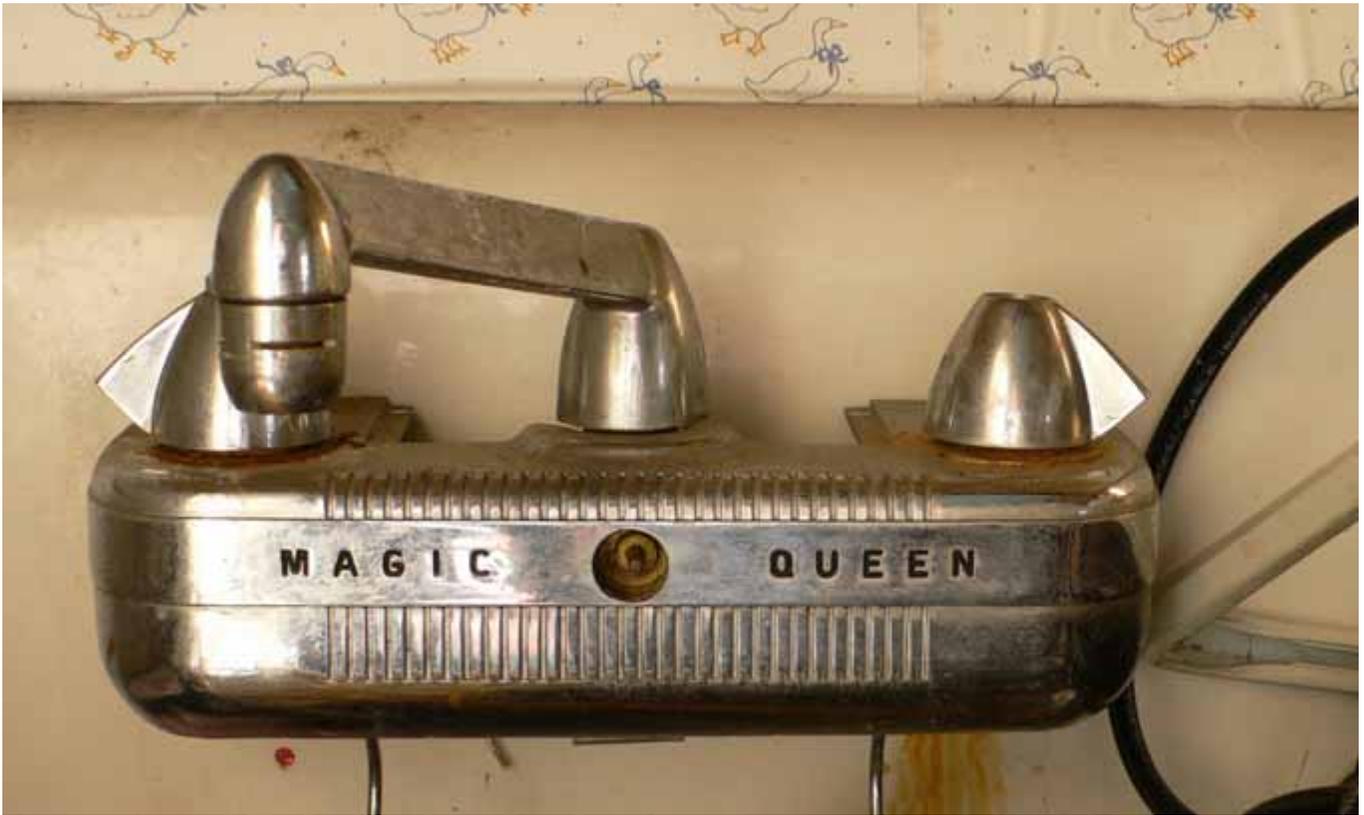
**Figure 21:** *Faucet in the kitchen addition of 17 East 12<sup>th</sup> Street.*

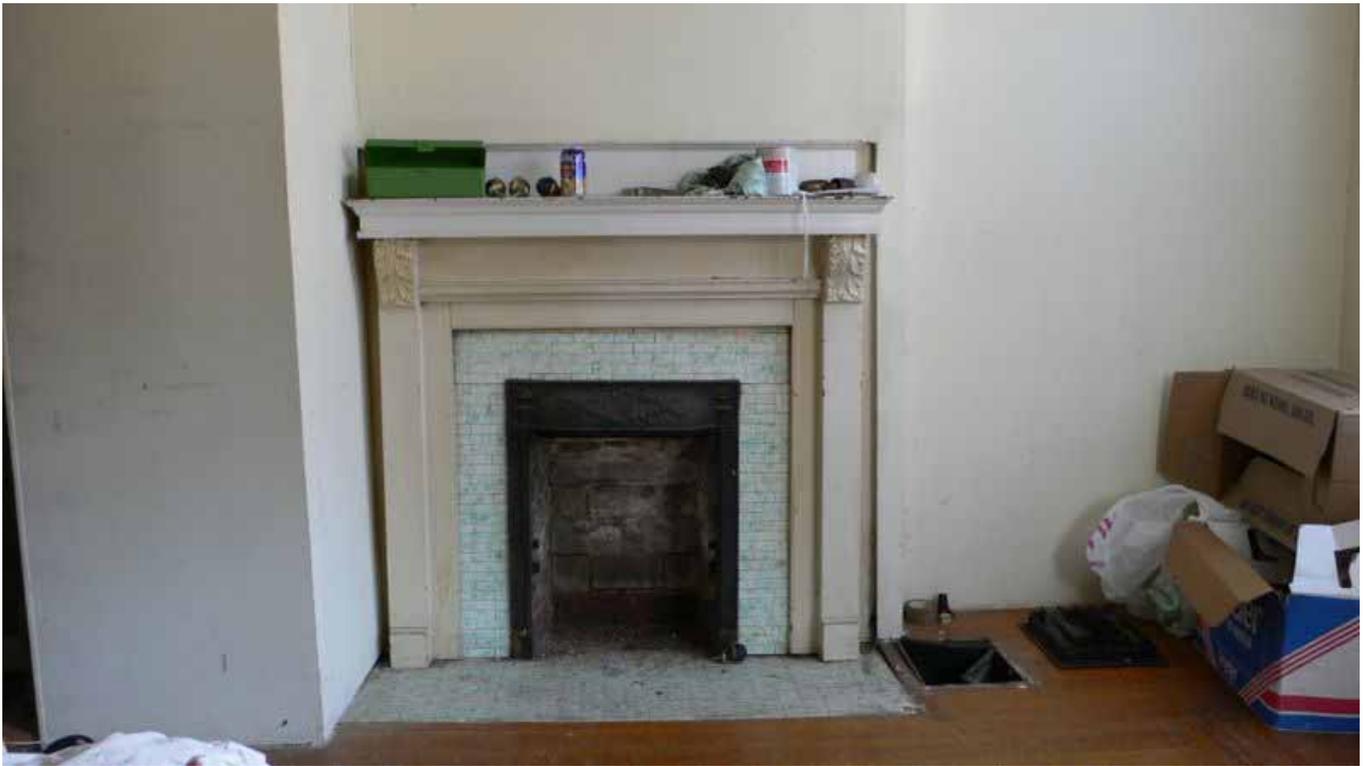
divided the space into at least three apartments. As the building stood in its final days, there was no interior access to the stair hall or the back rooms from the front two rooms. Many original architectural details in these spaces were absent, although the front room still retained an attractive late 19<sup>th</sup> century mantle (Figure 25 and Figure 26).

**Figure 25:** Mantle in front room of 15 East 12<sup>th</sup> Street.

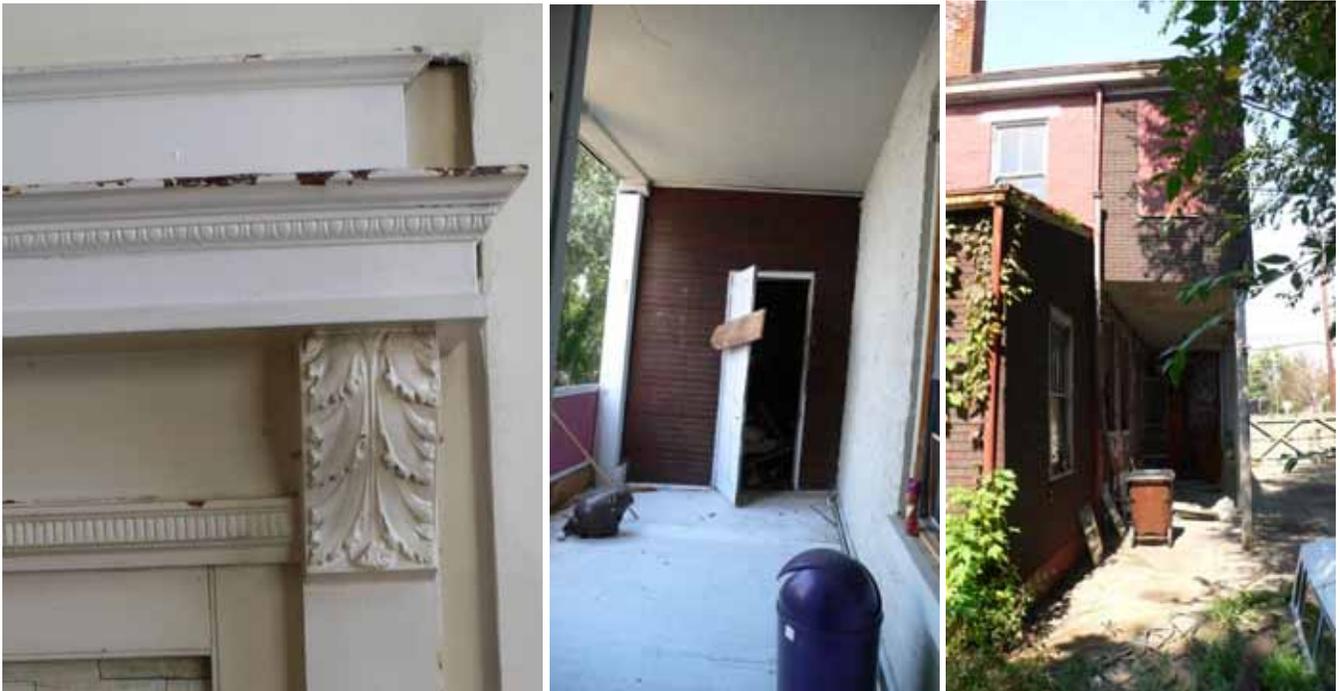
**Figure 26:** Left: detail of mantle in front room of 15 East 12<sup>th</sup> Street. Middle: open porch, 2<sup>nd</sup> floor, East side of building. Right: back of the open porch and the shed addition to 17 East 12<sup>th</sup> Street.

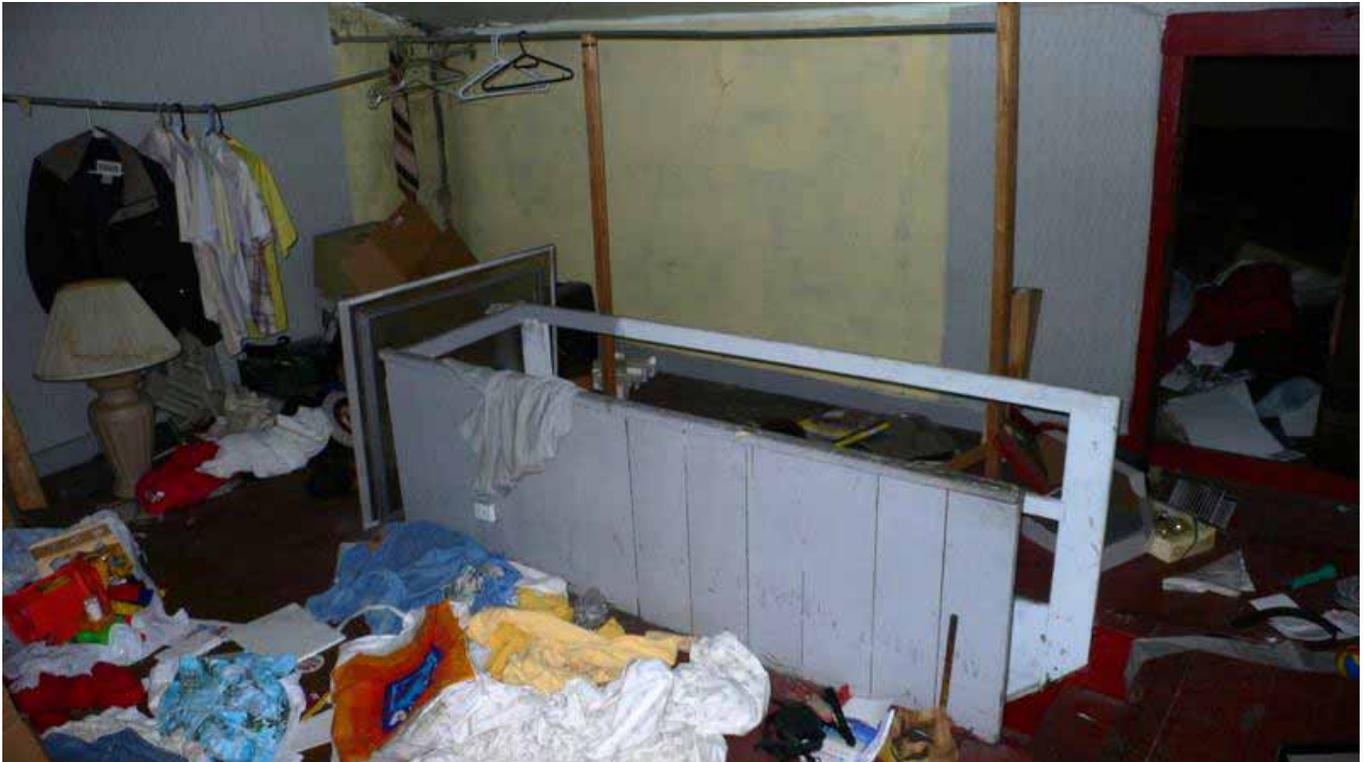
**Figure 28:** Interior of 15 East 12<sup>th</sup> Street, third floor attic loft.
