315 West 12<sup>th</sup> Street: Ruttle-Schlickman Packing Company; Bluegrass Provisions

315 West 12<sup>th</sup> Street (Figure 1) was a sprawling industrial building that filled the space bordered by Fisk, Watkins, 12th Street, and the unnamed brick alley that bisects the block north to south. The building was a very interesting and lively example of industrial architecture. Its numerous sections from various points in time in various styles and materials reflected a long history. Had it survived, it could have lent itself well to renovation as a gallery, restaurant, residential, or mixed use development. It was a document of over 150 years of the meat-packing and electrical industries in Northern Kentucky. While hazardous conditions in this structure limited our documentation to photography, we have established the basic outline of its complex evolution through analysis of its depiction in Sanborn maps over the years, from a sketch plan found posted at the site, and from the documentation photography.

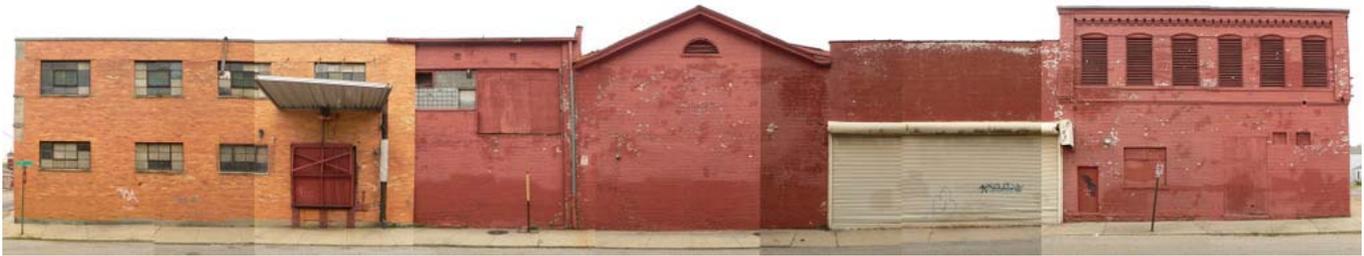
**Figure 1:** *Stitched panorama of the west façade of 315 West 12<sup>th</sup> Street. The front of the building faced 12<sup>th</sup> Street at the left of this illustration.*

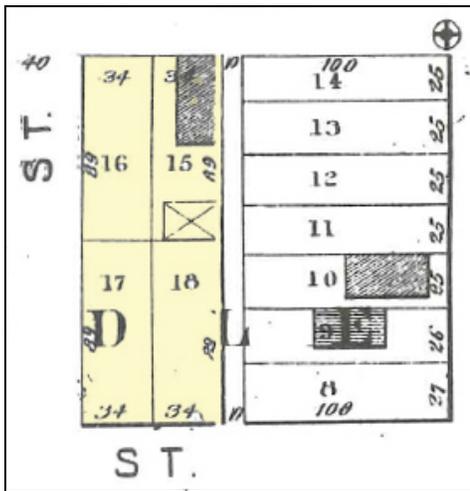
**Figure 2:** Detail of the property (shaded area) from the 1877 Hopkins' City Atlas of Covington, Kentucky. Twelfth Street is at the top of the figure.

The earliest depiction of the site available is in the 1877 Hopkins *City Atlas of Covington, Kentucky*, showing a rectangular masonry building its short side facing 12<sup>th</sup> Street. It stood adjacent to the alley, with a frame outbuilding behind, and no other structures on the block west of the alley (Figure 2). The footprint suggests the structure may have been a townhouse much like its neighbors. Some remnants of this house may have remained in the documented structure, but no evidence of that was noted. It is also not entirely clear if the business was run from this location at the time. By the time of the 1886 Sanborn depiction, the older structure on the 1877 map appears to have been enlarged to cover the whole front of the block, although it may have been demolished to create the larger structure. The property is now labeled “D. Ruttle and Co.’s Pork House” (Figure 3, left). The Ruttle’s meat company has a brief entry in the *Encyclopedia of Northern Kentucky*. Daniel Ruttle founded the business in 1859:

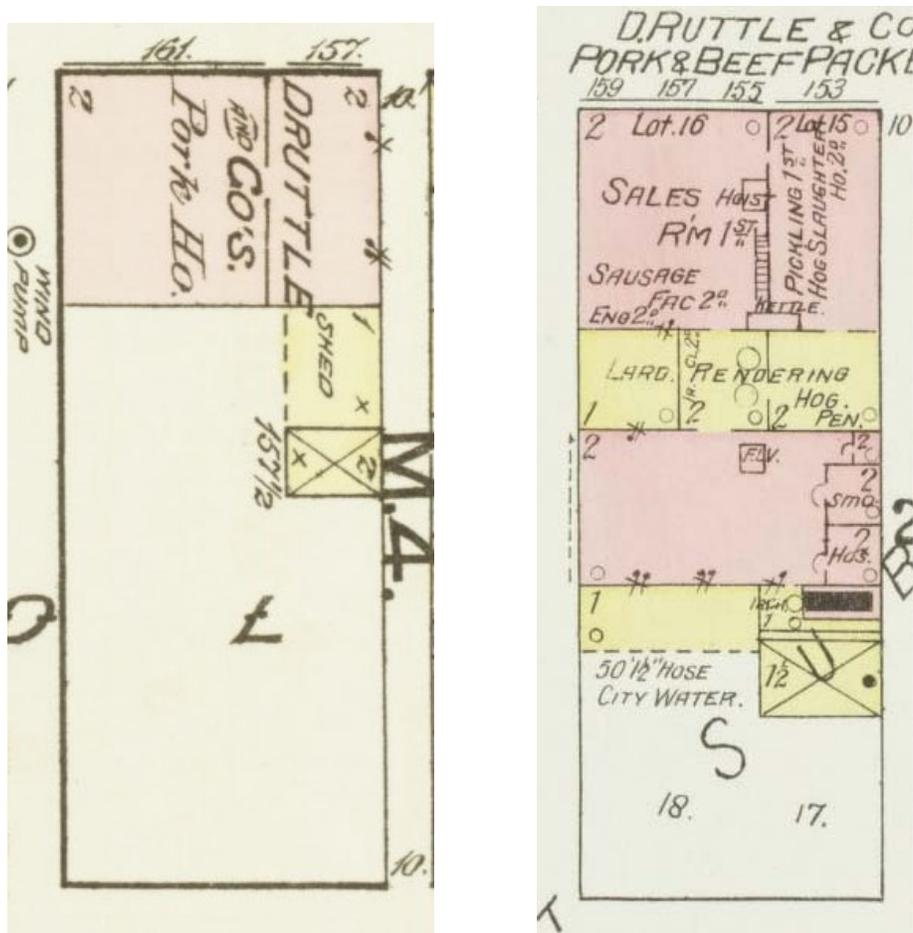
**Figure 3:** Sanborn map illustrations of 315 West 12<sup>th</sup> street. 1886, left, 1894 right. The 12<sup>th</sup> Street side of the building is at the top of the figures.

The next depiction, on the 1894 Sanborn map, shows that the business had expanded with additions covering roughly 2/3 of the block, and the business is now labeled the “D. Ruttle and Co. Pork & Beef Packers” (Figure 3, right). A second brick addition is shown joined to the original structure by a frame hyphen containing a hog pen and lard rendering facilities (Figure 3, right). The two story brick addition contained new masonry smokehouses, and the front part of the structure was divided between sales and pickling on the first floor, and slaughtering and sausage making on the second floor. Around this same period, the 1890 and 1892 Covington City Directories list the business at 153-159 West 12<sup>th</sup> Street (the same location - the address was later changed to 315 West 12<sup>th</sup>) as the Ruttle-Schlickman Packing Company, with Daniel Ruttle as the president of the company.<sup>2</sup>

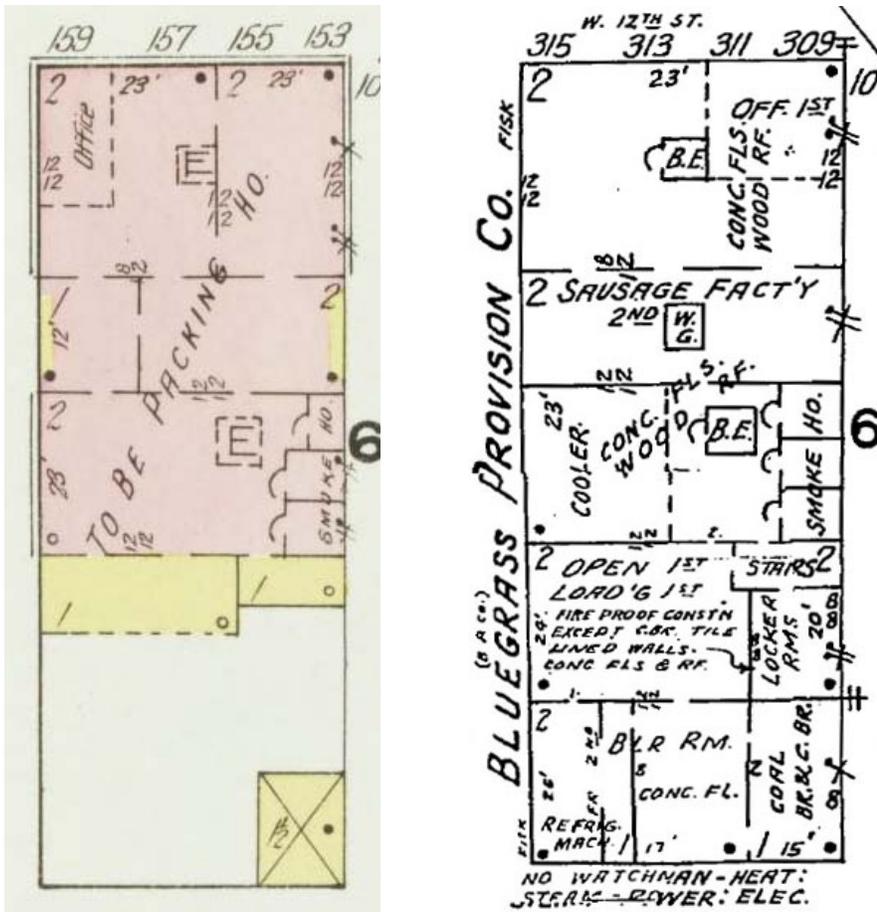
**Figure 4:** Sanborn Map illustrations of 321 West 12<sup>th</sup> Street, 1909, left, and 1945, right. The 1959 update of the map included no further changes. The 12<sup>th</sup> Street side of the building is at the top of the figures.

Little appears to have changed structurally by the time of the 1909 Sanborn map, except that an office is delineated on the northwest corner, but the association with D. Ruttle and Company has been dropped: the structure is now labeled “To Be Packing House,” suggesting that it was still vacant at that time following the bankruptcy of the Ruttle-Schlickman Company in 1904 (Figure 4, left).

The next Sanborn depiction available is 1945, by which time the building had been extended all the way to the back of the block on Watkins Street with the addition of a loading dock, a locker room, a boiler room and coal storage. It was owned by the Blue Grass Provision Company, another meat packing concern (Figure 4, right). During the tenure of Blue Grass Provision Company, the front end of the building was remodeled as well, the façade clad in Art Deco style with orange brick, concrete tile, metal casement windows, and glass blocks (Figure 9). The office was moved to the northeast corner of the building. The company name was identified by a carved sign above the front entry (Figure 16).

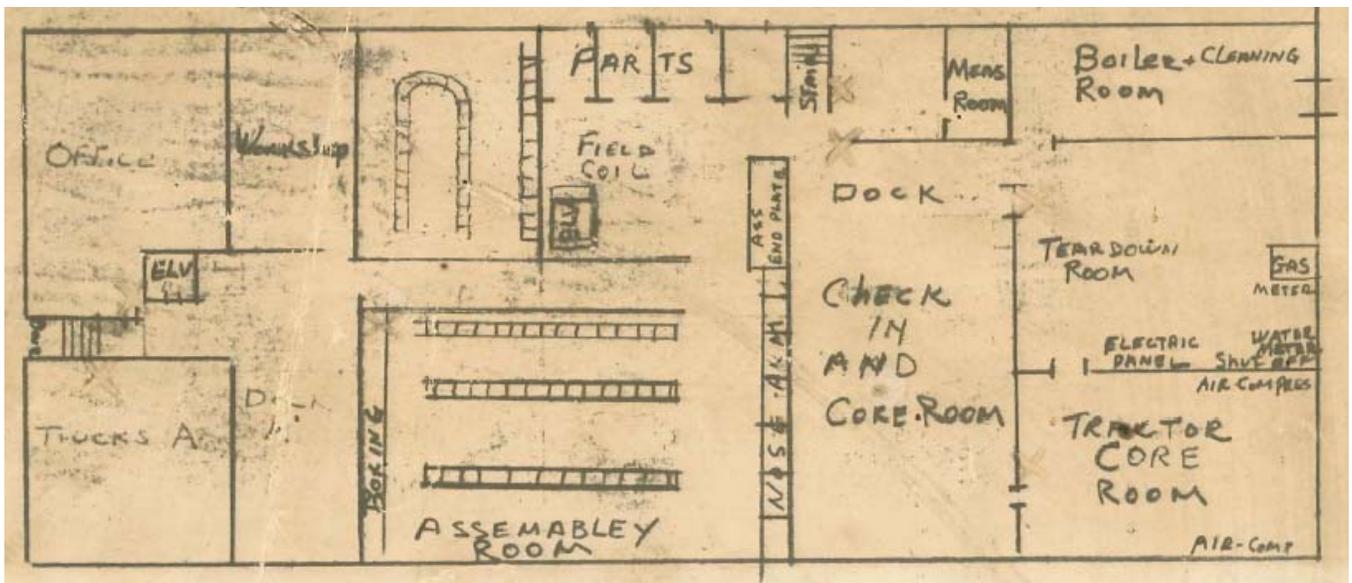
**Figure 5:** First Floor Plan of 315 West 12<sup>th</sup> Street, from drawing found on site. The 12<sup>th</sup> Street side of the building is at the left of the figure.

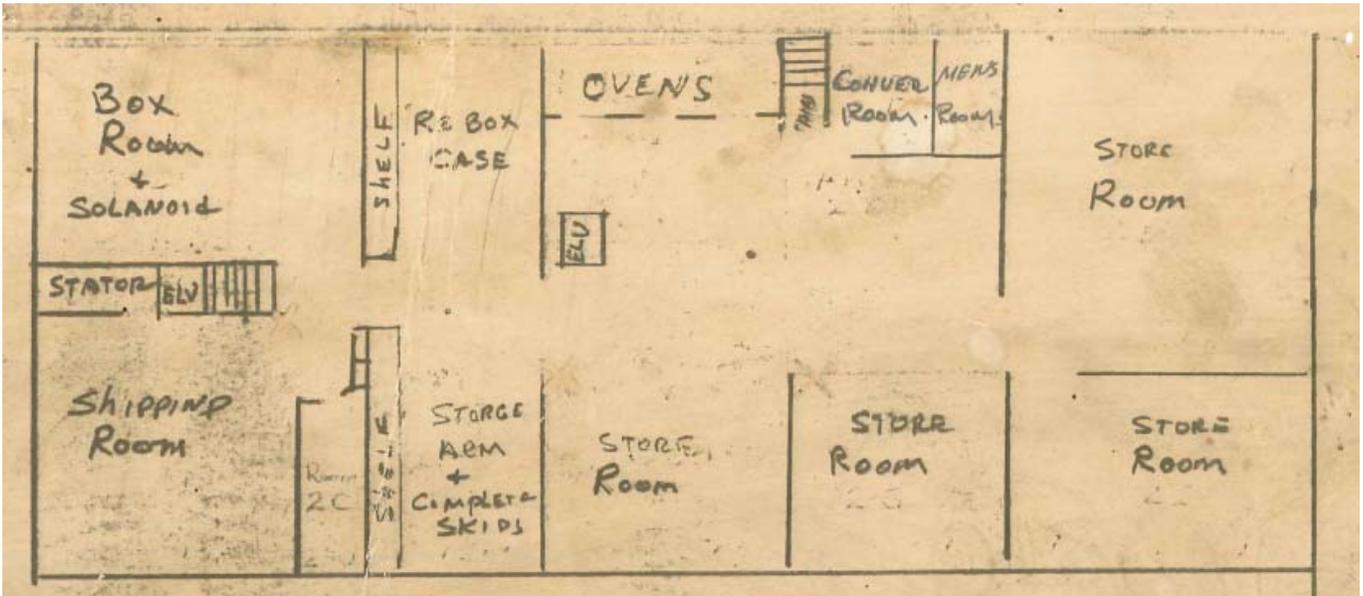
Figure 6: Second Floor Plan of 315 West 12<sup>th</sup> Street, from drawing found on site. The 12<sup>th</sup> Street side of the building is at the left of the figure.

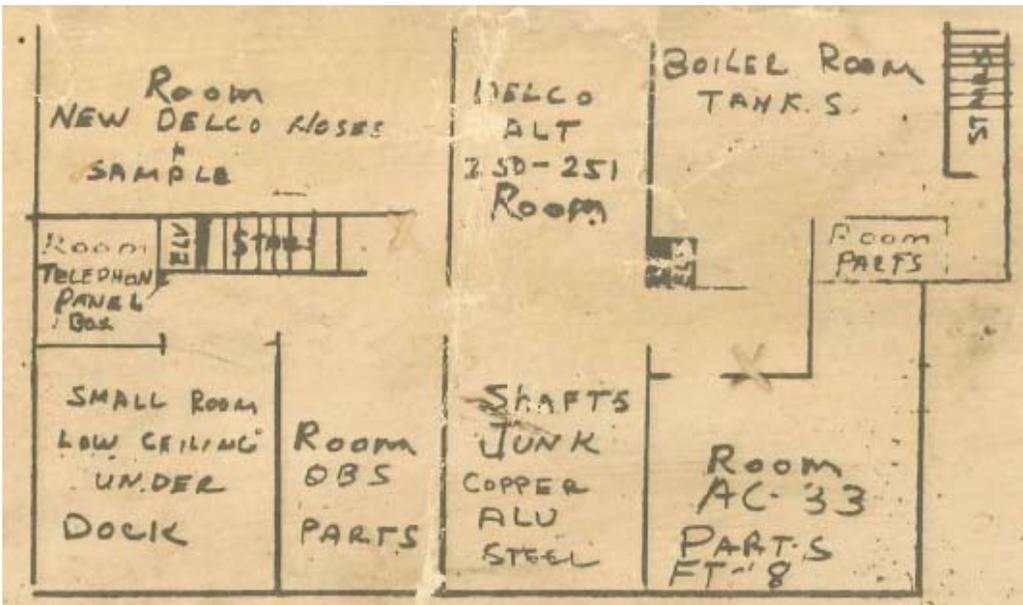
Figure 7: "First Basement" plan of 315 West 12<sup>th</sup> Street. The 12<sup>th</sup> Street side of the building is at the left of the figure.

It's not clear when the Blue Grass Provision Company sold the building, but by the time of our documentation, the building had for some time been occupied by Oberjohn's OEM Electric, builders of starters, alternators, and generators. The layout of the building remained roughly the same, but it was now used for engine building. The meat packing facility turned out to be quite adaptable for metal grinding. Where hogs were once rendered, workers now assembled engine parts. Floor plans that document the structure's use as an engine parts company were found posted on a billboard at the site (Figure 5 - Figure 8). The first floor plan (Figure 5), corresponds closely with the late Sanborn footprint of 1945 (Figure 4, right). The elevators are both marked in the same location; the smokehouses had been adapted for parts storage (Figure 37), and the general room arrangement was roughly the same as it was in the meat production period. The building also had a full second floor consisting of several work and storage rooms (Figure 6), and three levels of basement beneath the first floor, with more storage and a boiler room (Figure 7 - Figure 8).

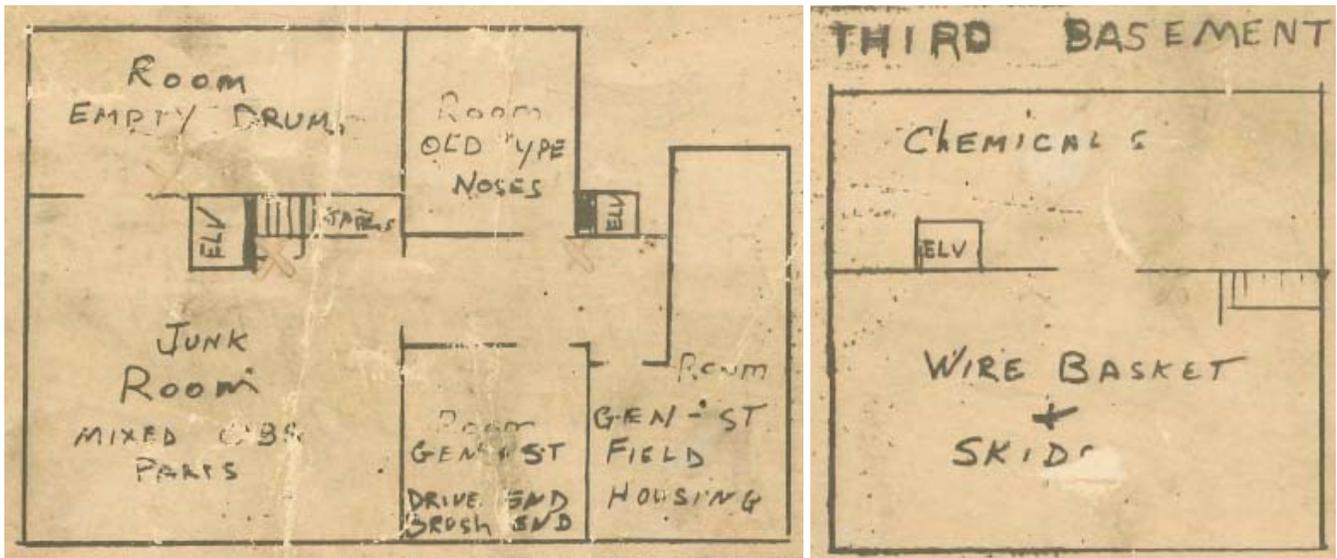
**Figure 8:** “Second Basement” and “Third Basement” plans of 315 West 12<sup>th</sup> street. The 12<sup>th</sup> Street side of the building is at the left of the figure. These areas were too dark and inaccessible to document..

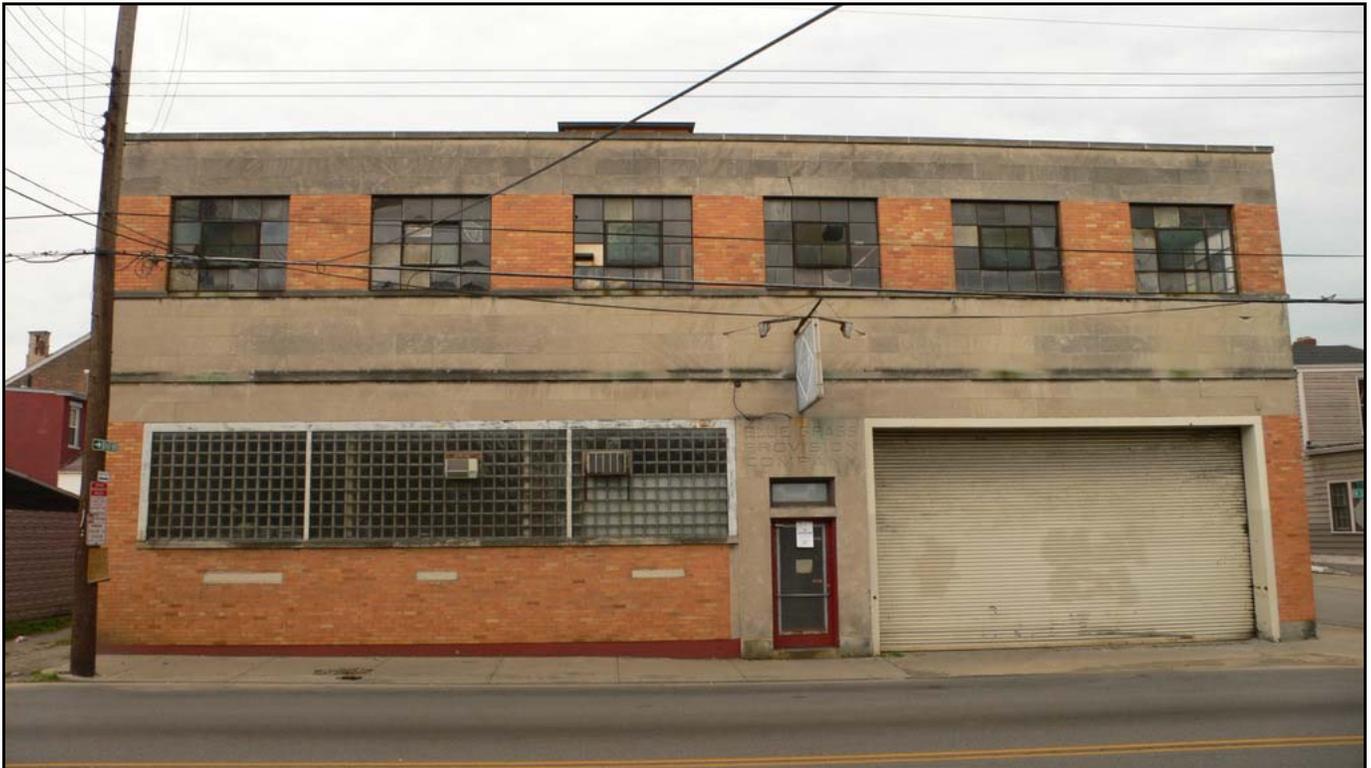
**Figure 9:** 315 West 12<sup>th</sup> Street, front façade facing 12<sup>th</sup>. Offices are to the left, loading dock to the right.

This mid-twentieth century renovation to the front of the building included handsome new office spaces at the North East corner (Figure 18 – 23). The offices included a reception area, two small private offices, a large main office and conference room, a walk-in safe, and restrooms. The interiors of the new offices were lined with a yellow beige glazed tile surfaces and lit at the front by glass block windows. A third of front part of the building was taken up by a large loading dock area accessed through a corrugated metal overhead door (Figure 9, Figure 25, & Figure 26).

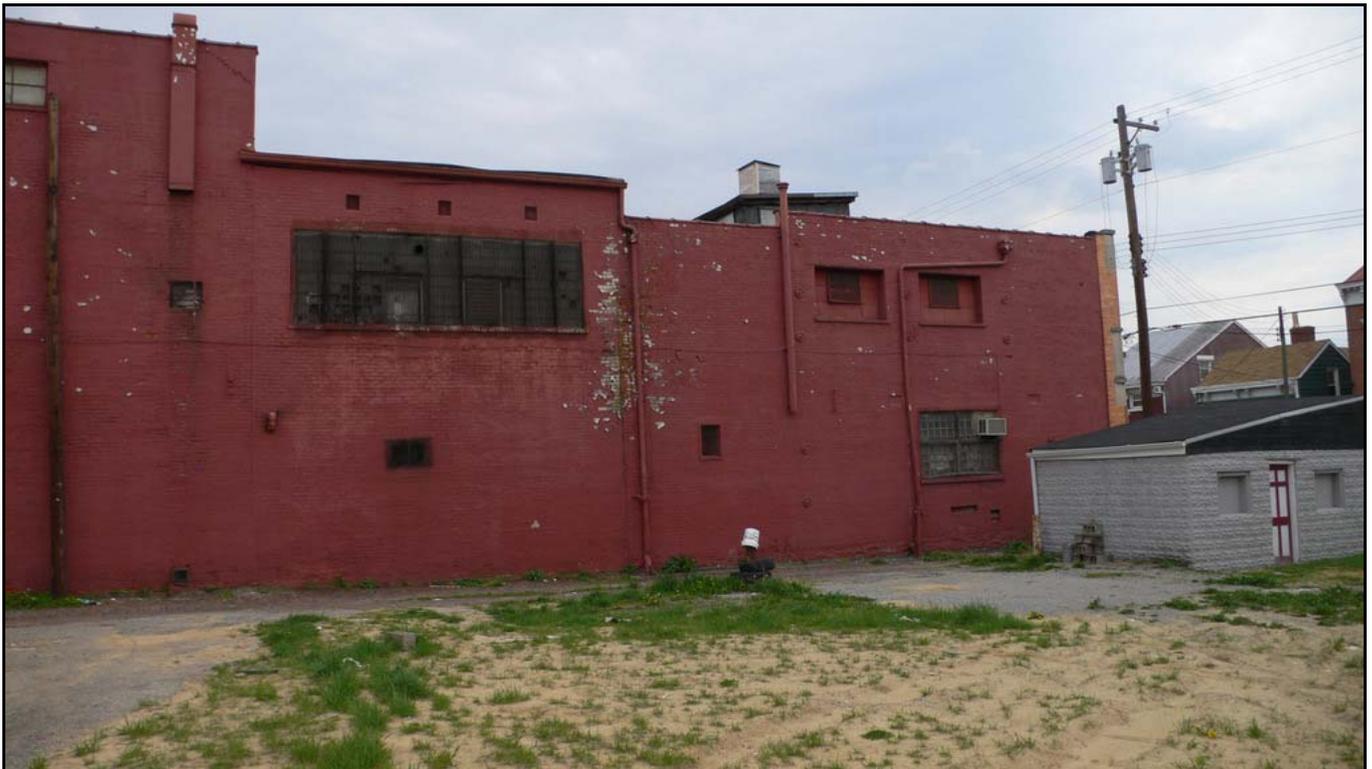
**Figure 11:** 315 West 12<sup>th</sup> Street from east. The stepped roofline reflects different periods of addition.

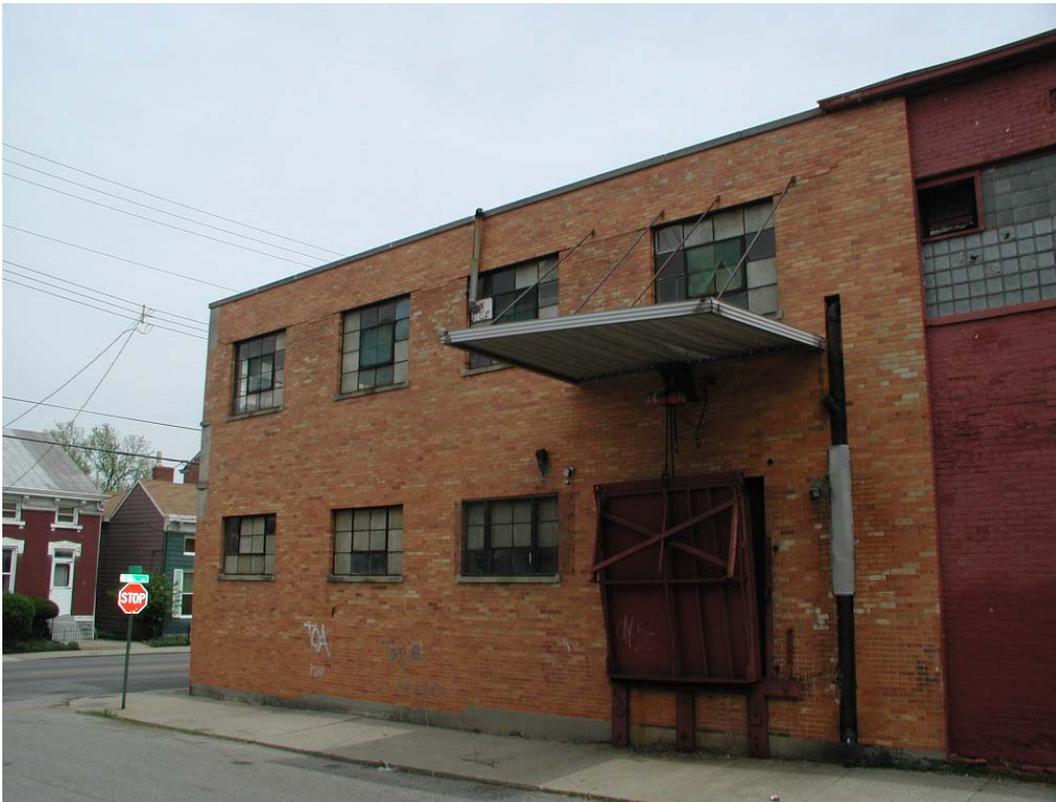
**Figure 14:** 315 West 12<sup>th</sup> Street, Northwest corner with side loading dock on Fisk Street.

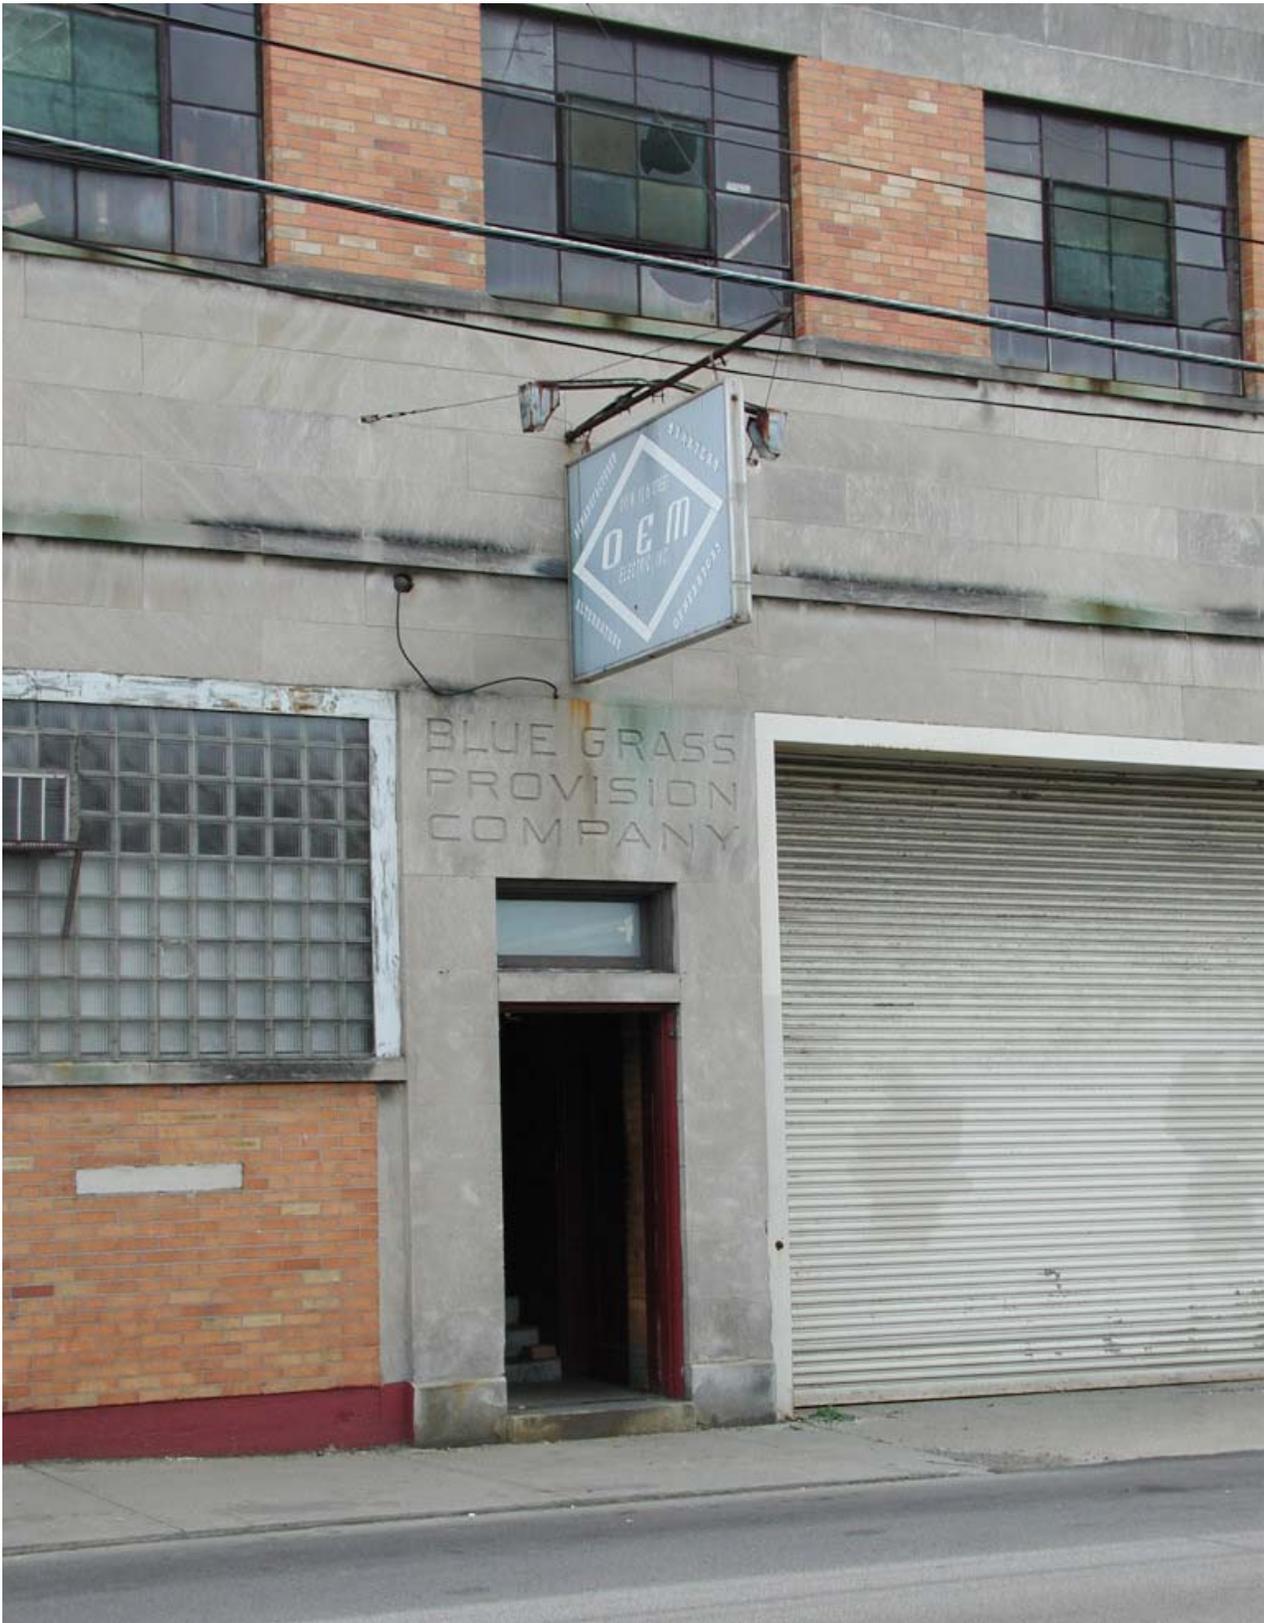
**Figure 16:** 315 West 12<sup>th</sup> St., Front door of Blue Grass Provision Company, with later hanging OEM sign.

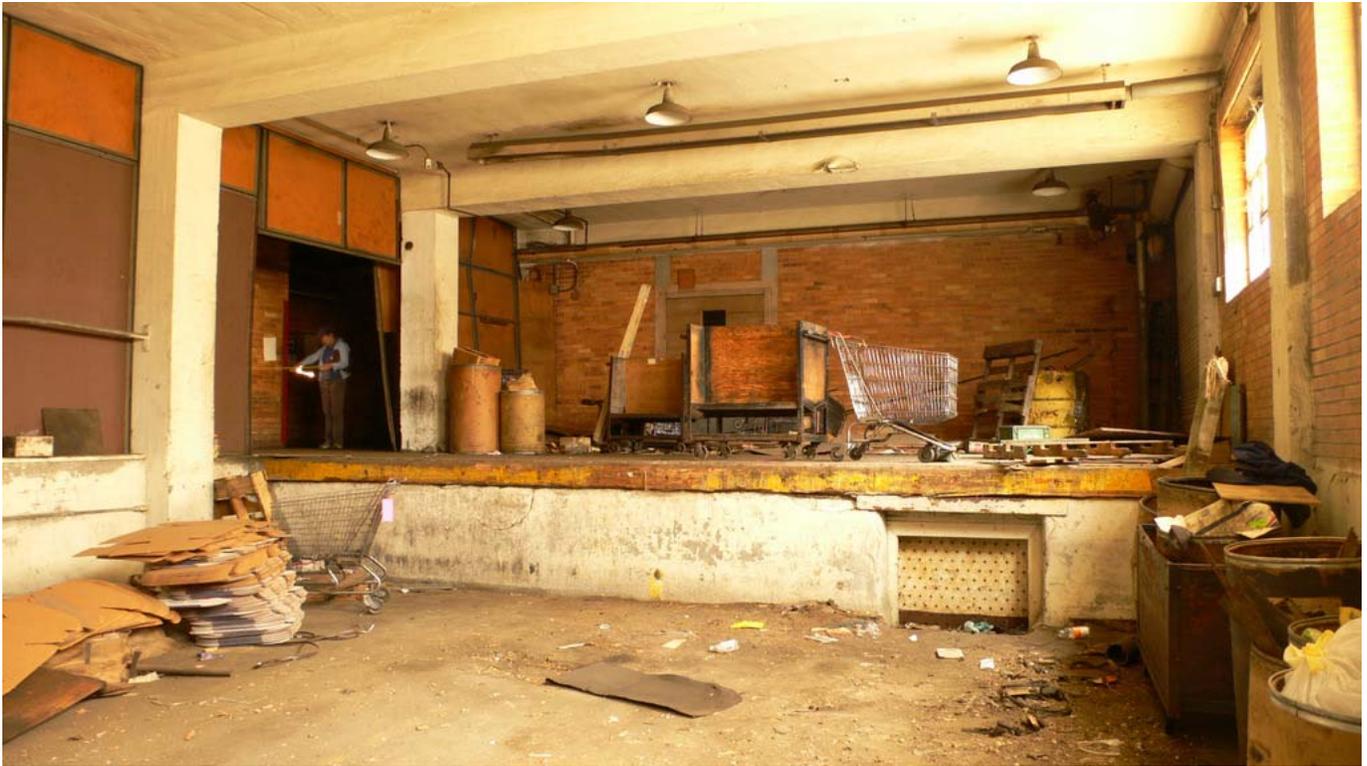
**Figure 25:** 315 West 12<sup>th</sup> Street, first floor, loading dock area in front section of the building, marked “Trucks A” in Figure 5.

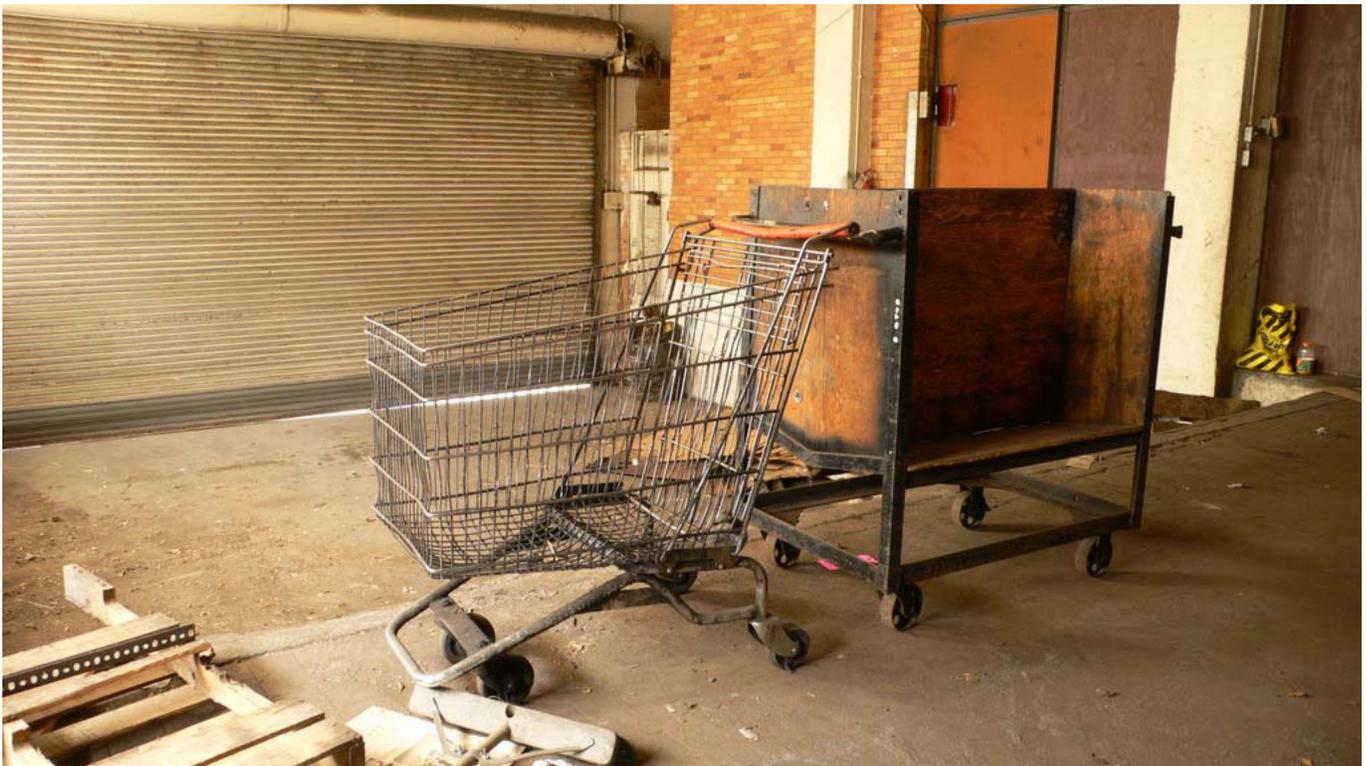
**Figure 26:** 315 West 12<sup>th</sup> Street, first floor, loading dock, looking toward front garage door.

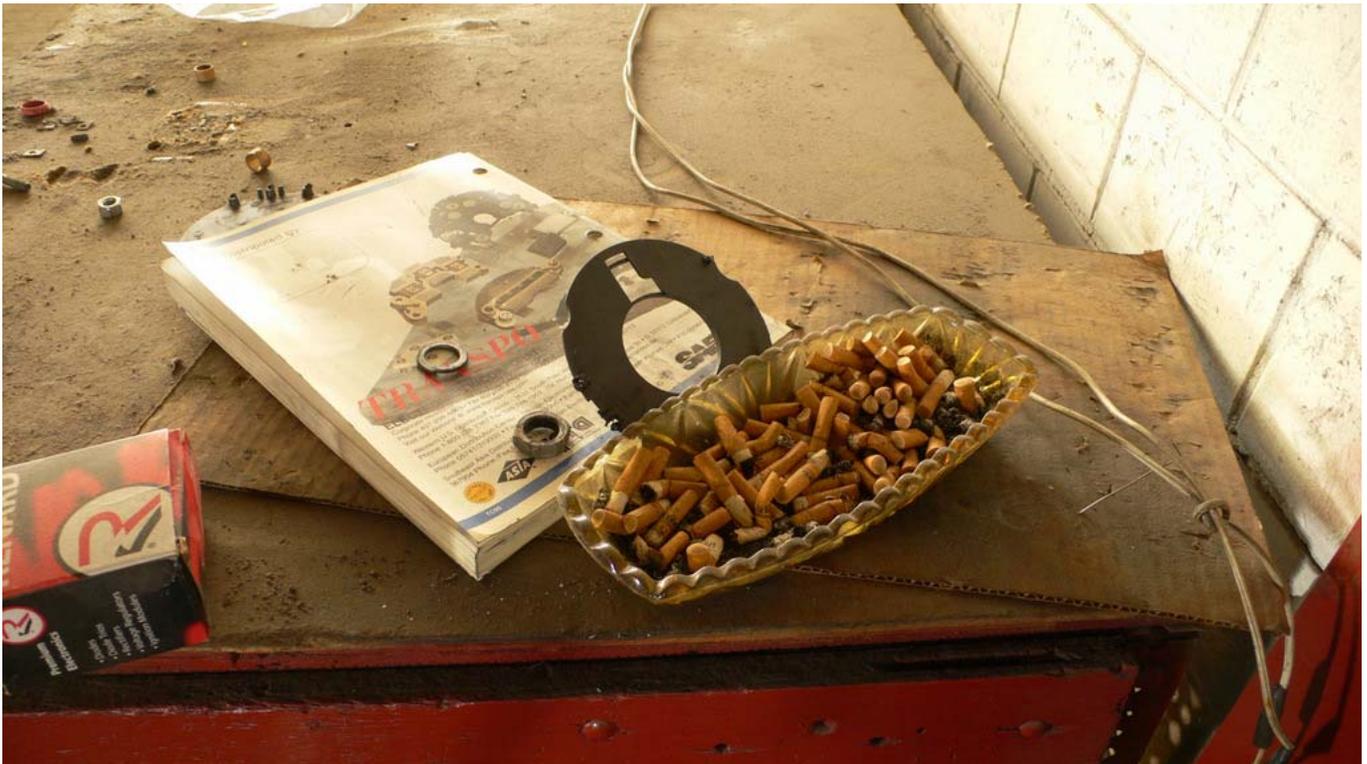
**Figure 30:** 315 West 12<sup>th</sup> Street, ashtray in the “workshop” area. The work conditions appear to have been potentially hazardous, with exposure to solvents and fine metallic dust, as well as open smoking in some areas.

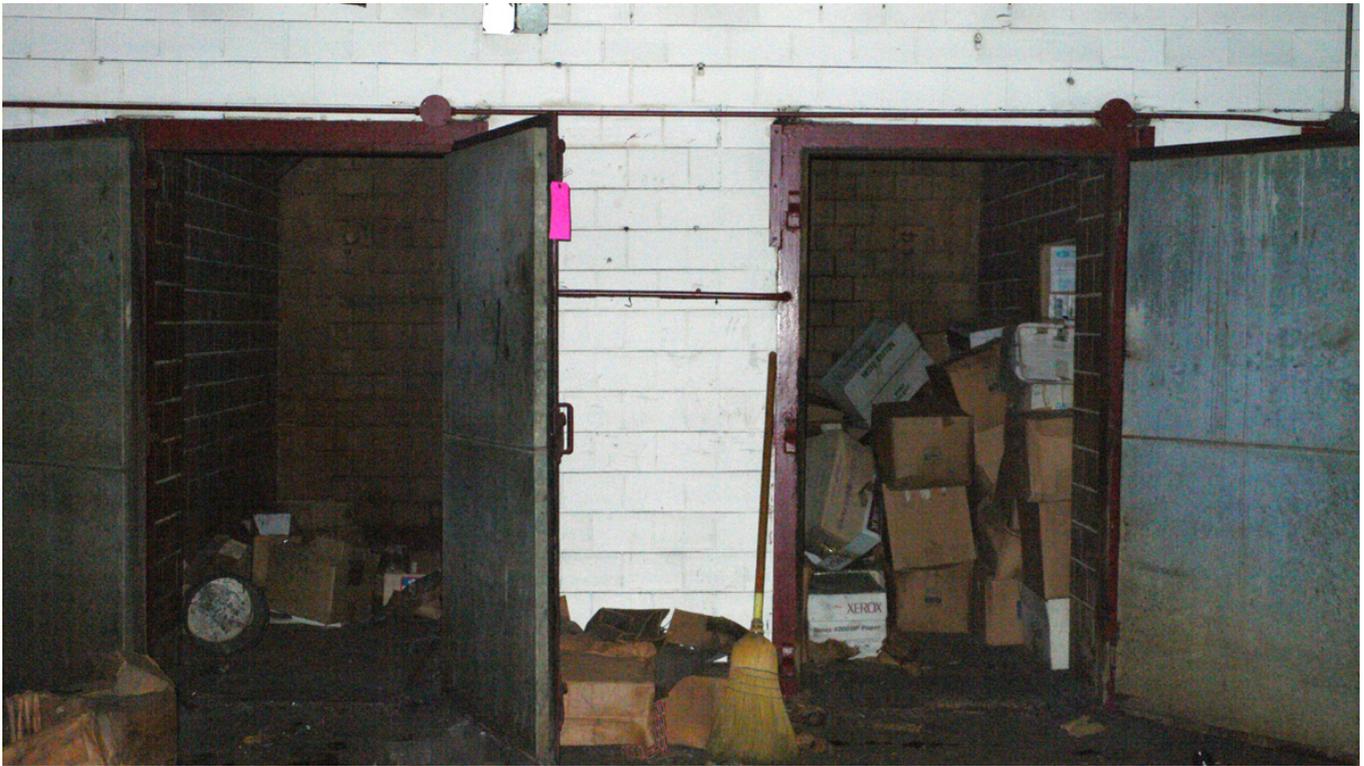
**Figure 37:** 315 West 12<sup>th</sup> Street, storage rooms – these are in the location labeled smoke houses on the Sanborn maps, and as “parts” in Figure 5

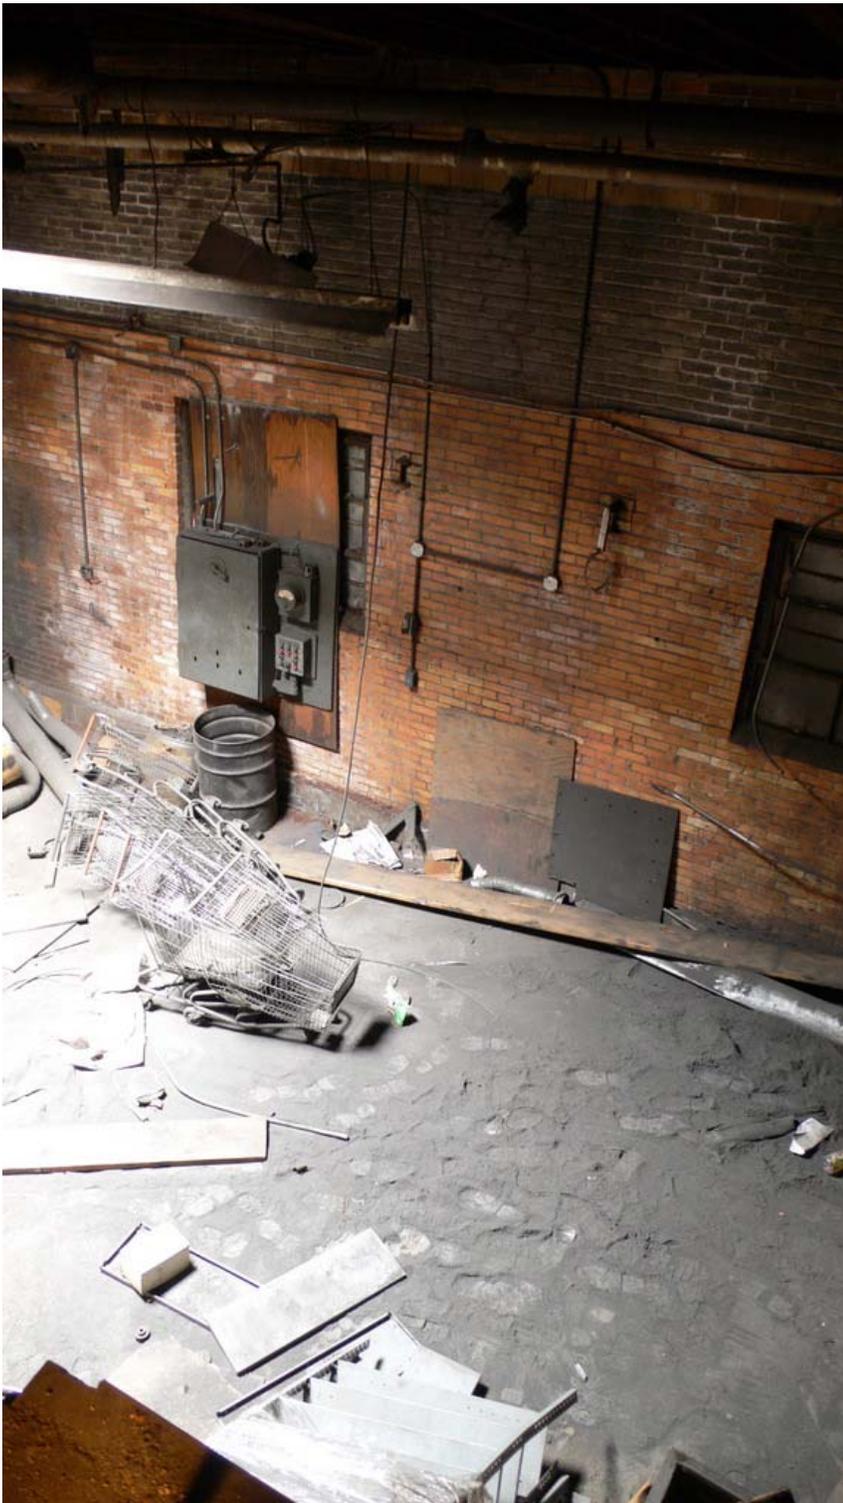
**Figure 40:** 315 West 12<sup>th</sup> Street, First floor, looking down into the area marked “Boiler & Cleaning Room” in *Figure 5*.
