411 West 12th Street (formerly 197 West 12th)

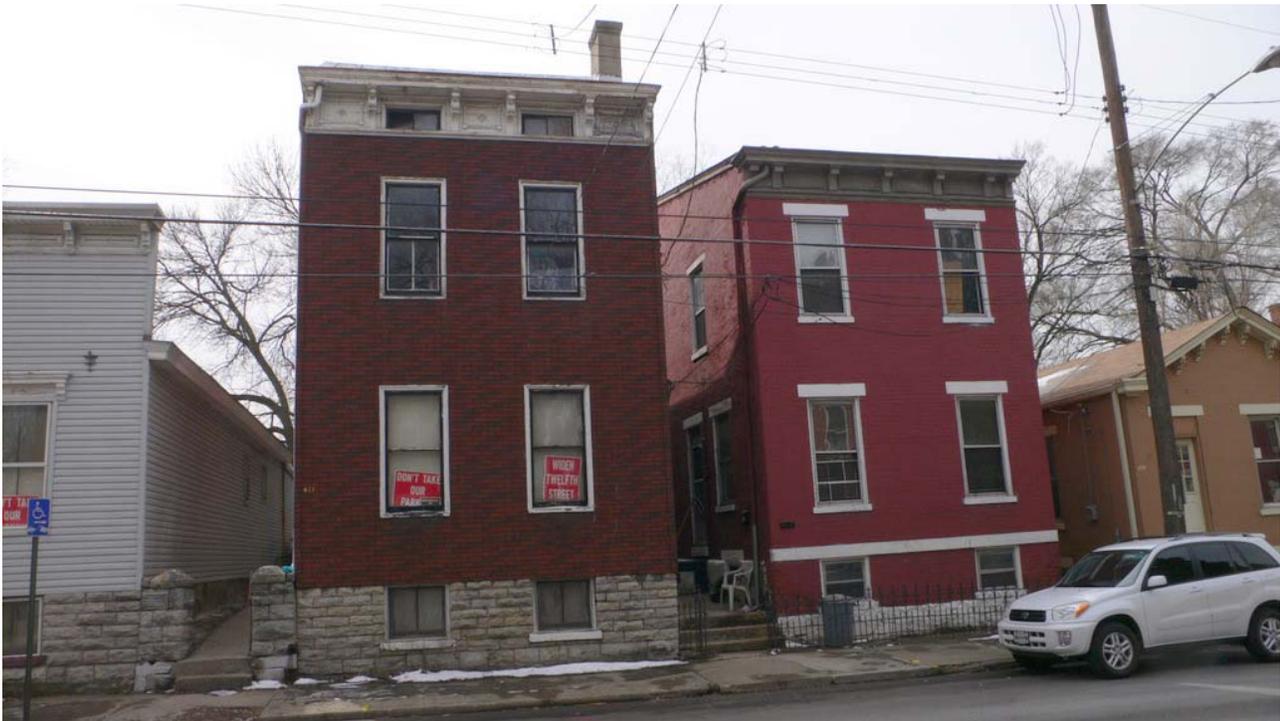
411 West 12th Street was a frame Italianate, two and half story Northern Kentucky Townhouse (Figure 1). The front façade was two bays wide with 1/1 and 2/2 sash windows (possibly early replacements, as the side gable had a 6/6 window (Figure 5)). The side-gable front section was capped with an ornate bracketed cornice pierced by two narrow windows. The principal hearth was vented by a chimney on the west side of the building. Behind this front section ran a two story, two-room ell with a center chimney, its gable perpendicular to the front section. The exterior was clad with a mid-twentieth century artificial siding of brick-patterned asphalt over the original weatherboards

Figure 1: 411 West 12th Street, center left.

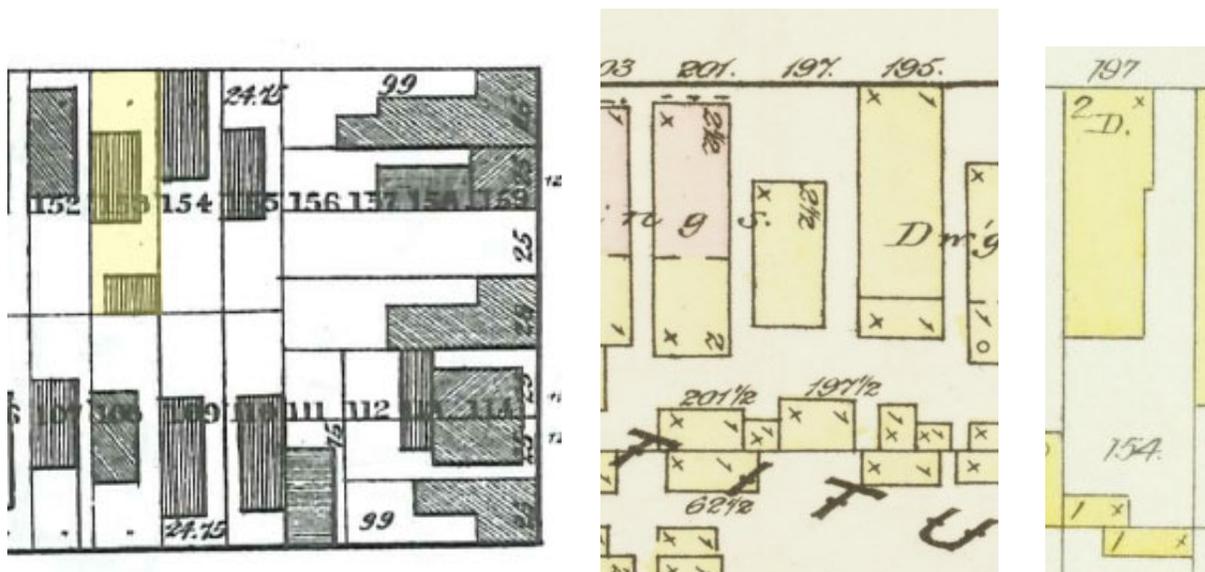
Figure 2: Left: Detail from Hopkins 1877 Atlas – 411 West 12th Street at that time had the address of 153 West 12th. Center: Detail of the 1886 Sanborn map, with 411 West 12th now with the street address of # 197. Right: Detail of the property as depicted on the 1894 Sanborn map, showing the building enlarged in size (compare with the floor plan, Figure 3 –note that the top of the map corresponds to the bottom of the floor plan). By 1894, the structure at the back of the property earlier identified with an address at 197 ½ has apparently been removed.

¹ It's also interesting that the historic maps prior to 1894 also show a small dwelling at the back of the lot with the address of 197 ½. Similar dwellings are documented at several of the neighboring houses. The backyard dwellings of Covington must have been an interesting social situation, but most of them appear to have been cleared in the 1890s.

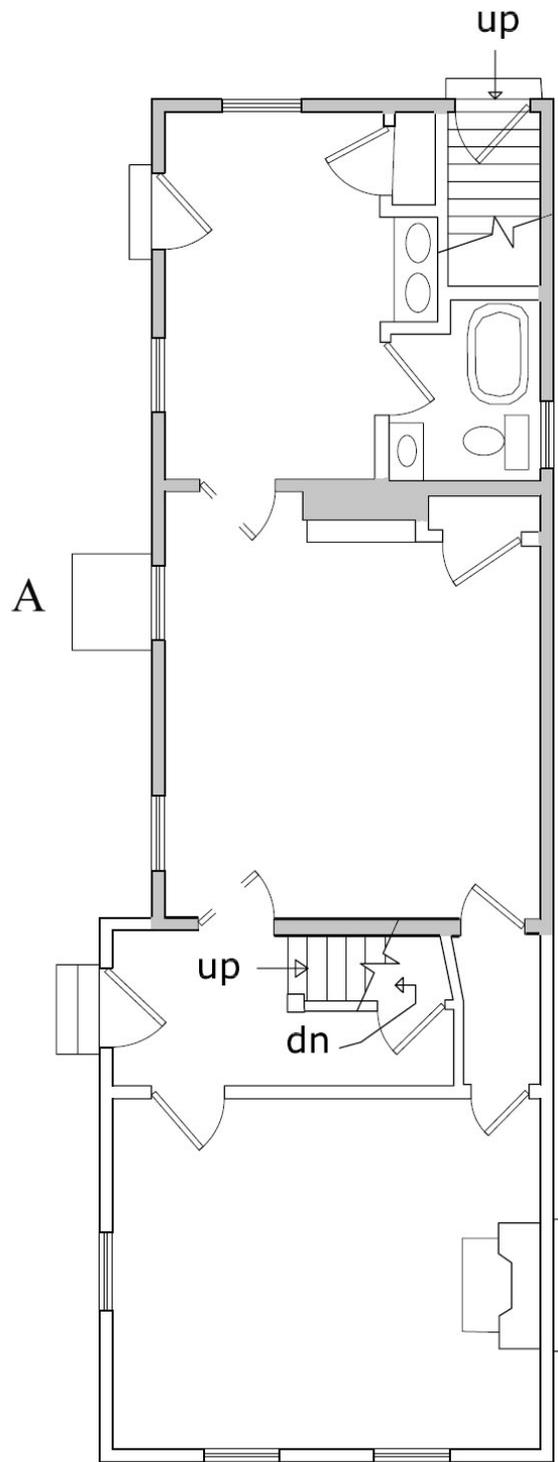
If this scenario is correct, the house began as a one or two story, two room plan town house set back some distance from the street, almost as if the later addition was planned from the beginning. This was essentially a center chimney hall/parlor or double-pen plan house oriented with one end facing the street. In its final form the house had an exterior back stair – it's not clear if this stair existed in this location prior to the addition of the front section of the house, or if the stair location was moved in the process of enlargement (refer to the floor plan in Figure 3). If the back stair was original, the original house may have been a duplex with different apartments on each floor, which is consistent with the city Directory evidence mentioned above.

Figure 3: Floor plan of 411 West 12th Street, Drawn by Danielle Jamieson, measured by Bill Macintire. Scale in feet. “A” indicates the location of a bulkhead entry to the cellar. The grayed walls indicate the first period structure.

same house. The cellar could be accessed either through narrow entrance beneath the front stair or from a bulkhead located below one of the middle room windows (at “A” in the floor plan, Figure 3).

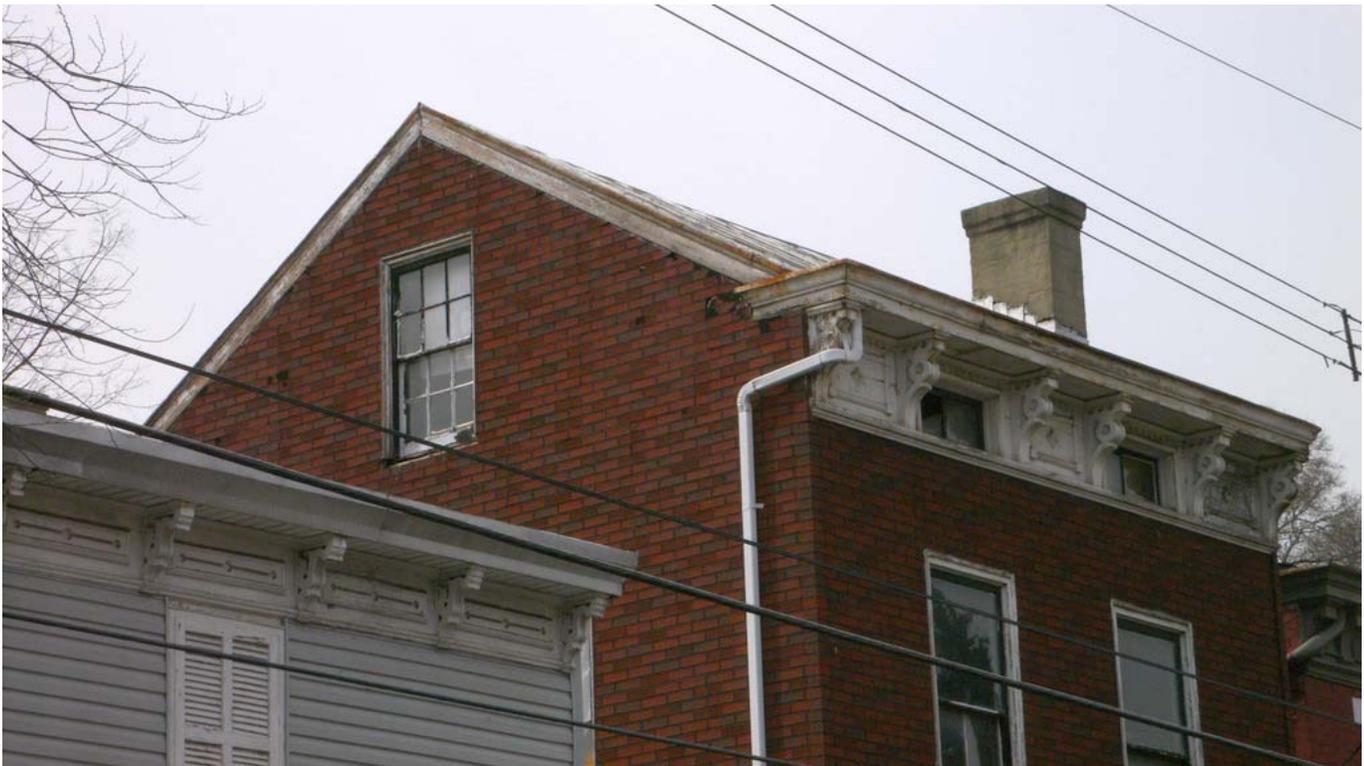
Figure 5: *411 West 12th Street, right, detail of side gable and cornice.*

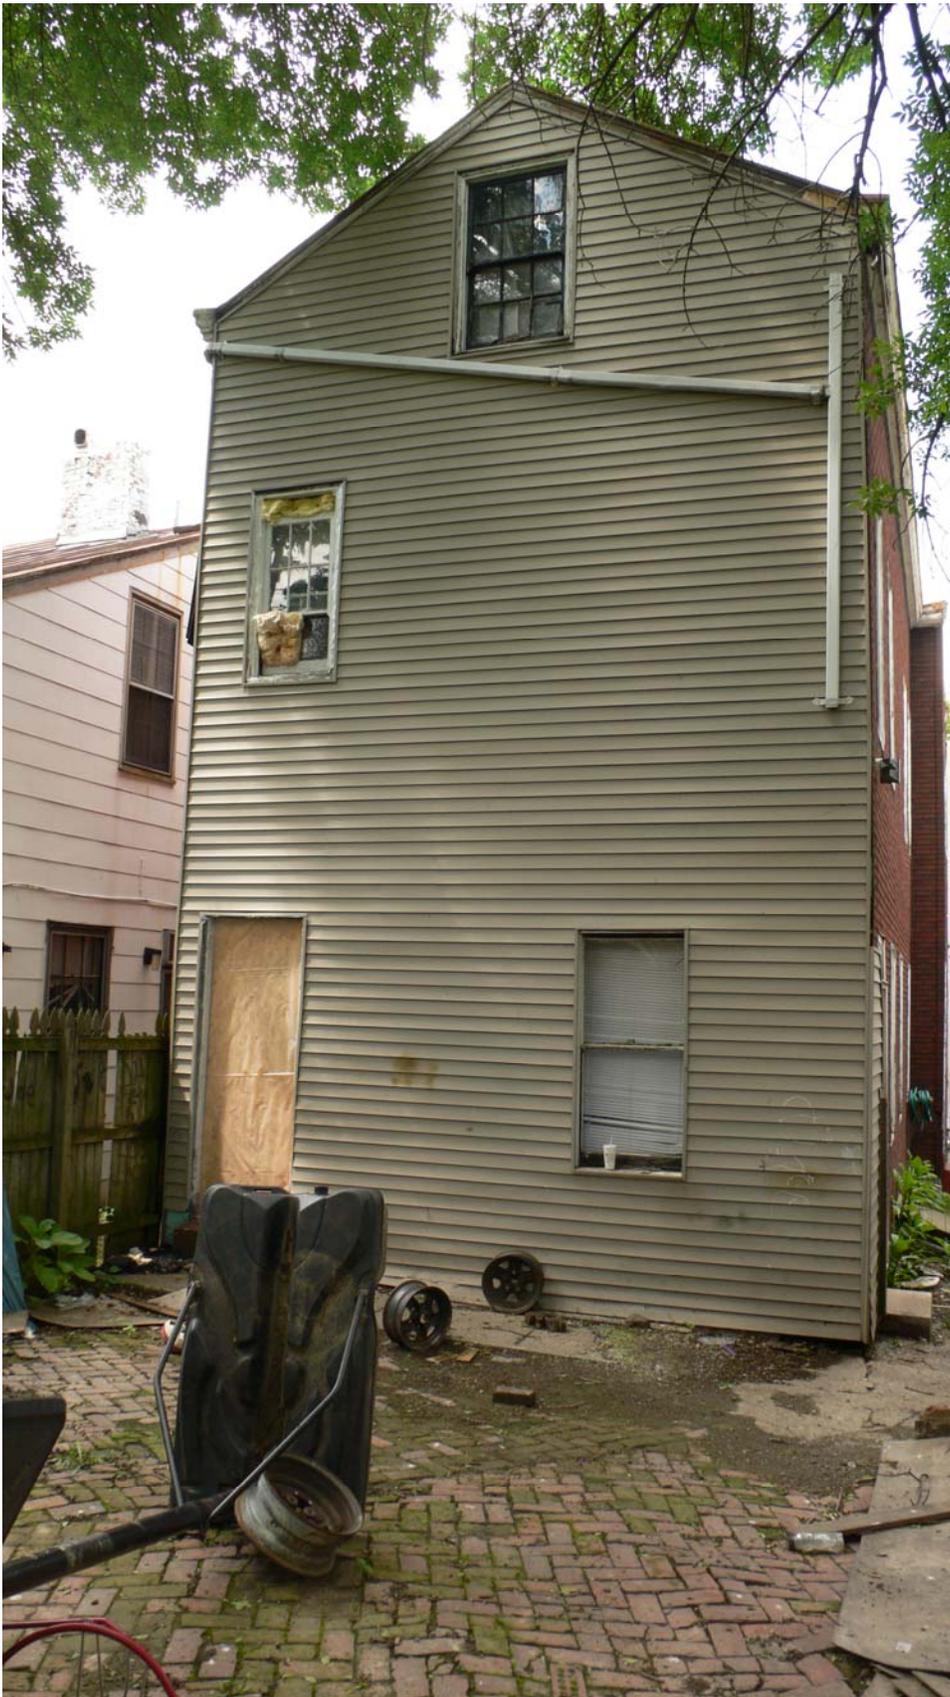
Figure 6: 411 West 12th street, back of structure from South.

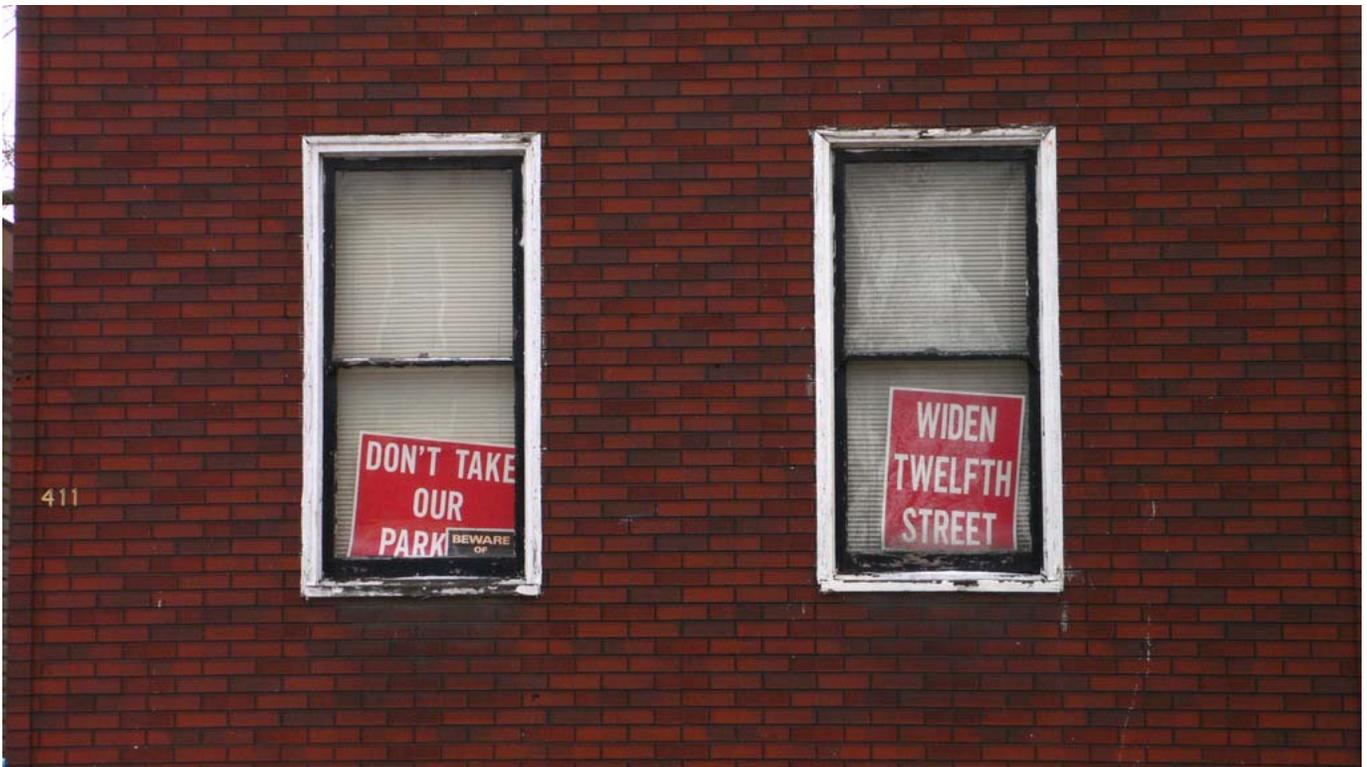
Figure 7: 411 West 12th Street, front windows.

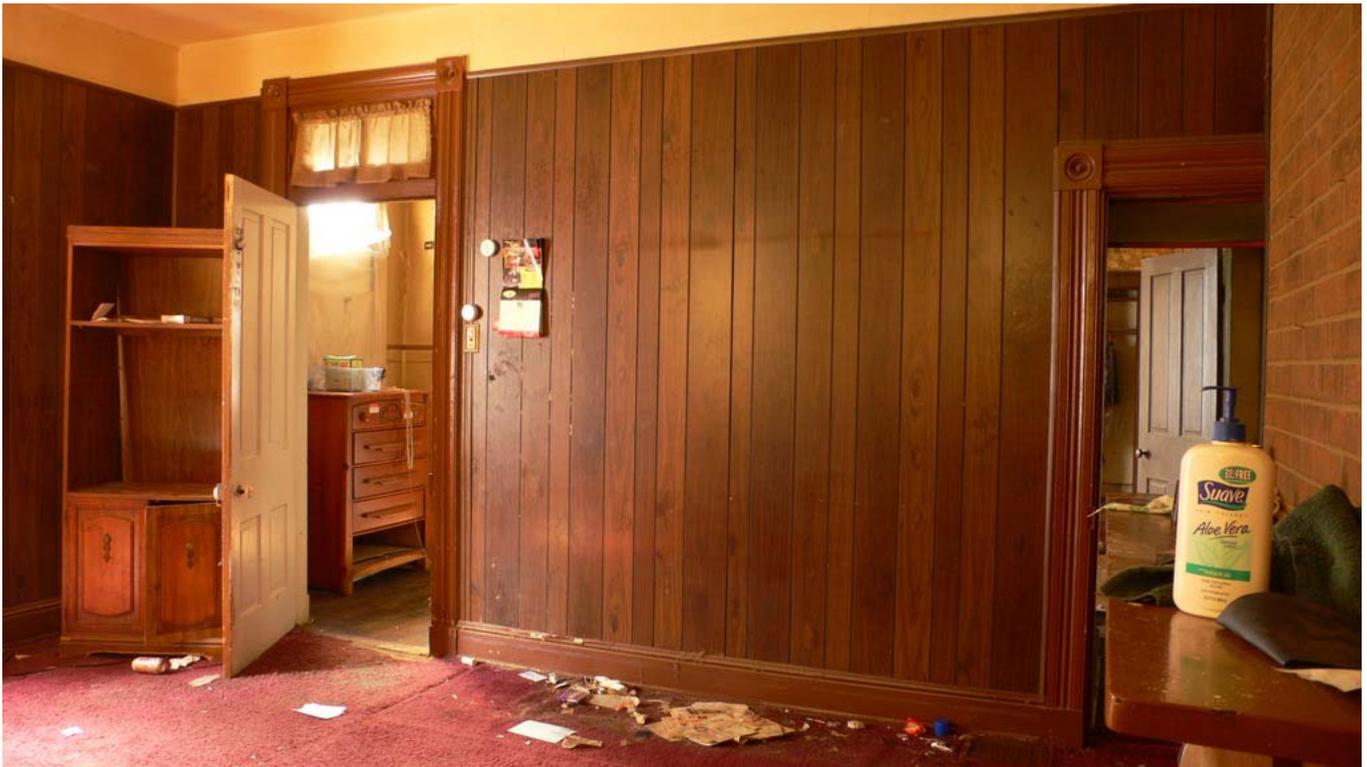
Figure 10: 411 West 12th Street, front room looking toward the back of the house. The passage behind the stair is visible to the right.

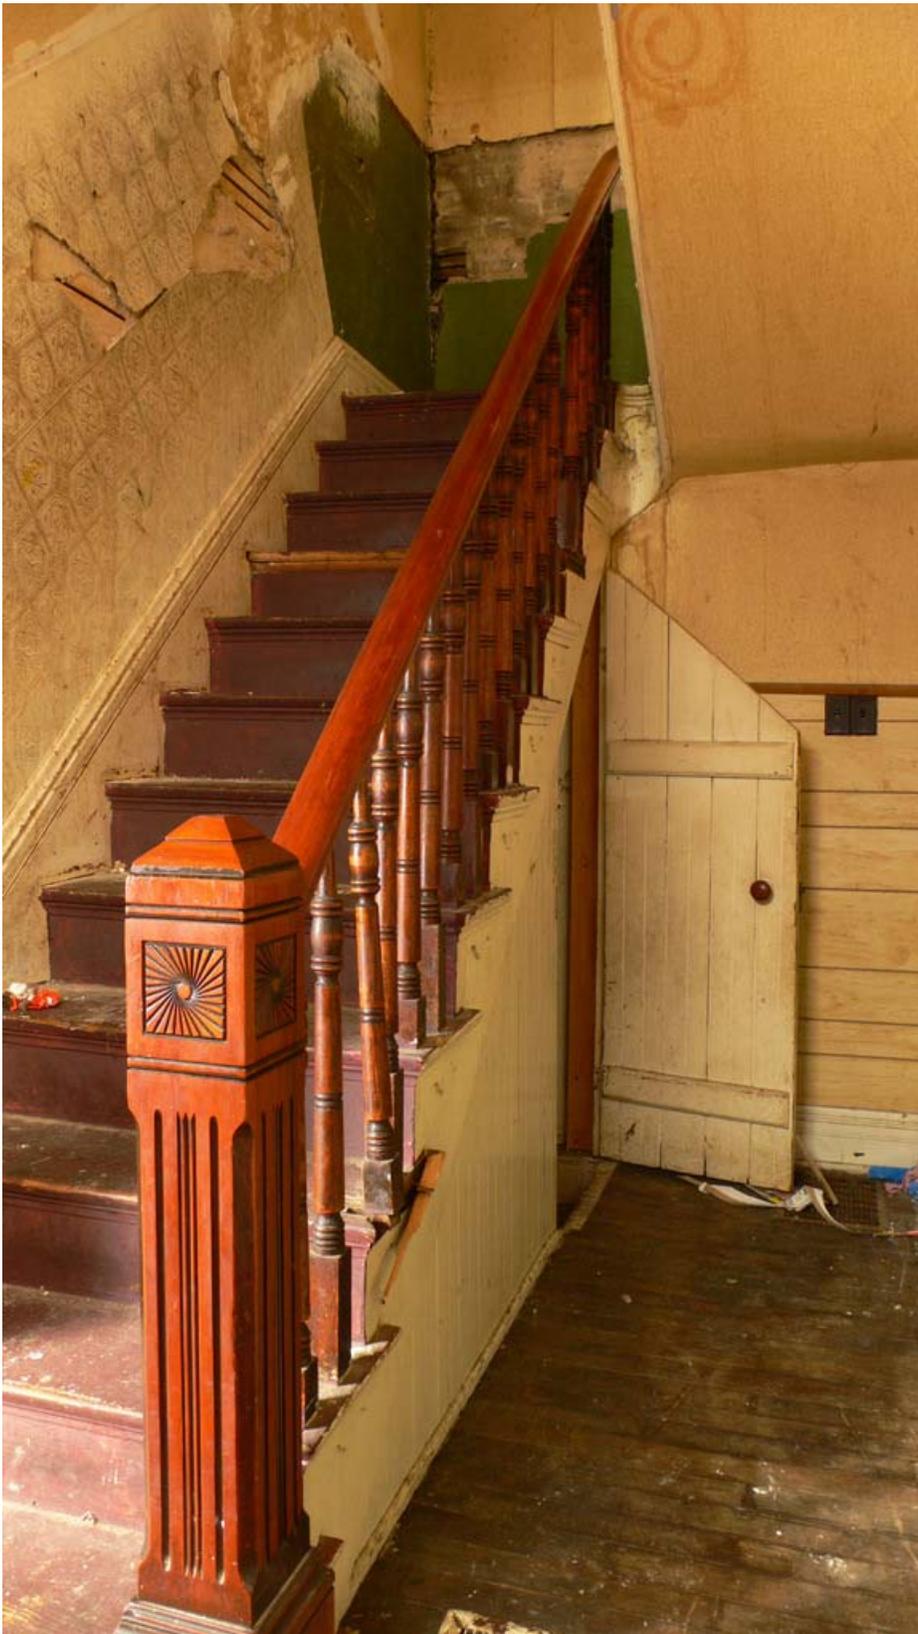
Figure 11: 411 West 12 Street, Stair Hall. *The open door at the back leads to a cellar stair.*

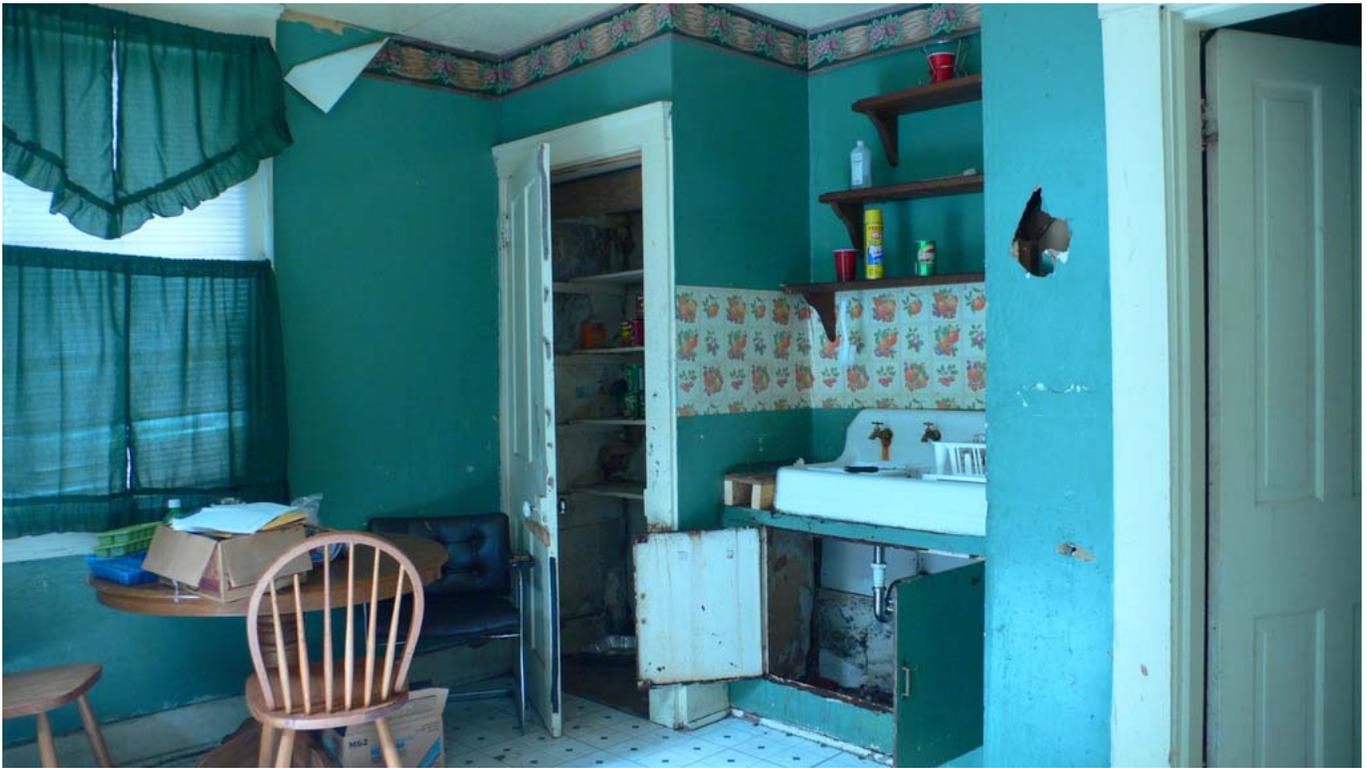
When documented, the house had a small kitchen and bath in the back room (Figure 18).

Figure 18: 411 West 12th Street, kitchen interior, first floor back room.
