Documentation of Historic Structures on Twelfth Street, Covington

Kentucky Heritage Council/
State Historic Preservation Office
October 2013

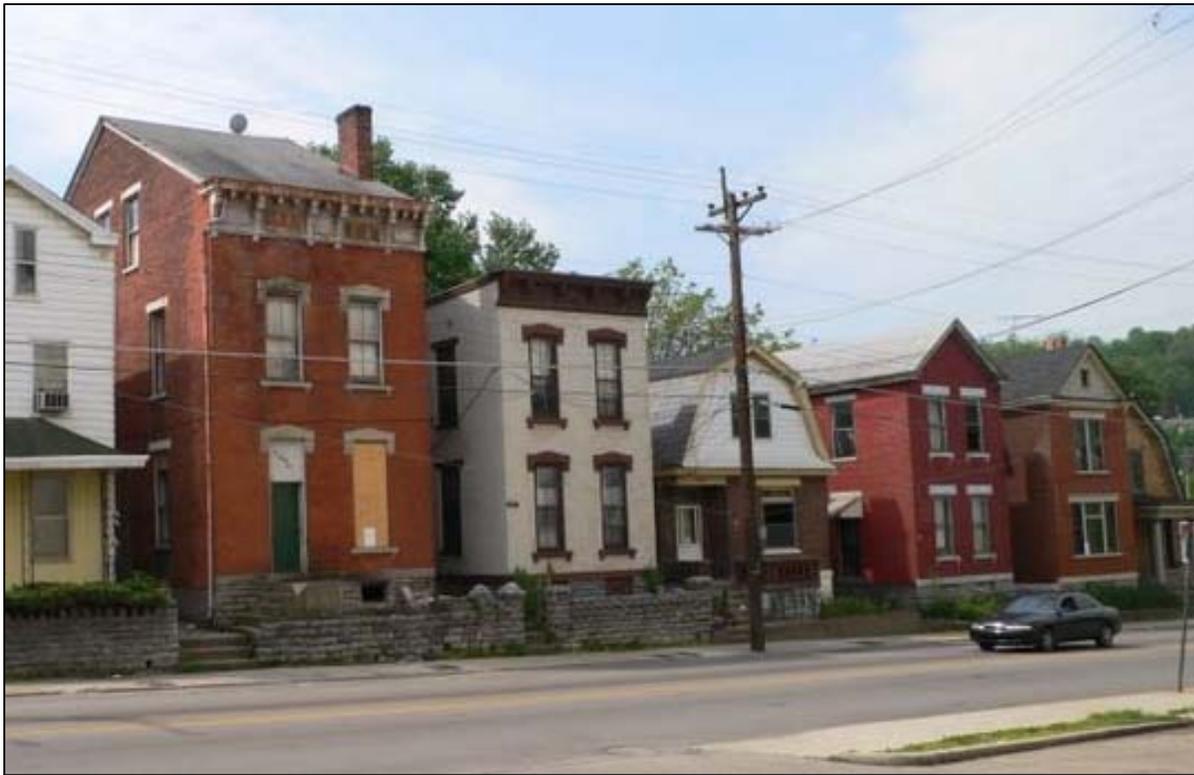
Figure 1: *The 500 Block of West 12th Street, looking south in 2006.*

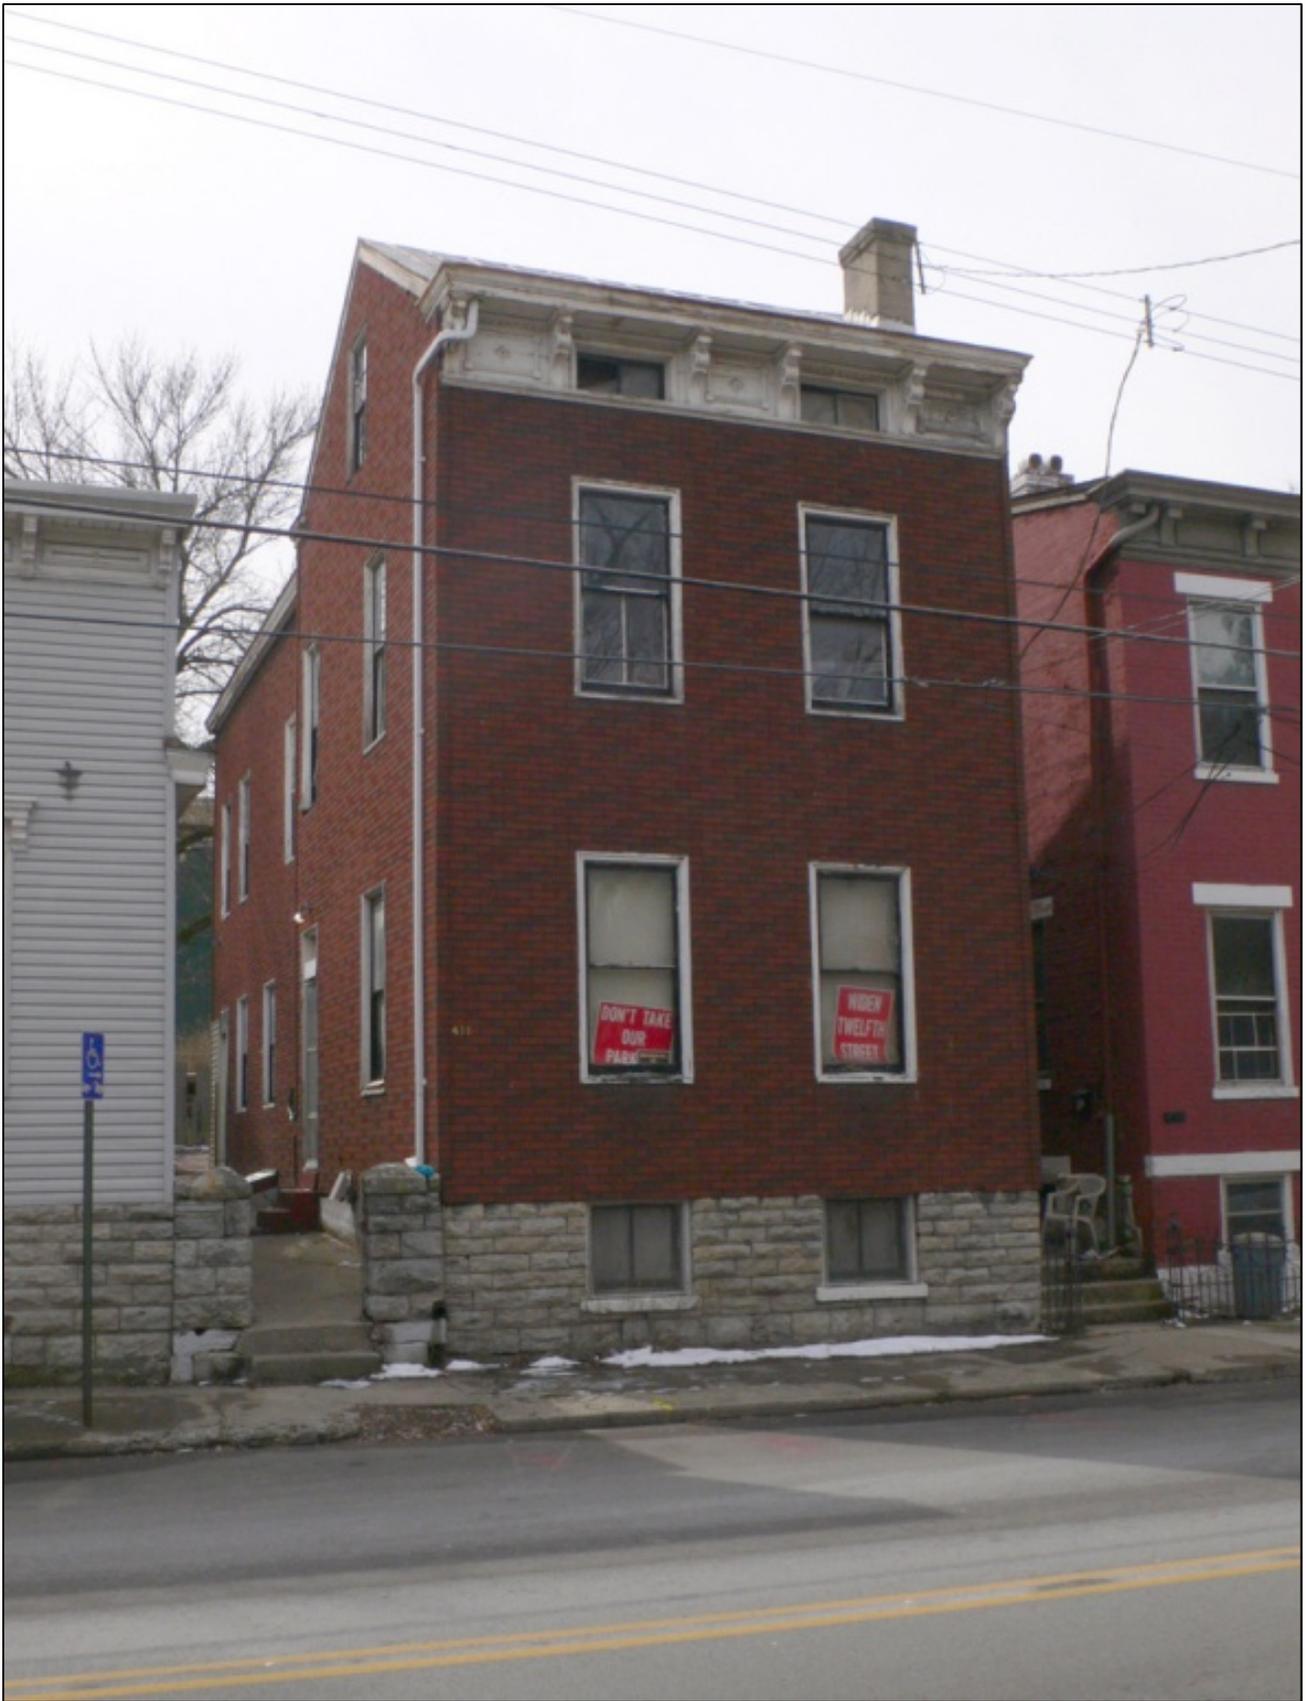
Figure 4: 411 West 12th Street, from north, a two window Northern Kentucky Townhouse.

Just a handful of the houses in the project area can be classified as shotguns, while most of the rest in the project area are what is known as a Northern Kentucky Townhouse (NKYTH), sometimes called a "Covington/Newport house" (Figure 4). This house type is less well known than the shotgun and is thought to have a restricted geographic range to Covington and surrounding urban areas, but it has striking similarities to townhouse forms found in east coast urban centers as disparate as Charleston and Boston. Additionally, Covington's large mid-19th century European immigrant population – Germans in particular - provided another strong cultural influence to Covington's built environment. With the Shotgun house and the NKYTH in Covington these traditions are all combined, and it is daunting to unravel the resulting tapestry. Since they are the majority of the buildings in the project area, this report concentrates mainly on few of the threads that run through the Northern Kentucky Townhouse, as it seemed like a good opportunity to explore that form in some depth.

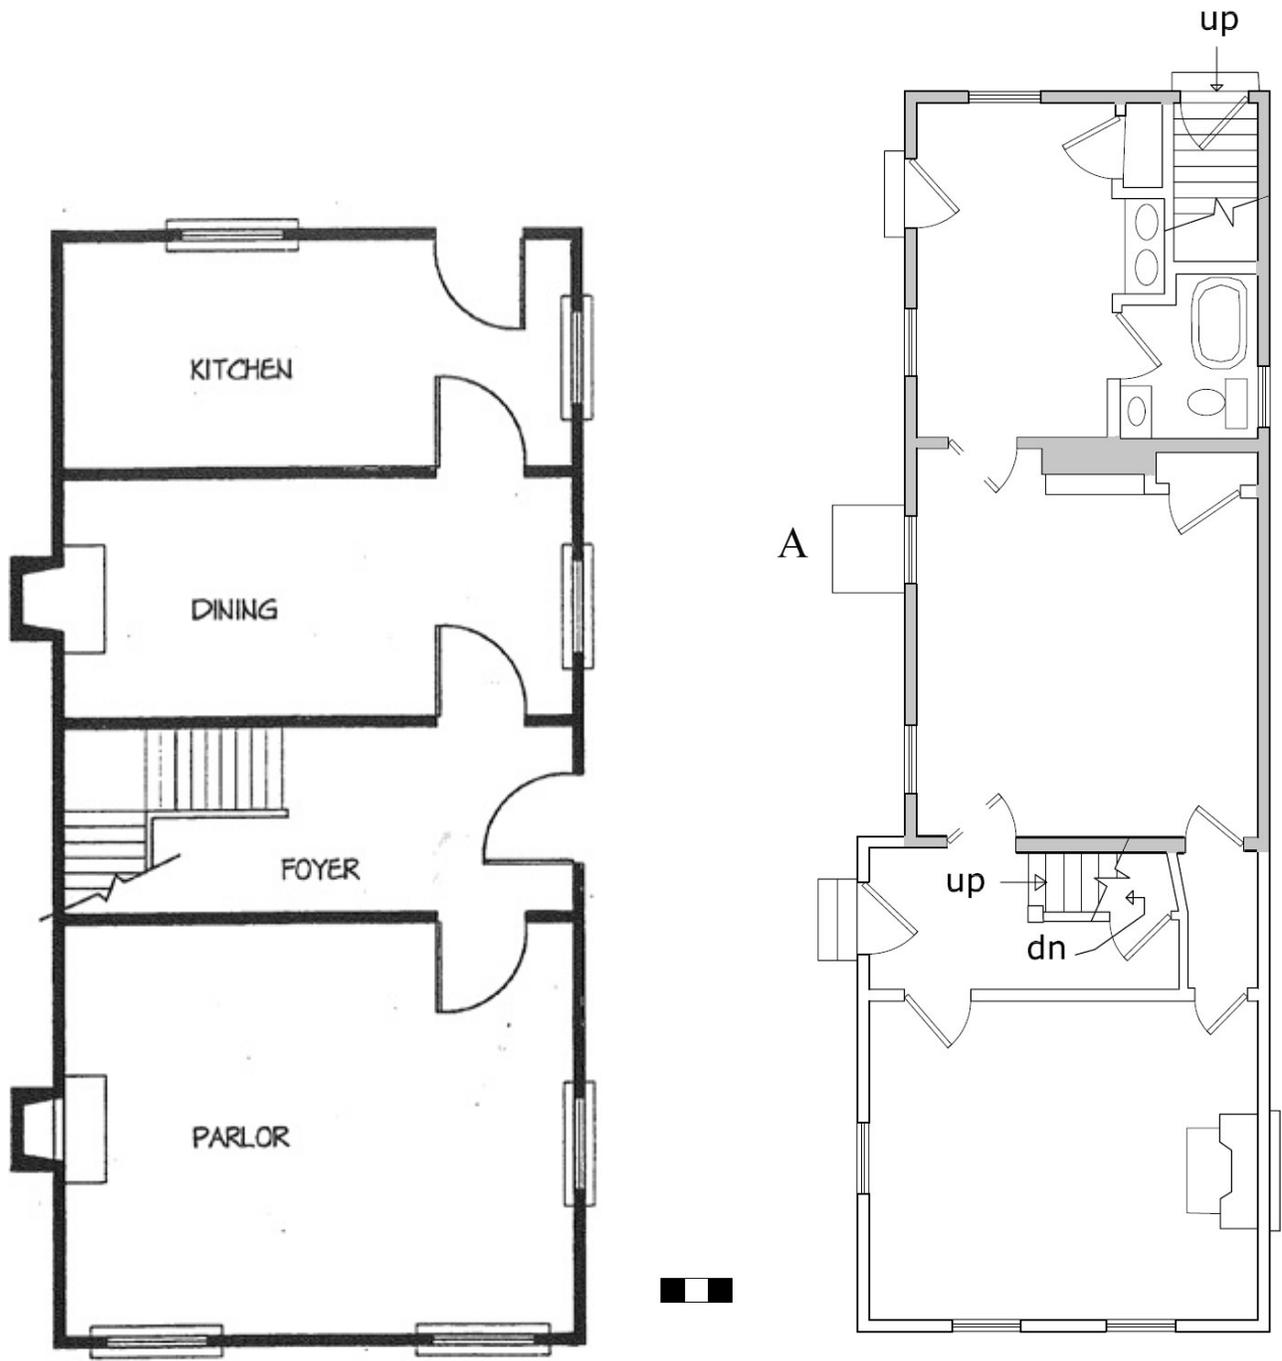
Figure 5: Left: "Typical Floor Plan of the Covington/Newport House Type" from *Northern Kentucky Townhouse Study* by Rita Walsh (Cincinnati, Gray and Pape, Inc., for the Kentucky Heritage Council, 1993). Right: 411 West 12th Street . Scale in feet. Shaded area is first period, "A" indicates the location of a bulkhead entry to the cellar. Drawing by Danielle Jamieson and Bill Macintire).

The Northern Kentucky Townhouse's narrow end faces the street in the same manner as the shotgun house – either is well-suited for one of the deep, narrow lots typical of Covington. The principle difference is that the NYTH has multiple stories, while the shotgun is a single story; both types are a single room wide and multiple rooms deep. Rita Walsh of Gray & Pape, Inc. studied the NKYTH and wrote a report, *The Northern Kentucky Townhouse Study*, prepared for the Kentucky Heritage Council in 1993. As defined in that report, the NKYTH is a "free-standing structure ... usually 2-½to 3 stories tall (though a fair number of 1-½story examples are found) with a two bay front, rectangular plan, and a side entrance, and it is notable in the absence of a door on the front."² Where typical shotgun houses have front entries, the typical NKYTH has no street façade entry, and adds upper stories, which requires the addition of a stair, resolved by the introduction of a stair hall. The main entry into the stair hall is found midway along the side of the building (Figure 5, left).

The documentation of 12th Street provides us an opportunity to compare several examples of townhouses in Northern Kentucky. They vary quite a bit in their details. The “Typical Floor Plan of the Covington/Newport House” presented in Walsh’s report has a kitchen, dining room, stair hall, and parlor on the ground floor (Figure 5, left). The bedrooms are all upstairs in her example, and this suggests a single family house, or perhaps one where an upstairs room is rented out. In the project area, one house quite similar to Walsh’s prototype was found at 411 West 12th street, (Figure 5, right; Figure 4). Interestingly enough, it was not initially constructed in that form. This dwelling began as a frame double-pen house, and evolved into a NKYTH through a process of addition. The original house, one of the oldest ones in the project area, existed by 1877, when it appears in the *City Atlas of Covington, Kentucky*.⁷ It had two rooms of nearly equal size with a shared central chimney stack, and the gable end facing the street, but set back further than its neighbors. Between 1886 and 1890 (as determined through maps published by the Sanborn company and examination of the building) the house was enlarged with a side gable addition to the front, which included a stair hall and a front room, with a second passage between the front and middle rooms inserted behind the stairway (Walsh mentions that some examples of the NKYTH have this back passage). The house at 411 was not always used as a single family house. The Covington City directory of 1890 lists a stonecutter, his wife, and an apparently unrelated carpenter as the residents at this address.⁸ The extra staircase entered directly from the exterior at the back of the house also suggests accommodation for multiple family occupancy, perhaps even before the house was enlarged – it’s not clear if this stair was original to the house. It’s possible that it began as a single-story dwelling and was raised to two stories at the time of or shortly prior to the front addition.

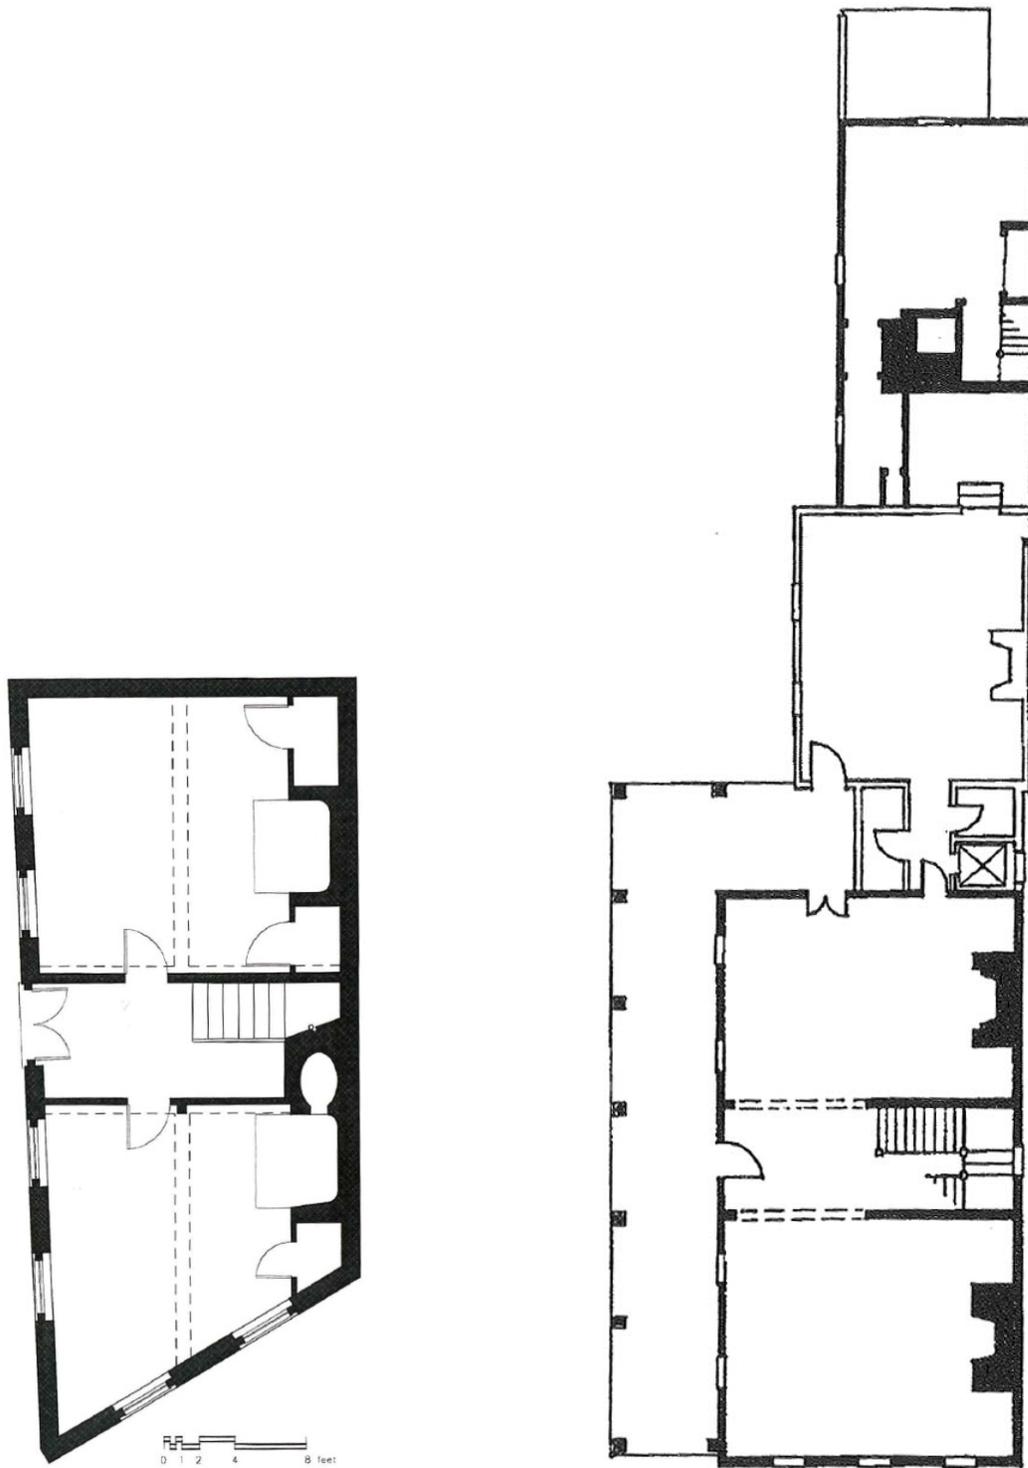
Figure 6: Left: Piercer-Hichborn House, North Square, Boston, first floor plan, after Historic American Buildings Survey, drawn by Jeff Klee, from Bernard L. Herman: *Town House: Architecture and Material Life in the Early American City, 1780-1830* (Chapel Hill: University of North Carolina Press, 2005), 11. Right: John Fullerton House, 15 Legare Street, Charleston, SC, 1772-1773. first floor plan. Measured and drawn by Phillips and Oppermann, architects. From *The Vernacular Architecture of Charleston and the Lowcountry 1670-1990: a Field Guide* (Charleston, SC: The Vernacular Architecture Forum, 1994), p165.

the end toward the street.” (Figure 6, right).⁴ The Charleston Single house, however, typically has a two-story porch sheltering the main, side entry, a feature not observed in Covington, at least in the project area. Whether or not there is any direct cultural link between the NKYTH and precedents such as Boston or Charleston is unclear, but all of these examples share the basic form of central stair passage, single pile houses, turned sideways to accommodate urban lots.

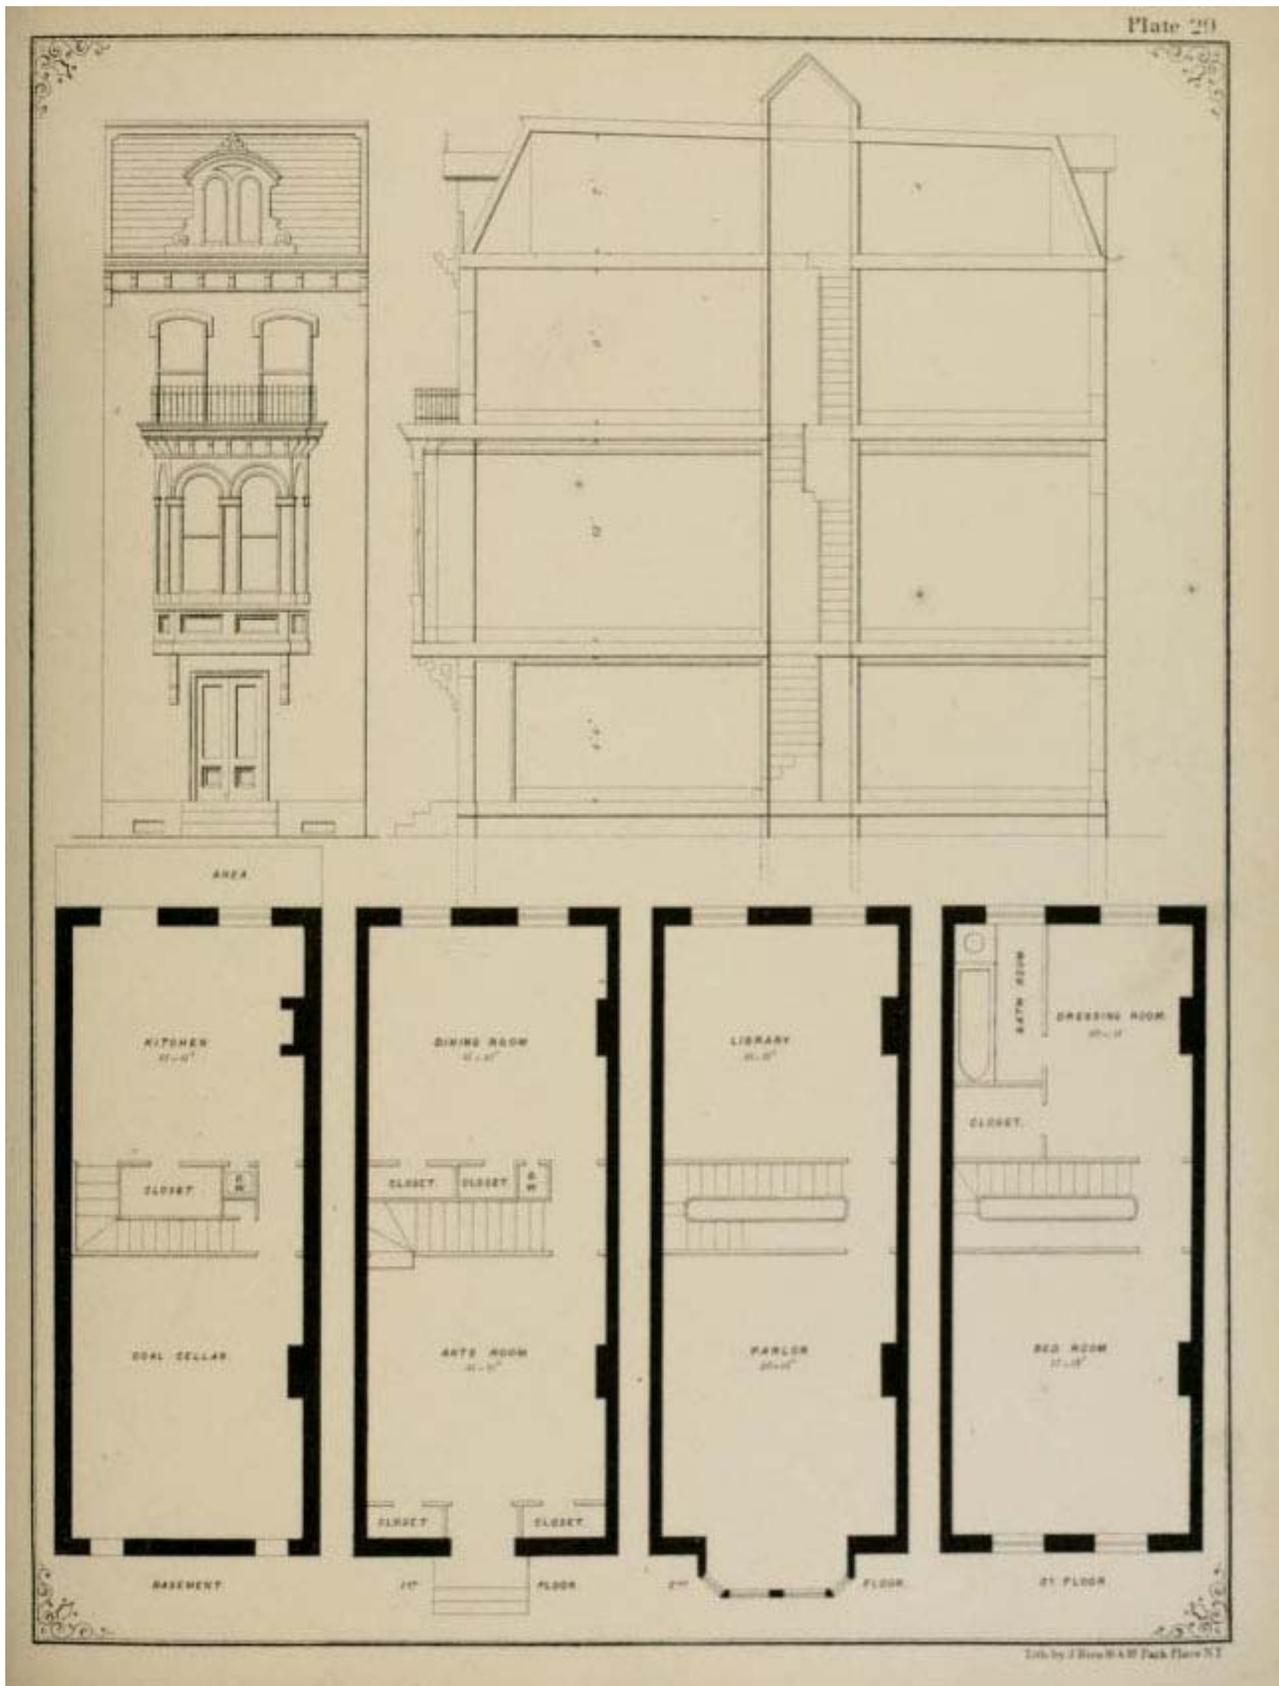
Figure 7: "Model design for a Cheap City Dwelling," from *Bicknell's Village Builder* (New York, A.J. Bicknell & Co, 1872, plate 29)

The Boston example is 1711, the Charleston single house was well established by the third quarter of the 18th century: the earliest known Northern Kentucky Townhouses date to about the 1860s.⁵ Perhaps a common thread runs through all three, but that’s very speculative. Multiple strains of influence are probable. Another possible source is found in the architectural style books that became so influential in the mid-19th century. Walsh examined several architectural pattern books of the period and found one plan with some striking similarities in Bicknell’s *Village Builder* in the 1870s (Figure 7). Bicknell’s plan, called a “*Model design for a Cheap City Dwelling*,” is similar to the NKYTH, although it has a central front door on the street façade. The more crucial dissimilarity is that Bicknell shows no direct exterior access to the central stair hall along the side of the house. It’s easy to imagine a builder changing that detail which seems to violate customary practice. The depicted architectural style of Bicknell’s cheap city dwelling is also similar to many Covington examples.

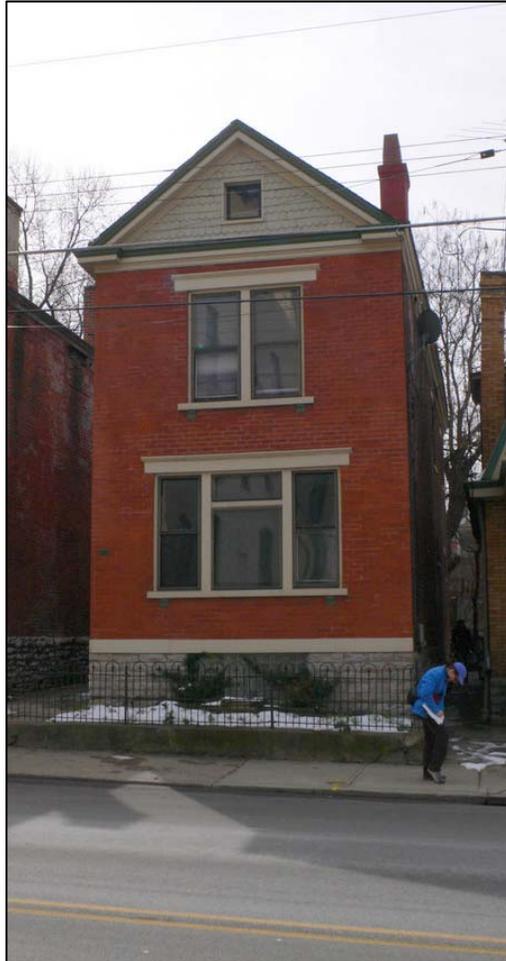
Figure 8: 529 West 12th Street. Left: First floor plan, drawing by Danielle Jamieson and Bill Macintire. Right: front of house from north.

Another example that conforms closely to Walsh’s prototypical plan is 529 West 12th Street, constructed in the very late 19th or early 20th century. While the front façade does lack a door, it had a tripartite window lighting the front room instead of a two bay window/window façade, reflecting the neoclassical styling of the house. The house also varies from the prototype by having a direct entry to the kitchen at the back via a small covered side porch (Figure 8). The kitchen pile is wider than the two front rooms to accommodate this entry, and also to allow room for a bath and pantry. This wider back room is a common feature of several examples in the project area, including the neighboring house at 527 West 12th Street, built about the same time (Figure 10 and Figure 10, left). The wider back room there was a single story but had its own entry, as did the front room, perhaps to conduct business or be let out to a tenant. Number 527 also differs from number 529 in that the stair hall is between the back two rooms rather than between the front two. The second room appears not to have been a dining room, at least in more recent history, as a bathroom was inserted into the space. The side porch entry at 527 was a proud architectural statement, heavily ornamental on an otherwise stylistically restrained house (Figure 50).

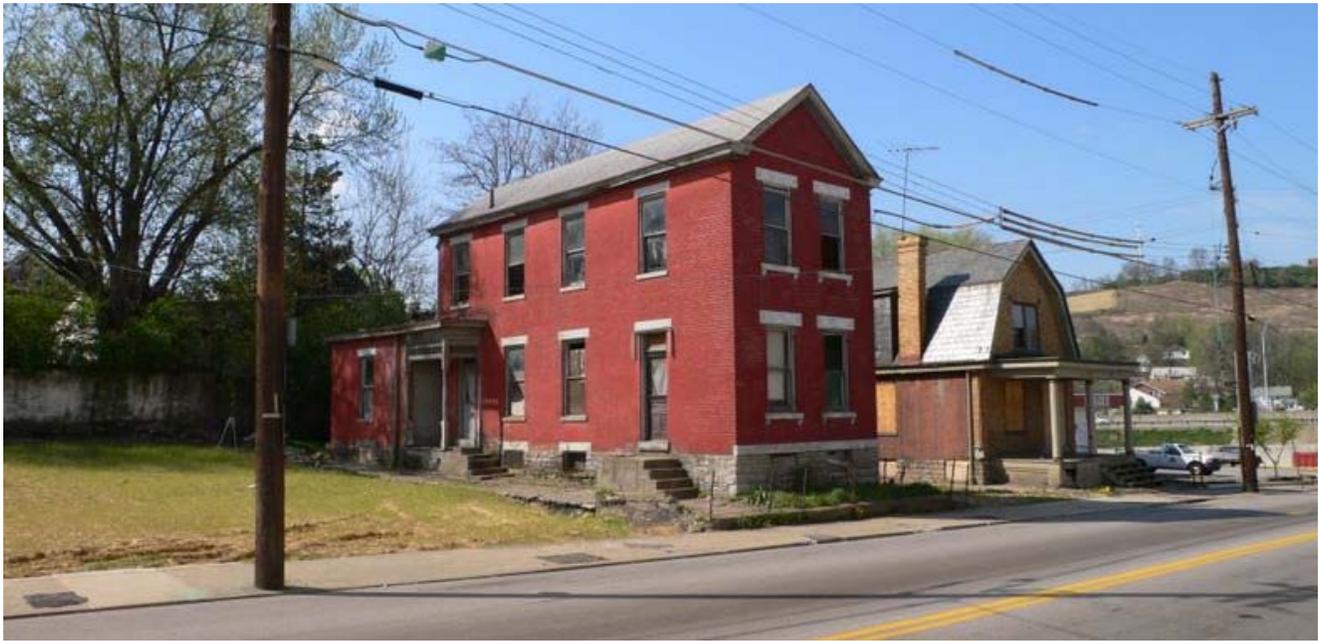
Figure 9: 527 & 531 West 12th street (529 West 12th had been demolished by this time)

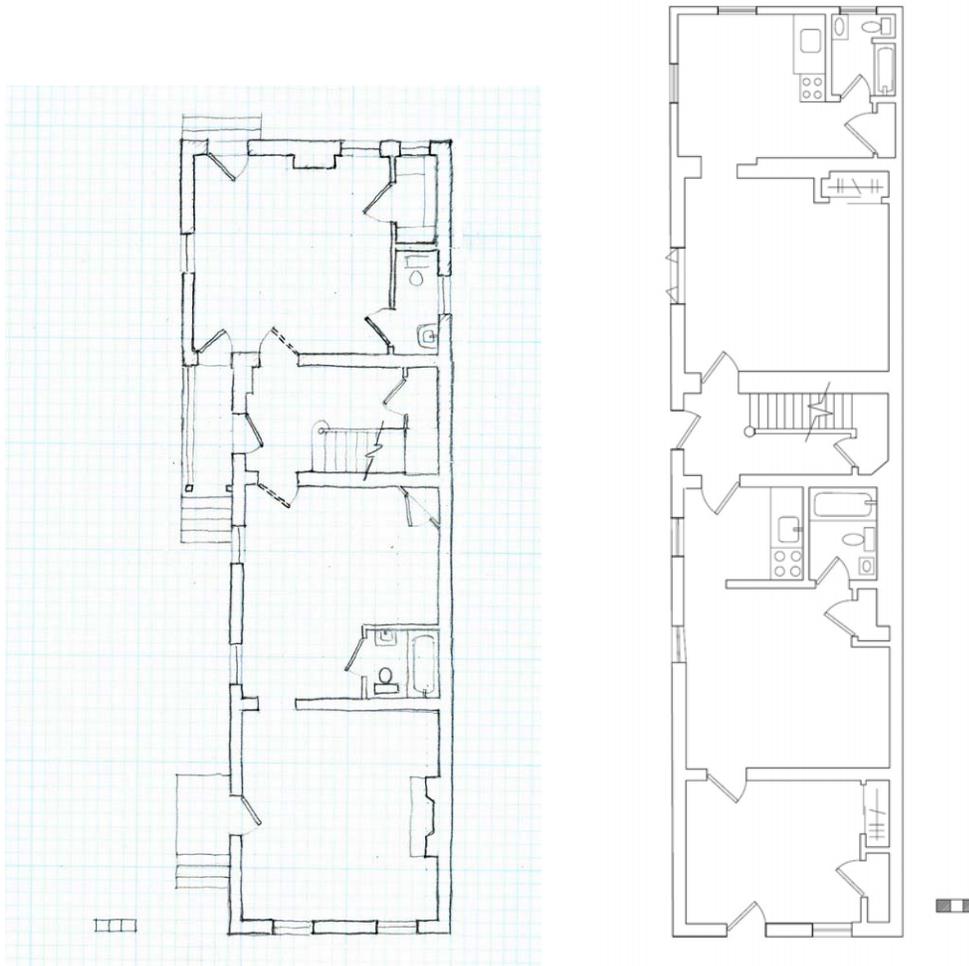
Figure 10: Left: floor plan of 527 West 12th Street measured and drawn by Bill Macintire, scale in feet; right: 521 West 12th Street. Floor plan drawings by Bill Macintire and Danielle Jamieson, scale in feet.

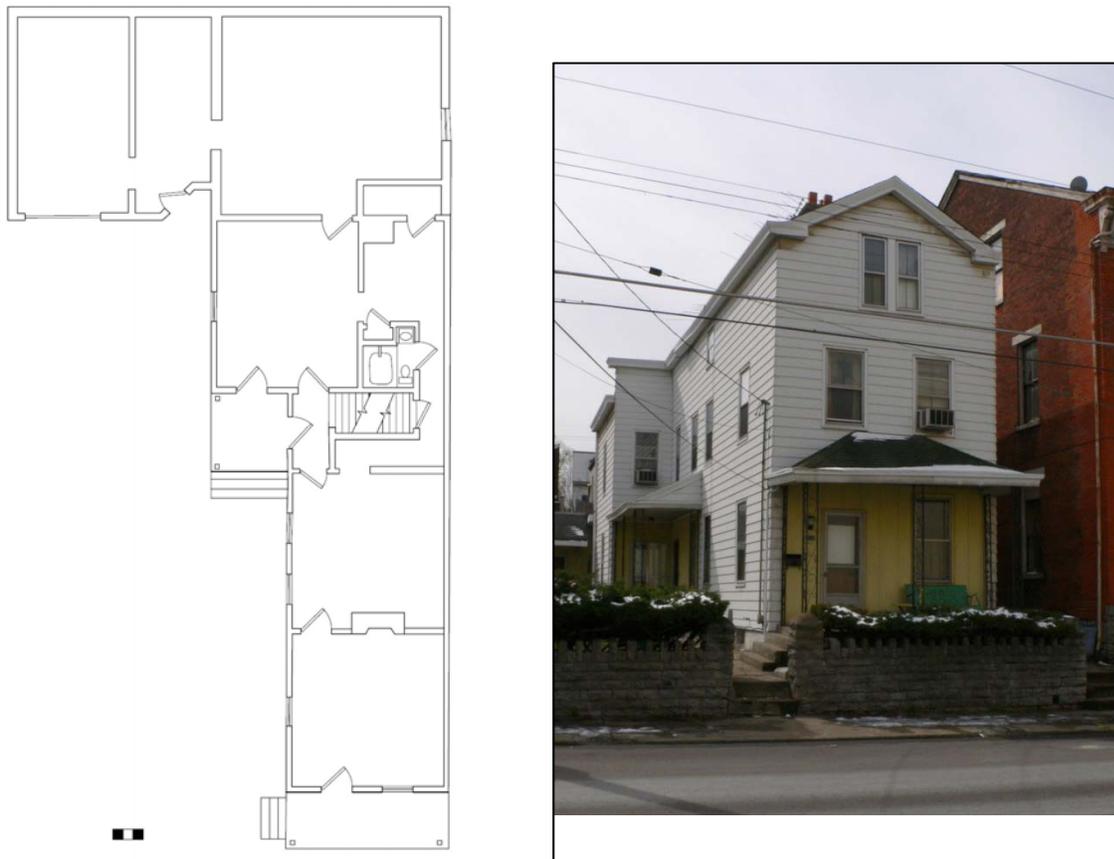
Figure 11: 519 West 12th Street. Left, floor plan, drawing by Danielle Jamieson and Bill Macintire. Right, front of house from north.

Provision for commercial activities called for elaborations to the basic NKYTH concept. In some cases this is fairly subtle: the front room might need to accommodate an office or store, and so they break the norm of the two-window façade to include a direct entry from the street. More notably, several properties in the project area had business spaces appended to the backs of the buildings. At 519 West 12th Street, for example, there was a large appendage to the back of the house that until recently housed a repair shop for televisions and other appliances, judging by the vacuum tubes and parts that had been left behind (Figure 11). The house over time had become attached to once free-standing outbuildings in the back yard. Parts of the back building were remnants of what was labeled a kitchen on the 1909 map, which depicts a crowded, but ordered urban backyard landscape of sheds, stables, shops, kitchens and privies (Figure 12). Similarly, 515 West 12th street had a backroom which included a workspace and a walk-in freezer at the time of documentation, apparently some sort of food preparation operation (Figure 14). Possibly the relocation of the stair in this case was undertaken as part of the commercial renovation of the back, creating a business entry where the private stair entry had been. The back rooms had collapsed and were only partially accessible.

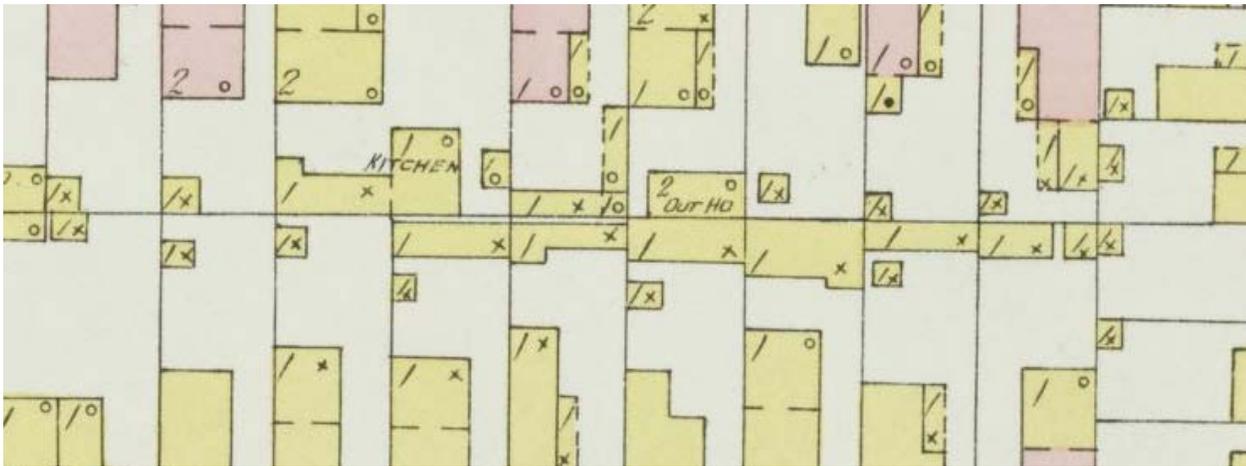
Figure 12: Back yards in the 500 block of West 12th Street in 1909, as depicted on the Sanborn Insurance maps. Twelfth Street buildings are at the top of the figure, red is masonry, yellow is wood. The building labeled “Kitchen” at upper left is the same location as the back building at 519 West 12th shown in Figure 11.

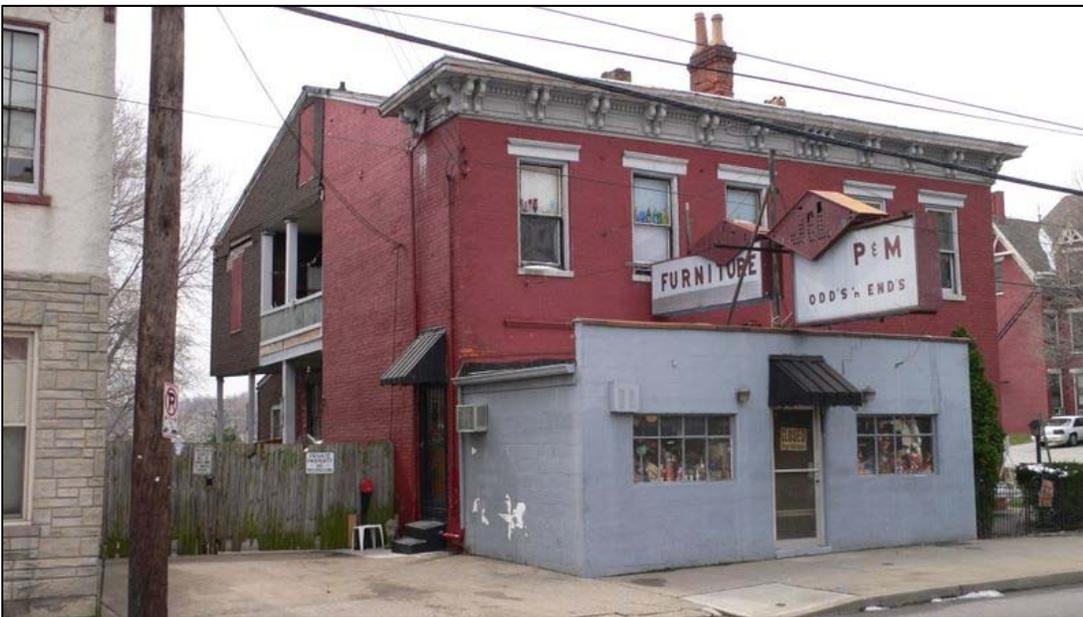
Figure 13: 15-17 East 12th Street, from northeast. The addresses run right to left here, so # 15 is at the right, # 17 at the left with the store front addition.

The duplex NKYTH at 15-17 East 12th Street (Figure 15 and Figure 13) had a store later attached to the front. This house began as a single NKYTH at # 17 (the shaded area on the left in Figure 15), but was subsequently enlarged through the addition of another unit at 15 East 12th Street. At around the same time # 15 was constructed, # 17 was also enlarged with the addition of a side passage, porch and expansion of the second floor, somewhat reminiscent of a Charleston single house (the porch is visible on the left had side of the building in Figure 13). Still later, a single story concrete block addition to the front of # 17 converted it into a commercial space, which extended into the former domestic rooms at the front. The ground floor at # 17 ended up as a furniture showroom behind the P & M Odds & Ends store. At the time of documentation, it had some pretty interesting fixtures (Figure 16 and Figure 17). There was a frame addition to the back of both units, and the entire building was broken up into multiple units early on – the addition of the side passage stair and porch to # 17 was probably to accommodate second floor tenants.

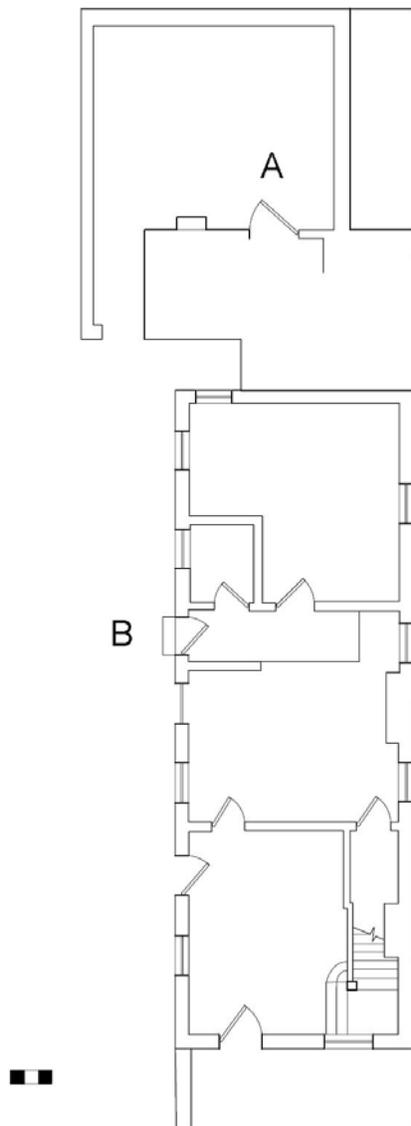
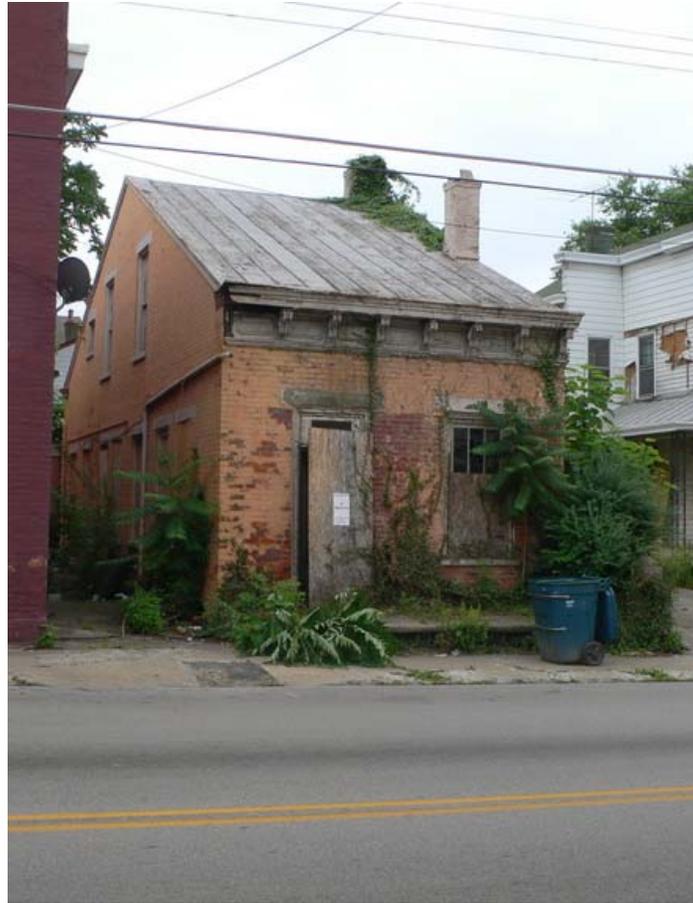
Figure 14: 515 West 12th Street. Left: floor plan, drawing by Danielle Jamieson and Bill Macintire. The space at the back had limited access due to partial collapse, but it included a walk-in freezer at "A." The original stair location was through the side door at "B." Right: front of house from north.

century with a frame addition for kitchen and bath facilities added to the back, another kitchen/bath inserted into the second room for the front apartment, and more kitchen/bath facilities inserted on the second floor for upstairs rental (Figure 10, right). We find an interesting NKYTH at 515 West 12th street, only 1.5 stories tall (Figure 14). It had a major alteration when the stair was relocated to the front room in the early-mid 20th century, crossing in front of the hearth in the front room (Figure 14, left).

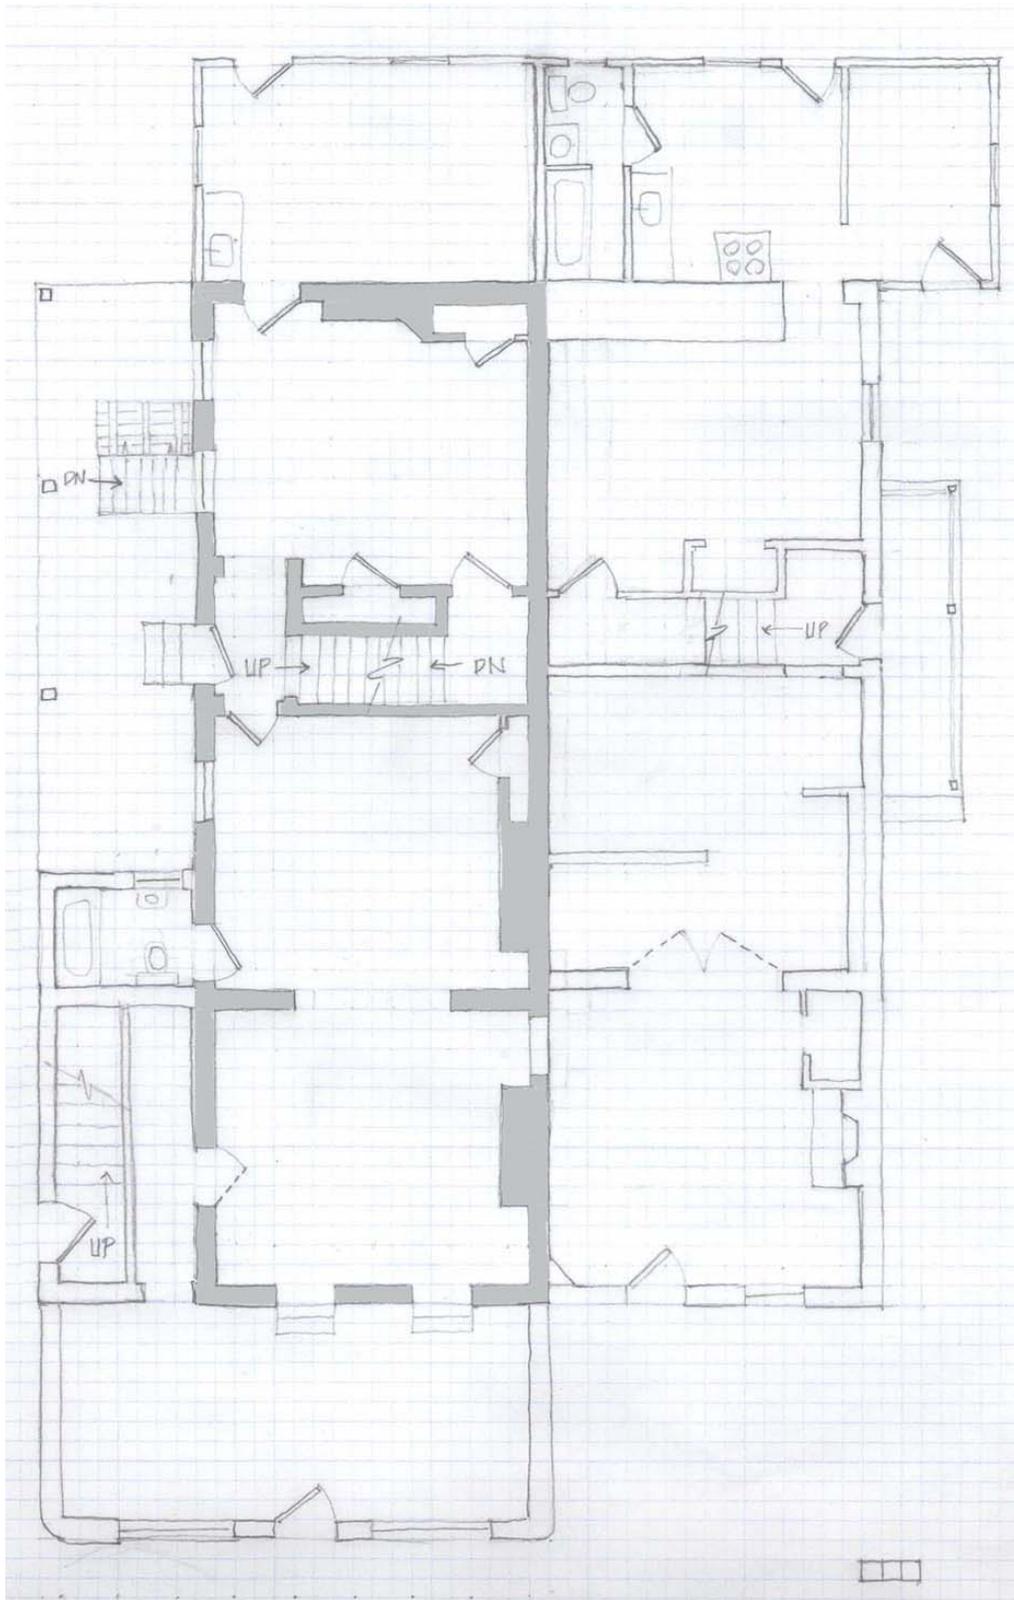
Figure 15: 17-15 East 12th Street, first floor plan, drawing by Bill Macintire. First period, # 17, is shaded.

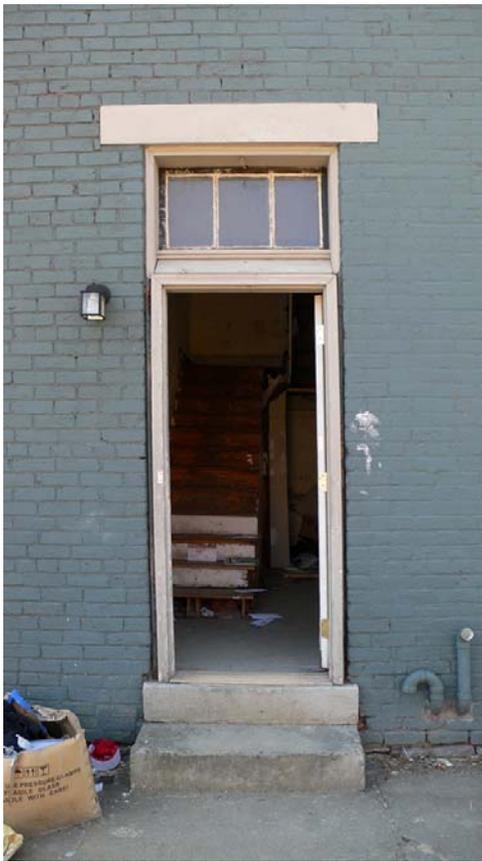
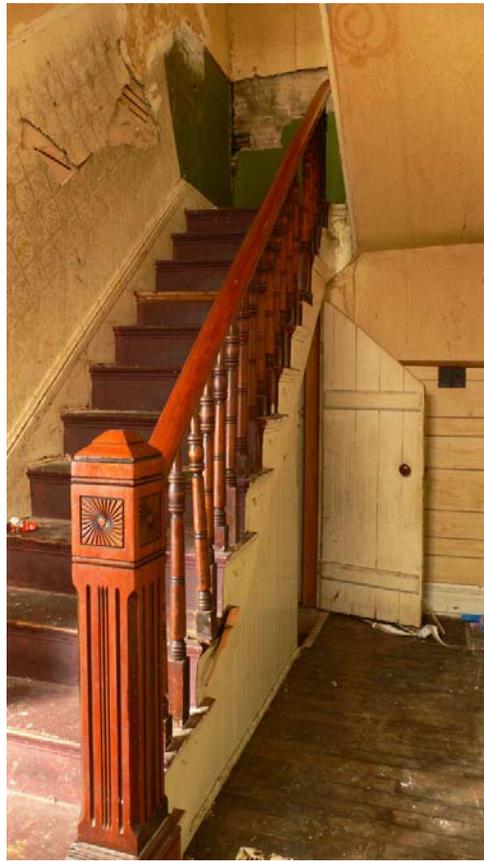
Figure 18: Left: Principal side entry into the stair hall at 1206 Banklick Street. Right: Interior of Stair hall at 411 West 12th Street.

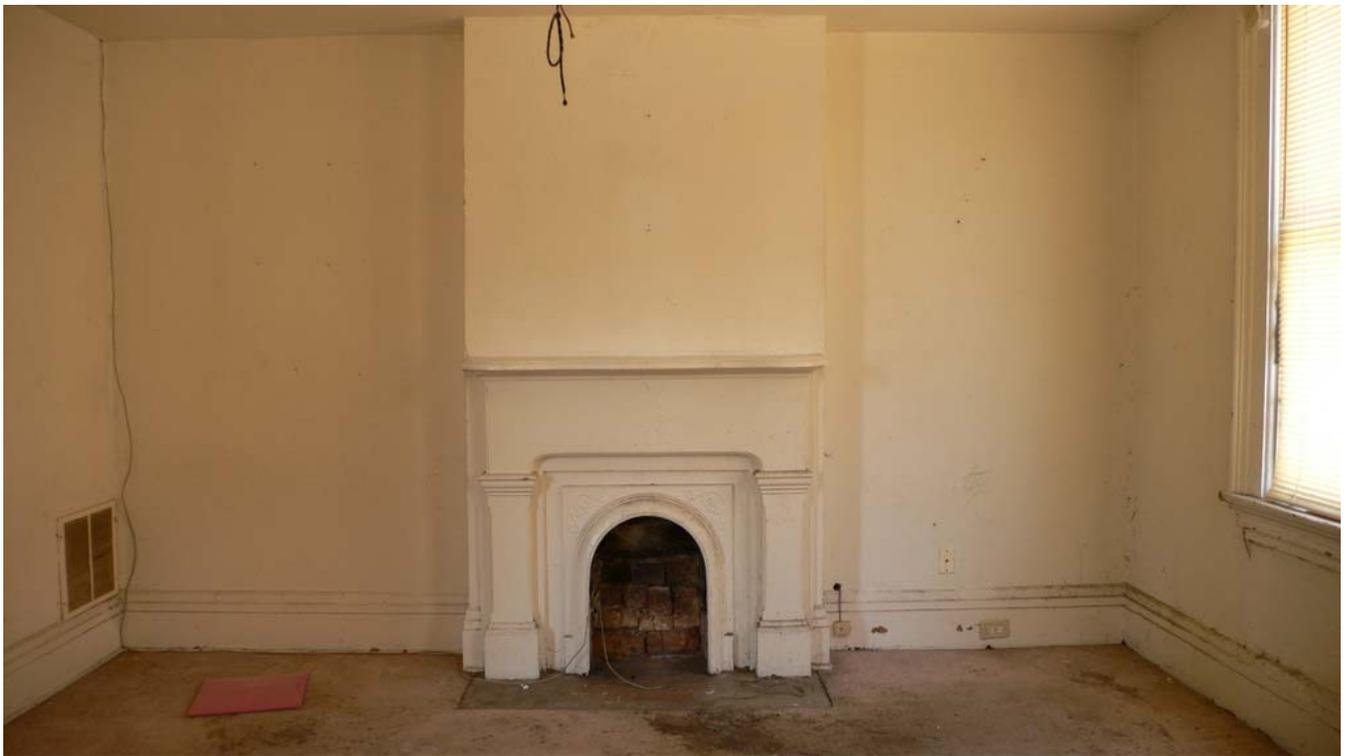
Figure 19: 1206 Banklick Street, ground floor front room hearth wall, fireplace located on outside wall.

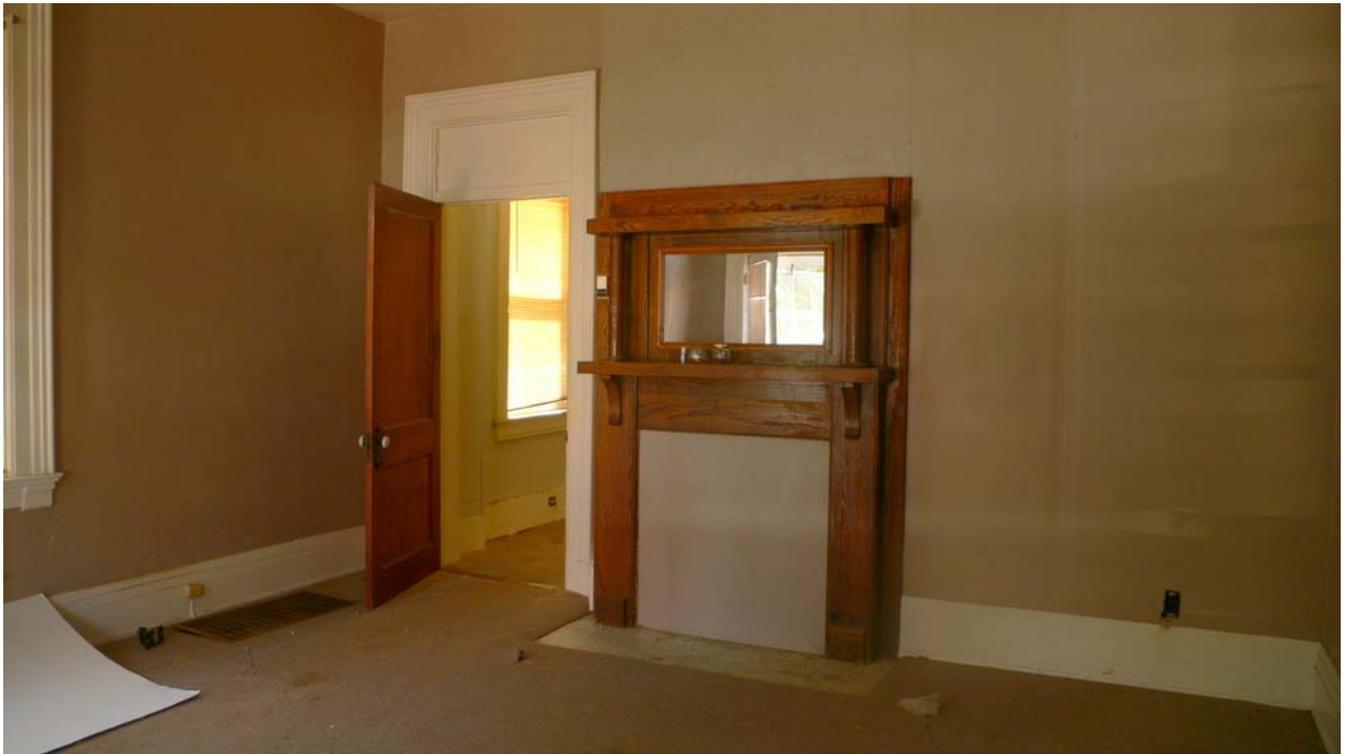
Figure 20: 419 West 12th Street, interior of ground floor front room hearth wall, fireplace located on interior wall. The Arts & Crafts style mantelpiece is a later replacement.
