Documentation of Historic Structures on Twelfth Street, Covington

Kentucky Heritage Council/
State Historic Preservation Office
October 2013

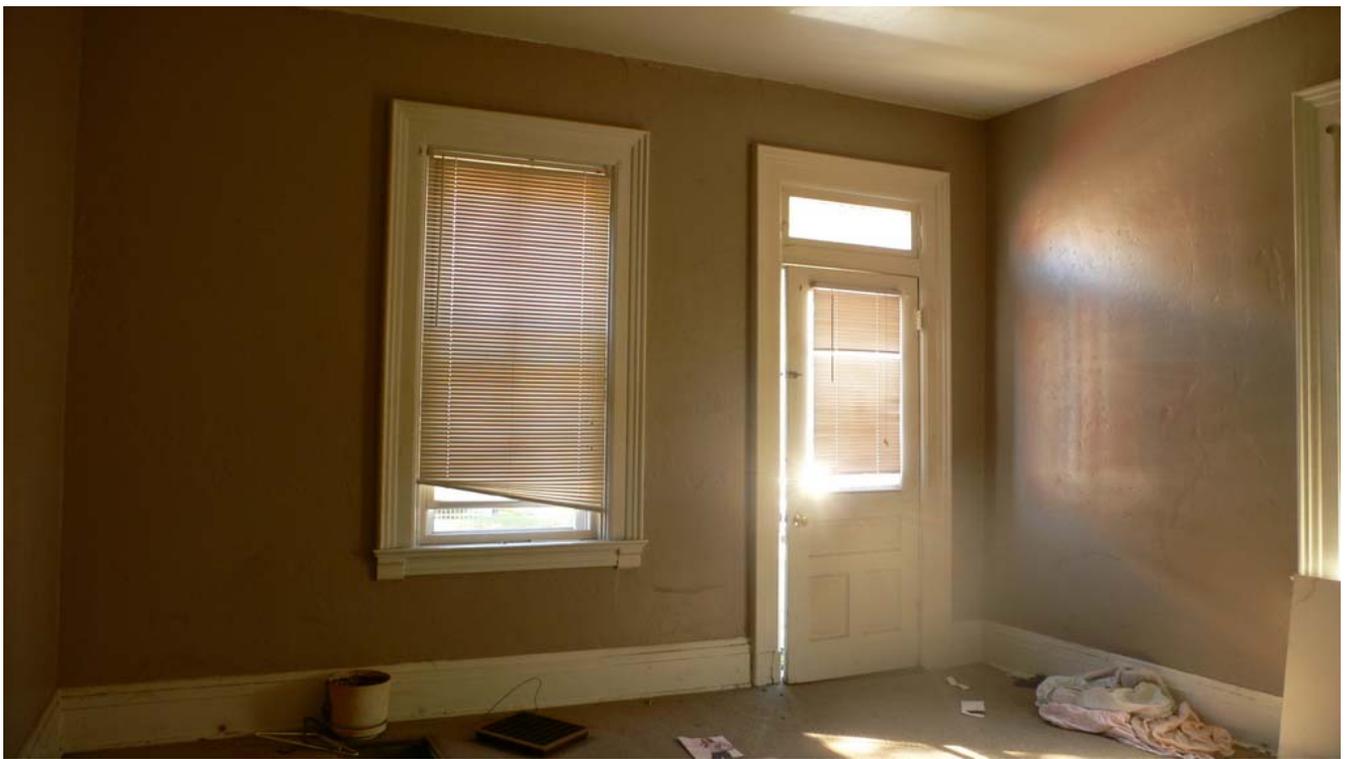
Figure 21: 419 West 12th Street, interior of ground floor front room, looking toward front door.

The front rooms are usually lit by windows on two sides of the room, the front wall with either two windows or a window/door configuration (Figure 21), and the (yard) side wall, which typically has one or two windows or a door and a window (Figure 22). The center rooms are lit only by the side yard fenestration, typically two windows (Figure 22), although some examples of the NKYTH in the project area have exterior doors going directly into the center rooms. In some cases there might be a small window higher up on the private side wall offering some additional light. Finally, in the back, we have the kitchen (Figure 24, Figure 26), lit by openings on the yard side and in many cases, the back wall as well. Many of the kitchens in the project area included built-in pantries, which in some cases included a trap door leading to the cellar beneath (Figure 36, right). The kitchens are small, and hampered by the large number of door and window openings (Figure 25, Figure 26). Typically, a small bathroom and a pantry are located directly off the kitchen (Figure 25).

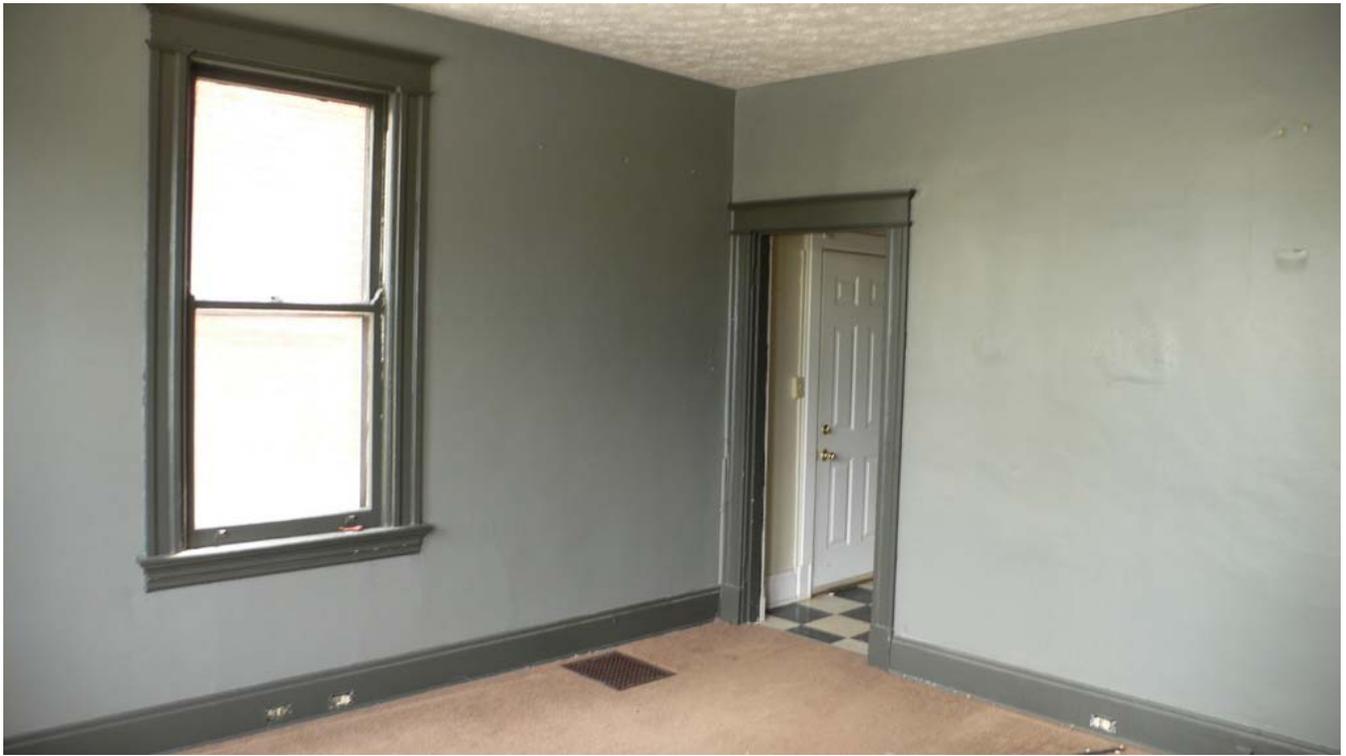
Figure 22: 529 West 12th Street, interior of front room looking toward stair hall door, with yard side window to the left.

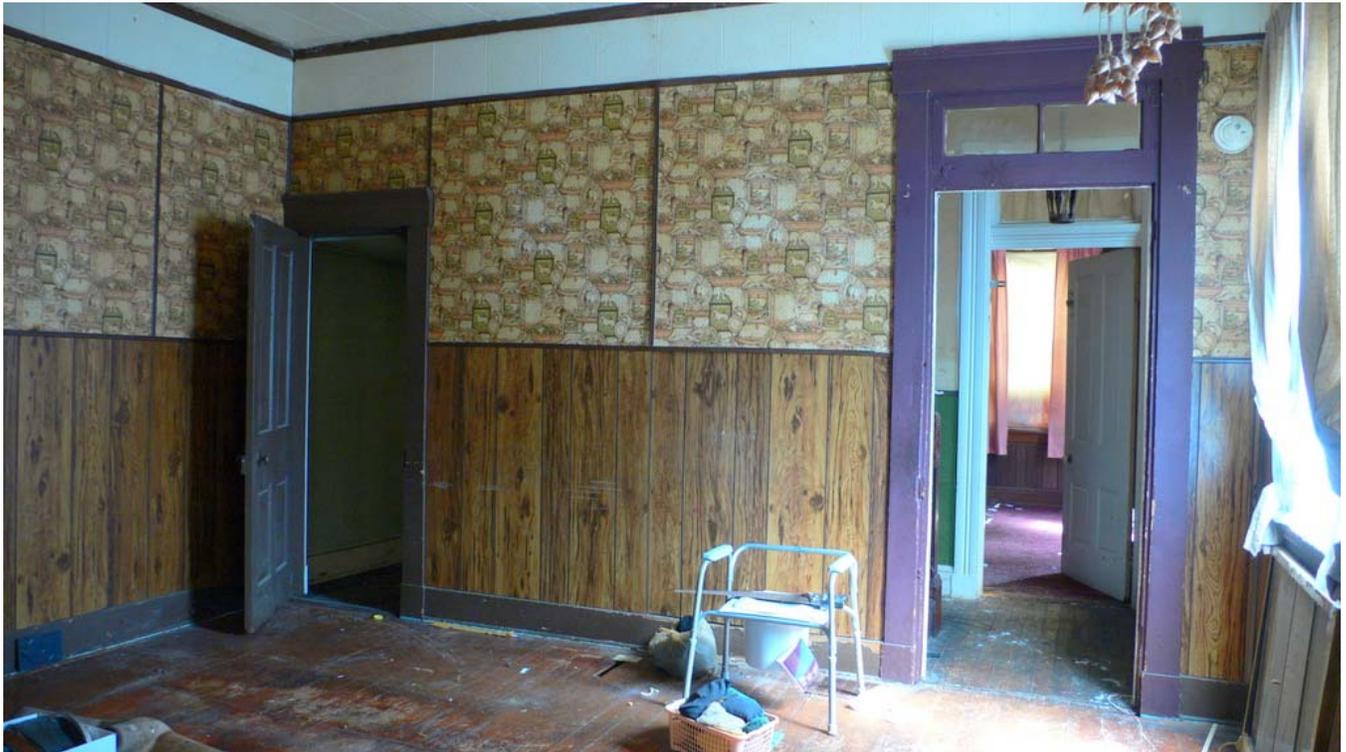
Figure 23: 411 West 12th Street, middle ground floor room, looking toward front room, through stair hall. The door to the left leads to a narrow passage underneath the stair.

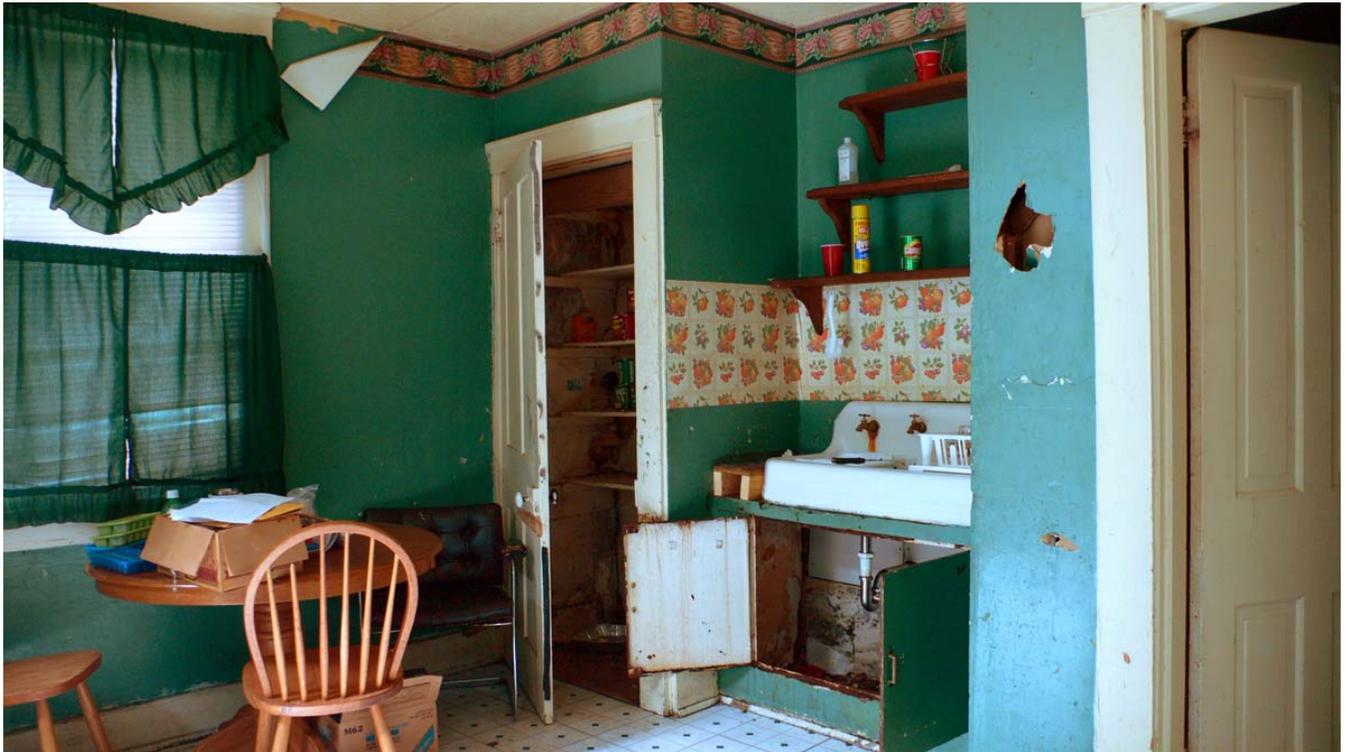
Figure 25: 411 West 12th Street, interior of Kitchen showing sink bay positioned between the pantry and the bathroom.

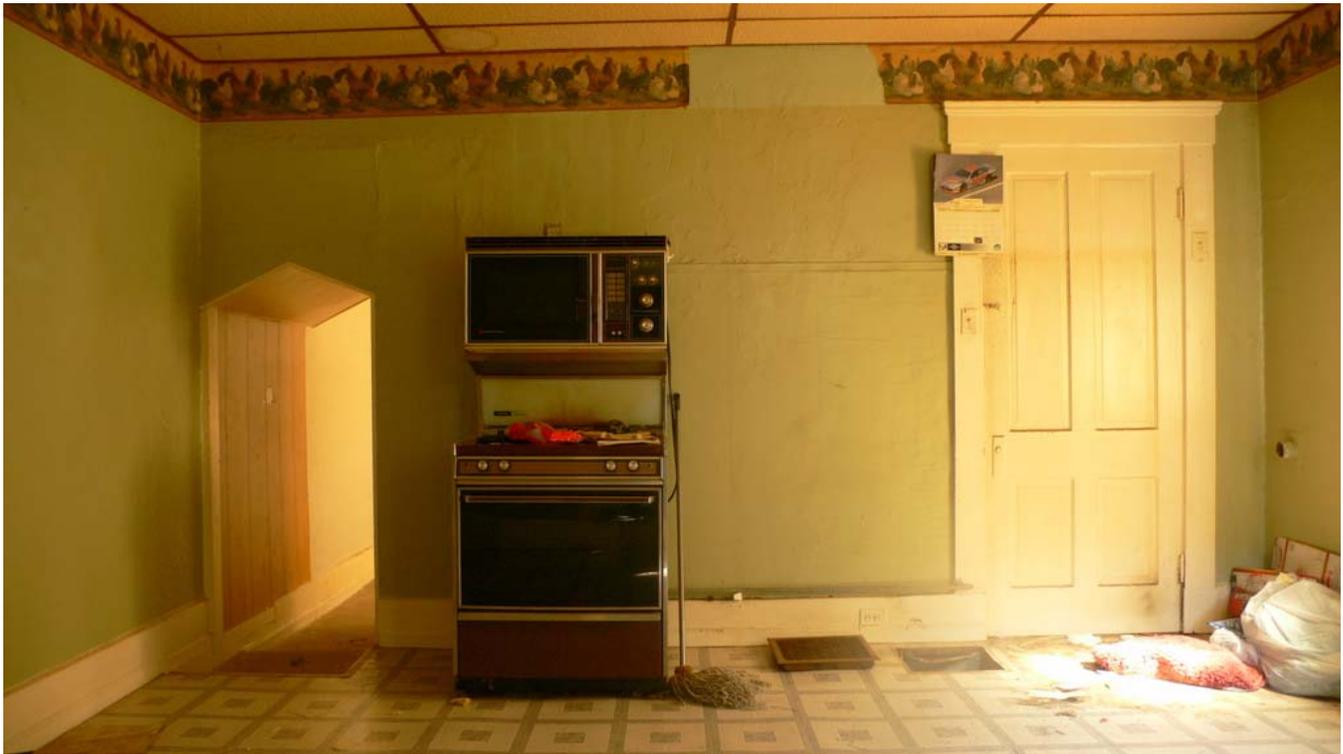
Figure 26: 419 West 12th Street, interior of kitchen, looking toward the stair hall between kitchen and second room, passage behind stairway to the left.

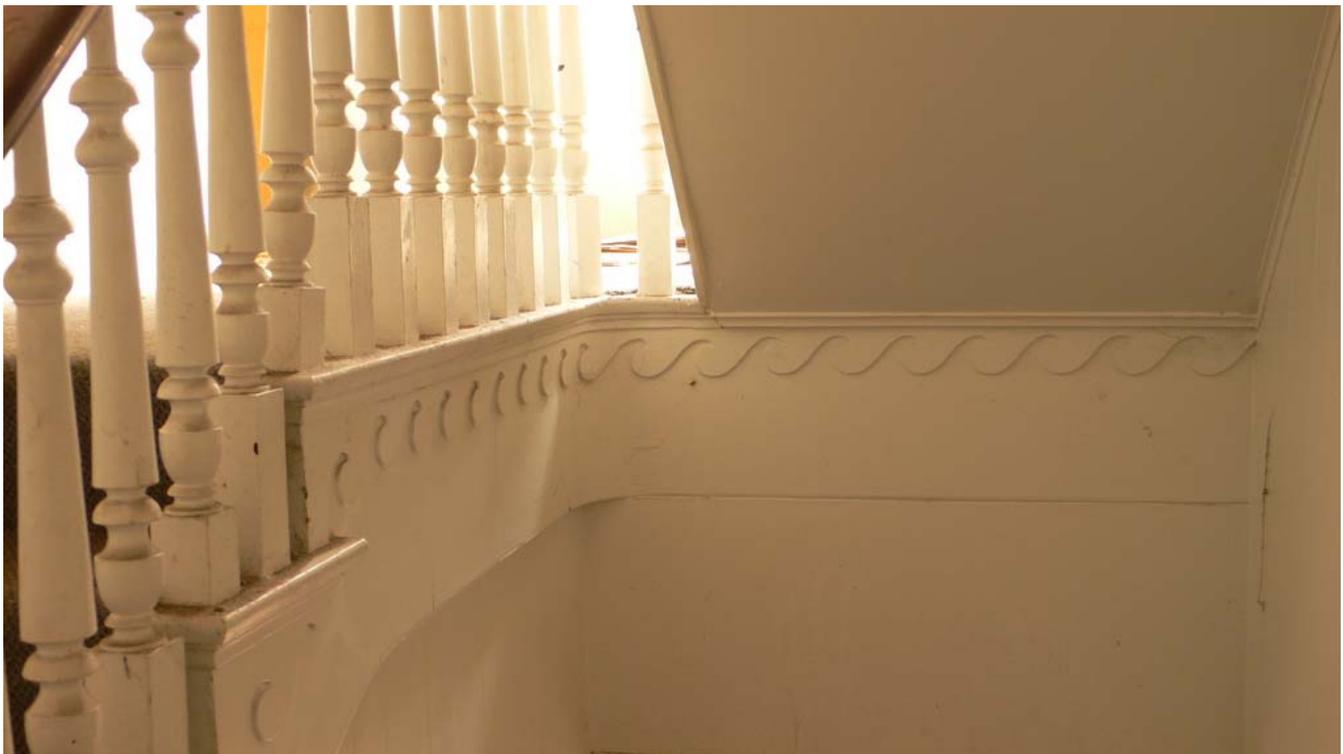
Figure 27: 521 West 12th Street, stair detail.

Floors are hierarchical not just in their stacking but also in their architectural finish. Typically the staircase from first to second floor in the NKTH has a high level of architectural detail and a formal presentation (Figure 27) The stair beyond to the third floor in contrast is often accessed through a door and has minimal architectural detail (Figure 31). And yet these garret stories often showed evidence of having been occupied spaces as well. In fact, third stories were among the most interesting of spaces encountered in the project area, because many of them were later given over to storage and consequently not remodeled.

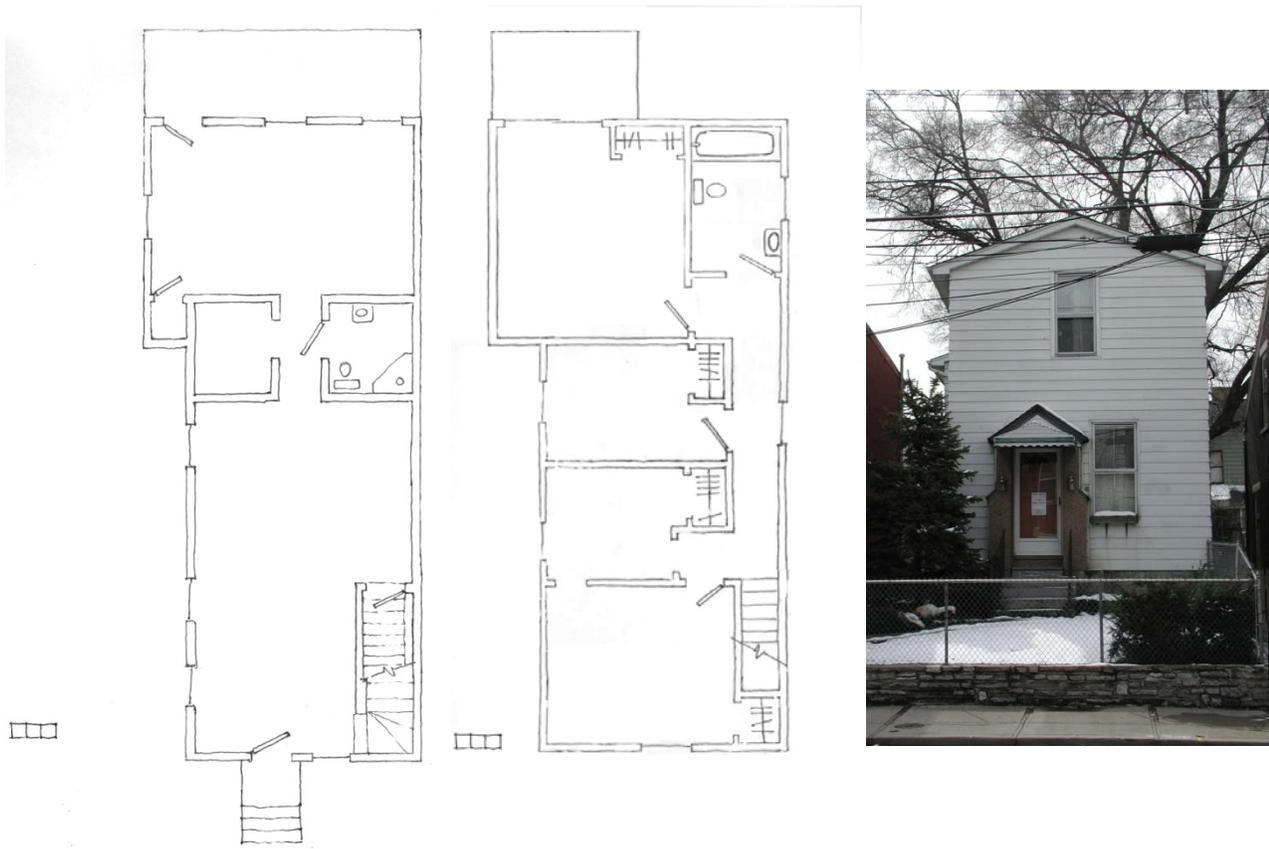
Figure 28: 421 West 12th Street, left to right: first floor plan, second floor plan, front from north.

of the building, providing access to a series of rooms that looked out over the entry yard, with a bathroom located at the back of the hall (Figure 28, center). In the project area, this was a pretty standard second floor configuration of private and semi-private rooms with a shared bath which could accommodate a family or multiple tenants.

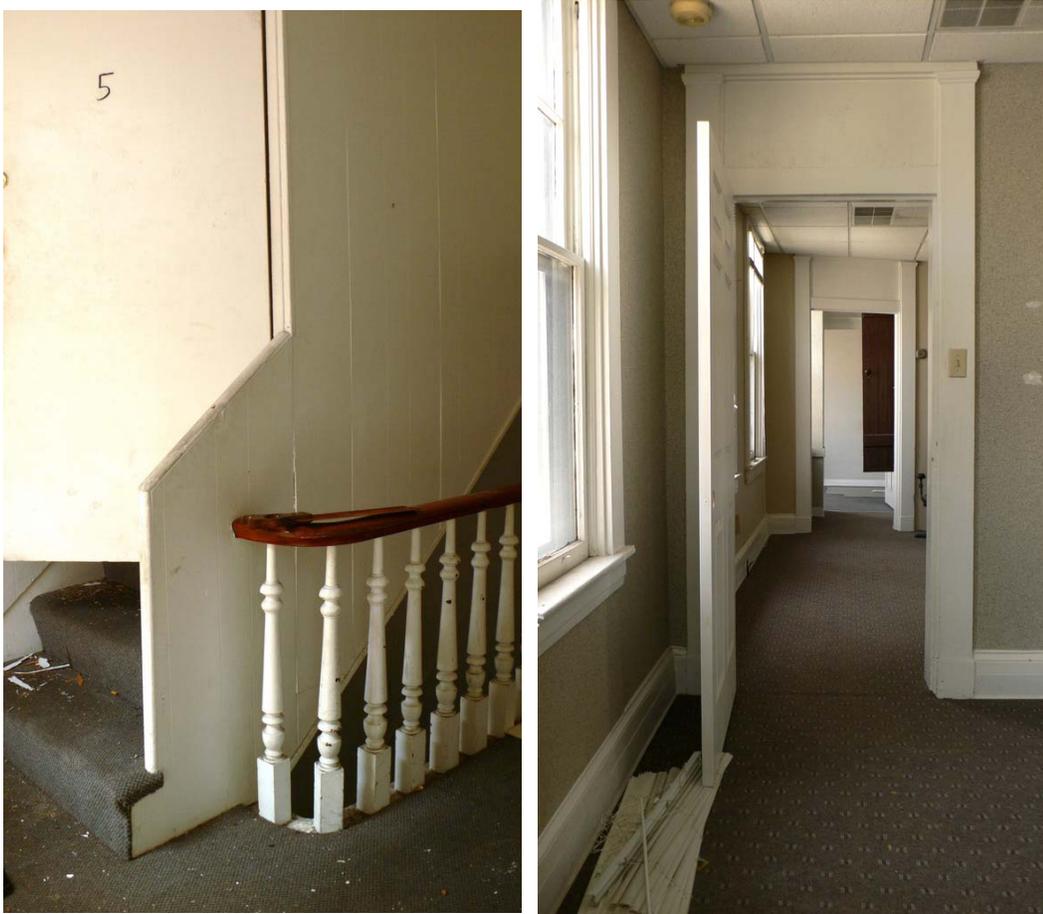
Figure 30: Left: 521 West 12th Street, stair transition from 2nd to 3rd floor. Right:

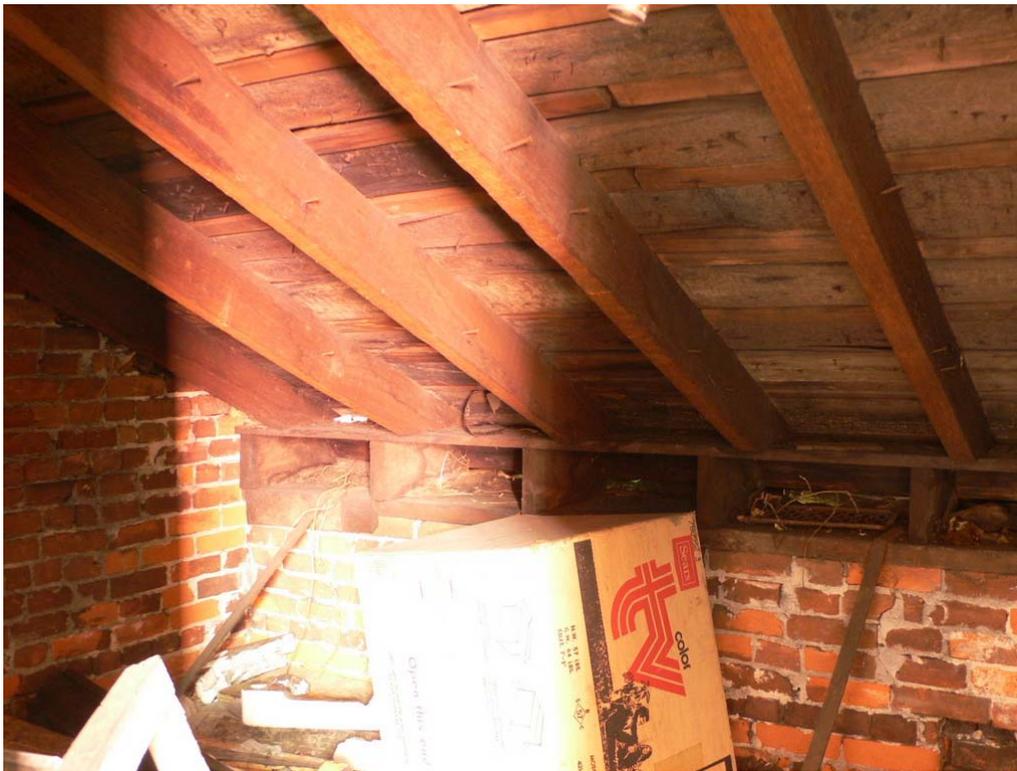
Figure 32: 515 West 12th, interior of front garret. The false plate arrangement with supporting joists crippled to maximize usable space is notable.

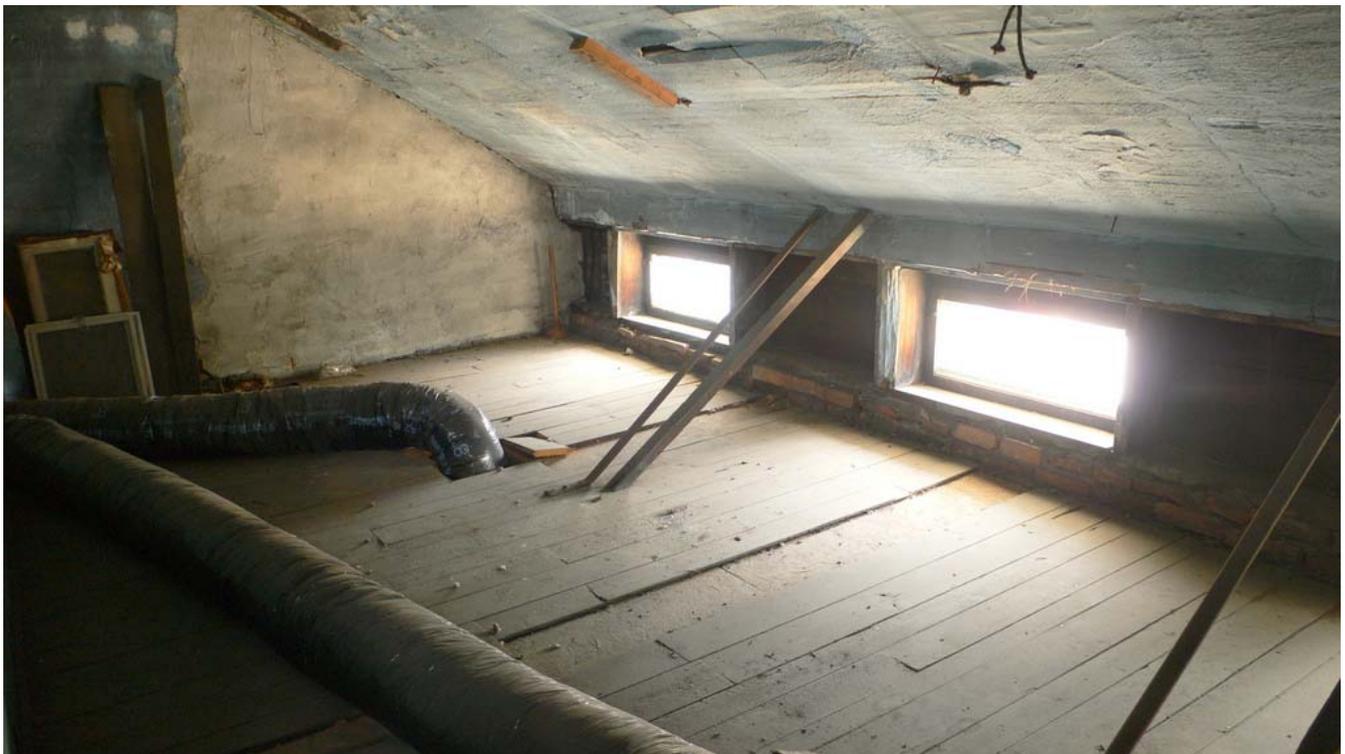
Figure 33: 1201 Main Street, interior of front garret. Unheated, but with floors, windows, and plaster finish this space was probably used as a bed chamber.

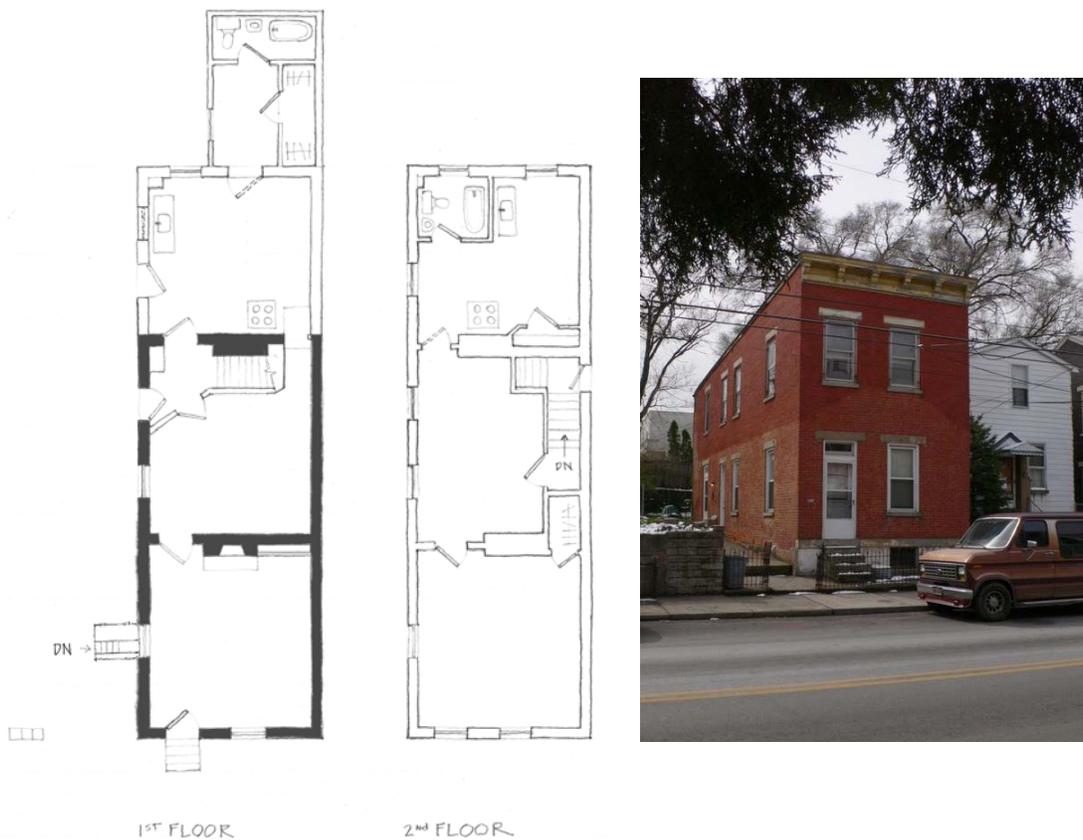
Figure 34: 419 West 12th Street. Left: first and second floor plans. Right: view from north. Scale in feet, shaded area is first period. Drawing by Bill Macintire.

Often the rooms off the hallway will also have doors opening to one another to form suites. The apartments above the liquor store at 23-25 East 12th Street, for example, were similarly configured (Figure 47 although the hallway was more like a small room than a corridor. Hallways were in many cases quite narrow, as at 529 West 12th Street (Figure 29), but in some cases, the stair would just lead directly into one of the middle rooms, as at 419 West 12th Street (Figure 34).

In contrast to the NKYTH type, there were several shotgun houses in the project area. The principal difference between the two is that the shotgun house is a single story and so lacks a stair hall. Though their ultimate cultural origins may vary, the close formal relationship of these two houses was illustrated at 419 West 12th Street, which evolved through alterations from a shotgun into a NKYTH (Figure 34). It began as a two-room shotgun (or double pen, sideways) prior to 1877, where it appears in the *City Atlas of Covington*. By the late 19th century, a room had been added to the back of the house. Sometime after 1909 (when it is still indicated as a single story building on the Sanborn insurance maps) a full second story was added to the house and a staircase was inserted at the back of the second room, blocking off the front of the hearth there. The outline of the original house was clearly visible in the brickwork of the walls (Figure 34, right).

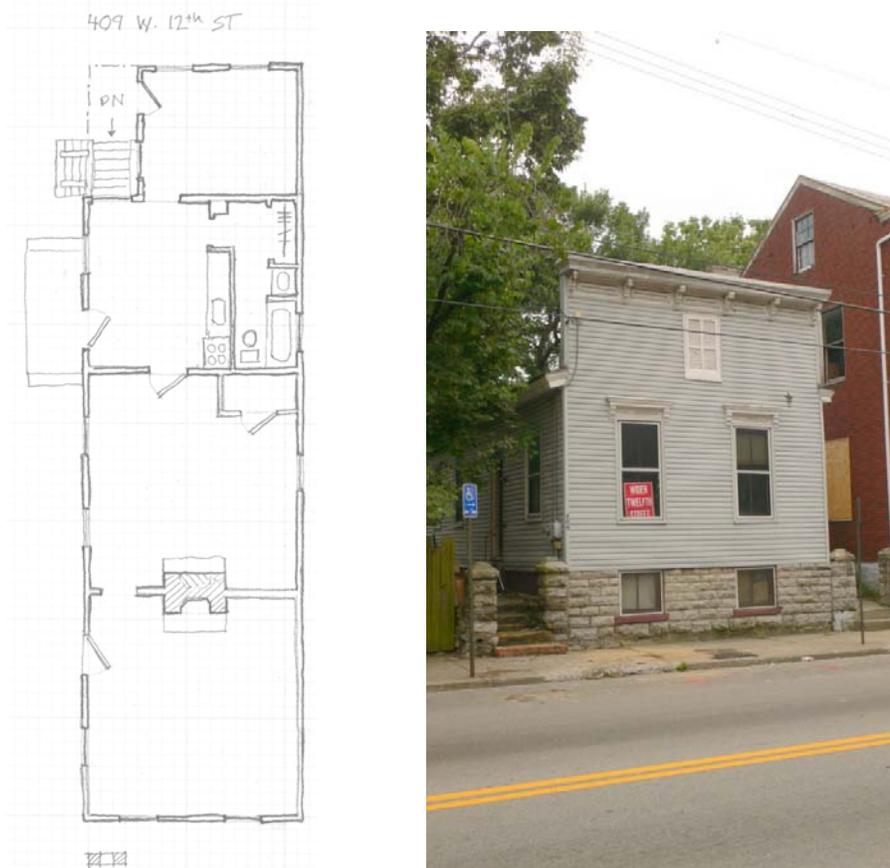
Figure 35: 409 west 12th Street. Left: Floor plan scale in feet, drawing by Bill Macintire; right: view of front from north.

Other examples of shotgun houses in the project area included 409 west 12th Street, a single story house several rooms deep, like a shotgun; but also like a NKYTH, in that its principal entries were along the side of the building and its street façade had two windows and no door (Figure 35). The false front furthered the illusion of NKYTH, and with the raised foundation of rusticated stone masonry, windows lighting the cellar space, and posts flanking the steps to the side yard, gave this small building a sense of mass, scale and solidity. A “purer” expression of the shotgun house form was found at 327 West 12th Street, with the slight variation of the back room being offset from the main body of the house to allow room for a back entry (Figure 36). An interesting feature of this house was the hatch in the floor of the pantry that allowed access to the cellar (Figure 36, right). A similar basement entry hatch was also observed at 1207 Main Street (Figure 37), which had the traditional

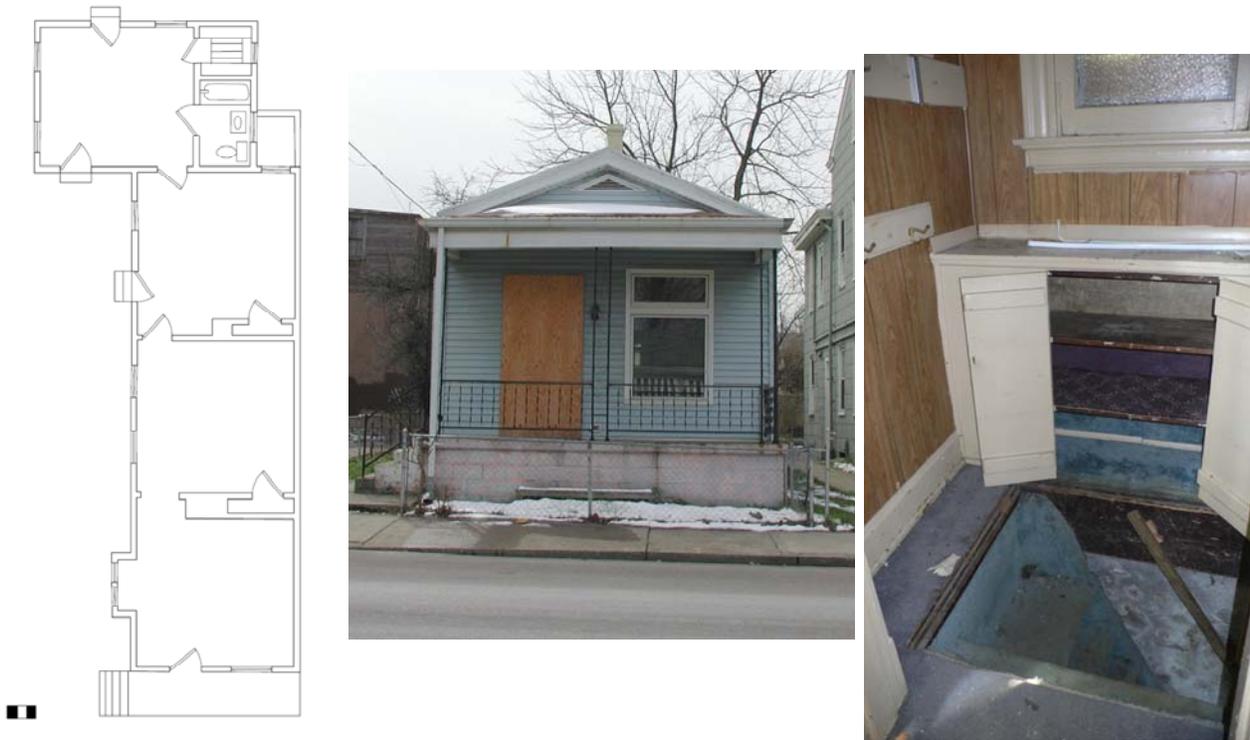
Figure 36: 327 West 12th Street. Left: floor plan, drawing by Danielle Jamieson, after field notes by Bill Macintire. Scale in feet. Middle: View of front from north. Right: basement access hatch inside pantry.

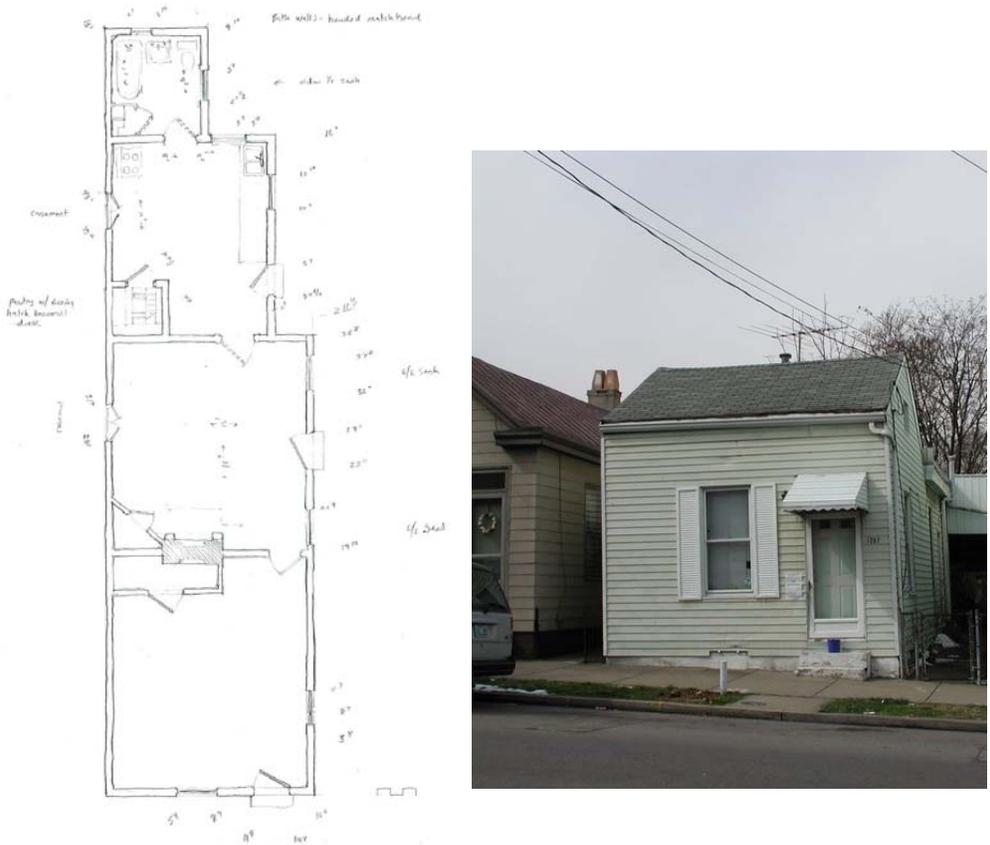
Figure 37: 1207 Main street. Left, floor plan, measured by Bill Macintire and Rachel Kennedy. Right, front, from east.

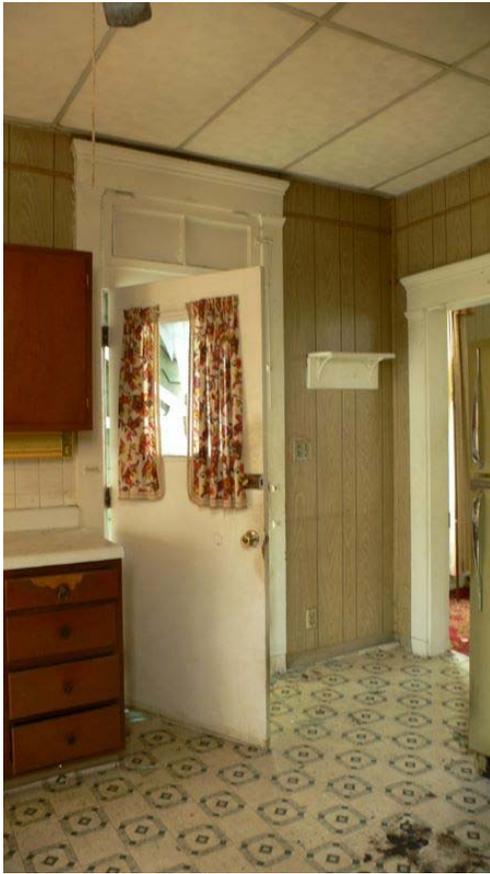
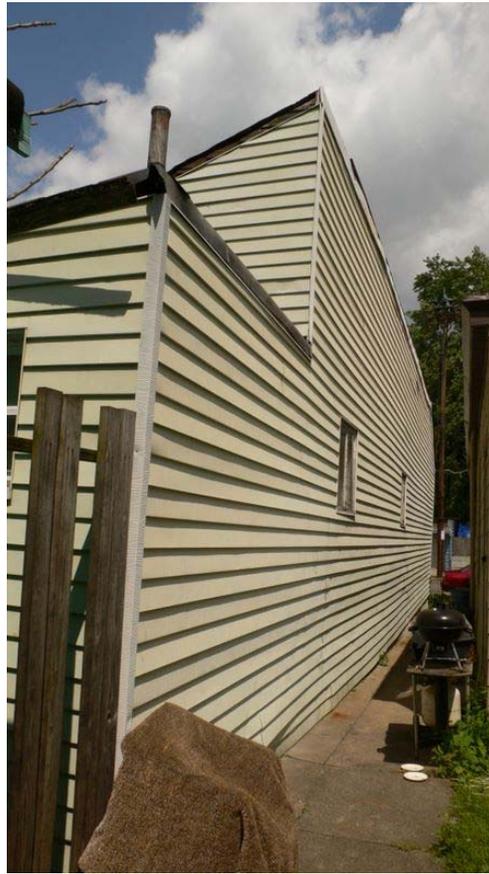
Figure 38: 1207 Main Steet. *Left: kitchen interior, looking toward outside door. Right: roofline at back of house.*

window/door façade of a shotgun, but whose principal entry appeared to be at the back along the side directly into the kitchen (Figure 38, left). The house had an unusual roofline, side gable in the front section, and a “flounder” roof on the back wing (Figure 38, right). Although it may not have been the original usage, at the time of documentation, the second room back from the front appeared to be the most formal mediating between a bedroom at the front and the kitchen behind (Figure 39). The bathroom was located at the very back, off the kitchen, and retained some of its turn-of-the-century interior details (Figure 40) The house was one of a small group of similar shotgun houses along Main Street (Figure 41).

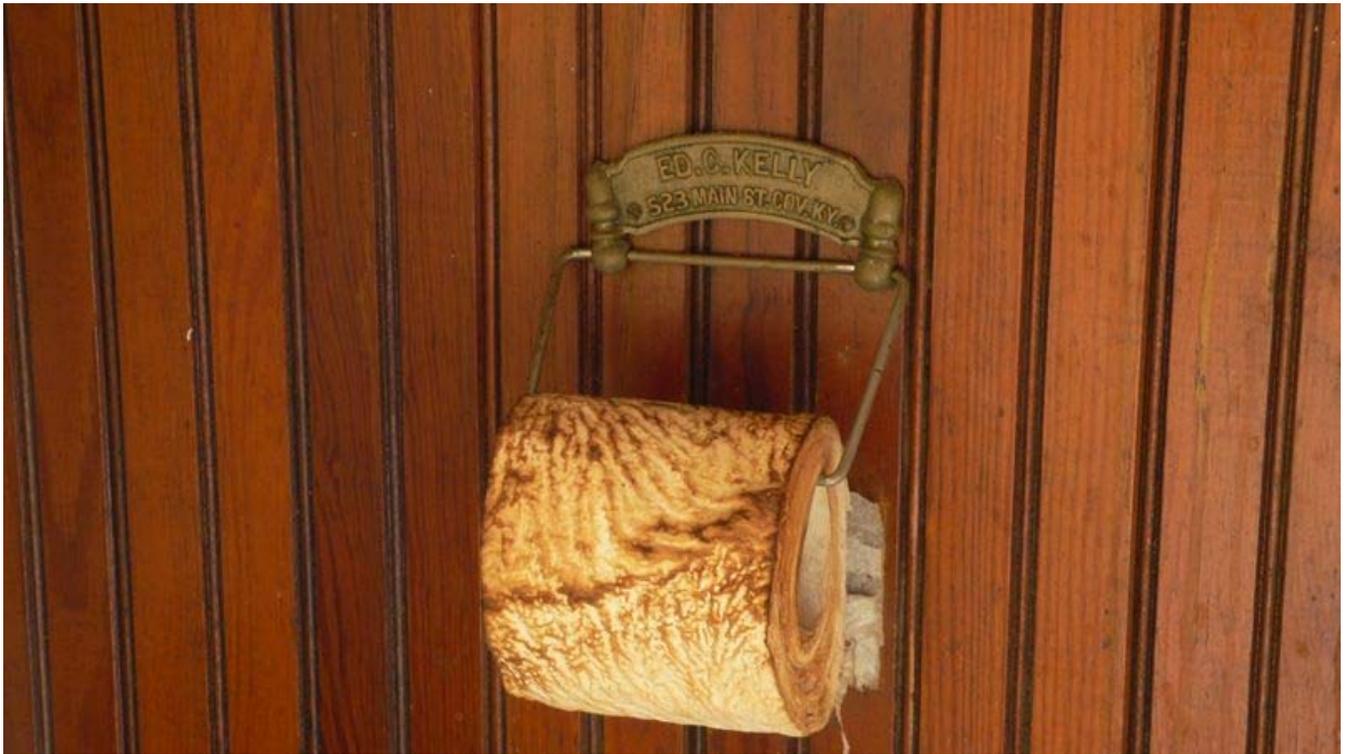
Figure 40: 1207 Main Street, interior of bathroom, detail of beadboard wall treatment and early toilet paper roll holder.

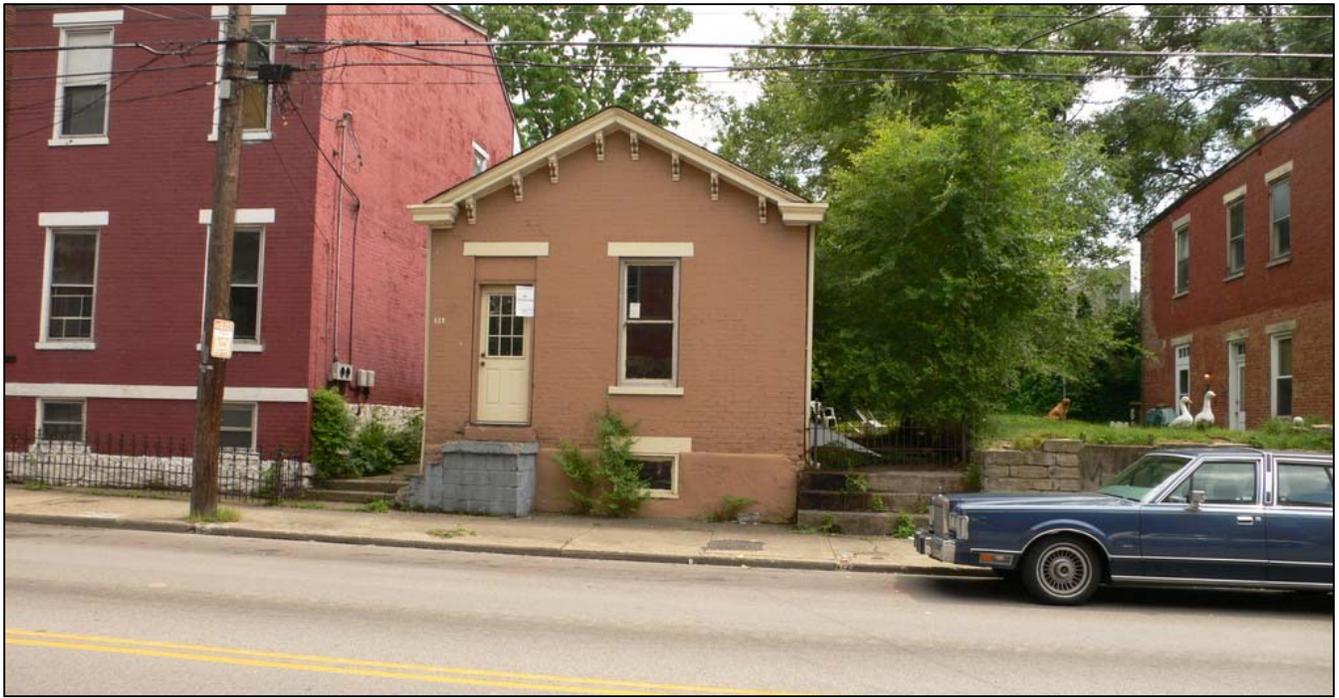
Figure 42: 415 West 12th Street, from North.

There were also shotgun houses in the project area of brick masonry construction. The tiny two-room shotgun at 415 West 12th street had been gutted inside, the original front door replaced and transom closed, but retained its fine bracketed Italianate/Neo-classical cornice with partial returns (Figure 42). The interior was in the process of rehab at the time of documentation and had great potential as a small commercial or domestic space (Figure 43). What at first appeared to be a frame house at 507 West 12th street turned out to be brick with vinyl siding (Figure 44). The house, built before 1877 was originally one story, but the roof had been raised, and still later, a dormer added to create space for second floor bedrooms. The front room retained its Greek Revival mantle (Figure 45). It was also a kind of semi-flounder variation of the shotgun house in that it had a hipped shed roof instead of a front gable

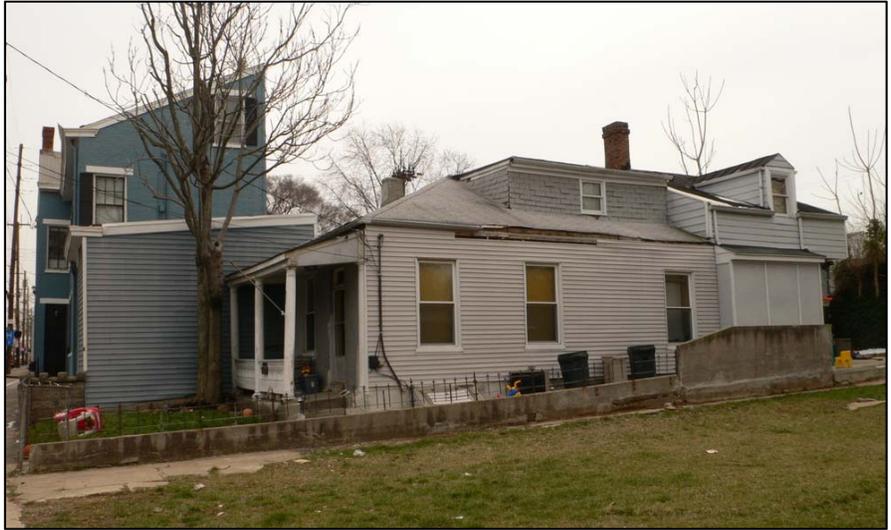
Figure 44: 507 West 12th Street. Left: Floor plan, drawn by Bill Macintire and Danielle Jamieson. Right, house from West.

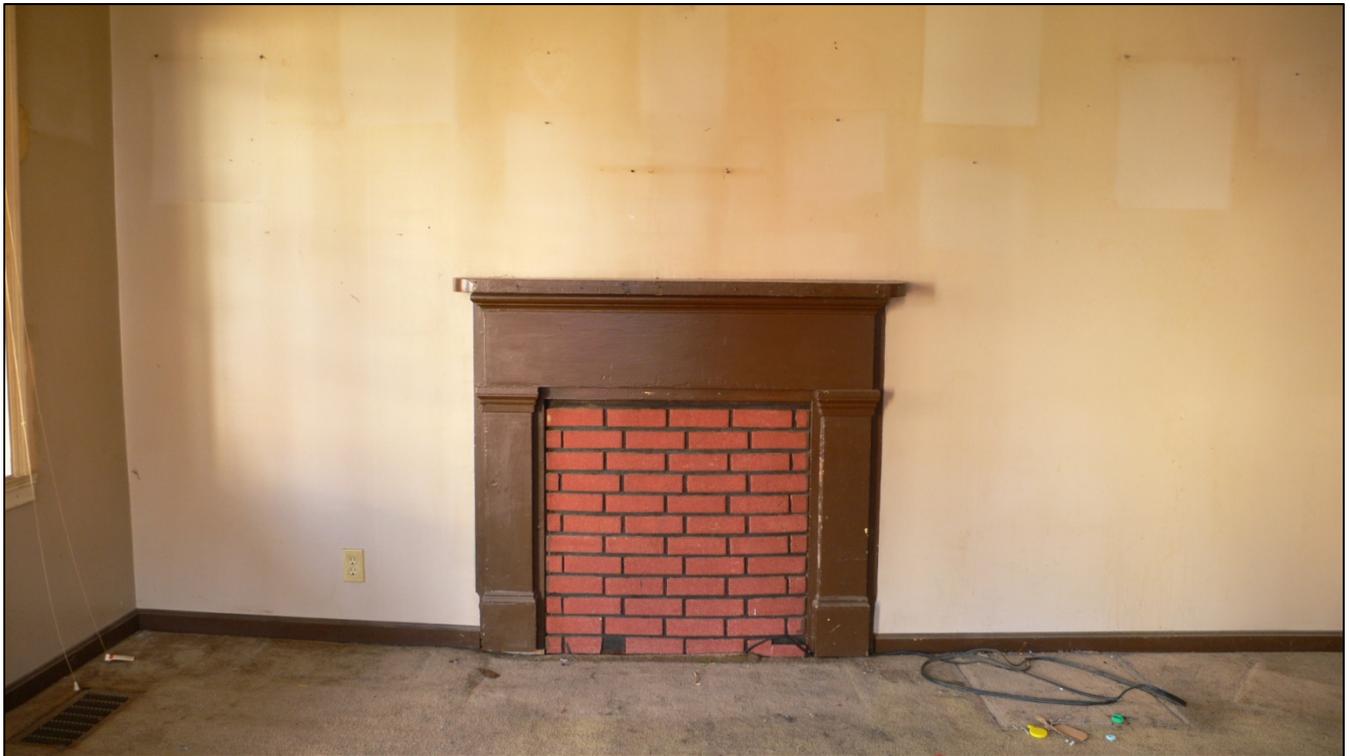
Figure 45: 507 West 12th St, mantle on East wall of front room.

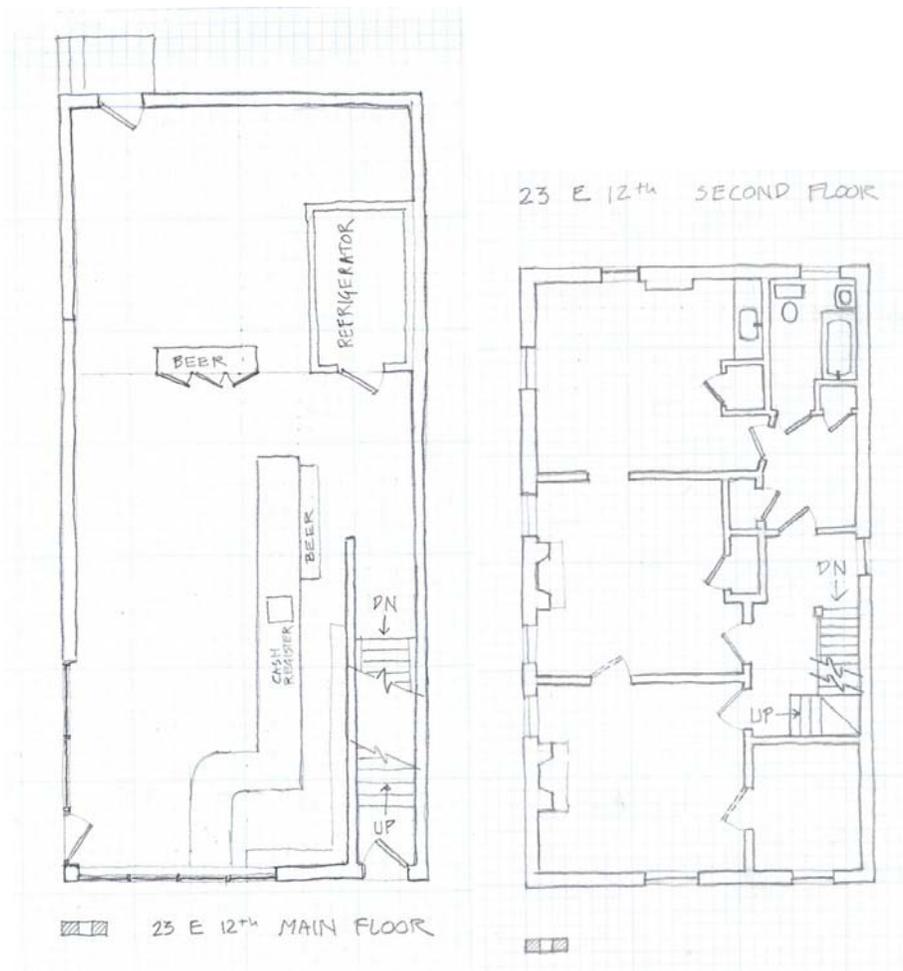
Figure 47: 23-25 East 12th Street, first and second floor plans, drawing by Bill Macintire.

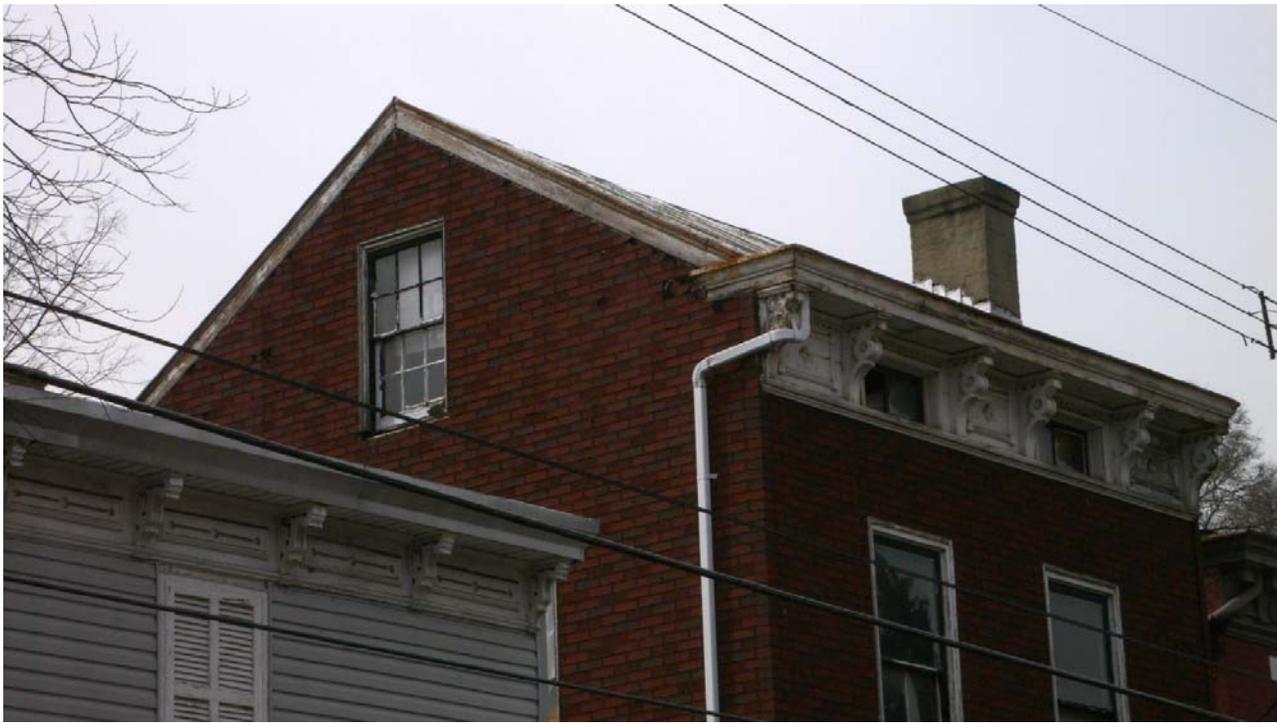
Figure 49: Cornice details, 409-411 West 12th Street.
