Documentation of Historic Structures on Twelfth Street, Covington

Kentucky Heritage Council/
State Historic Preservation Office
October 2013

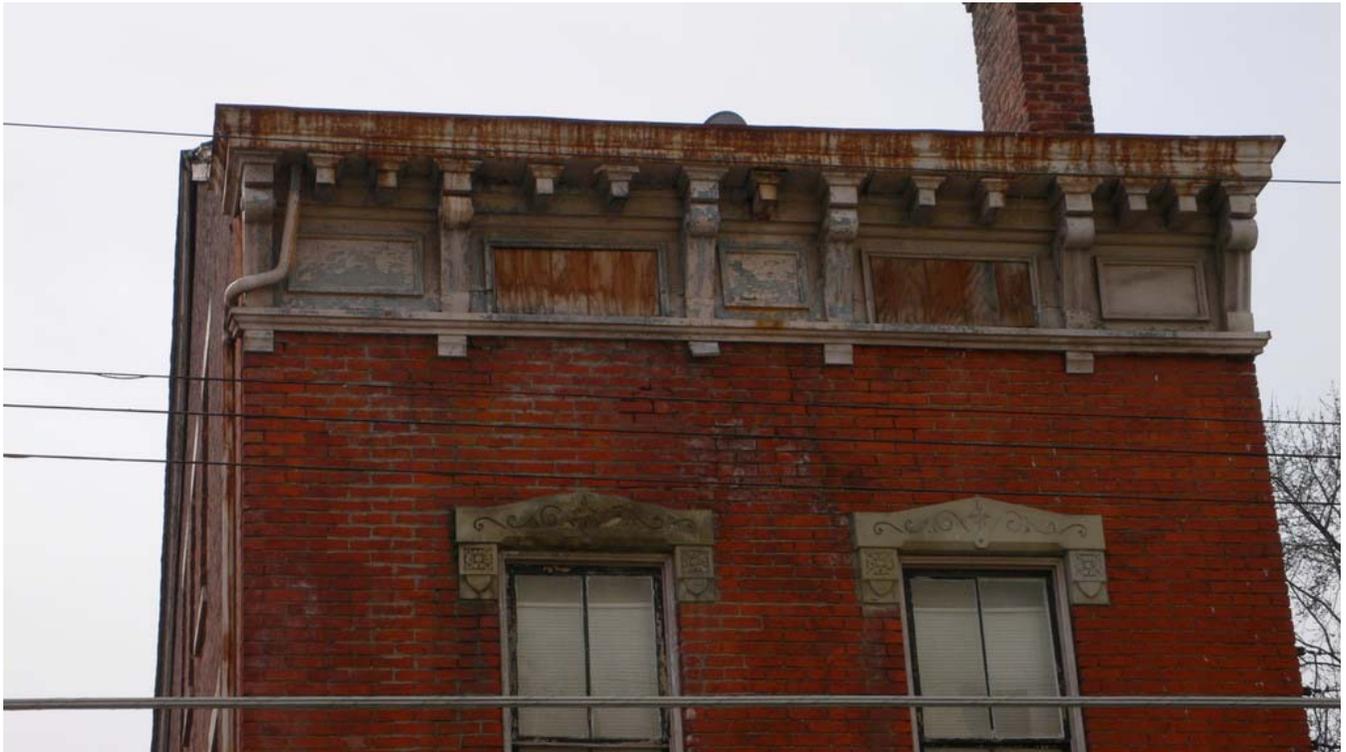
Figure 52: 521 West 12th Street, box gutter cornice and window detail.

While they vary in styles, the 12th street houses share a common vocabulary. The forms are straightforward and repetitive, mostly narrow side gable or shed roof houses. Other than those on corner lots, the houses had limited visibility on the sides, so ornamentation is heavily concentrated on their fronts (Figure 54). It is mostly concentrated on front cornices, doors, and window surrounds; on the principal side façade, ornament concentrates on entries and porches. Some of the plainer houses, such as 19 East 12th street, have few architectural details at all aside from the simple molded cornice and narrow window surrounds (Figure 51 – the stone veneer on the first floor and probably the stucco on the second floor came later, the building was brick underneath). In contrast, examples such as 521 West 12th Street sported highly elaborate cornices with brackets, dentils, and cornice windows, together with carved stone jack arches over the window openings (Figure 52).

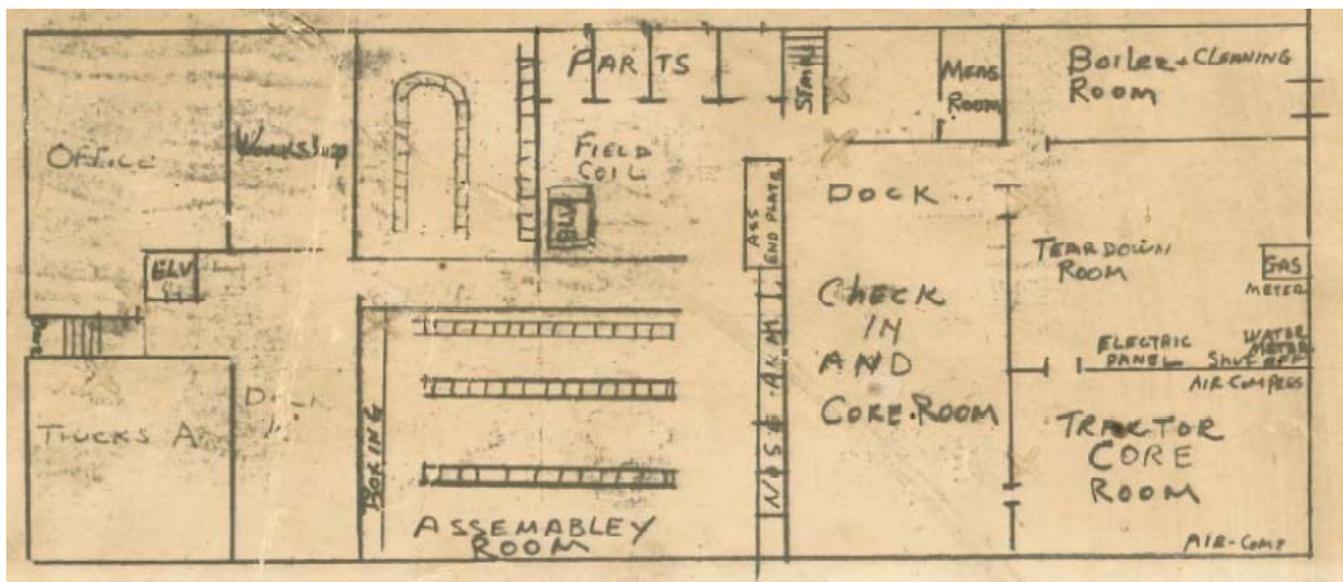
Figure 58: First Floor Plan of 315 West 12th Street. The drawing was found at the site. Front of the building is at the left.

The building reflected its complex history of development and changes to the industries it housed over time. In 1877 the site just had one masonry building, probably a townhouse form, with a frame outbuilding behind, as seen in the Hopkins *City Atlas of Covington, Kentucky*. Some remnants of this house may have remained in the documented structure, but no evidence of that was noted. We don't know what the décor of the original front of the building looked like – it had a wonderful art deco renovation to the front offices and warehouse at some point in the 1930s – 40s. The front façade was the product of an early-mid 20th century renovation (Figure 66), while the side façade running along Fisk Street was a catalogue of 19th-mid 20th century industrial architecture (Figure 65, Figure 68). Plan views reveal a series of spaces dedicated to specific manufacturing processes, "pickling and hog slaughtering" in one space that later becomes an office, and so on (Figure 59 & Figure 58). The Ruttle's/Oberjohn's building was an excellent example of a small urban industrial/manufacturing plant.

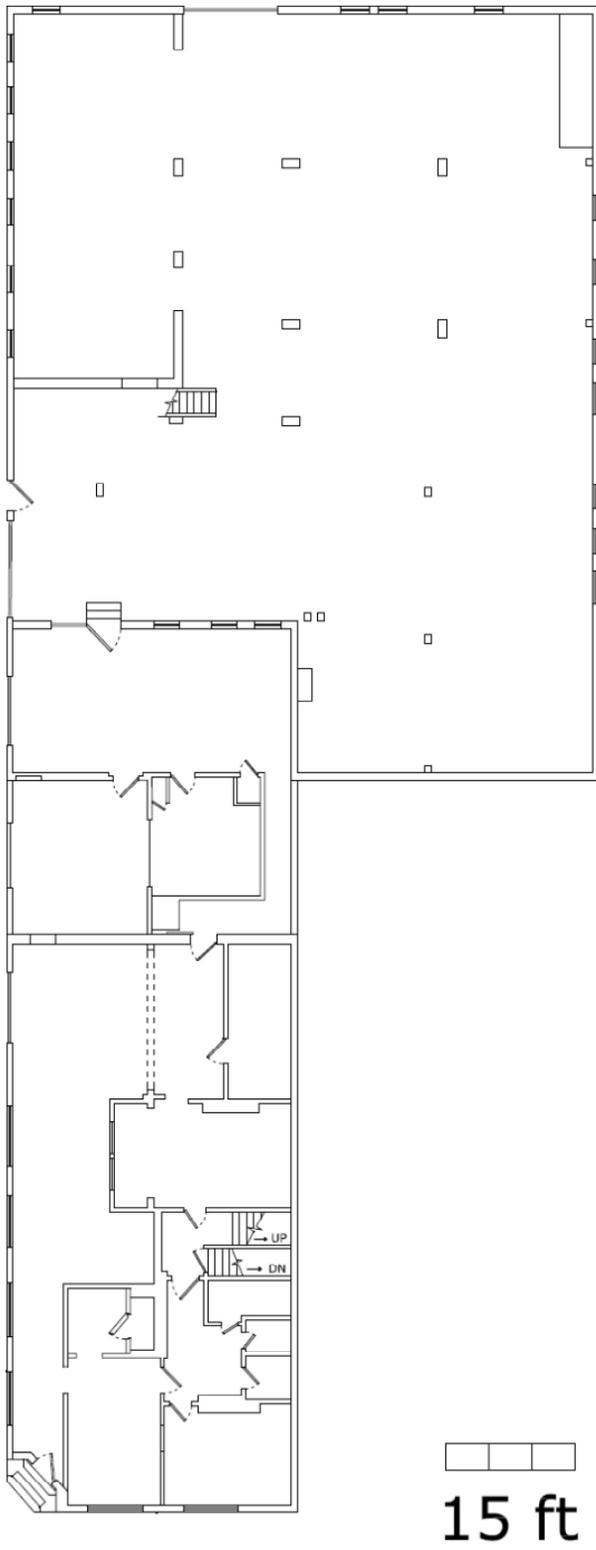
Figure 61: Floor plan of 321 West 12th Street, drawing by Danielle Jamieson.

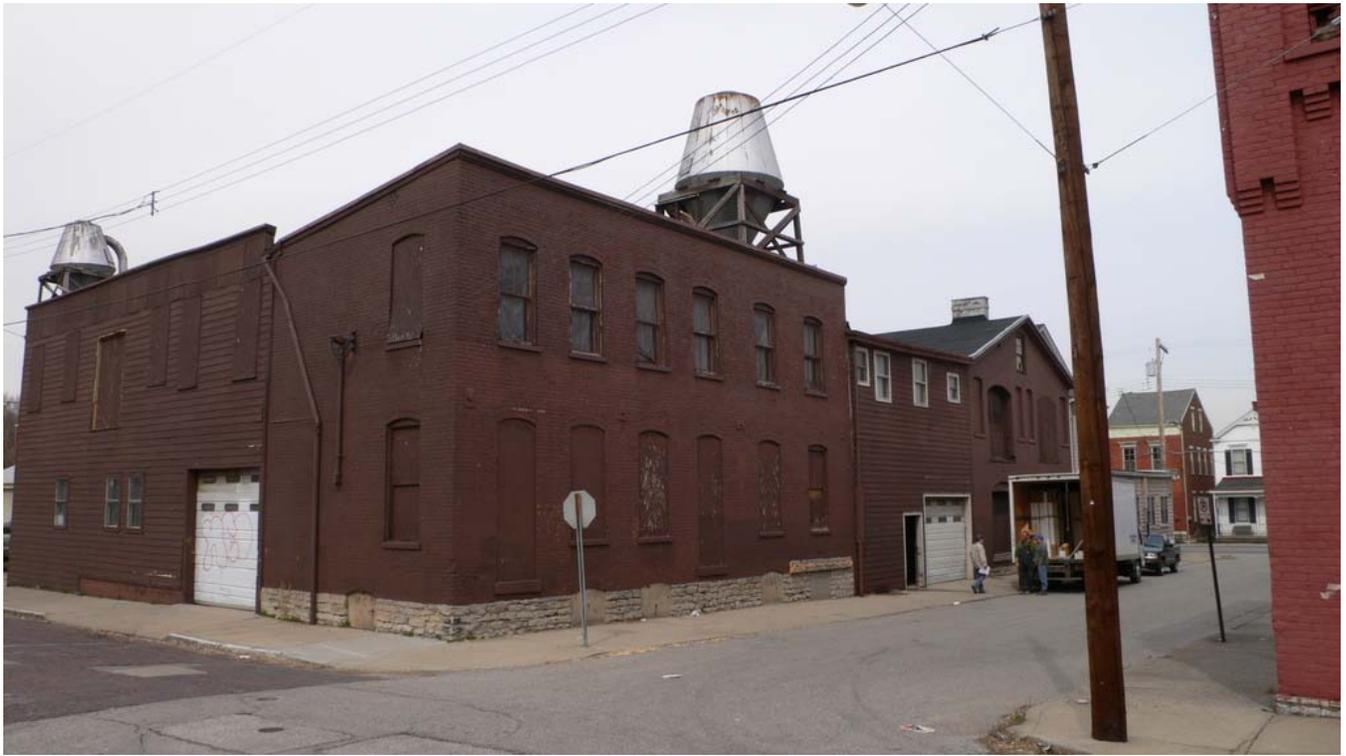
Figure 62: 321 West 12th Street, view looking northwest at the corner of Fisk and Watkins streets.

machinery, and warehouse spaces at the back (Figure 59, Figure 61, Figure 62, and Figure 63). The house at the front has been taken by the project, but the shops at the back happily still survive and will hopefully become the focus of a renovation project (Figure 64).

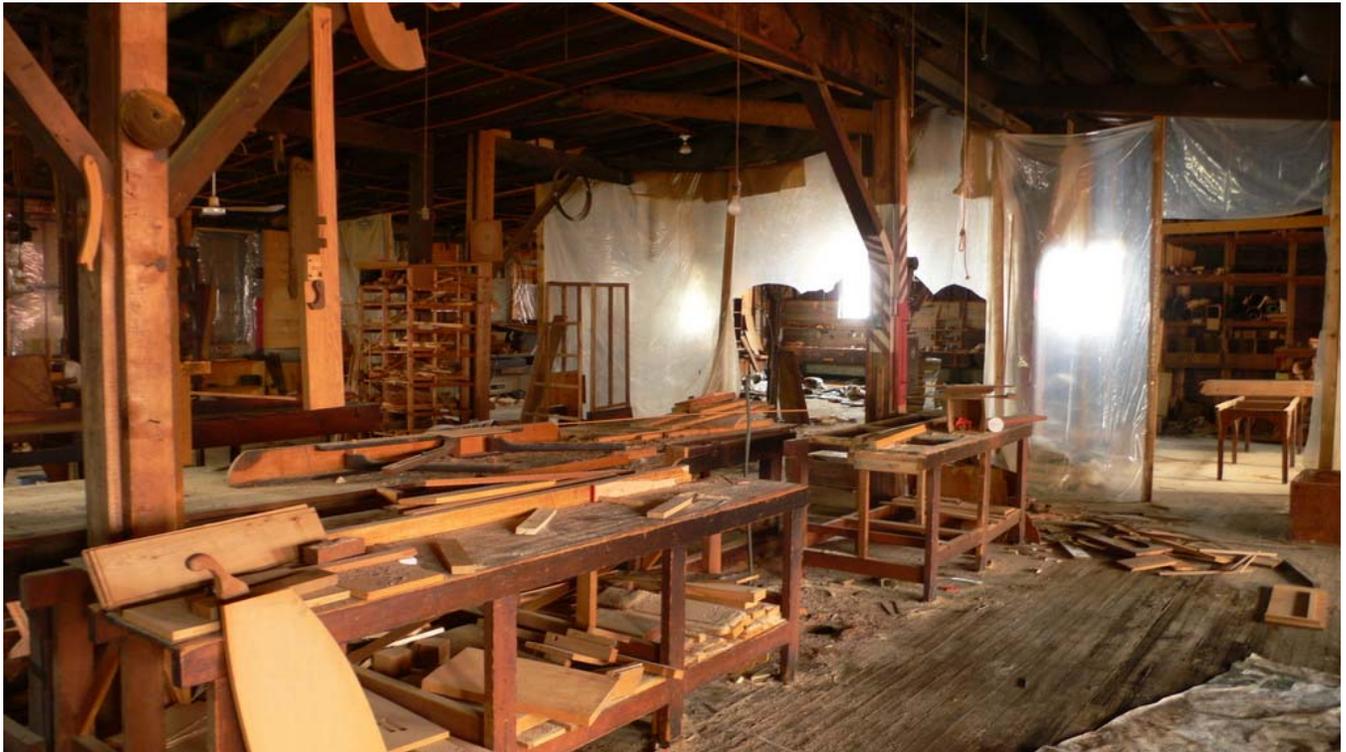
Figure 63: 321 West 12th street, Hellman's, shop floor.

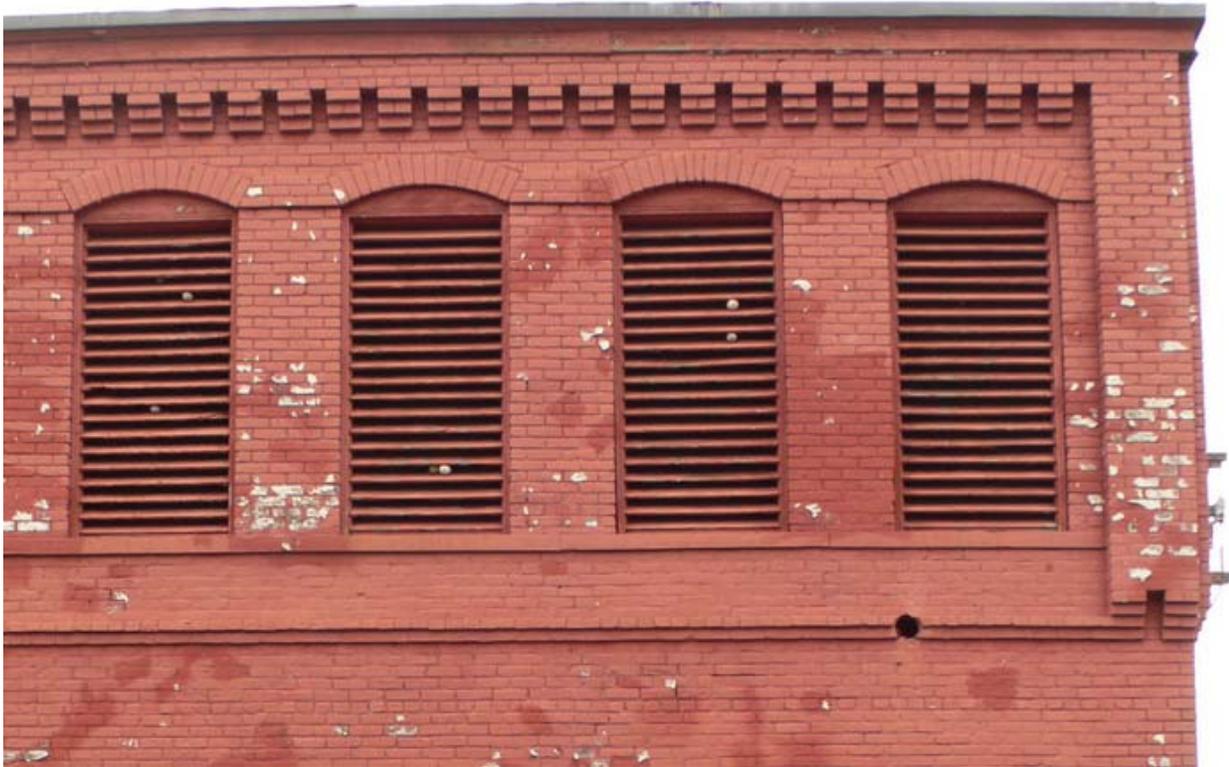
Figure 65: 315 West 12th Street, cornice and windows at back of building at the corner of Fisk and Watkins Streets

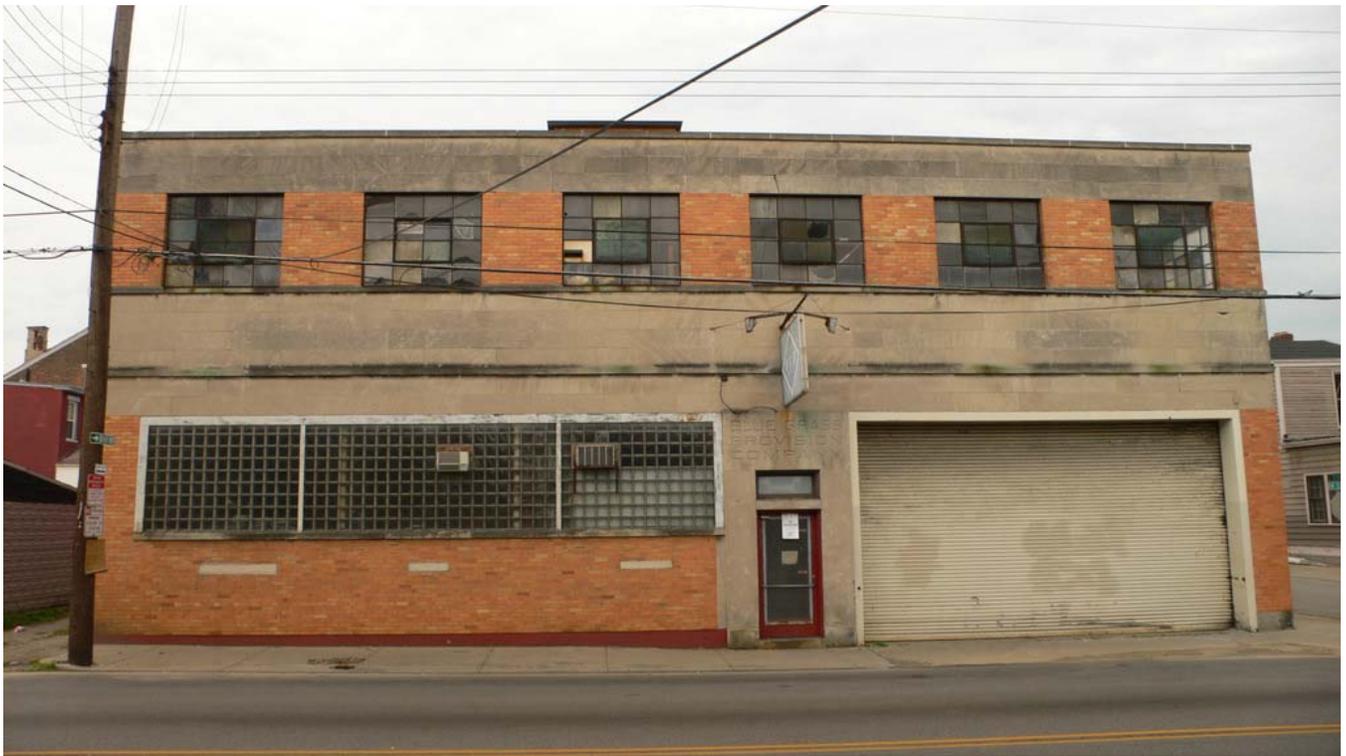
Figure 66: 315 West 12th street, from north.

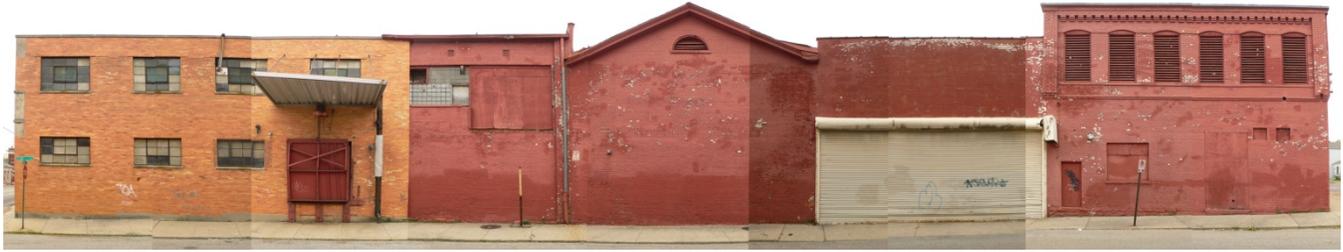
Figure 68: 315 West 12th Street, west façade along Fisk Street.
