United States Department of the Interior
National Park Service
National Register of Historic Places Registration Form

Historic name: Downtown Morehead Historic District

Downtown Morehead Historic District

Rowan County,
Kentucky
County and State

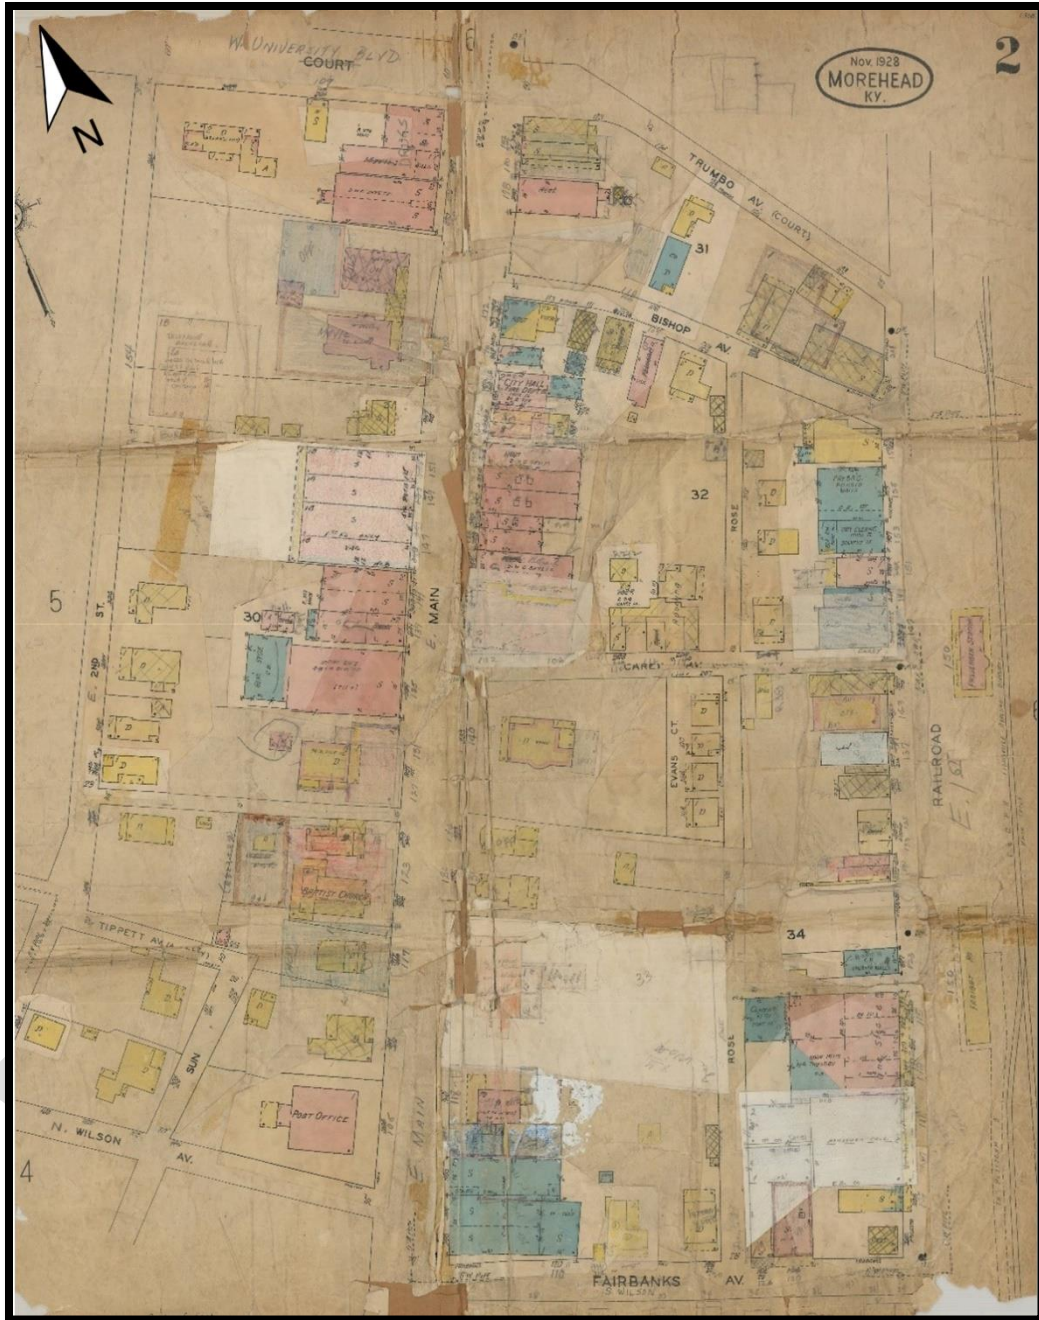
Figure 9. 1949 Sanborn Insurance Map, Morehead, Rowan County, Kentucky.¹³

Indicative of the development spurred by Morehead State University and US 60/the Midland Trail, the 1949 Sanborn maps reflect a greater density and variety of buildings. On the courthouse square, WPA-era construction is reflected in the previous brick jail having been rebuilt in stone and a new stone building labeled “Board of Education offices,” constructed on the western corner of the square. In 1949, along Main Street near the courthouse, there was a large brick bakery adjacent to a business selling and servicing automobiles. Closer to the railroad

was a dry cleaner and laundry adjacent to an automobile repair shop. There were new frame stores and new restaurants. There was also a two-story brick grocery/warehouse. Further along Main Street were brick drug stores, a brick restaurant, a new brick post office, a new movie theater, blocks of brick stores, and multiple locations for auto sales and service. Main Street closest to Wilson Avenue continued to have the densest development and was nearly completely built up by this point with brick commercial buildings. The Midland Trail Hotel remained a fixture in this block. A detailed map depicted industries expanding along Main Street including the Carr Lumber Company and the Cowden Manufacturing Company. By 1949, Morehead State Normal School had encroached on the block directly the northwest of the courthouse and a corrected section had been glued onto the Sanborn to indicate a “Student Union” building had taken the place of what were shown as frame dwellings in 1928. The most substantial and developed portion of Morehead was then, and continues to be, Morehead State Normal School (in 1928 and 1949 Morehead State Normal Teachers College, now Morehead State University). (Figure 9).

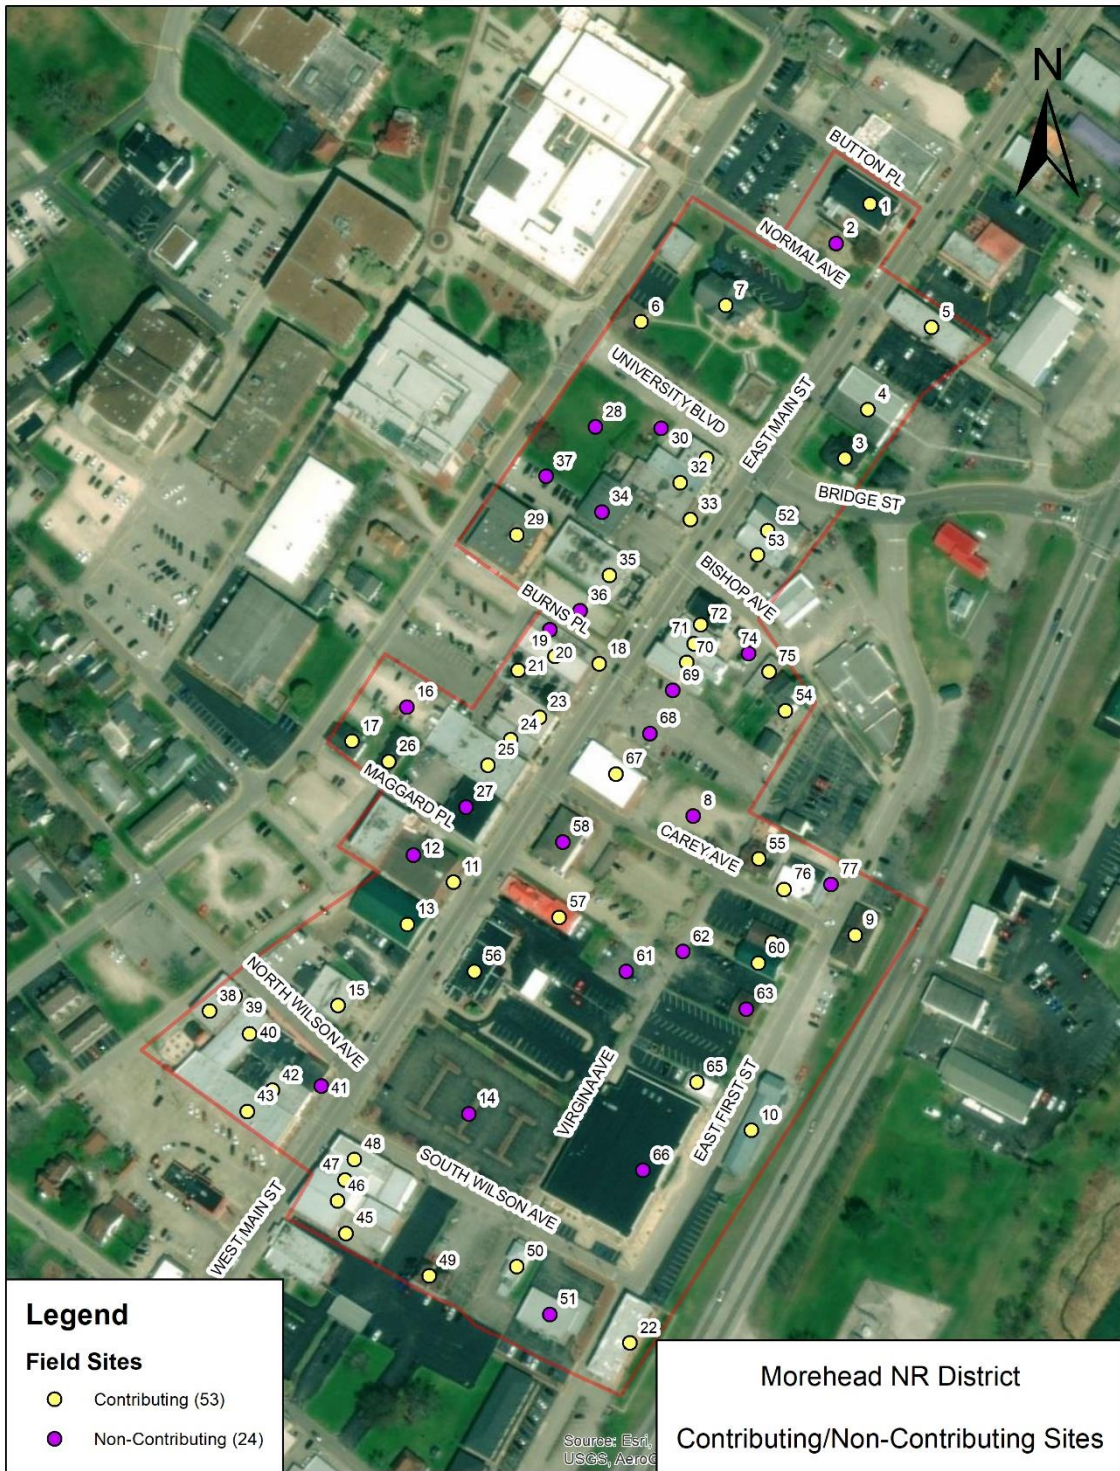
Figure 11. Downtown Morehead Historic District, Field Survey Map. Contributing Status is marked as yellow dots, and Noncontributing is marked by purple dots.

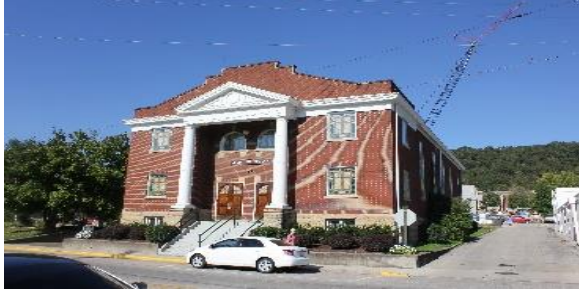
<p data-bbox="532 793 928 823">227 East Main St., looking northwest</p>	<p>This two-story church was constructed in 1925 and serves as the First Christian Church of Morehead. Its shallow pitched gable roof is surrounded by a brick parapet wall with false front, topped with formed concrete caps. The exterior of the building has a brick veneer. The façade features stained-glass windows. Two-story stained-glass windows are also present on the side elevations. The building rests on a stone foundation and features a two-story pedimented entry portico, supported by two large columns resting on stone piers. There are no additions or alterations to the original building. This building replaced the Union Church, built by Col. John Hargis, founder of Morehead, and housed all faiths during its tenure on this location. Contributing.</p>
FS 2/ RWM-162

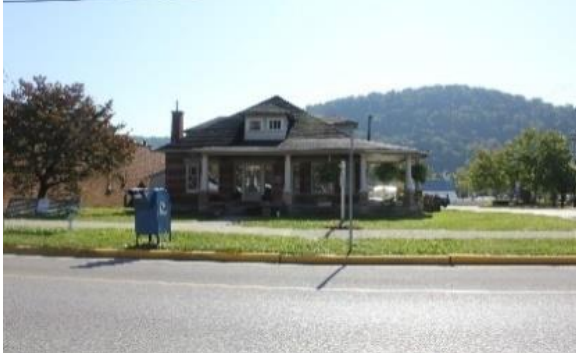
<p data-bbox="545 606 915 632">206 East Main Street, looking east.</p>	<p data-bbox="1044 254 1414 768">The Norman Wells House is a one-and-a-half-story 1927 brick Craftsman Style house. Its hipped roof has an asphalt shingle roof covering, and features roof dormers on three of the four roof slopes. A wraparound porch is present on the façade and south elevation, and is supported by wood columns that rest on stone piers. The first-story features wood sash windows. The upper sashes and the picture window transoms have a leaded glass in a diamond pattern. The brick used for this building's construction brought to Morehead via the C&O Railway. The building is currently home to Dehner & Ellis, Attorneys at Law.</p> <p data-bbox="1044 770 1192 798">Contributing</p>
FS 4/ RWM-185

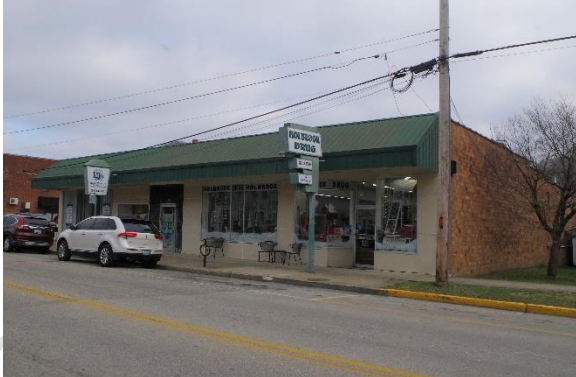
<p data-bbox="545 1207 915 1232">208 East Main Street, looking east.</p>	<p data-bbox="1044 831 1414 1373">This single-story commercial building was constructed circa 1945. Three storefronts are present on the façade. The concrete block and clay fire block building has been parged on its northwest elevation. The roof is flat. The storefronts have a vinyl panel covering, and a half gable awning covers the main entries. The right and left bay storefronts are recessed and have metal frame doors, transoms, and display window. A large metal frame, three-pane picture window, located to the right of a storefront entry, is present at the central bay. Currently, this building is the location of a drugstore and a professional medical business.</p> <p data-bbox="1044 1375 1192 1402">Contributing.</p>

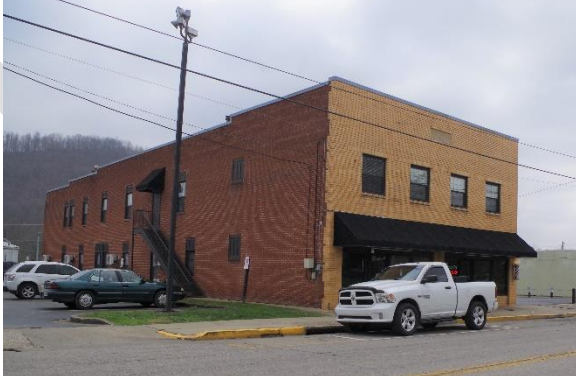
FS 5/ RWM-194

<p data-bbox="516 1785 948 1810">224 East Main Street, looking southeast.</p>	<p data-bbox="1044 1409 1414 1890">This two-story commercial building, constructed in 1940, and was the location of Caudill's Grocery and Elam and Wheeler Wholesale Grocery. The building is of common bond brick construction and the façade features a blonde brick veneer. Its roof features a stepped parapet wall capped with metal flashing. The windows are of metal sash construction with 8/8 light patterns. The facade features two storefronts with recessed entries, metal frame display windows, transoms, doors, and brick bulkheads. Canvas awnings cover the storefronts and side elevation</p>

Field Site No./KHC Number	Photo	Description
		<p>entries. The right bay storefront is currently the location of a barber shop. Contributing.</p>
<p>FS 6/ RWM-5</p>

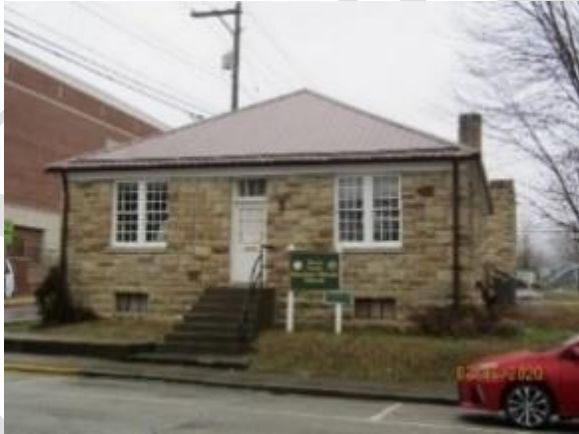
<p data-bbox="524 1486 937 1514">240 East Second Street, looking north.</p>	<p>There are two buildings on this property, in addition to the adjacent Courthouse. The first building is a circa 1935, two-story, rectangular limestone stone building which served as the Rowan County Jail. Many of the window and door openings have been enclosed with limestone blocks, Louver vents are present within the second story windows openings. The roof features a crenelated cornice. A set of exterior metal stairs, which lead to the second floor, is present on the southwest elevation, and an ADA compliant ramp is present on the façade.</p> <p>The second building is the former Rowan County School Board Superintendent's building (1935-2005). Constructed in 1935, this limestone building is a single-story in height with a raised basement. The hipped roof has a metal covering and the windows throughout are of wood sash construction, with 9/9 light patterns. A set of poured concrete steps lead up to the façade's central entry with transom and 9-light, half-light wood panel door.</p> <p>This property was added to the NRHP in 2017 as the Rowan County Courthouse Expansion NRHP nomination, NRIS 100000743. Contributing.</p>

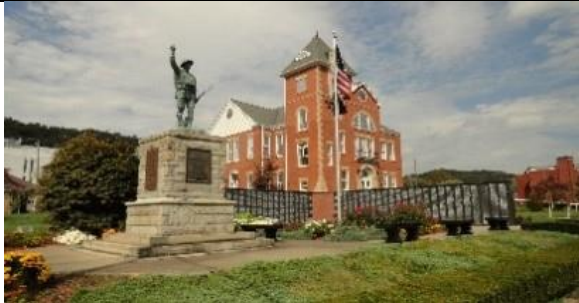
<p data-bbox="537 548 922 575">205 East Main Street, looking north.</p>	<p data-bbox="1044 247 1419 989">The Rowan County Courthouse was constructed in 1899 in the Richardsonian Romanesque architectural style, a common style for civic buildings constructed in this era. The main architectural feature of this building is a three-story tower located on its southern corner. This two-story common bond brick building is supported by a carved limestone foundation and features limestone quoins on the southern corner of the tower. The cross gabled roof has an asphalt shingle roof covering. The windows are of sash construction with 2/2 light patterns, and have carved stone sills and lintels. The façade's central bay entry is flanked with stone surrounds and features a half-arched transom. This building was added to the National Register on 7/21/1983 (NRIS 83002862) and is the current location of the Rowan County Arts Center in the heart of the downtown Morehead.</p> <p data-bbox="1044 989 1198 1016">Contributing.</p>

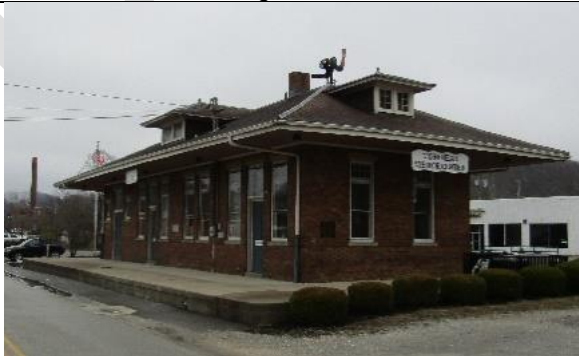
<p data-bbox="521 1808 938 1835">150 East First Street, looking northeast.</p>	<p data-bbox="1044 1455 1419 1894">Constructed circa 1910, the C&O Passenger Depot is of common bond brick construction and features a hipped roof, with an asphalt shingle roof covering, and metal roof cresting. Roof dormers, with paired windows, are preset on all roof slopes with the exception of the southeast slope. Large overhanging roof eaves cover all elevations. The windows are of sash construction with 1/1 light patterns and the original multi-light transoms have been retained, along with the carved stone lintels and sills. This building was a</p>

Field Site No./KHC Number	Photo	Description
		<p>former railroad passenger station and currently houses the tourism visitor's center and chamber office. Contributing.</p>
<p>FS 10/ RWM-6</p>

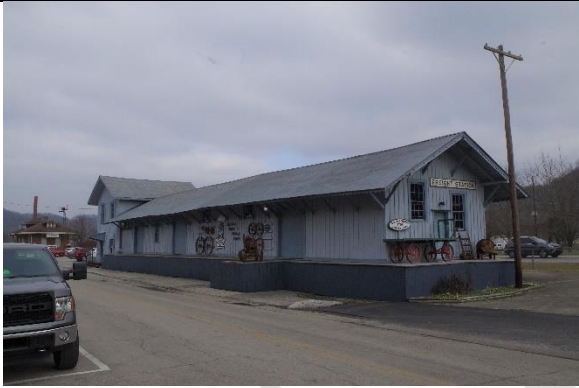
<p data-bbox="521 905 943 932">130 East First Street, looking northeast.</p>	<p>Built by the Elizabethtown, Lexington & Big Sandy Railroad, this freight station was constructed in 1880-81. The main section of this building is a single-story in height and has a gabled roof, with metal roof covering and elbow brackets support the overhanging roof eaves. The northern wing of the building is two-stories in height and has a front gable roof. The exterior is clad in board and batten siding. The windows are of wood sash construction with 6/6, 4/4, and 2/2 glazing patterns. A full-length loading dock, with three loading bays, is present on the west elevation. The building was listed on the National Register of Historic Places in 2016 (NRIS 1600013), as the Morehead Chesapeake and Ohio Railroad Freight Depot. Contributing.</p>

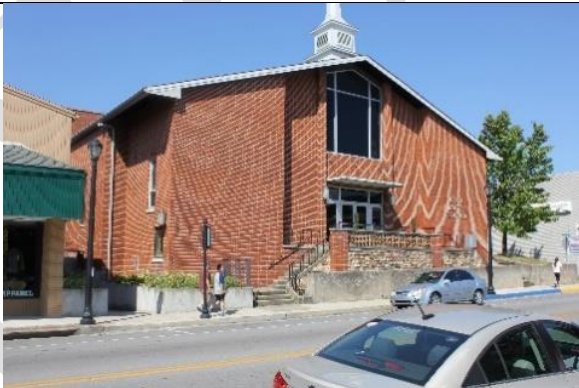
<p>FS 11/ RWM-124</p>

<p data-bbox="516 1535 948 1562">123 East Main Street, looking northwest.</p>	<p>The First Baptist Church features a front gabled roof, with an asphalt shingle roof covering. A short belfry, topped with a steeple, is located on the southeast section of the roof. The building's exterior is clad in brick veneer. The central bay entry features a set of metal frame double doors, with metal frame transoms and sidelights. This entry is covered with a metal awning. Above the awning is a large set of metal frame triple windows with triangular transoms. Single pane windows, with simulated light dividers, line the side elevations of the church and a three-story concrete block wing is located on the northwest elevation. This section of the building matches the main congregational section of the building in materials. This location was the site of the original First Baptist Church building, which was constructed in the early 1900s. The current building replaced the original wood</p>

Field Site No./KHC Number	Photo	Description
		<p>frame church in 1958. Contributing.</p>
<p>FS 12/ RWM-184</p>

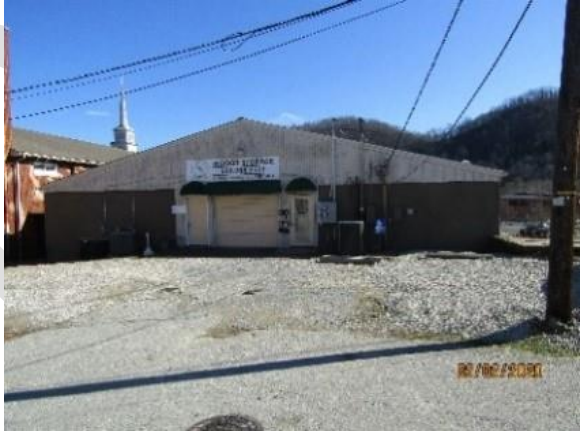
<p>114 Council Street (upper rear entrance), looking southeast.</p>	<p>Built-in 1962, this concrete block commercial building, features a front gabled roof with a metal and asphalt shingle roof covering. The building rests on a concrete block foundation, and the façade features a brick veneered storefront, with a recessed metal frame double entry, transoms, and sidelights. Large display windows fill out the rest of the storefront. A wood frame awning, with asphalt shingle covering, covers the full length of the storefront. Vertical wood panels are located on the awning's fascia and above the storefront. Currently, the main section of the building is the location of office space. Storage units are located on the rear second story section accessed from 114 Council Street. Contributing.</p>

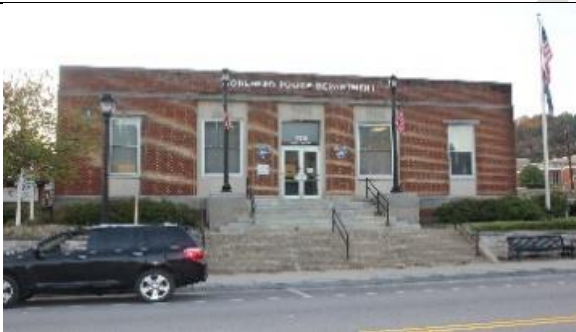
<p data-bbox="516 961 945 987">105 East Main Street, looking northwest.</p>	<p data-bbox="1045 632 1417 1346">This building was constructed in 1938 as a post office and is rectangular in form. This common bond brick building is a single-story in height and features a symmetrical façade with a W-W-D-W-W fenestration pattern. A parapet wall is located at the roof's cornice line and a decorative cast concrete band encircles the upper section of the building. The central bay double entry is of metal frame construction and is covered by a large single-pane transom. The windows are of vinyl sash construction with 3/3 light patterns, and are supported by cast concrete lintels and sills. A two sets of poured concrete and sandstone steps lead to the main entry, and are flanked by stone and brick retention landscape walls and a set if light poles. This WPA era building is currently the location of Morehead City Hall and Morehead Police Station.</p> <p data-bbox="1045 1346 1198 1371">Contributing.</p>

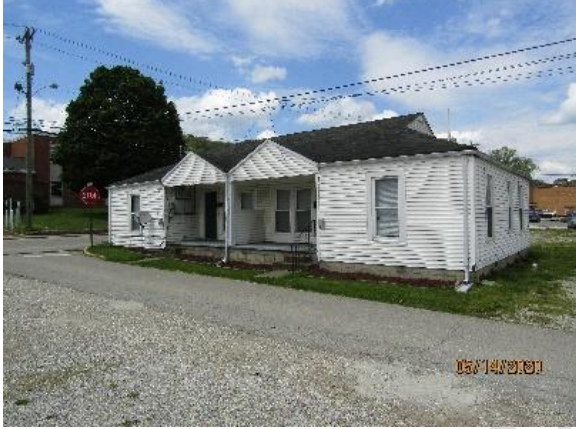
<p data-bbox="526 680 935 709">120-122 Maggard Place, looking north.</p>	<p>This circa 1940 frame residential duplex is a single-story in height, rectangular in form, and has a side gable and hip roof, with an asphalt shingle roof covering. Its exterior is clad in vinyl siding and the windows are of vinyl sash construction with 1/1 light patterns. The building rests on a concrete block foundation, and the façade features a recessed entry divided by a frame half-wall. A single-story addition is present on the northeast elevation; research indicates that a porch, located on the north corner, has been enclosed. Contributing.</p>
FS 18/ RWM-87

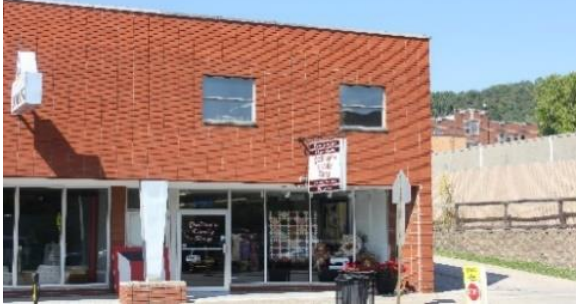
<p data-bbox="526 1024 935 1054">151 East Main Street, looking northwest</p>	<p>This circa 1962, stacked bond, brick veneer commercial building, is two-stories in height, has a flat roof, and is the northeastern section of a larger commercial building with a series of four total storefronts. The façade's second-story of the building, supported by reverse conical metal support posts, create a portico which covers the recessed storefront and walkway. The second-story windows are of metal sash construction, with 1/1 light patterns. The storefront consists of a metal frame single entry door and full-length, vertically aligned, four-pane metal frame display windows. Contributing.</p>

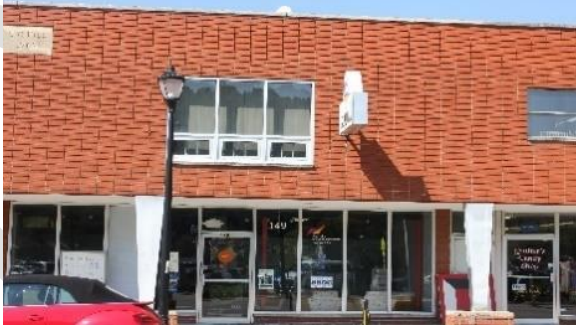
FS 19/ RWM-86

<p data-bbox="526 1566 935 1596">149 East Main Street, looking northwest.</p>	<p>This circa 1962, stacked bond, brick veneered commercial building, is two-stories in height, has a flat roof, and is the central, northeastern section of a larger commercial building with a series of four total storefronts. The façade of the second-story of the building, supported by reverse conical metal support posts, create a portico which covers the recessed storefront and walkway. The second-story windows are of metal frame construction, with a lower, three-light, hopper transom. The storefront consists of a metal frame single entry door with transom, and full-length, vertically aligned, four-pane metal frame display windows. Contributing.</p>

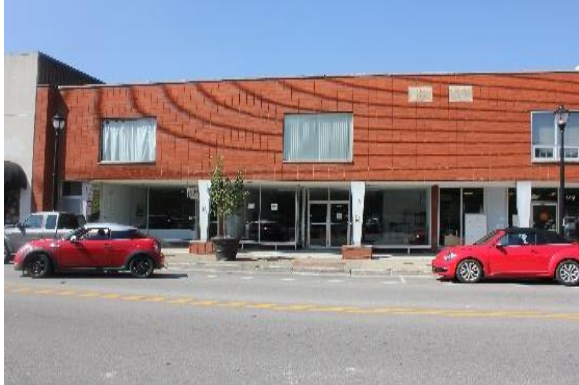
<p data-bbox="492 930 969 955">145-147 East Main Street, looking northwest.</p>	<p data-bbox="1044 548 1421 1119">This circa 1962, stacked bond, brick veneered commercial building, is two-stories in height, has a flat roof, and is the southwestern section of a larger commercial building consisting of a series of four storefronts. The façade of the second-story of the building, supported by reverse conical metal support posts, create a portico which covers the recessed storefront and walkway. The second-story fixed windows are of metal frame construction. The two storefronts feature metal frame single and double entry doors with transoms, and full-length, vertically aligned, metal frame display windows. This building was originally Western Auto Store. Contributing.</p>

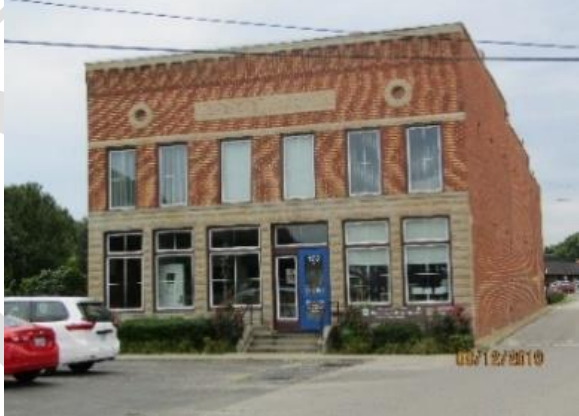
FS 22/ RWM-127

<p data-bbox="537 1570 924 1596">102 West First Street, looking south.</p>	<p data-bbox="1044 1157 1421 1877">Constructed circa 1904, this common bond brick commercial building is two-stories in height and rectangular in form. This resource has a flat roof that gently slopes toward the rear of the building. The façade's cornice features brick brackets. A carved stone sign plate, which reads "Morehead Grocery Co.," flanked by small enclosed round windows, is present above the second-story windows. The fixed windows are vinyl with 2/2 simulated light dividers. The façade's second-story windows have a carved stone belt course lintels and sills. The storefront windows are surrounded by carved stones. This building was the former location of the Morehead Grocery Company and then Union Grocery, which operated at this location from 1907-1972. These businesses served 10-12 counties in eastern Kentucky and most goods were delivered via the C&O Railway, as</p>

Field Site No./KHC Number	Photo	Description
		<p>there was a rail spur on the south side of the building. This resource currently houses the Kentucky Folk Art Center. Contributing.</p>
<p>FS 23/ RWM-83</p>

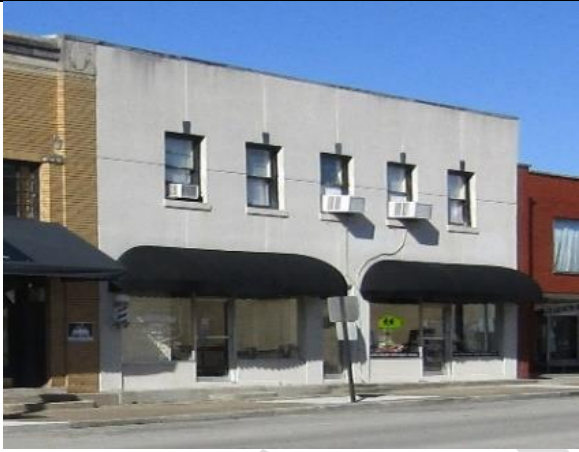
<p>141-143 East Main Street, looking northwest.</p>	<p>Constructed circa 1940, this two-story commercial building has two storefronts, originally used for retail, with residential units in the upper floor. The second-story windows are of wood sash construction with 1/1 glazing patterns. The two storefronts, which flank a central bay entry that leads to the upper floor, feature entries flanked by metal frame picture windows, and are covered by canvas awnings. Contributing.</p>
<p>FS 24/ RWM-81</p>

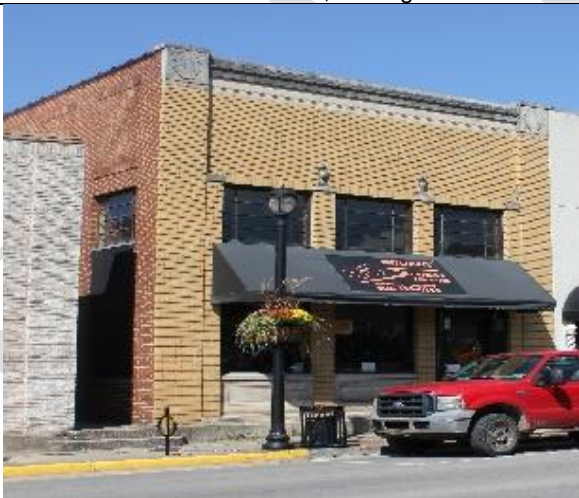
<p>139 East Main Street, looking northwest.</p>	<p>Constructed circa 1940, this commercial building is two-stories at the northeast section and a single-story at its southwestern section. Its exterior is clad in a brick veneer and the façade features a decorative light brick veneer. The storefront features Beaux Arts elements including a cast concrete cornice line with end caps featuring a decorative sunburst motifs, and brick pilasters capped with cast concrete urns, which separate the store front windows and entry. The façade's upper level, multi-pane display transoms are of fixed metal construction. The second-story windows on the southwest elevation are infilled with brick. Originally constructed as a bank, this building is now the location of a retail business. Contributing.</p>

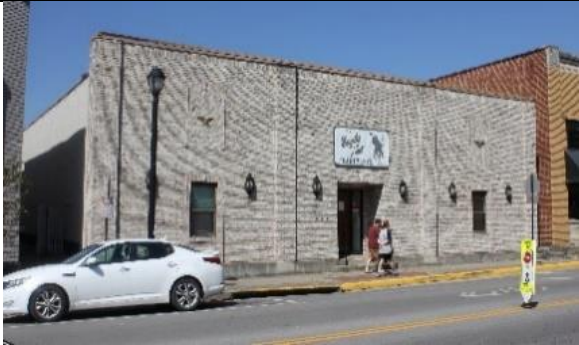
<p>FS 25/ RWM-80</p>

<p>This concrete block commercial building is currently used as residential apartments. It is rectangular in form and features a flat roof. A brick veneer is present on its façade and features brick pilasters and a central bay entry. Small windows are located in the left and right bays of the façade. Second-story faux-window openings give the impression they were enclosed with bricks laid out</p>

<p>in a chevron pattern. The original use was 5 & 10 Store. Readapted for apartment living with some alterations. Contributing.</p>
<p>FS 26/ RWM-136</p>

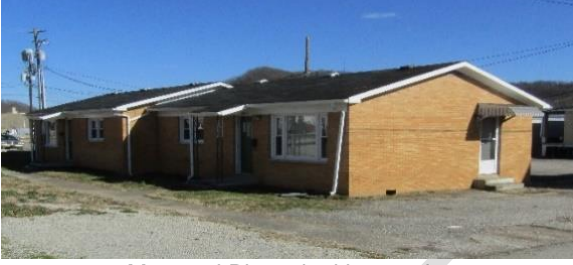
<p>114 Maggard Place, looking northeast..</p>	<p>This single-story residential duplex was constructed circa 1965. Its side gabled roof has an asphalt shingle roof covering and its exterior is clad in a brick veneer. The windows throughout are of vinyl sash construction, with 1/1 light patterns. A shed roof entry covering is located at each unit's façade entries. Contributing.</p>
<p>FS 27/ RWM-97</p>

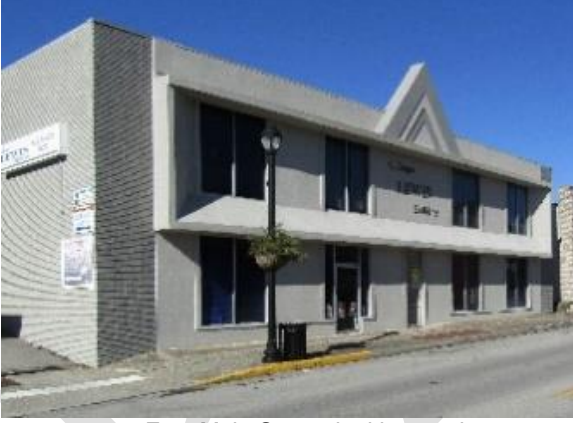
<p>129 East Main Street, looking north.</p>	<p>Constructed in 1966, this commercial building is clad in a brick veneer and the façade features a modern stucco finish. The façade windows are fixed with single or double panes of glass. No windows openings are present on the side elevations. Noncontributing</p>

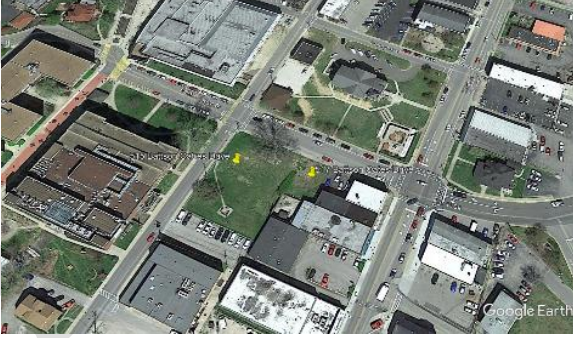
<p>FS 28/ RWM-163</p>

<p>515 Battson Oates Drive</p>	<p>This vacant lot is the former location of the Morehead State faculty house, which was demolished circa 2015.. Noncontributing.</p>

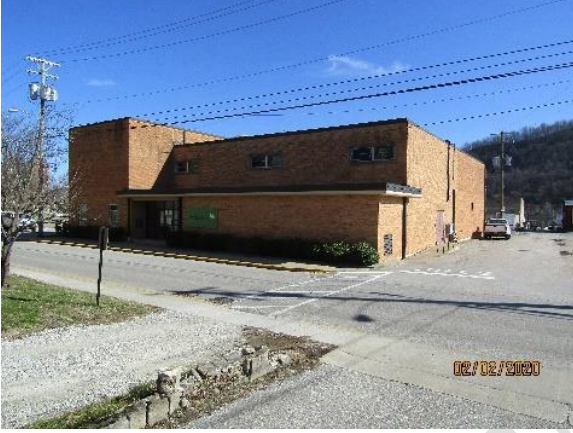
<p data-bbox="527 682 933 703">150 East Second Street, looking east.</p>	<p>The building was constructed for General Telephone circa 1958-60 in the contemporary style. Two-stories in height, the building has a brick veneer and very little exterior decorative ornamentation. Its Second Street fronting façade features a recessed entry with an eight-light picture window with transoms and single full-glass entry. It has a flat roof and its paired second-story awning windows have metal frames. The first-story hopper windows have four, horizontally oriented, window panes. This building currently houses the centralized communication infrastructure for Northeast KY. Contributing.</p>
FS 30/ RWM-164

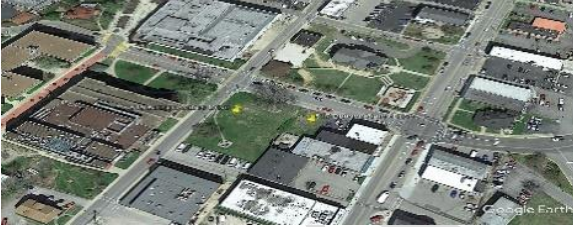
<p data-bbox="592 997 868 1018">517 Battson Oates Drive.</p>	<p>Vacant lot. Former location of the law office of Allie Young. The previous building was demolished in 2014 due to neglect. Noncontributing.</p>

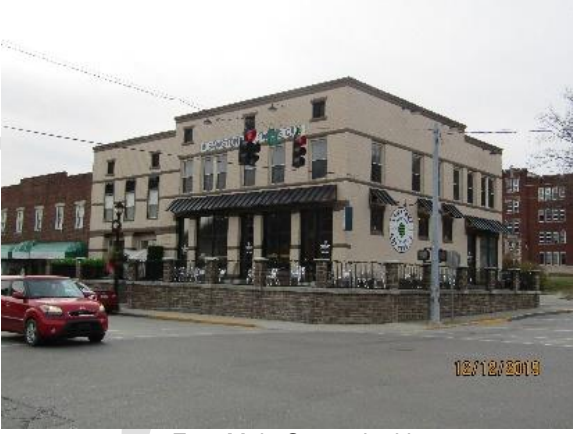
<p data-bbox="511 1459 950 1480">173-175 East Main Street, looking west.</p>	<p>The "COZY" Building was built in 1915. Constructed of sawn limestone block, this site has the stone foundation and timbers from the original Judge Carey House (1856). This building is two stories in height, features a brick veneer, and has a flat roof with parapet wall. Limestone belt courses are preset at the cornice line and above and below the second-story windows. The second-story windows have 1/1 light patterns. The first story windows have fixed metal frames. The storefront features a right bay single, full-light, entry and full length display windows with fixed metal frames. An elevated concrete block walkway, with a stone veneer, surrounds the façade and northeast elevation of the resource. Rehabilitation was completed in 2019 adapting the building to accommodate a micro-brewery, returning this corner of Main St to its prominent status downtown. Contributing.</p>

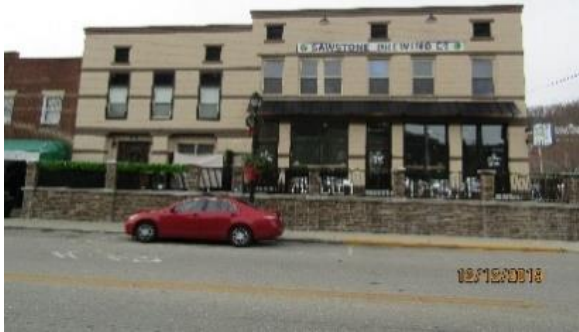
<p data-bbox="516 646 945 674">171 East Main Street, looking northwest.</p>	<p>Part of the original “COZY” Building, this southwest side, constructed in 1915, originally was the location of the Cozy/Mill theater for many years. Like resource RWM-2A, this building is also constructed of sawn limestone with a cut limestone foundation, and features an exterior brick veneer. The façade’s original double entry has been infilled with brick and modern doors and windows. The façade’s second story window openings have been enlarged and sash windows with 1/1 light patterns are installed. A raised concrete block walkway, with stone veneer, is present on the façade elevation. The slanted floor of the theater can still be seen in the basement today. This building was adapted to upscale living, completed in the spring of 2019. Contributing.</p>

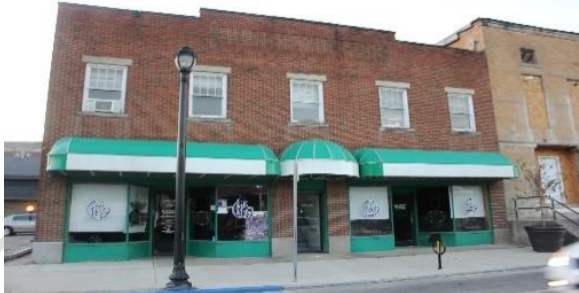
<p data-bbox="516 1220 945 1247">169 East Main Street, looking northwest.</p>	<p>Constructed in 1956, this two-story commercial building is veneered in brick, and has a flat roof with a parapet wall, capped with cast concrete coping. The façade features two recessed storefronts that flank a single entry which leads to the second-story. The storefront’s picture windows have fixed metal frames. The second story windows are of wood sash construction with 8/1 glazing patterns. This building was originally designed and operated as a Hardware store for many years. Rehabilitated in the early 1990s for restaurant and entertainment business. Contributing.</p>
FS 34/ RWM 70

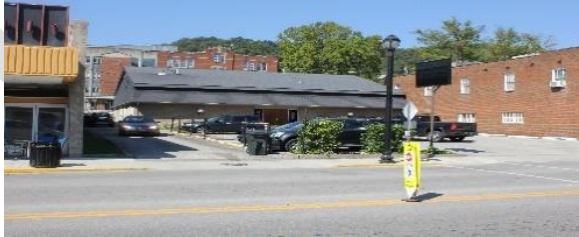
<p data-bbox="493 1675 971 1703">163-165 East Main Street, looking northwest.</p>	<p>This single-story, wood frame building has a brick veneer. Its shallow pitched side gable roof has an asphalt shingle roof covering, and a wood frame awning covers the façade. This building is set back significantly from Main Street and has a front parking lot. Currently it is the location of a professional medical office. Noncontributing.</p>

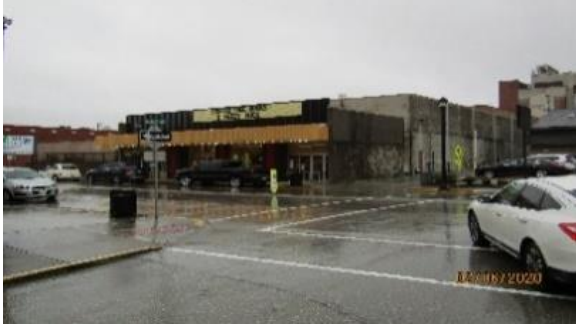
Field Site No./KHC Number	Photo	Description
FS 35/ RWM-88

<p data-bbox="542 575 919 604">159 East Main Street, looking west.</p>	<p data-bbox="1042 247 1419 604">This 1968 building was the former location of the Morehead Cinema. A single-story in height this concrete block building has a stucco veneer. The façade features decorative cast concrete pilasters, metal frame picture windows, and two double entries. An awning runs the length of the façade and is topped with a marquee. This building has been adaptively reused as a coffee shop and book store in 2010.</p> <p data-bbox="1042 604 1198 632">Contributing.</p>
FS 36/ RWM-169

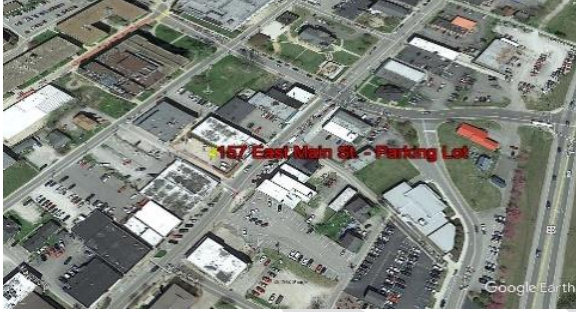
<p data-bbox="613 947 847 974">157 East Main Street.</p>	<p data-bbox="1042 632 1419 827">This surface parking lot is on the western side of main street. Stone fence posts and a metal fence is located on the western, Main Street fronting side of the lot. Currently this parking area is dedicated to Windstream.</p> <p data-bbox="1042 827 1240 854">Noncontributing.</p>

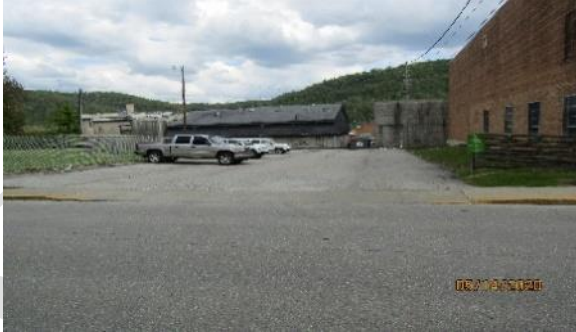
FS 37/ RWM-165

<p data-bbox="529 1304 932 1331">154 East Second Street, looking east.</p>	<p data-bbox="1042 968 1419 1058">This concrete paved surface parking lot is currently leased as a parking area for Windstream.</p> <p data-bbox="1042 1058 1240 1085">Noncontributing.</p>
FS 38/ RWM-94

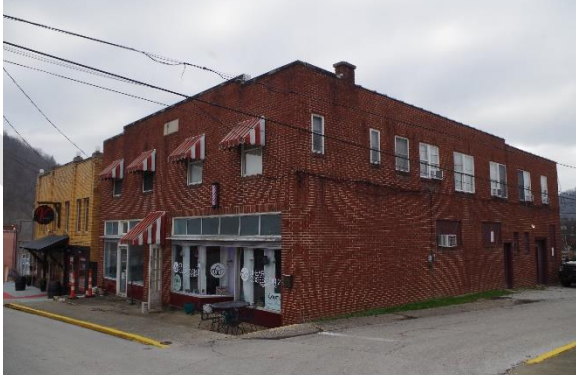
<p data-bbox="500 1709 964 1766">111-113-115 North Wilson Avenue, looking southwest.</p>	<p data-bbox="1042 1331 1419 1881">This circa 1940 two-story, brick veneer commercial building has two storefronts, flanking a central bay entrance which leads to the second-floor units. It has a flat roof with a parapet wall, which has a false front on the façade's cornice. The right bay storefront entrance is recessed and both storefronts have a central storefront entrance with flanking display windows and full storefront transoms. All of the first-floor windows, not including the storefront, are infilled with wood panels and the second-floor windows are of sash construction with 1/1 light patterns. Metal awnings cover the façade second-story windows and central entrance. Contributing.</p>

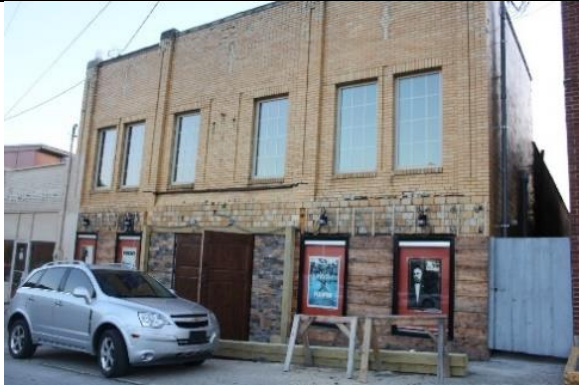
Field Site No./KHC Number	Photo	Description
FS 39/ RWM-93

<p data-bbox="488 917 972 947">109 North Wilson Avenue, looking southwest.</p>	<p data-bbox="1044 533 1401 915">Built-in 1928, this building constructed as the Midland Trail Theater, by municipal pioneer Ed Maggard, and operated into the late 1970s. This clay fire block building is two-stories in height and has a brick veneer on the façade. The façade's second-story, twelve-light windows have fixed frames, and are separated into pairs by four brick pilasters with end caps. This building has been converted into an entertainment venue in 2018.</p> <p data-bbox="1044 917 1195 947">Contributing.</p>
FS 40/ RWM-92

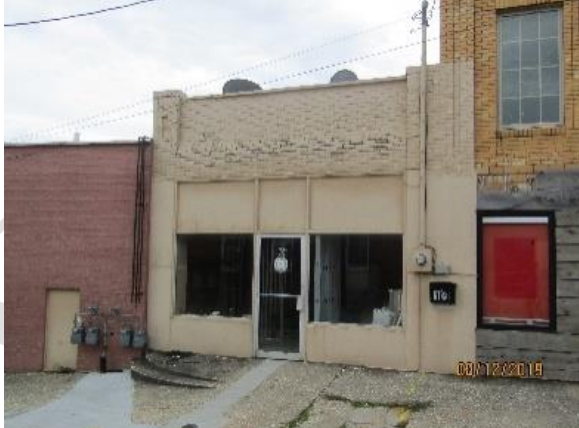
<p data-bbox="488 1375 972 1402">107 North Wilson Avenue, looking southwest.</p>	<p data-bbox="1044 949 1401 1247">This resource is a circa 1940, single-story, brick veneer commercial building. Its flat roof features a parapet wall with paired brick brackets on façade's cornice ends. The storefront features a central entry flanked by single-pane display windows. The storefront transoms are enclosed. Currently, this building is undergoing a renovation.</p> <p data-bbox="1044 1249 1195 1278">Contributing.</p>

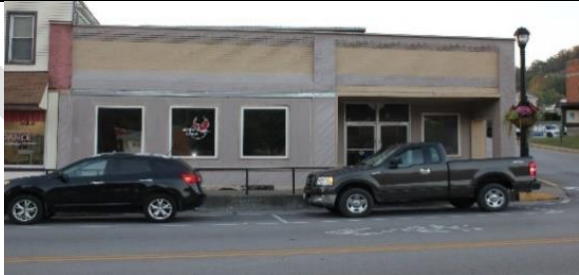
FS 41/ RWM-119

<p data-bbox="511 1677 950 1707">101 West Main Street, looking northwest.</p>	<p data-bbox="1044 1404 1401 1898">Constructed circa 1940, this single-story commercial building's exterior is clad with a brick veneer. The flat roof features a corbeled cornice line on the façade which is divided into two sections by two end brick pilasters and a central brick pilaster. The façade features two commercial storefronts. Both storefronts have been modified and the right bay storefront is recessed, featuring a double entry and display window. It is unknown if this recessed storefront is a later modification. The left storefront has been enclosed and features three fixed windows and offset wood paneling. This storefront</p>

Field Site No./KHC Number	Photo	Description
		<p>modification is due to combining the two separate commercial units into a single commercial unit. This resource's use is historically associated with a family operated department store. Noncontributing.</p>
<p>FS 42/ RWM-90 and RWM-106</p>

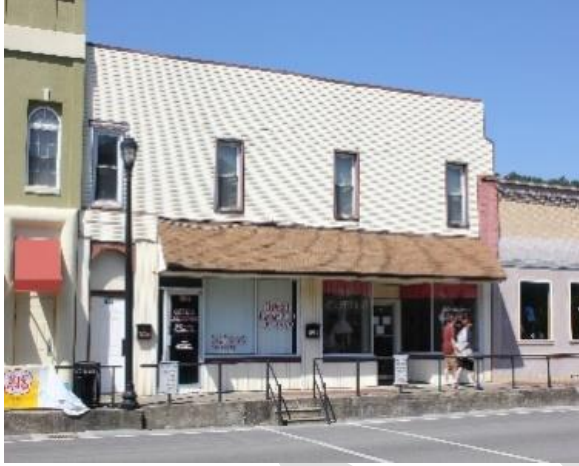
<p>103-105 West Main Street, looking northwest.</p>	<p>Constructed in 1939, this two-story commercial building is rectangular in form and features a false front. The building has a brick veneer. The building features two storefronts and a left bay entrance which leads to the second-story units. The façade's second-story has vinyl sash windows with 1/1 light patterns. The right bay storefront has a recessed entry, with enclosed transom, flanked by large single-pane display windows. The left bay storefront has a side entrance with pair of display windows. The bulkheads are enclosed with vertical vinyl siding. A wood frame shed awning covers the storefronts. Contributing.</p>

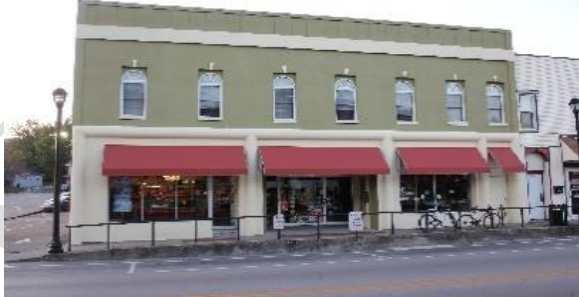
<p>FS 43/ RWM 75 and RWM-117</p>

<p>109-111 West Main Street, looking northwest.</p>	<p>This circa 1925 commercial building, is two-stories in height and features two commercial spaces. Evidence suggests this building may have had three commercial units, but the two right units have been combined into a single unit. This building has a brick veneer. Its façade has a stucco finish, and the southwest elevation is clad in vertical metal panels. The façade's second story windows are of vinyl sash construction with 6/6 light patterns, and feature arched transoms with sunburst light patterns and keystones. The southwest elevation windows are of vinyl sash construction, with 1/1 light patterns. The storefront's entries and display windows are of single-pane metal frame construction. Contributing.</p>

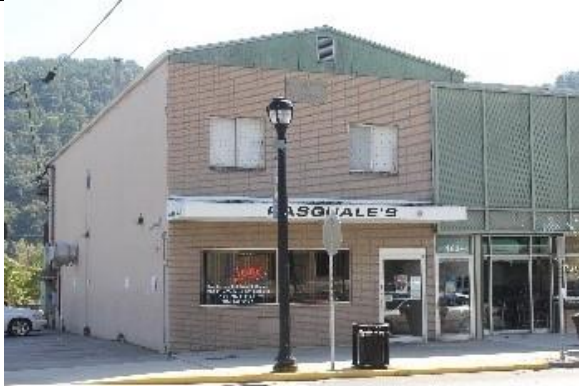
Field Site No./KHC Number	Photo	Description
FS 44/ RWM-78

<p data-bbox="516 636 945 663">182 East Main Street, looking southeast.</p>	<p data-bbox="1044 247 1409 716">This 1964, two-story, concrete block commercial building has a brick veneer on its façade. This resource has a shallow pitched, front gabled roof addition. The storefront features a right bay entry and two metal frame display windows. The façade's second-story, single light, two sliding windows are of metal frame construction. A single small slider window is present on the second-story of the northeast elevation. Eight parking spaces on the northeast side. For 62 years, this has been the location of Pasquale's Restaurant.</p> <p data-bbox="1044 716 1198 741">Contributing.</p>
FS 45/ RWM-103

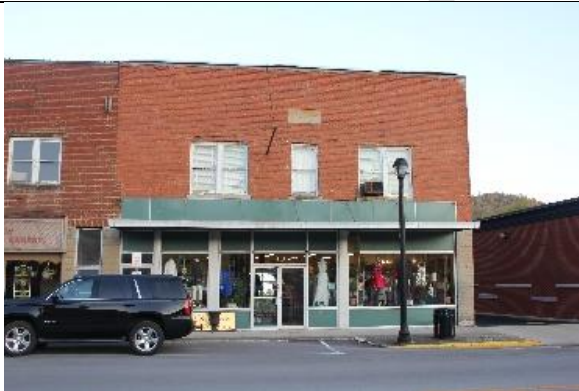
<p data-bbox="516 1136 945 1163">110 West Main Street, looking southeast.</p>	<p data-bbox="1044 741 1409 1318">Constructed in 1926 by J.A. Allen, this commercial building housed Allen's Meat Market and the first IGA grocery in town. The exterior of this building is clad in a brick veneer and features a flat roof. The façade features a single storefront with a central double entry, flanked by paired display windows. The storefront transoms, bulkheads, and cornice have a metal panel veneer, and are covered by a full metal frame awning. An entry, which leads up to the second-story units, is present on the façade's left bay. The second story windows throughout are of wood sash construction with 1/1 glazing patterns. Currently, the building is the location of a clothing boutique.</p> <p data-bbox="1044 1318 1198 1348">Contributing.</p>

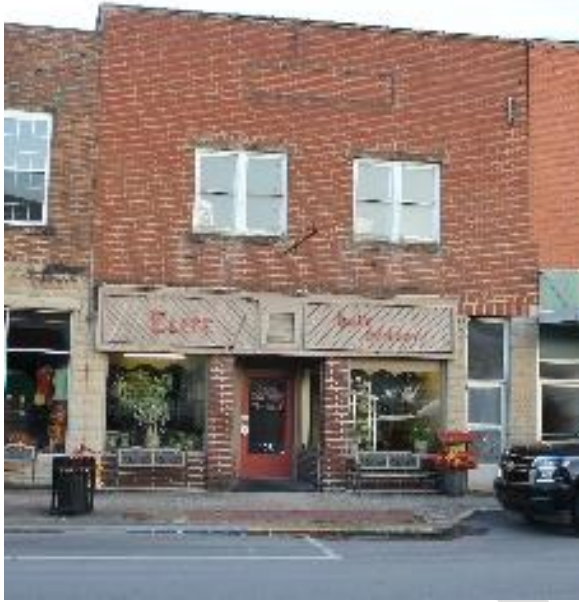
<p data-bbox="513 877 948 898">108 West Main Street, looking southeast.</p>	<p>Constructed circa 1920, this two-story commercial building is of brick construction. The building features a flat roof. The façade's storefront has a recessed entry, flanked by single pane display windows. The bulkheads and pilasters have been veneered in brick. The storefront's exterior pilasters are of carved sandstone. The storefront transoms are covered with a wood storefront sign. A single entry, which leads up to the second-story units, is present on the façade's right bay. The façade's paired second-story windows are of wood sash construction, with 1/1 light patterns. Currently the building is the location of a beauty salon. Contributing.</p>
FS 47/ RWM-105

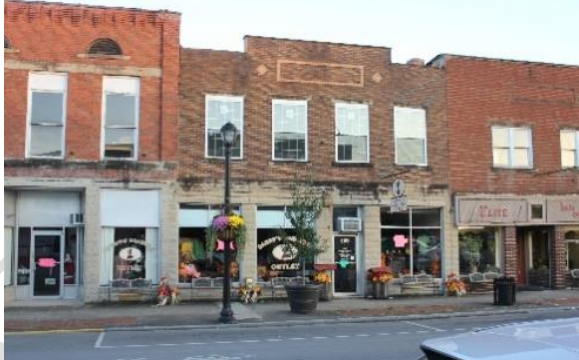
<p data-bbox="488 1266 972 1287">104-106 West Main Street, looking southeast.</p>	<p>Built circa 1920, this two-story brick commercial building was originally a single-story. The second-story was added in the 1940s. Its flat roof features a parapet wall with central false front on the façade. The storefront surround features a carved sandstone veneer, and an offset single entry, flanked by two-light display windows with transoms. The façade's second-story windows are of vinyl sash construction with 12/12 light patterns and the cornice line features an inset decorative brick sign boarder, flanked by inset brick diamonds. This building was originally the location of a hardware and paint store. Contributing.</p>

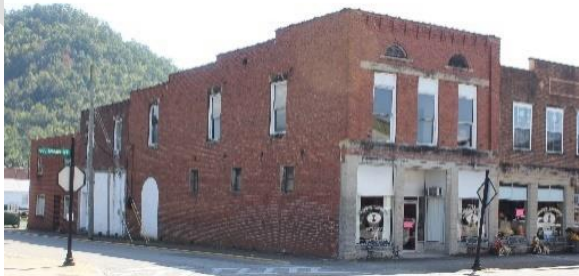
FS 48/ RWM-60

<p data-bbox="537 1770 924 1791">102 West Main Street, looking south.</p>	<p>Constructed circa 1900, this two-story commercial building is one of Morehead's oldest extant commercial buildings. The building's brick framing is of common bond and features a flat roof with capped parapet wall. Its façade is framed by full length brick pilasters, and brick brackets are located on its cornice line. The storefront surround is of carved stone and has a recessed entry, flanked by single pane display windows with transoms. The second-story windows are of wood</p>

Field Site No./KHC Number	Photo	Description
		<p>sash construction with, 1/1 light patterns, and belt courses serve as lintels and sills. A pair of half-arched windows, with stone sills and louver vents, are located below the façade's cornice line. The northeast elevation features an additional storefront addition on the left bay, and an enclosed, arched, secondary entrance which possibly leads to the second-floor units. The second-story windows on this elevation match the façade's second-story windows in design and materials, and the first story windows are four light, single sash, wood casements. This building was originally occupied by the Blair Wholesale Company. Later housed Perry Hardware and Kentucky Food Stamp Offices. Currently, it is the location of an antique store. Contributing.</p>
<p>FS 49/ RWM-121</p>	  <p data-bbox="492 1255 971 1283">121 South Wilson Avenue, looking northeast.</p>	<p>Built circa 1965, this professional office duplex is one-and-a-half stories in height and has a brick veneer. Its hipped roof has an asphalt shingle roof covering. The façade features two protruding flanking bays. The windows throughout are of sash construction with 6/6 light patterns. Vinyl siding is present on the central bay of the façade's second-story. Contributing.</p>

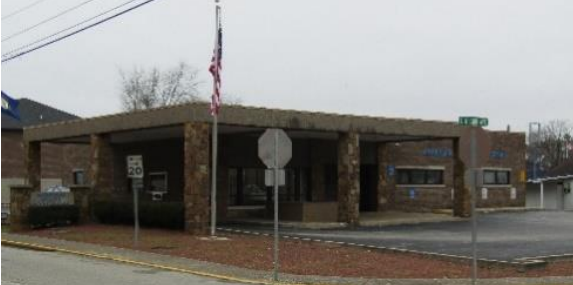
Field Site No./KHC Number	Photo	Description
FS 51/ RWM-123

<p data-bbox="495 541 966 567">135 South Wilson Avenue, looking southwest</p>	<p data-bbox="1047 252 1421 546">This single-story building was constructed circa 1980. Its exterior is clad in a brick veneer, and features single pane windows throughout, with metal frames. A drive through/awning is present on its east corner, which is supported by stone veneered posts. This building is currently used as the Morehead Utility Plant Board Administrative Offices.</p> <p data-bbox="1047 552 1242 577">Noncontributing.</p>
FS 52/ RWM-77

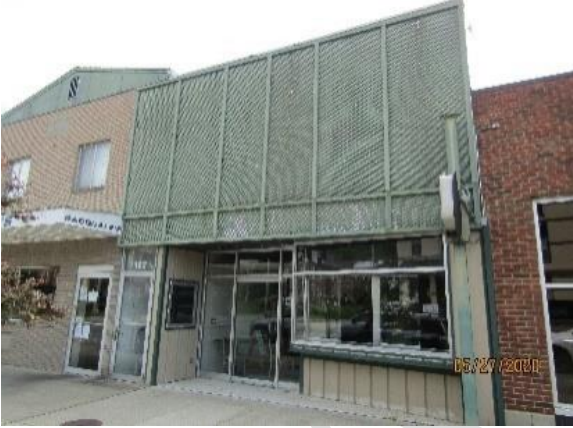
<p data-bbox="544 1014 917 1039">180 East Main Street, looking east.</p>	<p data-bbox="1047 583 1421 997">Constructed circa 1968, this concrete block commercial building is two-stories in height. The façade's second-story has vertical metal panel cladding. The recessed storefront features an off-centered entrance with sidelights and transoms. A left bay entrance leads to the upper level of the building, and the right bay has two display windows and a single transom. The commercial space was originally the location of a jewelry store. It is currently used as a restaurant. Contributing.</p>
