United States Department of the Interior
National Park Service
National Register of Historic Places Registration Form

Historic name: Downtown Morehead Historic District

Downtown Morehead Historic District

Rowan County,
Kentucky
County and State

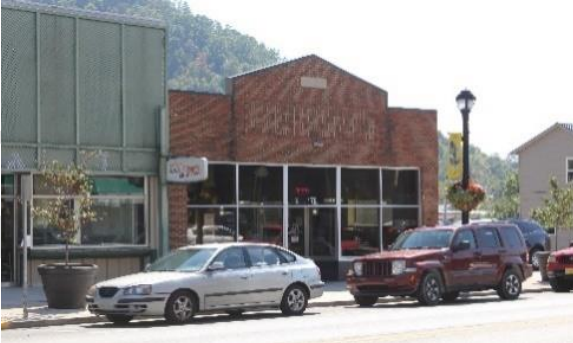
FS 53/ RWM-76

<p data-bbox="511 1381 950 1407">178 East Main Street, looking southeast.</p>	<p data-bbox="1047 1035 1421 1522">Built circa 1940, this single-story commercial building is of concrete block construction with a brick veneer. This building is rectangular in form and had a flat roof with a parapet wall and a false front at the cornice of the façade. The storefront features a recessed double entry, flanked by pairs of metal framed display windows and transoms. The southwest elevation features two metal framed fixed windows and two secondary entrances. This building has served the city as the Greyhound Bus Stop and Restaurant for many years. Also as retail outlet and salon. Contributing.</p>

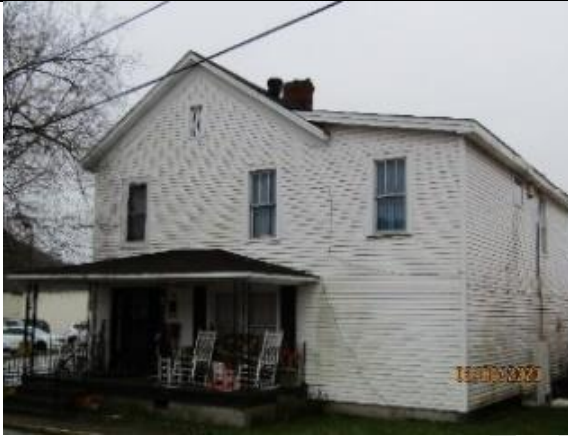
<p data-bbox="548 680 915 709">115 Bishop Avenue, looking south.</p>	<p>This resource is a circa 1940, two-story frame residence. The façade has W-D-W fenestration pattern, and its roof is cross gabled, with an asphalt shingle roof covering. Two-story frame additions, with shed roofs, are located on the northwest and southwest elevations. The windows are of wood sash construction, with 3/1 light patterns, and it rests on a concrete block foundation. The façade features an entry porch with a hip roof, and rests on a concrete block foundation. This porch has decorative metal columns and a metal balustrade. A two-story concrete block garage is located to the rear of the property and appears to serve a commercial or residential function. Contributing.</p>
FS 55/ RWM-181

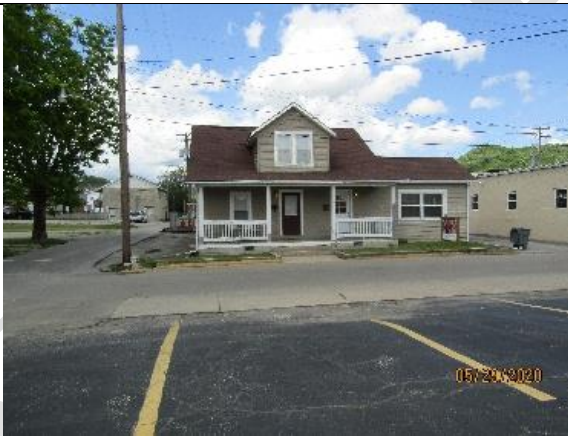
<p data-bbox="532 1283 932 1312">128 Carey Avenue, looking northeast.</p>	<p>This resource is a circa 1940, one-and-a-half-story Bungalow. Its façade features a W-D-D-W fenestration pattern, and its side gabled roof has an asphalt shingle roof covering. Its exterior is clad in vinyl siding and a large, front gabled, roof dormer is present on the façade. Vinyl sash windows, with 1/1 light patterns, are present throughout. The building rests on a concrete block foundation. An entry porch is located in its façade. This porch has a shed roof, supported by wood posts and a wood balustrade. A single-story frame addition is present on its northeast elevation. This resource is currently used as a hair salon. Contributing.</p>

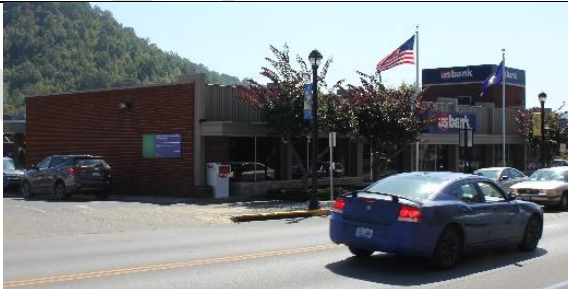
<p data-bbox="539 1688 925 1717">122 East Main Street, looking south.</p>	<p>Constructed in 1957, this single-story commercial building is constructed of reinforced concrete with a brick veneer. The façade is lined with seven sets of fixed metal frame windows and vertical metal panels, separated by protruding reinforced concrete pilasters. A two-story, brick veneer addition is present on the southeast elevation, and two three-bay drive-thru, one freestanding, is present on the southeast elevation. Opened as The Peoples Bank in 1957, this building is currently used as a US Bank branch. Contributing.</p>

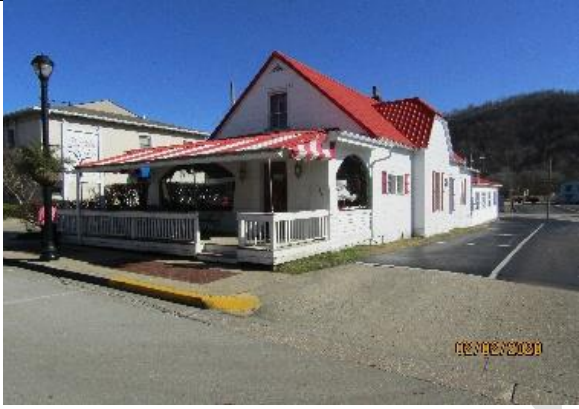
<p data-bbox="545 653 915 678">134 East Main Street, looking east.</p>	<p>Constructed circa 1940, this frame building is one-and-a-half-stories in height. Its roof is cross gabled, with a metal panel roof covering. Its exterior is clad in asbestos tile siding, and rests on a concrete block foundation. The façade features an enclosed entry porch with segmental arched opening, and a metal frame awning and patio. The windows are of wood sash construction, with 2/2 light patterns. This resource was converted from a residence to a doctor's office, and is currently used as commercial restaurant business. .</p> <p>Contributing.</p>
FS 58/ RWM-82

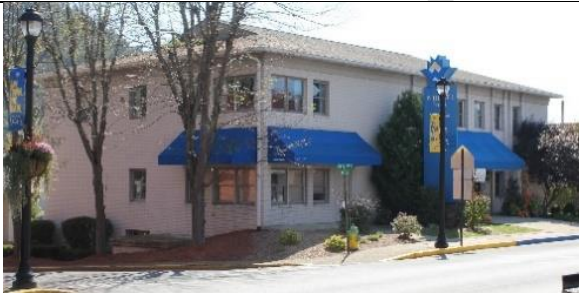
<p data-bbox="537 1031 924 1056">140 East Main Street, looking south.</p>	<p>This two-story commercial building/professional office was constructed in 1985 on the former site of the historic William Young House. Constructed of concrete block, this building has a brick veneer. It hipped roof, with a gable cap, has an asphalt shingle covering. The façade features a central bay recessed entry, covered by a canvas metal frame awning, and the windows are of sash design, with 1/1 light patterns. Currently this building is the location of a financial institution. Noncontributing.</p>

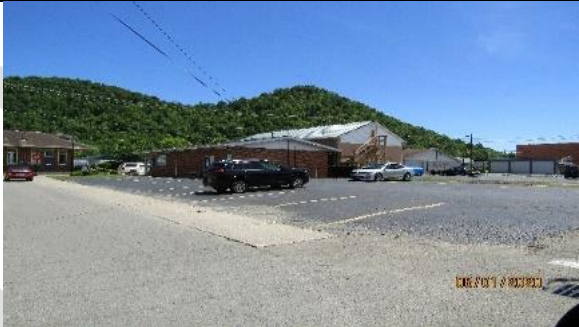
FS 59/ RWM-37

<p data-bbox="540 1507 920 1533">143 East First Street, looking south.</p>	<p>This 1967 commercial building is a single-story in height, and has a shallow pitched front gabled roof, with a metal roof covering. The exterior of the resource is clad in a brick veneer. The entry is located on the northeast corner of the building, and consists of a single entry and three display windows. Currently the building is used as office suites. Contributing.</p>

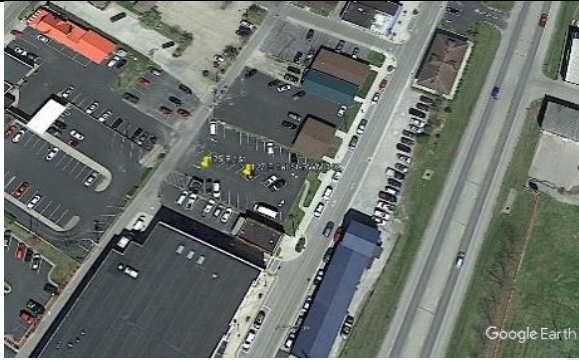
Field Site No./KHC Number	Photo	Description
FS 64/ RWM-142

<p data-bbox="597 604 863 630">125-127 East First Street.</p>	<p data-bbox="1044 247 1422 331">This resource is a paved surface parking lot owned by City of Morehead. Noncontributing.</p>
FS 65/ RWM-34

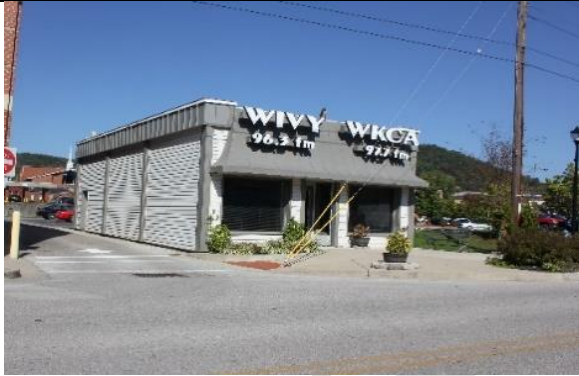
<p data-bbox="521 1003 940 1029">123 East First Street, looking northwest.</p>	<p data-bbox="1044 630 1422 961">This circa 1940, single-story, commercial building is of concrete block construction. It has a flat roof and its exterior is clad in vinyl siding. The roof's cornice is clad in metal flashing. The storefront features a recessed entry, flanked by single pane picture windows. A full-length metal awning covers the storefront. Currently, this resource is used as an office building. Contributing.</p>
FS 66/ RWM-128

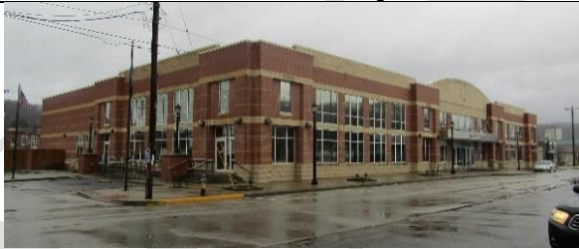
Field Site No./KHC Number	Photo	Description
FS 67/ RWM-84

<p data-bbox="521 1276 940 1302">111 East First Street, looking northwest.</p>	<p data-bbox="1044 1029 1422 1690">Constructed in 2008, this resource serves as the Morehead Conference Center. This two-story building is of concrete block construction and its exterior is clad in a brick veneer. Its flat roof features a parapet wall and arched false front is located above the façade's main entry, which is covered by a metal frame awning. The roof's cornice features brick corbeling and stucco finishes. The façade and southwest elevation features a series of fixed metal frame windows, and the façade's full glass entry features transoms and single doorways, which flank a revolving door. Protruding sets of brick pilasters are symmetrically located throughout the façade and southwest elevation. The foundation of the resource has a rusticated block veneer, Noncontributing.</p>

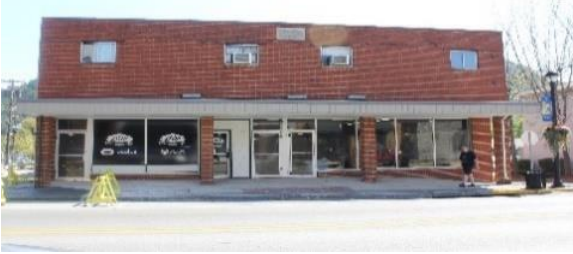
FS 68/ RWM-158

<p data-bbox="511 514 950 546">146 East Main Street, looking southeast.</p>	<p data-bbox="1047 252 1421 829">Constructed in 1969, this resource is two-stories and height, and its exterior is clad in a brick veneer. Its northeast elevation is clad in vertical metal panel siding. This building has a flat roof. Two storefronts are located on the first floor and residential units are on the second. The storefronts have single pane, metal picture windows and metal frame glazed entry doors. A full-length flat awning, supported by four brick veneered posts, create a covered portico. The second story features vinyl, single light, slider windows. An exterior stair well, leading to the basement level, is located on the southwest elevation. This resource's original use was a commercial department store.</p> <p data-bbox="1047 829 1193 850">Contributing.</p>

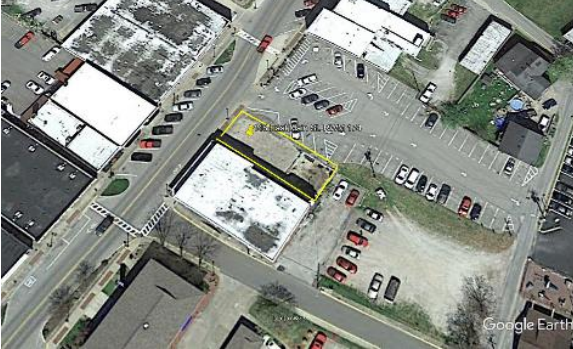
<p data-bbox="609 1207 852 1239">148 East Main Street.</p>	<p data-bbox="1047 861 1421 997">This resource includes a gravel lot and the remnants of a below grade foundation of a former building. This property is currently owned by the City of Morehead.</p> <p data-bbox="1047 997 1242 1018">Noncontributing.</p>
FS 69/ RWM-157

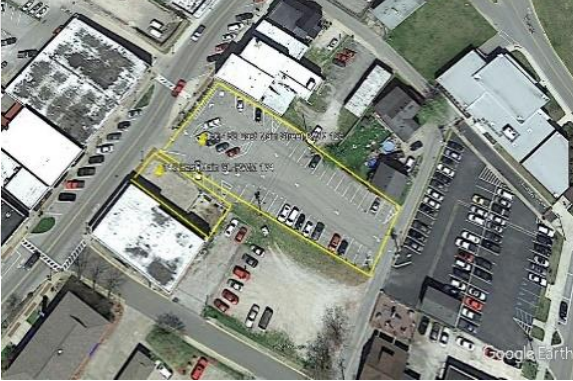
Field Site No./KHC Number	Photo	Description
FS 70/ RWM-89

<p data-bbox="592 1627 868 1659">150-158 East Main Street.</p>	<p data-bbox="1047 1239 1404 1323">This resource is a paved surface parking lot owned by the City of Morehead.</p> <p data-bbox="1047 1323 1356 1344">Noncontributing.</p>

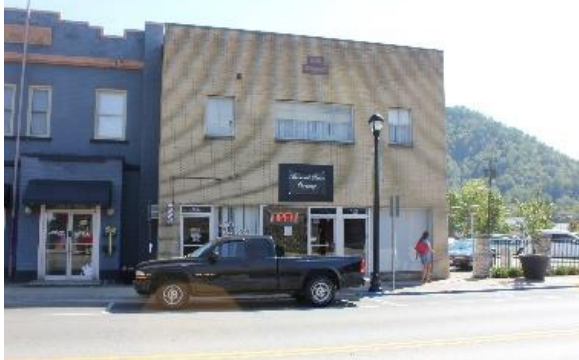
<p data-bbox="495 632 966 657">162-164 East Main Street, looking southeast</p>	<p>Constructed in 1959, this two-story, concrete block commercial building has an offset running bond brick veneer. Rectangular in form, the resource has a flat roof with a parapet wall. The façade features two storefronts. The left bay is a single commercial unit and features a side entrance with transom, and a full-length display window. The center and right bays are a single commercial unit with a double entry with transoms, flanked by full length display windows. The right bay of this storefront is covered by a canvas awning. The second story of the façade features a large vinyl picture windows flanked by vinyl slider windows. Vinyl slider windows are also present on the second floor of the southwest elevation. Contributing.</p>
FS 71/ RWM-71

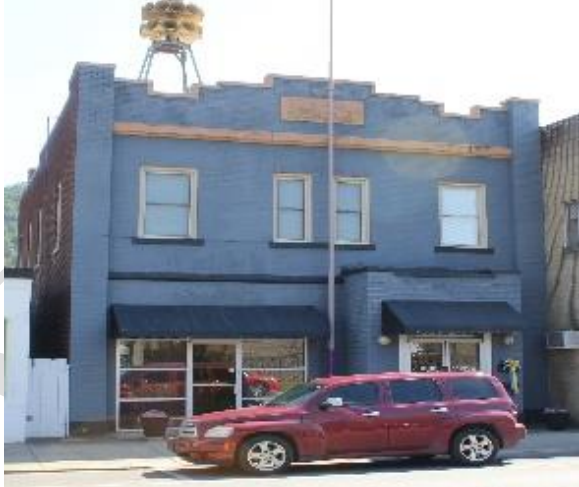
<p data-bbox="516 1394 945 1419">168 East Main Street, looking southeast.</p>	<p>Built in 1927 as Morehead's City Hall, Judge's Office, and Volunteer Fire Department, this building is of brick, common bond construction. The two-story building is rectangular in form and features a flat roof, with a parapet wall. The façade has a stepped false front with inset stone sign plate which reads "City Hall, 1927." A circa 1945 single-story concrete block addition is located on the rear elevation. Evidence suggests the façade's left bay garage, formerly used by the fire departments, has been enclosed with a metal frame storefront. A single-story vestibule is located on the façade's right bay, and provides access to the upper level units. The façade second-story windows are of sash construction, with 1/1 light patterns. The city sold this building in the 1990s after the municipal offices were relocated. Recently this building has been adaptively reused for residential units on the second floor and commercial units at the ground level. Contributing.</p>

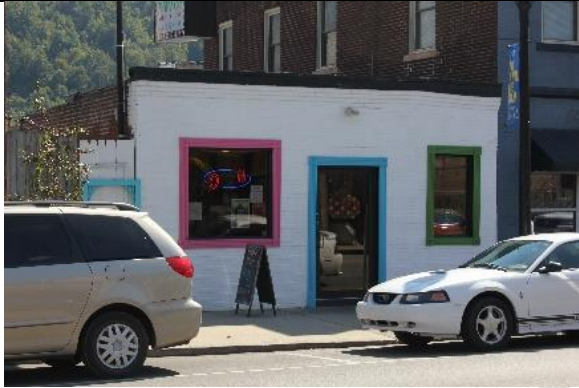
<p data-bbox="516 632 945 659">170 East Main Street, looking southeast.</p>	<p data-bbox="1044 247 1417 659">This resource is a circa 1935, single-story, brick and concrete block commercial building. The current building replaced an earlier single-story frame office building. Its flat roof has a parapet wall, with brick corbeling at the façade's cornice line. The storefront features a central bay entrance, flanked by two, fixed-frame, picture windows. This building has been previously used as a restaurant, antique shop, and now a specialty store after being adapted for re-use in 2011.</p> <p data-bbox="1044 659 1198 688">Contributing.</p>
FS 73/ RWM-74

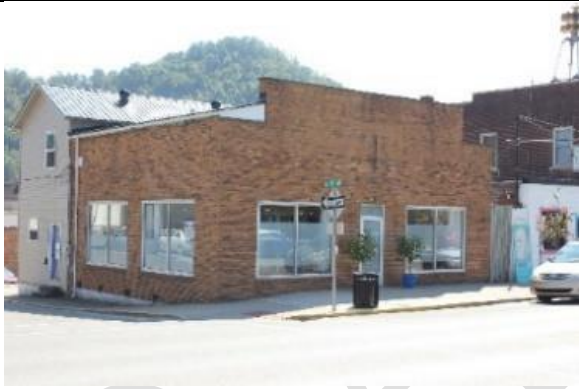
<p data-bbox="537 1073 922 1100">172 East Main Street, looking south.</p>	<p data-bbox="1044 688 1417 1373">This circa 1940, single-story, commercial building is constructed of concrete block, veneered with brick. The front gable roof has a metal panel roof covering, and features a stepped false front at the façade's cornice. The storefront design includes a central bay entry with transom, flanked by paired display windows. The right bay of the northeast elevation also has a set of paired display windows. A two-story frame addition is present on its northeast (rear) elevation. This addition has a side gable roof and is clad in asbestos tile siding. It is currently used as a residence. Research indicates it was originally used as a kitchen for the restaurant formerly located in the main building. The building was originally a photography studio. For many years the building housed the Dixie Grill.</p> <p data-bbox="1044 1373 1198 1402">Contributing.</p>

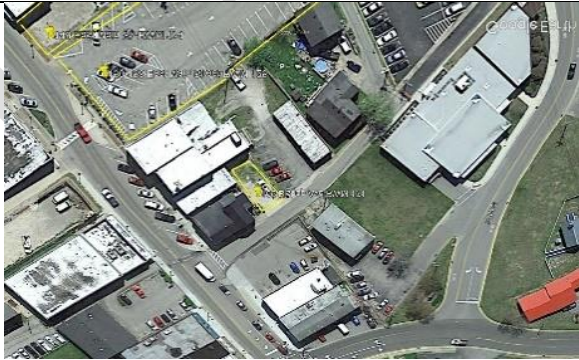
<p data-bbox="626 1759 836 1785">105 Bishop Avenue</p>	<p data-bbox="1044 1402 1417 1486">This resource is a paved surface parking lot currently owned by Charmed Enterprises.</p> <p data-bbox="1044 1486 1239 1516">Noncontributing.</p>

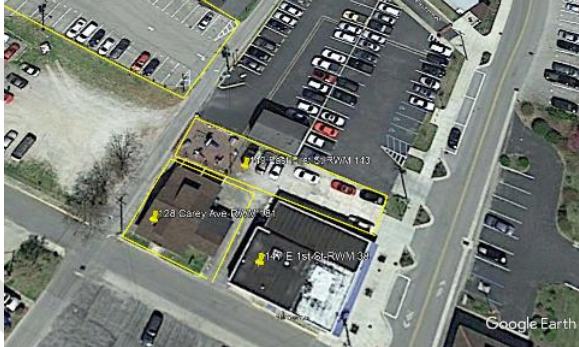
<p data-bbox="618 1535 842 1562">149 East First Street,</p>	<p>This resource is a partially paved surface parking lot currently owned by Rick Stone. Noncontributing.</p>

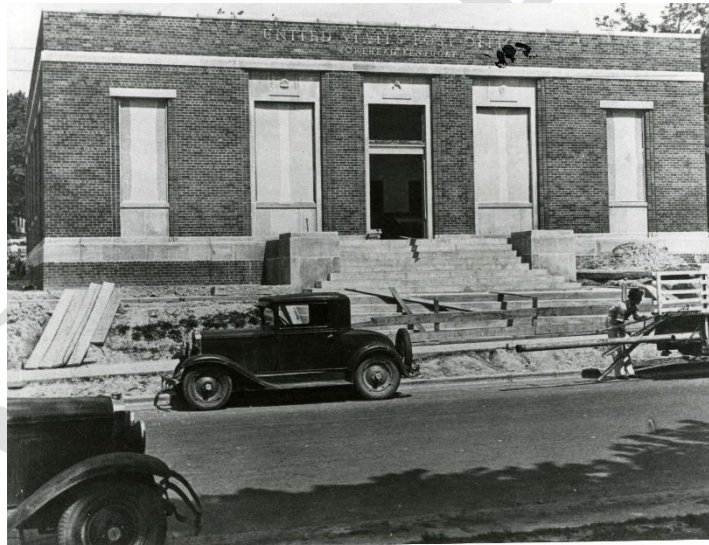
Figure 13. United States Post Office (RWM-3/FS 15), 105 East Main Street (Constructed 1938). Note the automobiles and smooth, evenly paved Main Street (US 60) through Morehead.

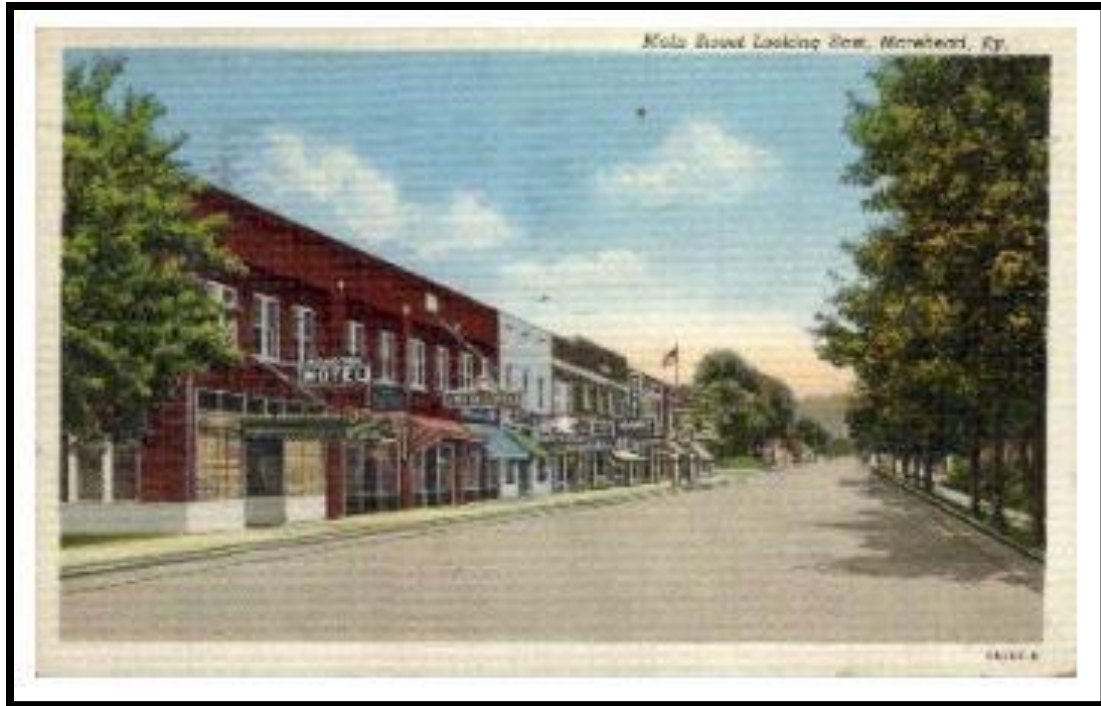
Figure 14. 1947 postcard of Main Street (US 60), Morehead, Kentucky.

Travel through Rowan County began with a pre-Civil War path westward through the heart of the county. This path would later become a portion of the Midland Trail and, subsequently, the Roosevelt-Midland Trail. The Midland Trail, in place by at least 1916, was one of the first national transcontinental automobile routes in the United States and grew out of the 1911 National Highways Association movement to promote the development and maintenance of a network of federal highways. In 1921, the Midland Trail and the Roosevelt National Highway were formally combined into the Midland-Roosevelt National Highway.³¹ A 1924 map, produced by the National Highways Association, referred to the newly combined Midland-Roosevelt National Highway as “the Main Street of America.”³² By 1929, the road received the highly-coveted US 60 designation, and was paved through Morehead with concrete.³³ (Figure 13 and Figure 14).
