National Register of Historic Places Registration Form

Historic name: Marshall-Wallace House

Historical & Architectural Resources of Boyle County, KY (NRIS #64500226)

Street & number: 350 Harberson Lane

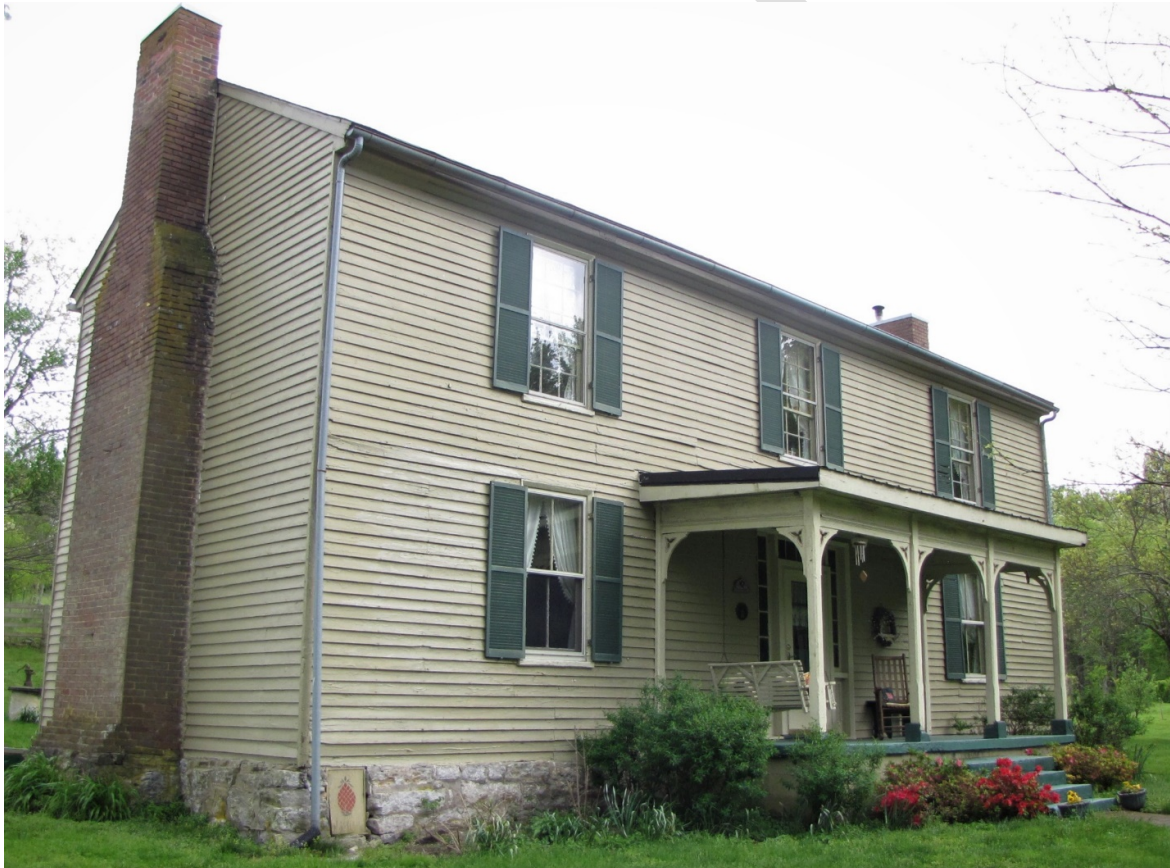
The Marshall-Wallace House.

The Marshall-Wallace House (BO-226) is located at 350 Harberson Lane in western Boyle County, Kentucky, near the community of Parksville. The timber frame, two-story, center passage house was likely built between 1830 and 1840. The single pile pens measure approximately 19'x17' and the center passage measures 9'x 19'. The property is being interpreted for its architectural significance. The hewn posts and beams of the house's timber frame construction display unique and skilled craftsmanship before the advent of the balloon framing technique which came to dominate frame house construction. Many of the architectural elements in the original portion of the Marshall-Wallace House have been preserved and display important techniques, materials, and aesthetics. The nominated area contains about half an acre and one contributing building with a non-contributing addition.

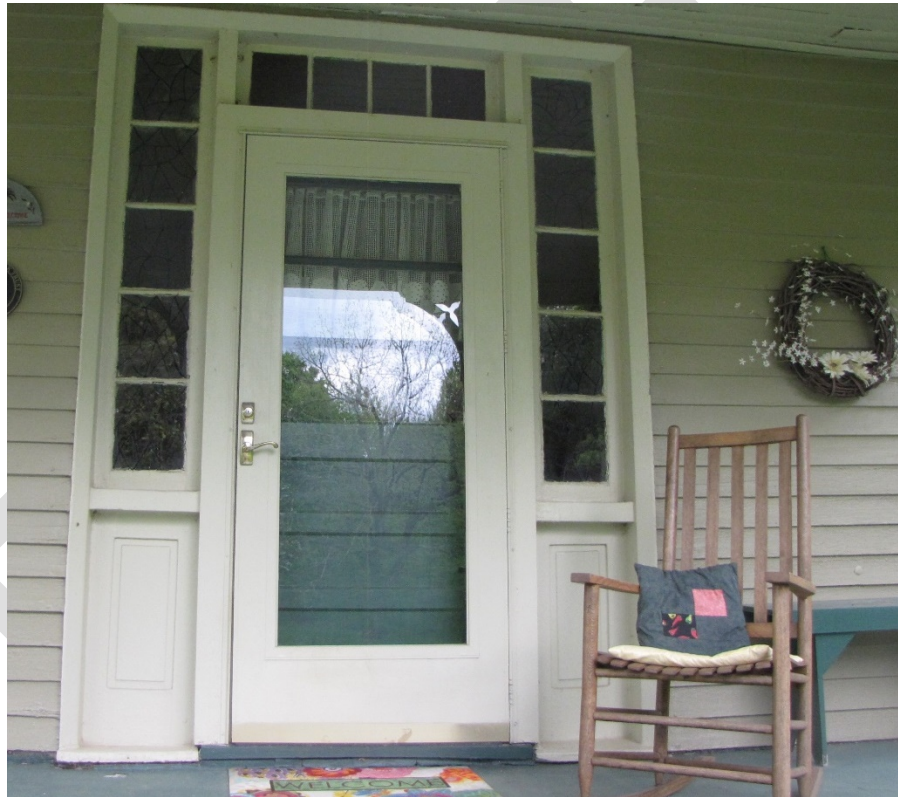
Front door with sidelights and transom.

The front door is located in the center of the first floor, with the threshold about 36 inches above ground level on the level of the concrete front porch. First-floor windows are located on both sides of the front door, and three second-floor windows are evenly spaced above. The second-floor double-hung windows are original. Each of the windows on the west (front) elevation has shutters that were built to match the originals which deteriorated beyond repair.

The front porch, comprised of concrete slab atop concrete blocks, was added in the 1960s and includes decorative brackets and a tin roof. The entrance door is framed by sidelights and a rectangular transom. Sidelights have three glazed panes above a single solid panel at the bottom. The transom consists of four glazed panes measuring 13" x 42" and is original. Nine of the ten sidelight panes are original.

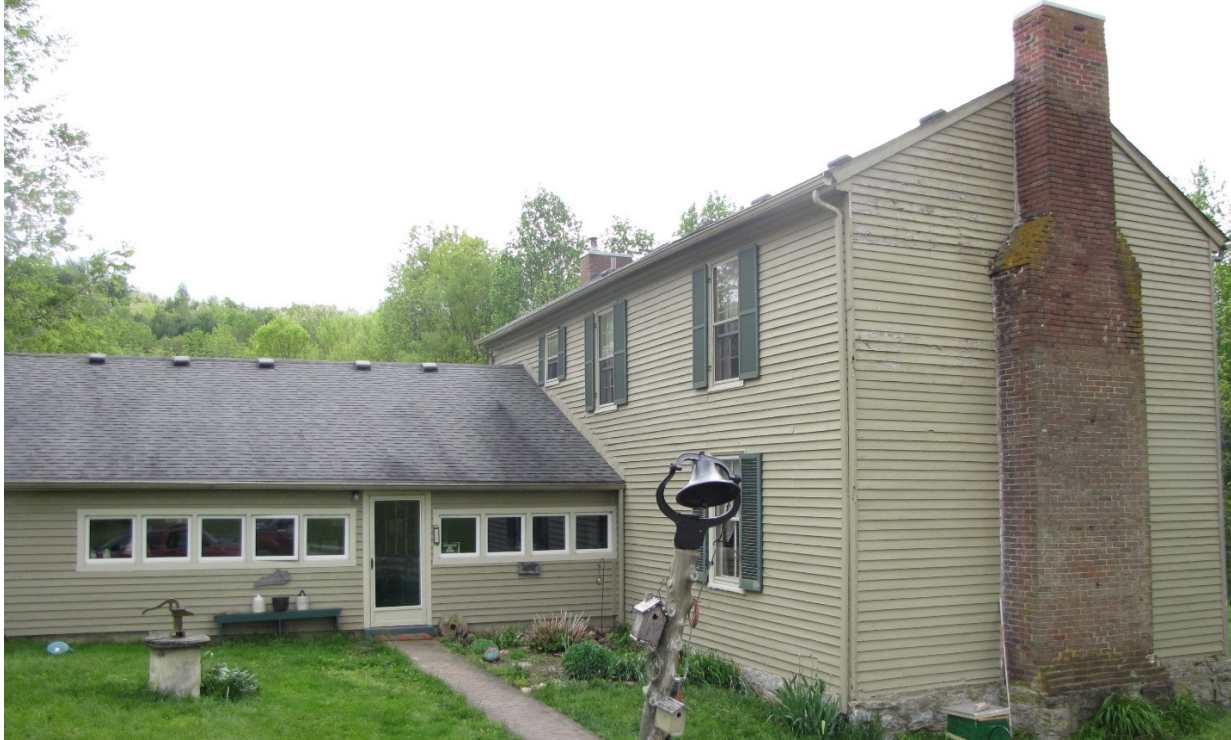
North elevation with original brick chimney and ell addition to left.

The north elevation features the original brick chimney built on top of a bulky stone foundation. No windows are on the north side of the original portion of the house. The north elevation features an ell consisting of a side entry above a concrete cistern that runs 28 feet from the back door of the central passage. This side entry has nine windows (installed since 2010) 4 feet above the ground, flanking a back door.

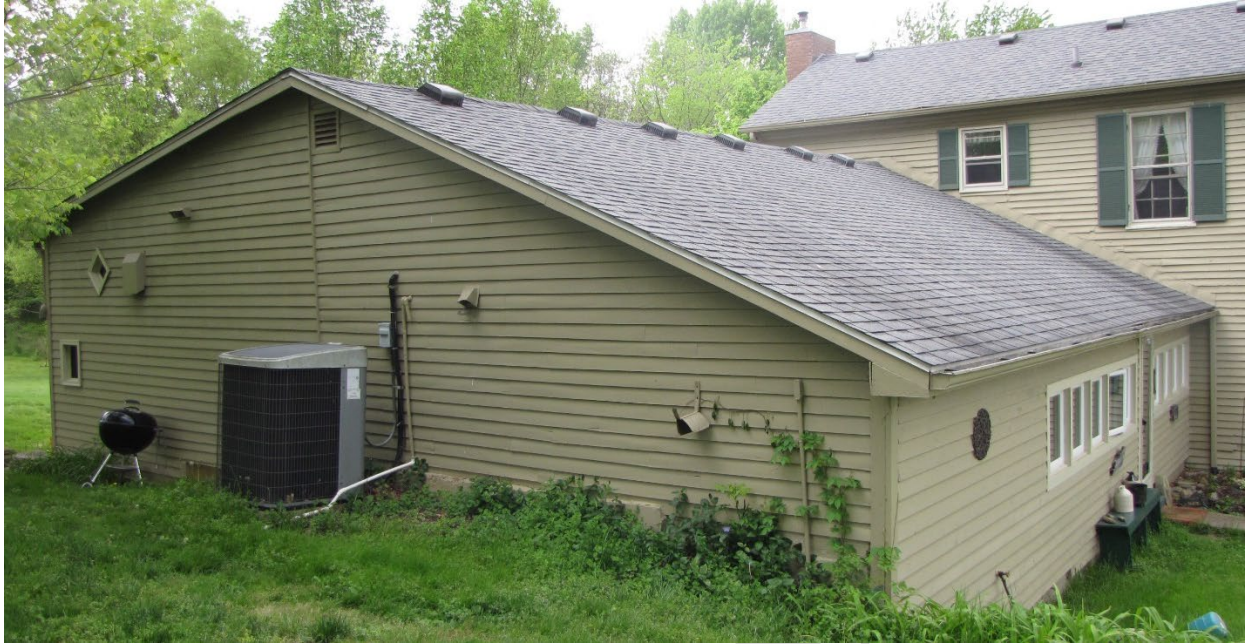
Rear (east) elevation, built into a slope. The window at the top right is original (upstairs landing); farthest left window upstairs was added when bathroom was added.

The rear of the house is built into the slope of the gentle incline rising to the east. Three windows are present in the east elevation of the original portion of the house: downstairs in the north bay, upstairs in the north bay, and upstairs in the landing room. The lack of a window in the upstairs south bay hints that an ell of some type was present – or contemplated – originally.

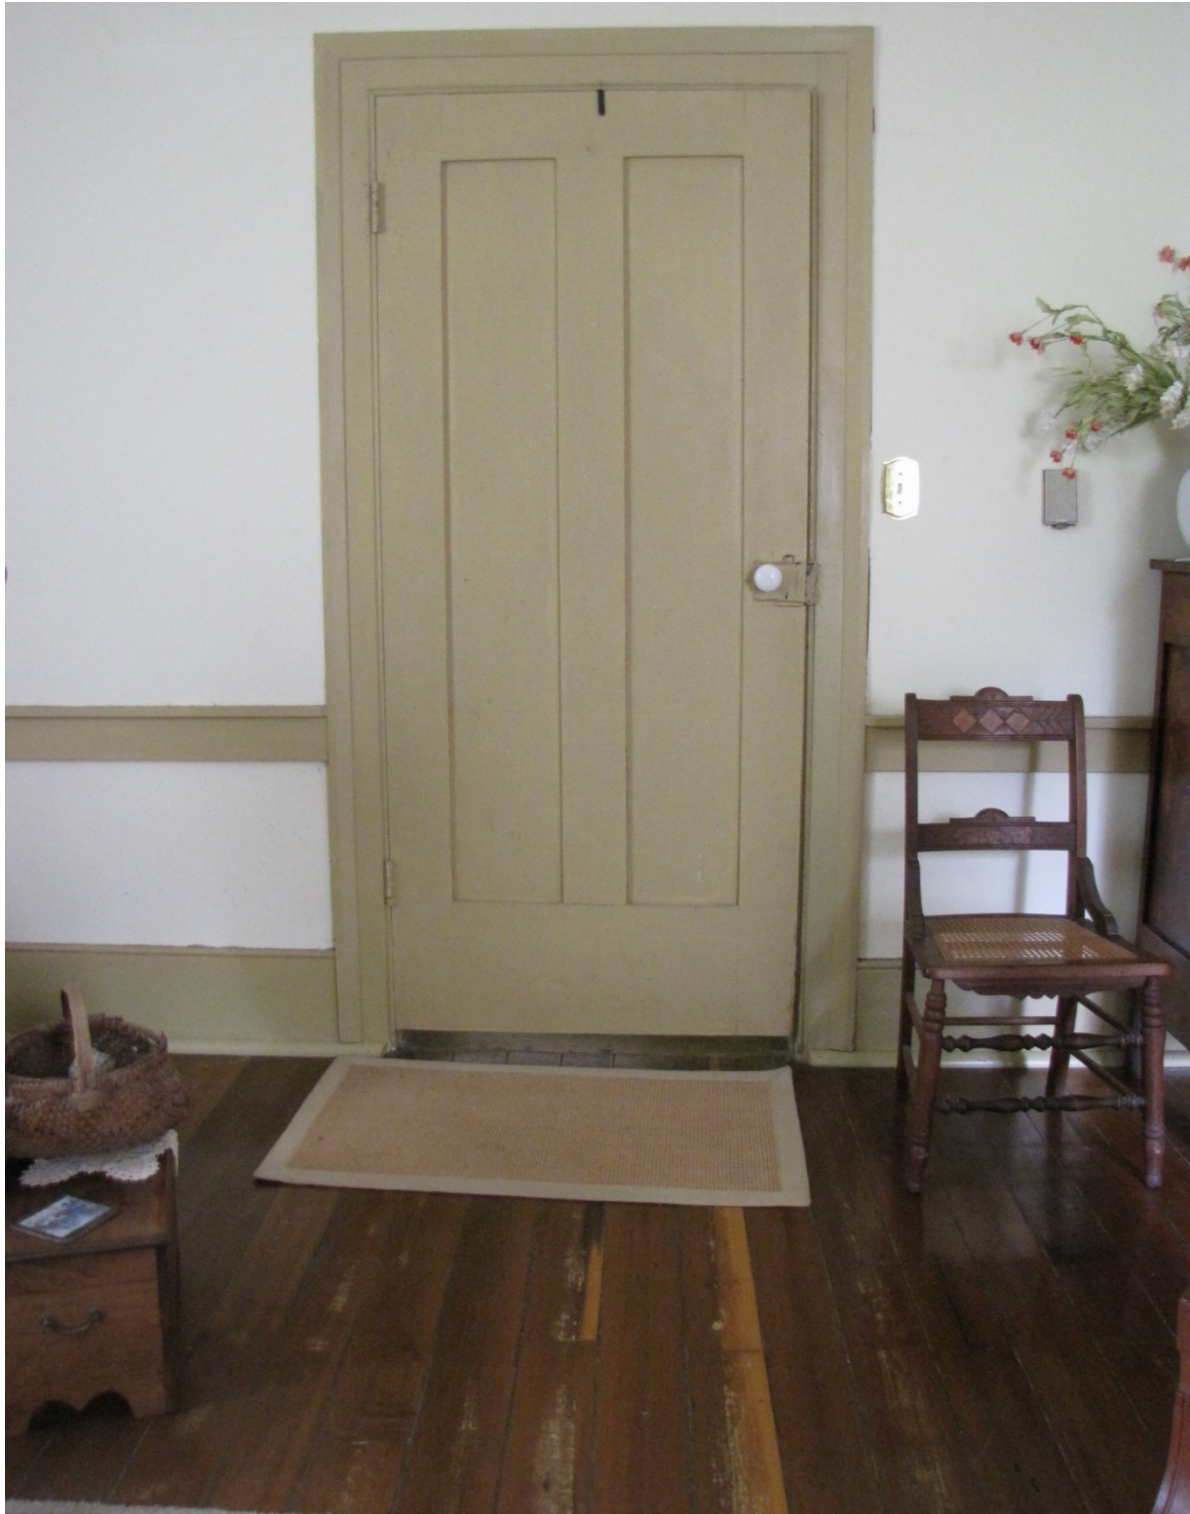
Interior door from downstairs south bay to entry hall; also showing the baseboard and chair rail of the south bay room, and the restored original poplar floors.

All baseboards downstairs are believed to be original. In the south bay, baseboards measure 10 inches in height and are accompanied by a chair rail 5 inches tall and 26.5 inches above the floor. Baseboards in the entry hall measure 16 inches tall, and those in the north bay measure 17 inches in height. There is no chair rail in the entry hall nor the north bay. Previous owners related their belief that these differences reflected that the downstairs south bay served as a dining room, common area, and room for entertaining guests. The north bay, by contrast, served as sleeping quarters. This intentional design harkens back to the hall-parlor house design which was only just being replaced by the center-passage house around the time of the construction of the Marshall-Wallace House.¹

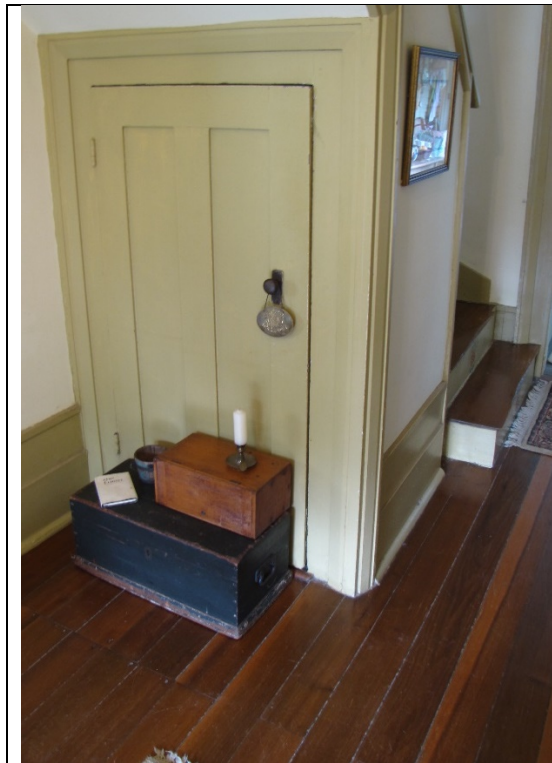
Closet in Entry Hall under stairs.

The quarter-turn staircase is located in the entry hall and shows fine craftsmanship, with a starter step protruding into the entry hall. The staircase includes four winders, one of which has a maximum width of the board of 21 inches. A spandrel encloses the soffit with a closet opening toward the front door. The closet door measures only 58 inches in height and is of the same Greek Revival style as the other original interior doors.

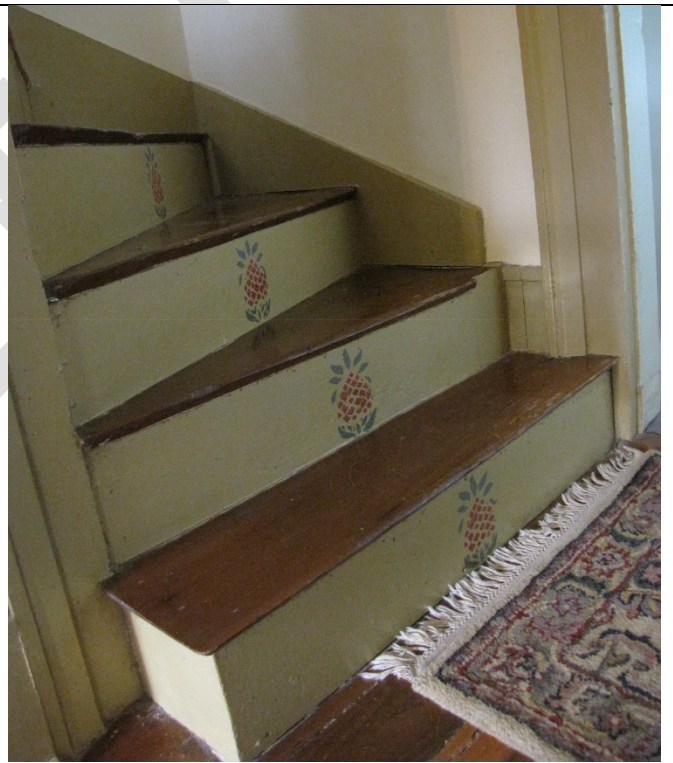
Quarter turn staircase.

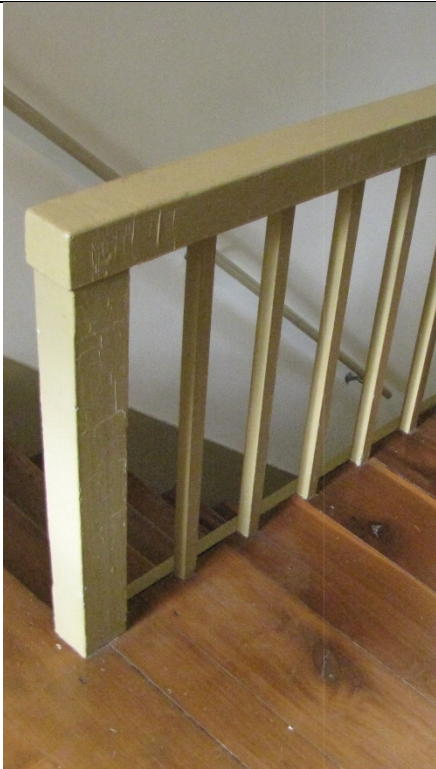
Balustrade in upstairs landing.

The upstairs landing features an original landing return balustrade, with a handrail measuring 3.5" wide and 3" tall. The two newel posts also measure 3" x 3.5" and are not adorned by a newel cap. Eighteen spindles measure 1" x 1" and comprise the east-west balustrade. Both original doors upstairs that open into the bedrooms from the landing are the same two vertical

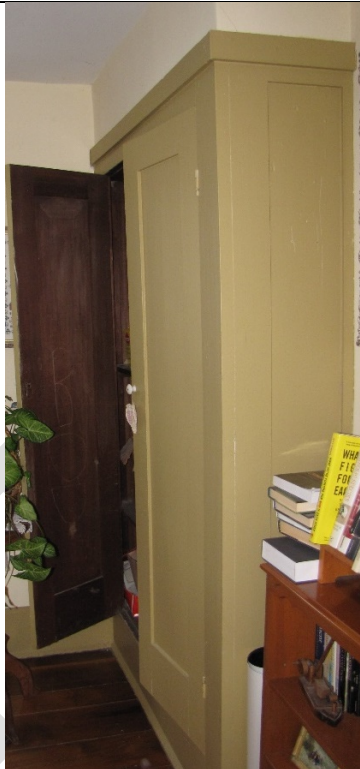
Cupboard in its original location in upstairs landing area.

Two cupboards are present in the landing and are believed to have been built at the time the house was constructed. Both cupboards measure 50 inches wide by 7 feet tall and include back panels that are over 20" wide. The eastern cupboard is in its original location. The cupboard now on the western side of the landing is also original construction, but it was moved to its present location when the bathroom was added to the southern bedroom in 1988.

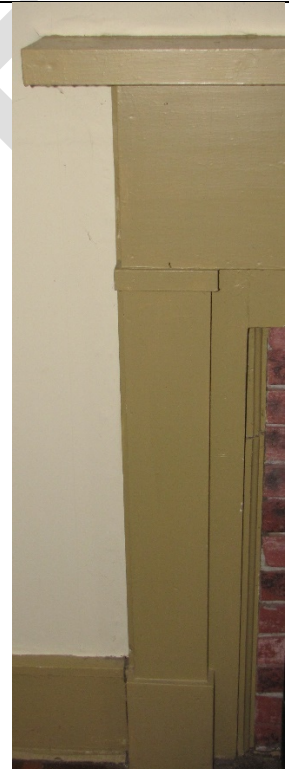
Original mantle in upstairs south bedroom.

The southern upstairs bedroom also features an original mantle on the south wall identical to the mantle in the north bedroom. An identical small closet is located in the southwest corner. A bathroom was added in 1988 to the northeast corner of the bedroom. The double-hung window on the west side of the south bay is original, but the window on the south side of the south bay and the window in the bathroom are not original.

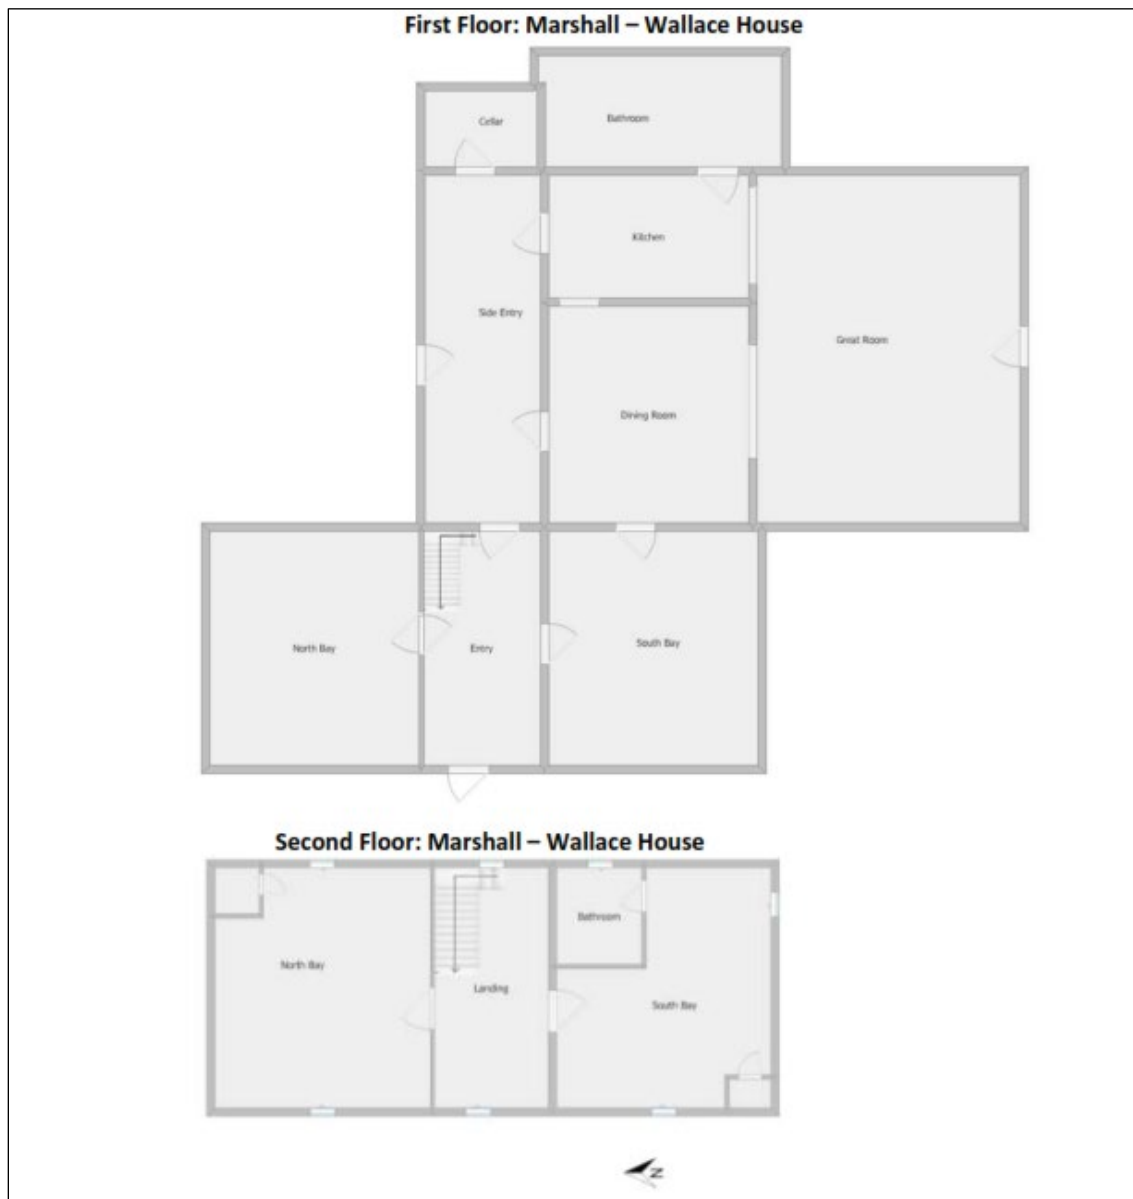
Floorplan of Marshall-Wallace House.

The original six rooms of the Marshall-Wallace House consist of two 19x17 rooms downstairs with the entry hall between, and two 19x17 rooms upstairs with the landing between. Original woodwork is present throughout the interior of this original part of the house, including baseboards, door jambs, and six original interior two-panel Greek Revival doors. The original poplar hardwood floors have been restored and enhance the historic appearance.

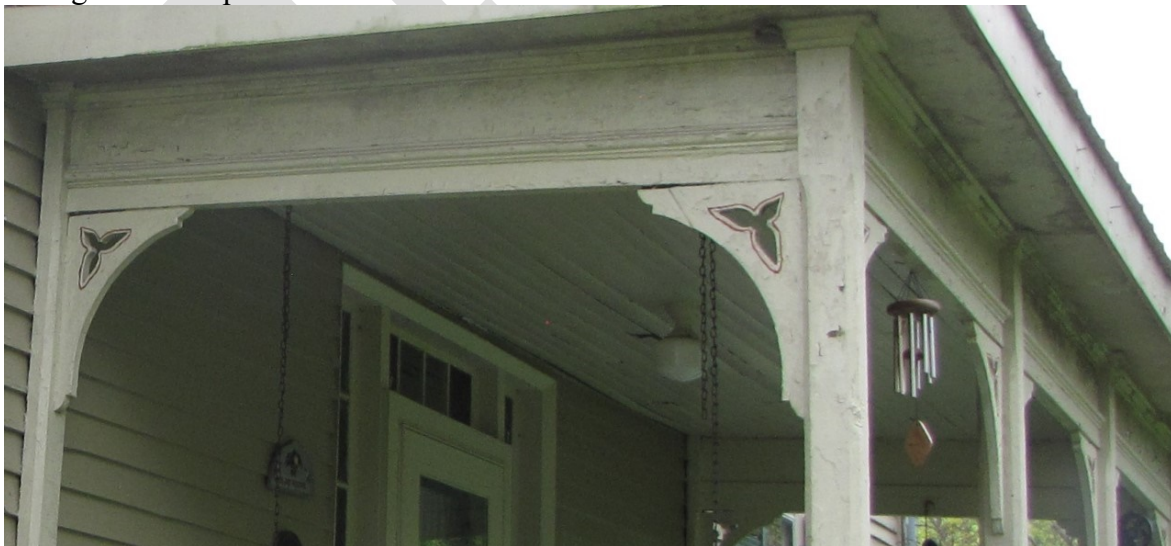
Detail of decorative brackets adorning the front porch.

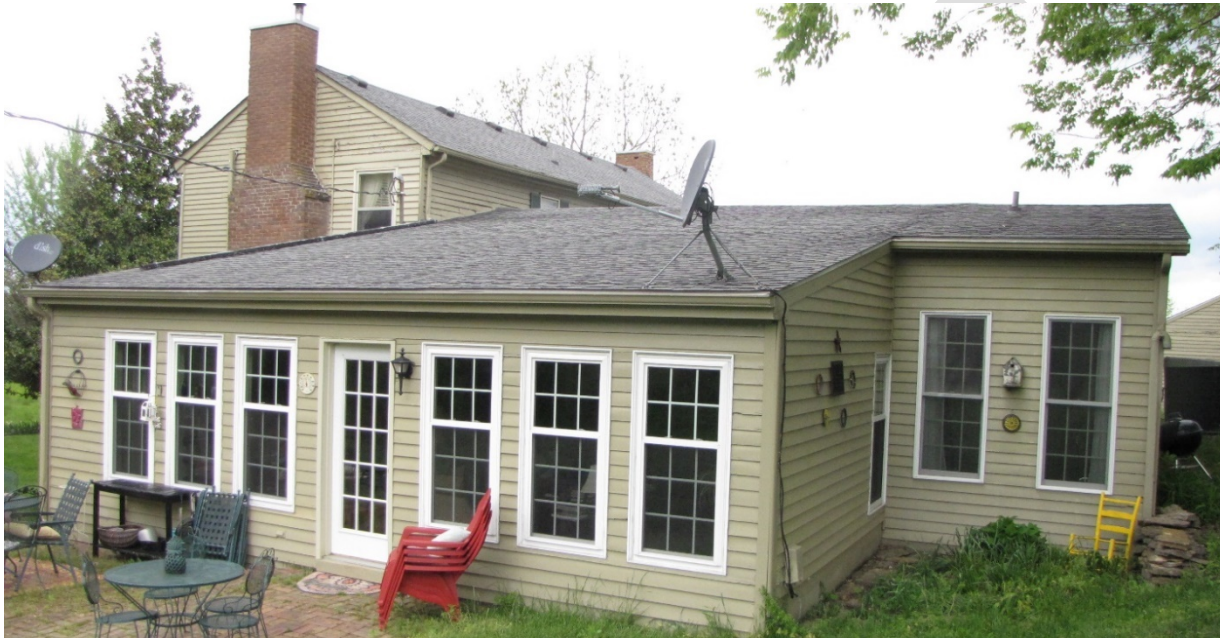
South elevation with the great room at left and the two-windowed bathroom at right; all added or remodeled in 1990.

In 1990, the kitchen was remodeled and the 27x22 great room was added to the south side of the kitchen. Around this time the dining room floor collapsed and was replaced. In 1997 the downstairs bathroom was widened to the south a few feet, and rooflines were consolidated. The current asphalt shingle roof was added in 2006.

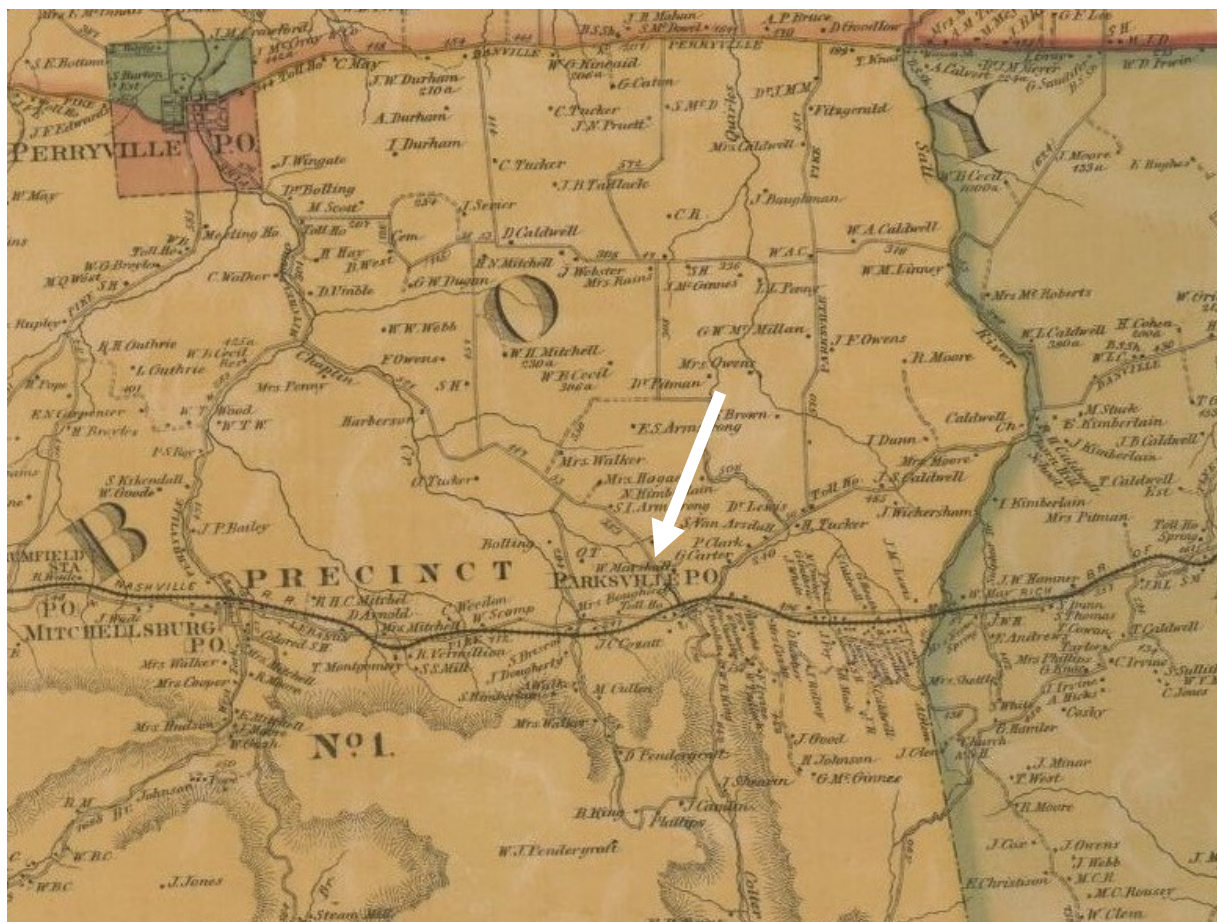
Detail from the 1876 D.G. Beers & Co. “Map of Boyle & Mercer Counties, Kentucky,” showing “W. Marshall” living in the Marshall-Wallace House in that year.

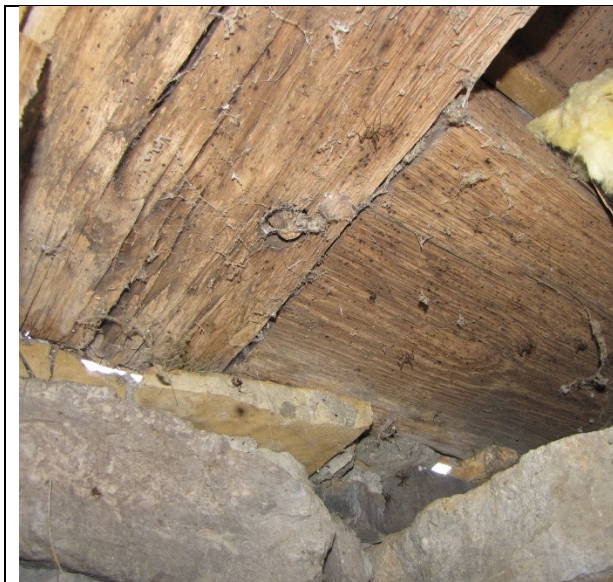
Sill timbers at corner, as seen from crawlspace in northwest corner of house.

The Marshall-Wallace House was built during the Transitional Period and exhibits many of the characteristics identified as indicative of this period. In particular, while the timbers of the framing were hewn, many other components of the house were sawn in mills. The studs in the walls were milled, as well as flooring and interior details. The large hewn floor joists measure 9” tall by 3” wide and are on 24” centers. The roof joists have the same 9”x3” measurements. These large joists further demonstrate the transition from earlier larger building components to the later milled joists that are generally much smaller.

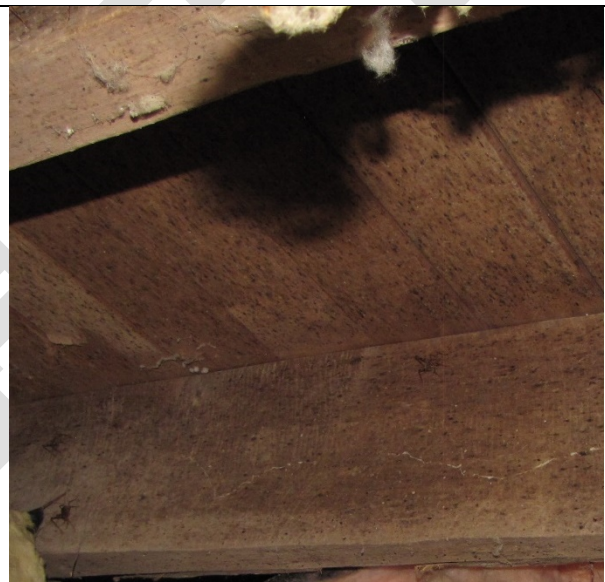
Large milled floor joists as seen from crawlspace.

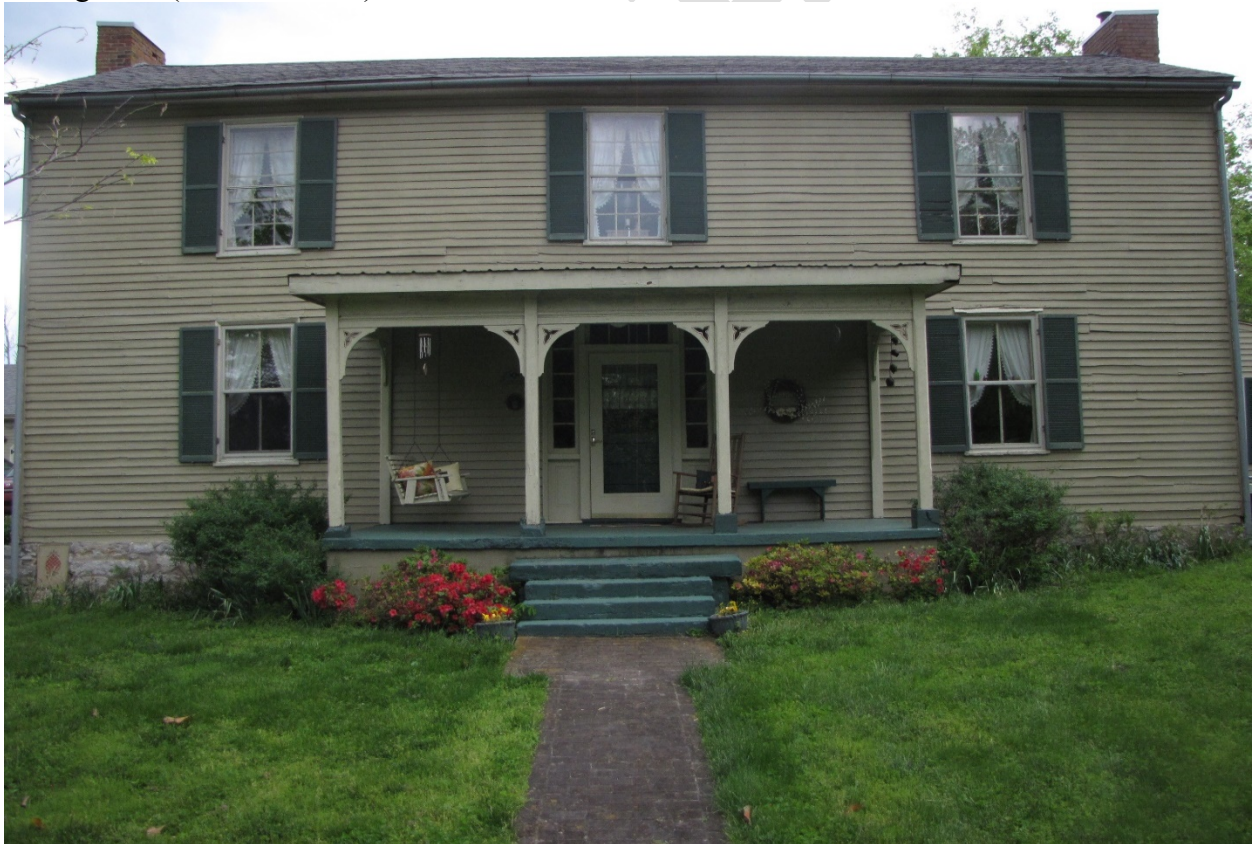
1 of 6.

Facing front (west elevation) of Marshall Wallace House.

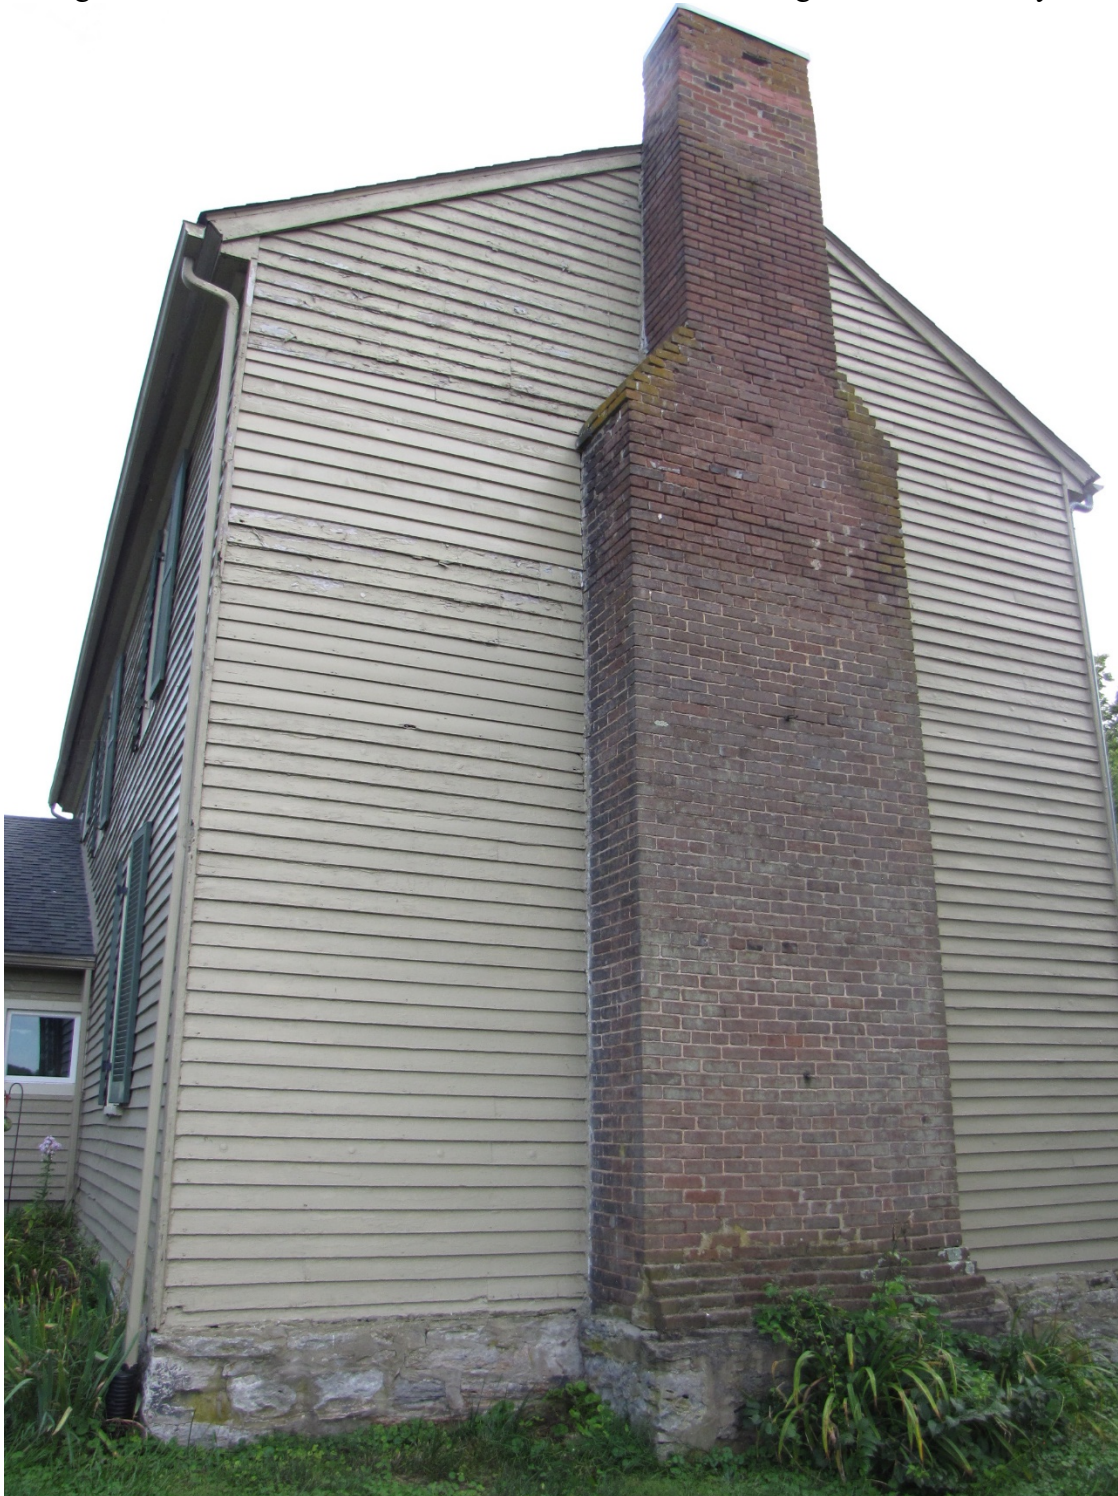
2 of 6.

Facing north elevation of the Marshall Wallace House and original brick chimney.

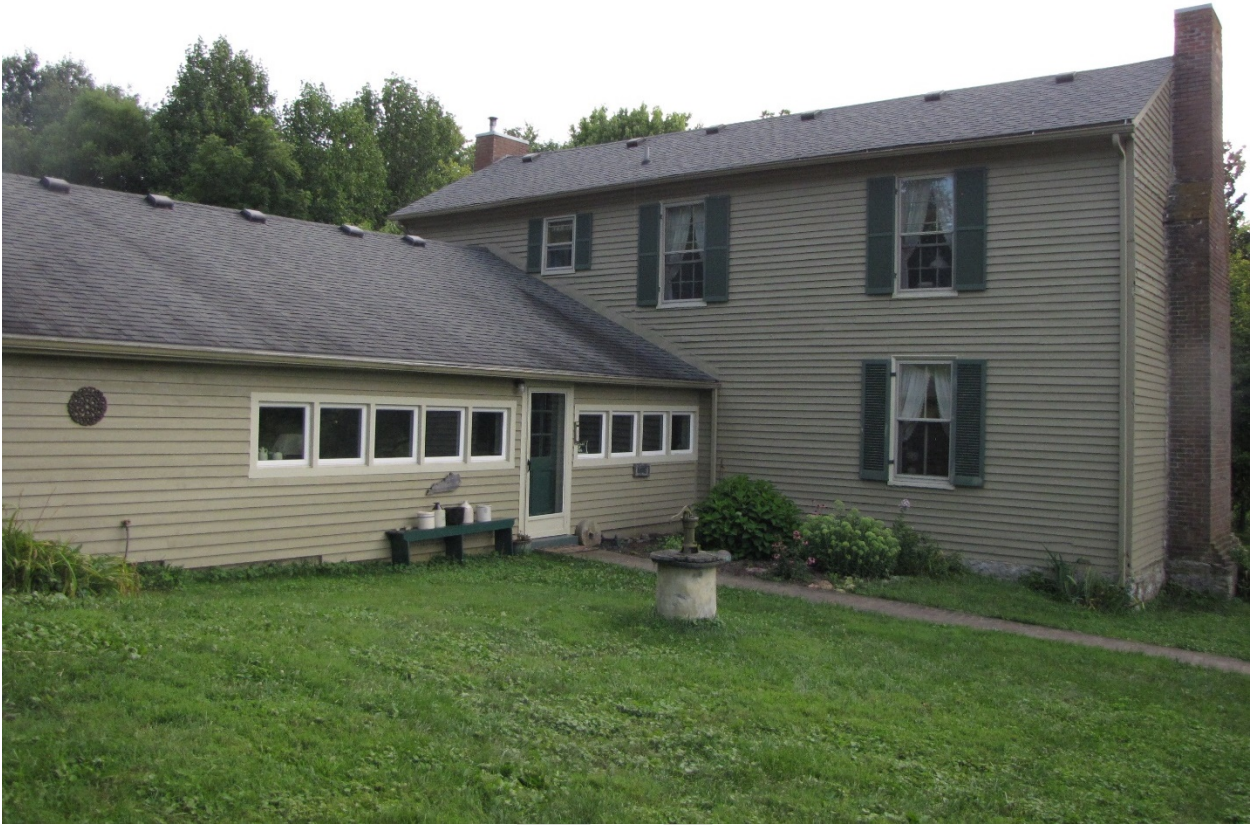
3 of 6.

Facing rear (east elevation) of original portion of Marshall Wallace House at right, with the north elevation of the ell addition at left.

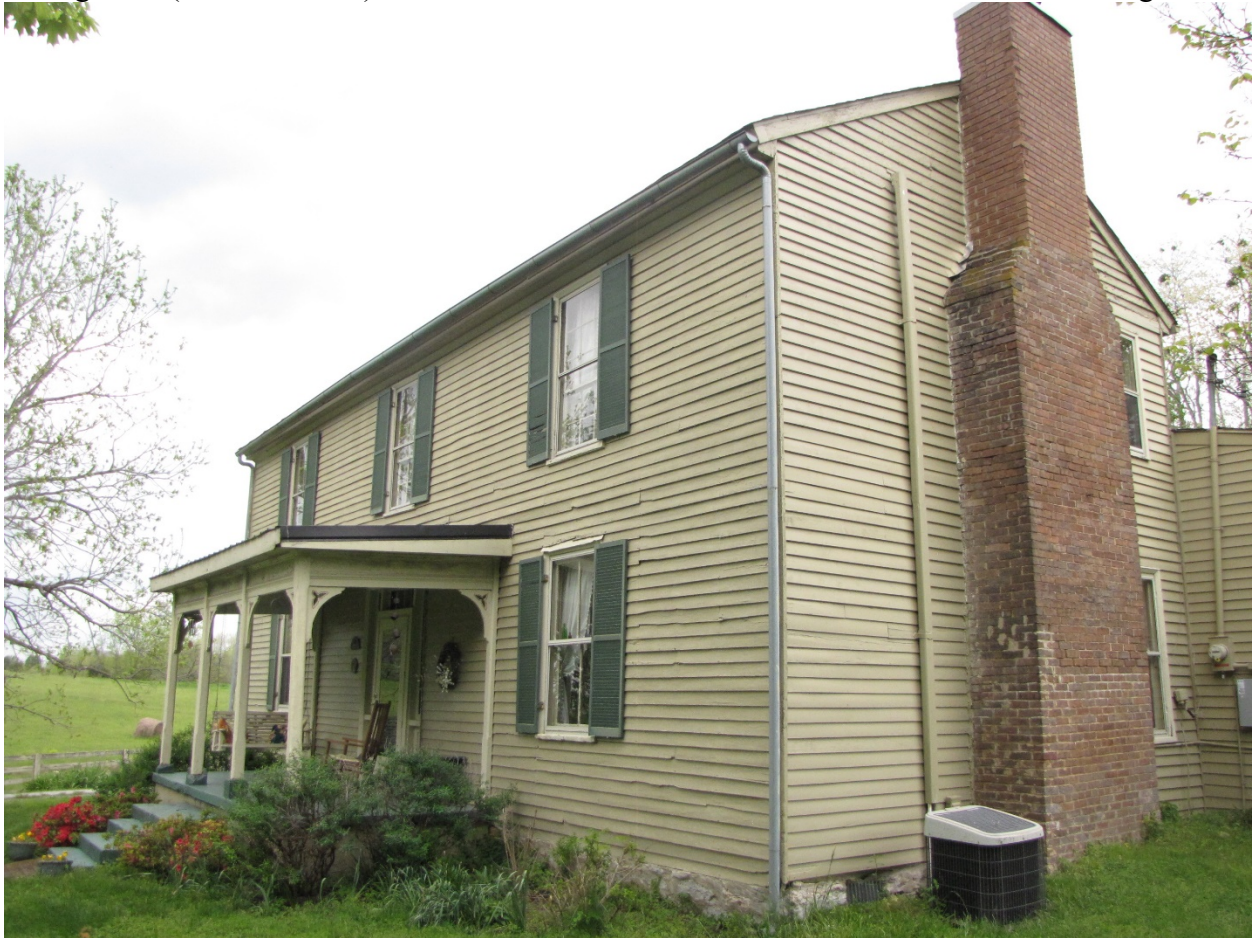
4 of 6.

Facing front (west elevation) of Marshall Wallace House at left, and south elevation at right.

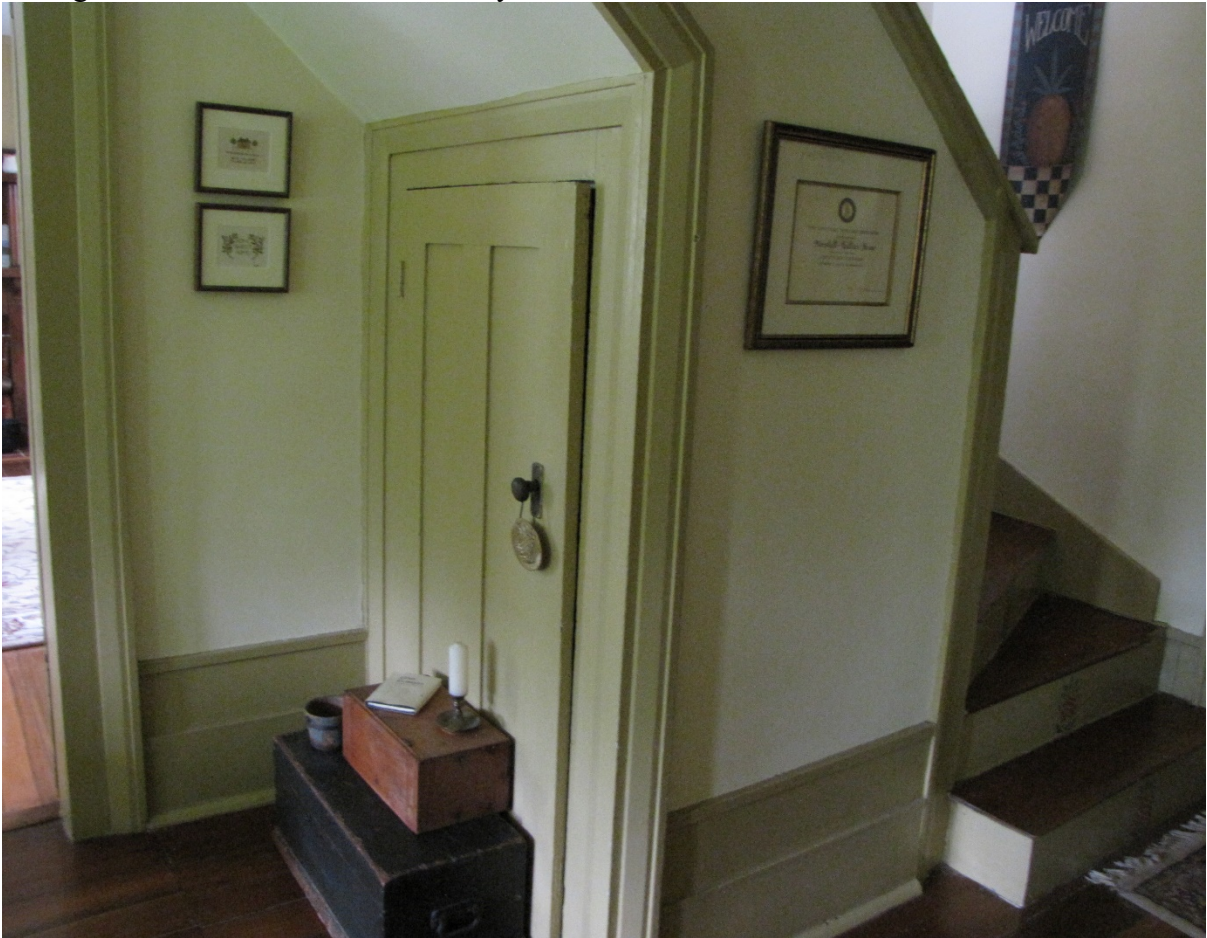
5 of 6.

Facing small closet under stairs in entry hall of the Marshall Wallace House.

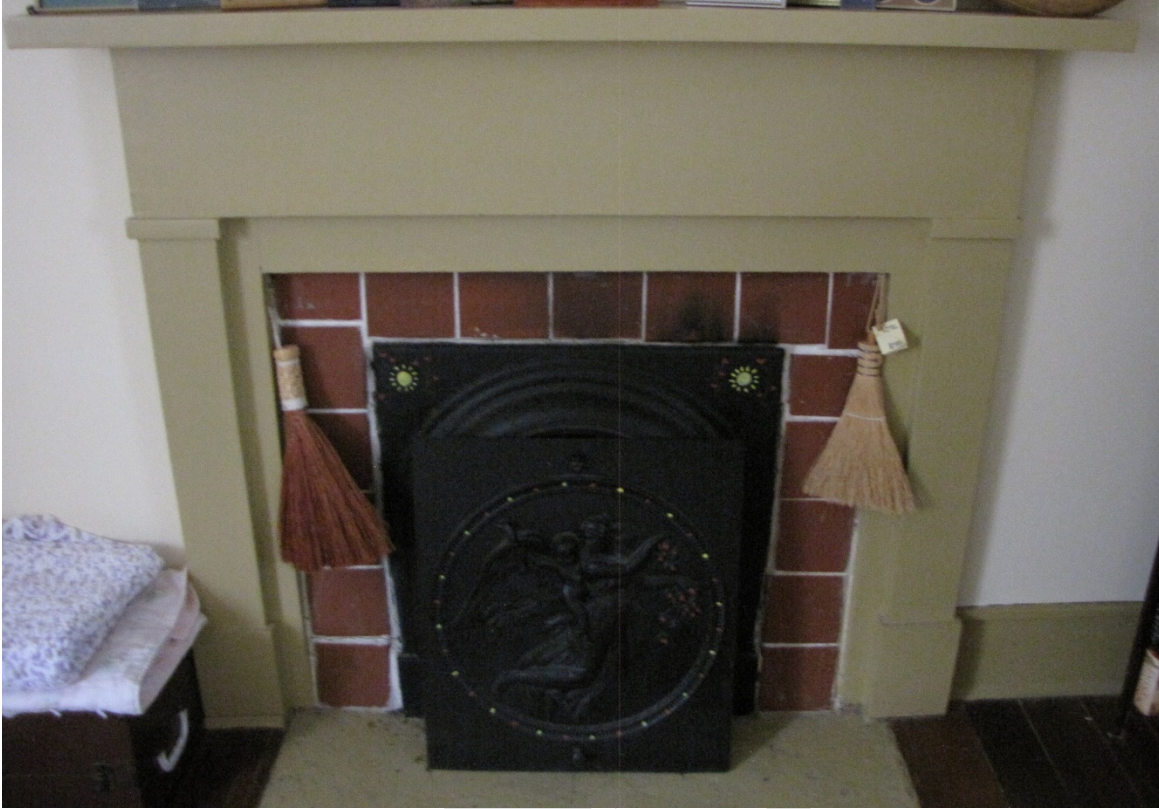
6 of 6.

Facing mantle in north bay second floor bedroom.
