A Survey of Historic Sites in Rural Marion and Washington Counties, Kentucky

A Report on the Findings of the *Rural Heritage Development Initiative Survey*
A project funded by a National Park Service Preserve America Grant

Kentucky Heritage Council

The State Historic Preservation Office, 2009

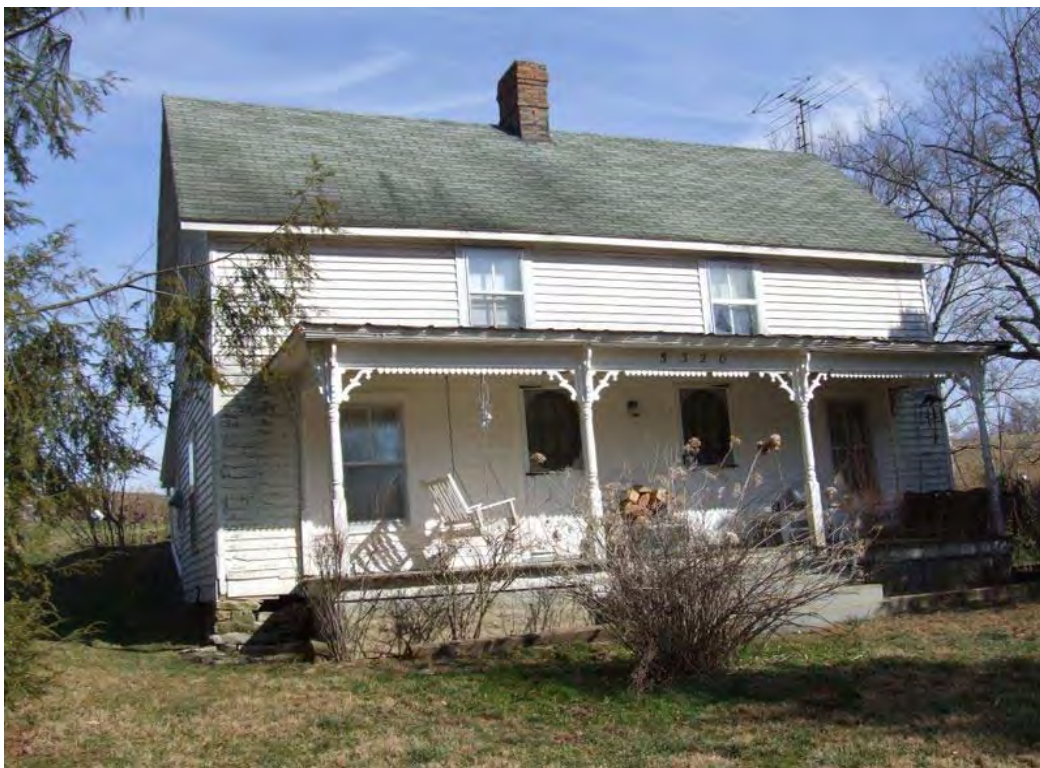
Figure 2: WS 476, Main House, early twentieth century, Mackville vicinity. See Figure 3 for a site plan of the property.

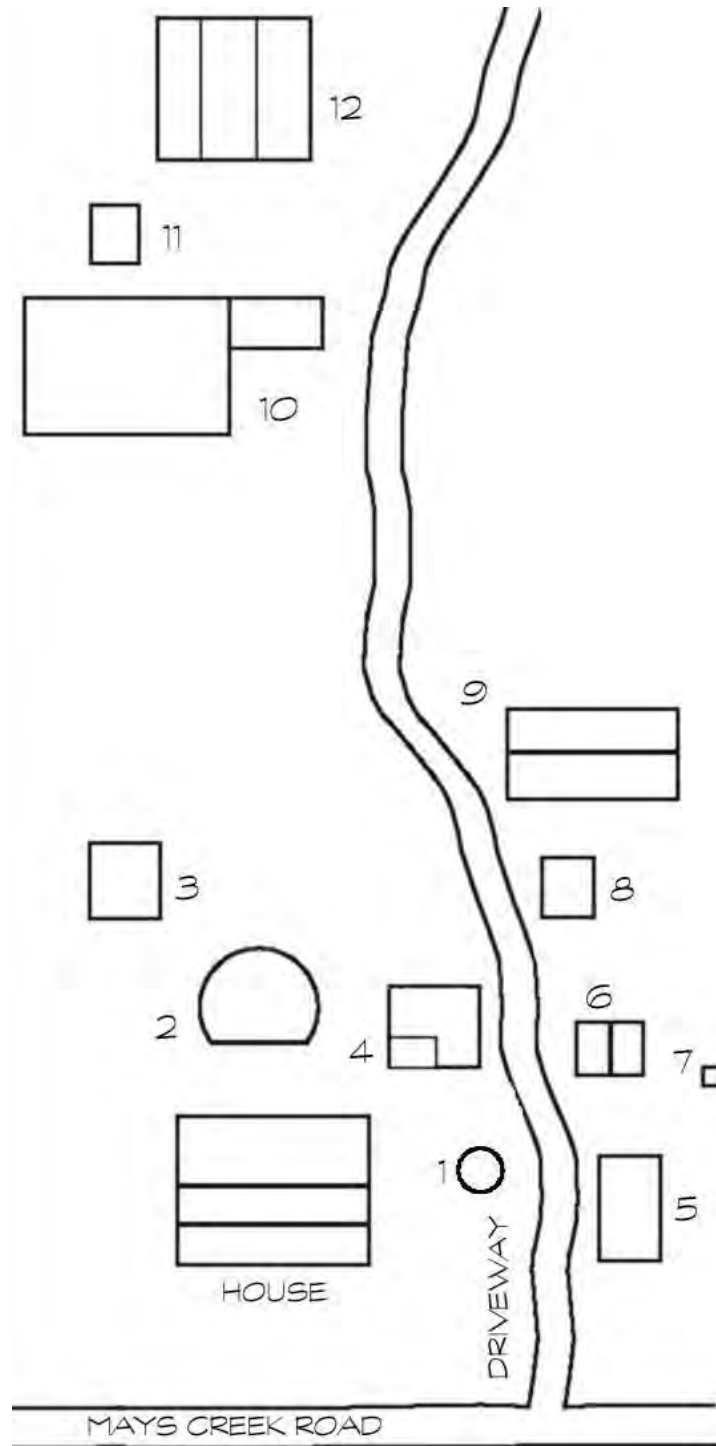
Figure 3: WS 476, Site Plan. House (Figure 2), 1) Well (Figure 231), 2) Cellar (Figure 191), 3) Brooder House (Figure 4), 4) Meathouse (Figure 209), 5) Garage (Figure 224), 6) Shed or Shop (Figure 216), 7) Privy (Figure 185), 8) Granary (Figure 310), 9) Stable (Figure 265), 10) Tobacco Barn with Stripping Shed (Figure 286), 11) Poultry House (Figure 292), 12) Multi-purpose Stock/Tobacco Barn (Figure 260). Domestic outbuildings cluster around the house and agricultural outbuildings are set some distance away. (Illustration Bill Macintire, based on field notes by Danae Peckler and Jenn Ryall, 1/30/2007).

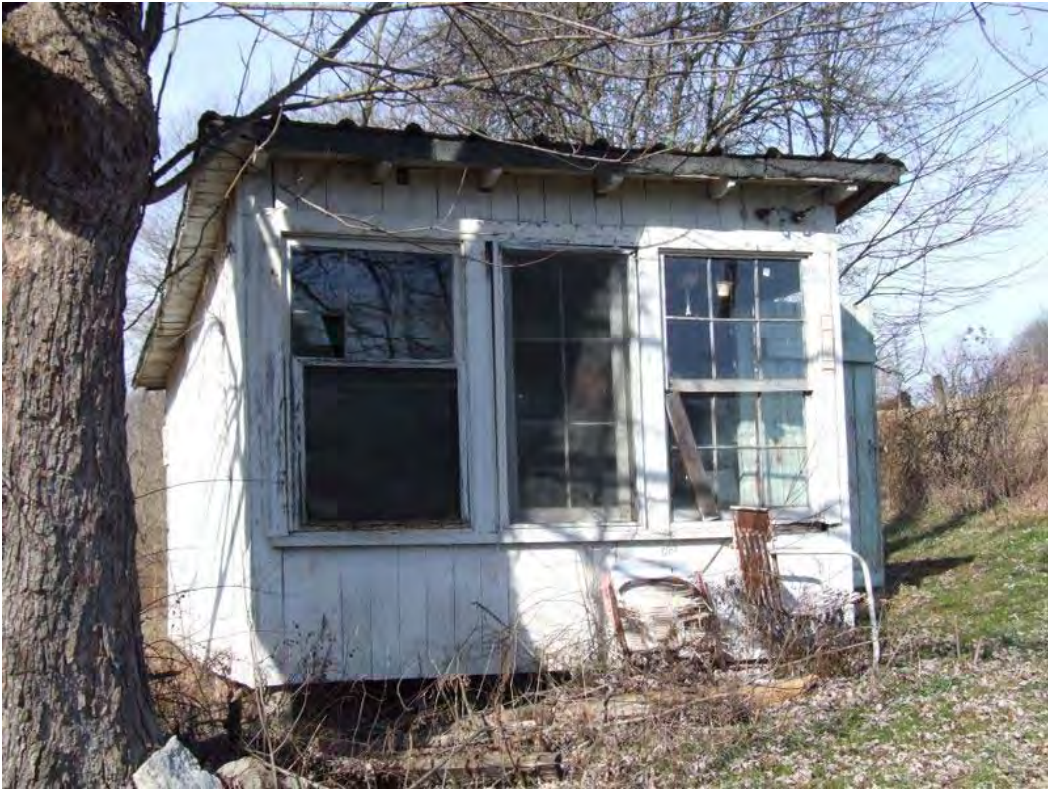
Figure 4: *WS 476, Brooder House, mid-twentieth century, Mackville vicinity.*

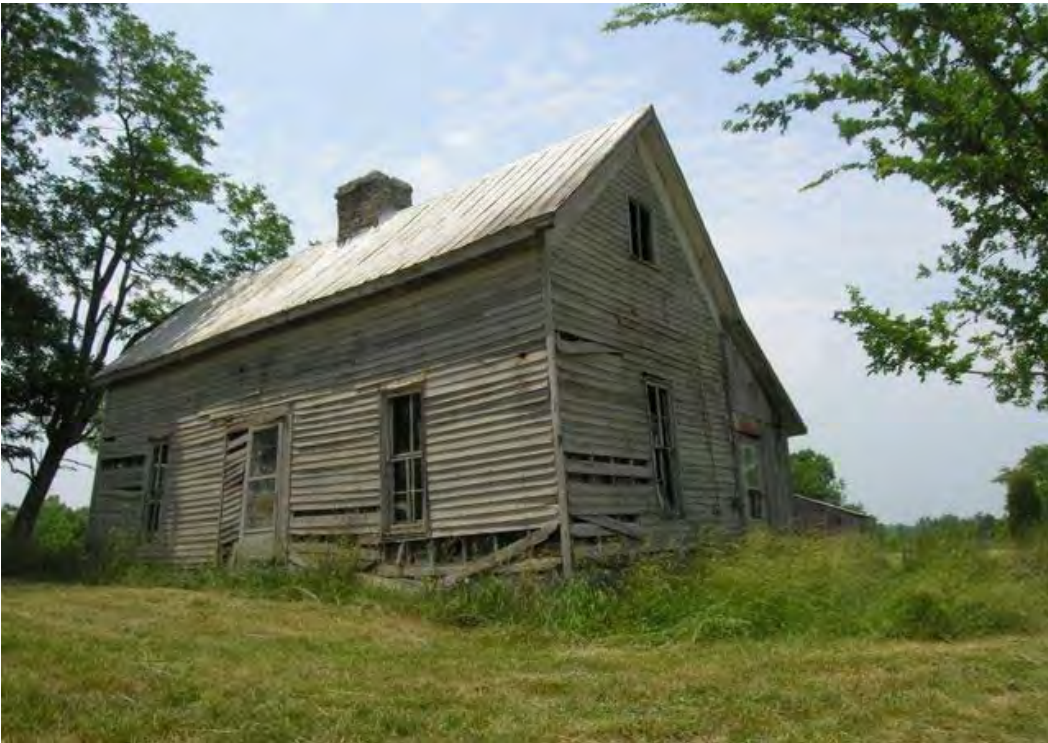
Figure 5: *WS 972, Cooksey House, central chimney double pen, mid-late nineteenth century, Willisburg vicinity. The resource itself is a document of the past.*

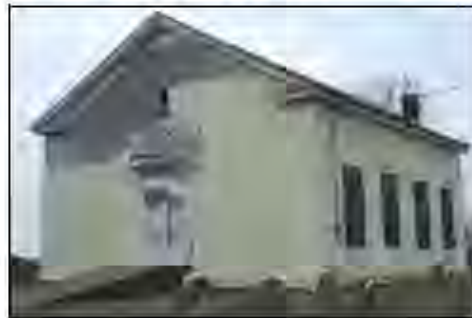
COMMENTS/HISTORICAL INFORMATION:
 This is the Smock's Methodist Chapel (now Smock's Chapel Mission). This church appears in its current location on the 1877 Beers Map of Washington and Marion Counties. The church was likely built in the mid-to-late 1800s. Evidence for this is also in the building's style. It has both Greek Revival and Gothic Revival elements. Its returned gable ends, front gable roof configuration, and bands of trim in the gables are Greek Revival features. The Gothic Revival feature is the decorative vergeboard on the front façade. The building has a brick chimney to the right side about 2/3 toward the rear of the building. We talked to one man in Marion County who went to school here. There were four windows on the eave ends of the building. The church is associated with a cemetery.

Figure 6: Front of Historic Sites Survey Form for MN 231, Smock's Methodist Chapel. See Figure 24 for a larger picture of the building.

The site number is printed in the upper right hand corner of the survey form. In the case of Smock's Methodist Chapel (Figure 6 - Figure 9) is identified as MN 231. Also in the upper right hand corner is space for an evaluation of National Register eligibility. In the case of Smock's Chapel, the surveyor has put in the letter "D," which is a code for eligible. This is a recommendation made by the field surveyor: official determinations of eligibility are made by the SHPO. There is also a space to note (usually at a date later than the field survey itself) if the resource has been demolished or lost in some way. While the form employed for this survey project is an older version, recently revised, it remains substantially similar to the one employed today.

Below the heading on the left side of the survey form is a space for the name of the resource, Smock's Methodist Chapel, its address, and then its exact location as defined by Universal Transverse Mercator (UTM) coordinates.⁴ In this survey, UTM coordinates were obtained by the use of a hand-held GPS unit. The form contains space for the owner's name and address, the name of the person or persons completing the form and their affiliation, the date the site was visited, and the sponsor of and reason for that visit (for instance was it surveyed as a grant project, or during an environmental review process).

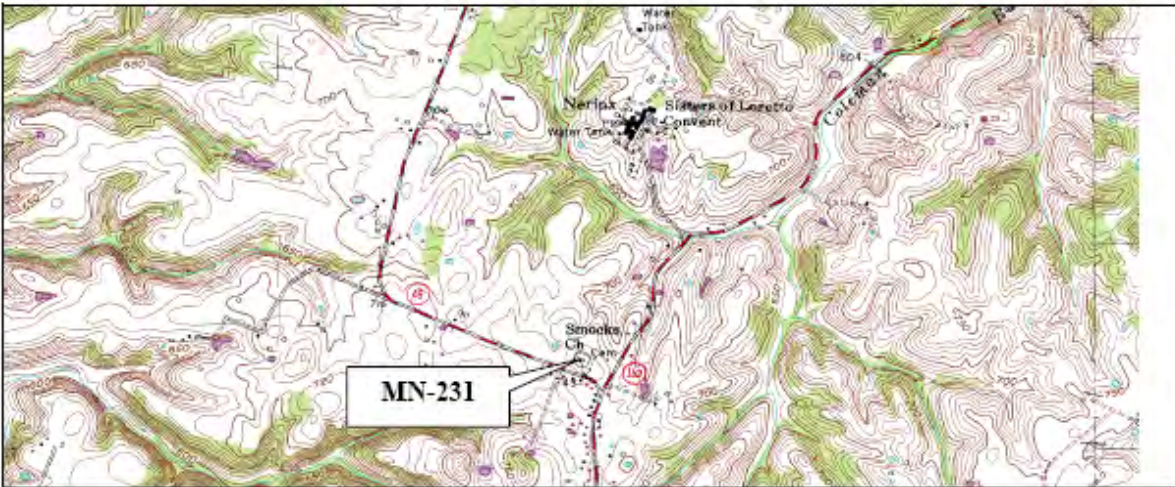
Figure 7: Back of the MN 231 Survey Form. The Site Plan is on a Continuation Sheet, Figure 9.

The back of the form has space for a list of support resources, an annotated site plan, and a map showing the exact location of the site (Figure 7). For the RHDI survey forms, a copy of the site plan from the field notebook is attached on a continuation sheet (Figure 9). Extra photographs and information are found on continuation sheets (Figure 8). Further text, forms for associated resources, pictures, related correspondence, newspaper clippings, or copies of references may be attached to the form as well. Some of this material may be appended at a later date, such as copies of correspondence about the property

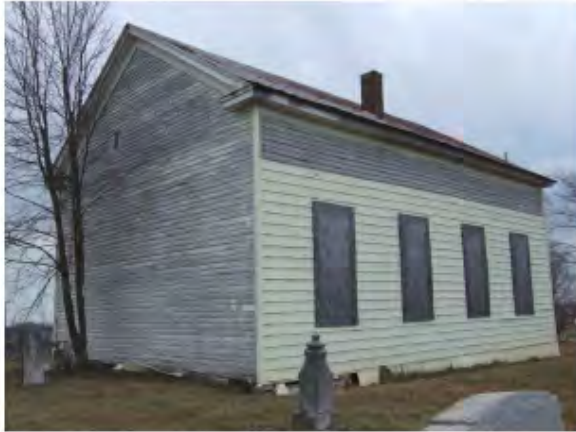
This is a rear/left side photo of Smock's Chapel.

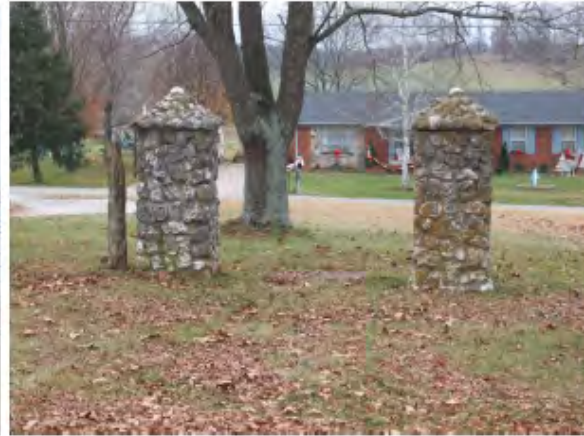
These are the entrance posts (made of coral heads) to Smock's Chapel. They are located to the front.

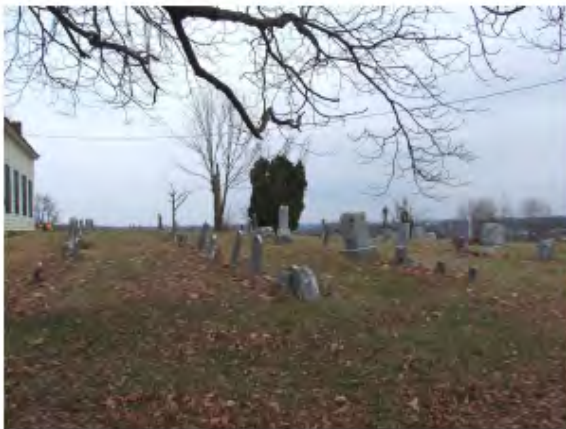
1. This is a photo of the cemetery at Smock's Chapel. It is quite extensive and contains early to mid-19th century graves.

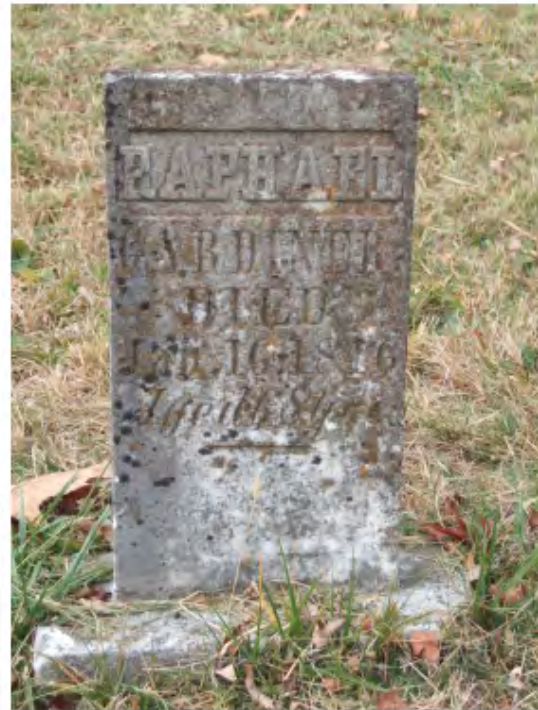
1. This is the oldest gravestone we could find in the cemetery. It appears to read "Raphael Gardiner DIED Jan 16, 1846 . . ."

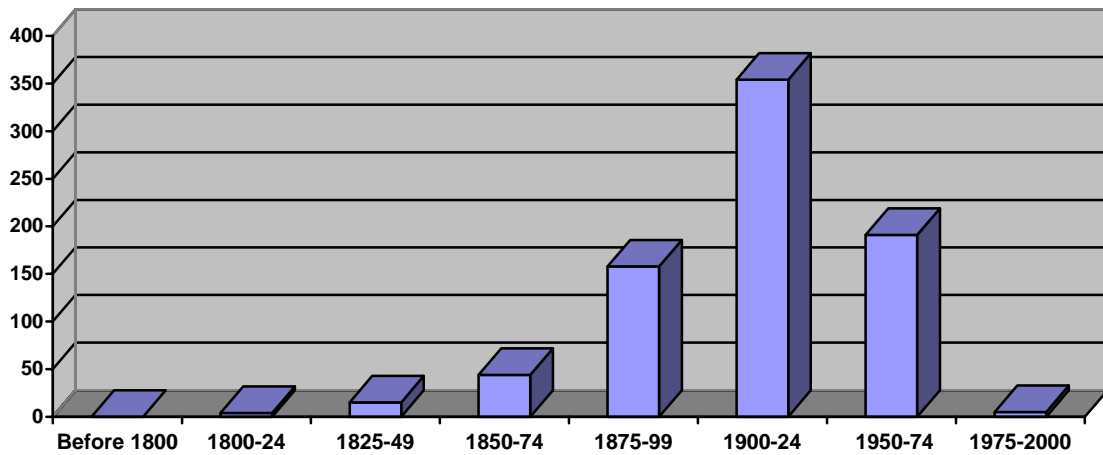
Figure 13: Number of resources documented by date range.

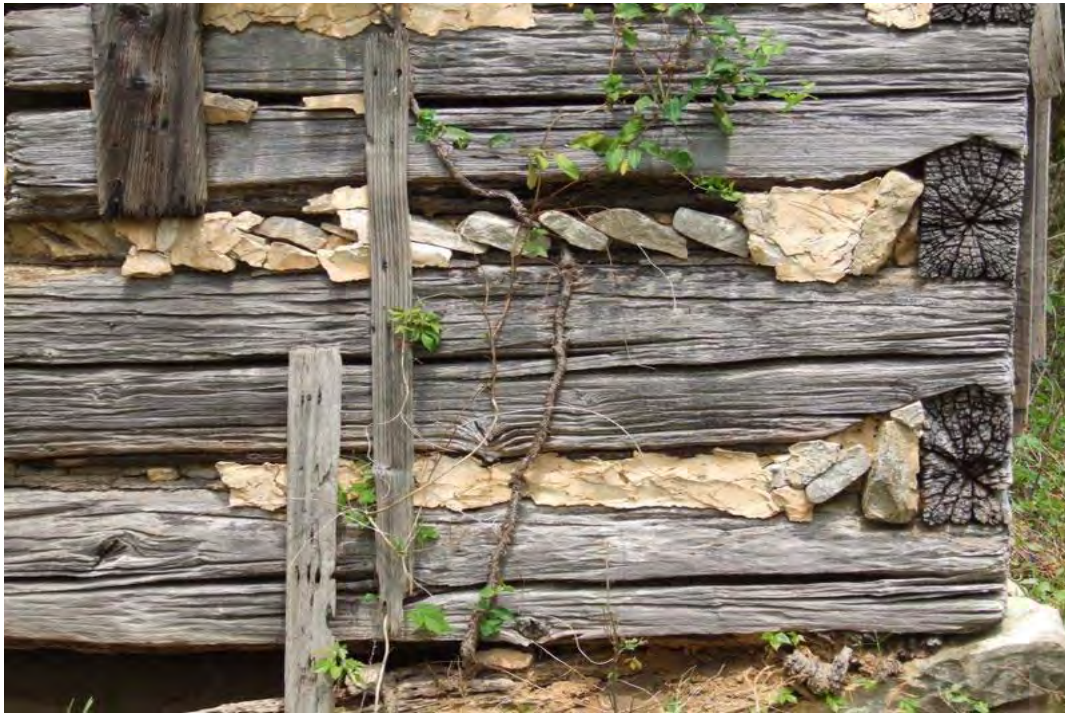
Figure 14: MN 80, Log House, early nineteenth century, Mt. Gilboa vicinity: detail of wall and corner notching.

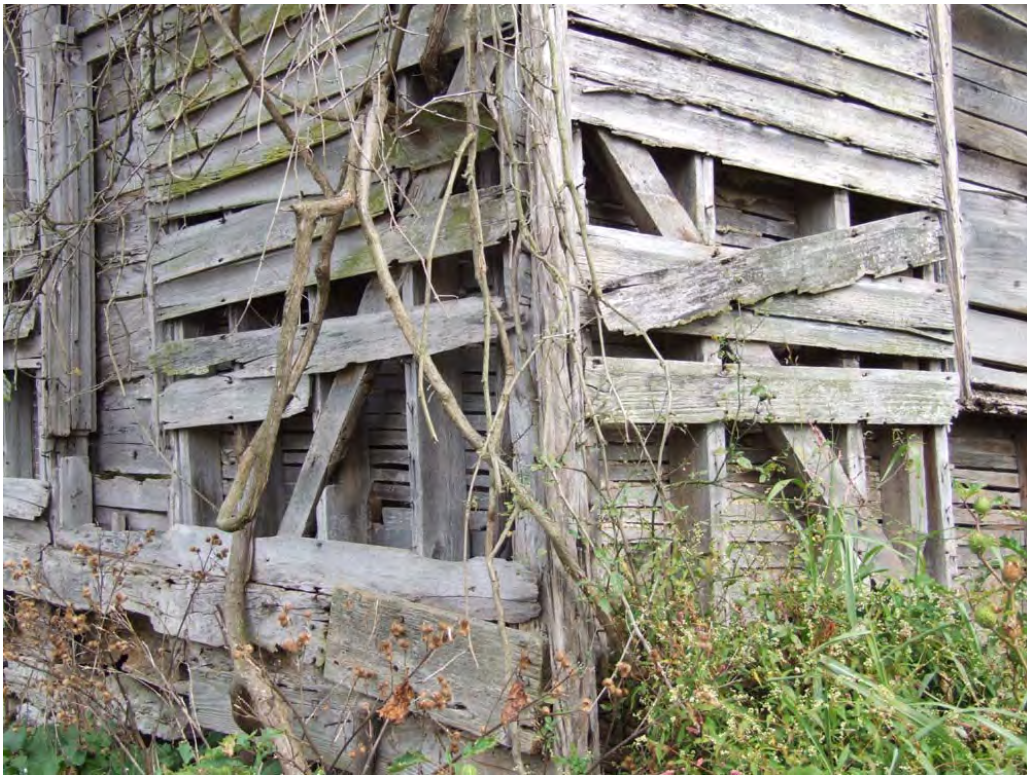
Figure 15: *WS 359, Frame House, 1860s-1880s, Maud vicinity. Detail of nailed frame with corner braces.*

stud framing (Figure 15) and vertical plank framing (also known as box framing: the chicken house in Figure 290 is a good example). Nailed stud framing includes structures with braced frames (Figure 15); balloon frames (Figure 16); and later developments, such as platform frames and related construction types still in use today. Houses framed by any of these methods have hollow spaces in the walls, enclosed by the exterior and interior finish materials applied to the frame. Vertical plank or box framing is a method often used for smaller houses or outbuildings (Figure 140). In this method, the walls are built of sawn boards, usually 8-12 inches wide, nailed to the sills (the horizontal timber at the bottom of a wall that lays on the foundation), and to the plates (the horizontal timber at the top of the wall that supports the rafters). The resulting walls have no cavities – they may be as thin as the boards in the case of an outbuilding, or have added exterior and interior finish in the case of a house. At WS 247 (Figure 73), we can see this vertical plank framing in the attic of the house where a balloon frame addition is attached to the original vertical plank frame portion of the house. Note that there, in the balloon framed addition, the studs are spaced quite widely apart.¹³

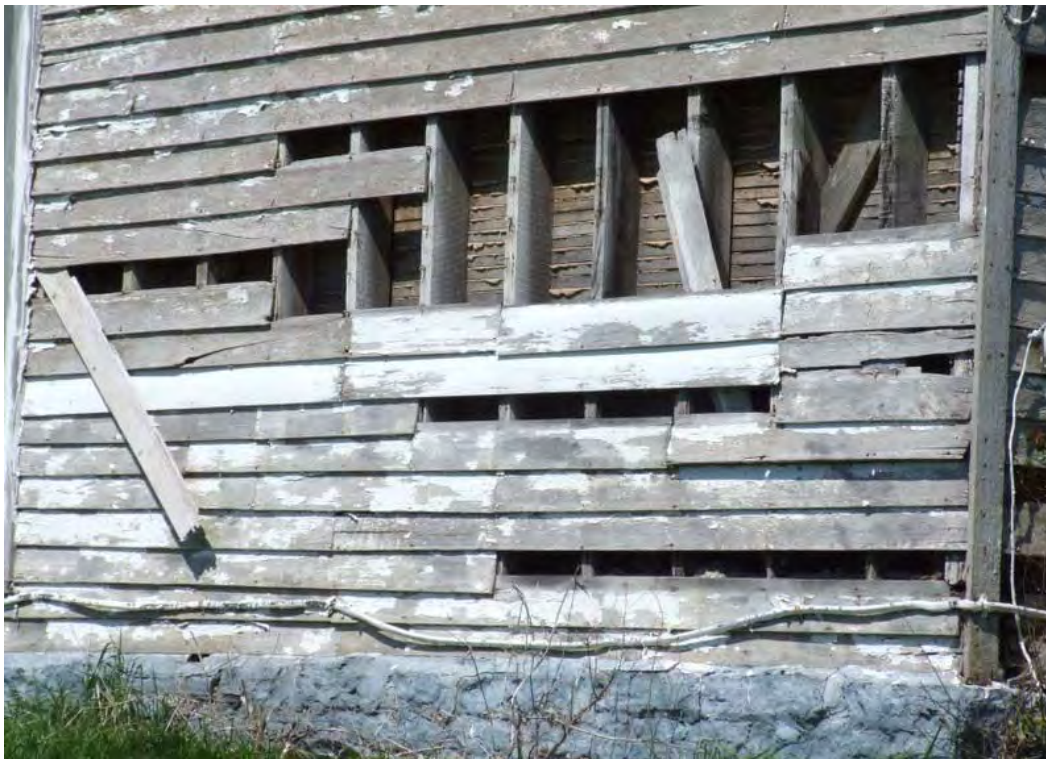
Figure 16: WS 721, *Frame House, 1870s-80s, Cisselville vicinity. Detail of stud balloon framing, in this case with 2 x 6 studs rather than the 2 x 4 that ultimately became the standard.*

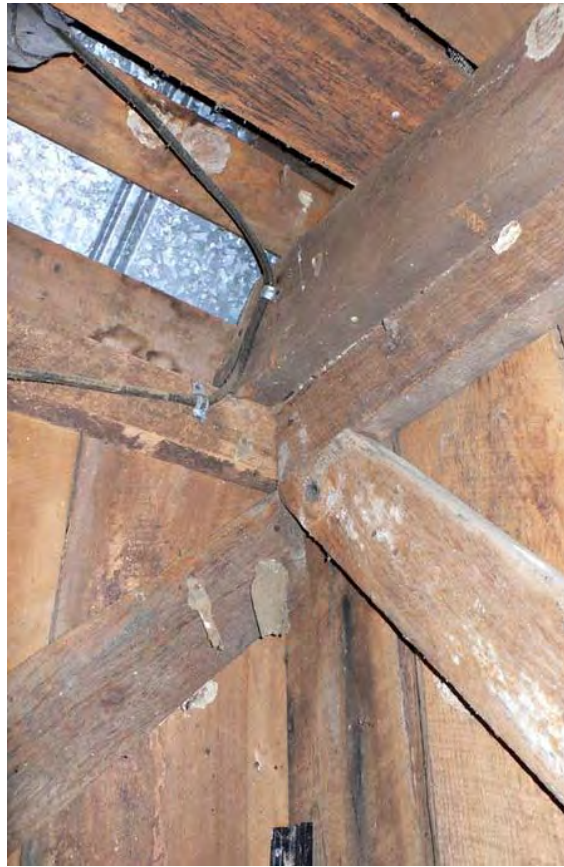
Figure 17: *MN 685, Frame House, late nineteenth century Gravel Switch vicinity. Detail of interior corner bracing in a vertical plank frame building.*

Several if not most of the wood frames documented in the survey area might be called hybrid frames. Some mix box framing with additional support from posts, studs, or braces. For example, MN 685 (Figure 17) has a plank frame with diagonal braces in the corners, but no corner posts. Another example, WS 362 (Figure 130) has a combination frame of corner and intermediate posts with lighter studs. The studs do not reach all the way to the plates in the loft, although exterior board walls do, giving the house some element of box framing.

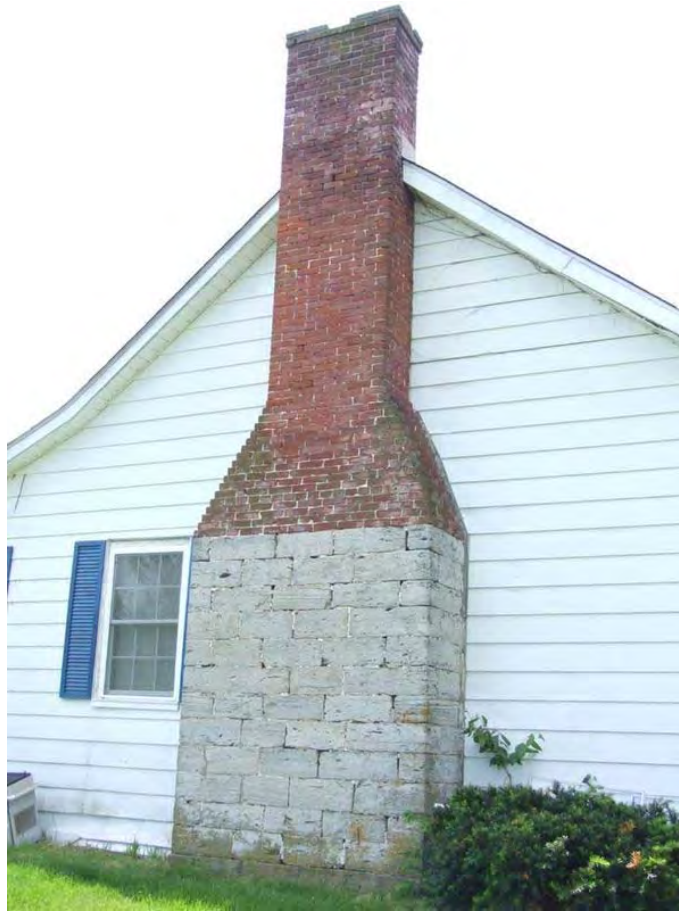
Figure 18: WS 834, Cut Stone and Brick Chimney, probably 1850s-60s, Sharpsville vicinity.

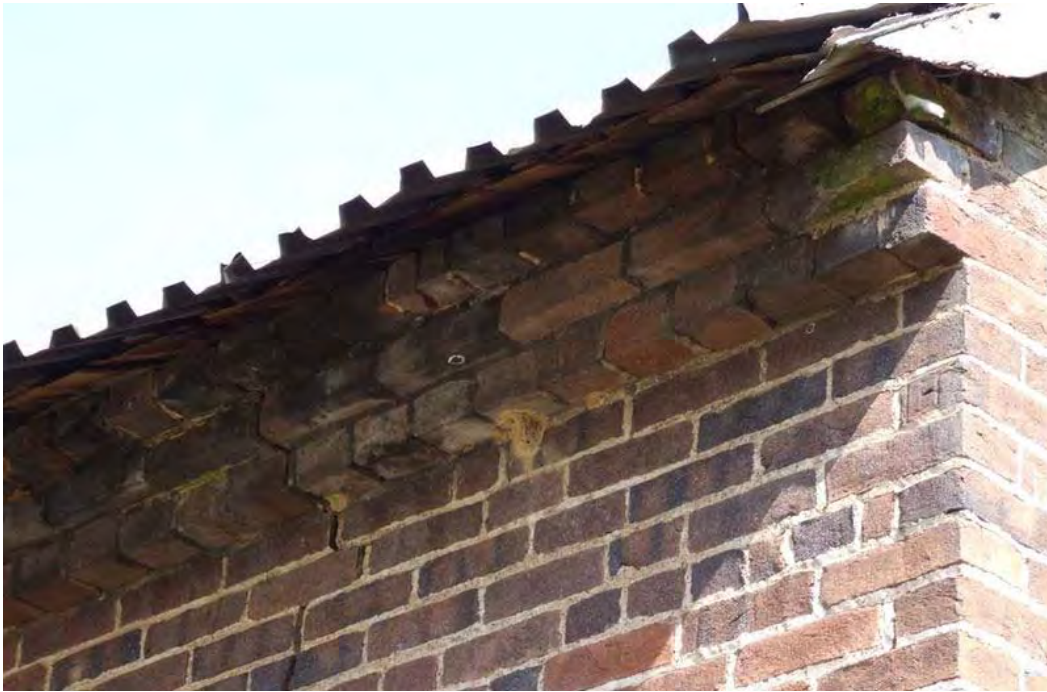
Figure 19: *WS 15, Meathouse, early 19th century, 1840s, Fredericksburg vicinity. A good example of a corbelled eave.*

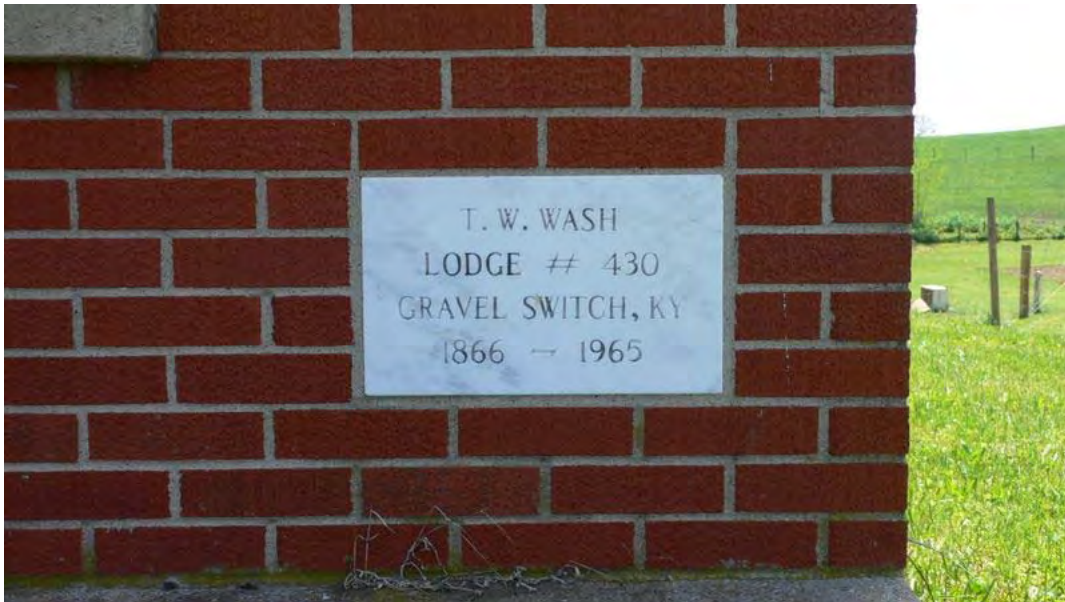
Figure 20: MN 677, T. W. Wash Lodge # 430, 1968, Gravel Switch, detail.

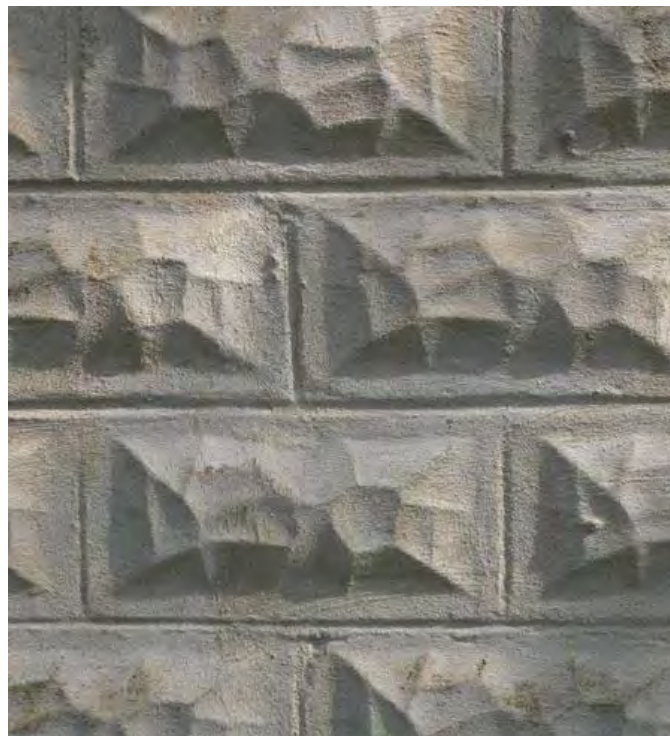
Figure 21: MN 672, Stone-faced Concrete Block House, mid 20th century, Gravel Switch vicinity, detail.

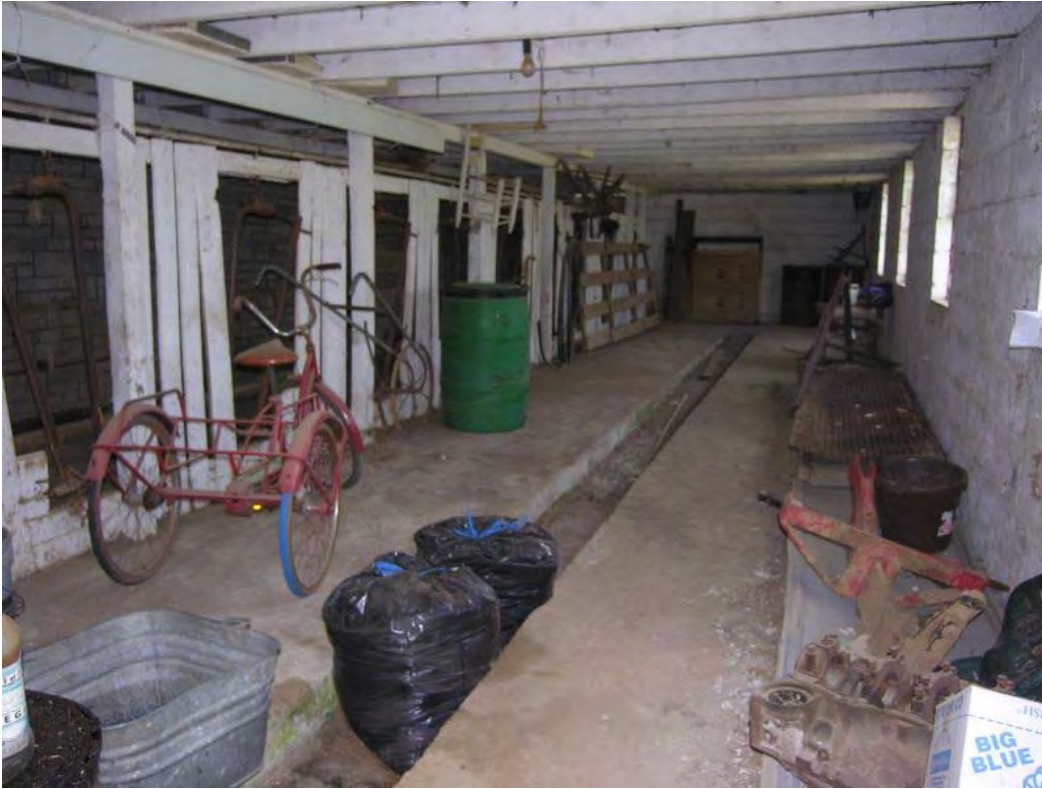
Figure 22: WS 974, Cheser Dairy Barn, 1949, Willisburg. Interior view of milking parlor with poured concrete floor and concrete block walls. See also Figure 276.

Another type of masonry construction is poured concrete, which became especially common for structures such as cisterns, foundations, sidewalks, and engineered structures such as bridges in the first half of the twentieth century. For example, a typical use in the survey area in agricultural buildings is found in the washable floors and slop troughs of milking and feeding parlors for cattle that were poured and molded on site (WS 974, Figure 22).

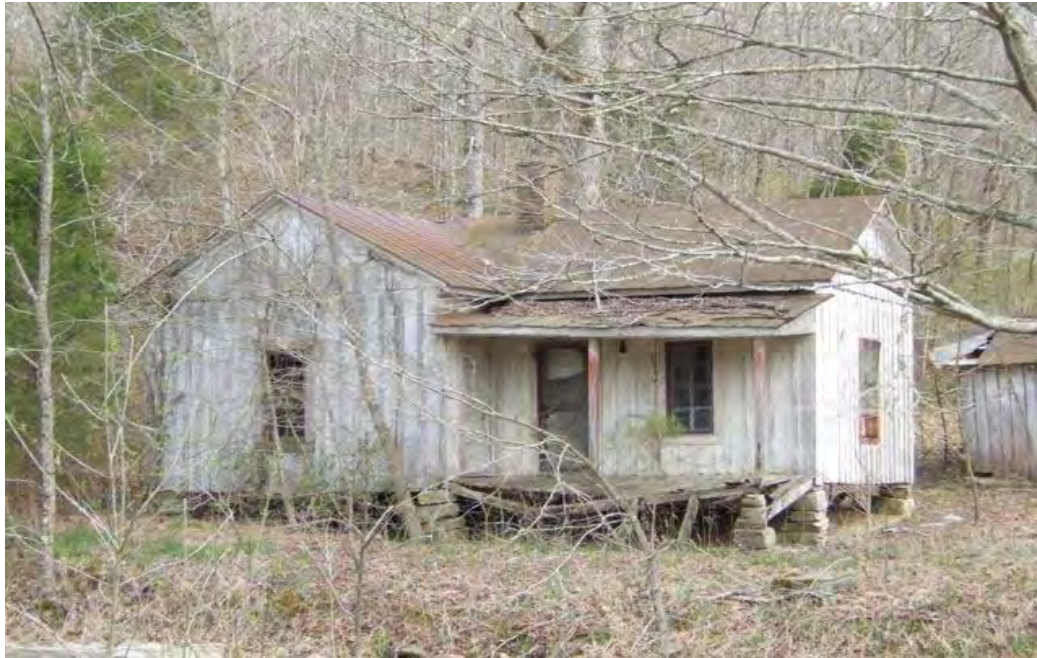
Figure 23: MN 650, Clark Tenant House, late nineteenth-early twentieth century, Rush Branch vicinity. The board and batten siding and the narrow window profiles reflect the Gothic Revival and Italianate styles. The interior, not documented, may well have other stylistic traits. A house such as this, situated in a scenic rural setting, could readily be renovated as a weekend retreat, hunter’s cabin, or a guest house.

In a historic sites survey, we consider the stylistic attributes of each historic resource, as architectural style helps us to categorize historic resources. Vernacular resources tend to reflect styles in regionally distinct ways which contribute to the sense of place in a given area (Figure 23). Style often helps the modern observer to place a building in time, since trends in design correspond to certain periods in history (i.e. – Federal, circa 1790-1820; Greek Revival, circa 1820s-1850s; or Arts and Crafts in the early twentieth century).

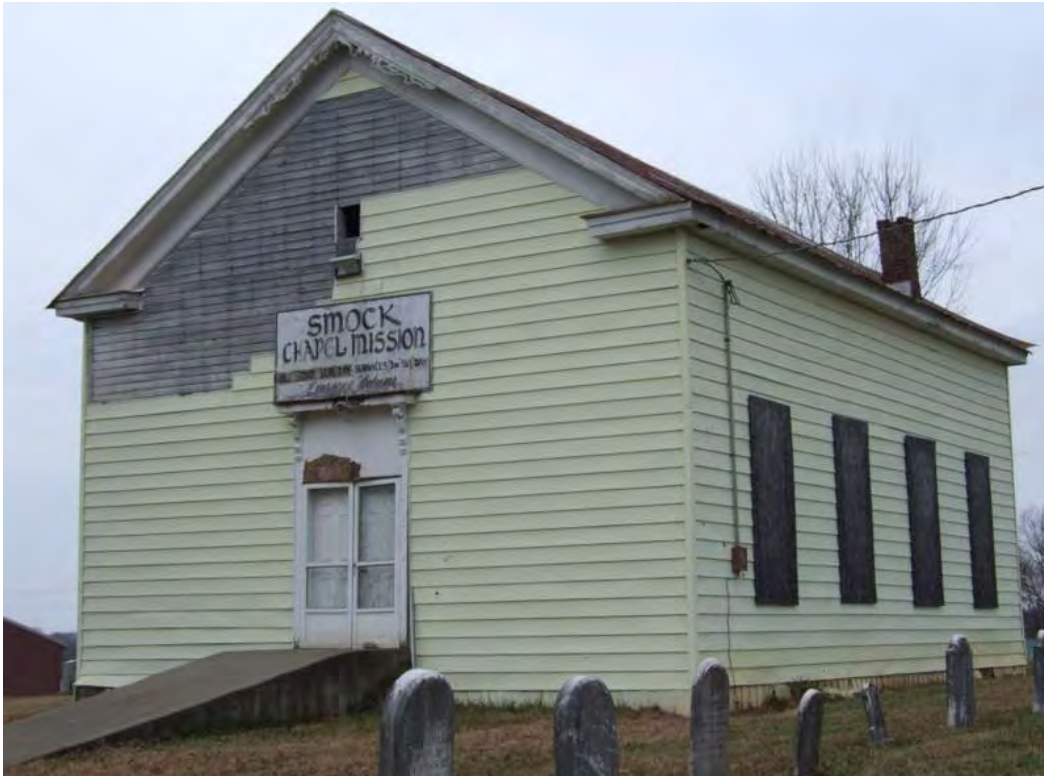
Figure 24: MN 231, *Smock's Methodist Chapel (now Smock Chapel Mission), 1870s, Loretto vicinity.*

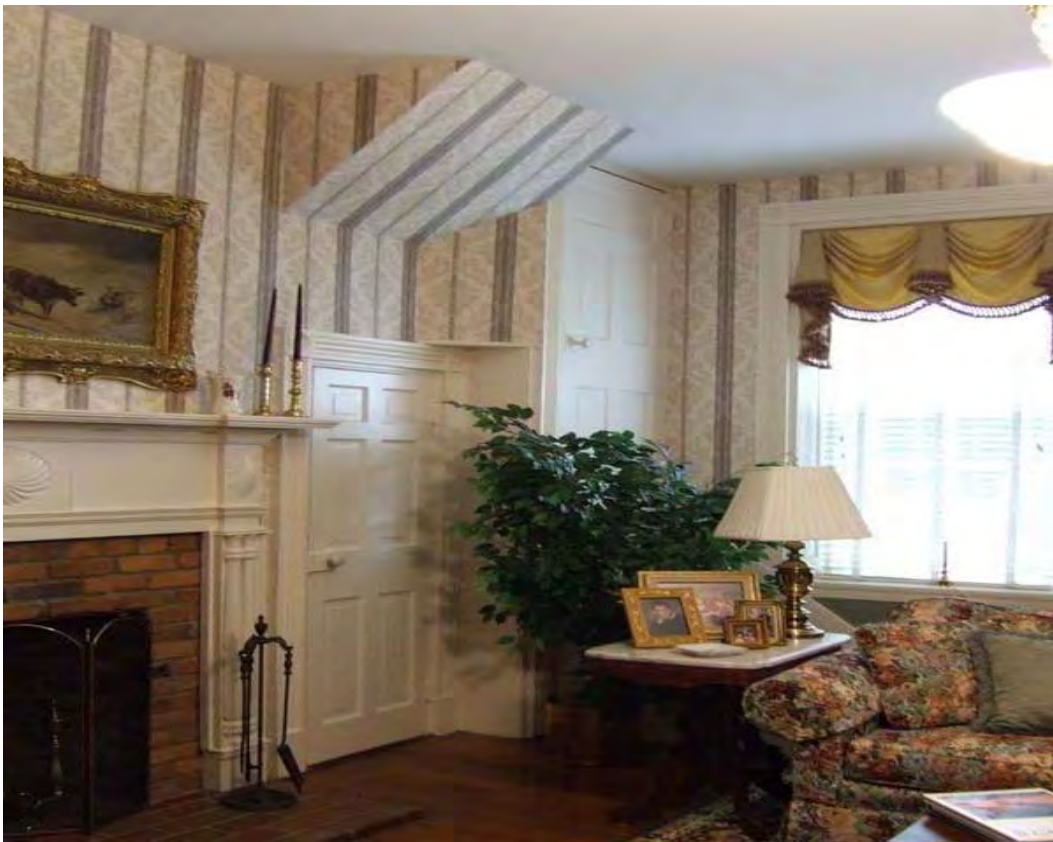
Figure 25: WS 27, Benjamin Pile House, early 19th century, Maud vicinity. Interior, showing mantle, closet, and stair doors. Late Federal style with some Greek Revival elements. Maud vicinity. See also Figure 27.

The earliest period style one will commonly encounter in most of Kentucky is the Federal Style (circa 1790-1825). The Federal style is characterized by elegance: thin straight lines, flat plains, narrow moldings (see Figure 25 and Figure 26). It tends to progress more toward these qualities over the period of its popularity. Early examples have wider moldings and window muntins, for example, but they narrow over the years. Early houses in this style often have exposed ceiling joists inside, while later examples have plaster ceilings. Baseboards are usually short, four-six inches high, with a beaded top edge. Window and door surrounds have beaded interior edges framed by a flat board and terminating in a narrow ogee molding. Principal rooms often have chair rail and elaborate, delicately styled mantles (Figure 25).

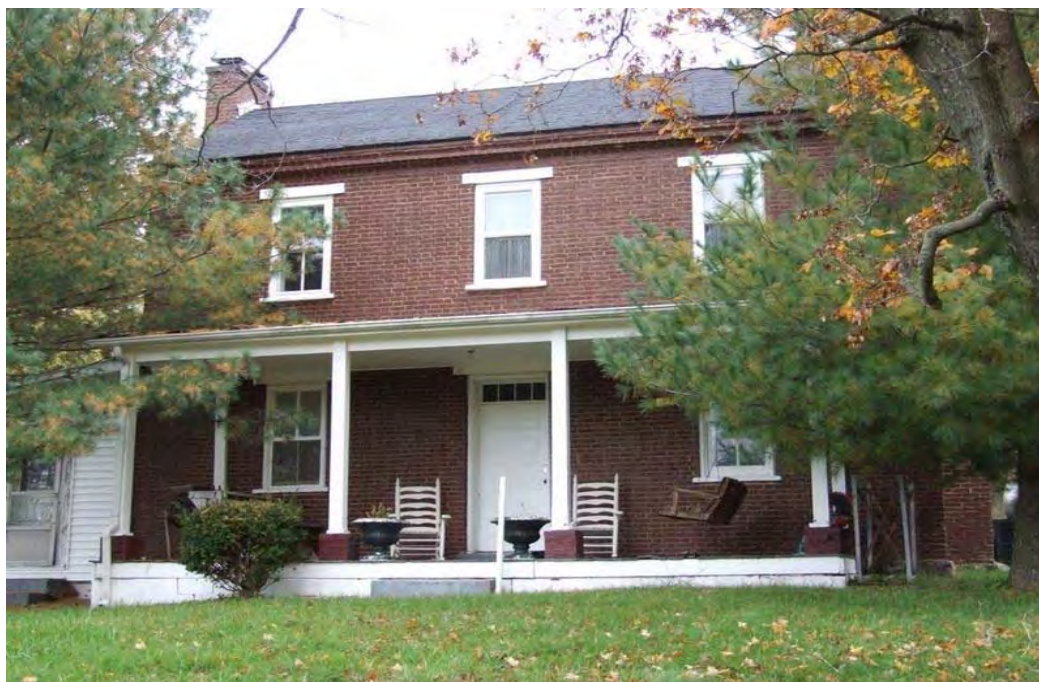
Figure 26: *WS 2, Gregory/Barlow House, early 19th century, Mooresville vicinity.*

The Gregory/Barlow house (WS 2, Figure 26), a previously surveyed house revisited in this project, is a modest but substantial brick example of the style. Notable features of this early nineteenth-century hall-parlor plan house include the center front door with transom windows above, and the corbelled brick cornice crowning the Flemish bond façade (for a discussion of the hall-parlor plan, see page 118). The porch is a later alteration. Near Bradfordsville, the house at site MN 919 (Figure 28) began as very similar form to WS 2. Probably a hall-parlor plan as well, the original main block of the house consisted of a two story section where the central three openings are located. Like WS 2, the front door was the center of the three openings; the door location is seen in the altered brickwork around the window where the door once was (Figure 29). In the Greek Revival period, 1830s-1840s, the house at MN 919 was expanded with a two-bay, two story section to the right, and a three bay single story service wing to the left of the main block of the house. The front door opening was converted to accommodate the window,

and a new entrance cut through the window opening to the right of that to center the door on the façade of the enlarged two-story section. The porch and a second story opening to the porch balcony were also added at this time. Even in this later period, the exterior of MN 919 remained more or less Federal in appearance, but the new interior spaces are more Greek Revival in appearance.

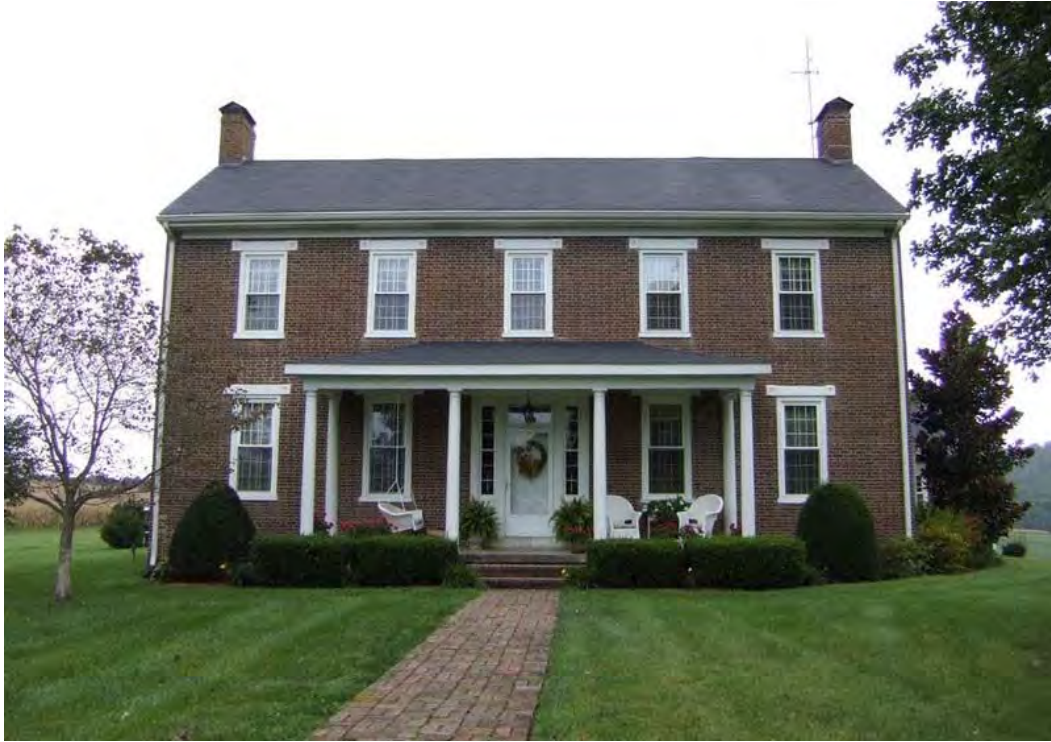
Figure 27: WS 27, Benjamin Pile House, Maud vicinity.

WS 27 (Figure 25 and Figure 27) is largely Federal in its styling. It is a good example of a standard large house of the period, a center-hall plan house, one room deep, also known as an I-house (see Figure 156). The alterations of WS 2 we discussed transformed it into a house of this same type, although there the service wing is attached to the side rather than stretching behind. WS 27 is really something of a transitional house with some of the trim inside being Greek Revival in style (Figure 38). MN 46, the Coppage House is an excellent example of the Federal style around 1825-30. It is also transitional with some elements of Greek Revival (Figure 161). It's a regionally unusual example of a side passage plan (Figure 160). The use of the plan here might be a link to the Maryland origins of so many of Marion and Washington County's early inhabitants.

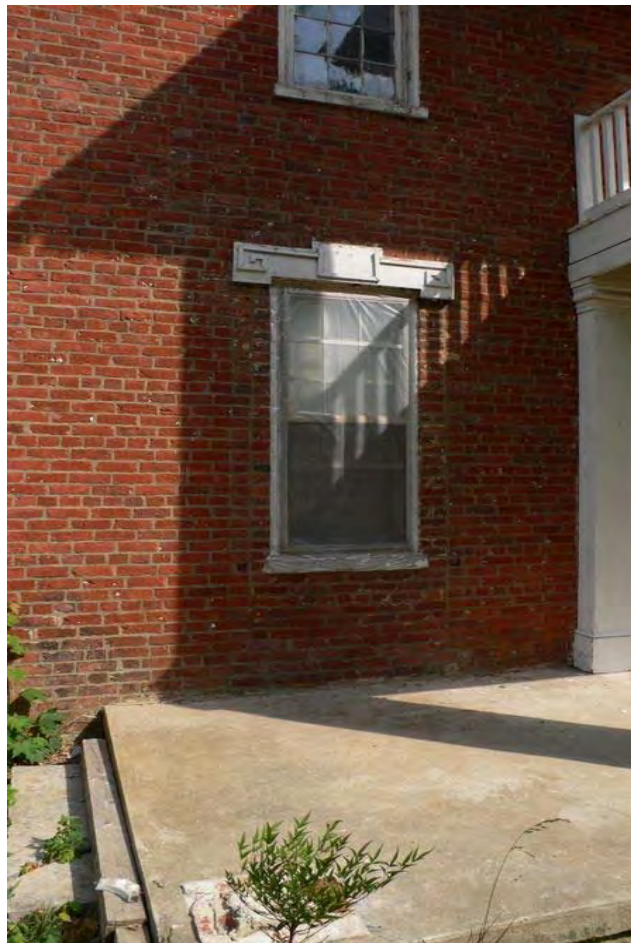
Figure 29: MN 919: detail of window to left of front door with brick infill scar indicating the opening was once a doorway.

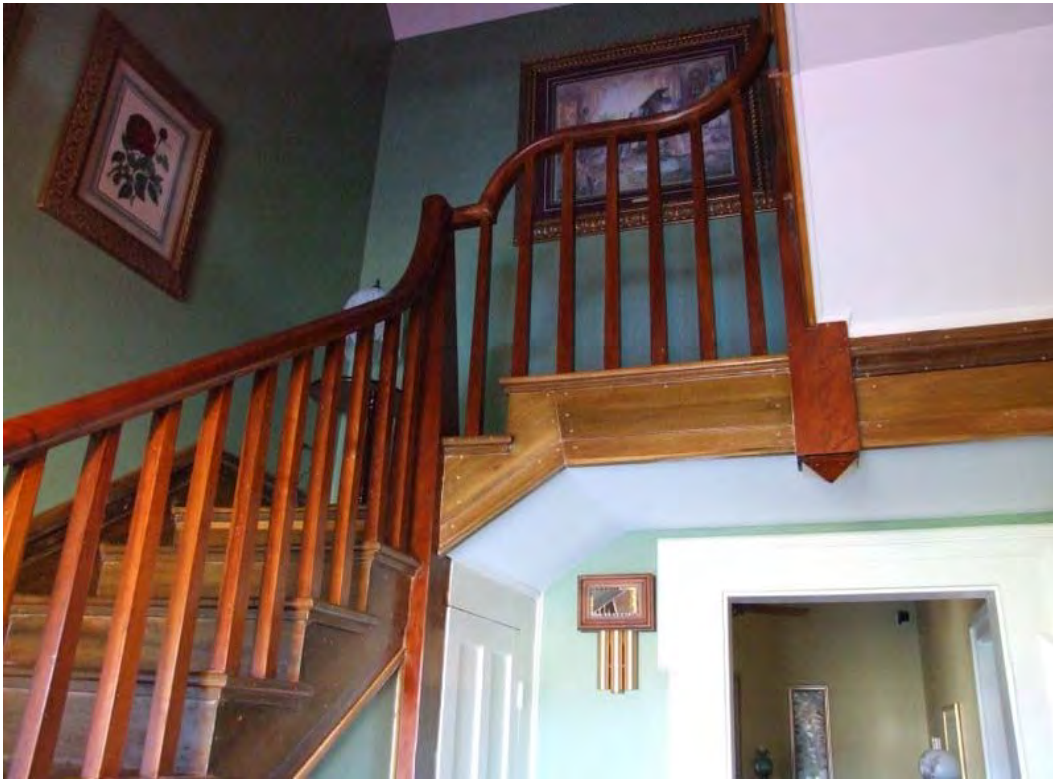
Figure 30: MN 336, “Old Loretto Farm” House, mid-nineteenth century, Loretto, stair detail. Stylistic details in this house have elements of Federal, Greek Revival, Gothic, and Italianate styles. See also Figure 31.

have some Federal details. At MN 336, for example, (Figure 30 and Figure 31) a house classified as mid-19th century romantic and Gothic, we find elements of Federal style in details such as the balusters of the staircase (Figure 30). Here, even though the house principally reflects later styles, some of the original materials still reflect the older Federal style. In this case it suggests that the house might have an older core with later historic alterations. A Federal detail that is often found in houses of the period, even ones with few other style markers, is a narrow bead molding marking the edges of base boards, inside edges of window and door openings, exposed structural elements such as ceiling joists, and the edges of boards aligned together vertically in batten doors or partition walls. The recognition of details such as this helps us to understand the history of a building. In the case of MN 336, it gives us a clue that the house might be older than it first appears to be, which needs further investigation for confirmation. A different case is found at WS 316. There, the stair door there has beaded edges on four of its boards, and then another board, the one on the left in the photograph, has no bead (Figure 32). The unbeaded board is clearly a later extension of the original door width: longer battens are scabbed on to accommodate the extra board, and the original battens remain in place. The door appears to be a narrow, late Federal door, salvaged in the later nineteenth century for use in this house. Salvage and reuse of architectural materials was a common practice in the construction of houses, and can sometimes confuse our attempts to date them. Knowledge of period styles and technologies is important in helping us to “read” old houses in this way to discover how they were built and how they have been altered over generations.

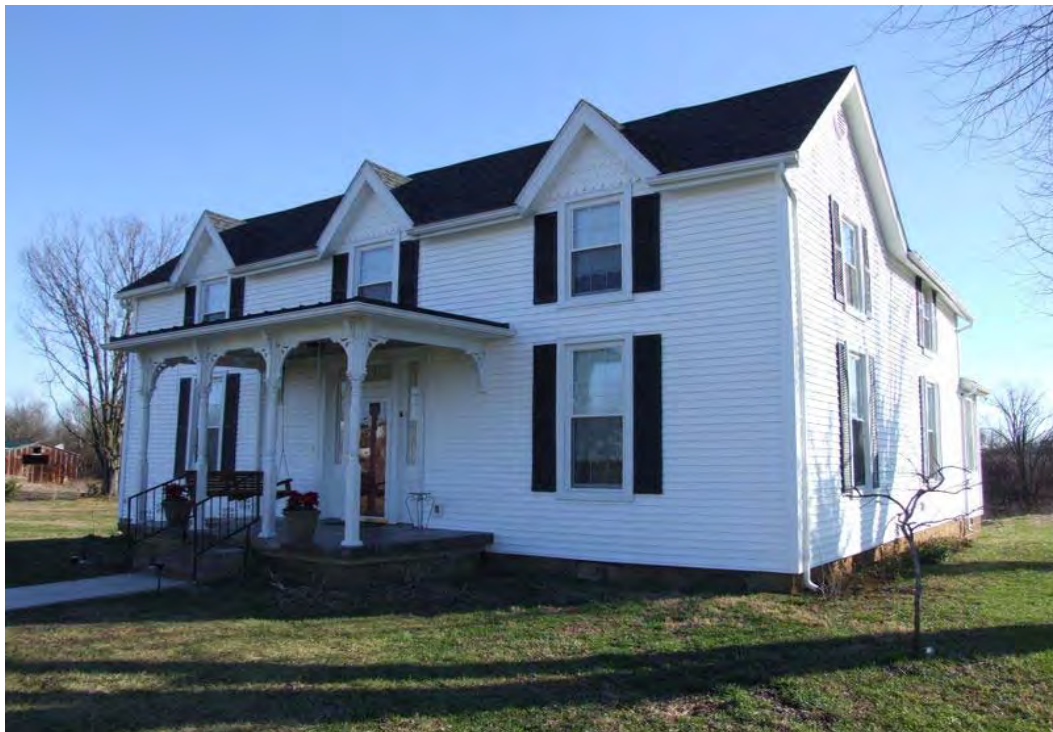
Figure 31: MN 336, exterior. The survey forms codes its stylistic influences as mid 19th century Romantic and Gothic Revival, but the exterior also shows influences of Queen Anne and Shingle style, due to a series of alteration and renovation. See also Figure 30.
