A Survey of Historic Sites in Rural Marion and Washington Counties, Kentucky

A Report on the Findings of the *Rural Heritage Development Initiative Survey*
A project funded by a National Park Service Preserve America Grant

Kentucky Heritage Council

The State Historic Preservation Office, 2009

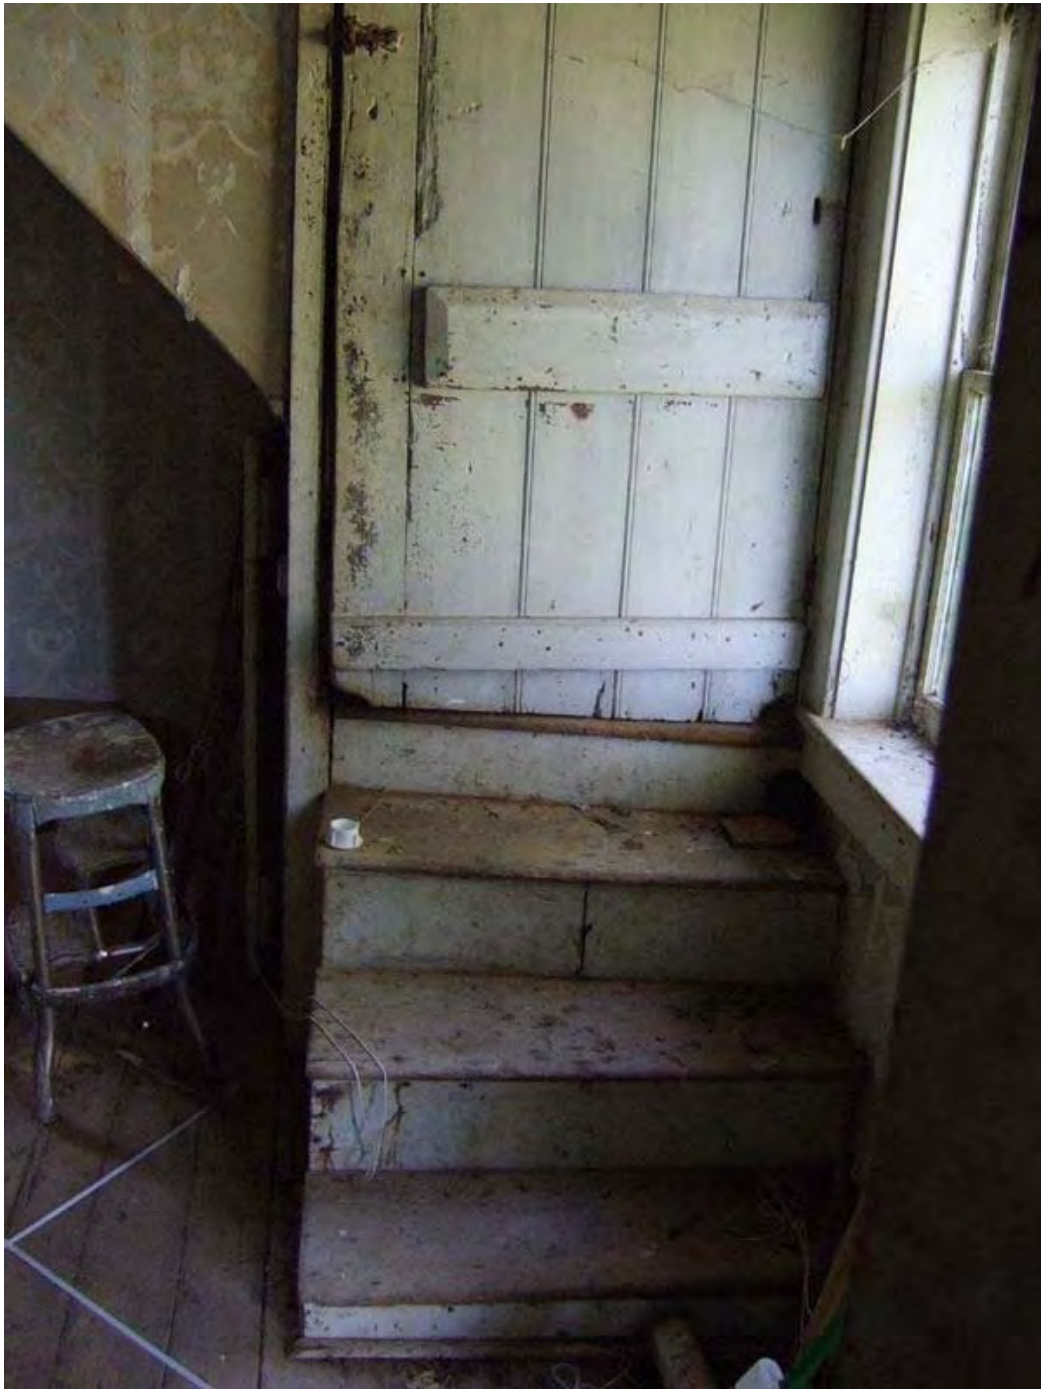
Figure 32: *WS 316, Slack's Cabin, mid-late nineteenth century, near Fredericktown: interior detail showing corner stair and door. The door is a historic example of architectural material that has been salvaged and reused. See Figure 129 for exterior view.*

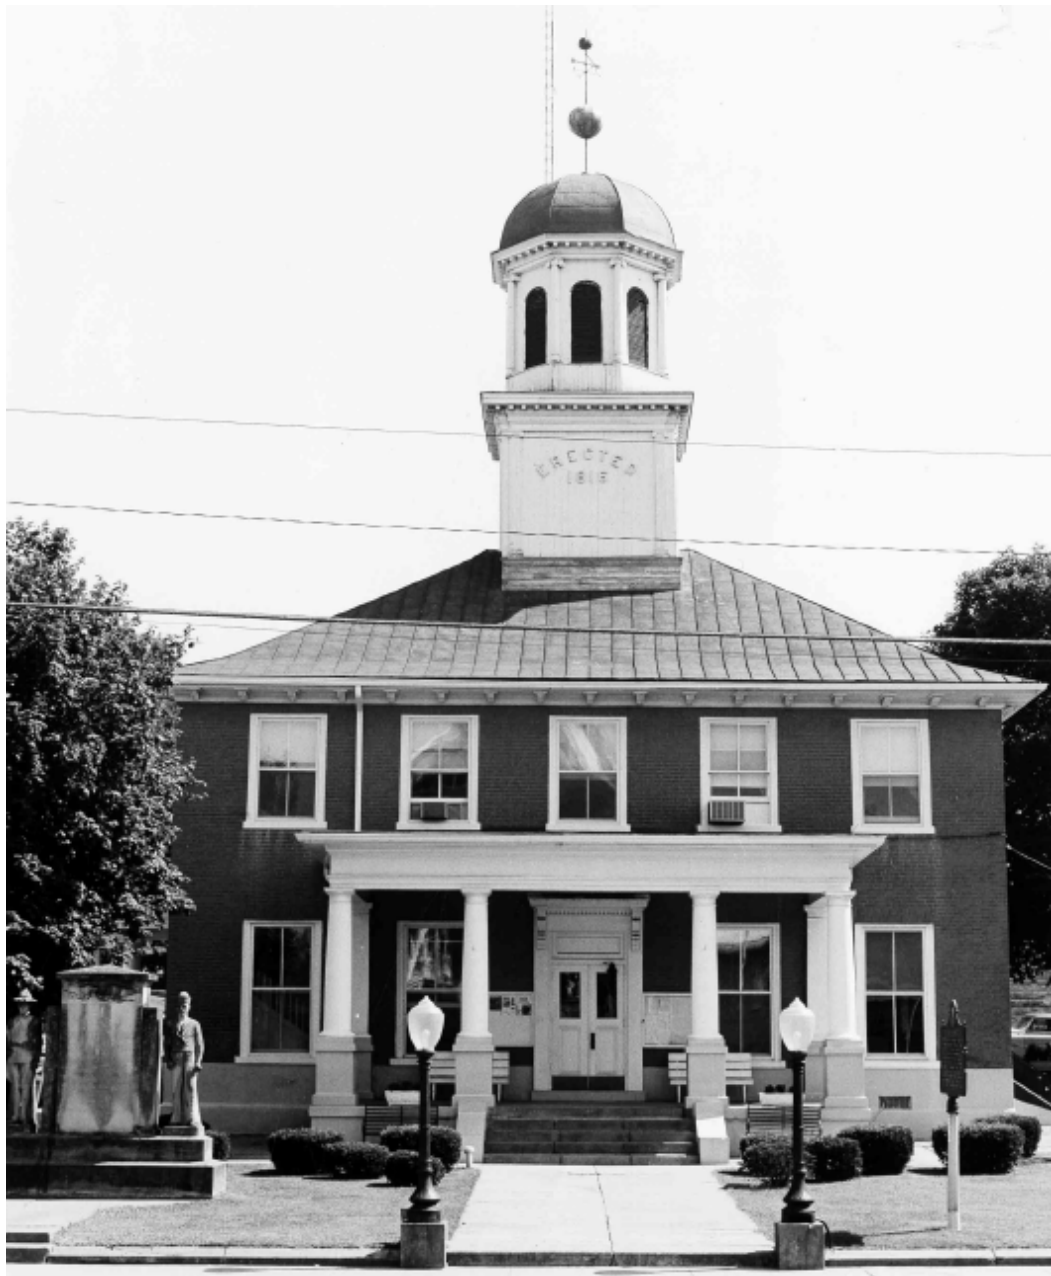
Figure 34: WS-S 2, Washington County Courthouse, 1816, Springfield. The cupola was added circa 1840. The Doric porches are a product of a 1918 renovation. National Register Photograph, Jack Bobbitt, KHC, 1974.

Many older houses were updated in the Greek Revival period through the addition of such porches. The Washington County Courthouse (Figure 34), a Federal style public building, was updated in the Greek revival period with the addition of a cupola. The porches there that look like they may be Greek Revival style came in the early 20th century Colonial Revival period.

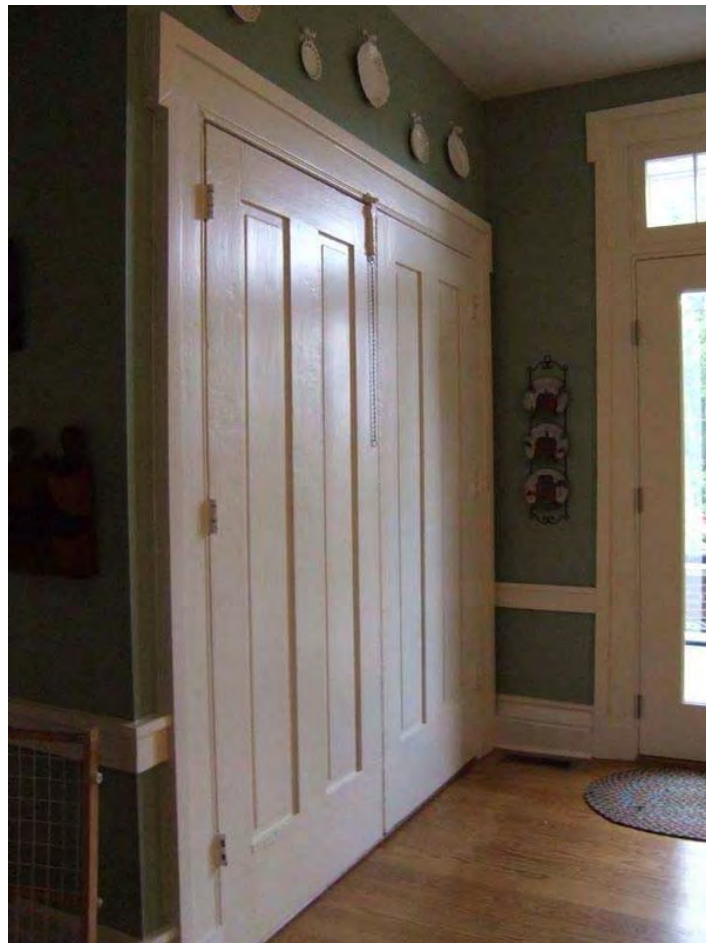
Figure 38: WS 27, *detail of Doors and Trim in Front Hall. See also Figure 25 and Figure 27.*

Federal detailing persists in the Greek Revival period. It might be credited to builders with long careers and older tools, or to their clients' preference for established styles. At WS 27 (Figure 38) for example, we see the persistence of chair rail, a popular Federal feature typically abandoned in the Greek Revival period. Houses built earlier in the Greek Revival period are more likely to retain some Federal details. Houses late in the era, say 1860s-80s, are more likely to be mash-ups with newer styles such as Italianate, as at MN-1, the Bradford House (Figure 39- Figure 40), or Gothic, as at MN 683 (Figure 45- Figure 46). The same process of mixing in new styles with existing ones continues on to the present day.

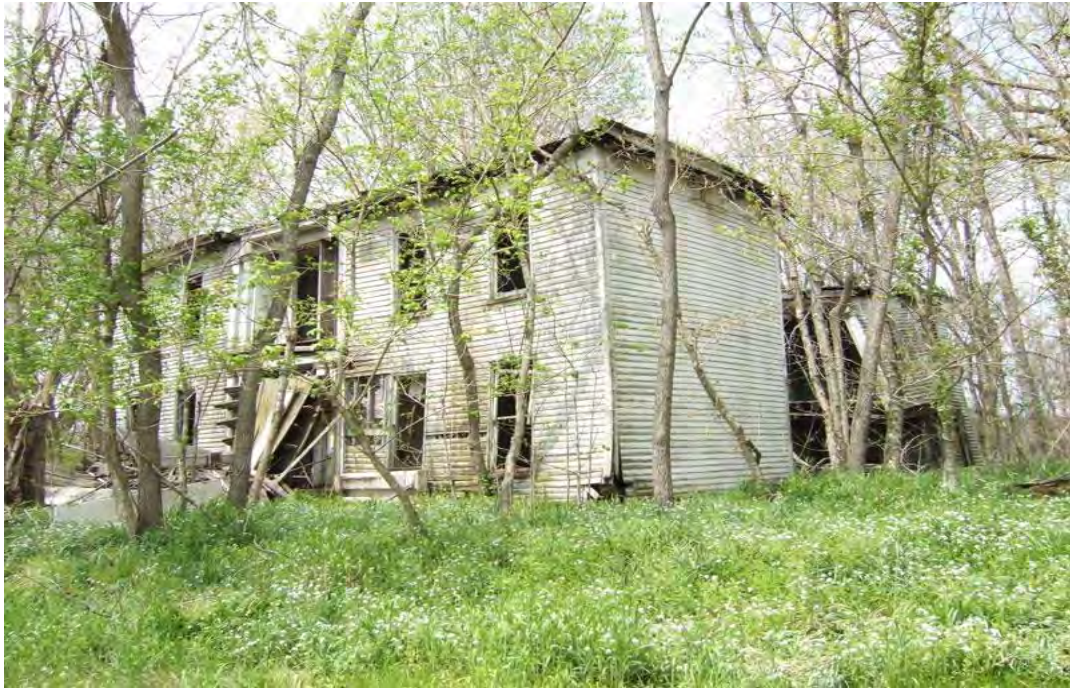
Figure 39: MN 1, Bradford Place, second quarter nineteenth century, Bradfordsville Vicinity. Now badly deteriorated, the Bradford house has elements of Greek Revival and Italianate styles. See also Figure 40.

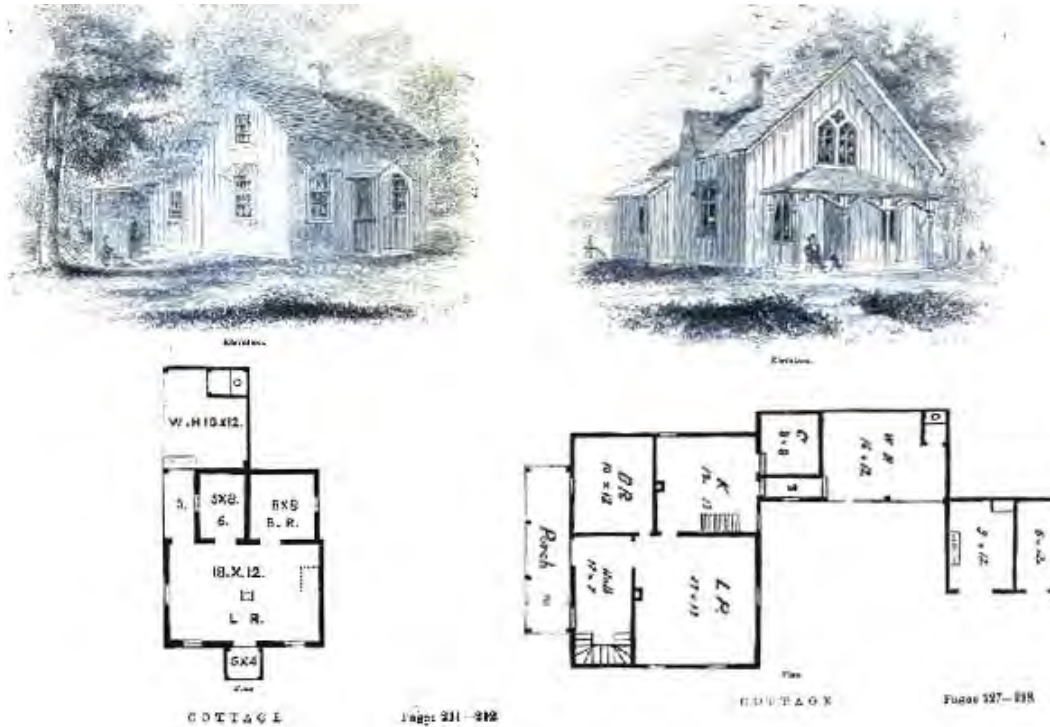
Figure 44: Plans for cottages from Lewis F. Allen, *Rural Architecture, Being a Complete Description of Farm Houses, Cottages and Outbuildings...* (New York: C.M. Saxton, 1852).

The styles he promoted, chiefly Gothic and Italianate, were seen as a means toward the end of establishing a more civil society. His houses covered the spectrum of society so that even the tenant or laborer's cottage could be a stylish dwelling. Similarly, Lewis F Allen provided designs (Figure 44) for small cottages suitable for farm tenants:

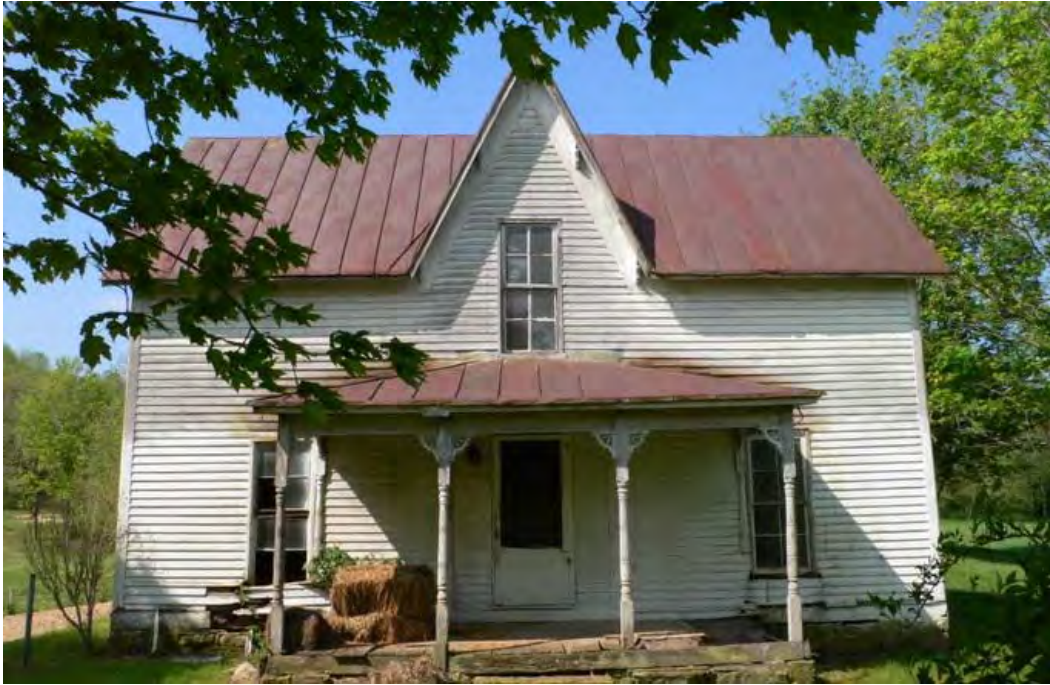
Figure 45: MN 683, Balloon frame single cross gable Gothic/eclectic style house, 1860s-1870s, Bradfordsville/Gravel Switch vicinity. See also Figure 43, Figure 46, and Figure 47.

MN 683 (Figure 45) is an excellent single cross-gable example, located near Jones Creek, near Bradfordsville. It is a three-bay I-house with a narrow vestibule entry rather than a center hall, flanked by two rooms, with an ell stretching out behind the main body of the house. The tall, narrow cross gable identifies with the Gothic style, but the brackets in the gable and the tall windows reflect the Italianate Style. The two front rooms share a central hearth situated behind the front vestibule. The trim inside is more Greek revival in flavor than Gothic, the mantles having wide, flat surfaces rather than angular pointed moldings. The room to the left of the front entry is the less elaborate of the two main rooms and, from there, a door to the left of the hearth opens to a winder stair. The stair leads to a room above which has no access to the rest of the second story - a private bedroom chamber. The room to the right of the front entry has a showier mantle with a Cupid's bow arch poised above the coal grate. A smaller urban example, the Mudd House, or WS 938, in Briartown (see Figure 48: compare it to Allen's Cottage on the left in Figure 44), outside of Springfield, is either a one or two room plan with a shed room behind the main body of the house, two stories tall, with the single and central cross-gable dormer framing the lone second story front window as the single nod to Gothic. The peaked cross gable very effectively gives this small house a sense of scale and presence.

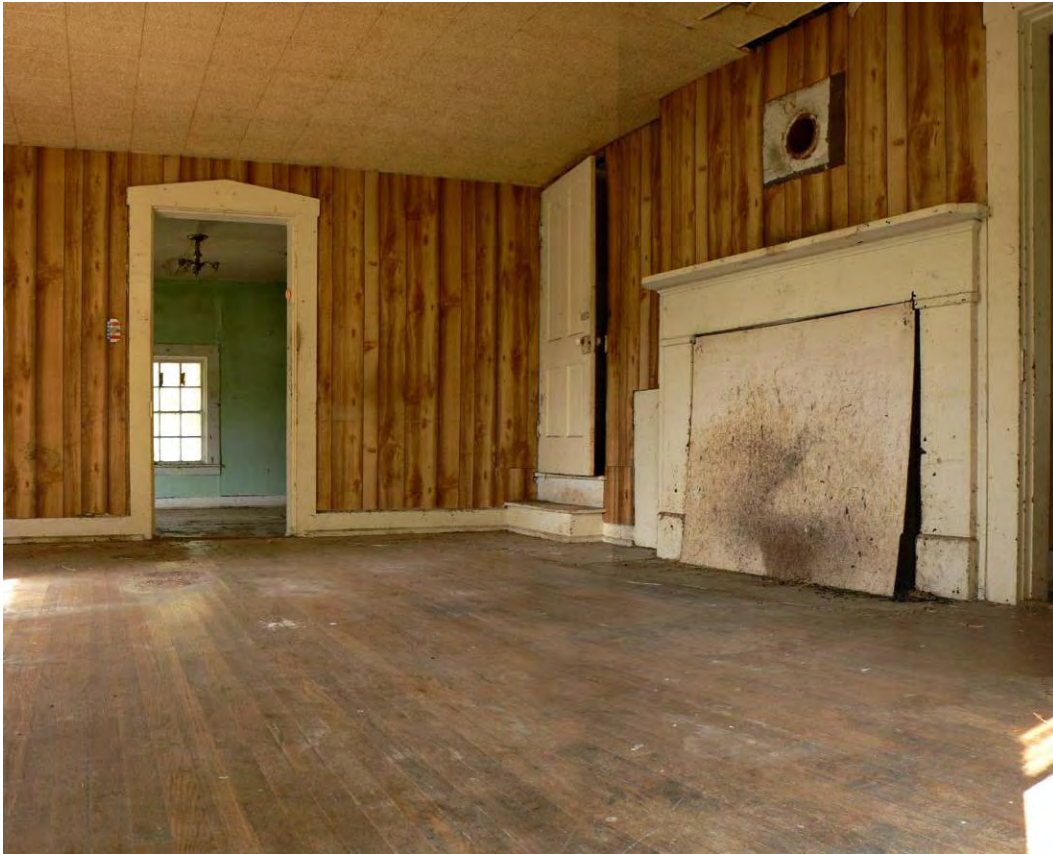
Figure 46: MN 683, Interior of left hand room, showing Greek style mantle & door surround. See also Figure 43, Figure 45, and Figure 47.

Seventeen newly surveyed structures in the RHDI survey area were classified as Greek Revival, bringing the total to 68, but that doesn't reflect the larger impact of the style on the region's architecture. The mantle and door surrounds at MN 683 (Figure 46 and Figure 47), for example, are very much Greek Revival in style, but are contained within a house classified as Gothic Revival (Figure 45). As late as the 1880s, as we have seen, the style is still often found in the

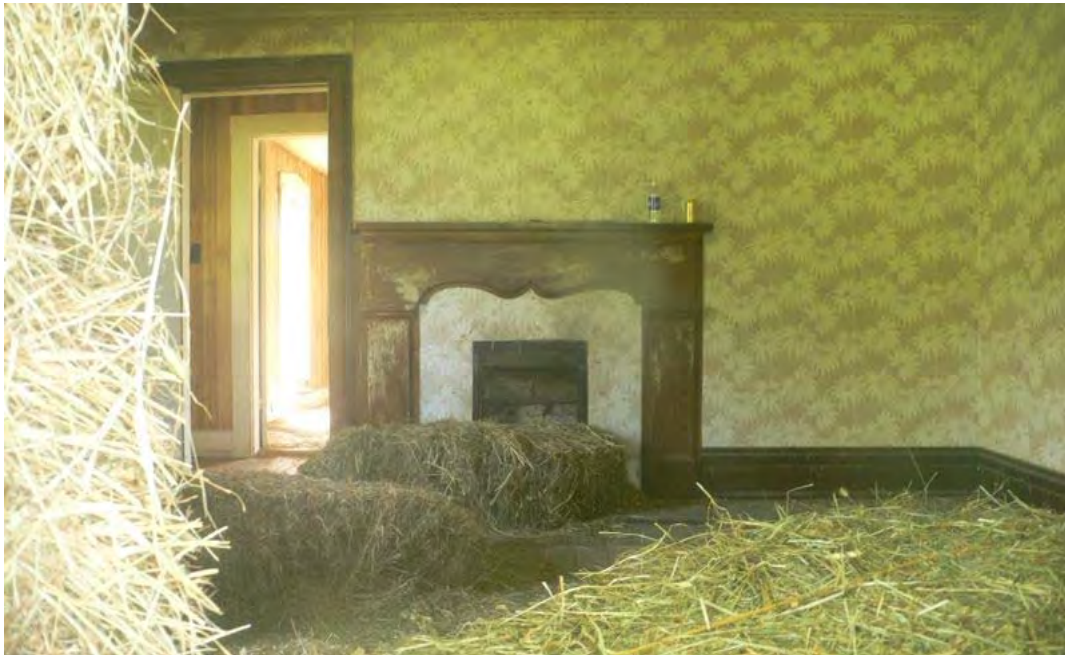
Figure 47: MN 683, Greek style mantle in right hand room. See also Figure 43, Figure 45, and Figure 46.

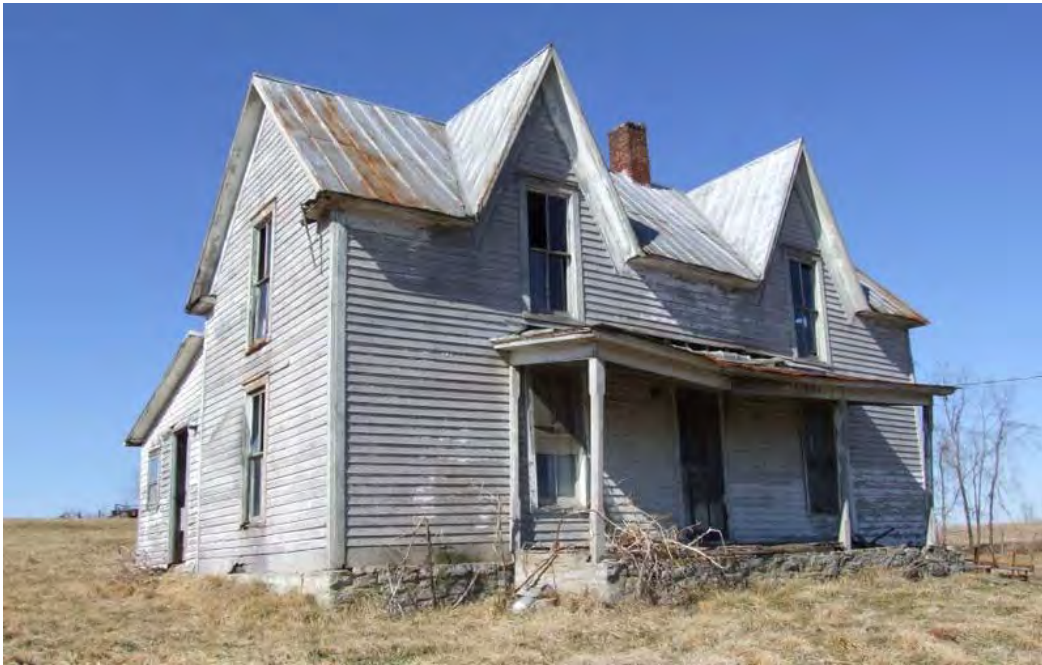
Figure 55: WS 523, frame two-gable Gothic house, center passage plan, late nineteenth century, Mackville vicinity.

Double cross gable examples are also common in the two-county area, usually appearing in two-story medium size houses with double pen or center hall plans. WS 523 (Figure 55) has a center hall plan and interior chimneys serving two rooms flanking the hall, just like the single gable houses mentioned above. Here, though, the second floor bedrooms, rather than the upstairs stair hall, enjoy the additional light and space afforded by the dormers. The house has some elements of Colonial, Queen Anne, and Italianate styles. Service rooms are in a shed that runs the full length of the back of the house. WS 852 (Figure 57 and Figure 56), near Hardesty in Washington County is another example, with windows in the tall, narrow aspect ratio of the Italianate style, the gables sheathed in a chevron pattern echoing shingle or stick style, the porch basically Queen Anne, Eastlake, or most simply, “Victorian.” Otherwise, the form of the house is remarkably similar to that of MN 683 (discussed above, Figure 45), a lobby entry, central chimney, three bay, and two equal sized front rooms.

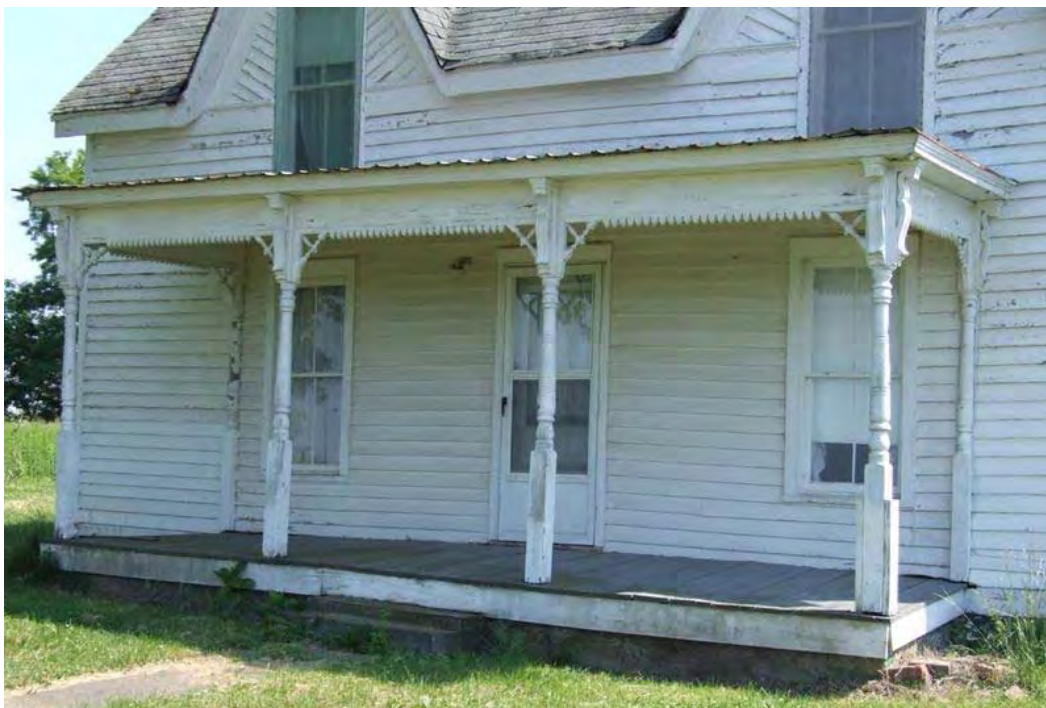
Figure 56: WS 852, detail of porch. Frame two-gable double pen house, late nineteenth century, Hardesty vicinity. See also Figure 57.

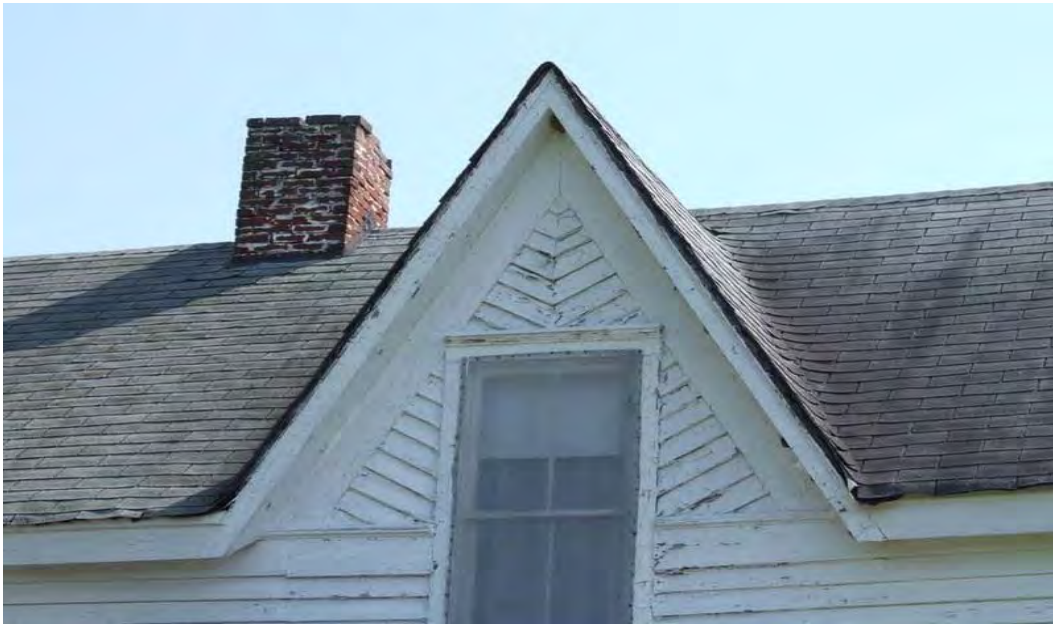
Figure 57: WS 852, *Detail of cross gable. See also Figure 56.*

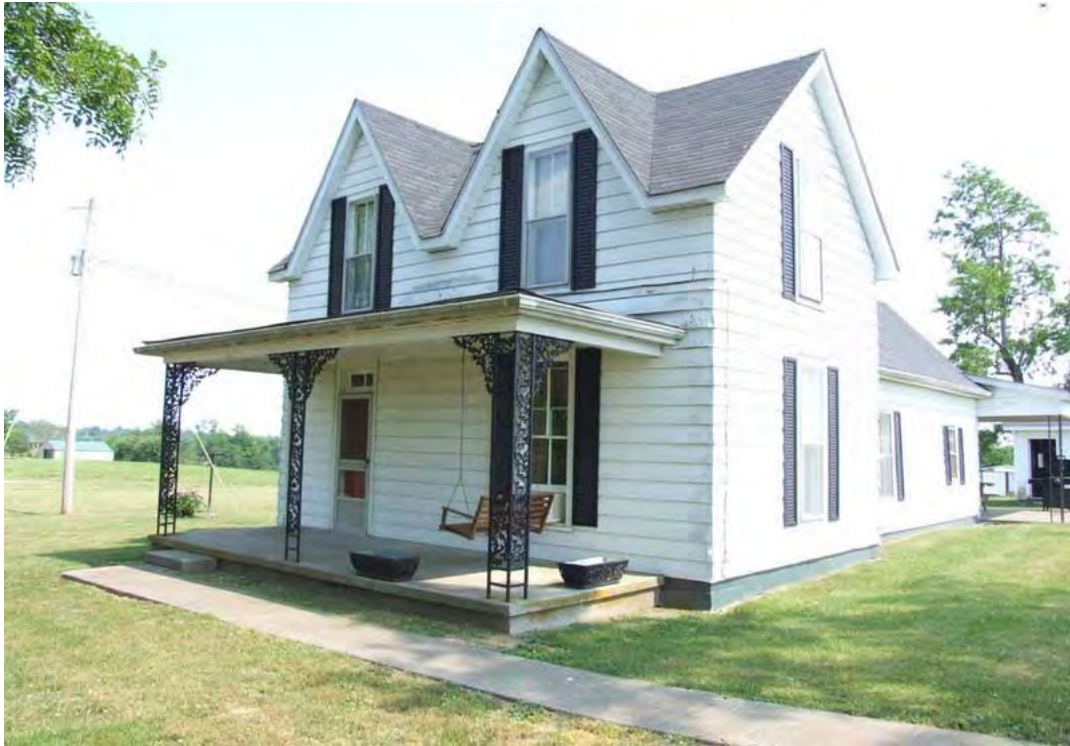
Figure 59: *WS 869, late nineteenth-early twentieth century, Springfield vicinity.*

Eighteen two-gable examples were documented, and they can be divided into three major types. One house alone, WS 869 (Figure 59), has an asymmetrical two-bay door/window arrangement on the first floor, suggesting a possible side passage or hall/parlor plan. Nine examples are two-door, double pen plan houses, a type discussed in some detail below in the section on house plans. These are characterized by a 4-bay fenestration on the first floor, window/door/door/window, as at MN 911 (Figure 63), MS 190 (Figure 62) and WS 1115 (Figure 64). Seven

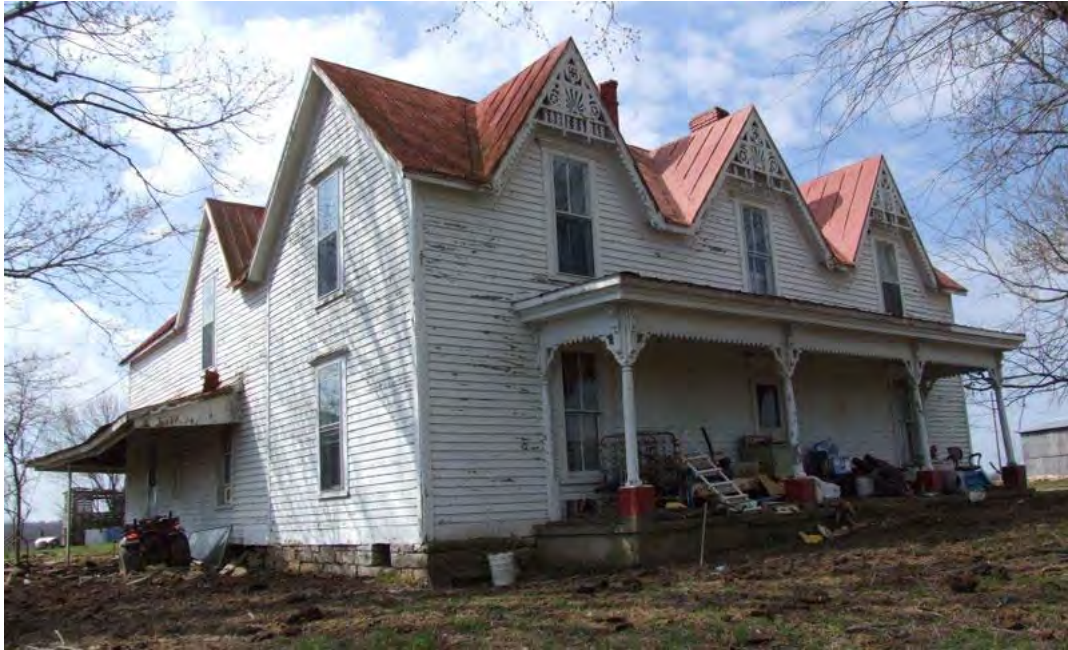
Figure 65: *WS 718, Cocanaugher house, late twentieth century, Texas vicinity.*

Larger Gothic houses sometimes have three front gables for maximum effect. Five examples were documented in the region. WS 718, the Cocanaugher house (Figure 65), is an excellent example, a center hall plan house with unusually elaborate turned and sawn embellishments on the porch and the gables, and another projecting gable along the long ell side of the house. The ornament really alludes more to other prevalent styles of the period, stick or spindle style, Queen

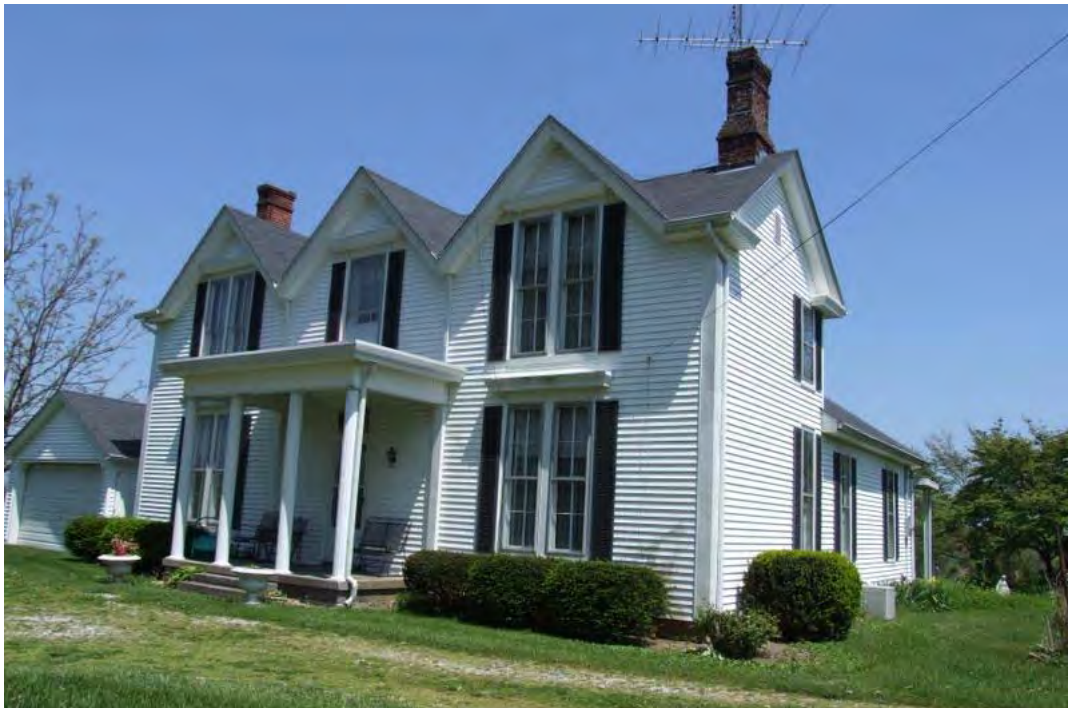
Figure 66: *MN 552, Cecil house, late nineteenth century, St. Mary vicinity.*

Anne, and even some elements of Italianate in the porch cornice. Again, the major element of Gothic style is the use of gables to create a distinctive roof line. We see even less influence of the Gothic in the three gable house at MN 552 (Figure 66) where Italianate, Greek Revival, and perhaps Colonial Revival details are much in evidence. Other three-gable houses are shown in Figure 31, Figure 67, and Figure 68

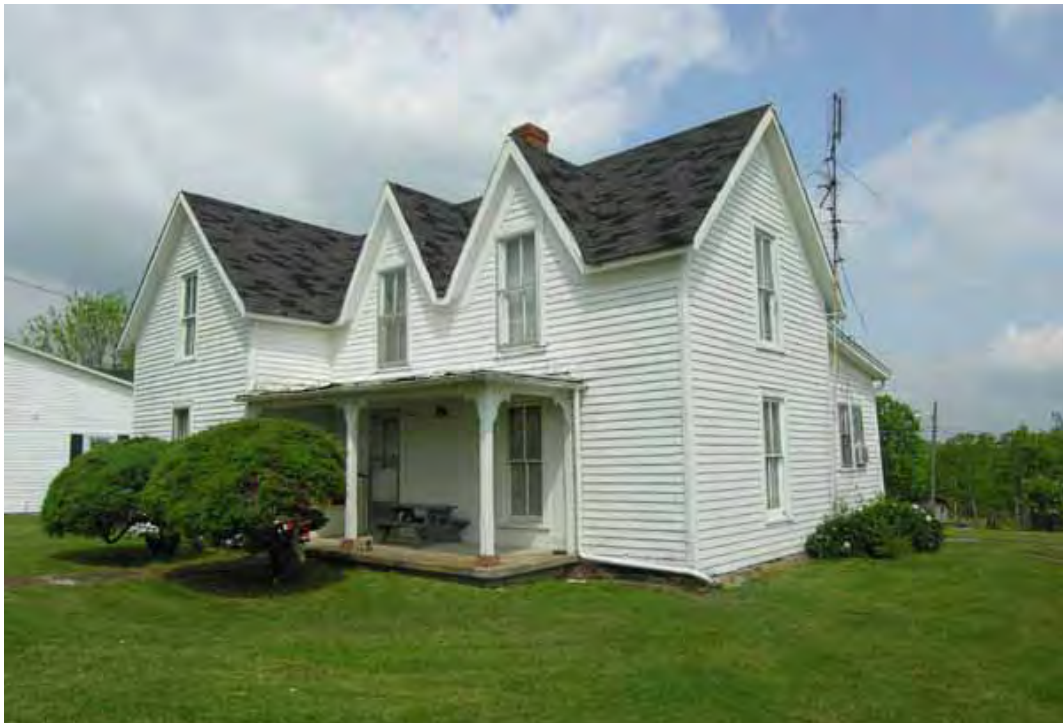
Figure 69: WS 780, Haydon house, late nineteenth century, Mackville.

In eight cases, we found steep cross gables on houses in a T-plan or other asymmetrical arrangement, as at WS 780 (Figure 69). The asymmetrical forms are commonly associated with the Queen Anne style in Kentucky, although asymmetry is common in high style Gothic houses. Other examples from the survey are seen at WS 49 (Figure 70), Ws 640 (Figure 71), and WS 247 (Figure 72). WS 247, although in poor condition, is an interesting example because it began as a standard two gable, double door form. The wing to the left in Figure 72 was added on later, closely mimicking the style and detailing of the original. Although it looks the same, the construction is quite a bit different, as is apparent in the attic (Figure 73).

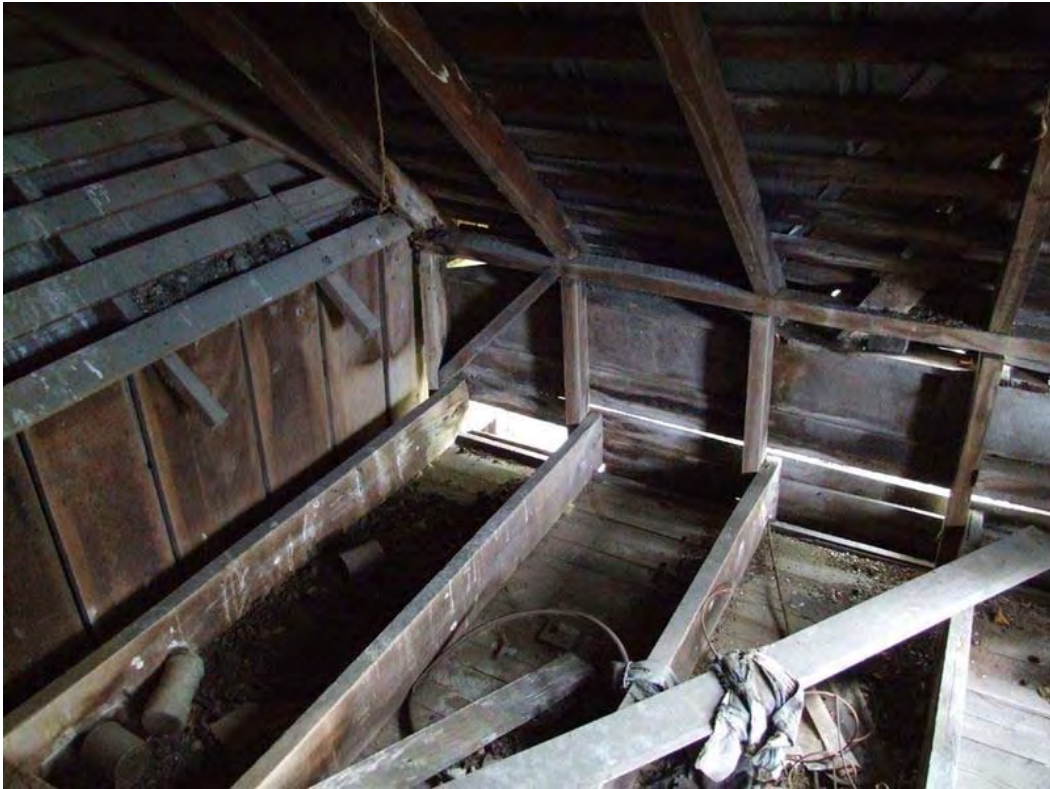
Figure 73: WS 247, Detail of attic framing in wing where it joins the main body of the house. The original house is vertical plank frame, the addition is light balloon frame. See also Figure 72.

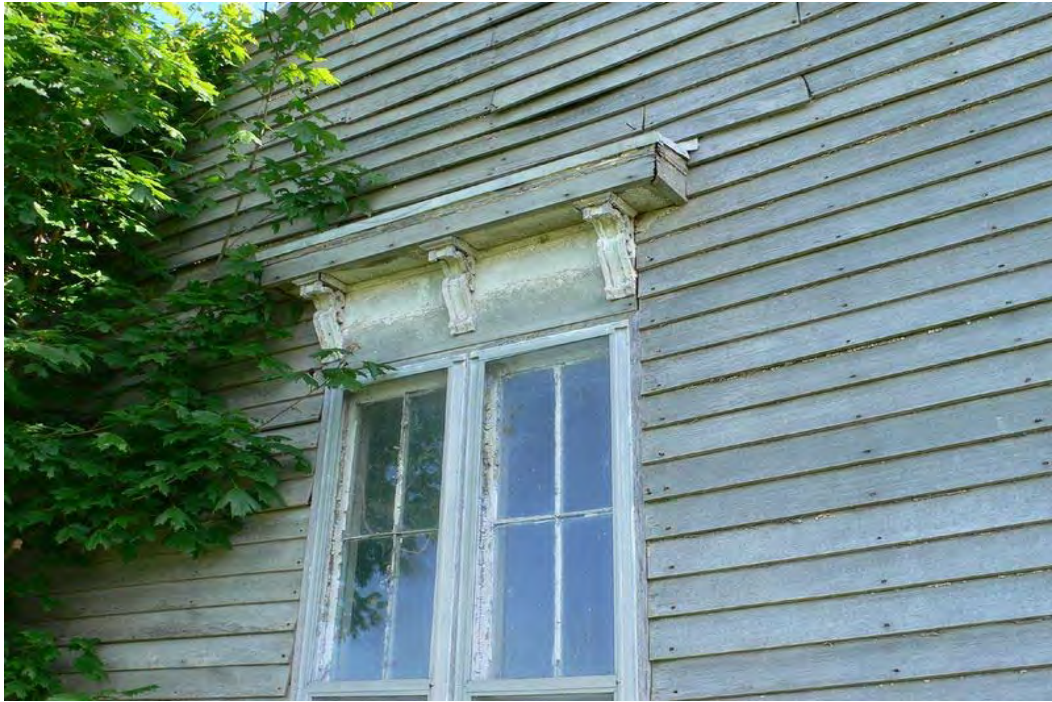
Figure 77: MN 688, Glasscock house, window detail, Beech Grove vicinity. See also Figure, Figure 54, and Figure 80.

arches (Figure 77) have Italianate influence, while the interior stair (Figure 80) shows a whole range of Federal, Greek Revival, and Italianate influences. Other examples include the Harmon house in Mackville (WS 172, Figure 76), a sort of Queen Anne/Colonial that also has the Italianate type windows mentioned above, and MN 961, near Bradfordsville (Figure 78), a late nineteenth-century, Gothic/Italianate/Queen Anne/Colonial cottage.

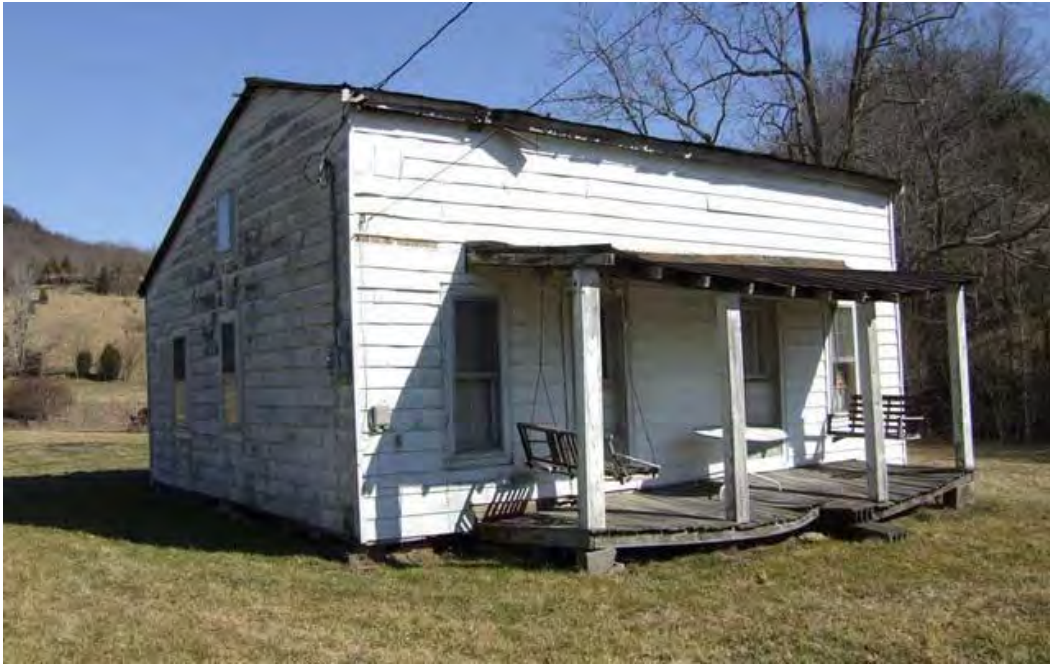
Figure 79: MN 604, Early twentieth century, Bradfordsville vicinity. A double-door house of no particular style, but with the vertical window proportions associated with the Italianate style and front doors consistent with Arts & Crafts style.

In Kentucky, the tall and narrow window proportion becomes particularly pervasive, showing up even on extremely modest dwellings of the early twentieth century, as at MN 604 (Figure 79) and at WS 453 (Figure 109). Perhaps it is a bit of a reach to associate those two examples with the style, but in the survey area, examples of Italianate influence are found mostly where it is intermingled with other styles, as at the Glasscock house near Beech Grove (MN 688, Figure 53, Figure 54, Figure 77, and Figure 80). There, the house has a single gable Gothic shape, but details are drawn freely from other styles: the tall, narrow windows with bracketed, applied

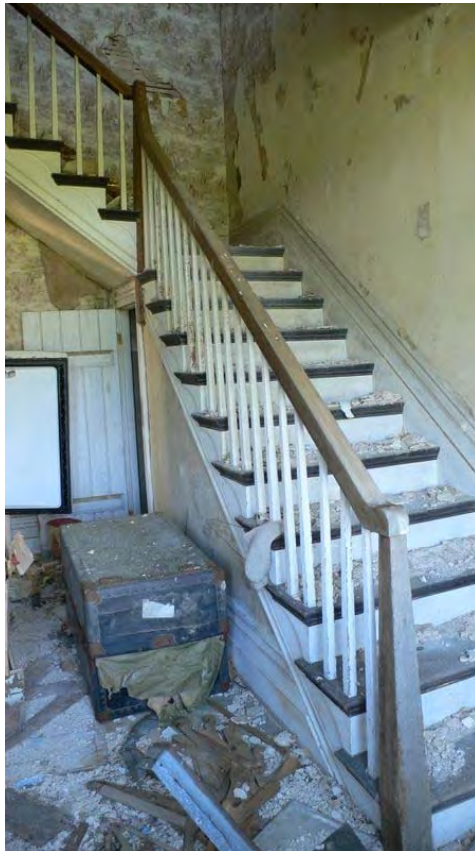
Figure 80: MN 688 staircase, Federal/Greek/Italianate style, in a house that also has Gothic elements. See also Figure 53, Figure 54, and Figure 77.

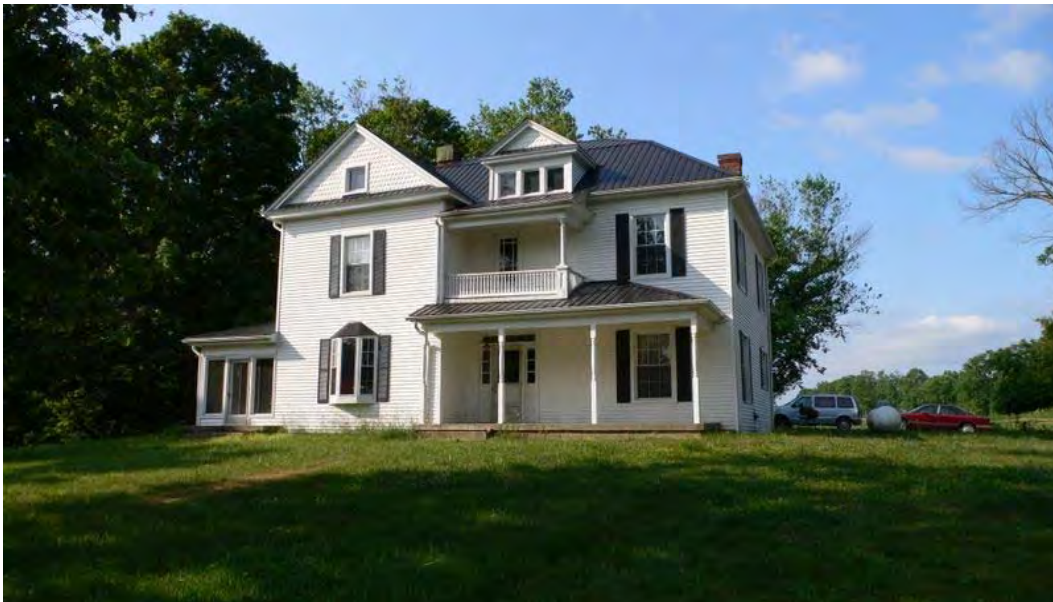
Figure 81: *MN 917, late nineteenth-early twentieth century, Bradfordsville vicinity. Victorian/Queen Anne massing, with Colonial Revival detailing.*

Figure 166, a design by the architect George Barber, is a good example from the period style books of the asymmetrical massing common to the style. Although Barber calls it a “Colonial” style house, based upon the decorative details such as the Palladian window centered above the classic pediment of the front porch, the overall massing of the house is very much in the Queen Anne style. While the massing is not as complex as this published example, we can see similar influences at work in the large house at MN 917 (Figure 81), a mainly Colonial Revival house with the massing and some of the detailing of the Queen Anne style.

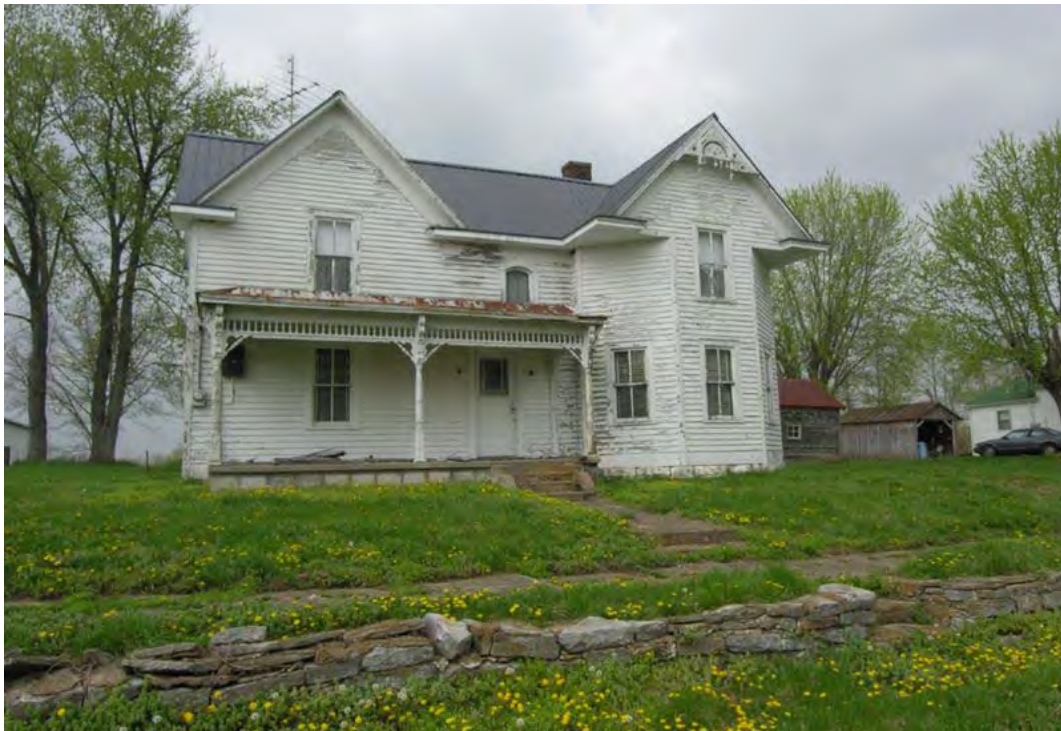
Figure 82: *WS 171, John Harmon House, late nineteenth century, Mackville.*

WS 171 (Figure 82) is a good example of a house that has the asymmetrical massing of the Queen Anne style and also consistent detailing, particularly on the porch decoration and the peak brackets of the right hand gable. With the partial returns on the cornices, the house can also be said to have some Colonial Revival influence as well.

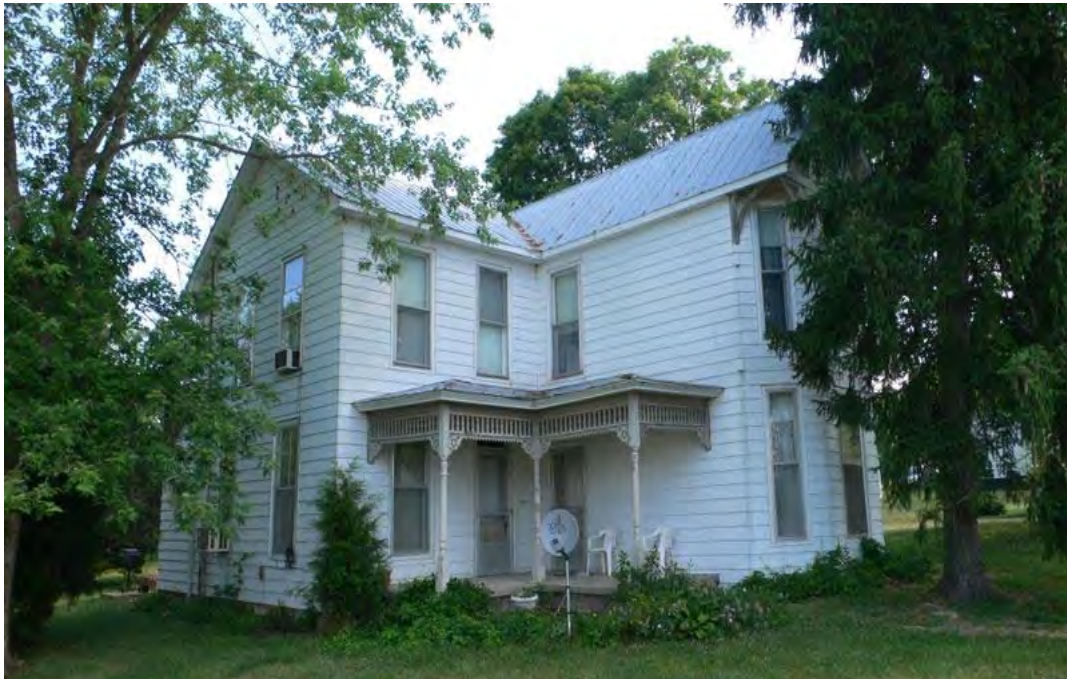
Figure 85: MN 930, late nineteenth century, Bradfordsville

MN 930 (Figure 85) is a typical example of the use of the Queen Anne style in the survey area. Although it seems somewhat restrained in its use of decorative detail, the house may have lost some elements with the application of aluminum siding in the 1950s or 1960s. It retains two turned and sawn spindle work porches (Figure 86), with star cut outs in the brackets that may be a patriotic reference. Even more restrained examples in the survey area are typified by the house at MN 666 (Figure 87), which has an asymmetrical, but straightforward T-plan, and decorative detailing limited to the gable peak and the porch posts and brackets.

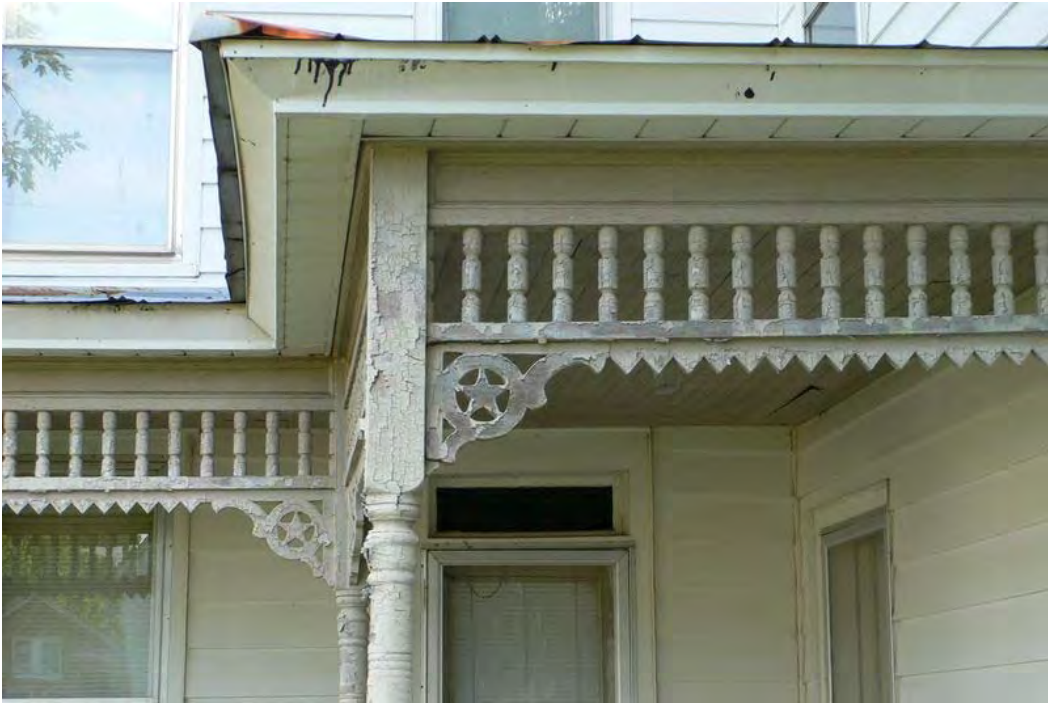
Figure 86: MN 930, Porch ornamented with sawn and turned elements, late nineteenth century, Bradfordsville.

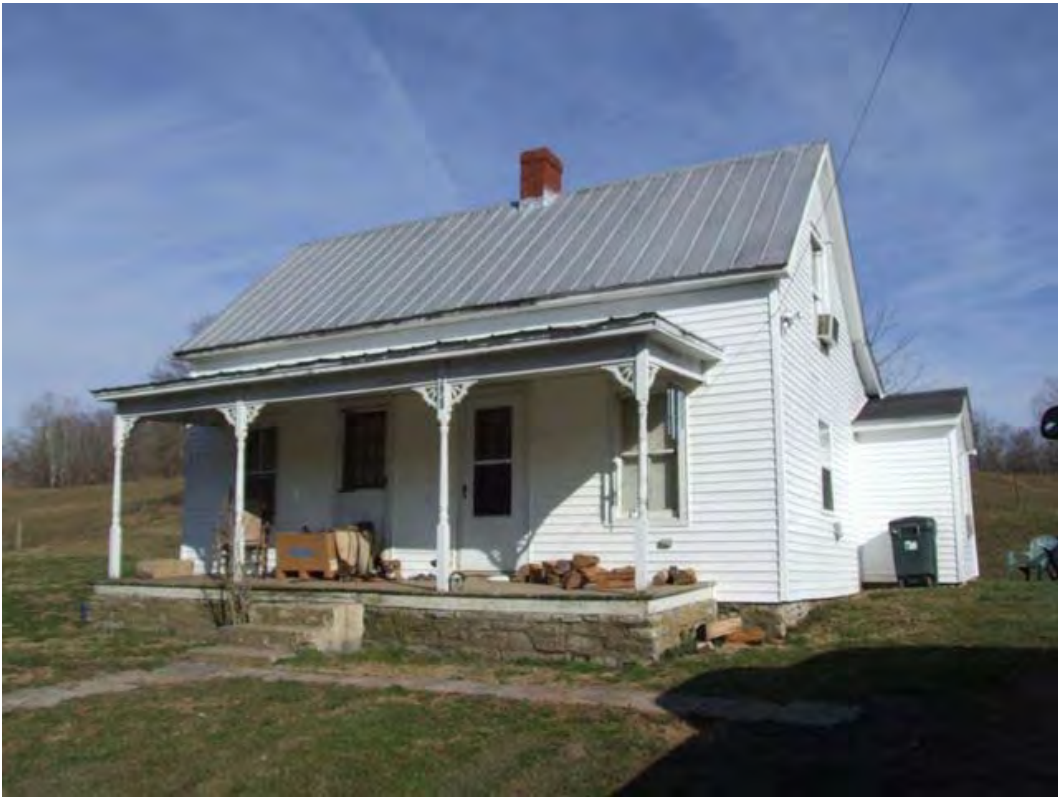
Figure 88: *WS 477, early twentieth century, Mackville vicinity.*

The limits of categorizing things by style can be seen in an example such as WS 477 (Figure 88) where the only apparent stylistic detail is found in the decorative trim of the porch brackets. Inside we might find other stylistic details in mantles and other trim, but the exterior is very restrained in its use of decoration, relying instead on the quality of craftsmanship and materials to present itself as a solid and comfortable house. Decoration is limited to those areas where it will have maximum visual impact with minimal effort.
