A Survey of Historic Sites in Rural Marion and Washington Counties, Kentucky

A Report on the Findings of the *Rural Heritage Development Initiative Survey*
A project funded by a National Park Service Preserve America Grant

Kentucky Heritage Council

The State Historic Preservation Office, 2009

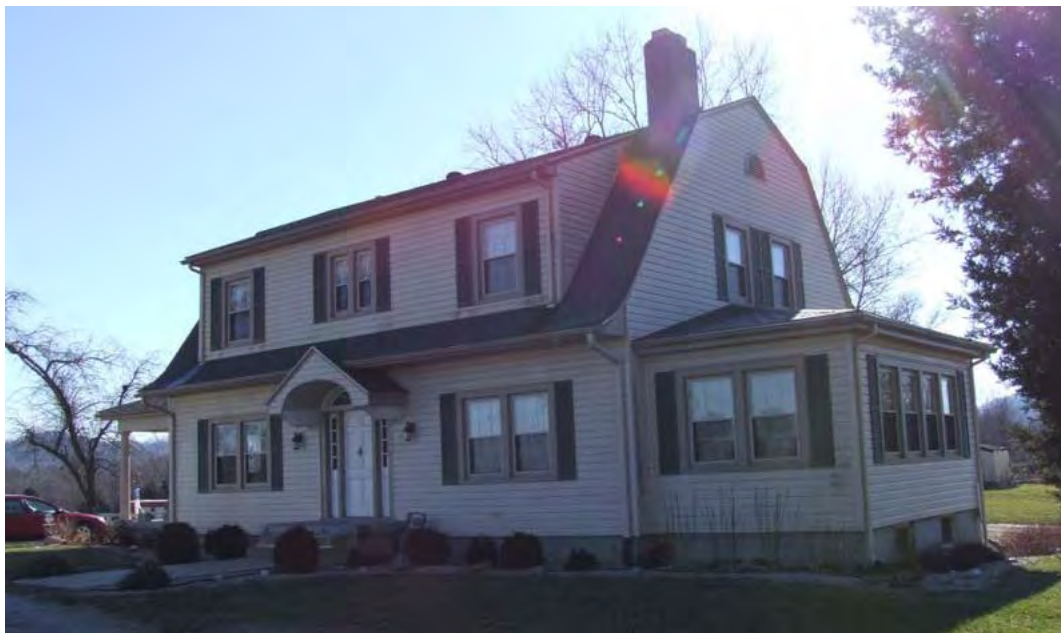
Figure 93: MN 328, George Dant house, Dant, 1936. See also Figure 94.

Styles in the twentieth century grow increasingly national in scope. Now style is not only distributed through popular literature and plans, it is also distributed through the mail order of whole houses. MN 328, the Dant house, for example (Figure 93) is a Dutch Colonial with interior detailing in something of a Federal mode (Figure 94). It is said by the current owner to be a Sears House built in 1936. It is similar to a model they sold called the "Rembrandt," offered in 1921-26, although the doorway and some of the detailing differ (Figure 95). There were several companies that sold mail-order house, although Sears is perhaps the best well known.

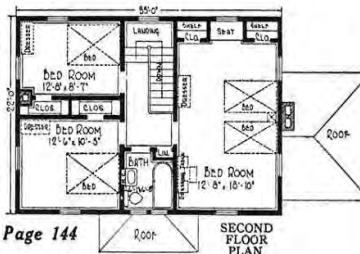
THE REMBRANDT is an unusually well arranged Dutch Colonial house. It has many special features not generally found in houses of this price. It has a charming entrance that gives an atmosphere of welcome. It has Colonial windows with divided lights above and one light below. French windows in the sun room. Add to this the white siding and contrasting red or green roof with the red brick chimney and you have a home that is sure to charm the most critical.

Figure 95: "The Rembrandt," Sears home, 1921-26, from <http://www.searsarchives.com/homes/1921-1926.htm>.

Some Craftsman style houses were prefabricated and sold through catalogs just as we have seen with the Colonial Revival Sears house, the Rembrandt (Figure 95). While no confirmed examples have been documented in the current survey, mail-order houses had a tremendous influence - not just through their presence on the landscape, but quite possibly through the catalogs themselves. Houses such as the “Pomona,” a bungalow available mail-order from Aladdin homes really did have something of the Craftsman ideal about them (Figure 103). For a reasonable price, the consumer could purchase a stylish, attractive, and comfortable house. It was probably still less expensive for most people to have a local contractor build their house. Catalogs and home magazines helped drive consumer taste toward the new styles, but many people retained their preference for traditional house types. The Buckner house, (MN 359, Figure 105), for example, has a wonderful poured concrete and molded concrete block porch in the Craftsman style (Figure 106), but the house is a traditional double-door type much like the foursquare at site WS 850 (Figure 104).

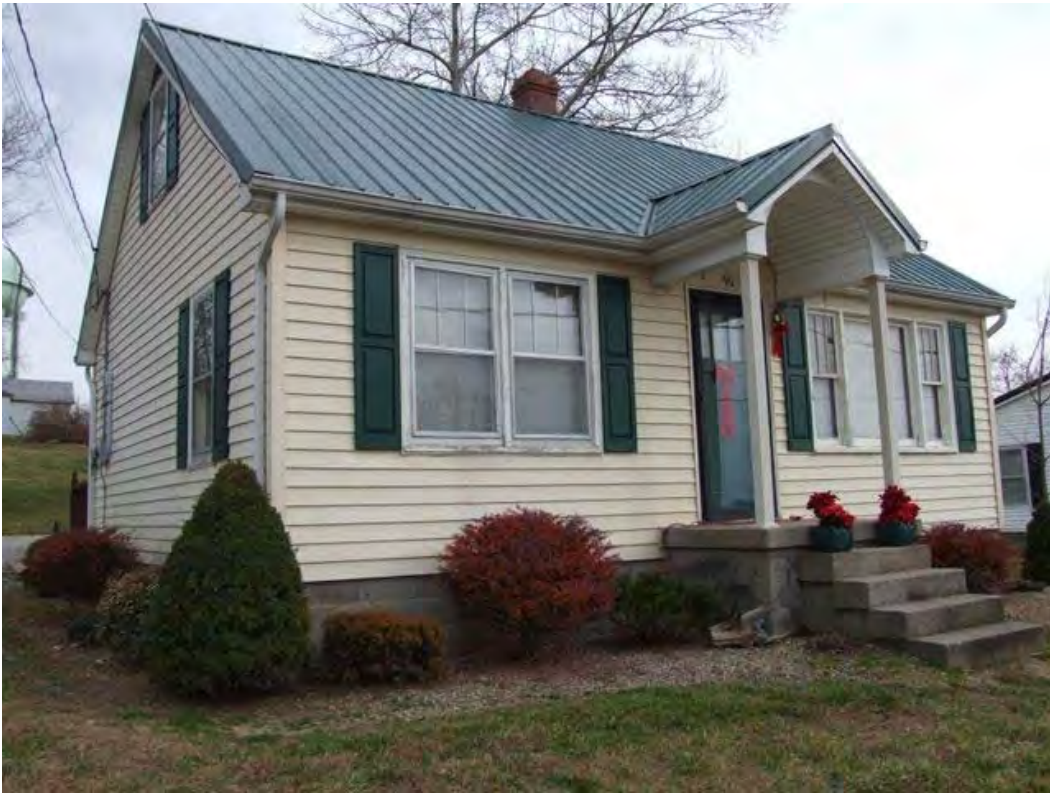
Figure 96: MN 263, 1930s-40s, Loretto.

In addition to style, the Colonial Revival movement is strongly associated with particular forms. One of the most popular forms is the Cape Cod type, much like MN 263 (Figure 96), WS 770 (Figure 97) and MN 9 (Figure 98). The Cape Cod is a one-and-one-half story house, typically two rooms deep on the first floor and a single room deep on the second, with a central entry into a small entry hall or directly into the living room. This form has a strong influence on a house type, the American Small House or the minimal traditional, which is typically but not always Colonial Revival in style. Cape Cod or not, many Colonial Revival houses have symmetrical form with strong emphasis on the central doorway such as at WS 345 (Figure 90), the Dant house (MN 328, Figure 93), MN 263 (Figure 96), and the Graham house (WS 770, Figure 97). Other examples include the curious structures at WS 349-350 (Figure 99 and Figure 100), moved to the current site from Fort Knox in the late 1940s. These have the five-bay façade with center entry reminiscent of center hall plan houses first popular in America in the eighteenth century, but are intermingled with other contemporary styles such as Arts & Crafts. Finally, the Colonial style is often applied to forms more closely associated with other styles. Bungalows and

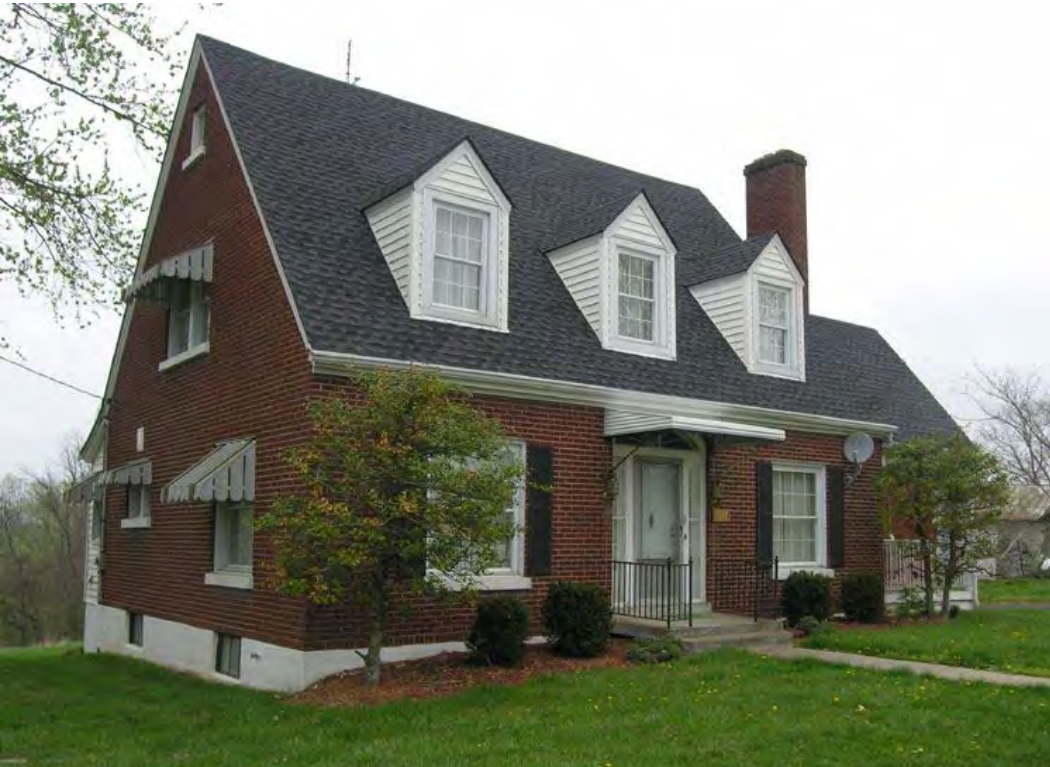
Figure 97: WS 770, Oakie & Kathryn Graham house, 1939, Mackville.

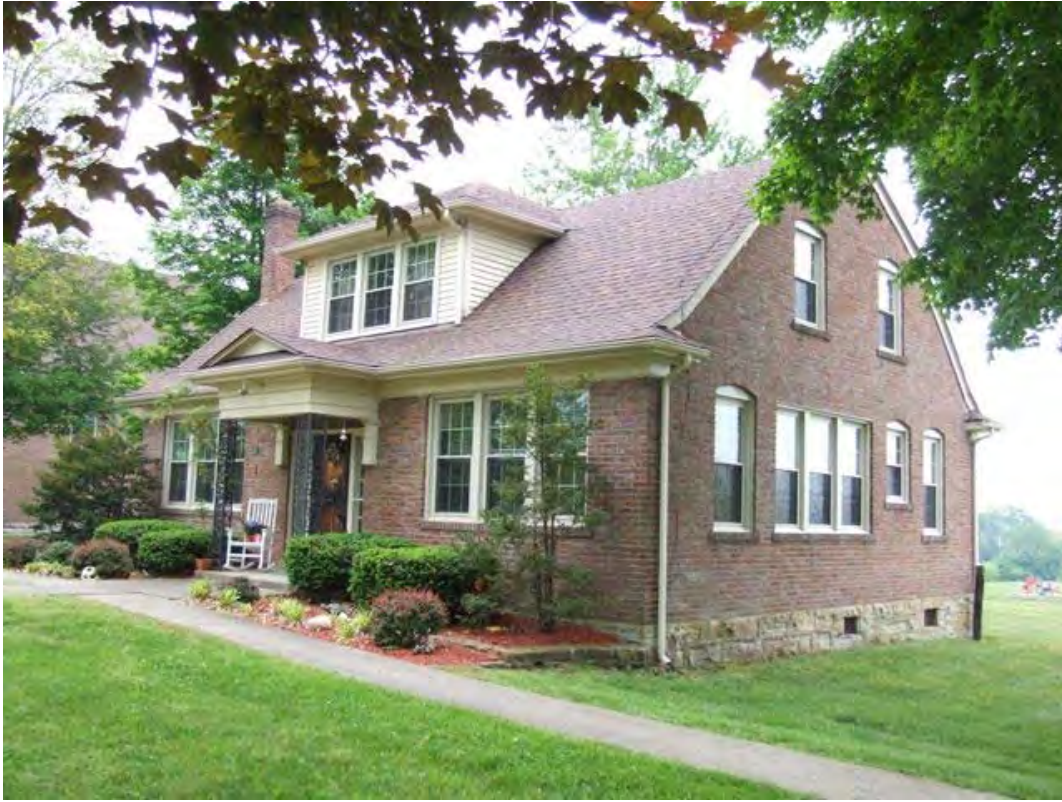
Figure 98: MN 9, Holy Name of Mary Church Rectory, Calvary, 1938.

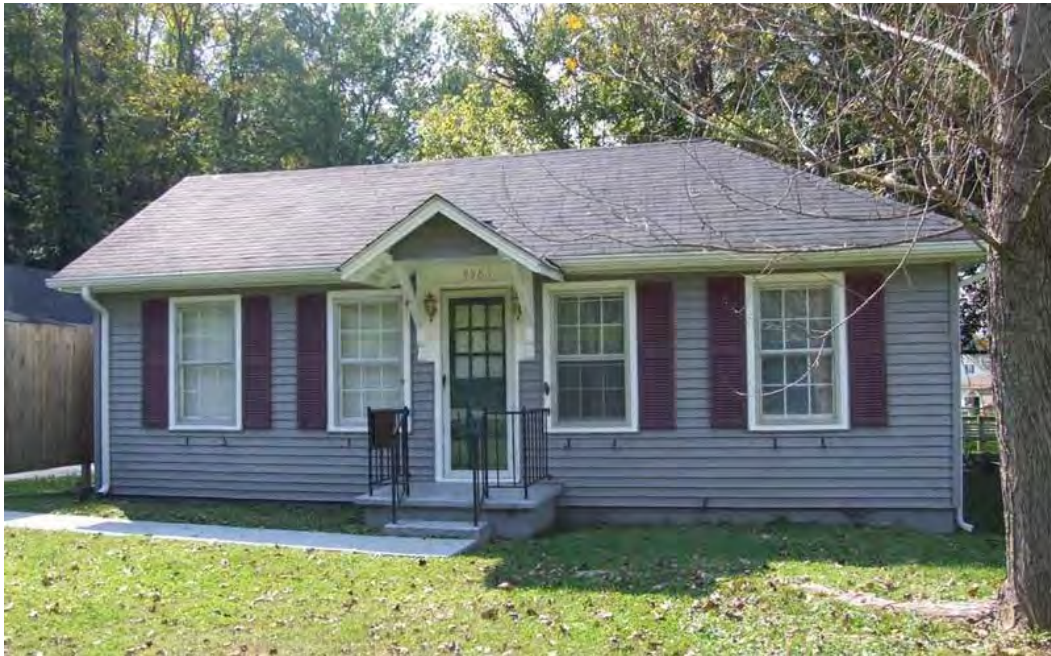
Figure 99: WS 349 & 350 (Figure 100), 1930s-1950s, Fredericktown. These two houses were both moved to this location from Fort Knox after World War II in the late 1940s by Colonel Everett Mudd. The structures were apparently built for housing for the War effort at Fort Knox, and then surplused after the war. WS 349 appears much as it did during its tenure at Fort Knox: a utilitarian structure with some elements of Colonial Revival and Arts and Crafts styling. Its neighbor, WS 350, below, is just barely recognizable as a related structure.

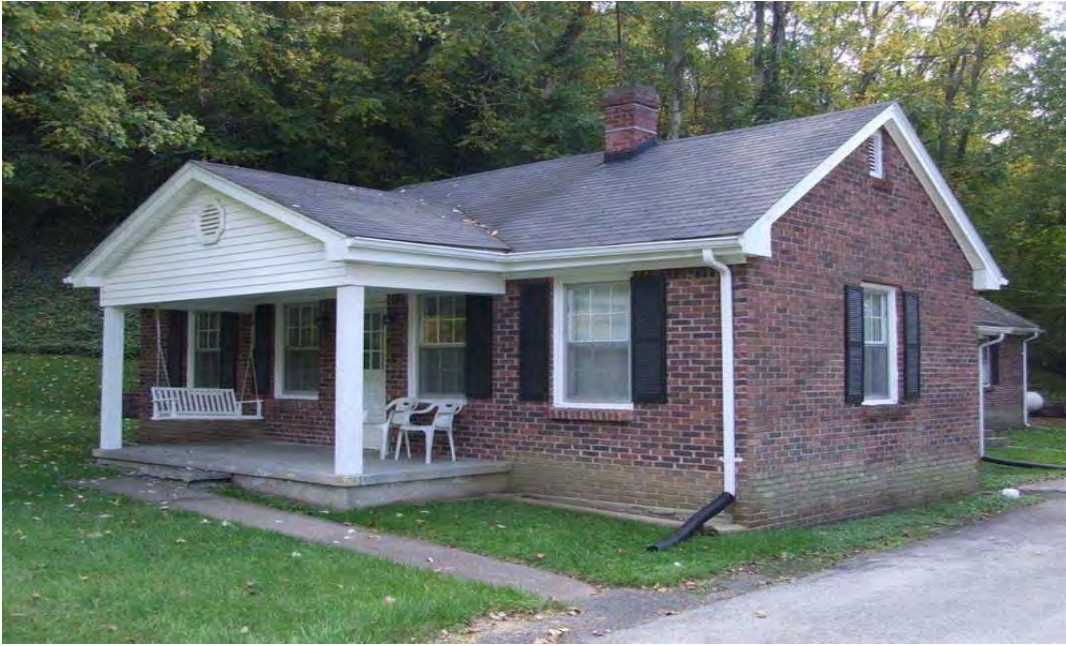
Figure 100: WS 350. At some later time after the move from Fort Knox, this house had a front porch added and was completely encased in brick, probably in the 1960s or 70s. This has had the effect of giving the structure over almost completely to Colonial Revival style, and giving it something of the appearance of a Ranch house, although it retains its basic center door, five bay form. The two houses share a common double garage, built in 1949 (Figure 101).

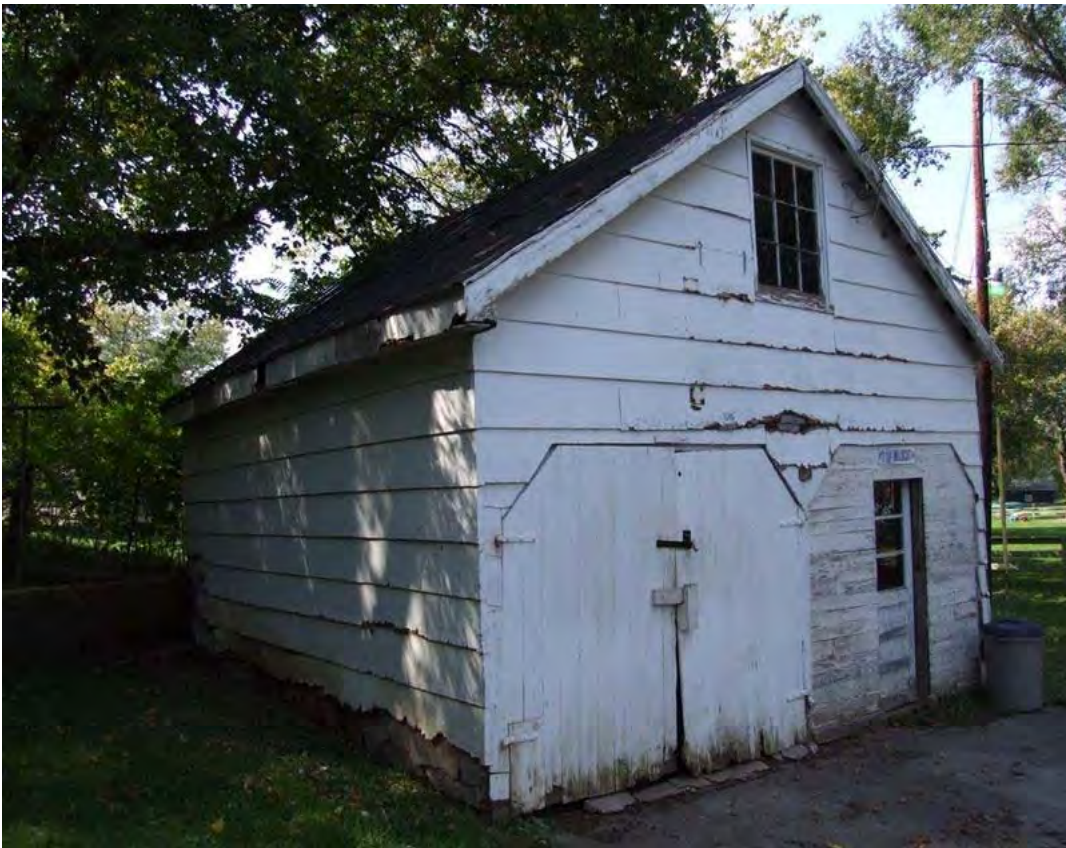
Figure 101: WS 349-50, shared garage, 1949. Built at the time the two houses were moved here from Fort Knox, the garage has no particularly stylistic details beyond the 6-pane window sash on the front gable. See also Figure 99 and Figure 100.

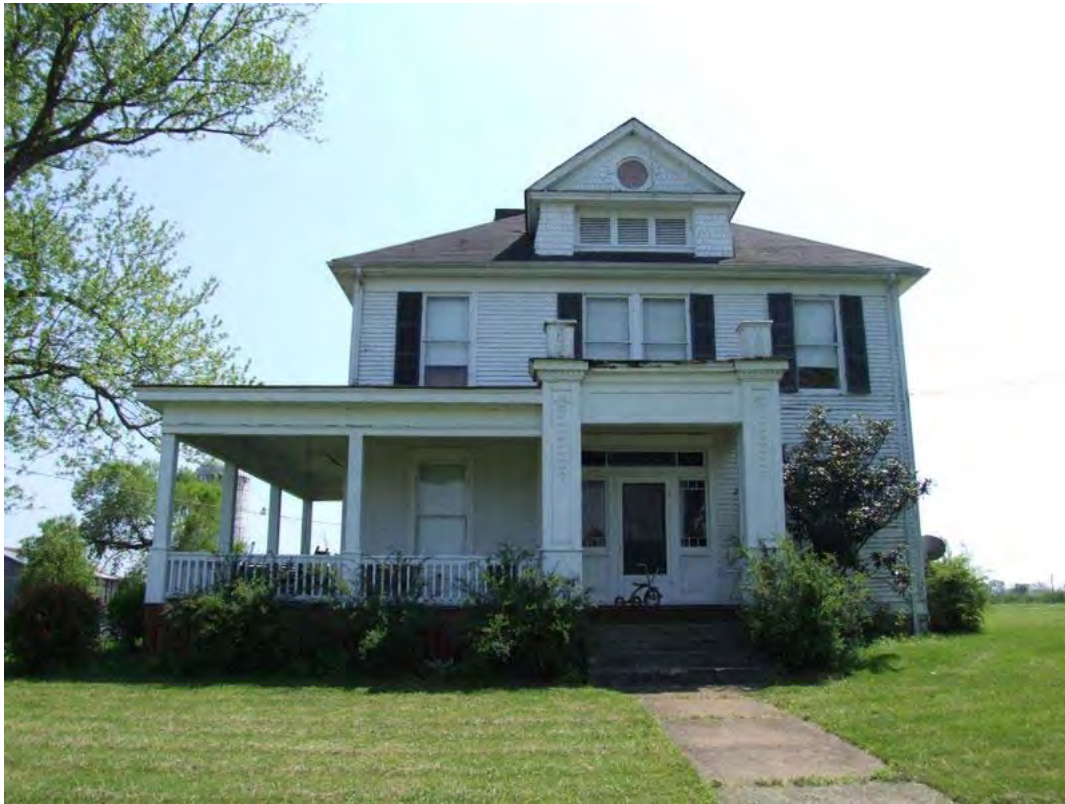
Figure 102: MN 564, *Spaulding house*, early twentieth century, *Lebanon vicinity*.

foursquares have a strong association with the Craftsman style, but also have Colonial variants. The foursquare house at MN 564 (Figure 102), for example, has the classical styling characteristic of Colonial Revival on the front porch and main entryway. The house nonetheless retains some feeling of the Craftsman style, mainly through form.

The Craftsman style is strongly associated with two house types, the foursquare and the bungalow. MN 564, previously discussed, is a good example of a foursquare house (Figure 102). The foursquare is essentially a large, two-story cube typically with a pyramidal or hipped roof, and a porch attached to the front. Many foursquares have four main spaces on each floor - typically an entry hall with a stair, living room, dining room, and kitchen on the ground floor (see the foursquare floor plan in Figure 170). Others, however, have more or less elaborate plans. Another example in the survey area is WS 850, which has some Craftsman detailing but which is very restrained stylistically, presenting mainly an overall Colonial feeling (Figure 104). It is also a variant of the double door house, which is discussed in further detail later in the report. WS 110, in Willisburg, has Craftsman style masonry column supports, but is otherwise strongly Colonial/late Victorian (Figure 169). Nine foursquares were documented in the survey area.

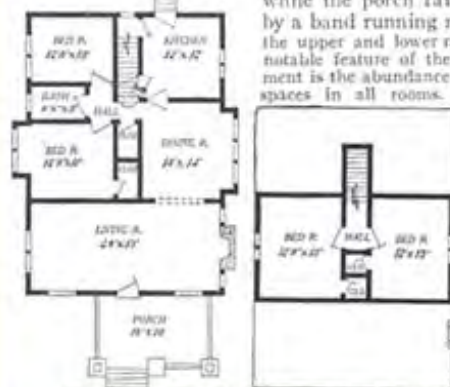
Floor Plan—The Pomona with second floor

and plaster are equally good non-conductors of heat and cold. Externally, many interesting ideas are worked out and each blends naturally into the whole. Observe the tapered porch pillars of stucco, surmounted by clean lined columns of the same design. The chimney outline matches this plan, as does the rafter ends and the projecting ends of belt encircling the house above the water table. Brackets supporting the eaves are shaped differently than any other bungalow you ever saw, while the porch rail is embellished by a band running midway between the upper and lower rails. An especially notable feature of the interior arrangement is the abundance of unbroken wall spaces in all rooms. Can't you just

imagine where you would place each piece of furniture? Two plans are illustrated, one story and two story.

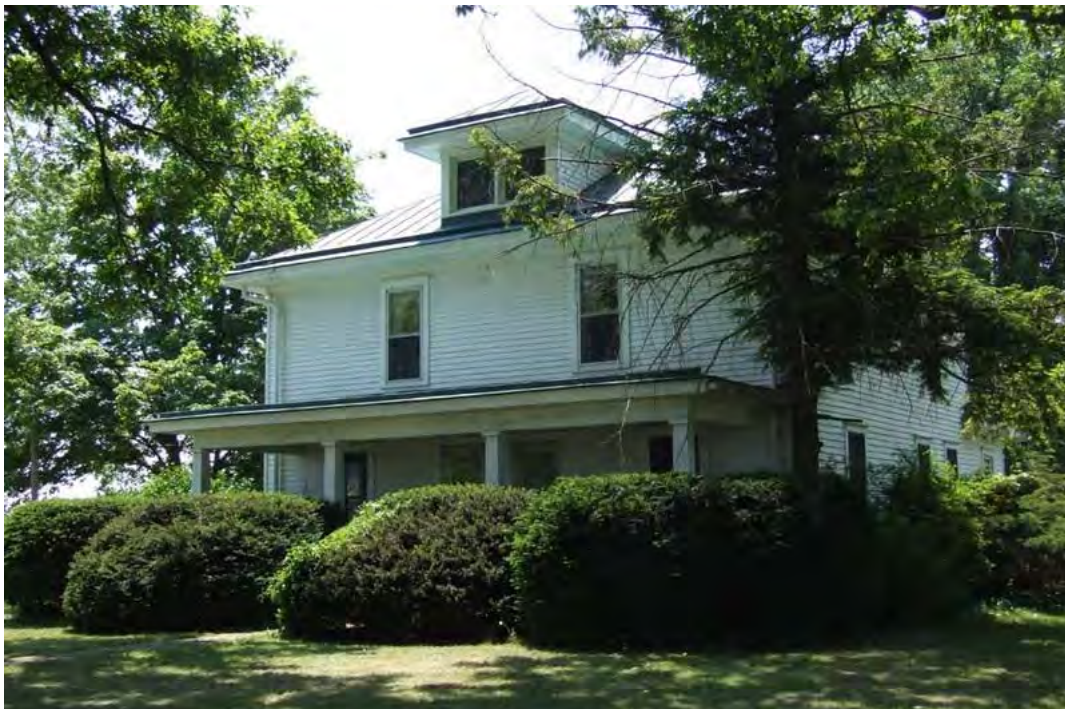
Figure 104: *WS 850, early twentieth century, Springfield vicinity.*

in the survey area are found at MN 710 (Figure 149), and possibly at WS 850 (Figure 104: the doors are not quite visible in the survey photograph). Bungalows with paired front doors are not uncommon in the survey region, as seen at MN 359 (Figure 105), WS 363 (Figure 147), and WS 1123 (Figure 148). One single pen house with two doors was also documented, MN 685 (Figure 150). In that case, though, it seemed like it might have once been divided into two smaller spaces of unequal size, more like a Hall/Parlor plan than a double pen.

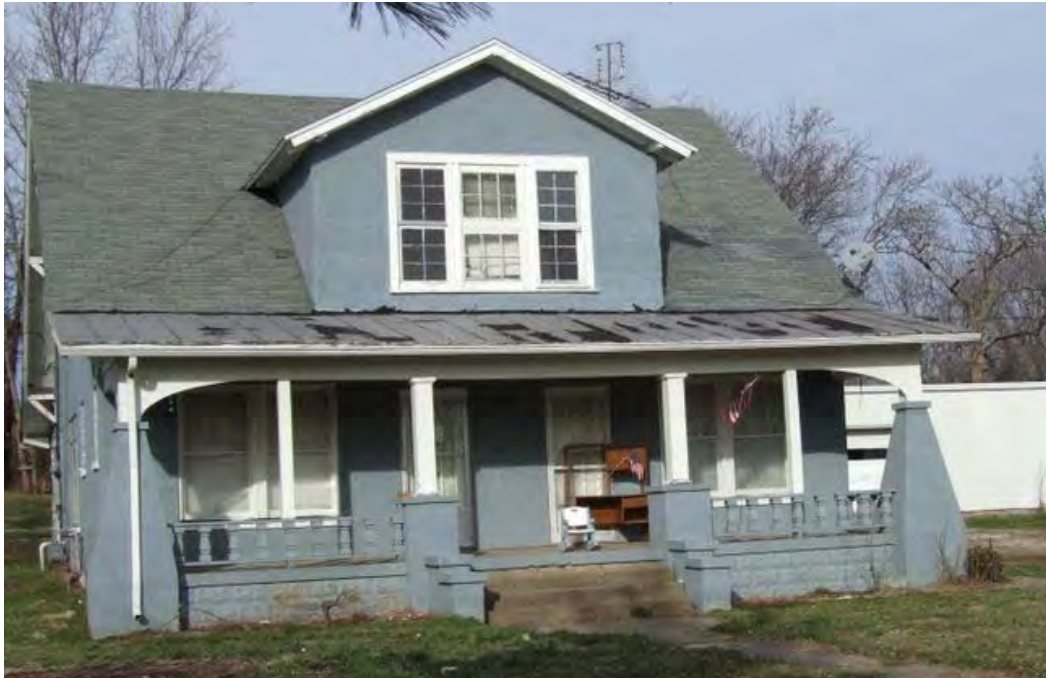
Figure 105: MN 359, *Buckner House, 1920s-30s, Loretto.*

While MN 686 is a single story example, the most common bungalow in the survey region is a 1-1/2 story, side gable house with a shed or gable dormer providing additional living space under the roof. MN 359 is one example of this (Figure 105). Other good examples include WS 814 (Figure 111) and MN 308 (Figure 112), both Colonial Craftsman examples; and WS 891 (Figure 113), a wonderful Craftsman example with an oversized dormer. Further examples include MN 541 (Figure 114), with a good example of Craftsman porch masonry, tapered posts, and a large shed dormer; and MN 343 (Figure 115), which has a rustic log front, possibly a later alteration.

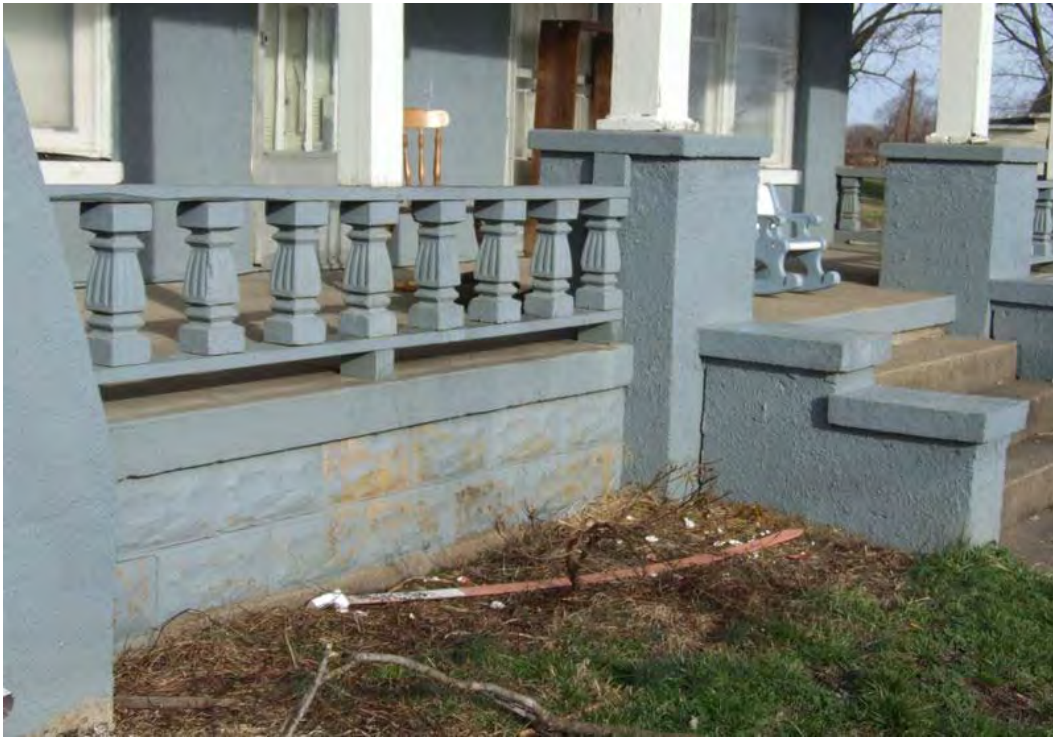
Figure 106: MN 359, detail of porch. See also Figure 105.

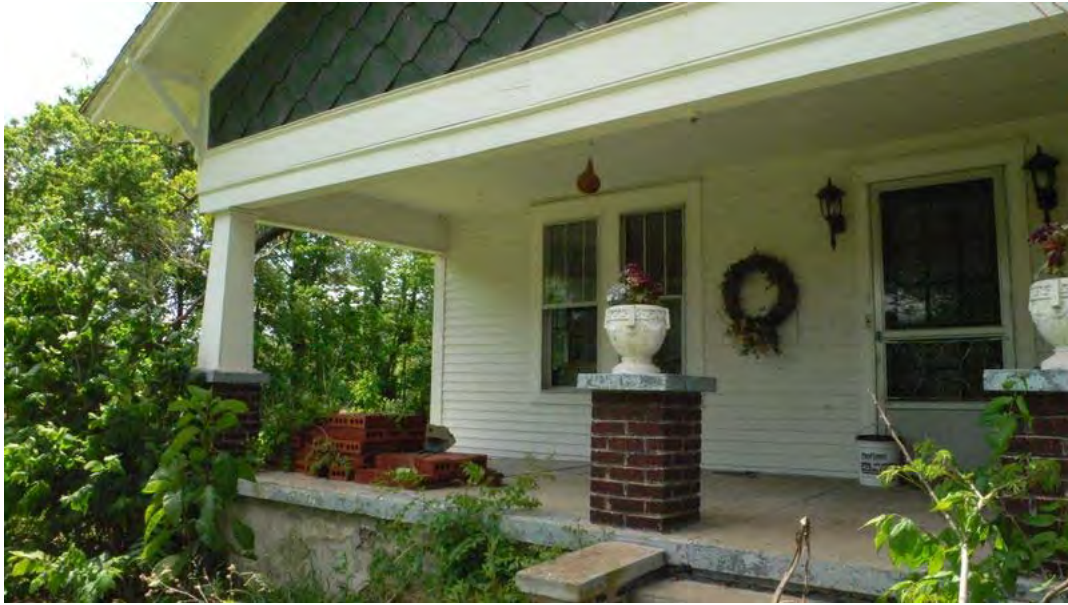
Figure 107: MN 686, 1920s Bungalow, Gravel Switch, Detail of Porch. See also Figure 108 and Figure 167.

Craftsman is the most frequently identified style in the survey area with 71 examples. Introduced by the 1910s, the style is still influential in the late 1930s-early 1940s, and is enjoying something of a revival in contemporary architecture. A very good example of the Craftsman style is MN 686, a house probably based upon published plans or purchased mail order (Figure 167). This house has a strong emphasis on horizontality, with a hint of the Prairie style popularized by Frank Lloyd Wright. In the detail view in Figure 107, we see some of the characteristics of the Craftsman style: the 3/1 sash windows, the plinth column supports and exposed brackets, and the exaggerated tapering of the columns. A detail that is especially characteristic of the style is the pattern of dividing the upper portion of a window into multiple vertical lights above a single pane lower portion, either the upper and lower sash or just the upper part of a single divided sash (see detail of MN 686, Figure 108). In some cases this is one of the few diagnostic features that can help us place a house in the early twentieth century time period. At WS 453, Figure 109, for example, we see the stylistic confusion that can arise when a house is built almost entirely from parts salvaged from an older structure, but where window sash and exposed rafter tails help signal its Craftsman period construction date. Compare it to another small house built during the Craftsman period, WS 691 (Figure 110, possibly a prefabricated cottage with a later porch). It was built of new materials rather than salvage, but also reflects the style mainly through window type and exposed rafter tails.

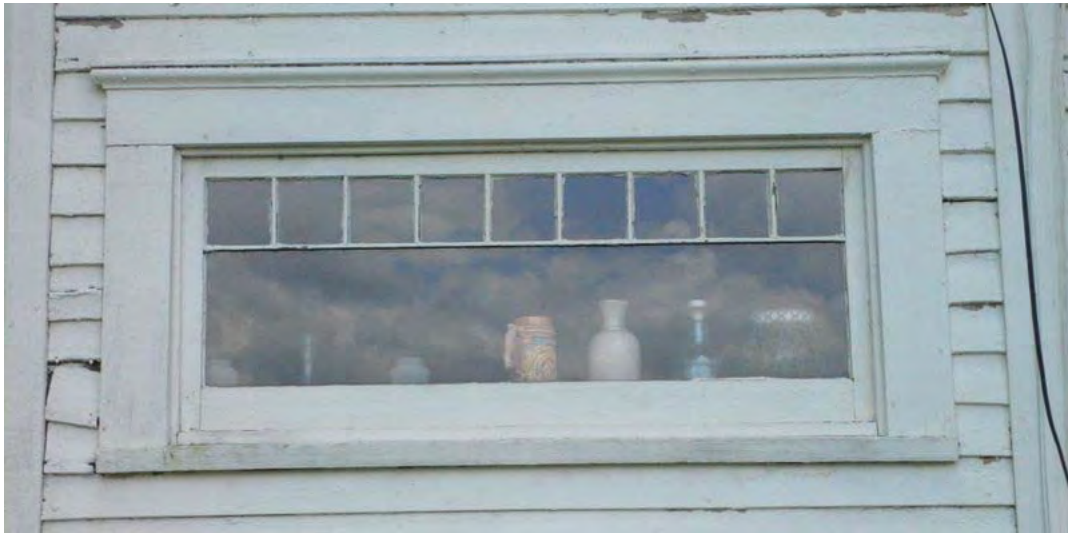
Figure 108: MN 689, Window detail. See also Figure 107 and Figure 167.

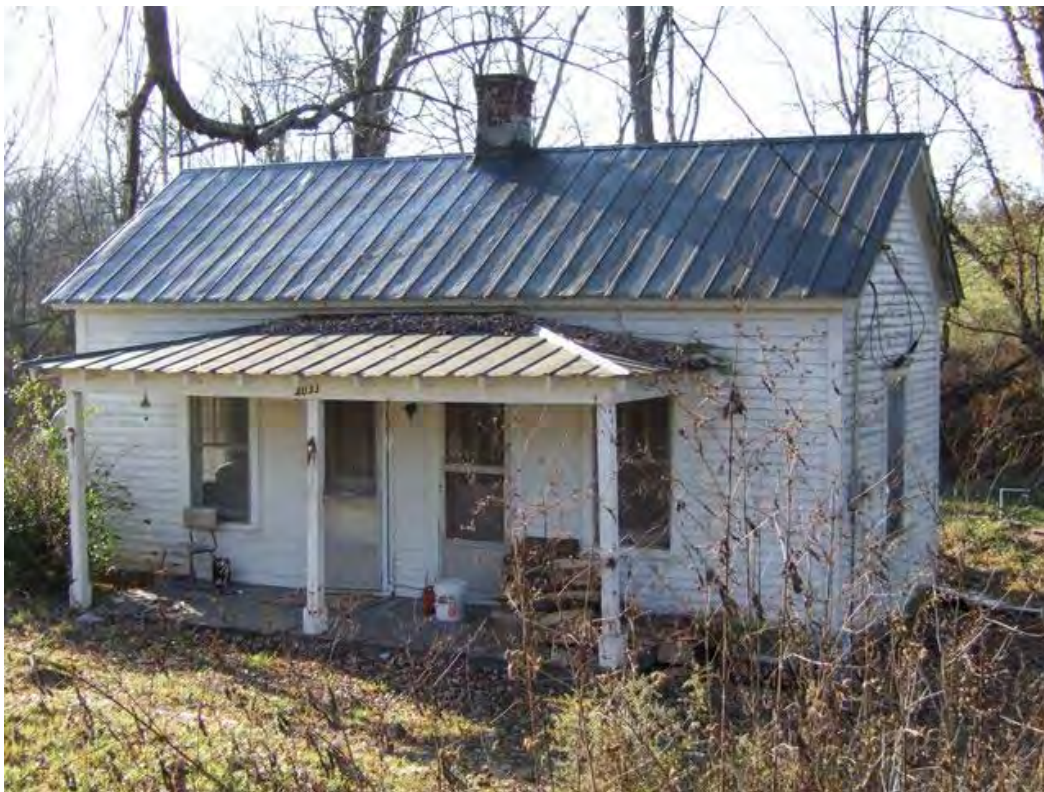
Figure 109: WS 453, Heel house, 1938-39. The house is said to have been built with lumber salvaged from a single room schoolhouse, which may account for its having the appearance of being older stylistically than its construction date would suggest. The 3/1 sash windows and the exposed porch rafter tails are consistent with the late 1930s.

One characteristic of many historic houses in the survey area is the presence of two front doors, generally paired with two windows in a symmetrical arrangement across the front facade (see WS 365, Figure 135). Most commonly, these houses are one – to one-and-one-half stories in height and often have service rooms in a shed or ell addition to the back. These houses are quite prevalent: almost 100 of approximately 1000 houses documented in the survey area in this project are of this type. A typical example is MN 963, near Gravel Switch (Figure 140). It has the standard fenestration pattern of W/D/D/W, a double pen plan, and a central chimney (although some examples have end chimneys). Other examples illustrated in this report include WS 476 (Figure 2), WS 730 (Figure 58), MN 911 (Figure 63), WS 1115 (Figure 64), MN 604 (Figure 79), WS 477 (Figure 88), WS 453 (Figure 109) and WS 365 (Figure 135).

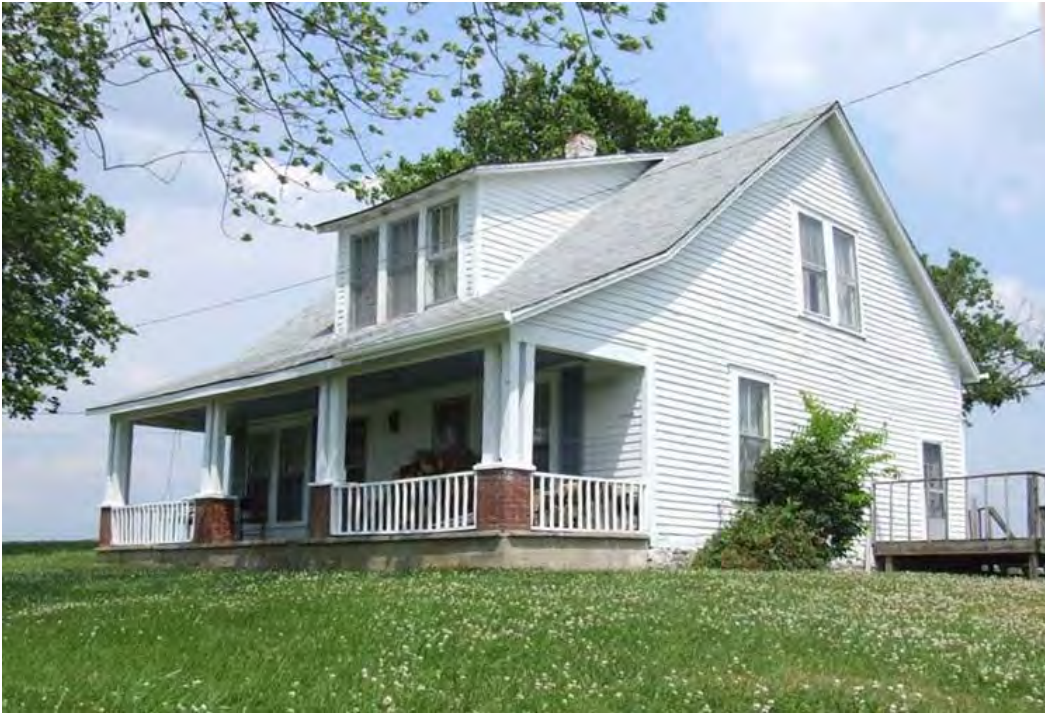
Figure 111: *WS 814, early twentieth century, Fairview vicinity.*

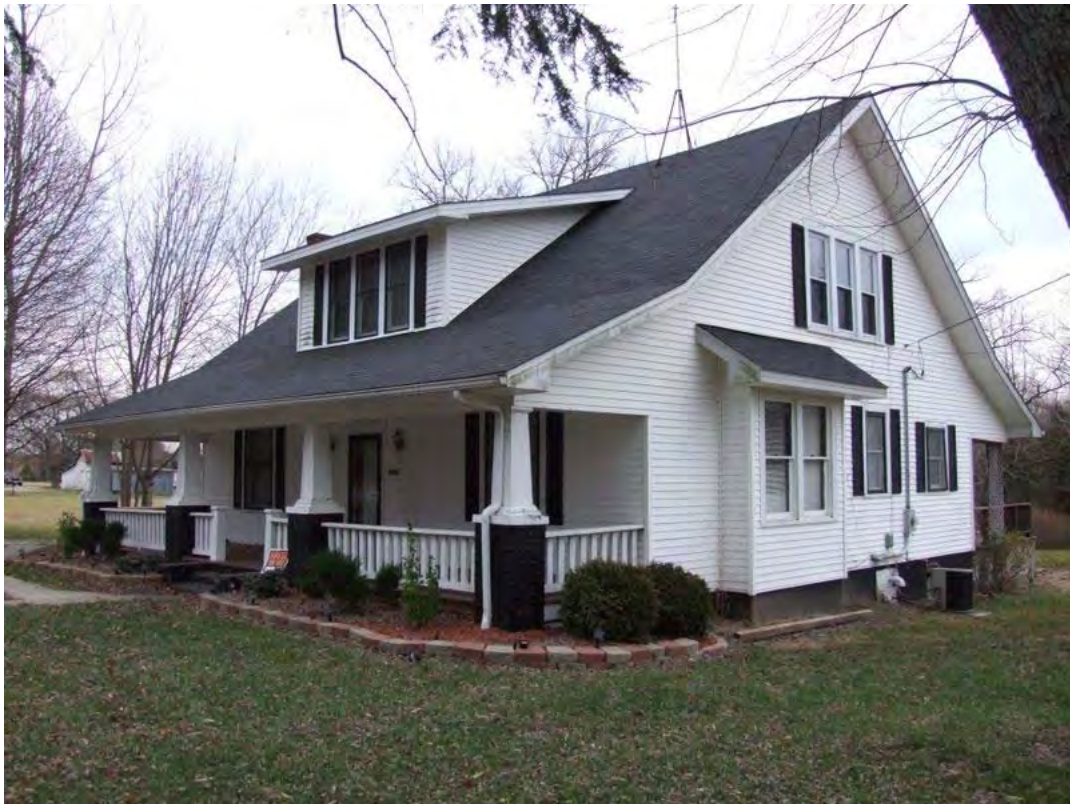
Figure 112: MN 308, early twentieth century, Saint Francis.

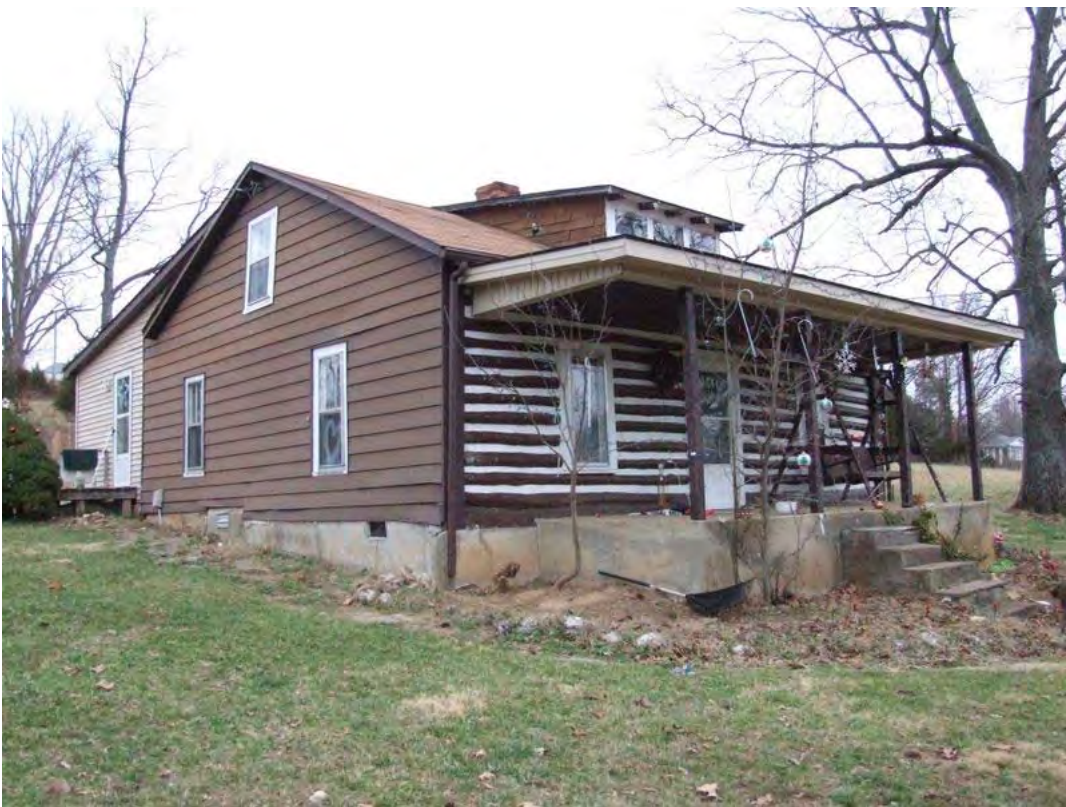
Figure 115: MN 323, early –mid twentieth century, Dant vicinity. The log wall on the front is an applied veneer to the frame building.

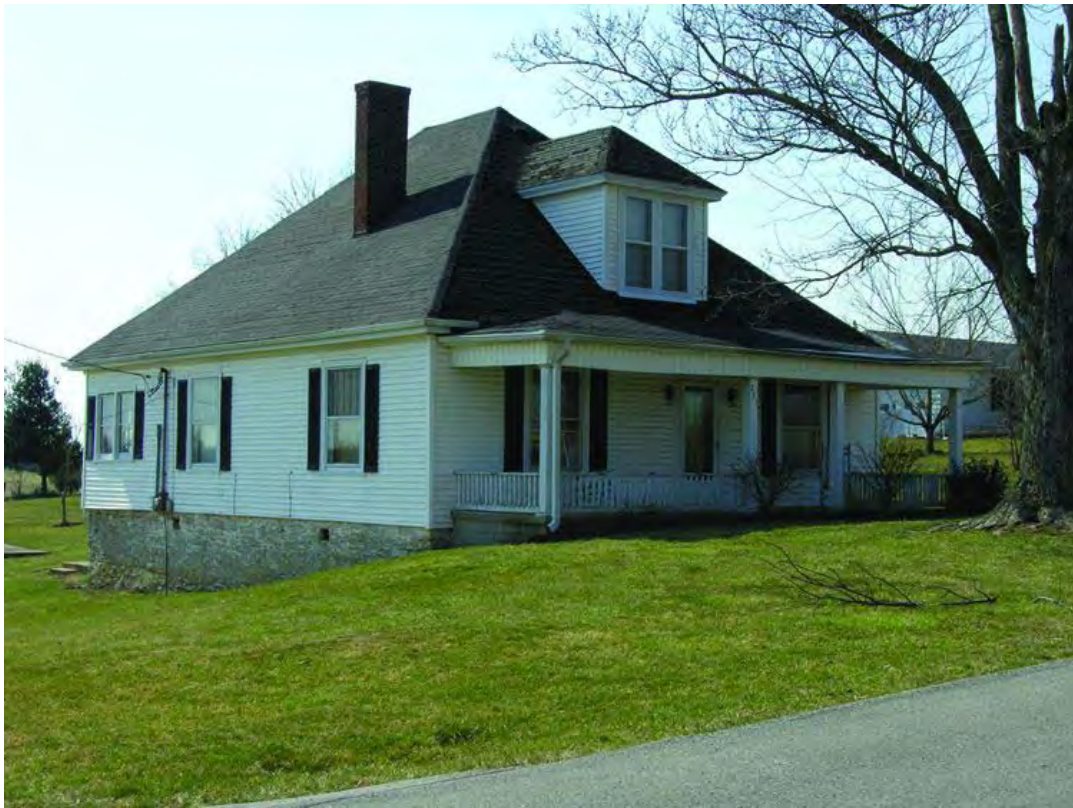
Figure 116: *WS 642, early twentieth century, Mackville.*

More traditional house forms dressed up to look something like bungalows include WS 642 (Figure 116). Here we have a traditional southern Pyramidal roof house (like a single story foursquare), “bungalowized” through the use of a dormer and the front porch. Interestingly, it is also set into a banked site so that the basement is accessible on the ground level in the back. MN 944 may well just be a hall/parlor or similar plan, a basic side gable house with a large dormer and a porch added to give it a bungalow appearance (Figure 117).

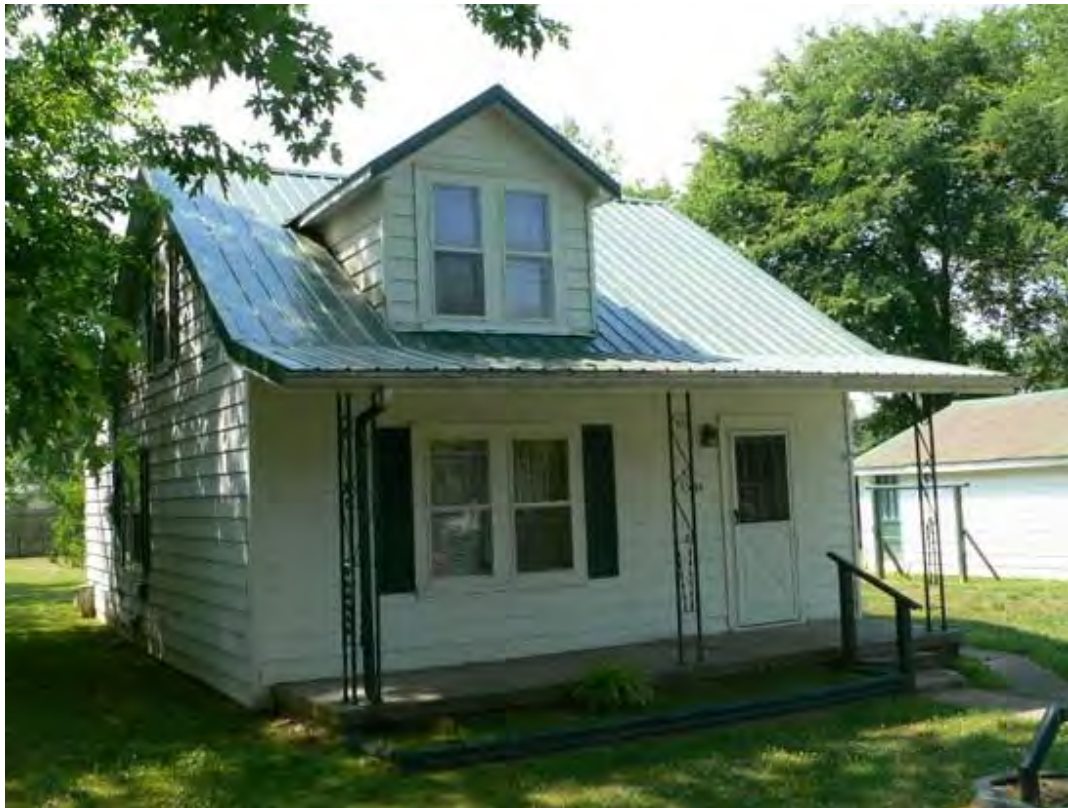
Figure 117: *MN 944, 1920s-30s, Bradfordsville.*

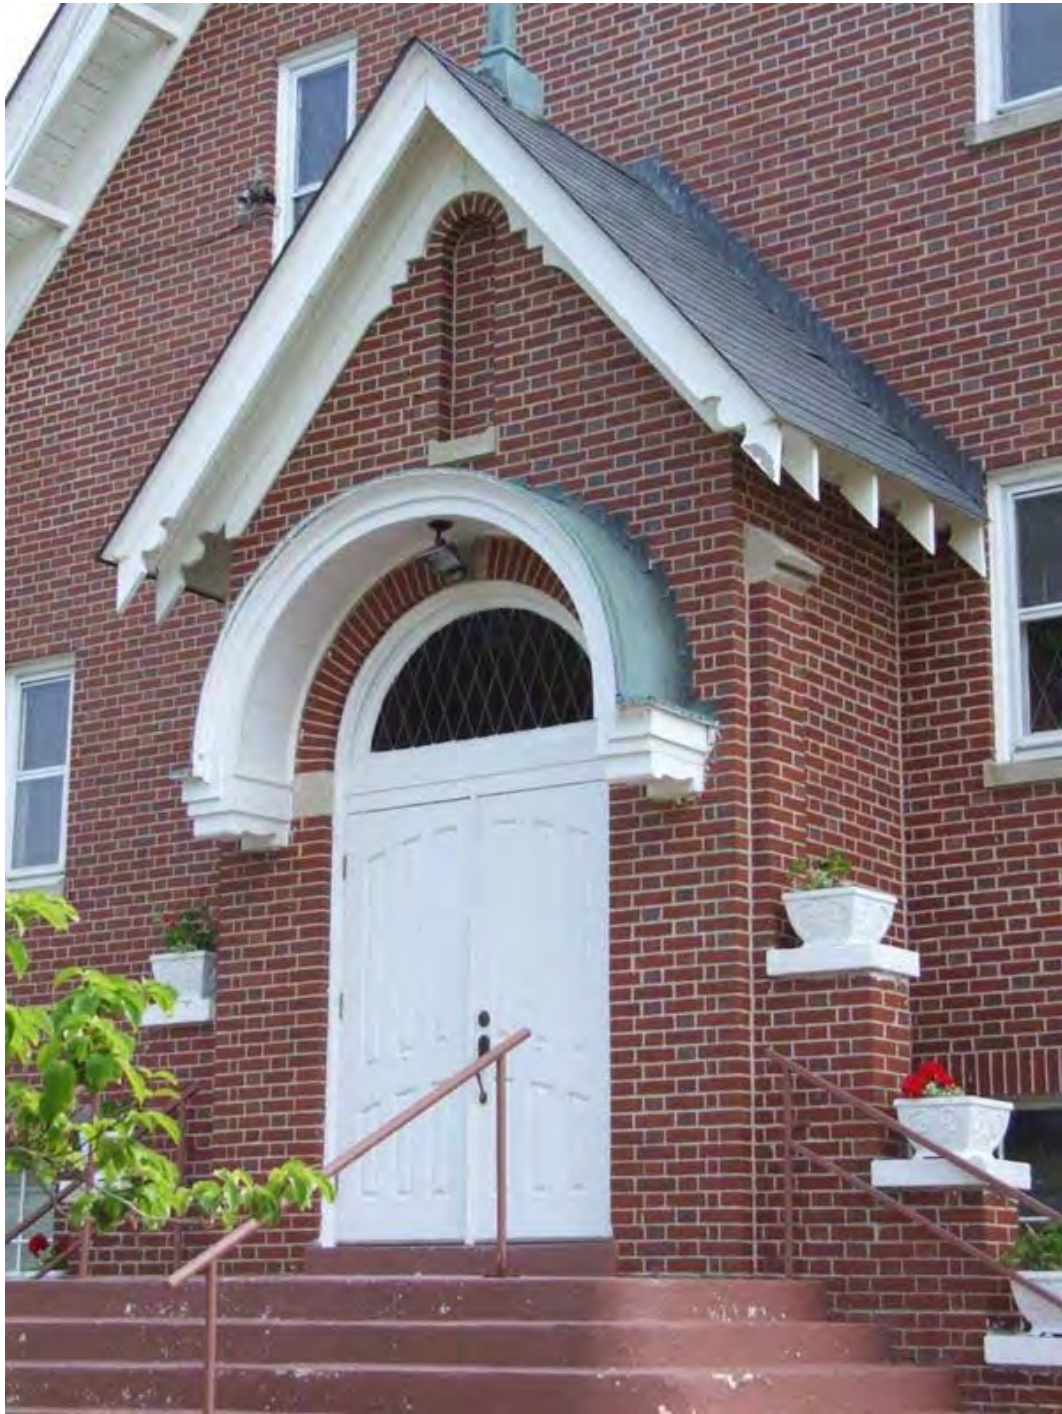
Figure 118: *WS 940, Holy Rosary Church, 1929, Springfield/Briartown, with elements of Colonial Revival, Arts and Crafts, and Gothic influences.*

Finally, we should not leave the impression that the Craftsman style is limited to dwellings. WS 940, Holy Rosary church (Figure 118) is a wonderful example of the Craftsman style intermingled with other stylistic cues including Colonial and Gothic. Public buildings such as churches, stores, and government buildings are important players in the story of style; here style is used to help convey a certain message such as the status of the institution to its users. The style of public buildings is often presented in a very different way than the more private use of style in the home.

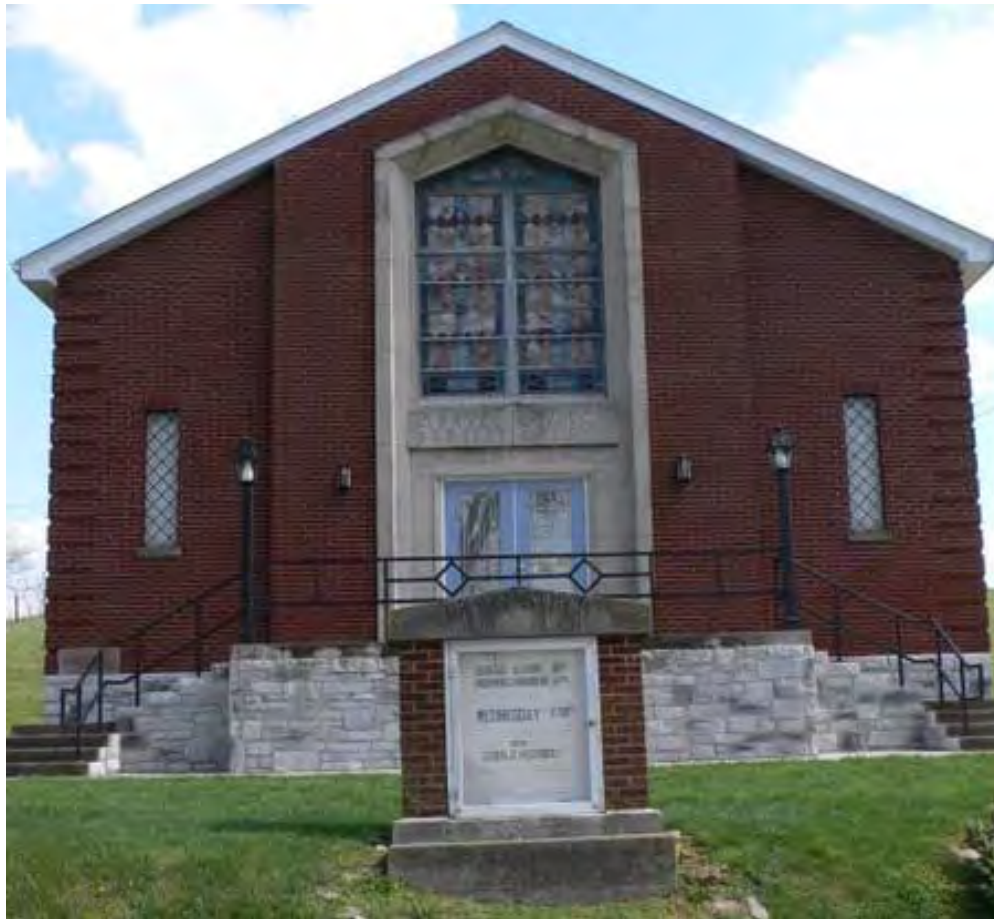
Figure 120: MN 667, *Gravel Switch Baptist Church, 1952, Gravel Switch.*

Many of the historic resources of the recent past in rural Marion and Washington Counties can be called “Modern” style even while they reflect a variety of influences. Some of the most creative examples of the application of modern styles in the region are found at public buildings such as churches. These are often modern versions of traditional styles. For example, WS 342, the Holy Trinity Catholic Church in Fredericktown is a modernistic version of Colonial Revival (Figure 119). At MN 667, the Gravel Switch Baptist Church, the absence of a steeple or a portico places greater emphasis on the entryway and the large stained glass window above (Figure 120).

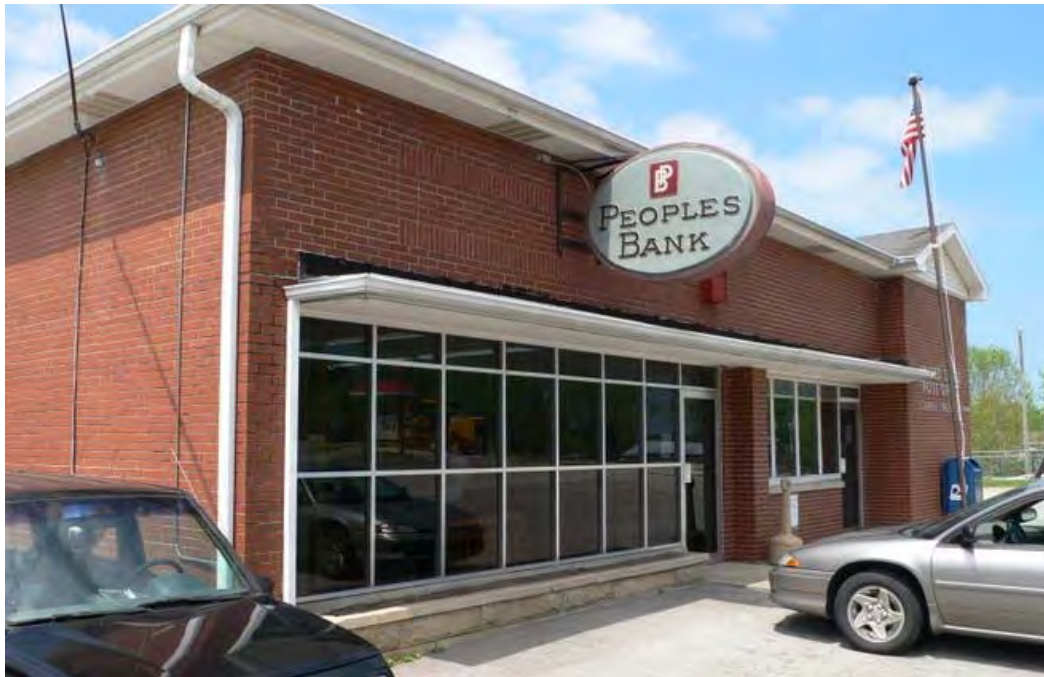
Figure 121: MN 673, Gravel Switch Bank & Post Office. Bank, before 1961, Post Office addition, 1961.

By the early 1960s, Modernism had a strong impact on downtown public and commercial buildings, reducing decorative detail and fenestration to a minimum and fronting the building with plate glass. The Gravel Switch Bank and Post Office is a typical example (MN 672, Figure 121). The trend toward reduction of detail is readily illustrated in this building, which was constructed in two stages. The Bank section, probably built in the late 1950s, is already quite minimal, but has a decorative brick pattern above the window. The Post Office addition was added in 1961. There, the brick veneer is a simple running bond on all sides. Even so, the
