A Survey of Historic Sites in Rural Marion and Washington Counties, Kentucky

A Report on the Findings of the *Rural Heritage Development Initiative Survey*
A project funded by a National Park Service Preserve America Grant

Kentucky Heritage Council

The State Historic Preservation Office, 2009

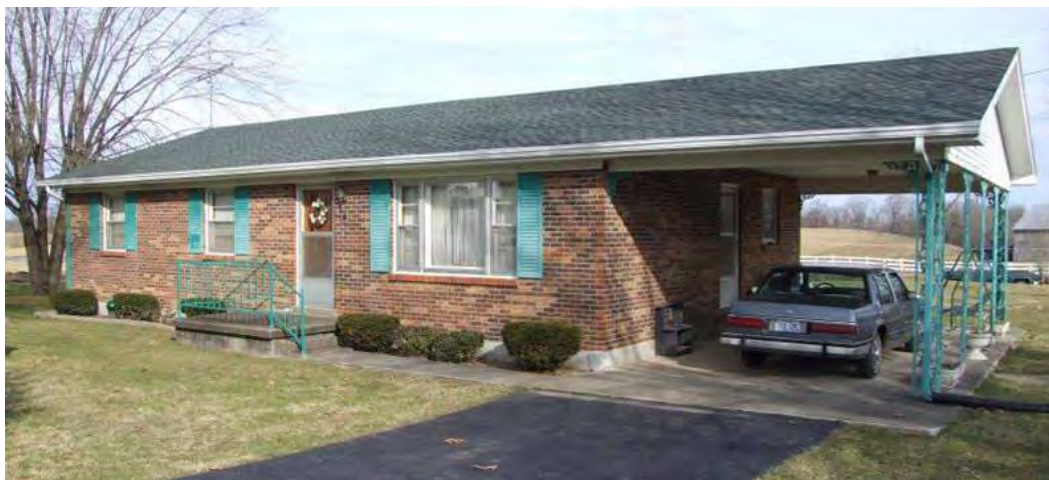
Figure 122: MN 315, 1960s-70s Ranch House, St. Francis.

fairly similar to older house forms (Figure 122). Ranch houses were really the first to place considerable emphasis on the automobile in the design of the structure and the surrounding landscape. The ranch style also brought in a new emphasis on the yard as a living space, and many examples have patio areas in back with grills for entertaining (Figure 125 and Figure 126). Front yard landscaping focused on features such as a large expanse of lawn, with asymmetrically placed shrubbery, and a sidewalk leading to the front entrance from the drive (Figure 181). At MN 536, we find an interesting wagon wheel fence bordering the drive (Figure 180). Ranch houses are discussed in further detail as a plan type beginning on page 147.

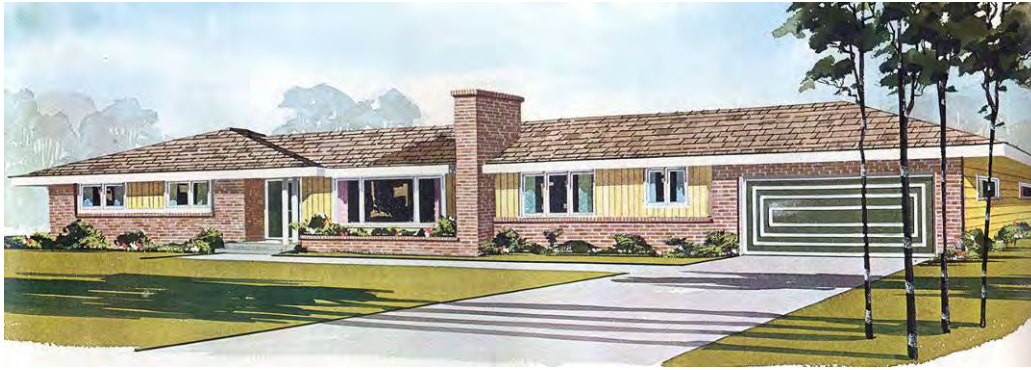
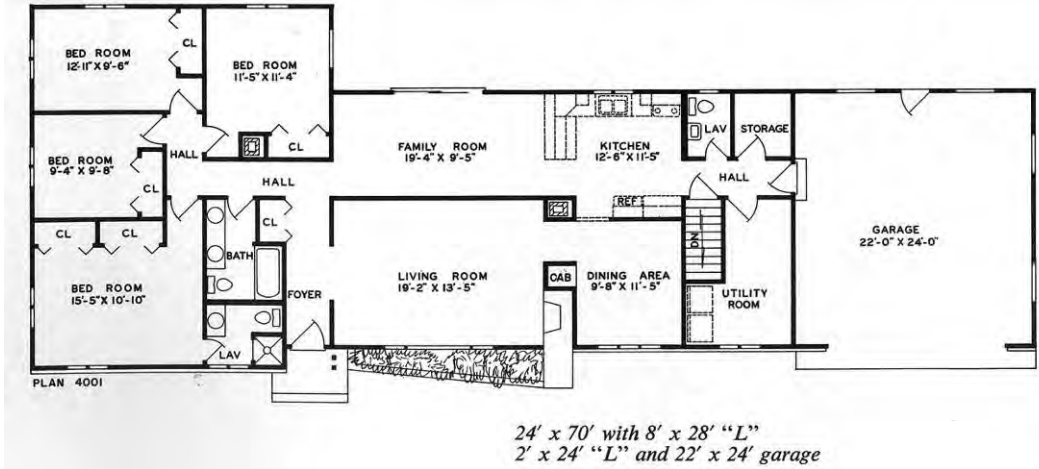
Figure 123: Elevation and floor plan of “The Capri,” a ranch house, from the catalog Capp Homes (Minneapolis, Capp-Homes, Inc., 1968, 40).

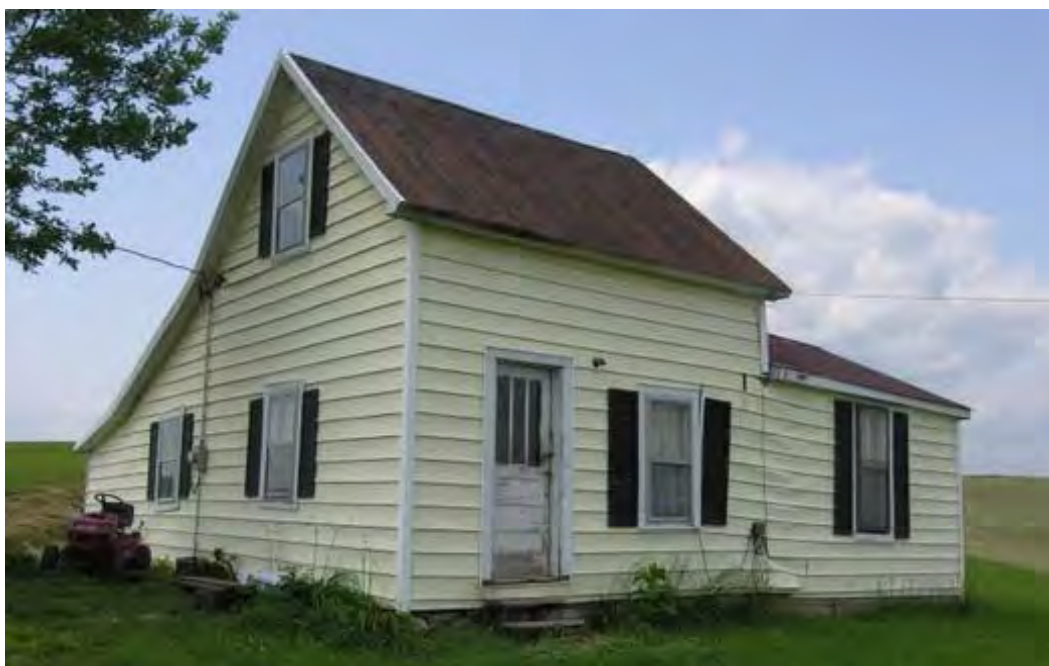
Figure 127: WS 797, single pen house with rear shed and side additions, late nineteenth-early twentieth century, Mackville.

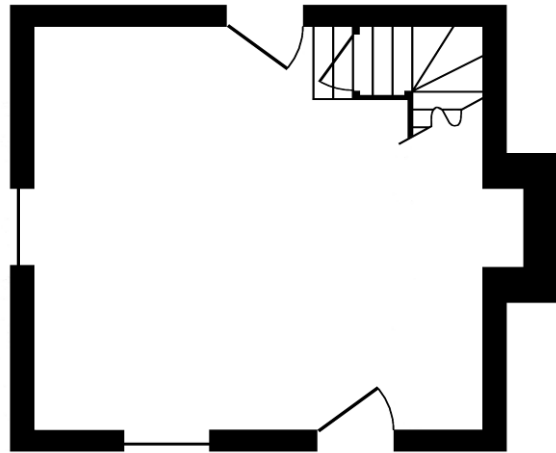
Figure 128: *Single pen floor plan.*

The simplest plan, the *Single Room* plan is a house with one room in the main structure on the ground floor (see Figure 128 for plan and Figure 129 for an example). The type has several variants, such as a single room with a loft, a full second story, a cellar below, or extensions such as shed rooms and porches. Single room plan houses also vary in fenestration, method of construction, and size. It might be a twelve-foot-square log cabin or it might be an 18 x 20 foot brick finished house. It could be the house of a laborer, slave or tenant, or, on the other hand, the house of a landowner, slaveholder, or middle class artisan, depending on the period of time and the context. The single room plan can have various subtypes. One subtype of the single pen house was identified in the Marion/Washington County survey - the “Starter House.” We will look at this subtype in greater depth.

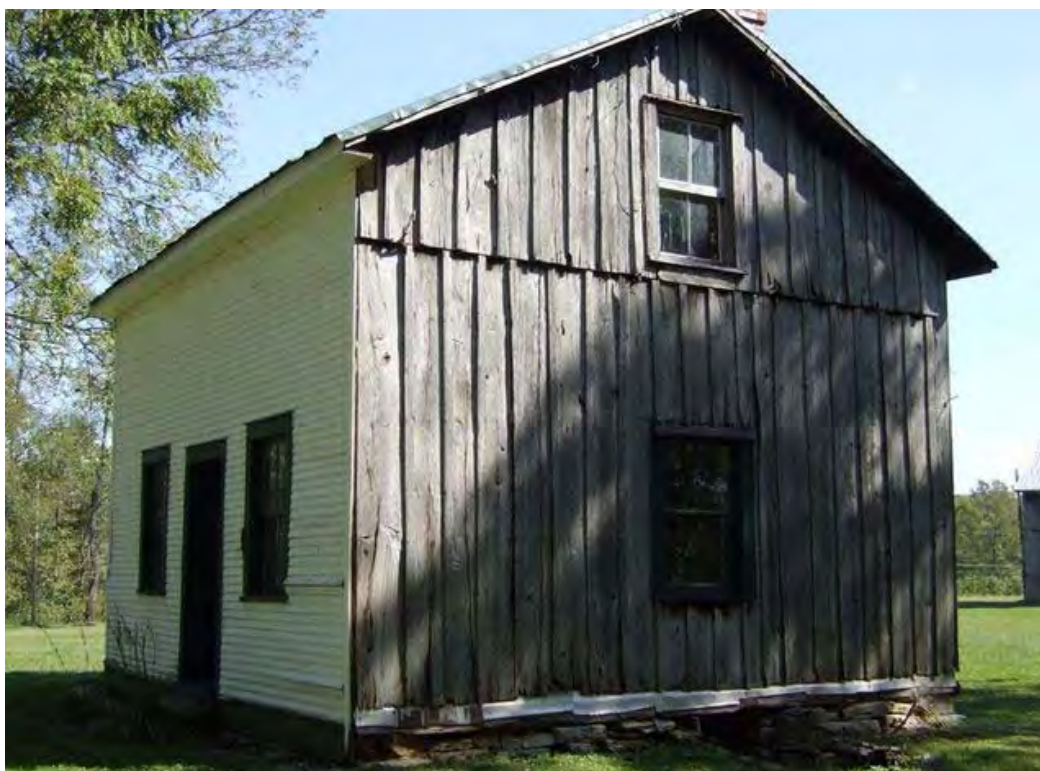
Figure 129: WS 316, Slack’s Cabin, mid-late nineteenth century, near Fredericktown. See also Figure 32.

The owners of Slack’s cabin reported that three young couples over the years “started up housekeeping” in this house in the late nineteenth and early twentieth century. The house is log on the first floor; the walls of the loft are raised above that in frame, a late hybrid of log and

frame construction.³¹ The first floor is finished in plaster, has an enclosed stair to the loft, and three glass windows, two on the front and one on the side. The loft area is unfinished, but does have a glazed window. The house's heat came from a stove vented through an interior chimney, which may have replaced an earlier exterior chimney and fireplace. There was once a small kitchen addition at one end of the house, since removed. The house has a cellar underneath for food storage, accessed from an exterior bulkhead beneath the side window. Two sides, the front and the far gable end are finished in weatherboard, the other two are vertical board and batten. The board-and-batten siding reflects the Gothic cottage style of the mid-nineteenth century. The weatherboarding is probably a later renovation, but occurred in the historic period. On the other hand, it might be original, as it was a common practice to finish the principal facades of buildings more finely than the sides or the back.³²

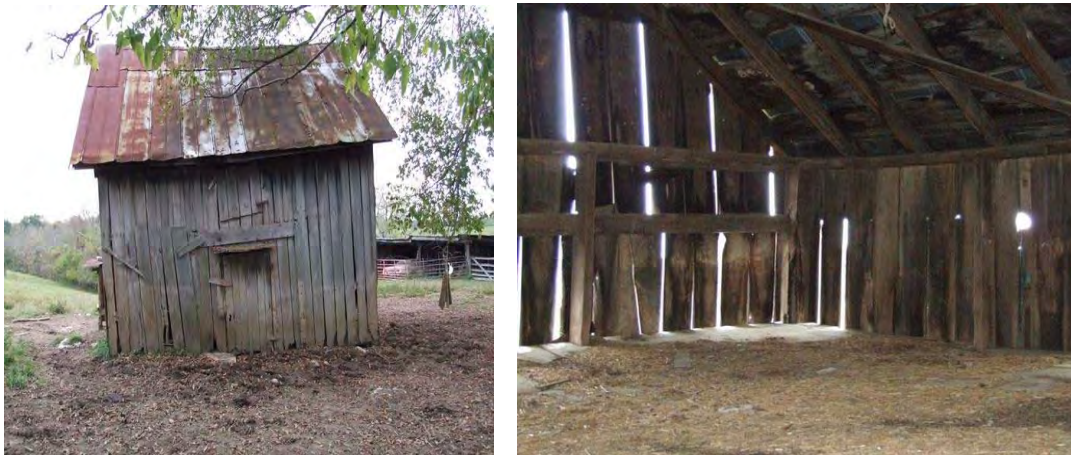
Figure 130: WS 362, single pen “Starter House,” late nineteenth century, Mooresville vicinity. Front elevation on left (a window to the left of the door is boarded over), interior of loft on right. See also Figure 131.

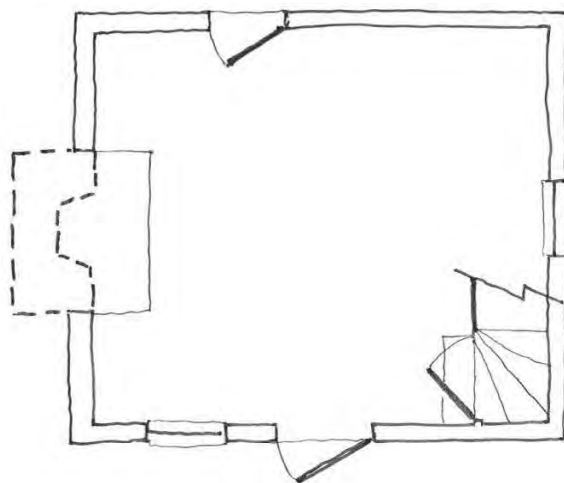
Figure 131: WS 362, plan (not to scale). See also Figure 130.

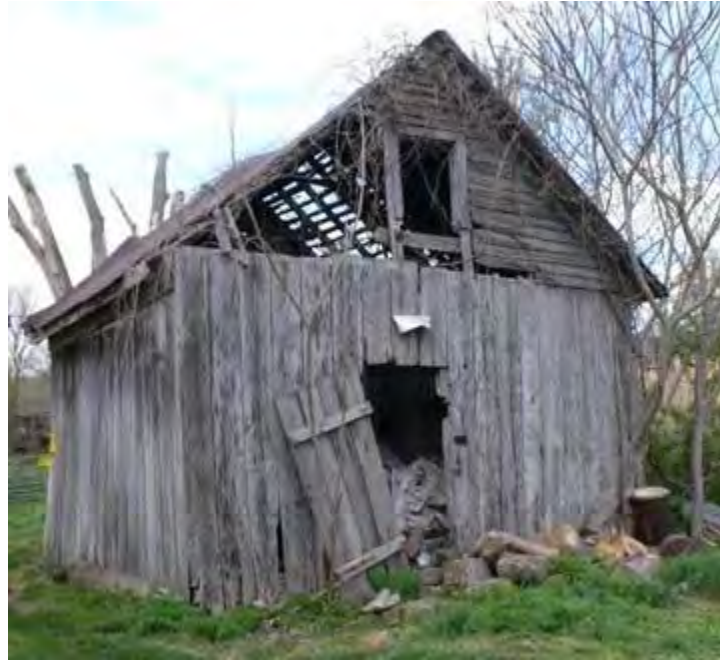
Figure 132: MN 666, tenant house or kitchen, late nineteenth century, Beech Fork/Gravel Switch vicinity.

Figure 87: MN 666, Late nineteenth-early twentieth century, Gravel Switch vicinity. The outbuilding just visible behind the house to the left is found in Figure 132.

A house with some similar characteristics is found at MN 666 (Figure 132). This late nineteenth or early twentieth century vertical plank frame structure is located directly behind a house constructed in approximately the same period (MN 666, Figure 87). Like the others, it is a single room downstairs, with a loft overhead, this one reached by a ladder rather than a stair. There is no fenestration on the façade of the building that faces the larger house, but there is a single glazed window on the side facing away from the main house. One other window is found in the loft above the only door in the gable end. The interior of the ground floor is treated with battens covering the cracks between the vertical planks of the structure and whitewashed. There is no apparent evidence of a chimney; the house appears to have been heated by a stove. Although the building may have been used as a kitchen, the orientation of the window away from the main house and the interior whitewashing suggests it might have been used as a tenant dwelling. Servant's houses and slave quarters are often oriented behind main houses with windows facing away from the house for reasons of privacy.³³ In contrast to Slack's Cabin and the small house at WS 362, this building is less substantial, has a smaller loft area not raised into a half story, is less well finished on the ground floor, and has fewer windows. It shares a similar form, but this example appears to be associated with a tenant rather than a landowner.

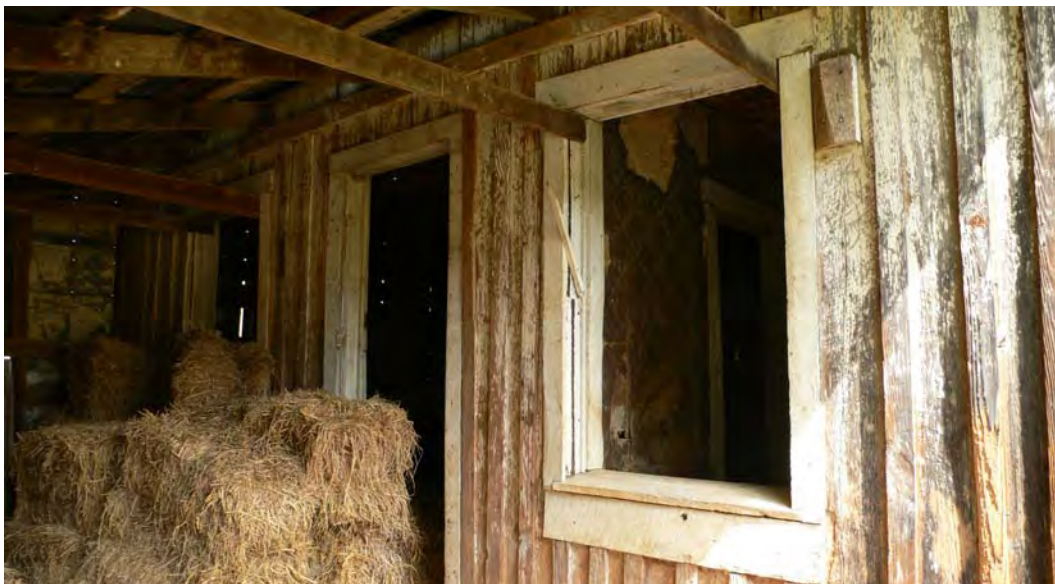
Figure 133: MN 920, Hall/Parlor house, nineteenth-early twentieth century, Gravel Switch vicinity: detail of front (covered by a later shed). The interior wall visible through the window divides the interior space of this house into two unequal size rooms. Dividing one of the two rooms with a wall results in a three-room plan.

In early houses, the next most common house type (after the single pen) was the two room *Hall-Parlor* plan (Figure 134). This plan consists of two rooms: the “hall,” accessed through the front door, and an inner room called the “parlor.” This plan was sometimes formed over time by adding on to a single room house, as at WS 797 (Figure 127). The hall is a more public family room where cooking and eating takes place, the parlor a more private inner chamber serving as a sitting room and bedroom. Although today we associate the word “parlor” with formal sitting rooms, in this context, parlor has an older sense of a private, inner chamber. The hall is typically the more formal and thus more finely finished of the two rooms. The smaller parlor is typically plainer, sometimes even unheated. By the late eighteenth and early nineteenth centuries, significant variations are found. Most typical is the addition of an ell or a freestanding kitchen in back, removing the cooking duties from the hall, and consequently allowing for more specialized usage of the two rooms of the main part of the house. Hall-parlor plans are somewhat less common after about 1820, although they tend to persist much later in rural areas, with examples being found as late as the late nineteenth-early twentieth centuries, as at MN 920 (Figure 133).

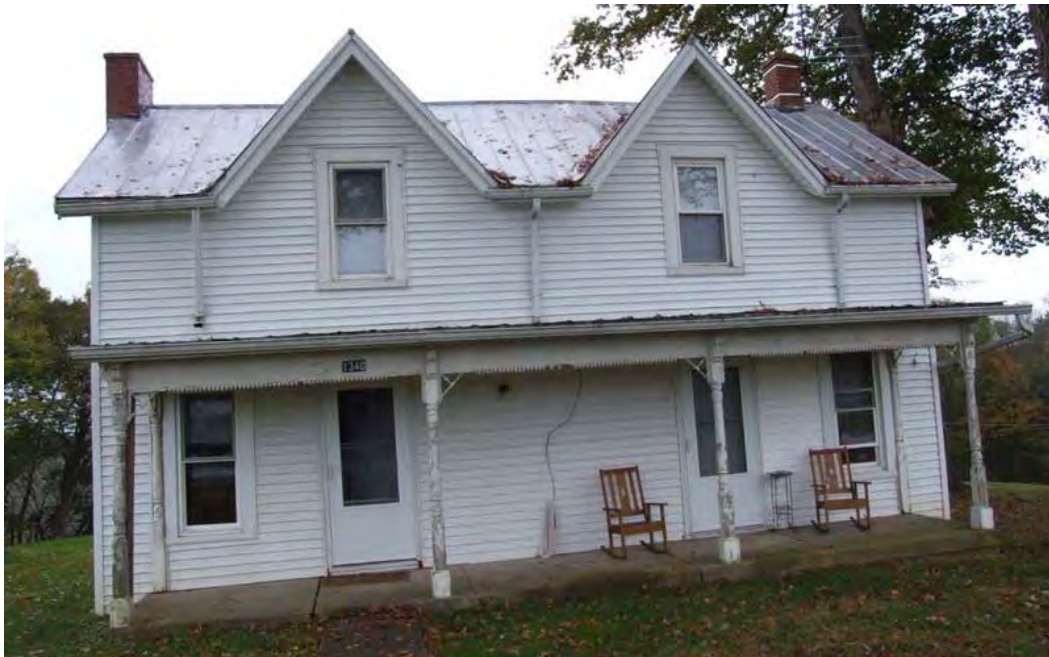
Figure 135: WS 365, *Side Gable I* house with two front doors, *double pen* plan, late nineteenth-early twentieth century, Mooresville vicinity

One characteristic of many historic houses in the survey area is the presence of two front doors, generally paired with two windows in a symmetrical arrangement across the front facade (see WS 365, Figure 135). Most commonly, these houses are one – to one-and-one-half stories in height and often have service rooms in a shed or ell addition to the back. These houses are quite prevalent: almost 100 of approximately 1000 houses documented in the survey area in this project are of this type. A typical example is MN 963, near Gravel Switch (Figure 140). It has the standard fenestration pattern of W/D/D/W, a double pen plan, and a central chimney (although some examples have end chimneys). Other examples illustrated in this report include WS 476 (Figure 2), WS 730 (Figure 58), MN 911 (Figure 63), WS 1115 (Figure 64), MN 604 (Figure 79), WS 477 (Figure 88), WS 453 (Figure 109) and WS 365 (Figure 135).

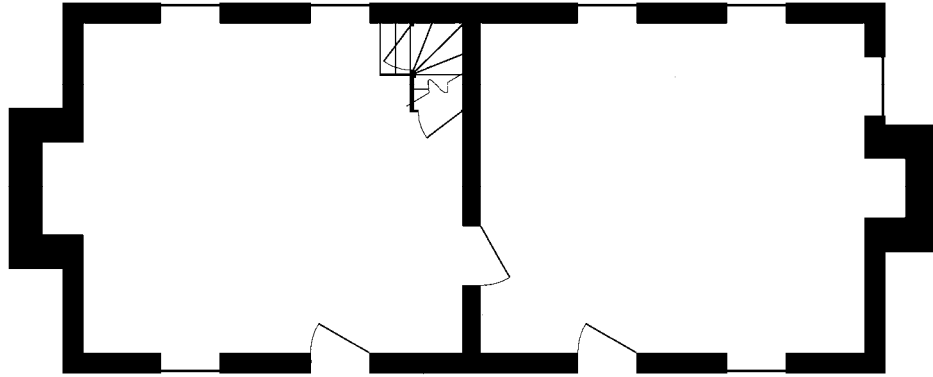
Figure 136: *Double Pen Plan*

The classic *Double Pen*, or *Two Room*, house plan is a long rectangle divided into two rooms of equal size by a partition wall. Several variations of double pen houses have been recorded. They can have chimneys at one or both gable ends (Figure 136), or a single center chimney. They can vary in the way the entries are configured. Some variants have a small lobby entry area in front of the chimney that leads to doors opening on either side to the two rooms as does the house at site MN 683, (Figure 45). Some have a door into one pen and no door into the other. Some have two separate front doors, one for each room, with a symmetrical fenestration pattern, usually window/door/-door/window. We will explore this latter double door type in more depth as a case study, below.

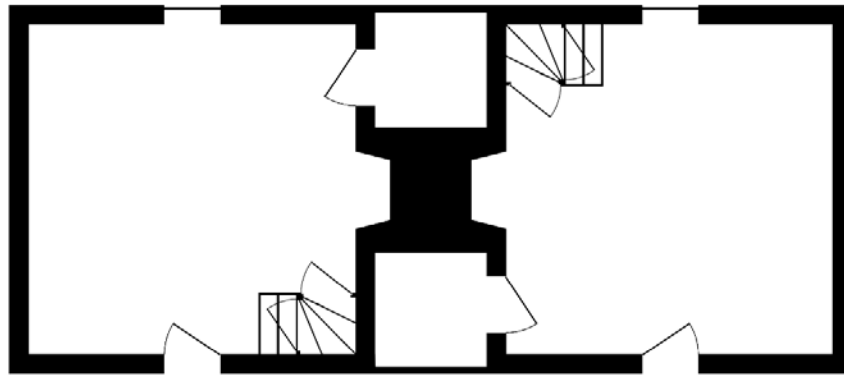
Figure 137: *Saddlebag Plan*

Some double pen houses with center chimneys can be further described as *Saddlebag* houses (Figure 137). The saddlebag is a type of double pen house which, like the *Dogtrot* house (discussed below, Figure 153), has a strong association with log construction. The classic

saddlebag house is constructed of two log pens sharing one chimney in the center (thus, the pens are like saddlebags and the chimney is like the horse). Similar forms were constructed of other materials, but the term tends to imply a log structure. Saddlebags were sometimes built in one campaign, but frequently resulted from two periods of building, such as a single pen house followed later by an addition to the (now shared) chimney end. Thus, a mix of construction materials may occur as well as time periods. For example, MN 925 began as a log house and later had a frame addition to the chimney end (Figure 138), but is still considered a saddlebag. Double pen frame or masonry houses with center chimneys are sometimes referred to as “saddlebags,” but the use of the term here can be misleading, and they are probably best termed double pen or two room plan houses so as not to imply log construction.

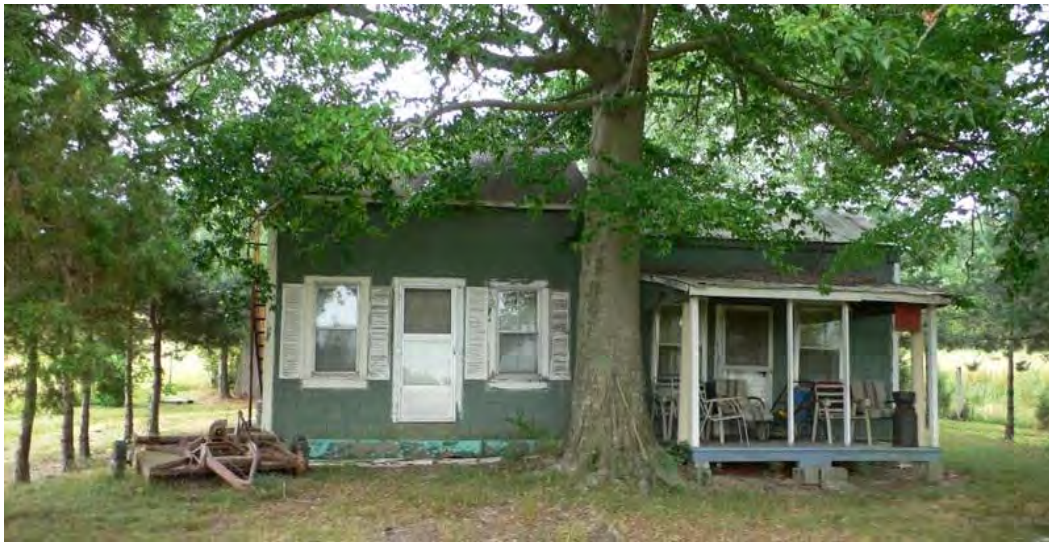
Figure 138: MN 925, saddlebag log and frame house, mid-late nineteenth century, Bradfordsville vicinity. The right side is log, the left side is later frame added to the chimney end of the log house.

The Cumberland form may have roots in double pen houses of the saddlebag variety (MN 925, Figure 138) or related double pen variations (WS 431, Figure 142). There is a precedent in the “Pennsylvania Farm House” an eighteenth - early nineteenth century house type associated with people of central European descent in the general region of Pennsylvania, Delaware, and Maryland. They later moved on from the Mid-Atlantic to help settle areas such as the Shenandoah Valley of Virginia, parts of the Upland South, and Kentucky. The Pennsylvania Farmhouse hides a Germanic asymmetrical three-room plan behind the symmetry of a Georgian English façade, ending up with a four bay, W/D/D/W front. Other precedents are found in the British Isles.³⁹ Early 19th century examples of similar form also exist in the central Bluegrass Region, such as Oakland in Fayette County (Figure 143). However, the link between these precedents and the late nineteenth/early twentieth century Cumberland house has not been clearly established. The fenestration is similar to the Pennsylvania farmhouse, but the floor plans are different. The floor plan is similar to that of Oakland (Figure 143), but there the paired doors are close together, preserving the tripartite effect of the front façade, and smaller bed chambers are appended to each end of the house.

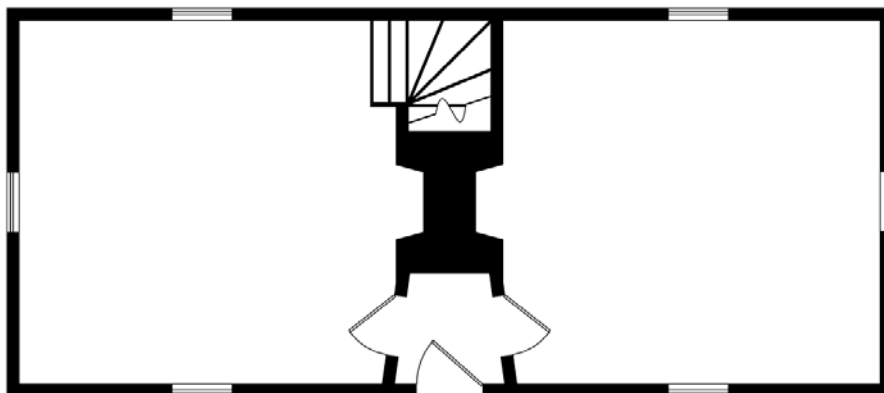
Figure 139: Double pen with lobby entry. MN 683, Figure 45, is an example of this floor plan type, with an ell attached to the back.

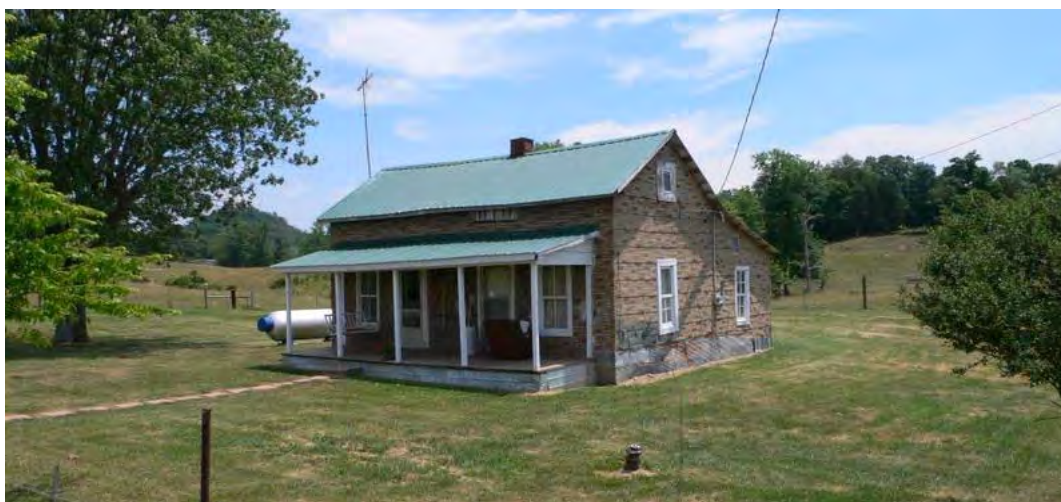
Figure 140: MN 963. Vertical Board frame double pen house with brick-patterned asphalt siding, late nineteenth-early twentieth century, Gravel Switch vicinity.

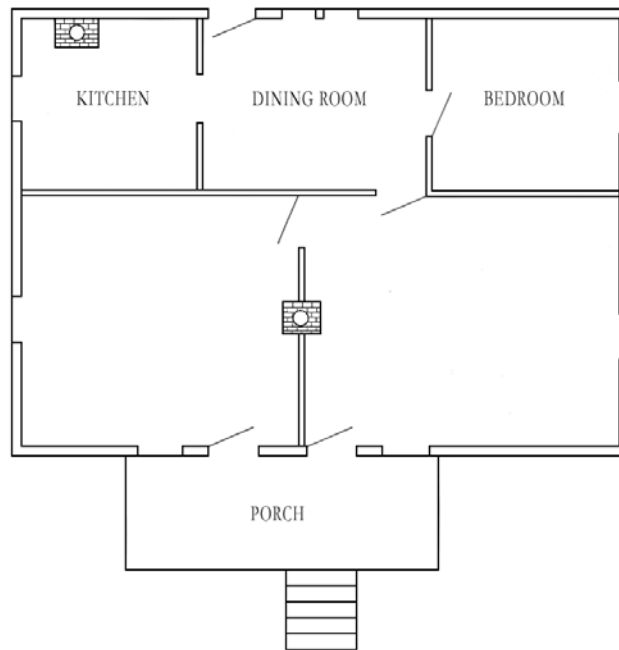
Figure 141: *Floor Plan of the Gunn House, from Norbert Riedl, Donald B. Ball, and Anthony P. Cavender: A Survey of Traditional Architecture and Related Material Folk Culture Patterns in the Normandy Reservoir, Coffee County, Tennessee (Knoxville: University of Tennessee, 1976), 234.*

This house type is commonly called the “Cumberland house”, a term coined by Norbert F. Riedl, Donald B. Ball and Anthony P. Cavender in 1976 in their survey of Coffee County, Tennessee.³⁵ That study noted a large number of frame double pen dwellings with two front doors, one for each pen (see floor plan, Figure 141). That same year, William Lynwood Montell and Michael Lynn Morse, based on fieldwork in south central Kentucky, named the same type the “tenant

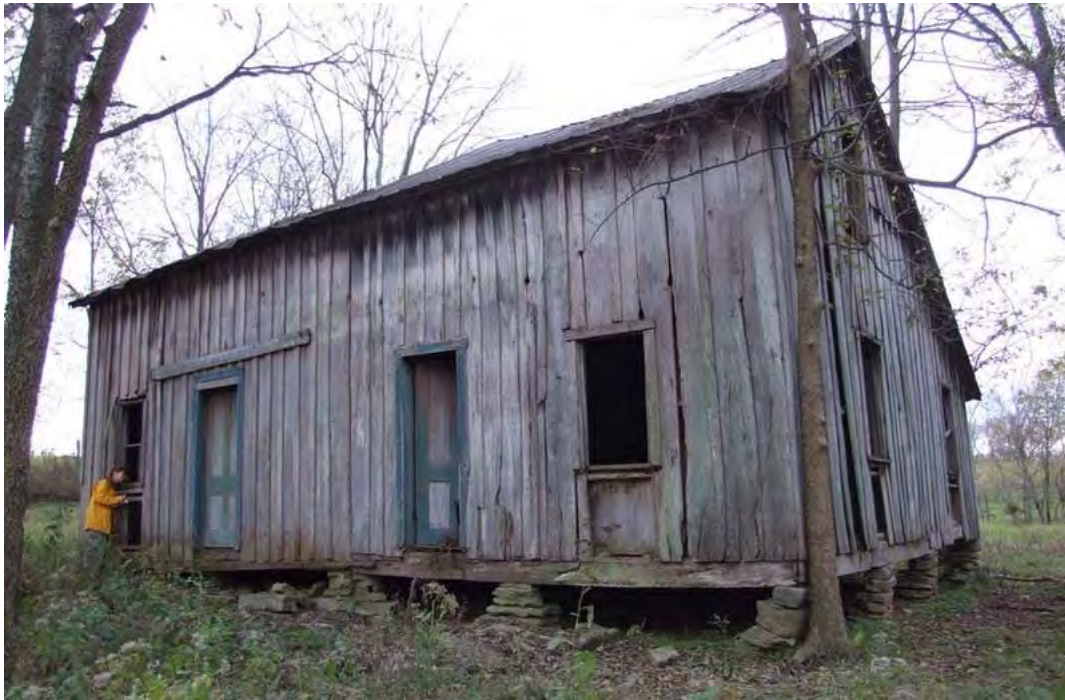
Figure 142: WS 431, Late nineteenth-early twentieth century, Valley Hill vicinity. House began as a single pen on the right but was later expanded into a double pen house.

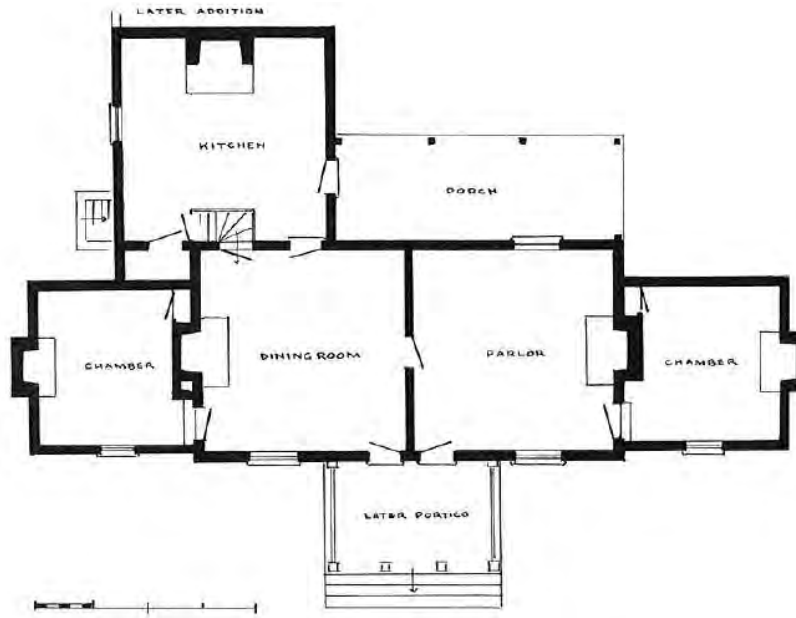
Figure 143: *Oakland, first floor plan (drawing: Clay Lancaster, Antebellum Architecture of Kentucky (Lexington: University Press of Kentucky, 1991), 80.*

One of the most dramatic developments in modern domestic architecture occurred prior to Kentucky's Statehood, in the late seventeenth through mid-eighteenth centuries. This was the introduction and diffusion of houses with hallways separating the rooms. This house type coincides with cultural shifts including a desire for more privacy, ceremony, and ordering of space. It was particularly common in places where the owners had servants or slaves living and working under the same roof. The center stair hall allowed for a greater number of circulation patterns, providing a formal greeting space for visitors, who could be directed toward the appropriate room depending on their business without intruding upon activities in other rooms. By the time of Kentucky's settlement, the center hall house was almost commonplace among genteel society, though even there not universal (see Figure 143, for example).

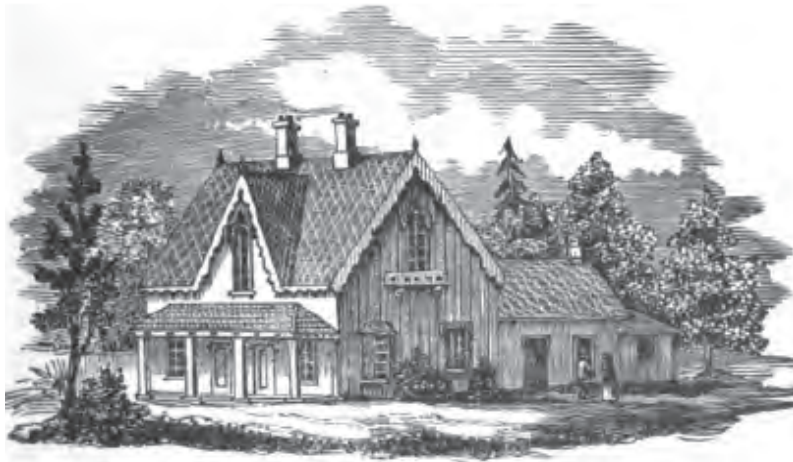
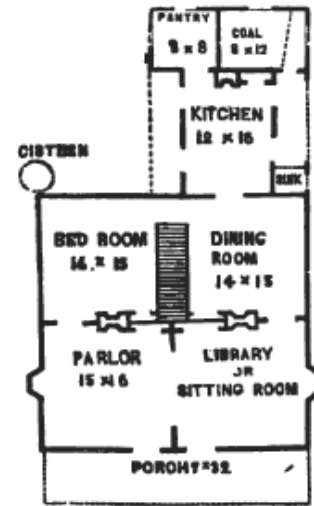
Figure 144: “A Plain House in the Cottage Gothic Style,” rendering and floor plan, from John J. Thomas, *Illustrated Annual Register of Rural Affairs, for 1858-9-60* (Albany: Luther Tucker & Son, 1873, 47-48).

In the popular literature of the day such as architectural pattern books, plans for double pen houses are common, but double door ones are unusual. One example of a house design with two front doors is found in John J. Thomas’s *Illustrated Annual Register of Rural Affairs, for 1858-9-60*, labeled “A Plain House in the Cottage Gothic Style” (Figure 144). The plan here is a double pen, double pile, with an ell trailing behind. The house looks very much like a fancier version of many of Kentucky’s rural Gothic style houses (compare to the Levi J. Smith house, Figure 42, which is not a double door house, but which has very similar massing and chimney placement). The text of the published plan explains that “the accompanying design was furnished by a correspondent, with a request for the suggestion of improvements.” They respond that “the most obvious defect is the direct passing from without through single doors, into the parlor and library. This *objectionable* feature may be removed by converting the central portion of the veranda into an entry or vestibule, opening into these two apartments”⁴⁰ (my emphasis), or in other words, an entry arrangement much like that found in Figure 139. It is quite interesting that they see the direct entry doors as a defect, since this was popular on the landscape, if not in the literature. Perhaps their disapproval can actually be credited to the widespread popularity of double-door designs and a perceived association with tenants or other lower classes.

Other house types are sometimes found with two front doors, such as the T- Plan house at WS 422 (Figure 146). The Victorian fashion for multiple doors opening onto verandas and porches may be an influence here. The published 1860s double pen, double pile, two-door plan in Figure 144 is similar to a twentieth foursquare or American Small House. Foursquares with paired doors

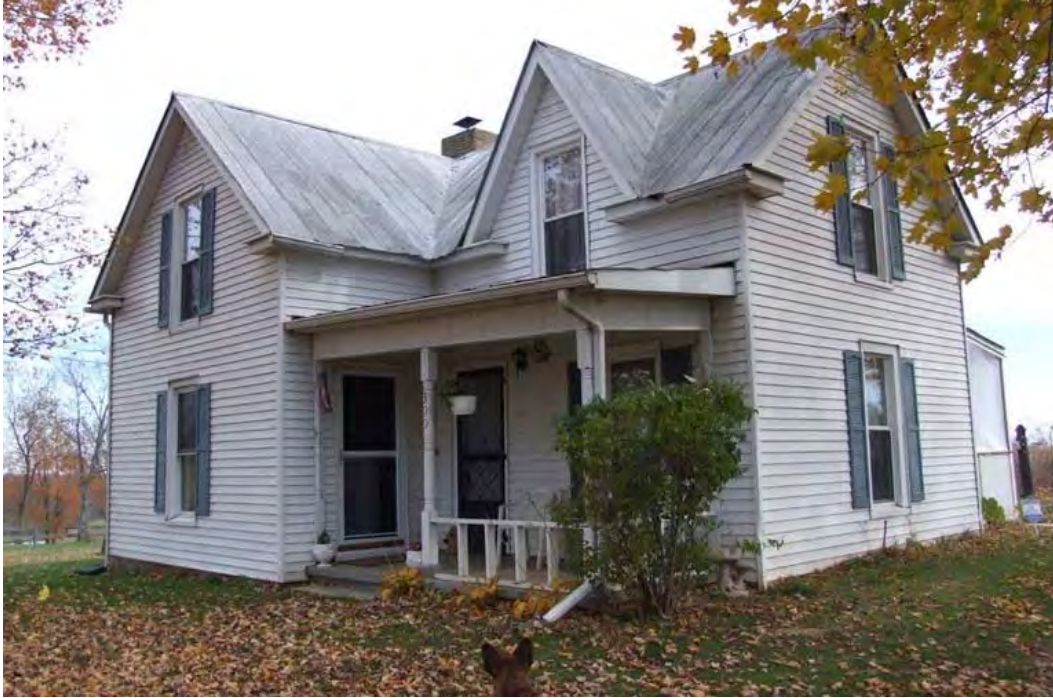
Figure 146: *WS 422, T-plan with Gothic cross gable, late nineteenth century.*

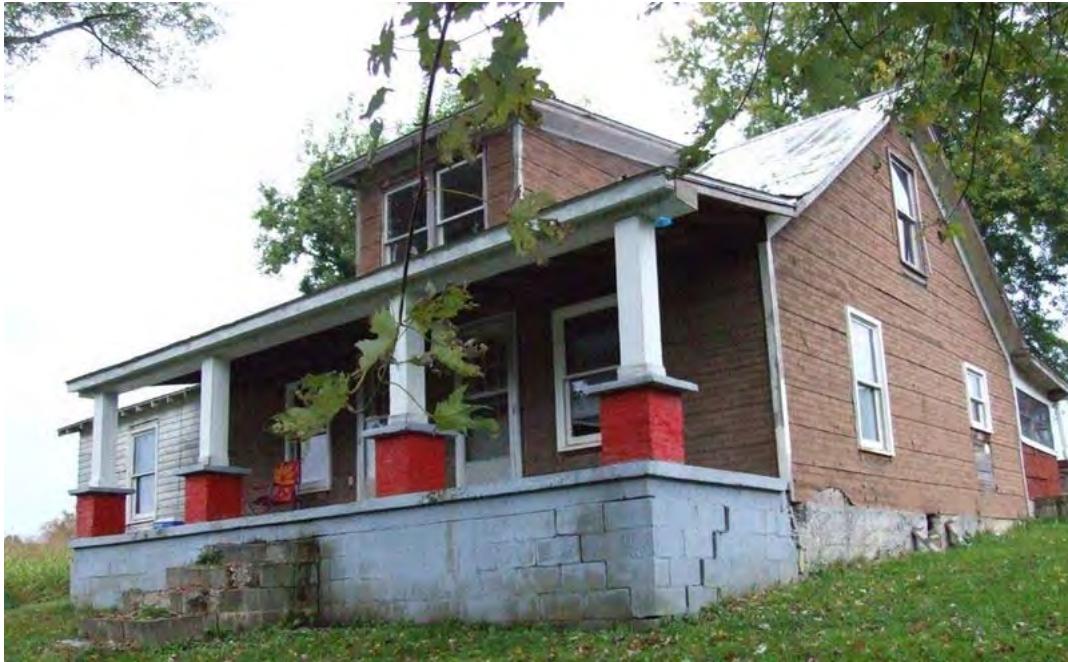
Figure 147: *WS 363, Two-door Bungalow, 1920s-30s.*

in the survey area are found at MN 710 (Figure 149), and possibly at WS 850 (Figure 104: the doors are not quite visible in the survey photograph). Bungalows with paired front doors are not uncommon in the survey region, as seen at MN 359 (Figure 105), WS 363 (Figure 147), and WS 1123 (Figure 148). One single pen house with two doors was also documented, MN 685 (Figure 150). In that case, though, it seemed like it might have once been divided into two smaller spaces of unequal size, more like a Hall/Parlor plan than a double pen.

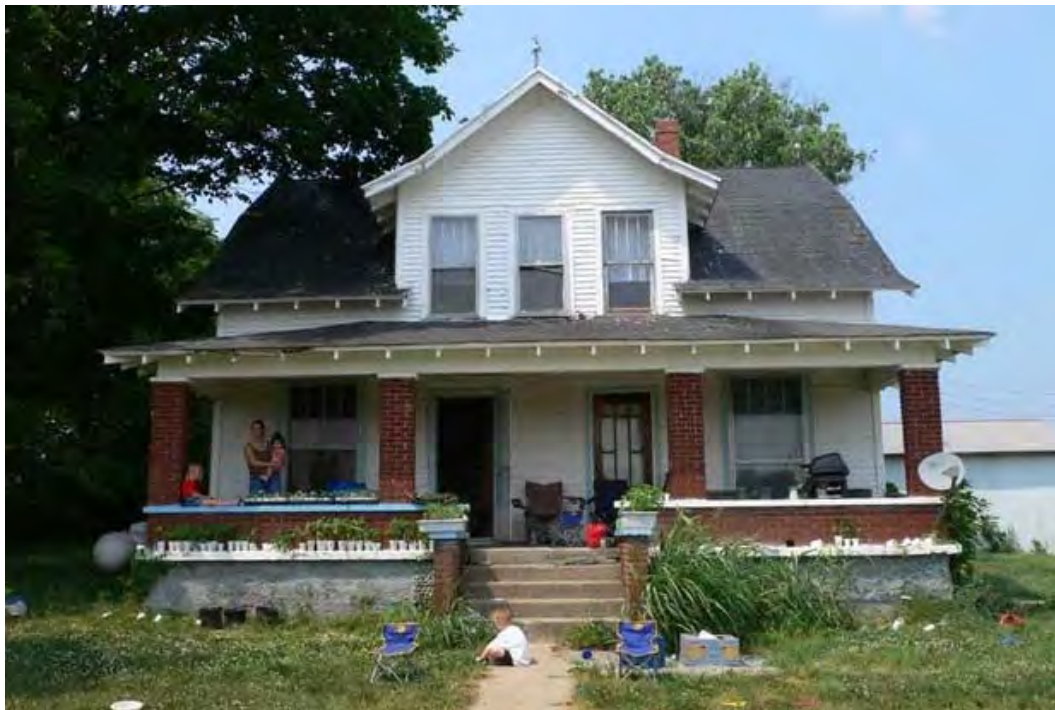
Figure 148: *WS 1123, Two-door Bungalow, early twentieth century, Willisburg.*

Rural bungalows and foursquares often have more traditional plans. As previously noted, double door varieties of each, the bungalow at WS 1123 (Figure 148) and the foursquare at MN 710, (Figure 149) illustrate often do not correspond to more high style or commercial printed plans such as those in Figure 168 and Figure 170. Examples of the latter are found, however, particularly as you get closer to major transportation routes such as railroads. The bungalow at MN 686 (Figure 167) near Gravel Switch, for example reflects national influence in its design, and may be a catalog house or built from a purchased set of blueprints with commercial millwork.

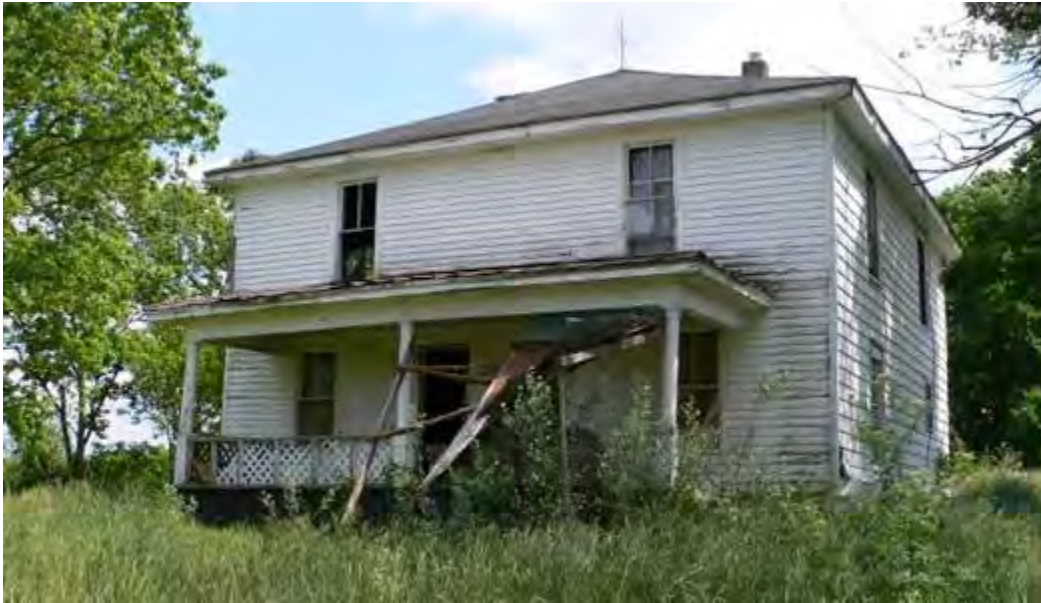
Figure 149: MN 710, early twentieth century foursquare, Greenbriar vicinity.

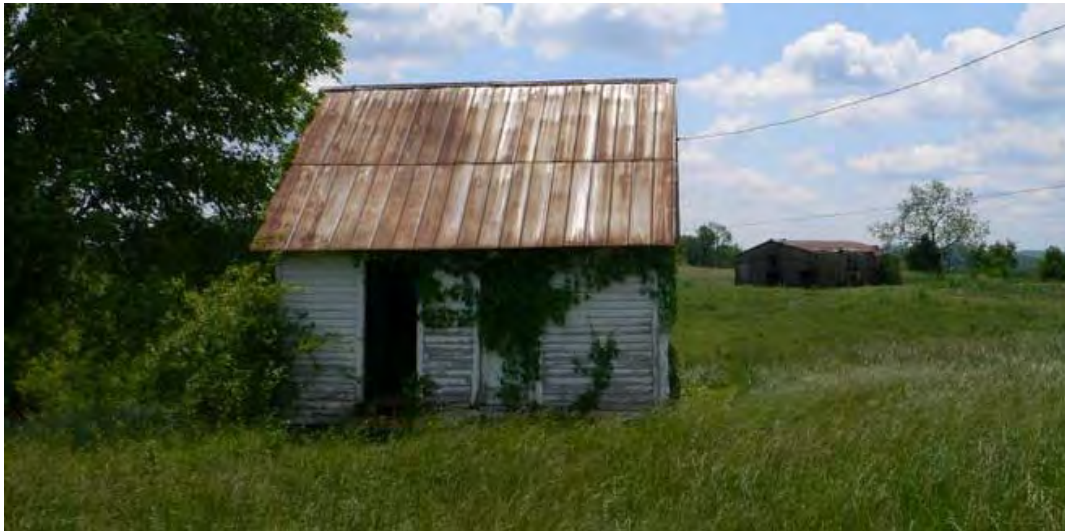
Figure 150: MN 685, Polly's house, a documented tenant house, has two doors with a single pen plan, but may have once been narrowly divided into two rooms on the ground floor. Ladder to the loft is near left hand door. Late nineteenth-early twentieth century, Gravel Switch vicinity. See also Figure 151.

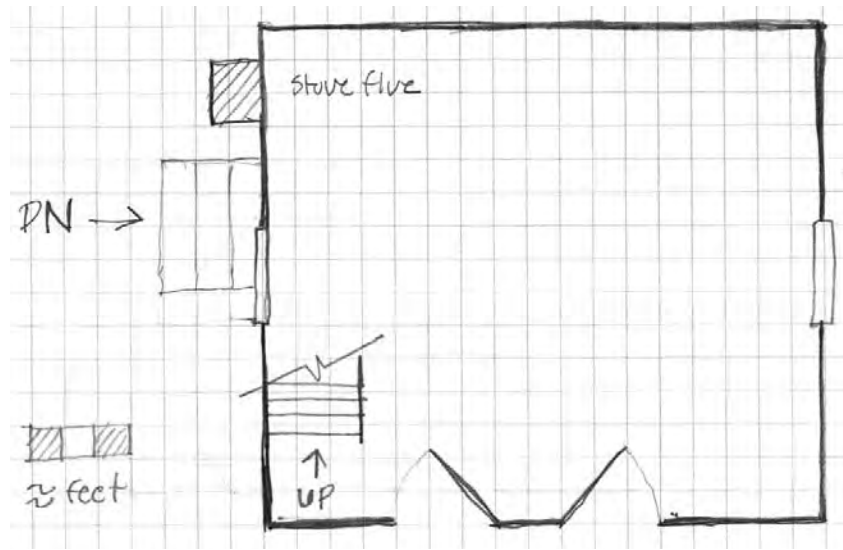
Figure 151: Floor plan of Polly's house, MN 685. There may well have been a wall dividing the room between the two doors. The House has a full cellar underneath accessed by the bulkhead stair near the stove flue on the left side of the building. Drawing from author's field notes. See also Figure 150.

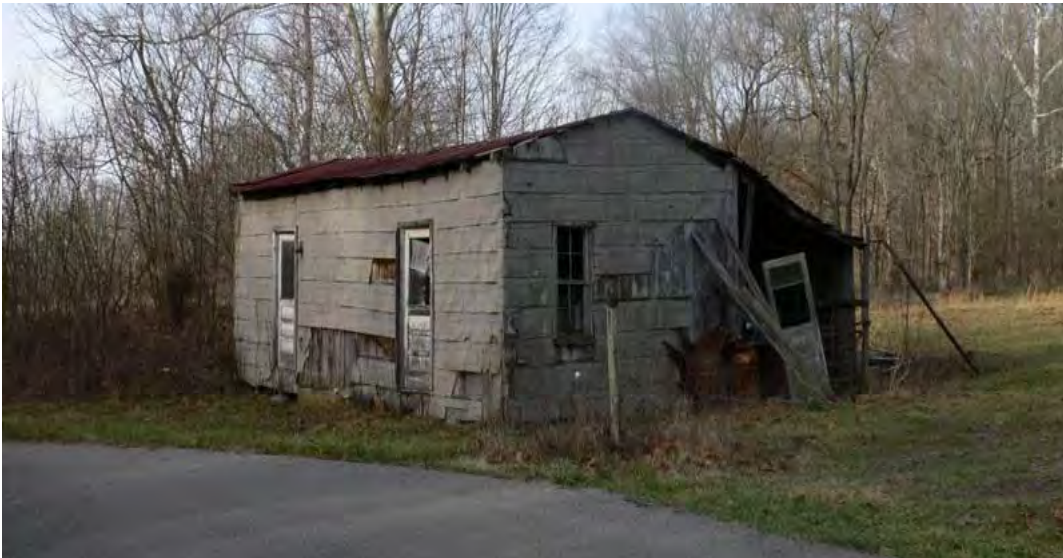
Figure 152: MN 605, early twentieth century, Bradfordsville vicinity.

MN 605 (Figure 152) is a remarkable example of a Cumberland house at something close to the most basic level. The house appears to have been constructed in the early twentieth century, probably before 1925. The house is box frame, single story with two rooms covered with a shallow pitched roof. Some additional space is allotted in a shed appendage along the back of the house. The front facade has just two doors, no windows. The windows are relegated to the side facades, and the rooms' heat is served by a central stove flue. Elements of architectural style are present only in minimal and contrasting bits - the tall, narrow window on the end has a hint of Italianate. The narrow, horizontal panels and large glass panes in the front doors and the exposed rafter tails of the roof share elements of the Craftsman style. The asphalt brick siding (which may be original), has echoes of Colonial Revival. It is a small, simple house for its era, an unusual survival. Although it must have been an uncomfortable house by modern standards, not

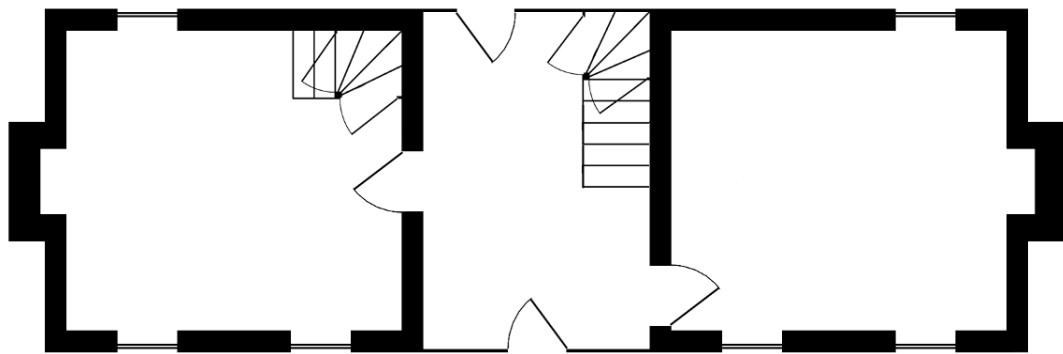
Figure 153: Dogtrot Floor Plan.

Houses with hallways occur in a number of basic types. The *Dogtrot* plan (Figure 153) in its classic configuration consists of two separate square or rectangular log pens with an open passage between them, all under one roof, as at MN 554 (Figure 154), or at WS 301 (Figure 155). Dogtrots may be one, one and a half, or two stories in height. Most commonly in Kentucky, as in these two examples from the survey area, the passage between the pens is enclosed as a center hall, with the stairway commonly located within this space. In some cases, the enclosure of the hall was a later modification, but it is also common for it to be enclosed as part of the original design. Often there is little difference in external appearance between a Dogtrot and a center passage, single pile plan (see floor plan below, Figure 156).

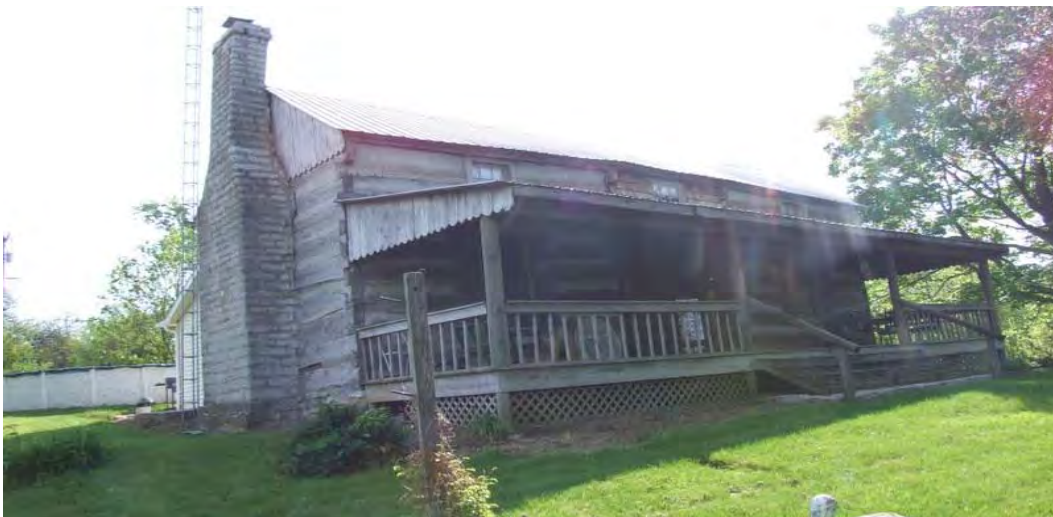
Figure 154: MN 554, *Dogtrot* type house. A log house constructed in the first half of the nineteenth century, St. Mary vicinity.

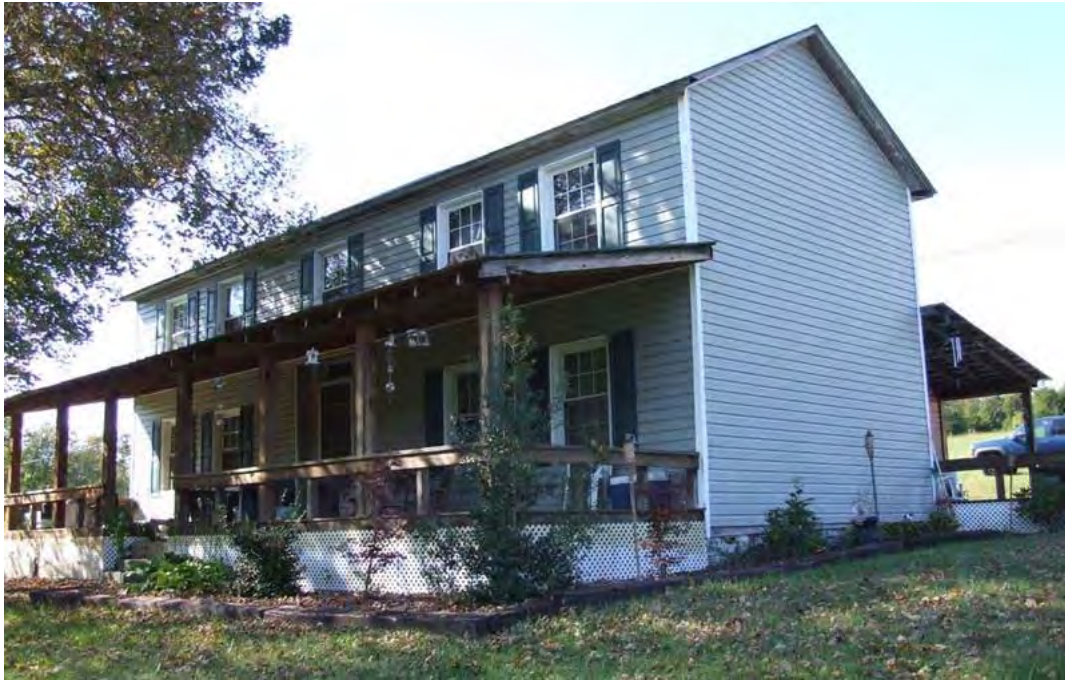
Figure 155: *WS 301, early nineteenth century, Booker vicinity. This house is built in a dogtrot fashion with the space between the two pens serving as the entry hall.*

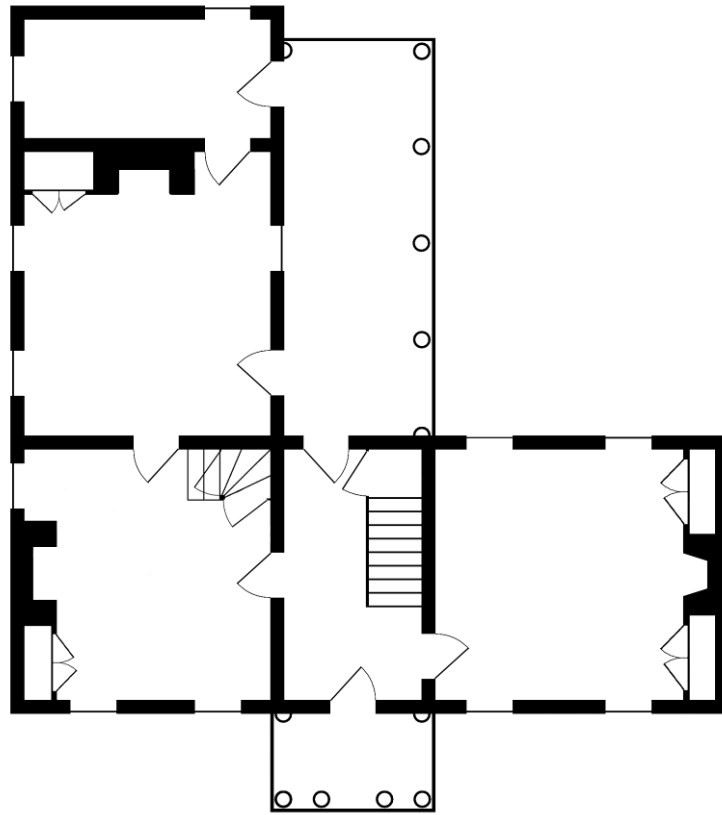
Figure 156: *Center Passage, Single Pile Plan (with rear ell). Figure 42, the Levi J. Smith house, is a good example of this plan, with interior rather than end chimneys.*

The *Center Passage Single Pile* house plan (Figure 156) was a common house type in nineteenth century Kentucky. These are often called I-houses, although the term is sometimes used to refer to houses of similar shape (a single room deep, multiple rooms wide, two stories tall with the principal entry on the eaves side) that do not have center halls. The classic examples have five openings across the front with a center doorway, although three bay examples are also common. Ells, whether original or added, are very typical features of this type of house, and there is often a two story open porch in the back cradled between the ell and the house. This adds an external means of circulation between the ell and the main house.
