A Survey of Historic Sites in Rural Marion and Washington Counties, Kentucky

A Report on the Findings of the *Rural Heritage Development Initiative Survey*
A project funded by a National Park Service Preserve America Grant

Kentucky Heritage Council

The State Historic Preservation Office, 2009

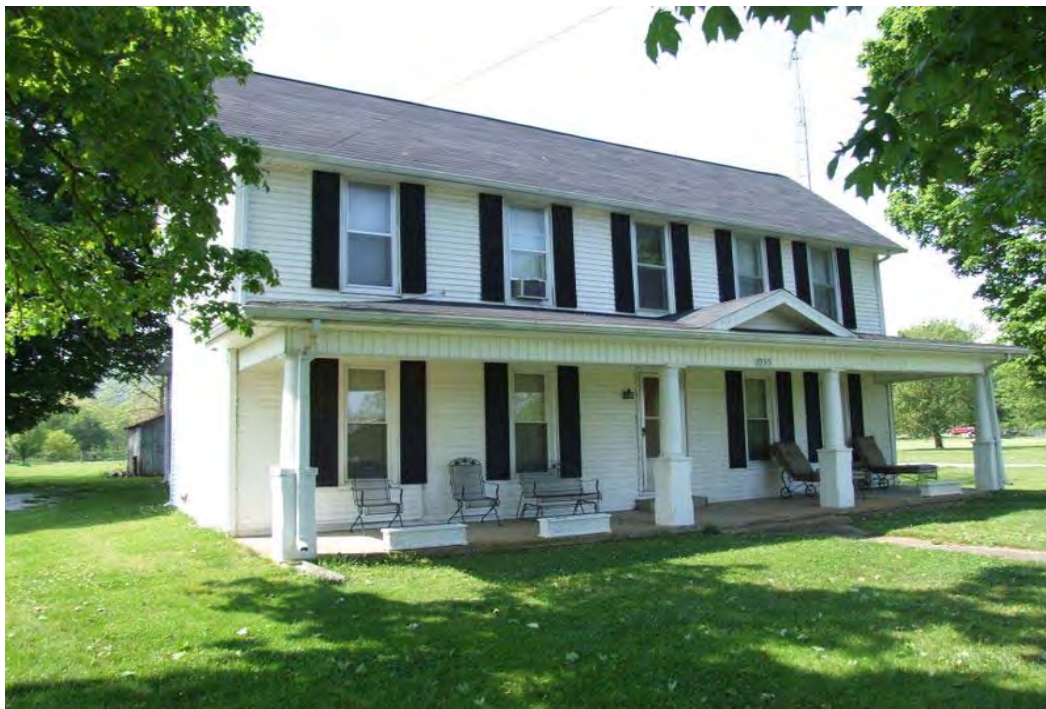
Figure 157: *MN 567, center passage, single pile house, late nineteenth-early twentieth century, New Market.*

Over 40 examples were documented in the survey area, MN 567 for example (Figure 157). Other examples include WS 27 (Figure 27), MN 919 (Figure 28), MN 336 (Figure 31), MN 1 (Figure 39), WS 45 (Figure 42), MN 684 (Figure 49), MN 682 (Figure 50), MN 674 (Figure 51), WS 1114 (Figure 52), MN 688 (Figure 53), WS 718 (Figure 65), MN 552 (Figure 66) WS 885 (Figure 67), and WS 648 (Figure 68).

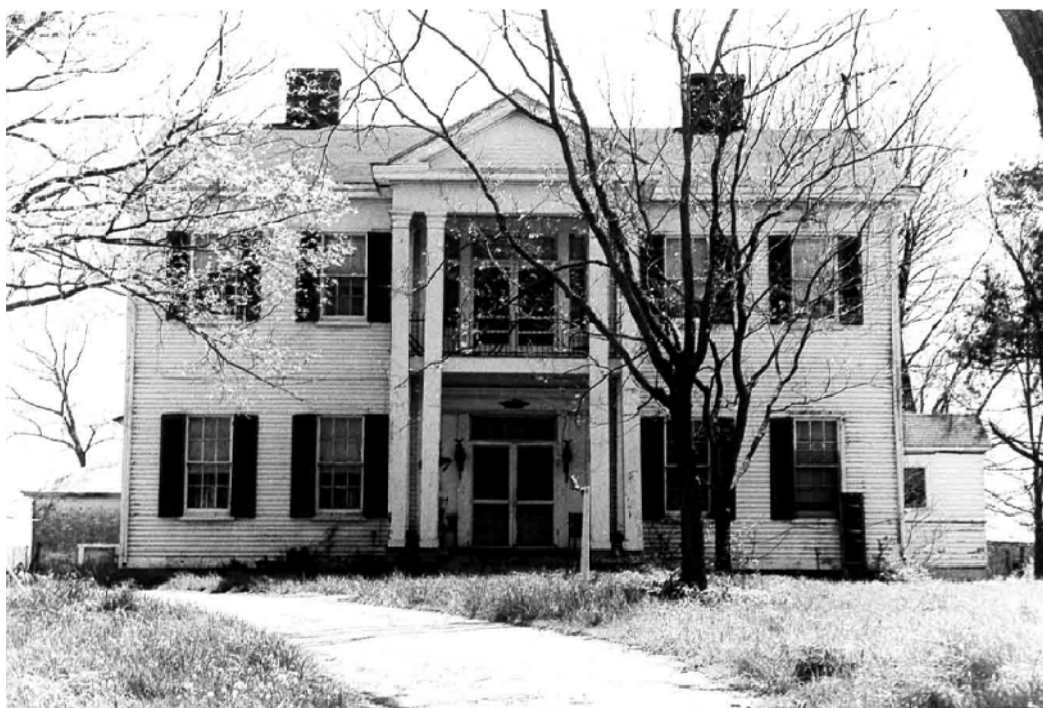
Figure 158: WS 24, Mayes house, circa 1830-50, Springfield vicinity. A Federal/Greek Revival Frame House, with a Center Passage Double Pile Plan. Photograph, 1983, KHC, Joe DeSpain.

Another example of a center hallway house type is the *Center Passage, Double Pile* plan (Figure 159), but these are quite uncommon in the rural areas of Marion and Washington Counties: less than 20 were previously identified in the two counties, and no new examples were documented in the current survey. One example was revisited at WS-24 (Figure 158).

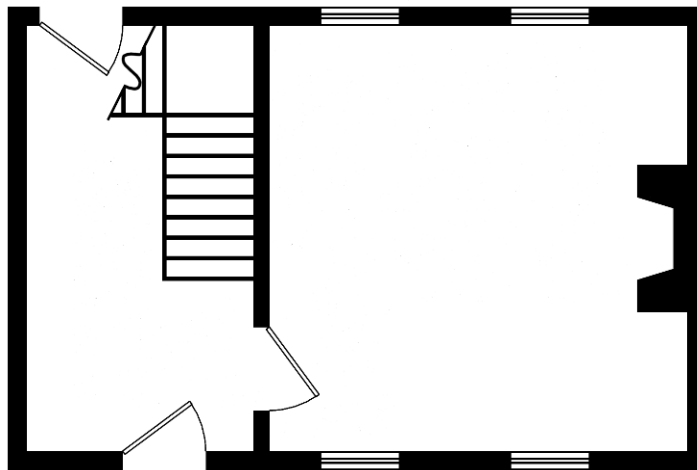
Figure 160: *Side Passage Plan. Side passages may also be double pile, like the plan in Figure 159 with two rooms along one side of the hall removed.*

Side Passage plans (Figure 160) are similar to center hall plans in social function and spatial division. They exist in both single and double pile forms. They are most commonly found in urban contexts, although not exclusively. They are fairly unusual in the survey area, with just 5 examples noted. One revisited site is at MN 46 (Figure 161), the Coppage house, a good example of an early Federal/Greek revival house in this area.

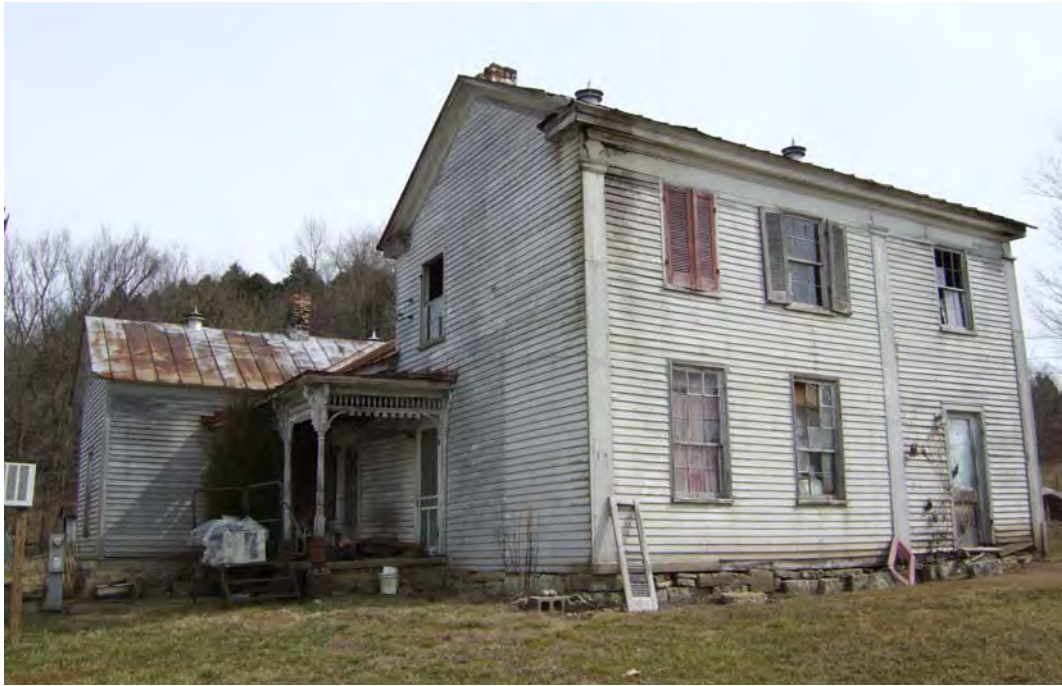
Figure 161: MN 46, *Coppage House*, early nineteenth century, side passage plan, Federal/Greek Revival style, Pleasant Valley vicinity.

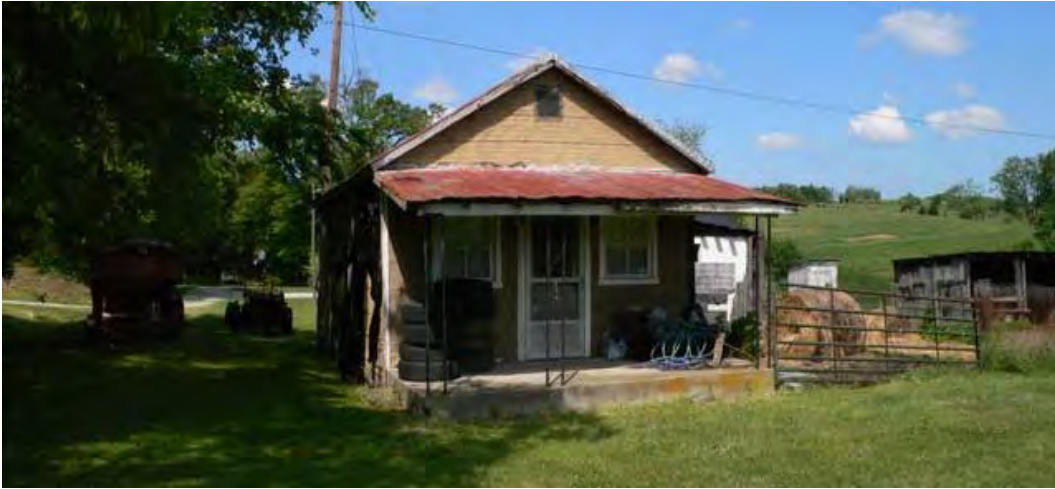
Figure 162: MN 691, Shotgun House, early twentieth century, Riley.

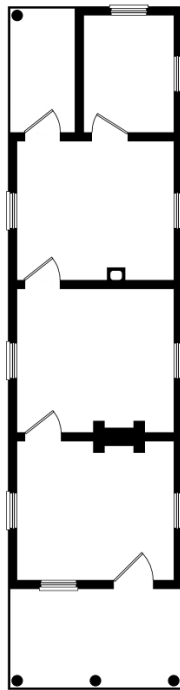
Figure 163: Shotgun Plan.

New house forms developed in the late nineteenth-early twentieth century, some of them quite important to the Marion and Washington County rural areas, others not so common. The *Shotgun* house, for example, is extraordinarily important in large urban areas in the south, including Kentucky, but, somewhat surprisingly, just one confirmed example was documented in this survey, MN 691 (Figure 162). In plan, shotgun houses are a single room wide with a number of rooms stacked behind one another (Figure 163).

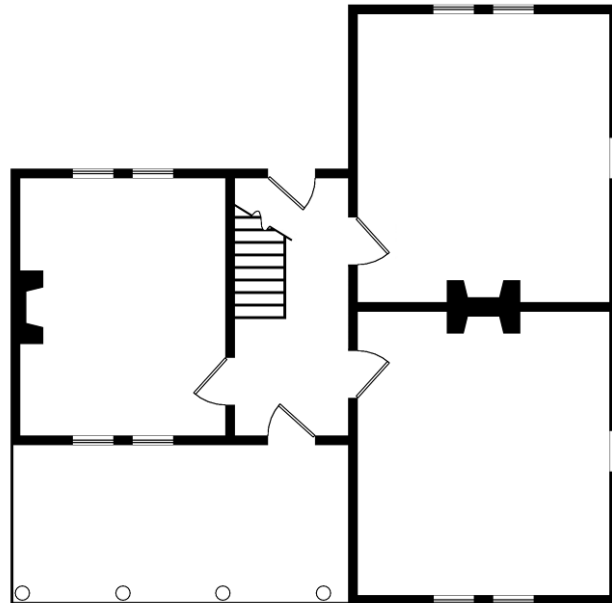
Figure 164: *T-Plan.*

The *T-plan* (Figure 164), another popular house type of the late nineteenth and early twentieth century, is far more common in the survey area, with 95 examples documented. The house gets its name as in plan it generally represents a “T” set on its side, with the cross bar of the “T” being a gable-fronted wing. It has also been called an “upright and wing” type house. It is actually a group of houses that includes a variety of floor plans. A porch generally fills the recess between the two wings of the building, and the main entry is off of the porch, sometimes into a stair passage, and sometimes directly into a room. A good example in the survey area is seen at WS

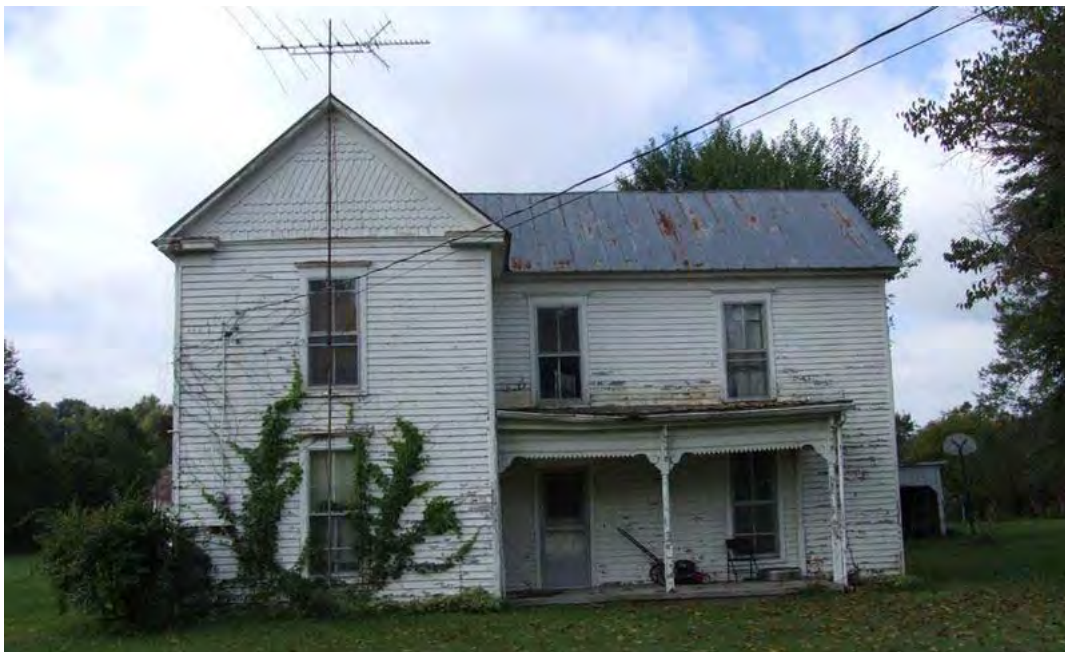
Figure 165: *WS 271, T-plan house, late nineteenth century, Maud.*

271 (Figure 165). Other examples we have already seen include MN 650 (Figure 23), WS 640 (Figure 71), WS 247 (Figure 72), MN 12 (Figure 74), MN 930 (Figure 86), MN 666 (Figure 87), WS 415 (Figure 91), and WS 422 (Figure 146).

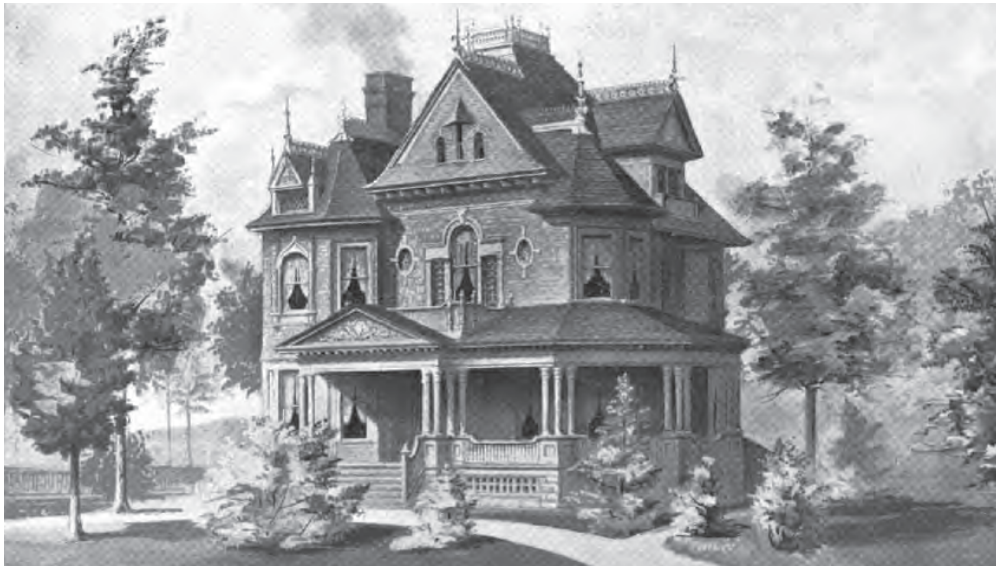
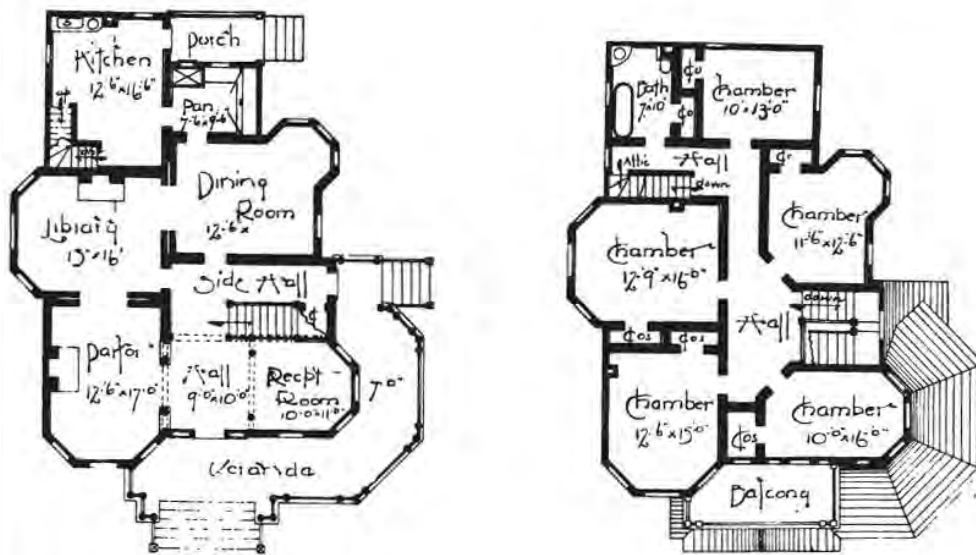
Figure 166: Elevation and first and second floor plans of “design number 15,” a “Colonial” model home, from George F. Barber, Architect: *Modern Dwellings, a Book of Practical Designs and Plans...* (Knoxville: S.B. Newman and Co., 1901). A good example of the complex asymmetrical massing that became popular in the larger homes of the Victorian era.

The *Asymmetrical/Pictorial plan* (Figure 166) builds upon the T-plan, illustrating the increasing complexity of late nineteenth century house construction and many sweeping changes in the

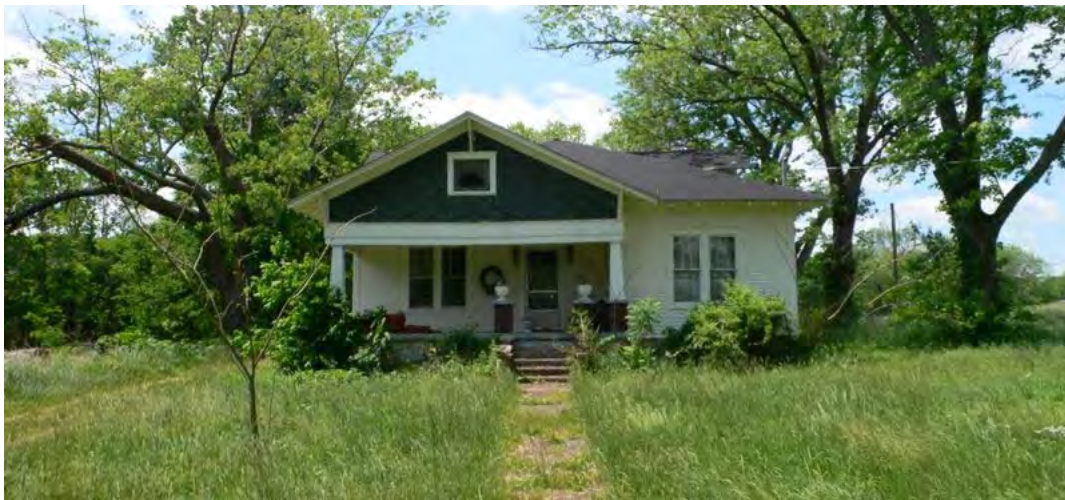
Figure 167: MN 686, *Bungalow*, 1926, *Gravel Switch*. See also Figure 107 and Figure 108.

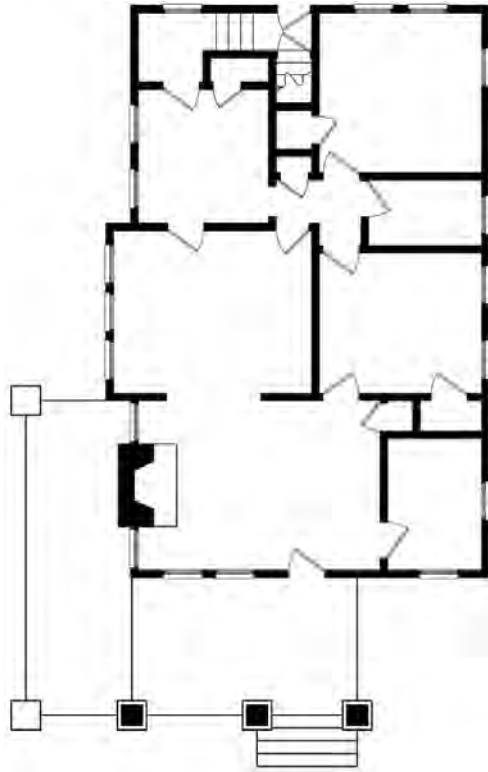
Figure 168: *Bungalow Plan. Bungalows vary in plan arrangements – the living room in front might be undivided, for example, with the area behind divided into spaces for the kitchen, dining, bath, and bed rooms*

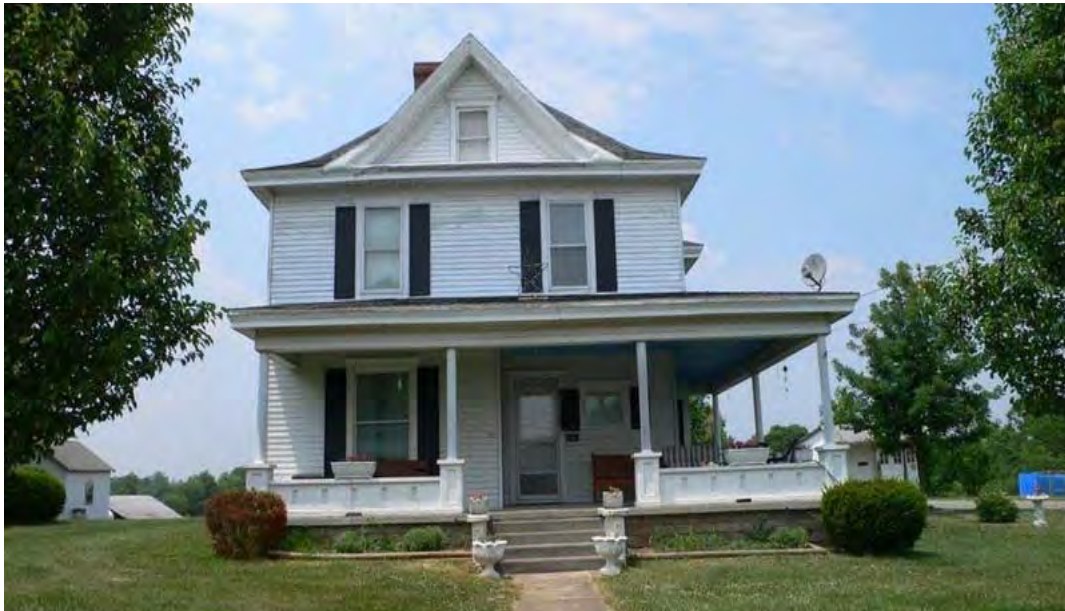
Figure 169: *WS 1110, early twentieth century, Willisburg.*

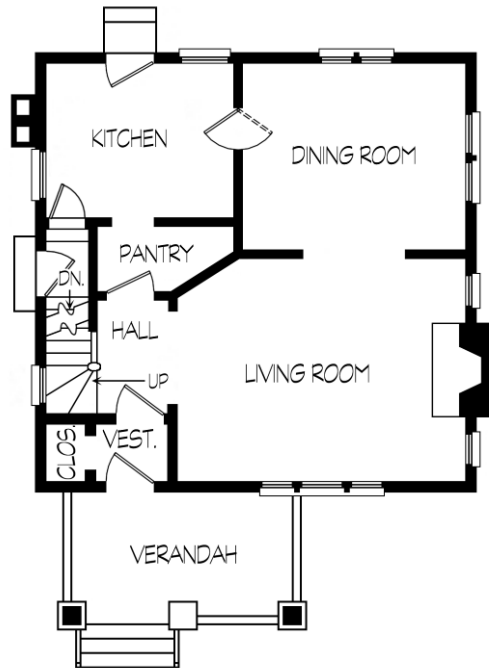
Figure 170: *Foursquare plan. Redrawn by the author from a published Aladdin house plan, “The Edmonton XVII,” available at <http://clarke.cmich.edu/aladdin/Aladdin.htm>.*

The *Bungalow* (Figure 168) and the *American Foursquare* (Figure 170) plans are closely allied with the Arts and Crafts style, although they occur in other styles as well. There were 54 bungalows and 9 foursquares documented in the survey area, but many houses reflect this era and its style. Bungalows are typically one story or have a smaller second floor under the eaves, while foursquares are two stories tall. The floor plans of either are typically two rooms wide and two or more rooms deep, but can grow more complex with the inclusion of stairs, closets, bathrooms, pantries, and small hallways connecting the bedrooms. Houses such as this introduced somewhat more open plans to the housing market, setting a trend for later twentieth century developments like the ranch house. Front halls, living rooms, and dining rooms generally flow into one another, for example, but the kitchen is usually segregated from the dining area by a swinging door.

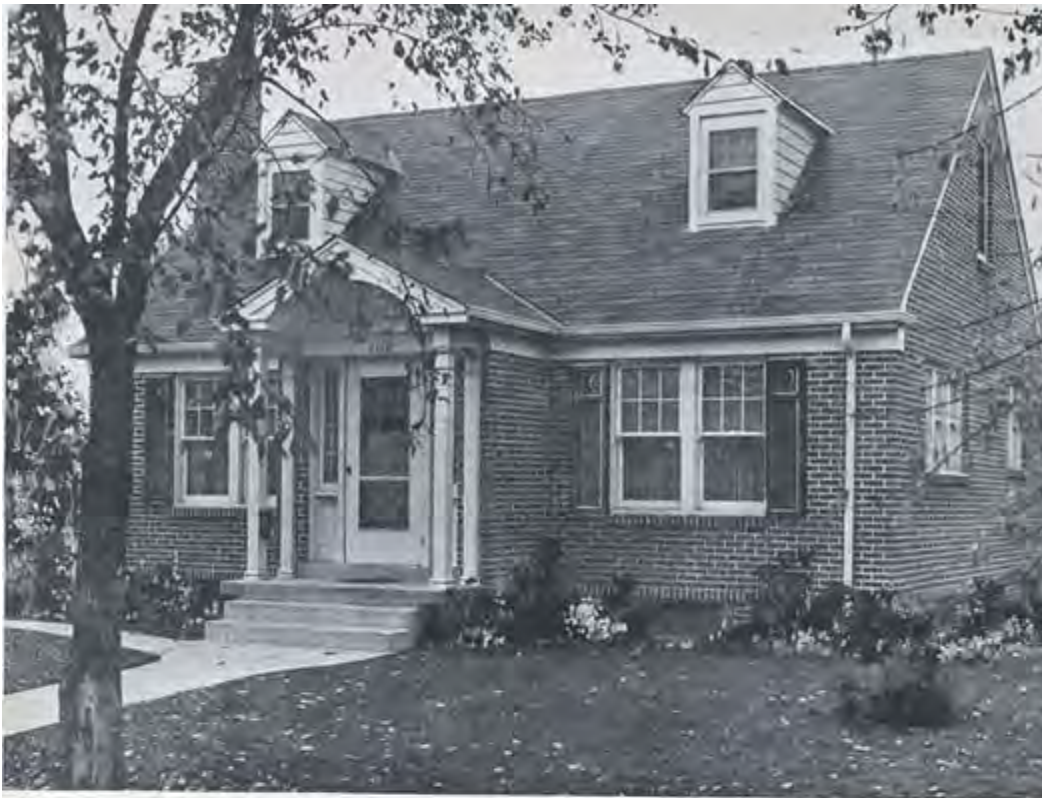
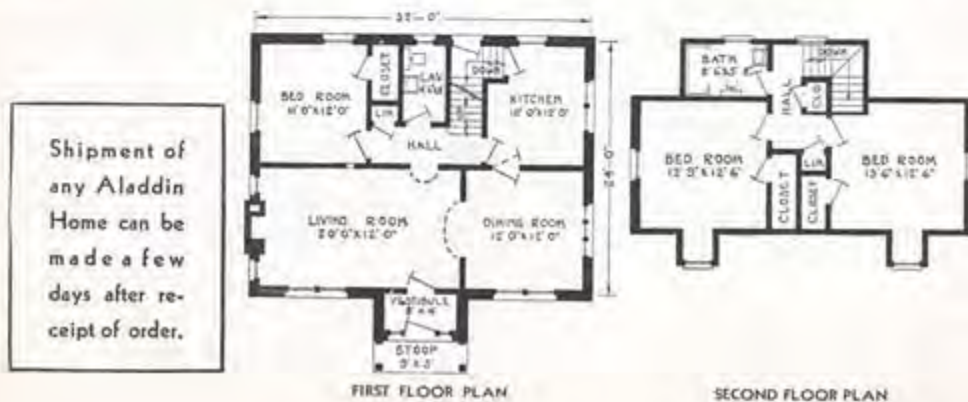
THE CONCORD—One of Aladdin's Newest— Price Given
On Enclosed
Price List

Distinction is given this charming design by an entrance at once original and appealing. Pillars grace the gabled vestibule while an arched ceiling adds a new touch to the design. Narrow side lights on each side of the front door afford light to the vestibule. The main structure of the Concord is beautifully proportioned. Besides a splendidly spacious living room, the first floor contains a suite including bedroom, lavatory, linen closet, and clothes closet. These are entered from the separate hall from which the stairway also leads to the second floor. Grade cellar entrance occupies the space under the main stairway. All four downstairs rooms have double exposure for light and air. The fireplace may be built in as shown or omitted if desired. On the second floor is found two well planned bedrooms, bathroom and four closets. Always keep in mind the high quality of materials built into all Aladdin Houses and that this quality can be had at such great economies only from The Aladdin Company. The Read-cut System backed by volume production is the reason. Our Golden Rule Service and money back guarantee are your protection. Complete detail specifications mailed on request.

Figure 171: "The Concord," a colonial styled minimal traditional or American Small House, from *Aladdin Read-Cut Homes* mail-order house catalog, 1948, available on line from the Clarke Historical Library, Central Michigan University, at <http://clarke.cmich.edu/aladdin/Aladdin.htm>. Compare to Figure 172.

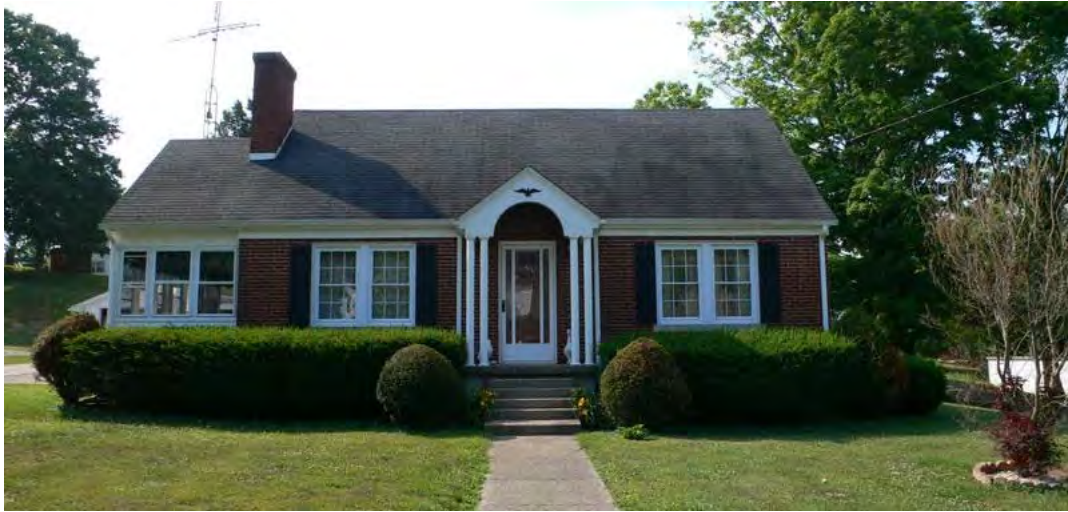
Figure 172: MN 924, a post-war Colonial Revival style American Small House, Bradfordsville. It is quite similar to the Concord in the Alladin house catalog in Figure 171, but lacks the dormers and has a screen porch on the left side.

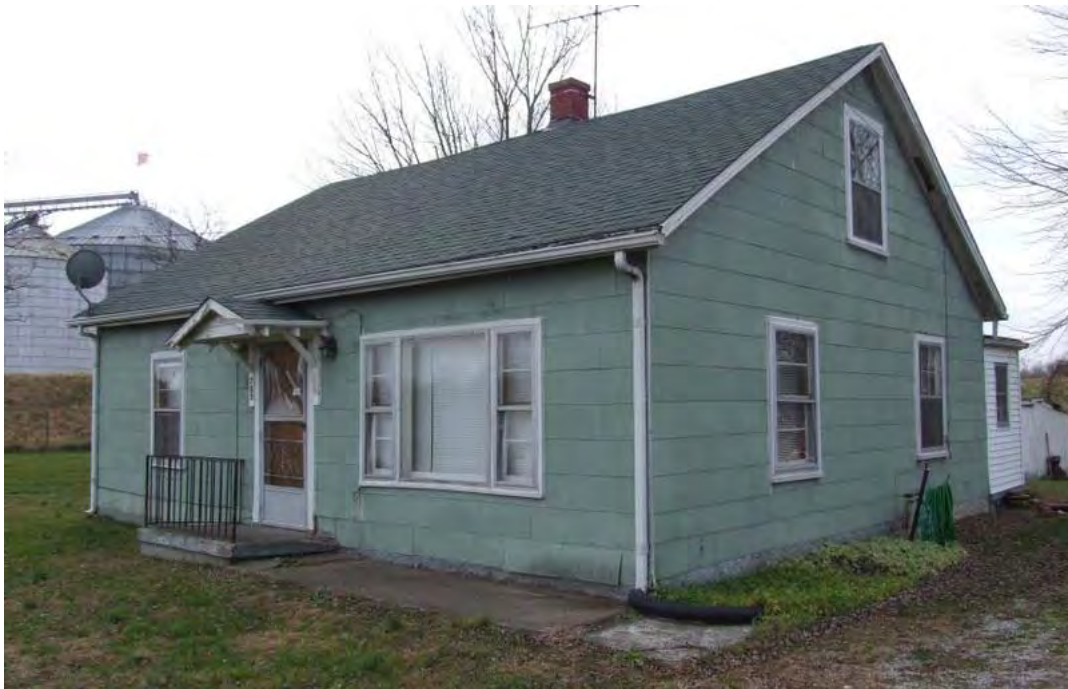
Figure 173: MN 241, American Small House, mid-twentieth century, Loretto vicinity.

One house type still searching for a commonly accepted name is the *Minimal Traditionalist* as it is called in the McAlester Field guide.⁴² The Georgia State Historic Preservation Office, on the other hand, calls it an *American Small House*, defined as “a compact three-, four-, or five-room house with an irregular floor plan, usually with a moderately pitched end-gable roof, sometimes with small wings or rear ells; built from the 1930s to the 1950s.”⁴³ Such houses were quite often pre-manufactured, as in the Aladdin house example in Figure 171, which is quite similar to the house at MN 929 (Figure 172). Many examples in the survey area are more simply designed than this example, as in the house at MN 241 (Figure 173). Others are just as stylish, but executed in frame as at MN 330 (Figure 174).⁴⁴

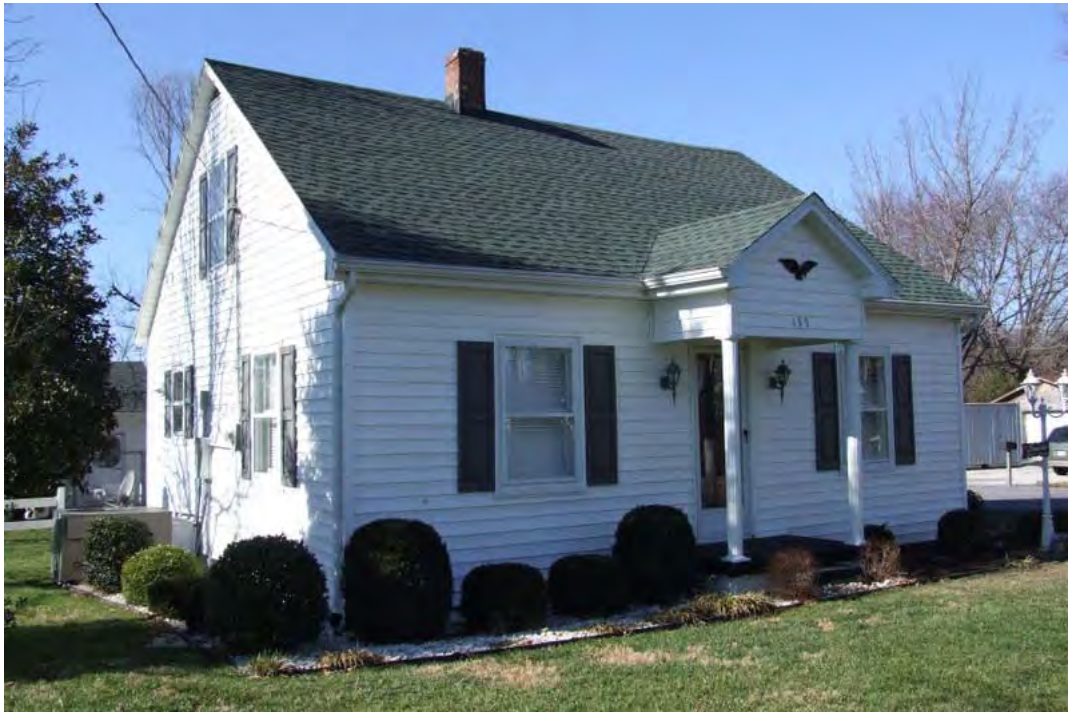
Figure 174: *MN 330, American Small House, circa 1950, Loretto.*

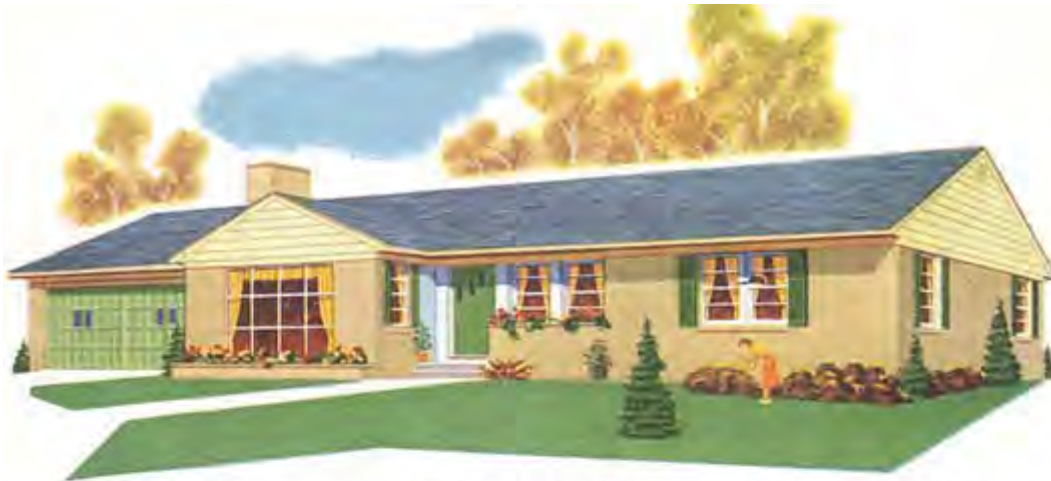
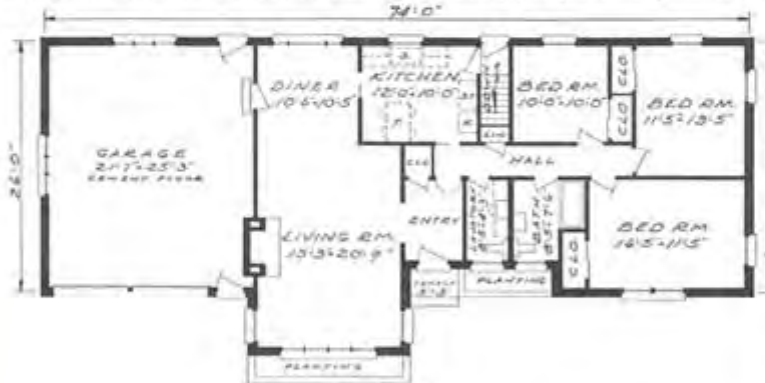
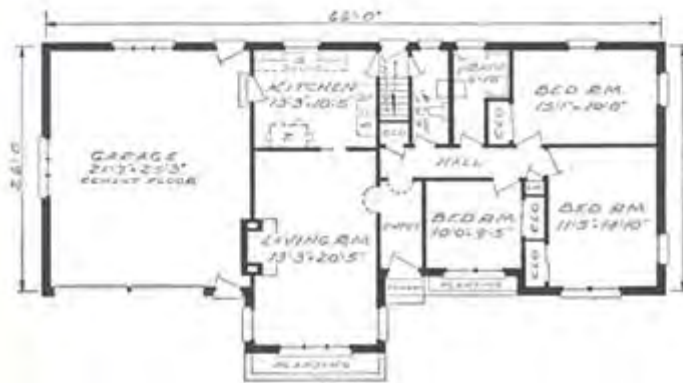
Above is illustrated the very latest architectural masterpiece just as it came from the draughting tables of our designers. Many hours of study and planning were patiently devoted to its final perfection and acceptance for our catalog. As shown above it pictures the exterior finished in brick veneer. We do not supply brick or any other masonry materials. If you wish to use wood siding or shake shingles on exterior walls write us for prices. The living room projects toward the front, from the main structure, and is in harmony, proportionally, with the whole. Well grouped

check rail windows break up the expansive front wall. Gable ends are furnished in siding as shown. Two plans are shown both in three bedroom sizes. In both plans you will find powder room as well as conventional bath. Attached garage does not protrude in front—another harmonious detail. Write for specifications.

Figure 175: "The Embassy," Ranch house, from *Aladdin Read-Cut Homes* mail-order house catalog, 1954, available on line from the Clarke Historical Library, Central Michigan University, at <http://clarke.cmich.edu/aladdin/Aladdin.htm>.

The geographical distribution of the ranch house (both as a style and as a type of house) resulted from historic events of the post-World War II period, which included a great new demand for houses, suburban places to build them, roads to the suburbs, and automobiles to get there. The ranch house (Figure 175) promised the new suburban homeowner drive-in convenience and spacious, comfortable living. The growth of suburbs stretching out into rural areas allowed for larger lots and thus for houses with larger footprints. A typical ranch house has all its rooms on one floor (although some later examples have two story sections or split level plans). Rather than adding space upwards, the ranch house placed private spaces further from the entry and main living rooms (Figure 123). The main living spaces of the classic ranch house often open up to one another, creating a more spacious-feeling interior. Kitchens were made more public and included space for a table for the family to dine more informally than in the main dining area between the kitchen and the family or living rooms. In larger ranch houses, these latter two are often separate: a formal living room where guests were received and entertained, and a less formal family room, where the television was likely located, and where children could play under watch from elders in the kitchen nearby (Figure 123).

Some of the surveyed examples of ranch houses in the region take on the more elaborate silhouettes like the “Capri” (Figure 123) or the “Embassy” (Figure 175), in a brick example at WS 432 (Figure 182) or stone examples at MN 566 (Figure 124) and WS 318 (Figure 125 and Figure 126).⁴⁵ More frequently recorded were simple rectangular houses, often much like a Minimal Traditionalist/American Small House, lengthened horizontally with a carport or a garage at one end, like WS 998 (Figure 177), MN 315 (Figure 122), WS 399 (Figure 178), MN 432 (Figure 227), and WS 961 (Figure 228).

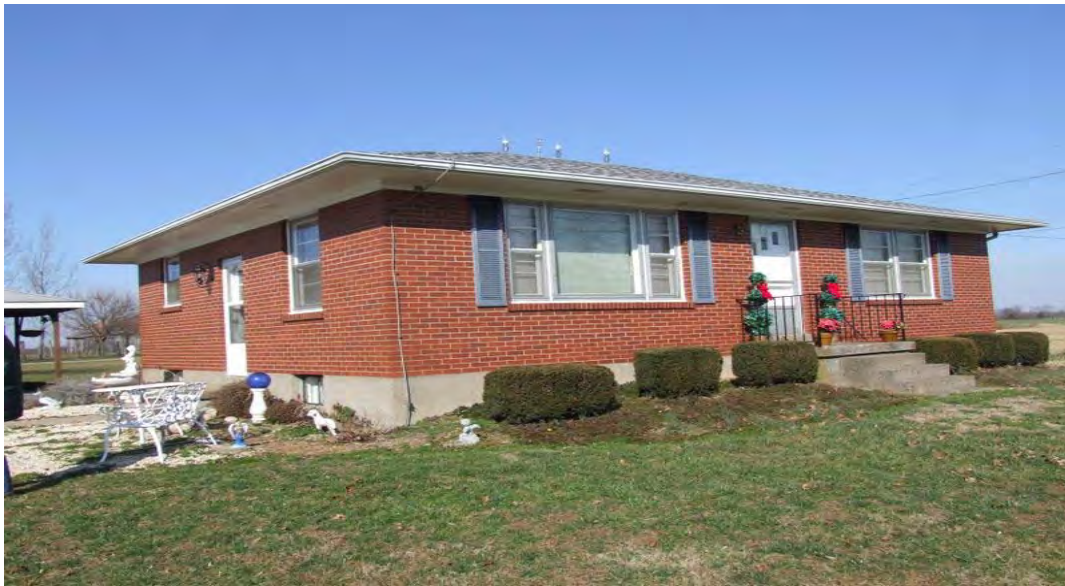
Figure 176: MN 420, *Ranch Style House, 1950s-60s, Loretto.*

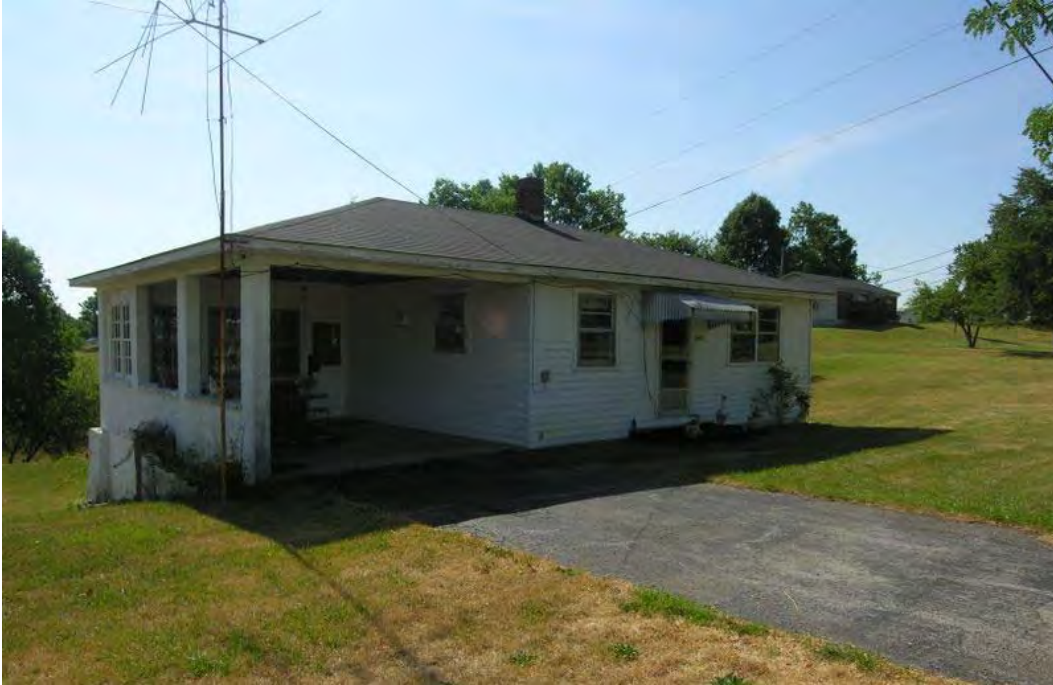
Figure 177: WS 998, *Ranch style house, 1950s, Willisburg.*

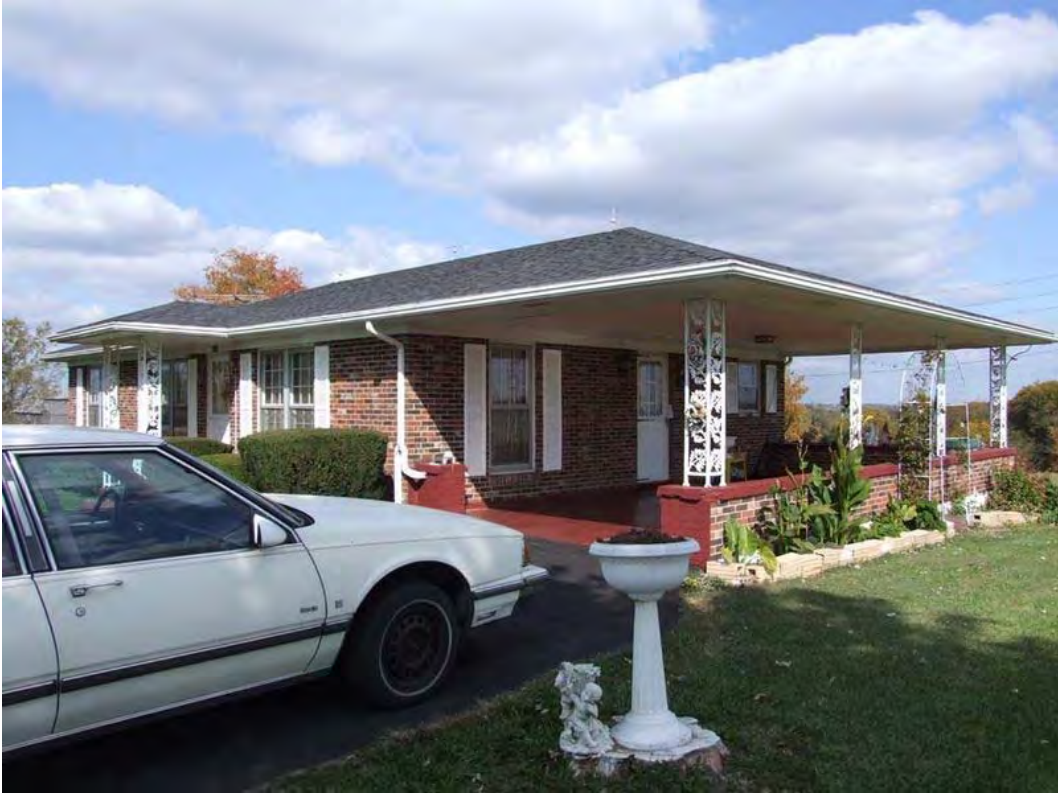
Figure 178: *WS 399, Ranch House, 1960s, Mooresville Vicinity. There is a cistern beneath the carport.*

To modern eyes the dependence on cisterns to augment wells may seem quaint, but it is a sustainable practice that could work well to augment municipal water supplies - urban cisterns and rain barrels, for example, could provide large quantities of water for uses such as watering lawns and gardens or washing cars, and keep more overflow out of sewers. Cisterns continue to be used even to the present, and are often noted in the survey even at quite modern residences, such as the ranch house at WS 399, which has a cistern beneath the carport (Figure 178).

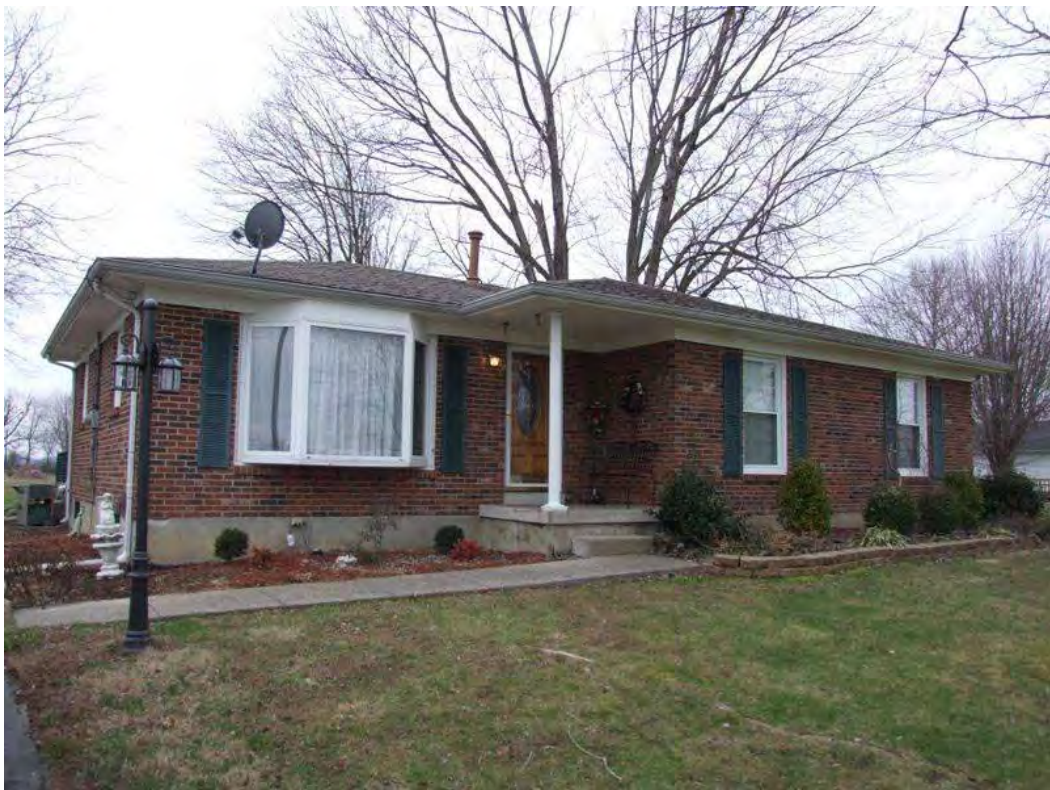
Figure 179: *MN 451, Ranch House, 1950s-60s, Loretto vicinity.*

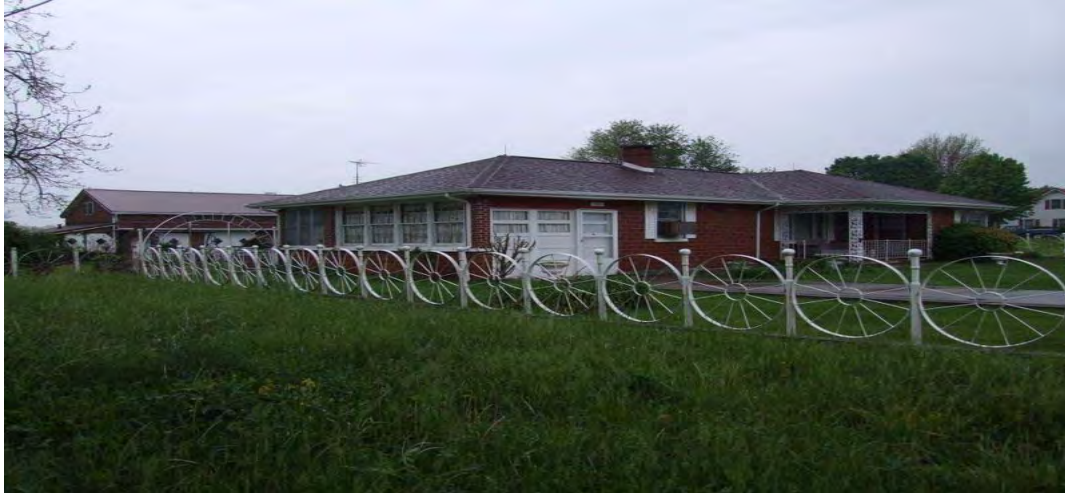
Figure 180: *MN 536, 1950s-60s, Saint Mary.*

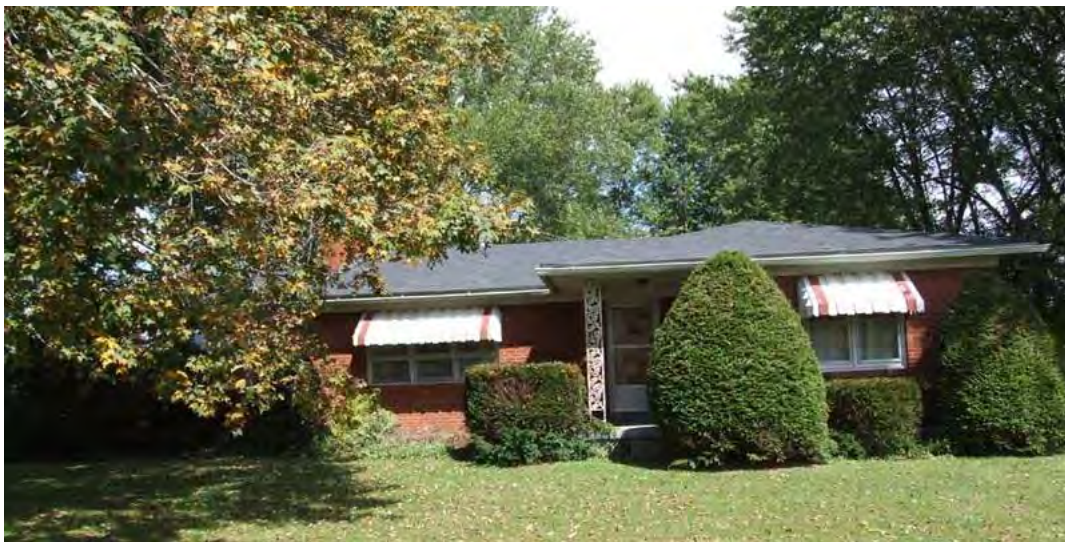
Figure 181: *WS 274, 1960s, Maud.*

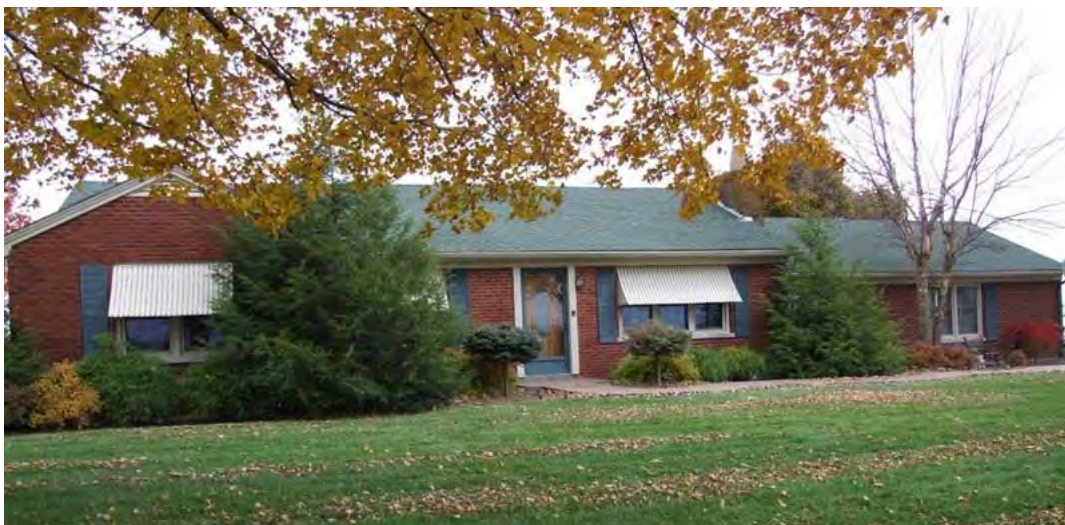
Figure 182: *WS 432, Goatley House, 1961, Valley Hill vicinity*

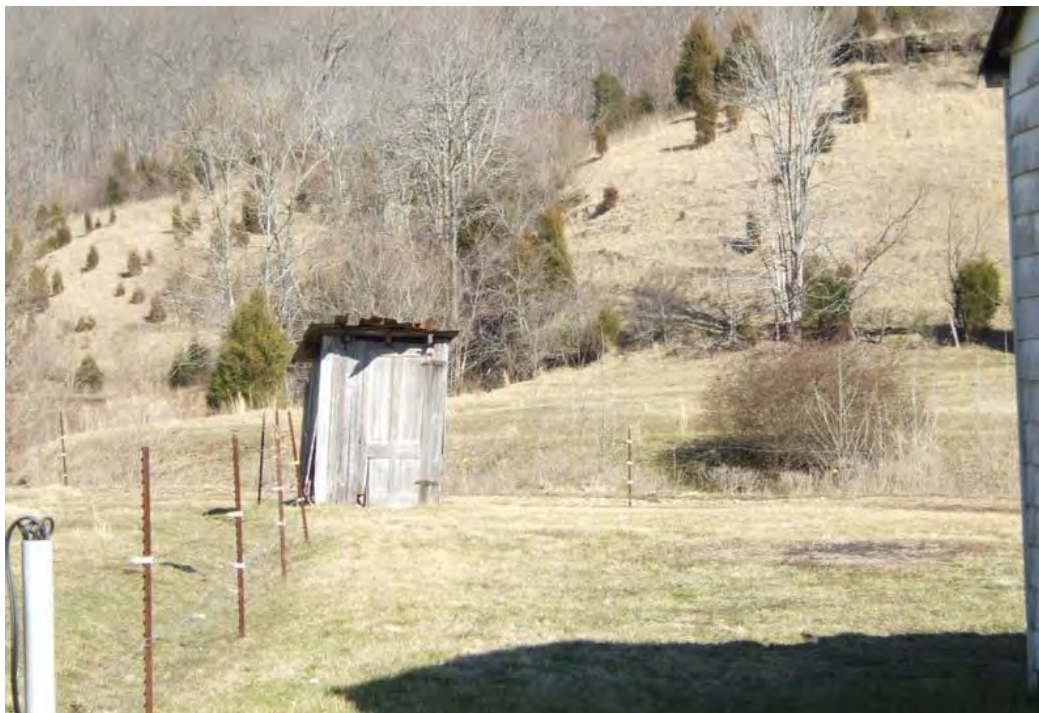
Figure 183: MN 604, Privy at the corner of the backyard, early-mid twentieth century, Bradfordsville vicinity.

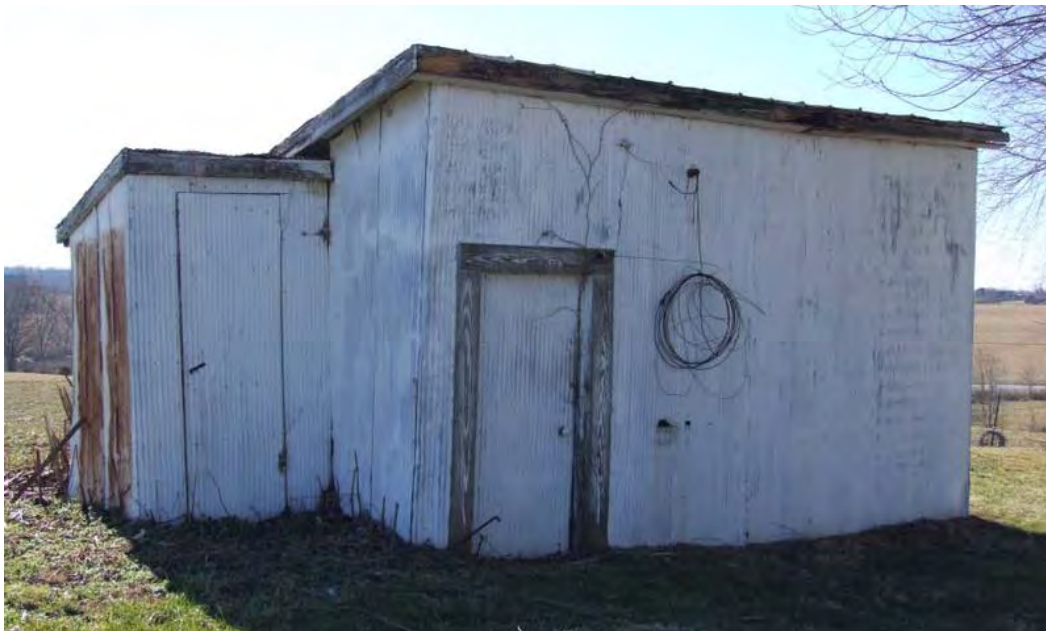
Figure 184: *WS 590, Privy (left) attached to Chicken House (right), frame, early-mid twentieth century, Mackville vicinity.*

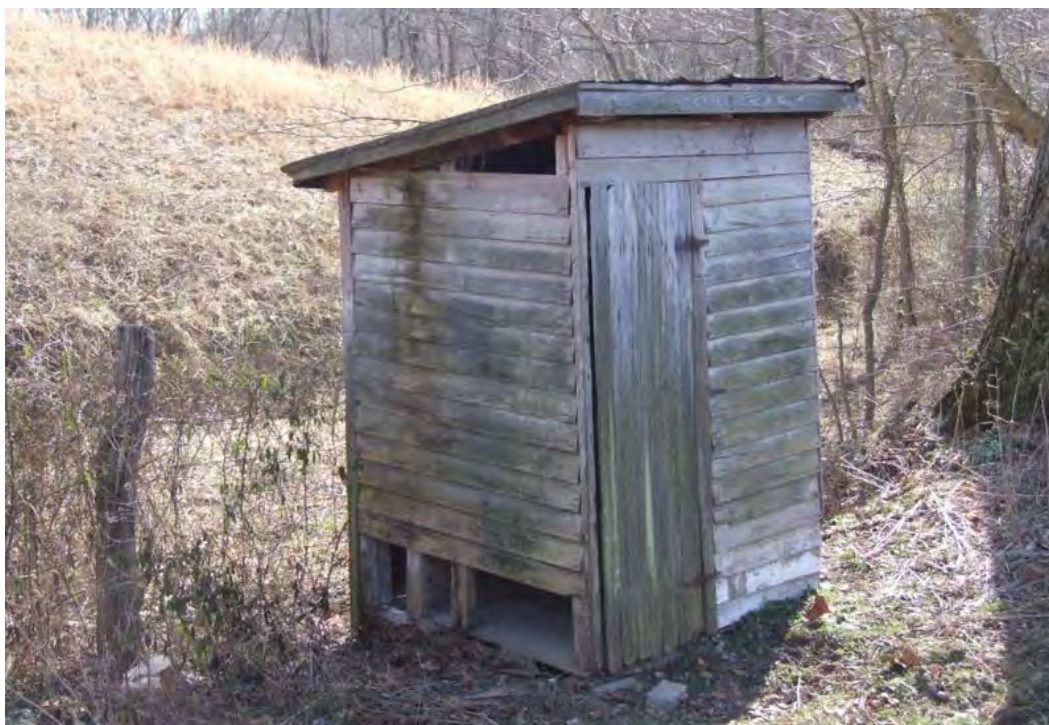
Figure 185: *WS 476, Privy, twentieth century, Mackville vicinity.*

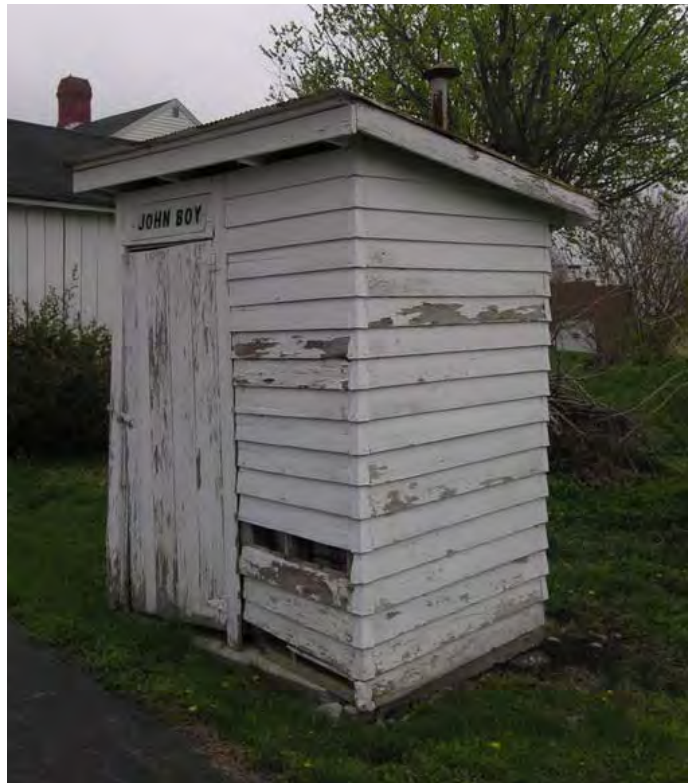
Figure 186: *WS 763, Mackville Baptist Church Privy, frame, early – mid twentieth century*

Privies, or outdoor toilets, are common features of Kentucky's rural landscape. 95 examples were documented in the RHDI survey. They are often located within a convenient distance from the house. A common spot is near the edge of the domestic yard area, well away from the well or cistern, but still within walking distance, as at MN 604 (Figure 183). Their location was not necessarily fixed as they were sometimes moved to different locations over new pits. Several examples were documented with placement near other outbuildings, such as chicken houses, storage buildings, or shops (Figure 184). The typical privy is a small frame building, square or somewhat rectangular in plan, with a shed roof and a single door, as at WS 476, (Figure 185), WS 763 (Figure 186), and MN 664 (Figure 187). Somewhat more elaborate examples were found which featured gable roofs (MN 681, Figure 188), or gambrel roofs and windows (WS 355, Figure 189). Privies were also found at many churches (WS 763, Figure 186) and schools.
