A Survey of Historic Sites in Rural Marion and Washington Counties, Kentucky

A Report on the Findings of the *Rural Heritage Development Initiative Survey*
A project funded by a National Park Service Preserve America Grant

Kentucky Heritage Council

The State Historic Preservation Office, 2009

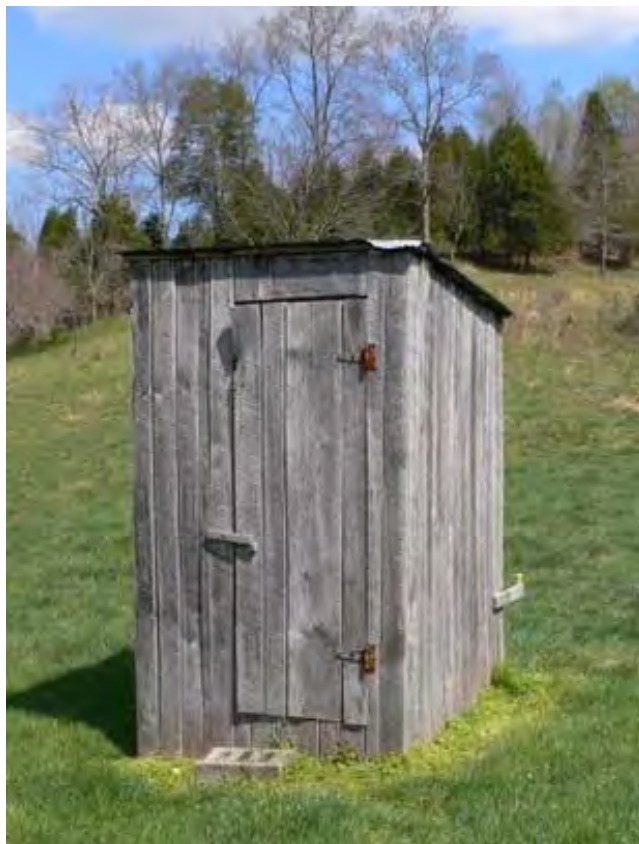
Figure 187: *MN 664, Privy, mid twentieth century, Gravel Switch vicinity.*

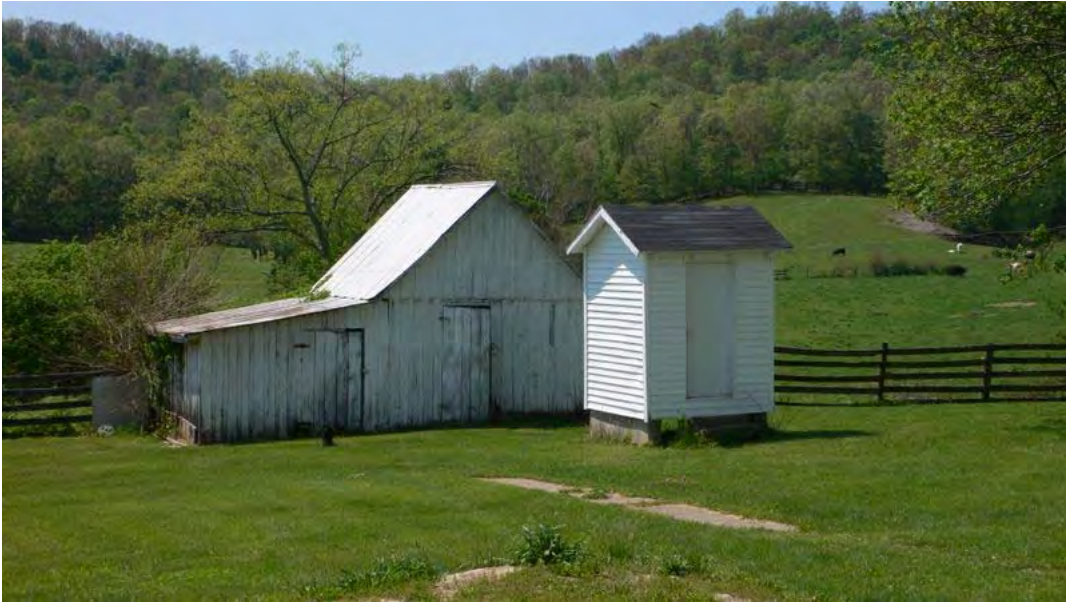
Figure 188, *MN 681, Sweazy-Kirkland farm, Privy (front) and Gable-front Outbuilding, early twentieth century, Gravel Switch vicinity.*

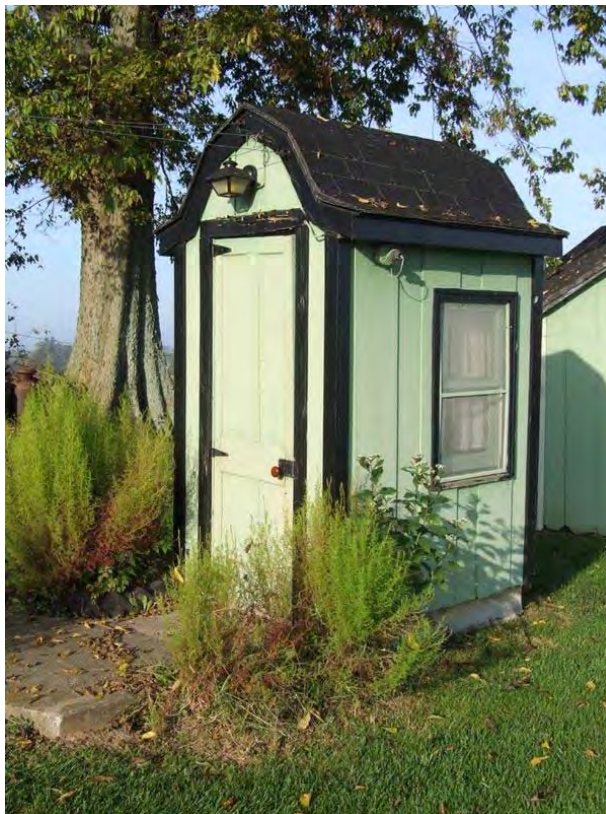
Figure 189: *WS 355, Privy, mid - late twentieth century, Mooresville vicinity*

Privies, or outdoor toilets, are common features of Kentucky's rural landscape. 95 examples were documented in the RHDI survey. They are often located within a convenient distance from the house. A common spot is near the edge of the domestic yard area, well away from the well or cistern, but still within walking distance, as at MN 604 (Figure 183). Their location was not necessarily fixed as they were sometimes moved to different locations over new pits. Several examples were documented with placement near other outbuildings, such as chicken houses, storage buildings, or shops (Figure 184). The typical privy is a small frame building, square or somewhat rectangular in plan, with a shed roof and a single door, as at WS 476, (Figure 185), WS 763 (Figure 186), and MN 664 (Figure 187). Somewhat more elaborate examples were found which featured gable roofs (MN 681, Figure 188), or gambrel roofs and windows (WS 355, Figure 189). Privies were also found at many churches (WS 763, Figure 186) and schools.

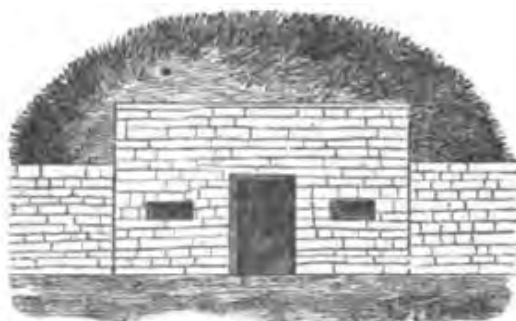
Fig. 233.—STONE FACING OF HILLSIDE CELLAR.

Figure 190: *Section and elevation of a root cellar, from Byron D. Halsted, Barn Plans and Outbuildings (New York: Orange Judd Co, 1898), 224-25.*

The cellar may be dug into the side of a hill, down into the ground, or partially dug in and covered with a mound (Figure 190). It is often located behind the house, near the kitchen door, as at WS 476 (Figure 191, see also the site plan in Figure 3), but is sometimes found further away, particularly if a convenient hill is located near the domestic yard, as at WS 633 (Figure 193). An urban example is found at WS 171 (Figure 192),

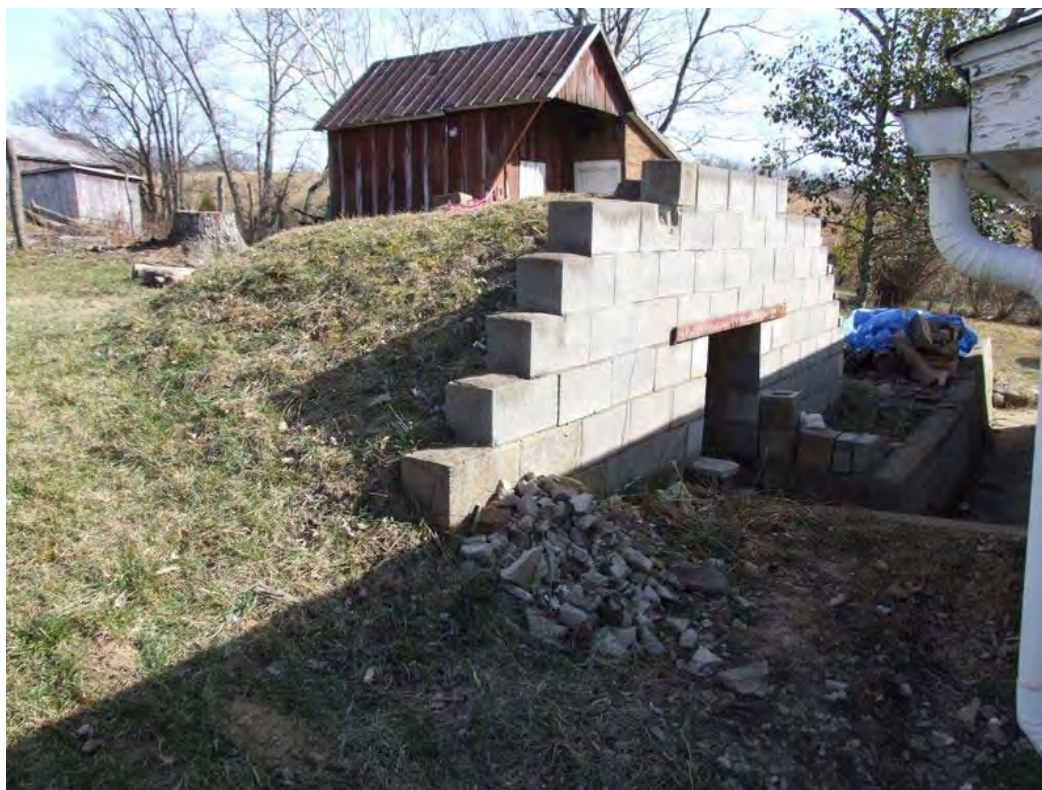
Figure 191: WS 476, Cellar, early twentieth century, Mackville vicinity.

Cellars are principally constructed of stone or brick masonry until the twentieth century, when materials such as concrete block (WS 476, Figure 191, MN 205, Figure 198) or poured concrete become more common.

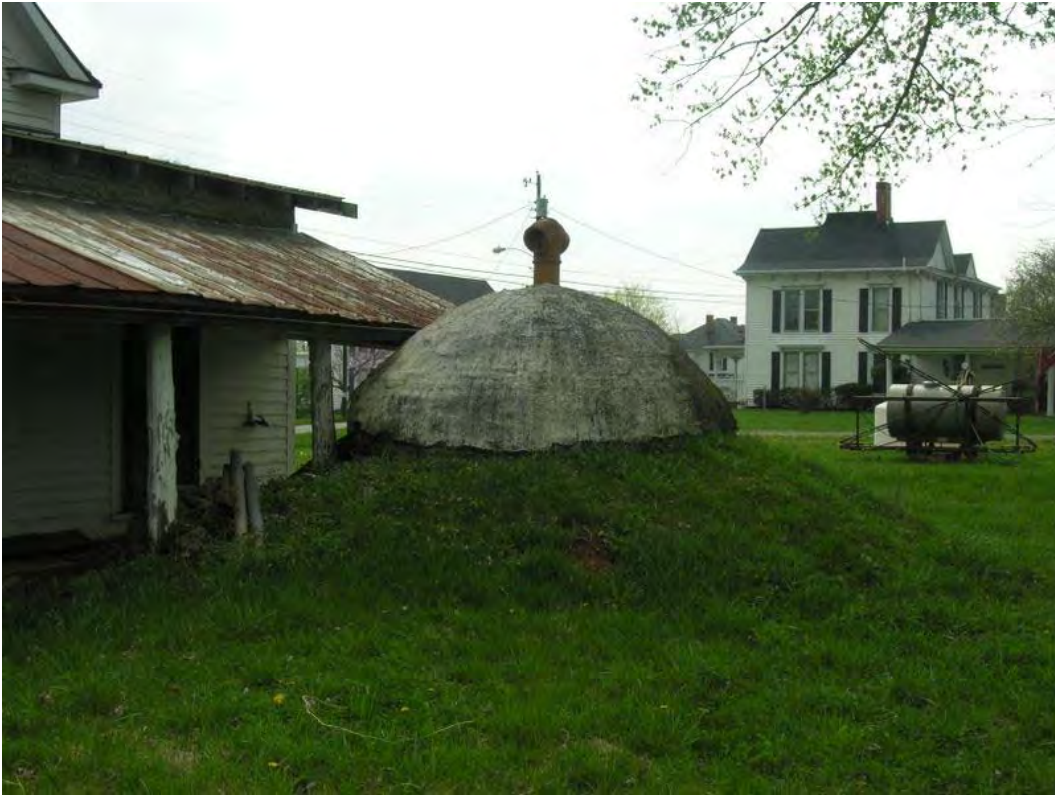
Figure 192: *WS 171, Brick- domed Root Cellar, behind the John Harmon house, late nineteenth century, Mackville.*

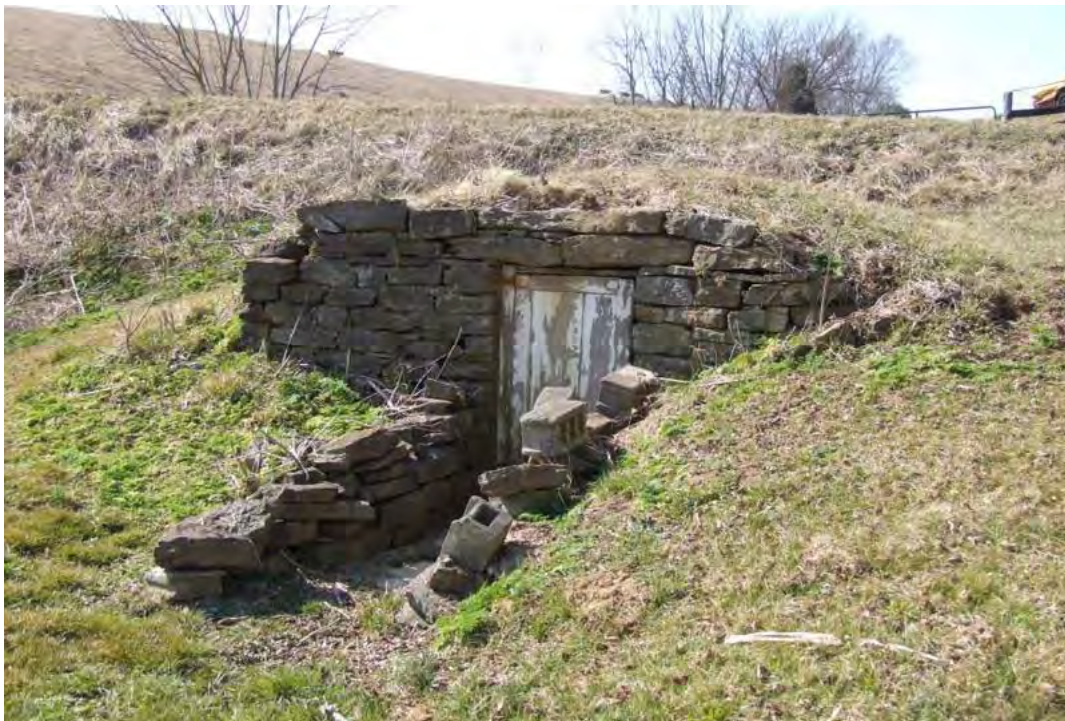
Figure 193: *WS 633, Dry laid Stone Bank Cellar, late nineteenth century, Deep Creek vicinity.*

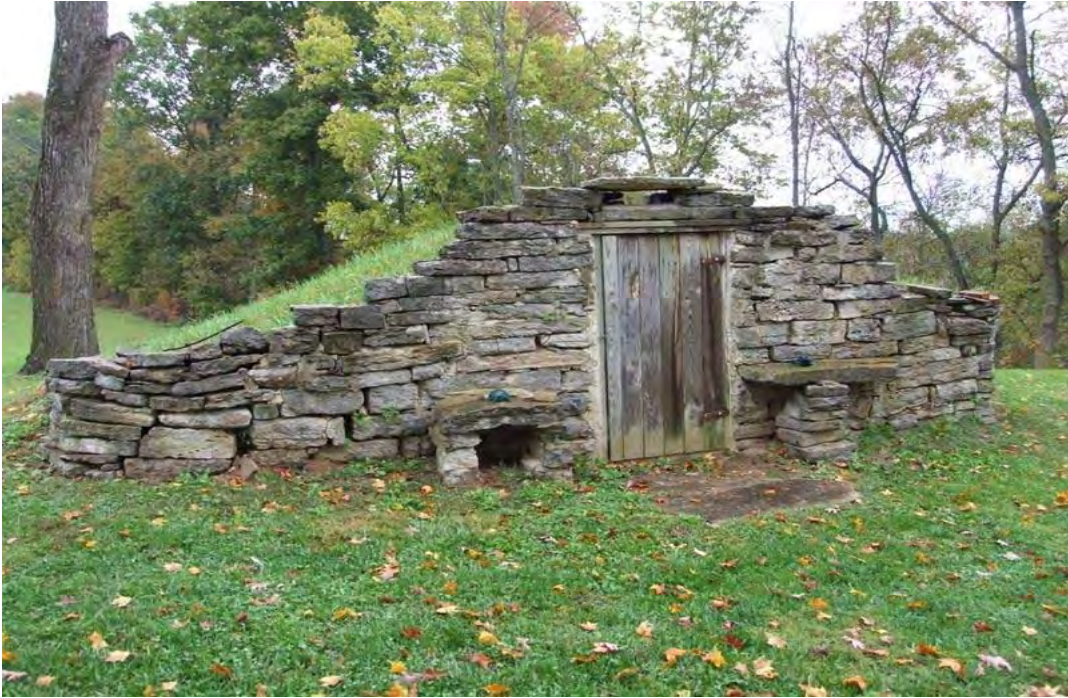
Figure 194: *WS 365, Dry-laid Stone Cellar, late nineteenth century, Maud Vicinity.*

Most cellars have a simple opening directly into the cellar space, often a doorway into a masonry retaining wall, such as the examples mentioned above, or WS 365 (Figure 194), or MN 273 (Figure 195). The interiors are lined with masonry, and some elaborate examples have domed ceilings, as at MN 273 (Figure 196). In some cellars, the entryway is covered by a small building which itself may be used for dry storage. The entry building may be frame, as at MN 480 (Figure 197), or masonry, as at MN 205 (Figure 198). Another type of storage building, sometimes called a *warmhouse* is unusual in this region, but found more frequently found in Eastern Kentucky. An example can be seen at WS 812 (Figure 200). The *warmhouse* is a two story building consisting of a cellar underneath with a small frame or log building above, creating a two story storage unit, with cooler, moist storage at the cellar level and warmer, dry storage above for tools, onions, seeds, cured meats, etc.

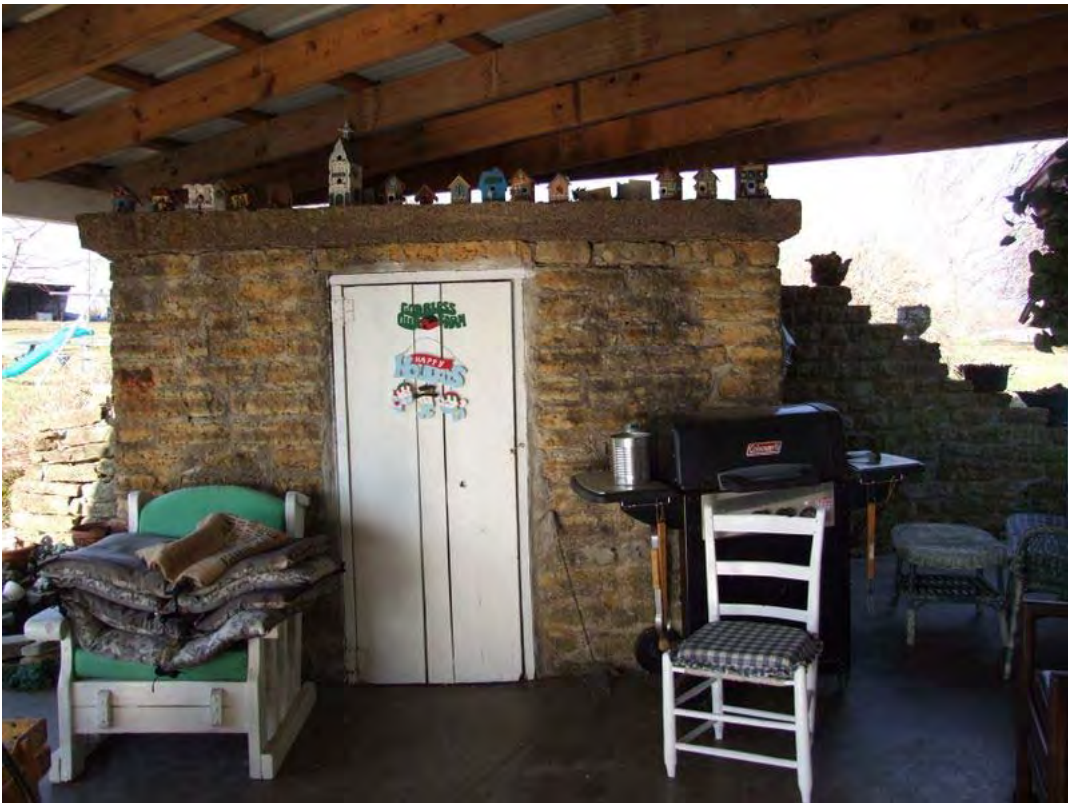
Figure 195: *MN 273, Cellar, ca 1860-1900, Holy Cross. The roof overhead is a recent addition.*

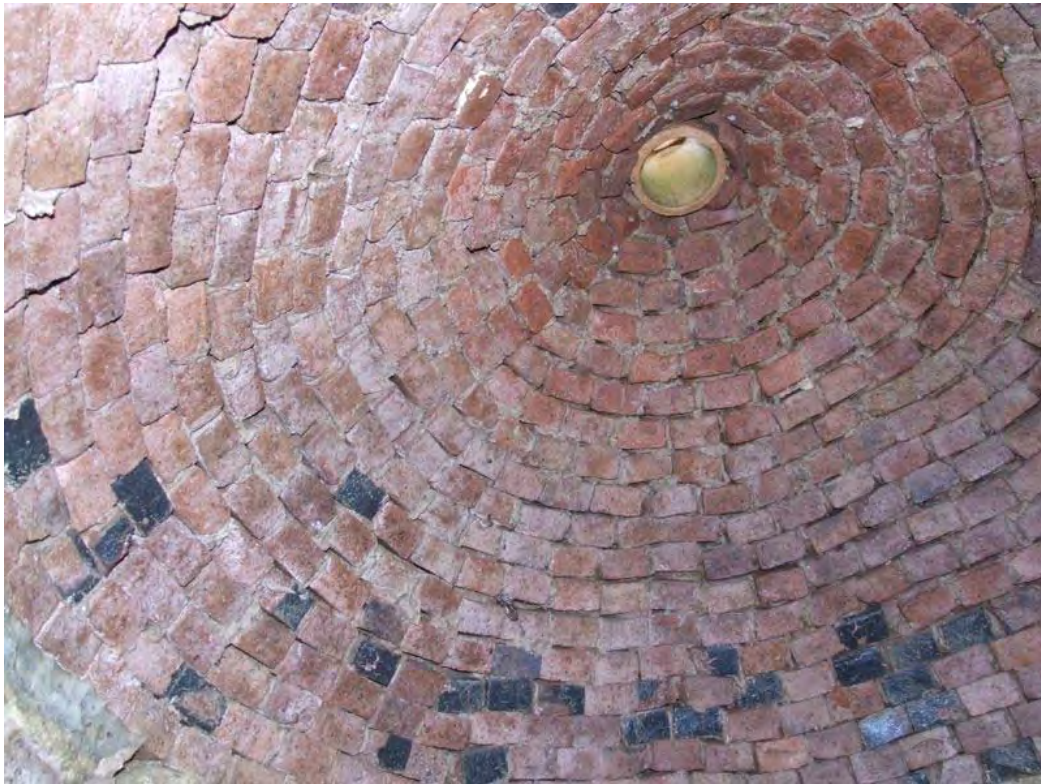
Figure 196: MN 273, Cellar, ca 1860-1900, Holy Cross. Interior view of brick dome ceiling.

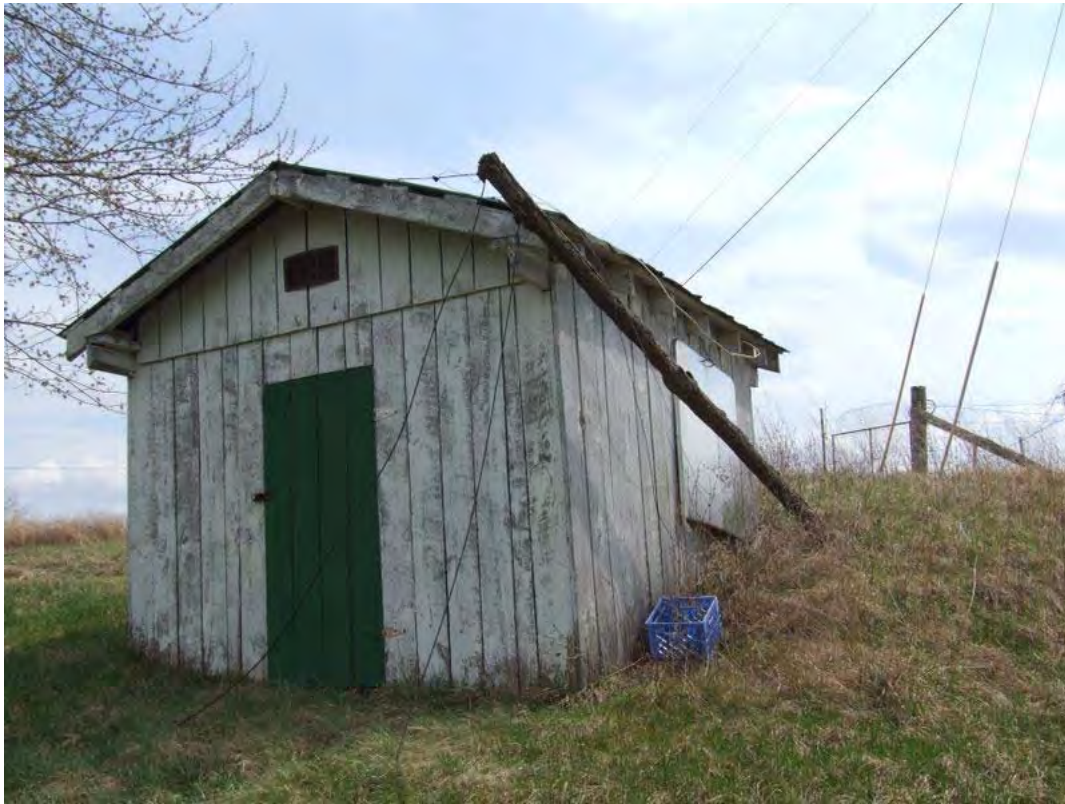
Figure 197: MN 480, Cellar with Frame Entry Shed, early-mid twentieth century, Pottsville vicinity.

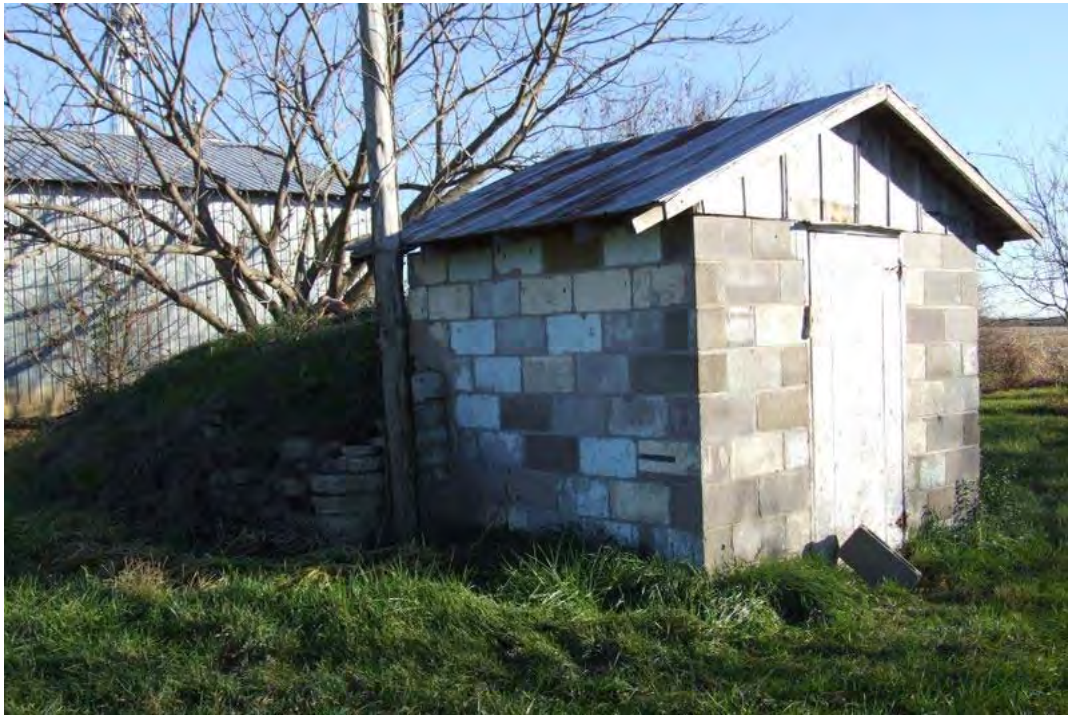
Figure 198: MN 205, Mid-twentieth century Concrete Block Entry Shed over older Brick-lined Cellar, Holy Cross vicinity.

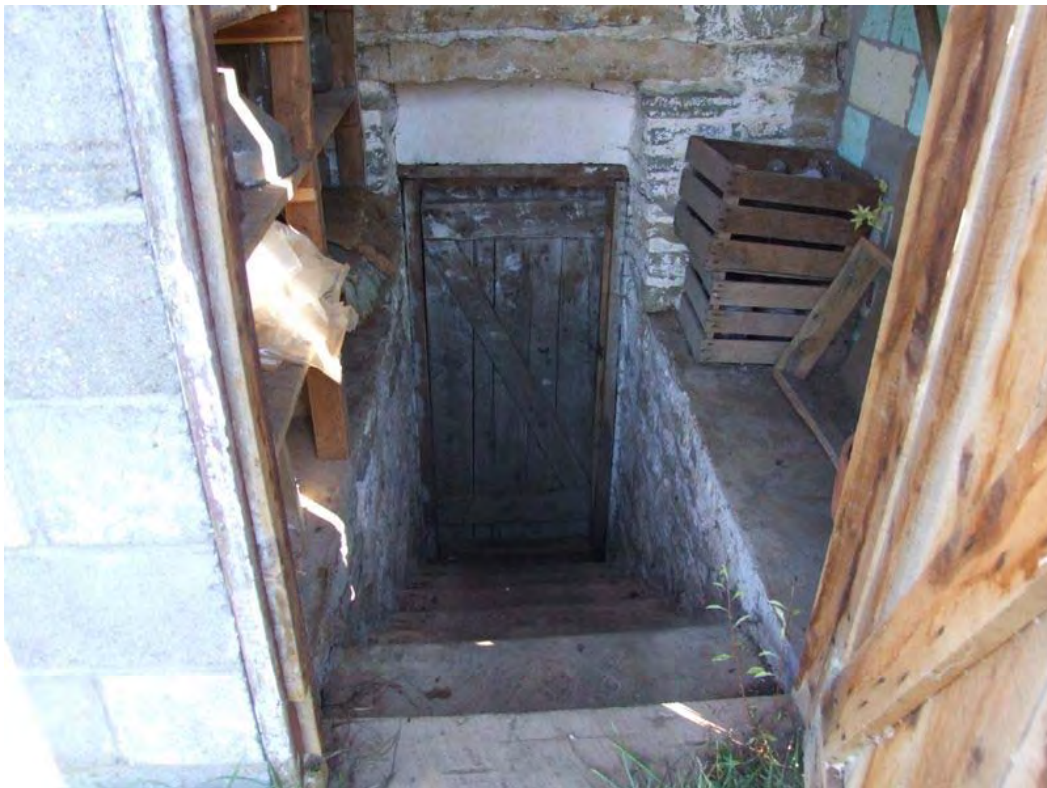
Figure 199: MN 205, view inside Entry Shed.

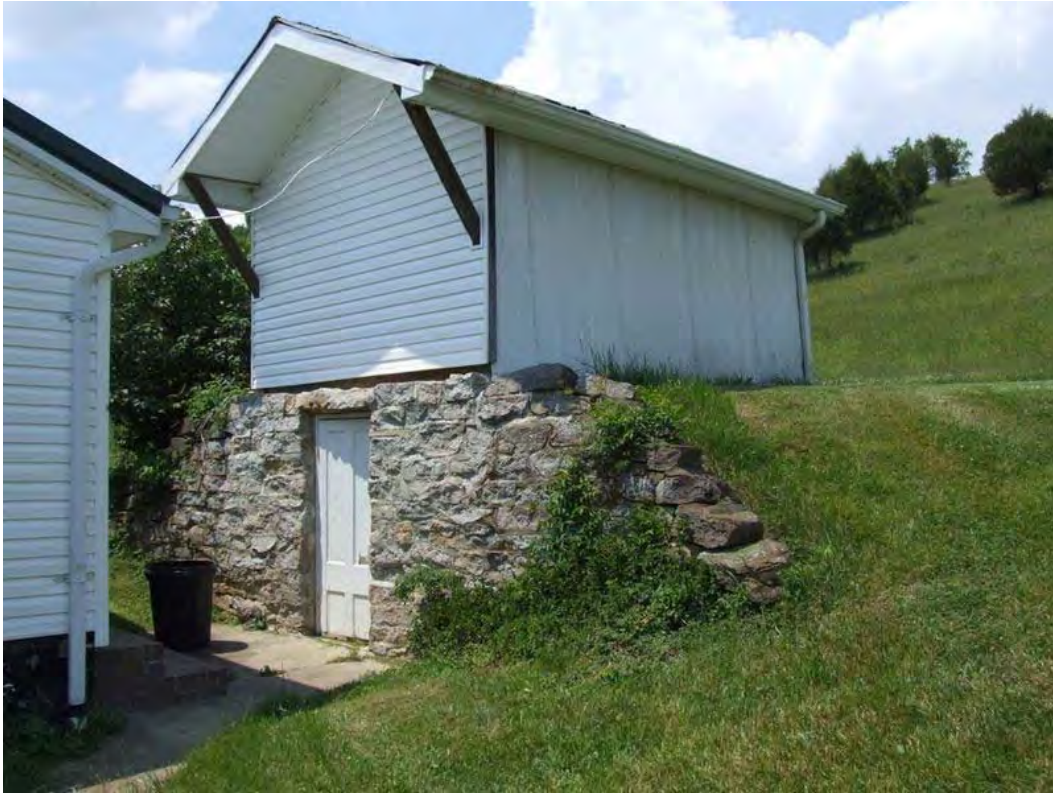
Figure 200: *WS 812, Stone-lined Cellar with frame Dry Storage Structure above, late nineteenth-early twentieth century, Tathum Springs vicinity. The upper level is accessed by a door in back.*

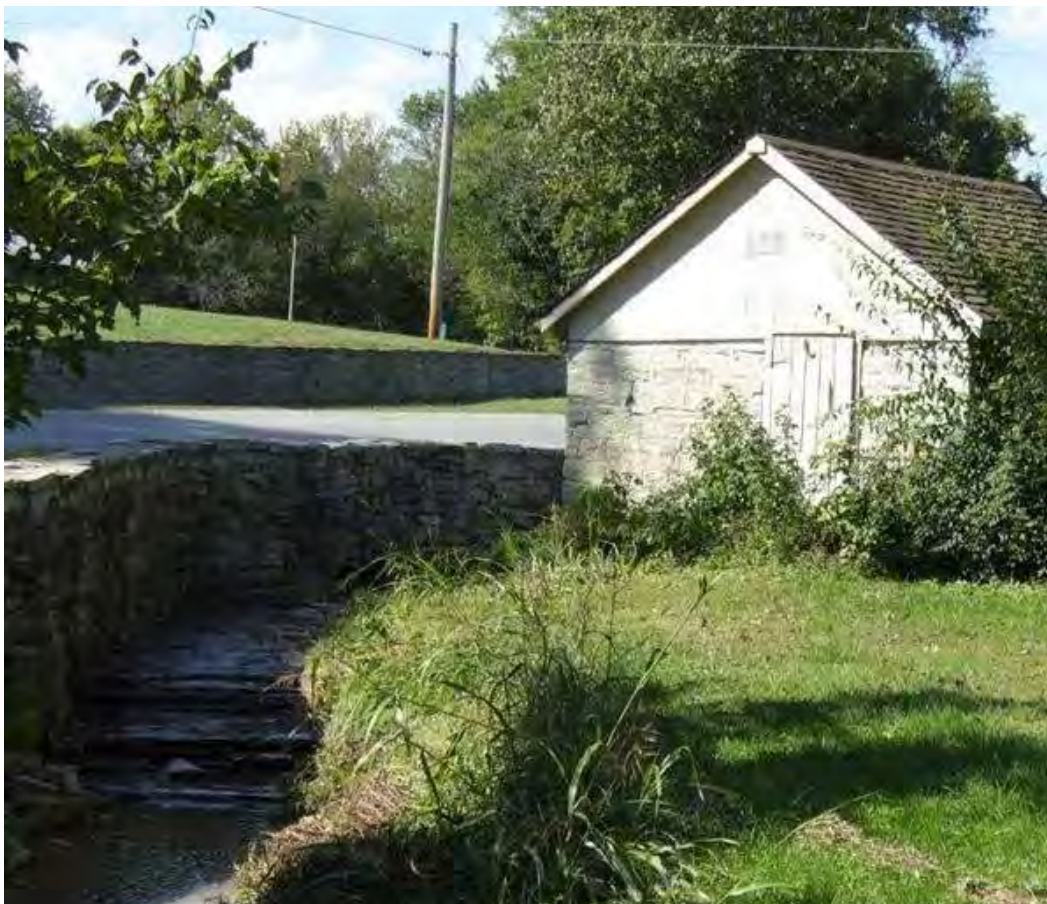
Figure 201: *WS 317, Springhouse, early-mid- nineteenth century, Fredericktown vicinity.*

Springhouses are common on rural farms of the nineteenth century. The springhouse at WS 317 is a good early example (Figure 201). Like the cellar, the springhouse was an important outbuilding for the storage of food, but also protects the source of water. Where the cellar held items such as root vegetables and apples, a spring house was often used for the storage of dairy items such as milk, cream, cheese, and butter. Spring houses are usually masonry structures or at least their foundations are because of the building's contact with water. The masonry also provides some insulation from summer heat. Just 14 examples were documented in the current survey. This may be a reflection of the greater numbers of later nineteenth - early twentieth century sites in the current survey. Inside the springhouse, water was typically channeled into a trough where it could pool to a convenient depth. Covering the spring just where it emerges from the ground captures the water at its coolest temperature and maximum cleanliness. Some springhouses have a second floor above the spring room, a small dry storage area, the use of which may have varied from structure to structure as at WS 579 (Figure 203).

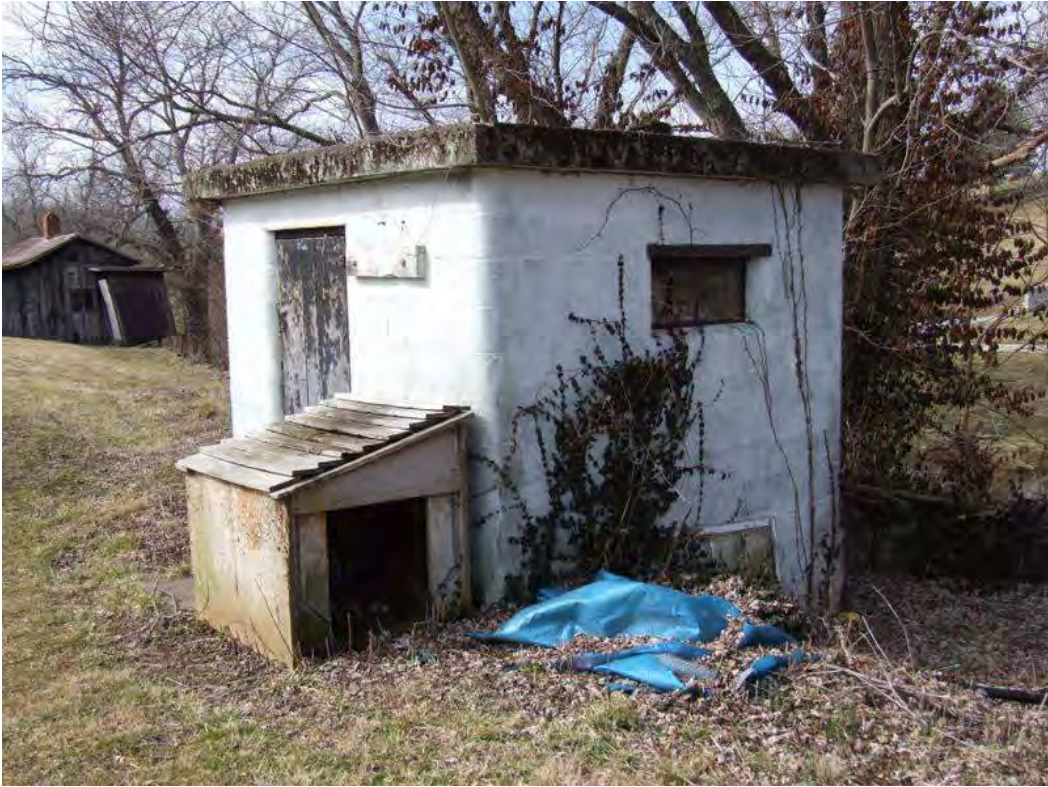
Figure 203: *WS 579, Springhouse, early-mid twentieth century, Texas vicinity.*

The development of well pumps, cisterns, and plumbing in the late nineteenth century, and particularly refrigeration in the twentieth century eventually made springhouses obsolete. Even so, those surveyed include examples from the twentieth century (WS 579, Figure 203, and MN 65, Figure 204).

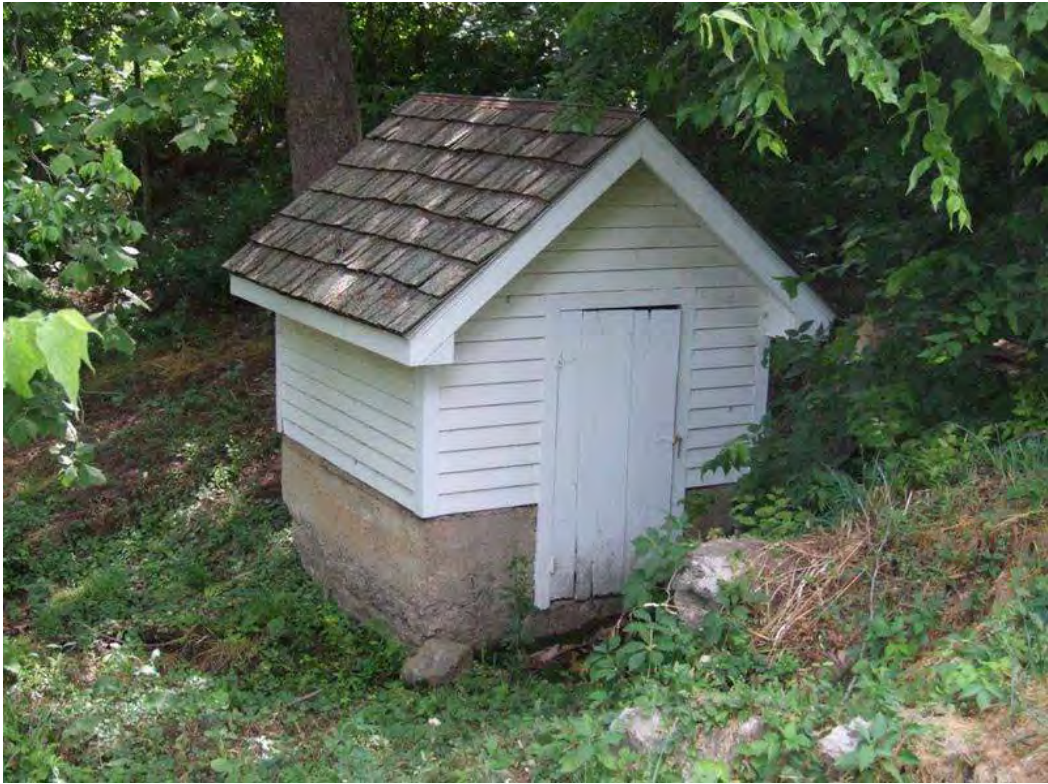
Figure 204: *MN 65, Springhouse, early twentieth century, Lebanon vicinity.*

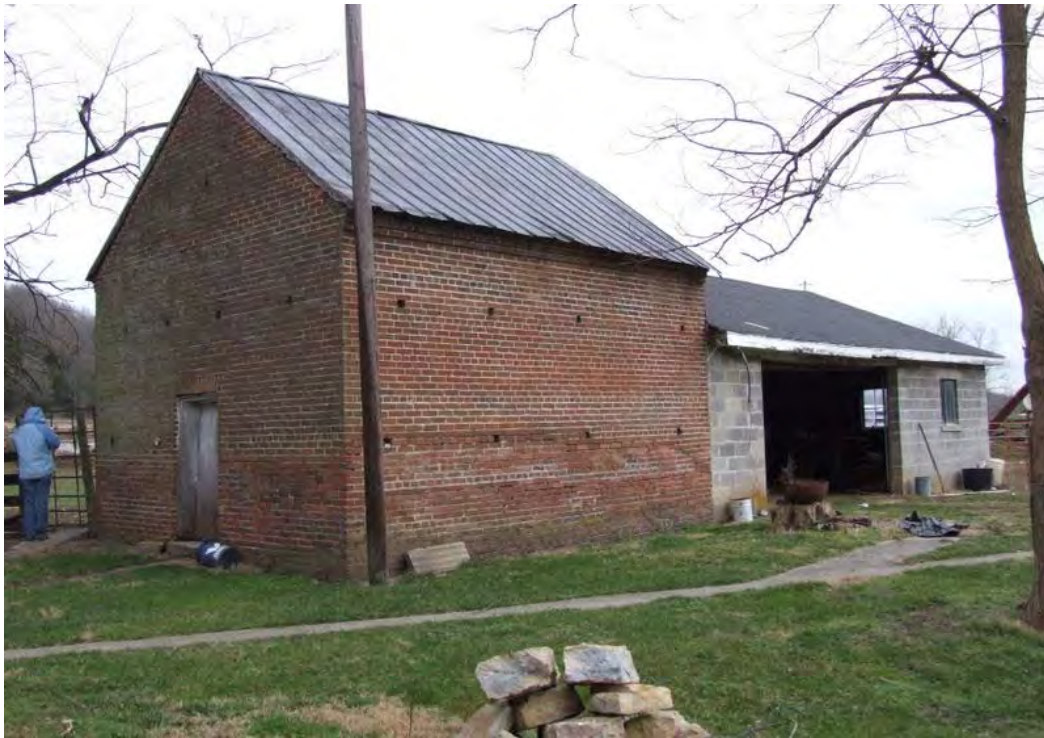
Figure 206: *WS 187, Brick Smokehouse, Manton vicinity, early nineteenth century. A substantial and early brick example, with a corbelled cornice and a much later concrete block addition in back.*

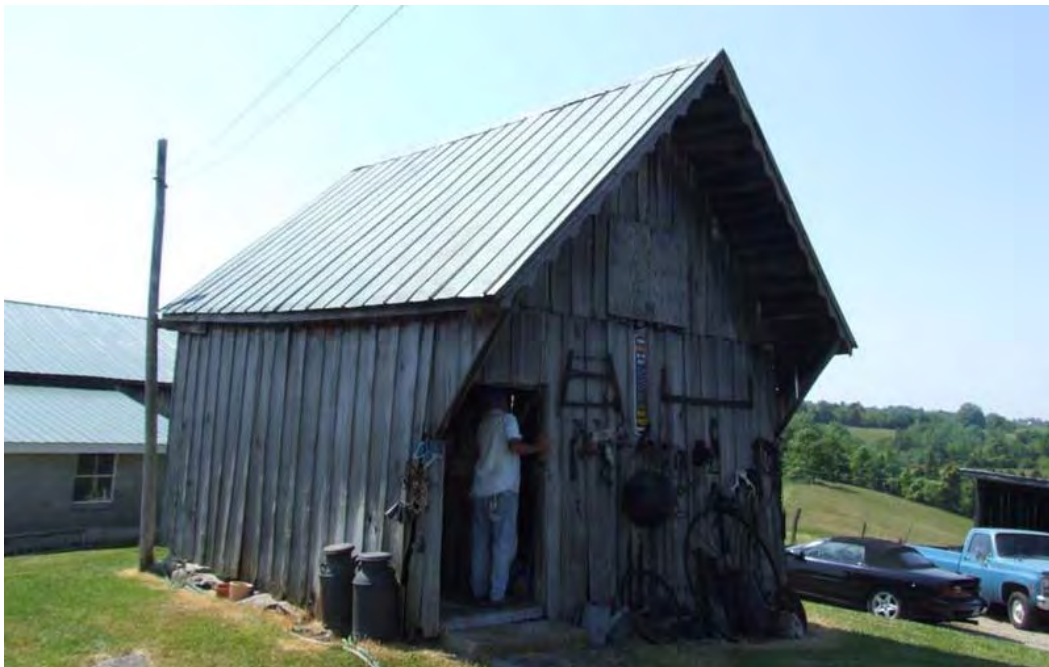
Figure 207: *WS 849, Meathouse, late nineteenth century, Willisburg/Brush Grove vicinity. The steep, Gothic style gable and board and batten siding are notable features.*

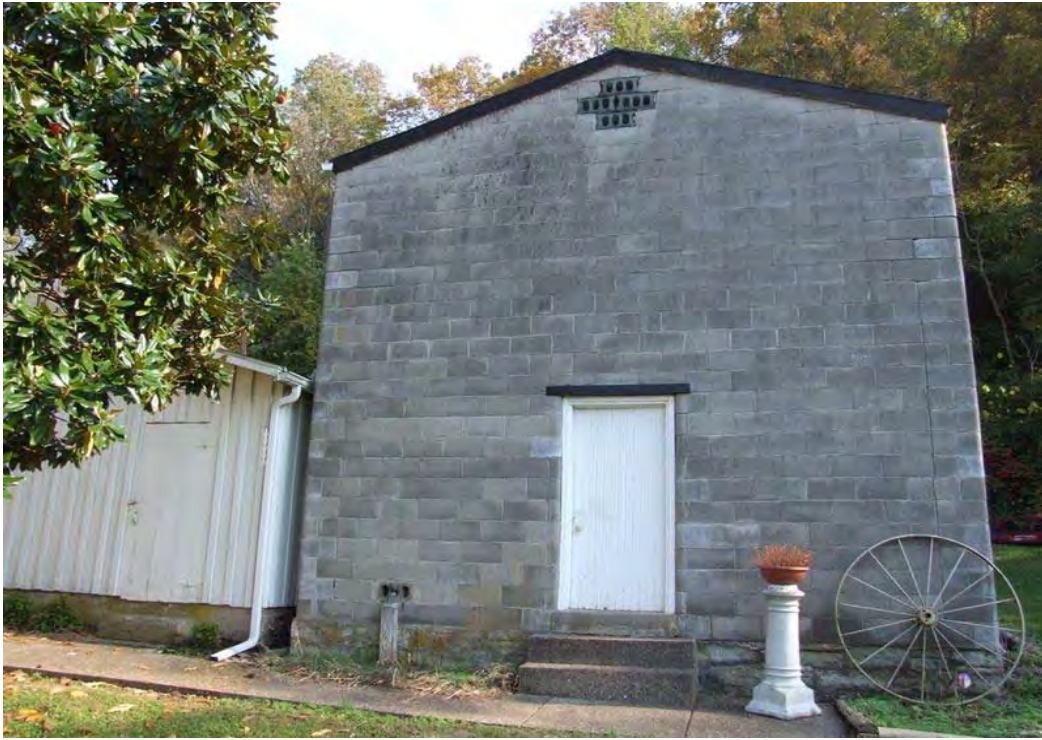
Figure 208: *WS 333, Leo Mudd's Smokehouse. Built in the 1950s by Leo Mudd in concrete block, on the cut stone foundation of an earlier smokehouse. Leo was known for the high quality of the hams he smoked here and sold from his store. The ventilators at the peaks and at regular intervals above the foundation were created by turning the blocks sideways.*

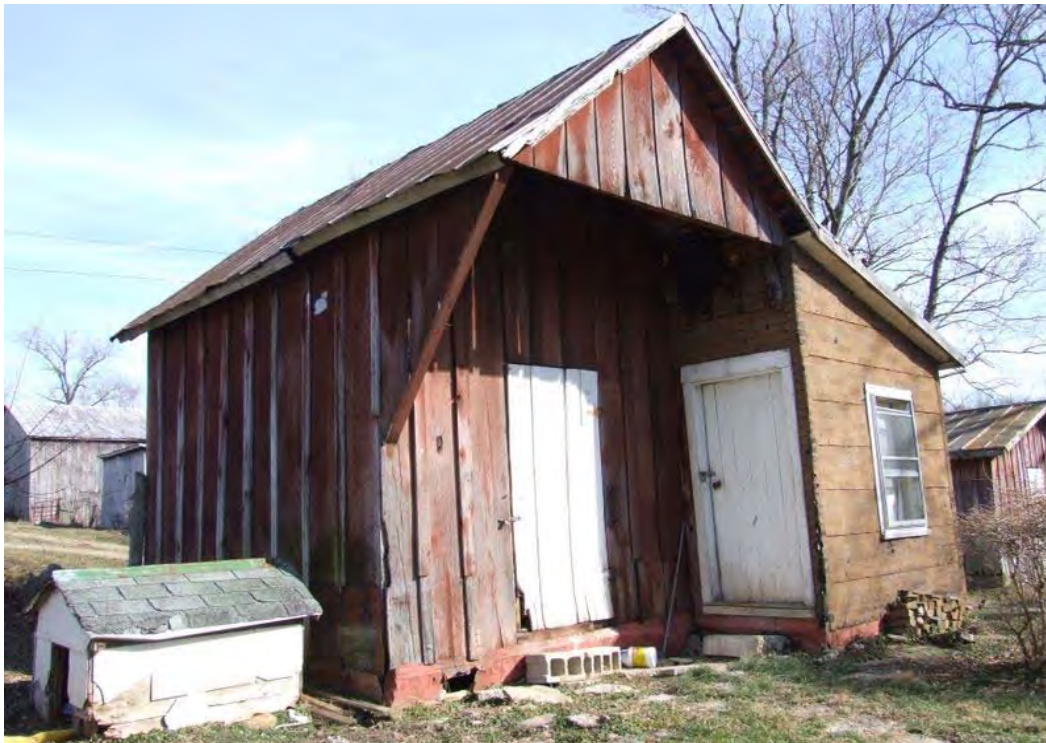
Figure 209: *WS 476, Meathouse with side shed, early twentieth century, Mackville vicinity. The shed to the side has two windows and a brick chimney for a stove.*

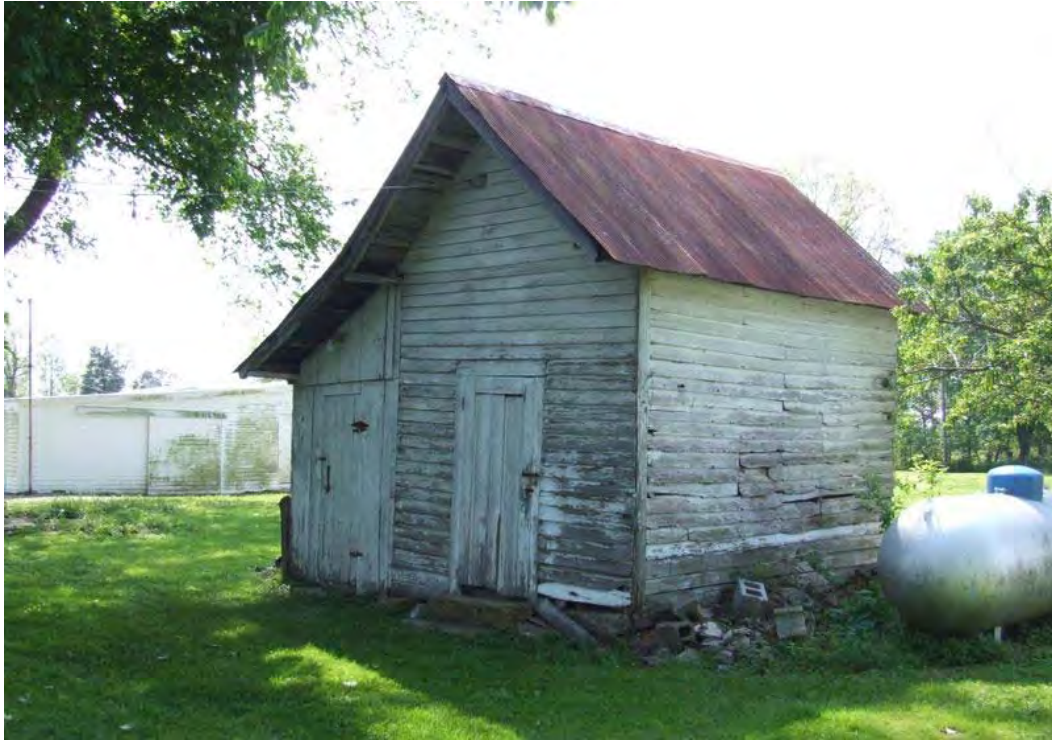
Figure 210: MN 567, Meat- or Smokehouse, New Market, late nineteenth-early twentieth century. Meat houses frequently have side shed appendages used for various functions such as tool storage.

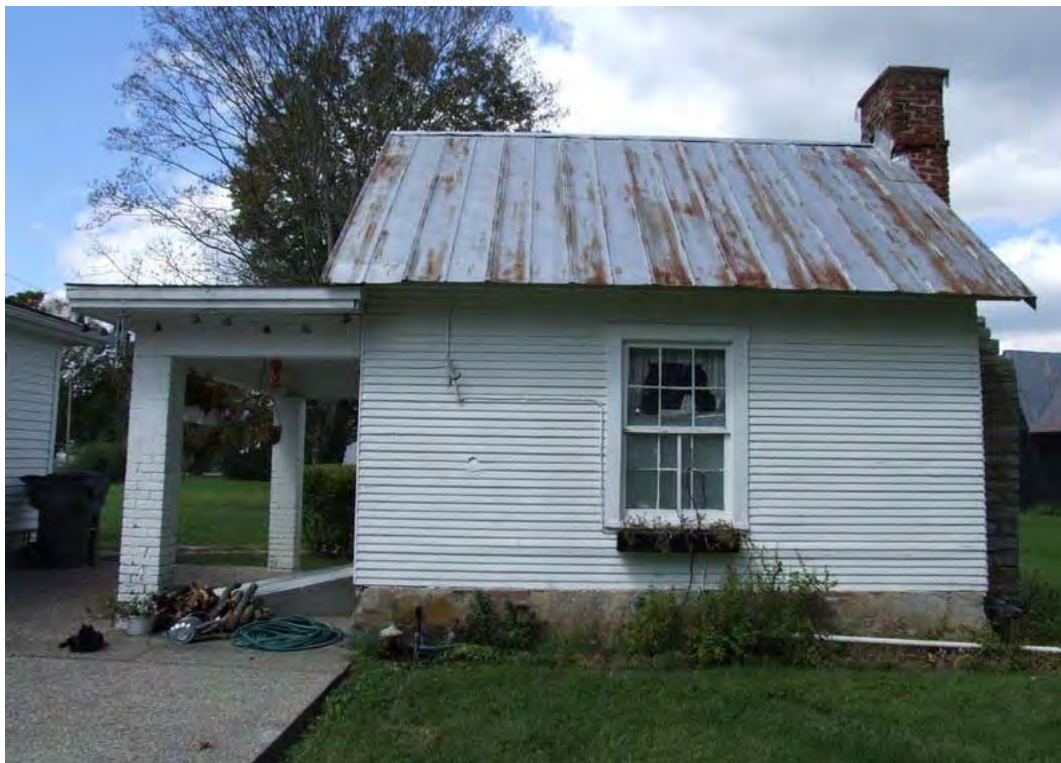
Figure 211: *WS 33, Kitchen, mid nineteenth century, Maud. The porch is an early twentieth century addition. The building later served as the Maud Post Office.*

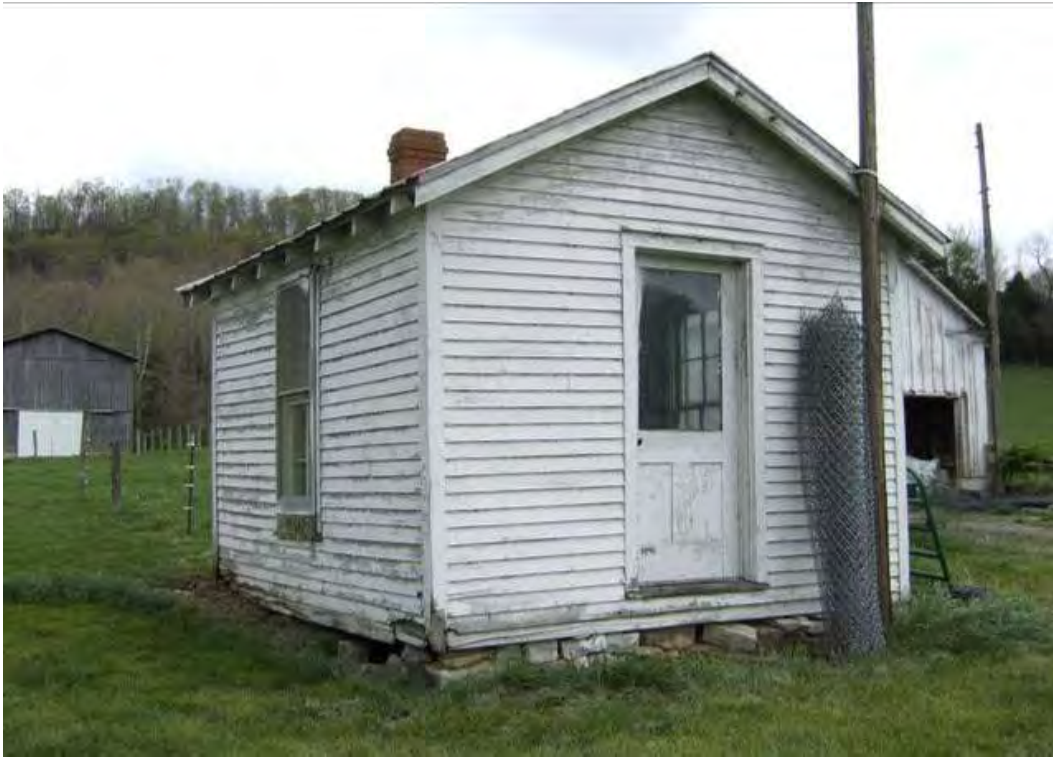
Figure 212: MN 656, Kitchen, early twentieth century, Bradfordsville vicinity. The buildings behind the kitchen include the garage at the right and a multi-purpose barn on the left in the field behind the house. See also Figure 213.

The kitchens documented in rural Marion and Washington counties mostly post-date the period of slavery. Many of them are doubtlessly associated with live-in servants in the Post-Bellum period. Others, particularly those of the twentieth century, are associated with more modest sites, where they were likely used for tasks such as canning vegetables and food processing. Examples from all periods are typically located behind and near to the main house (see the site plan for MN 656, Figure 213), and are close to other domestic food-related structures such as meat houses, cellars, and wells or cisterns. Since they were built for housework, kitchens have strong historic associations with women, children, and family life. Detached kitchens of more recent vintage may have been built for the convenience of separating the kitchen from the house. In many cases, kitchens also served as the laundry facility and frequently served as the dwelling of a slave or live-in cook. Several examples were documented in the survey area that date as late as the 1930s (MN 656, Figure 212).

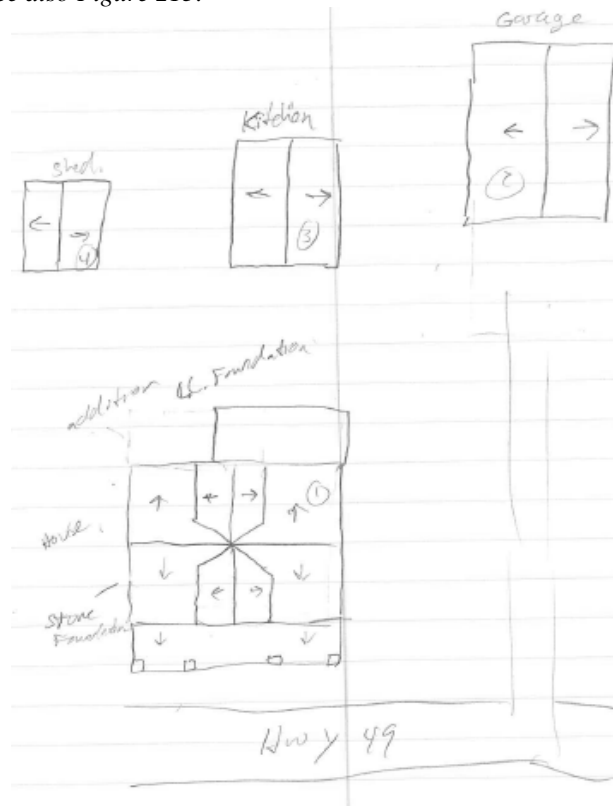
Figure 213: MN 656, Site plan. Building # 4, marked “shed,” appears to be a meat house (field notes: Danielle Jamieson & Anna Ruhl, 4/7/2007). See also Figure 212.

The garage is typically located conveniently close to the house, at the edge of the domestic yard area, but not too close to critical outbuildings. At WS 476 (see site plan, Figure 3), a two-car, shed roof garage (Figure 224) is located just off the main road, across the driveway from the house, nearest to the shop and the privy (for another example see the site plan for MN 656 in Figure 213).

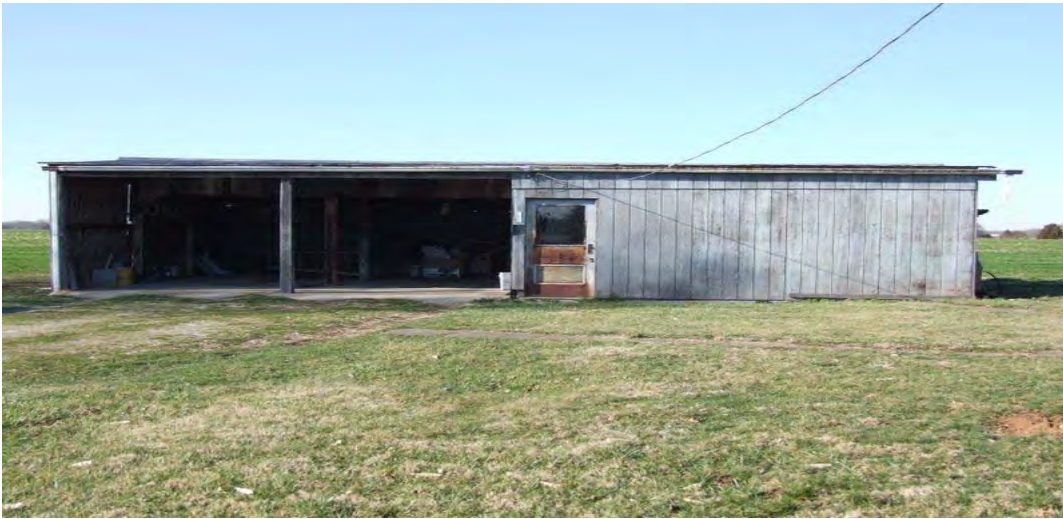
Figure 215: MN 426, Machines Shed/Workshop, mid twentieth century, Loretto vicinity.

two separate rooms inside, suggesting that the building serves multiple purposes. Shops are often found in multi-purpose buildings, most often combined with automobile or farm machinery storage, as at MN 426 (Figure 215).

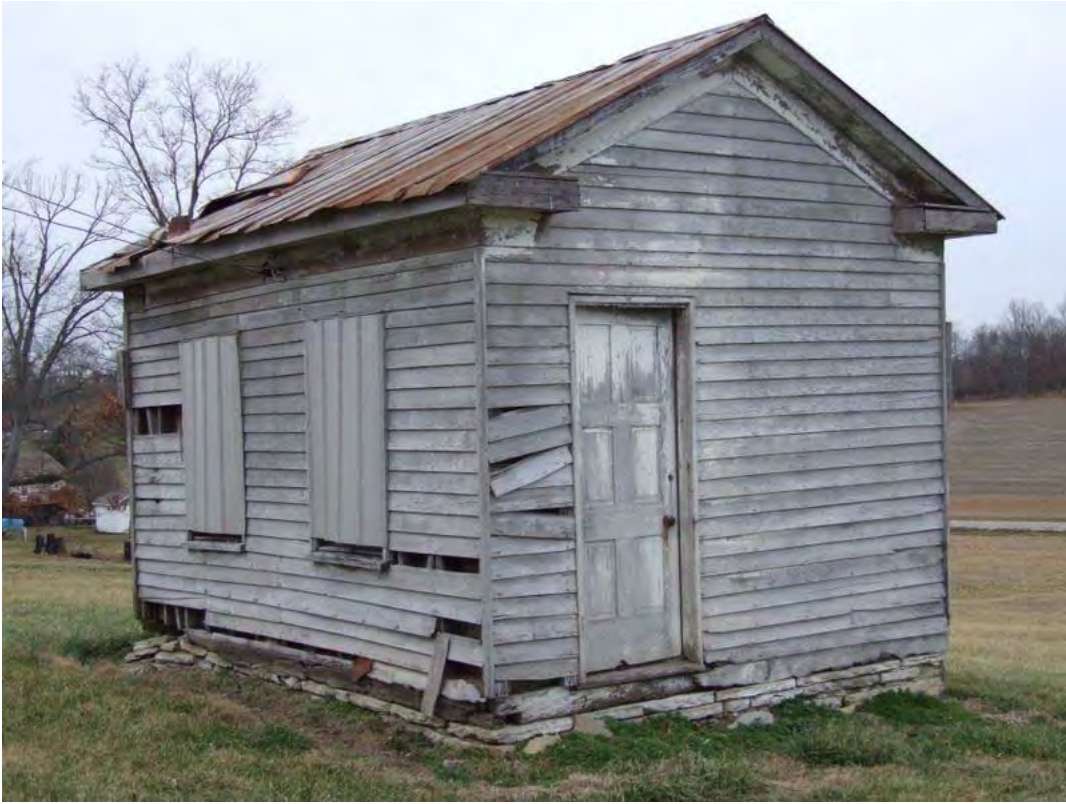
Figure 217: *MN 322, Workshop, late nineteenth-early twentieth century, Dant vicinity.*

Probably the oldest identified shop is the small building at MN 322 (Figure 217), which served as a small woodshop and has a workbench inside. Whether or not this was its original function is unclear – it has a chimney for a stove flue and the Greek Revival detailing of the cornice identifies it as a building of some importance. A far more typical example of a shop in the survey area is found at MN 933 (Figure 218), a shed roof structure which has two doors and presumably
