A Survey of Historic Sites in Rural Marion and Washington Counties, Kentucky

A Report on the Findings of the *Rural Heritage Development Initiative Survey*
A project funded by a National Park Service Preserve America Grant

Kentucky Heritage Council

The State Historic Preservation Office, 2009

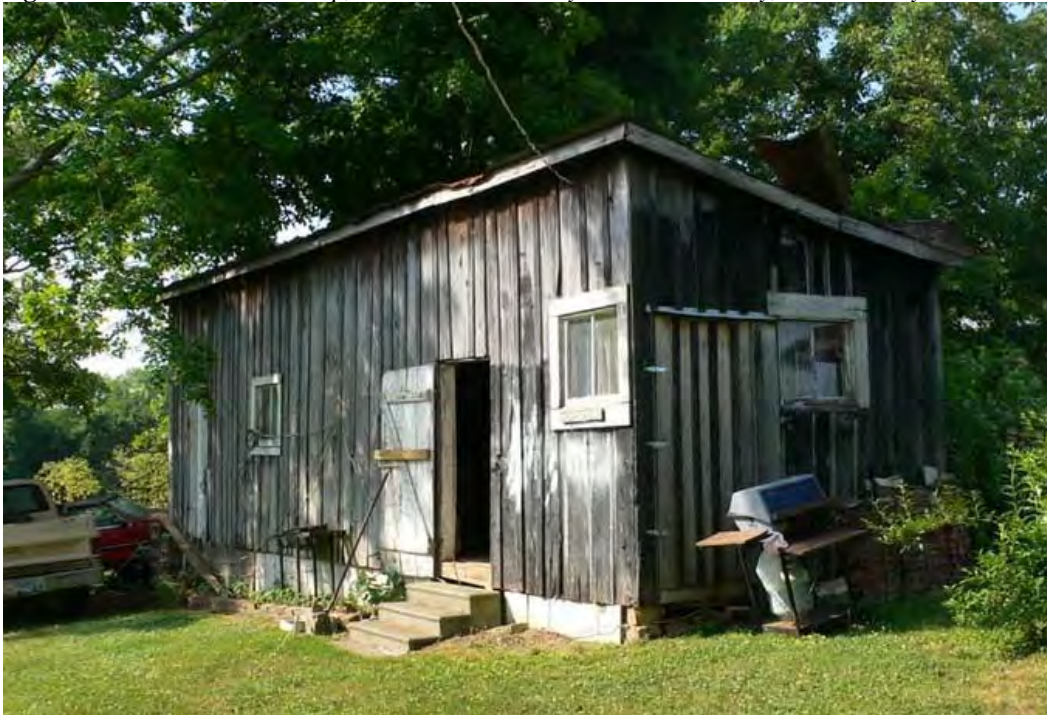
Figure 218: *MN 933, Workshop, early – mid twentieth century, Bradfordville.*

Probably the oldest identified shop is the small building at MN 322 (Figure 217), which served as a small woodshop and has a workbench inside. Whether or not this was its original function is unclear – it has a chimney for a stove flue and the Greek Revival detailing of the cornice identifies it as a building of some importance. A far more typical example of a shop in the survey area is found at MN 933 (Figure 218), a shed roof structure which has two doors and presumably

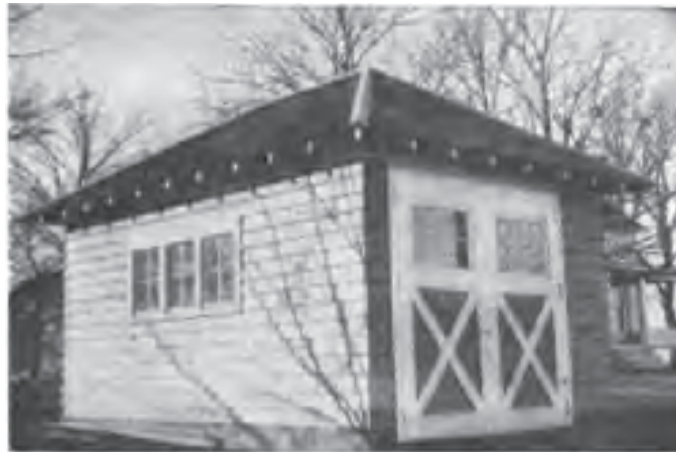
Figure 223: “A Frame Garage,” from W.A. Foster & Deane G. Carter, *Farm Buildings* (New York: John Wiley & Sons, 1922), 178.

Every modern farm has need of a garage for at least one or two cars. A separate building for power equipment is desirable, as no machine using gasoline or kerosene should be housed in the barn, corn crib to [sic] other building where the fire risk is great. A garage building provides a shelter for the car, reduces the fire risk in other buildings, affords storage for oils, fuel, and tools, and furnishes working space for handling repairs. The garage should be of good appearance, fireproof, light, clean, and reasonably warm.⁴⁹

⁴⁹ W. A. Foster & Deane G. Carter, Farm Buildings (London: Chapman & Hall, 1922), 178: see Figure 223.

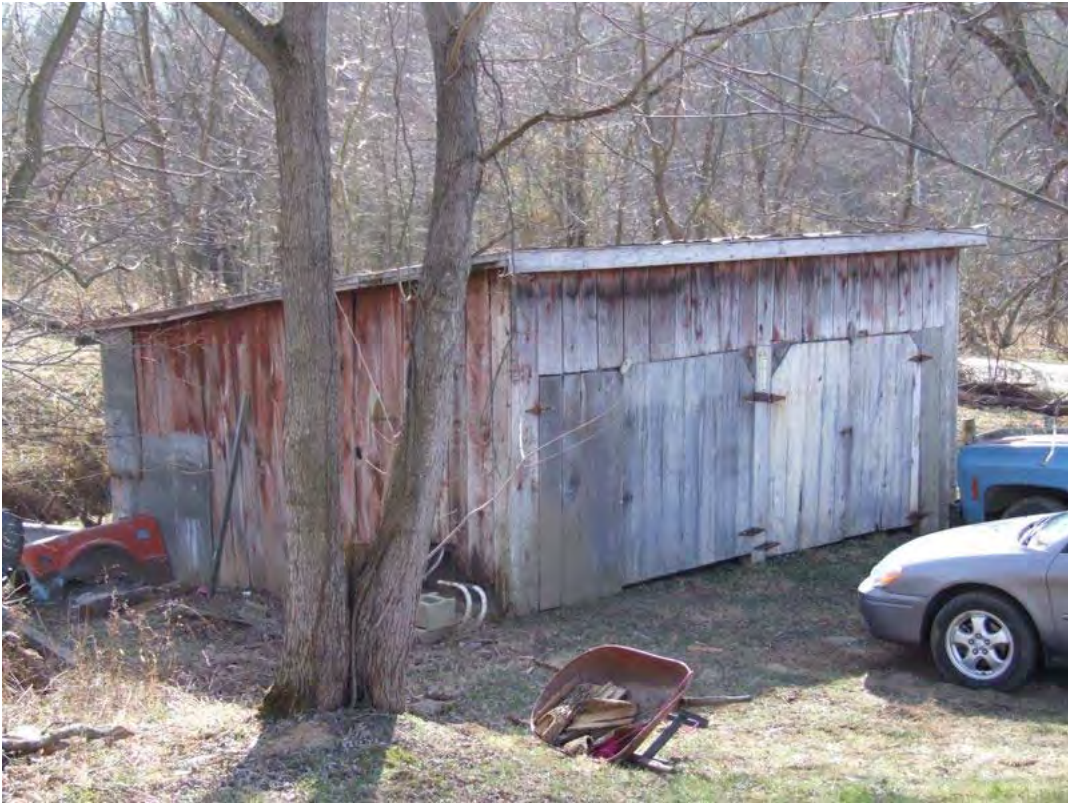
Figure 224: *WS 476, Garage, early-mid twentieth century, Mackville vicinity.*

The garage is typically located conveniently close to the house, at the edge of the domestic yard area, but not too close to critical outbuildings. At WS 476 (see site plan, Figure 3), a two-car, shed roof garage (Figure 224) is located just off the main road, across the driveway from the house, nearest to the shop and the privy (for another example see the site plan for MN 656 in Figure 213).

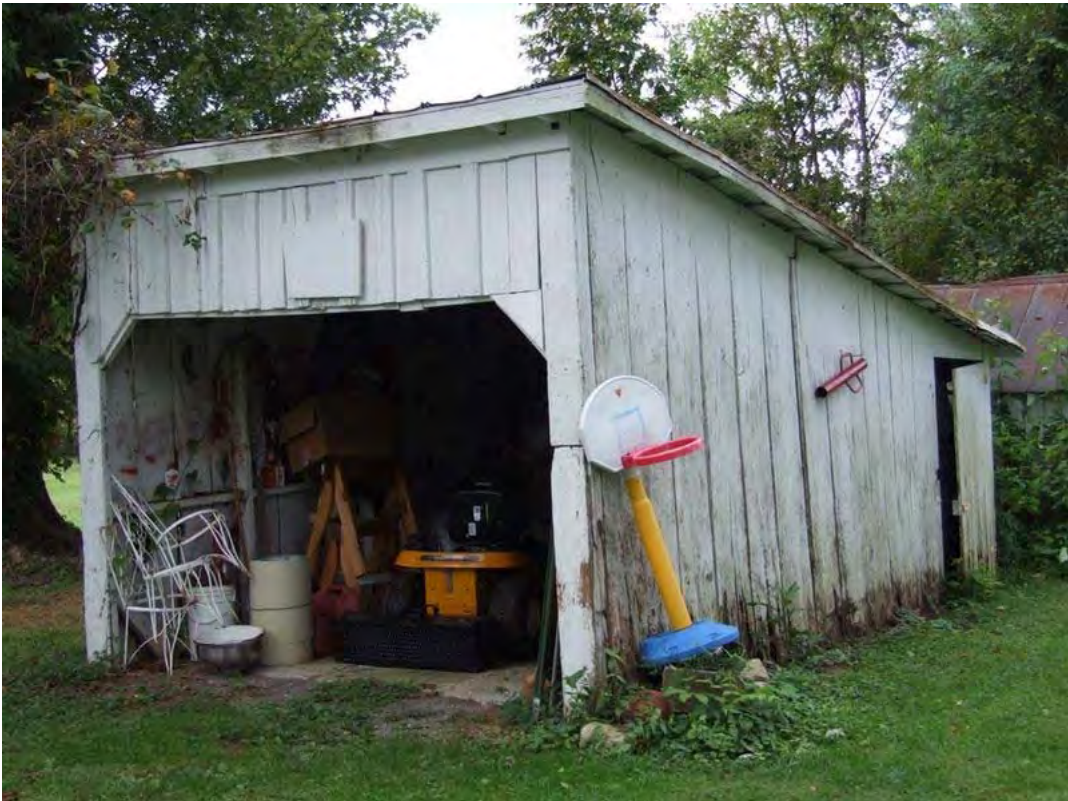
Figure 225: *WS 270, Early-mid twentieth century frame Shed Garage, Maud.*

The most common garage type in the survey area is a single story building, sometimes nothing more elaborate than a shed roofed shelter with or without doors (see WS 270, Figure 225), ranging to more elaborate examples with accommodations for multiple vehicles. In some cases, a second story was found being used as an apartment, studio, storage, or workspace (MN 936, Figure 226). Garages are sometimes shared between two or more dwellings, as at WS 349-50 (Figure 101).

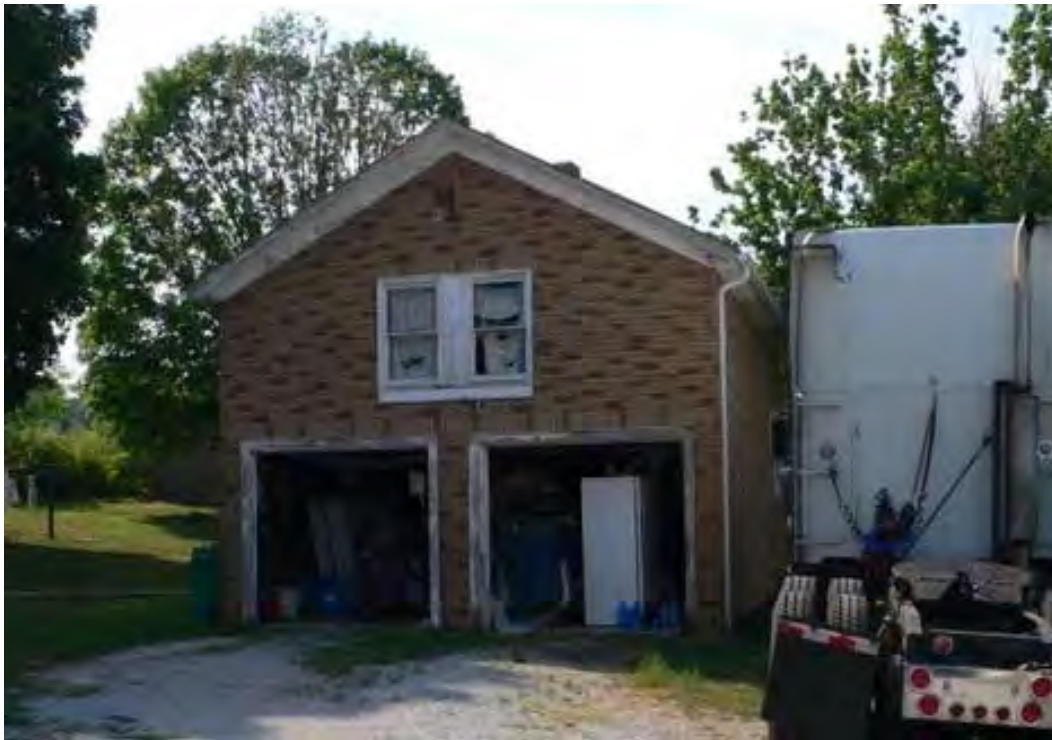
Figure 226: MN 936, 1920s-1930s frame two-car Garage with Apartment or Studio on second floor, Bradfordsville.

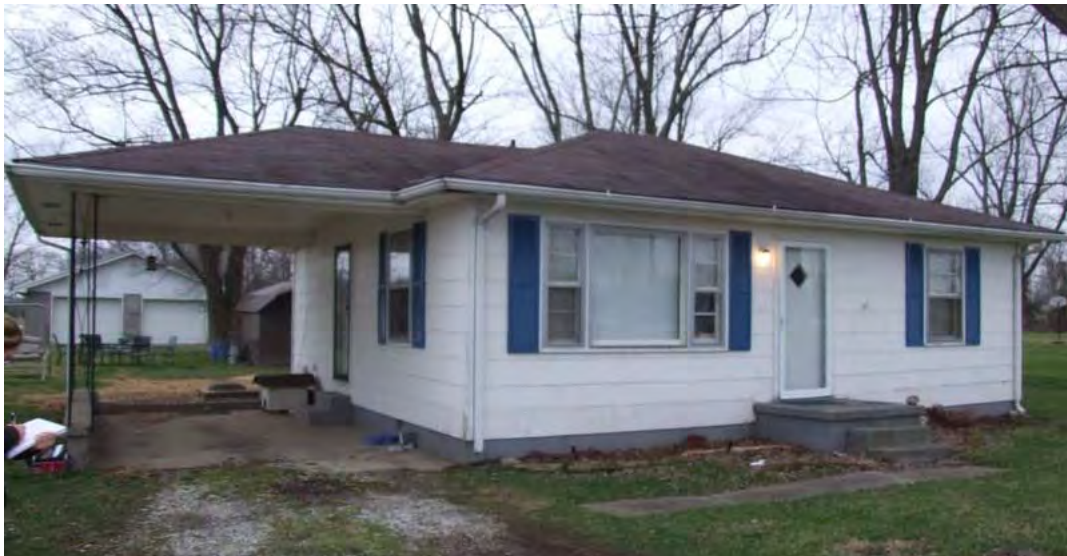
Figure 227: MN 432, Ranch style House with attached Carport, 1940s-50s, Loretto.

Garages were not commonly integrated into the design of houses until the Post WWII period. Many early ranch style houses accommodated cars through the use of an open carport. This feature helps emphasize the horizontality of the Ranch style (MN 432, Figure 227), and is frequently enclosed at a later date to create more living space. Although earlier examples are known, the incorporation of the garage into the main structure of the house itself is not common until the late 1950s-early 1960s (WS 961, Figure 228). Garages are sometimes incorporated into rural roadside commercial structures (see WS 556, Figure 229).

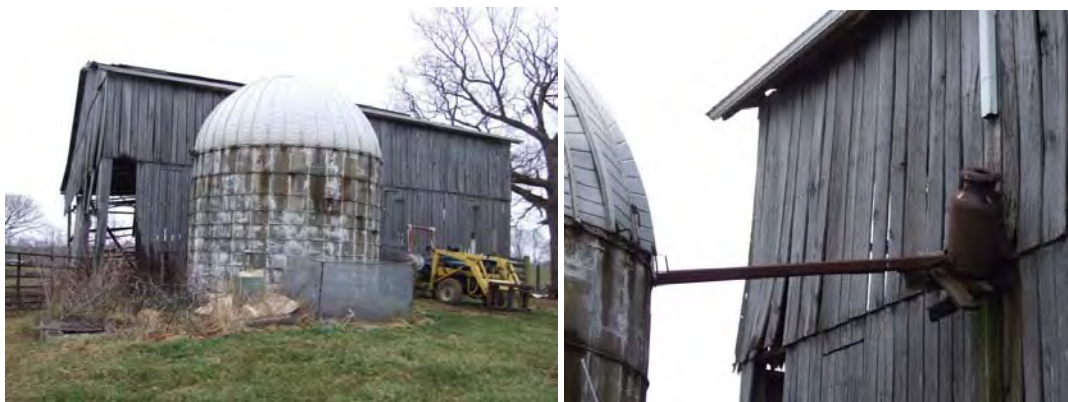
Figure 230: *MN 474, Multi-purpose Barn, early-mid twentieth century, with adjacent concrete Cistern, and detail right, Pottsville vicinity. Note the milk can used to connect the guttering.*

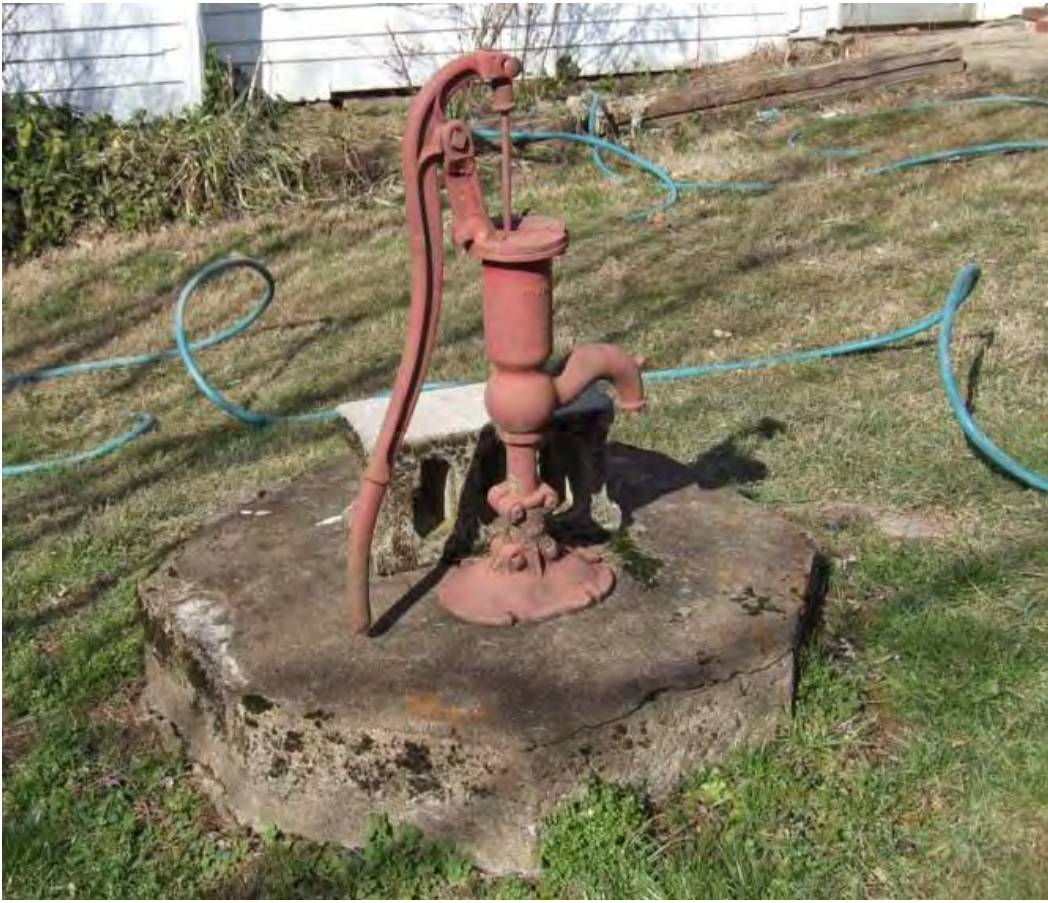
Figure 231: *WS 476, Well and Pump, twentieth century, Mackville vicinity.*

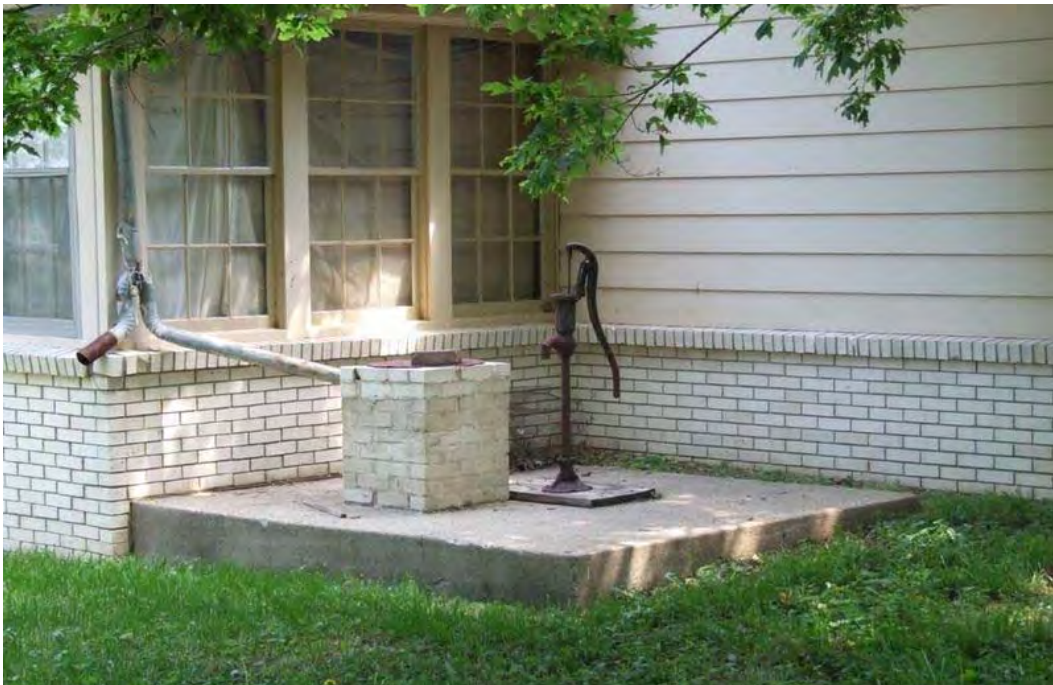
Figure 232: *WS 877, Cistern with Pump, Ward House, 1930s, Springfield vicinity.*

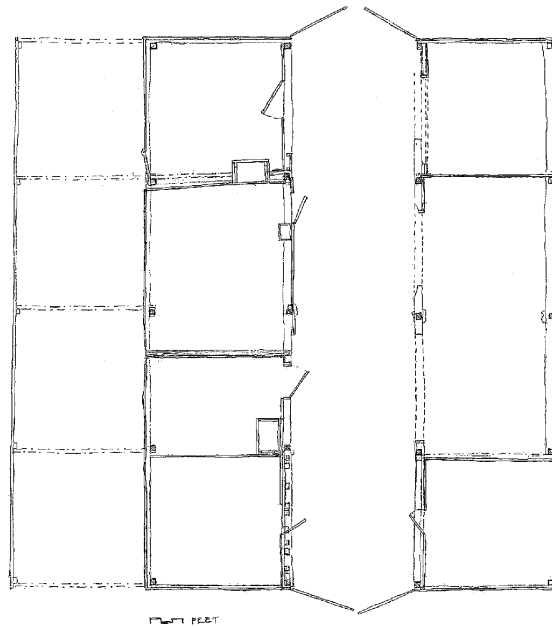
Figure 233: *Plan of a Transverse Frame Barn (Powell County, drawing by author).*

Barns are distinguished from other agricultural outbuildings mainly on the basis of their larger size. They are used for storing crops; sheltering, feeding, or milking animals; curing tobacco, agricultural processing; and storing farm machinery. Most of them serve multiple functions, but some are more specialized, built mainly for the purpose of dairying or curing tobacco, for example. Barns vary by form as well as function, and the two are not necessarily related. Many are built for one function and later used for another, a dairy barn becoming a tobacco barn, for instance. The predominant barn form in the survey area is the gable entry transverse-crib or transverse-frame barn.⁵⁰ Of 616 barns we have documented by form, 559 are classified as transverse frame barns. The form is very familiar: it has a long aisle down the center from one gable end to the other (Figure 233). The aisles on either side of the center may be divided into stalls or rooms as needed for various functions, and are often ceiled over to create hay lofts above. In cross section, the barn is a simple braced frame (Figure 234), which will vary in construction detail over time and from builder to builder. The transverse frame type may serve variously as a stock barn, multi-purpose barn, hay barn, machine shed, or perhaps most commonly, as a tobacco barn, as in the example at MN 217 (Figure 235).

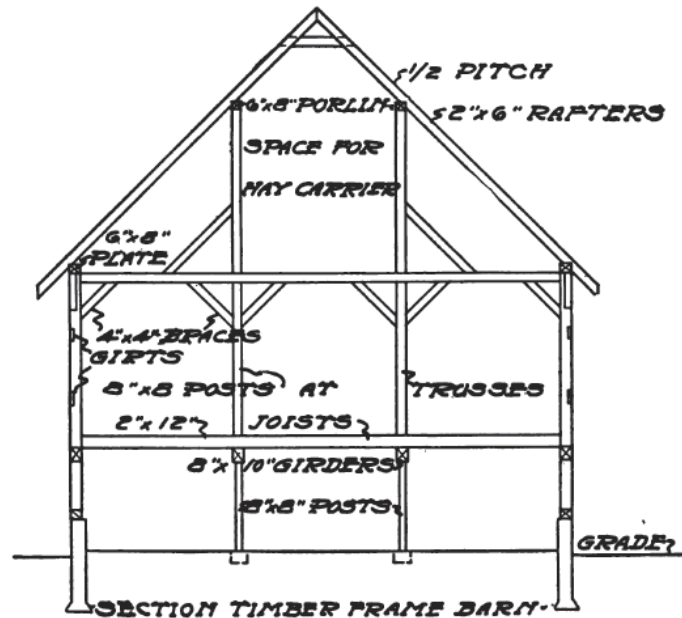
FIG. 65.—Illustrating timber framing for barns.

Figure 234: *Framing Section of a Barn*, from W.A. Foster & Deane G. Carter, *Farm Buildings* (New York: John Wiley & Sons, 1922), 75.

Frame barns account for over 95 percent of those surveyed. Frame construction supplanted log over time in barns, just as it did in houses. Most of the documented barns in Marion and Washington counties are late 19th through mid-20th century sawn and nailed frame. Just one heavy timber frame barn was identified in the survey, at WS 451 (Figure 248). In the figure, we see a detail of two sills joined to a corner post, resting on a precarious looking dry laid stone pier. The timbers have the characteristic rough hand hewn appearance of an early frame. A comparison of that foundation with a late 20th century one such as that at MN 602 (Figure 249), with its circular sawn post and poured concrete pad, hints at the revolution that took place in barn construction over the century to a century and a half between the two. From the outside, it's more apparent when we compare WS 451 (Figure 250) with MN 602 (Figure 251). The trend in the technological development of framing over the course of history examined in this survey is to use those two elements to enclose more volume of space with less material. Although it moved from mortise and tenon joinery to simply being nailed together, the traditional braced barn frame (Figure 234) remained essentially similar in form for a long period of time until new techniques

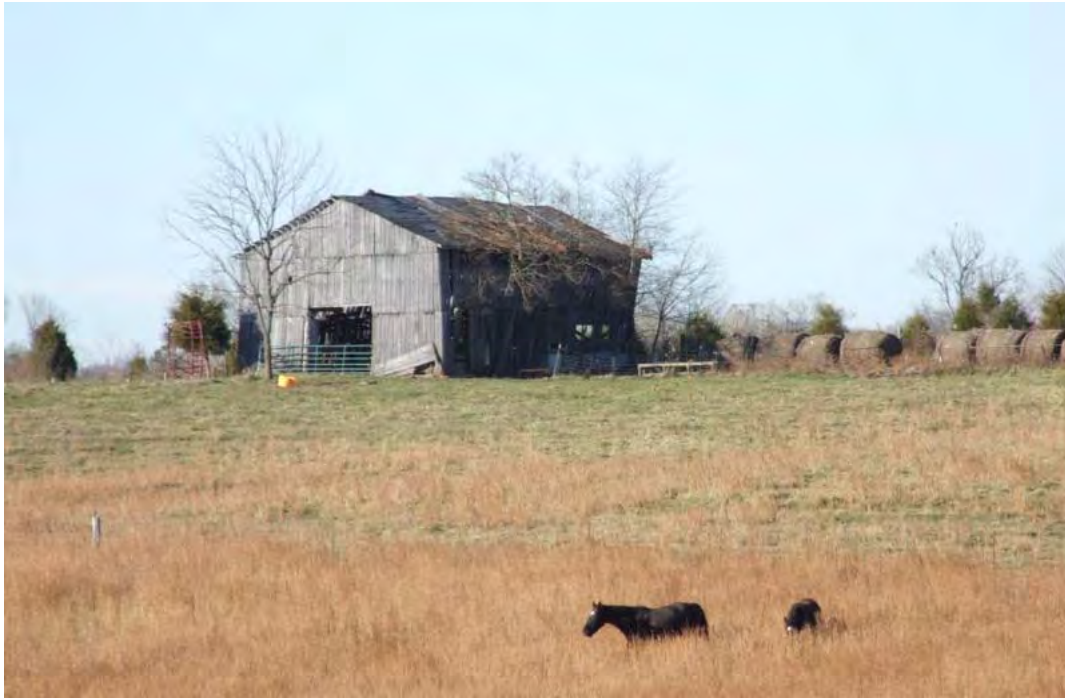
Figure 235: MN 217, Tobacco Barn, mid twentieth century, Holy Cross vicinity.

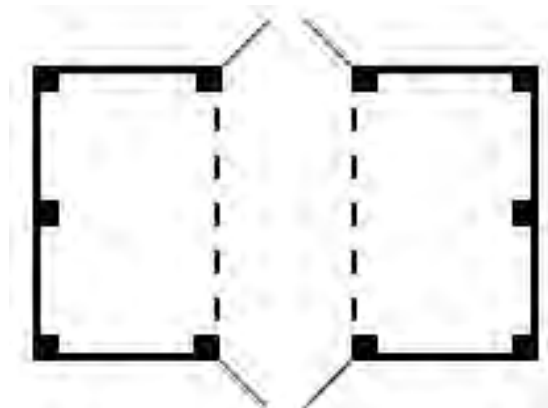
Figure 236: English Barn plan (drawing, author).

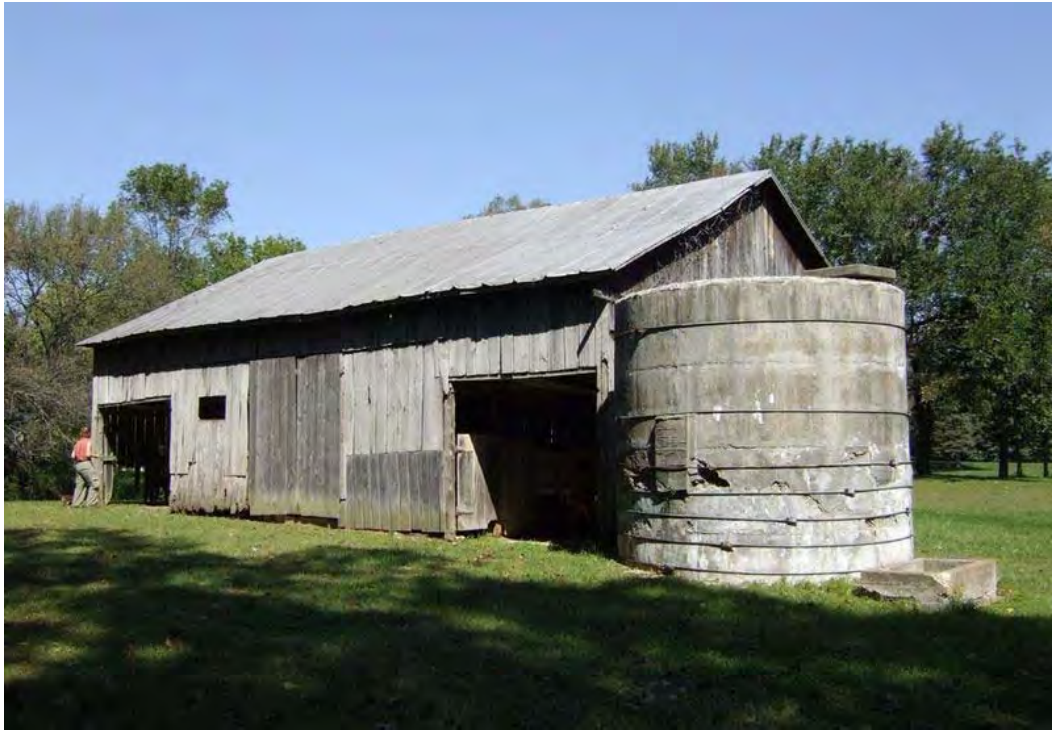
Figure 237: *WS 315, Multi-purpose Barn, early-mid twentieth century, Fredericktown vicinity. A modified English barn with extended end sections for storage of farm machinery. The central section has stables, and hay was stored in the loft. The concrete structure in the foreground is a cistern.*

Another important type is the English barn, which could serve the same purposes as the Transverse frame barn. The English barn has its aisle running through the center across the gable rather than parallel to it (Figure 236), and typically has three sections on the ground floor, the center aisle and the bays on either side of the aisle. Just 17 barns of the 616 we have classified by type are English barns, but the form was much more common in the antebellum period, so documented examples are sometimes early. In some cases, however, the form continues to be built late, even into the 20th century, as at WS 315 (Figure 237).

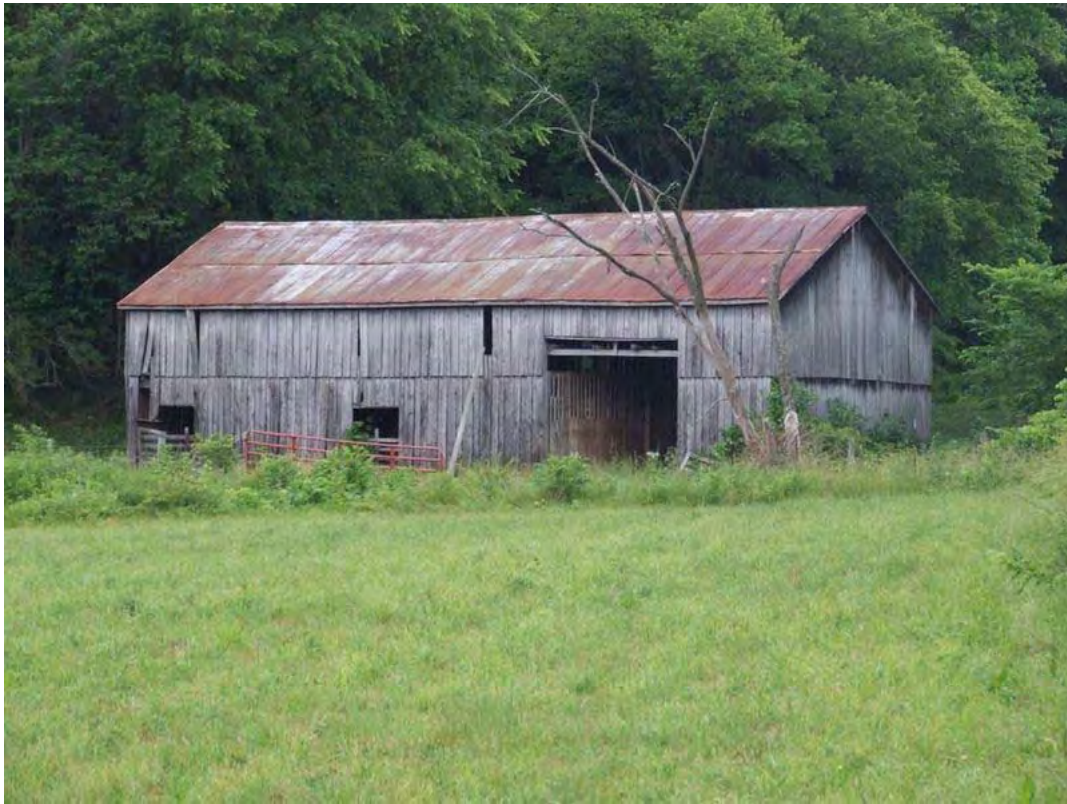
Figure 238: *MN 715, Stock or Multi-purpose Barn, twentieth century, Jessietown vicinity.*

In a small number of documented cases, a barn will have a floor plan that varies in significant ways from both the transverse frame and the English types, as at MN 715 (Figure 238) which has a cross aisle much like an English barn off center at one end, and may have a transverse aisle through the rest of the barn (the interior was not inspected). Another variation is for a transverse frame barn to have two or more aisles as at the large stock barn at MN 917 (Figure 239), which has two aisles, each flanked by stables, or the barn at MN 685 (Figure 240), which has three with the added shed along the right side. Both of these barns have very large loft spaces to store a large amount of hay for the animals sheltered inside.

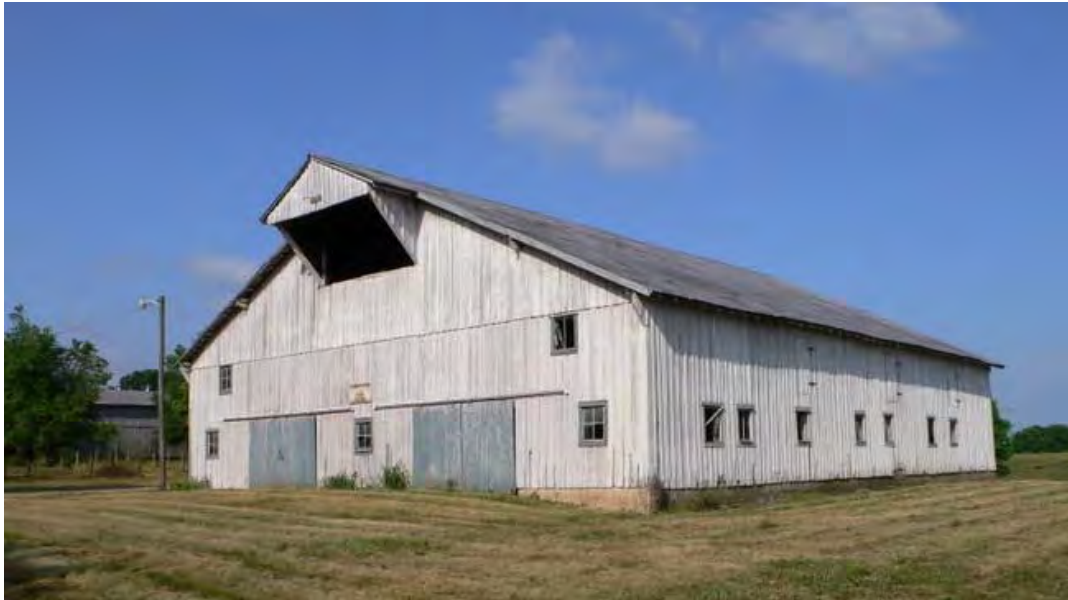
Figure 239: MN 917, Cattle or Stock Barn, mid twentieth century, Bradfordsville vicinity.

A good portion of a multi-purpose barn is typically dedicated to the shelter and feeding of larger farm animals, as we find at MN 749 (Figure 263), where there are several dedicated stable areas on the ground floor (Figure 264). The distinction between a multi-purpose barn and a stock barn isn't always clear, but in short, stock barns are almost completely dedicated to that purpose on the ground floor, although they typically have loft storage overhead. 144 barns were identified as stock barns in the survey. A quite interesting example is found at WS 33 (Figure 262). This is an English barn type with a shutter that opens for hay loading in the steep cross-gable. It is one of the few barns with an identifiable style with its gothic profile. Impressive for its size is the stock barn at MN 917, which has two parallel aisles on the ground floor, each lined with stables (Figure 239).

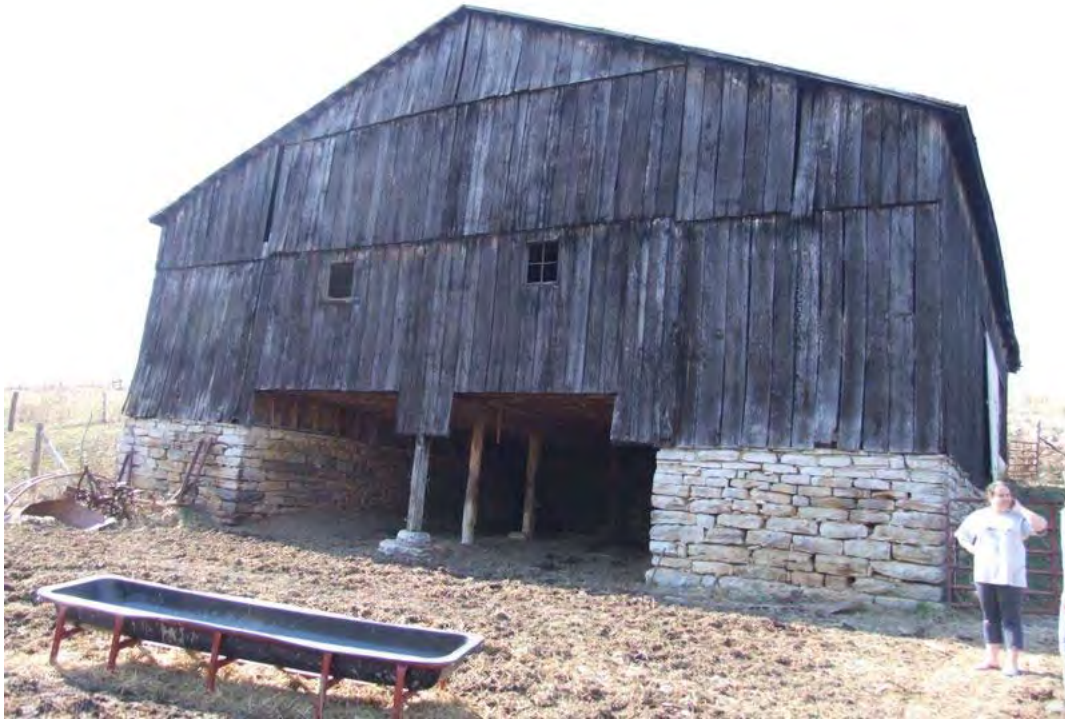
Figure 241: WS 633, Stock Barn, mid-late nineteenth century, Deep Creek vicinity. See also Figure 242.

Just as barns can vary in form and construction material, they vary in function. An English or a transverse frame barn may suits a variety of functions with simple changes to interior spaces. Some functions become closely allied with particular forms, however. A bank barn (Figure 241) is typically a stock and hay barn for example, the lower floor as stabling, feeding, and milking areas, the upper floor as hay loft. The double pen drive through corn crib (Figure 302) and the cantilevered chicken house (Figure 291) are both examples of highly specialized agricultural building forms, although the center drive corn crib one that exists over a very long period of time while the cantilevered chicken house has a shorter run. Agricultural buildings tend to become more specialized, more engineered over time: a multi-purpose barn eventually is replaced by multiple buildings each designed for one, or perhaps two specific functions – loft storage over a milking parlor, or over a stabling area, a free-standing stripping room, tobacco and machine storage. Where there was once a single chicken house, there is now a brooding house and a laying house, granaries are replaced by metal bunkers and silos, and so on.

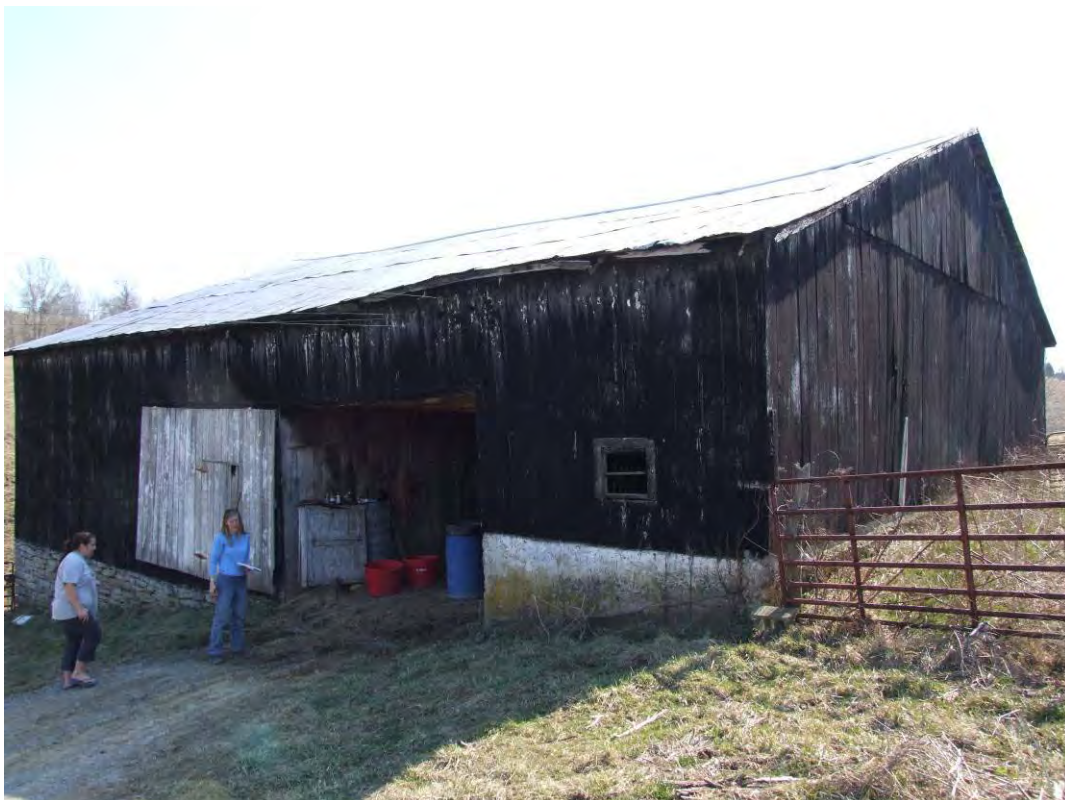
Figure 242: WS 633, Stock Barn, uphill side. See also Figure 241.

Another type of barn sometimes found in the region (at least two documented examples) is a bank barn, which may be transverse frame or English or some variant in plan. The distinguishing feature of the bank barn is that it is set into the side of a hill, so that access can be gained on two levels. The lower level, being partly under ground, has some measure of relief from hot or cold weather for sheltering farm animals. A good example is found at WS 633 and which has an open entry on the down hill end (Figure 241) flanked by massive stone foundations, and an English barn type cross aisle on the uphill side (Figure 242). A 20th century example can be found at WS 98 (Figure 271 - Figure 273).

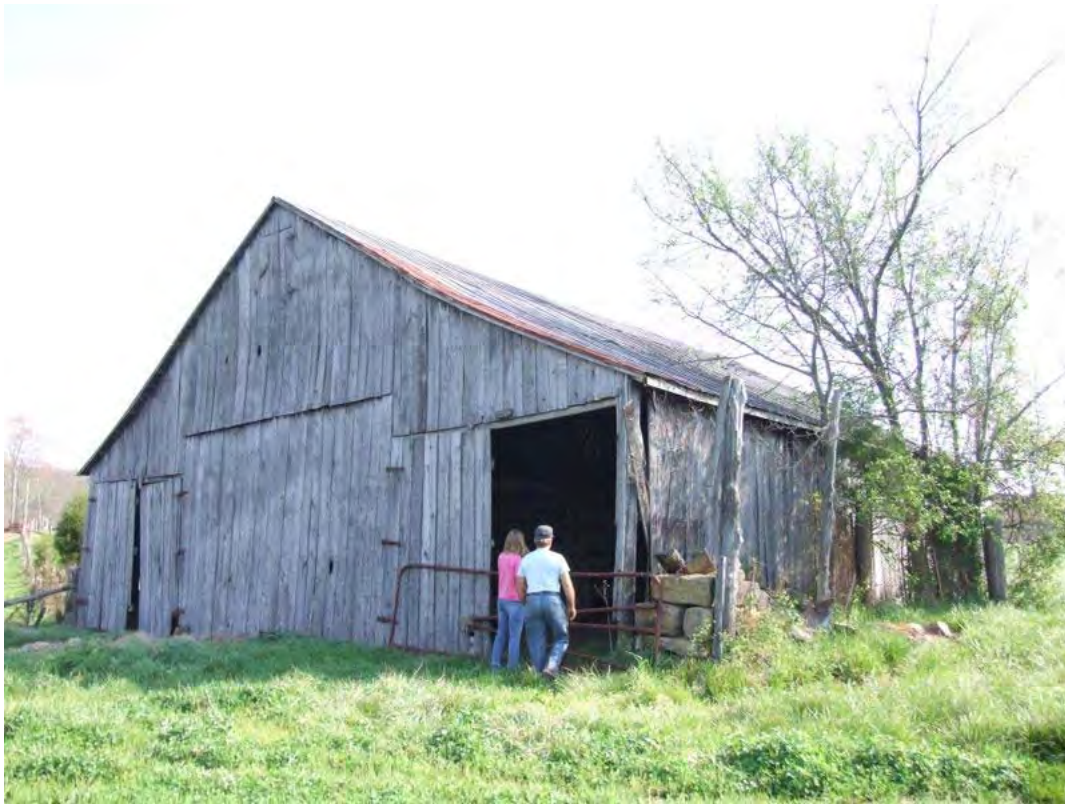
Figure 243: MN 514, Mid-nineteenth century Log Barn, Raywick vicinity, exterior view. See also Figure 244.

Although 95% of the barns surveyed were frame, 12 log barns were documented in the survey area. It is possible that some log barns were not identified as such, because they often look like any other barn from the exterior, as does MN 514 (Figure 243). It is only upon going inside that one finds one or more large log cribs (Figure 244). In some cases, although none were found in the current survey, the crib inside turns out to be an old log house. It can be a mistake to assume that the original barn consisted of just the log portion: pretty often, the frame extensions around the log crib turns out to be an original part of the barn. The log cribs often held hay or corn, while the shed extensions sheltered stock. The crib served as a strong internal structural element around which a larger frame building could be anchored. One clue to the larger frame being original is that the top logs are often cantilevered out beyond the log pen to the extent of the whole barn to support the roof. Intermediate logs are also often extended to support the sheds. Even where the larger barn is a later alteration of the original log pen, it is typically good preservation practice to preserve the whole, as the exterior barn helps protect the log pen inside, and is a reflection of a later historic period itself.

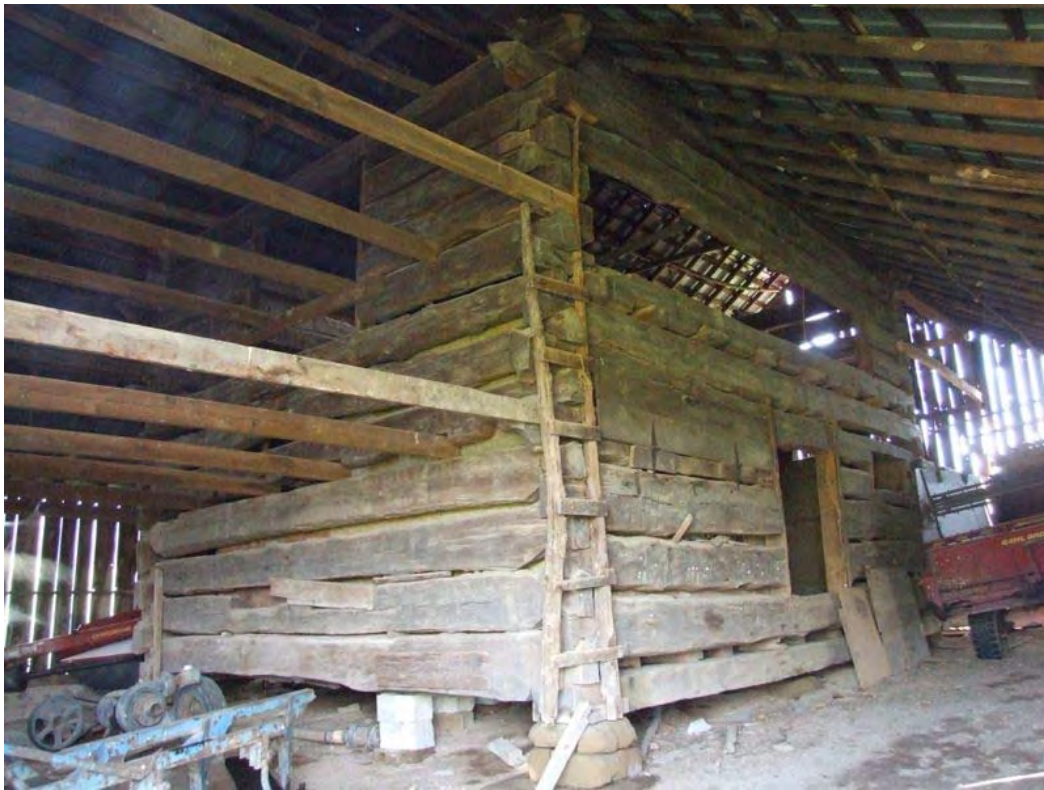
Figure 244: MN 514, Interior. See also Figure 243.

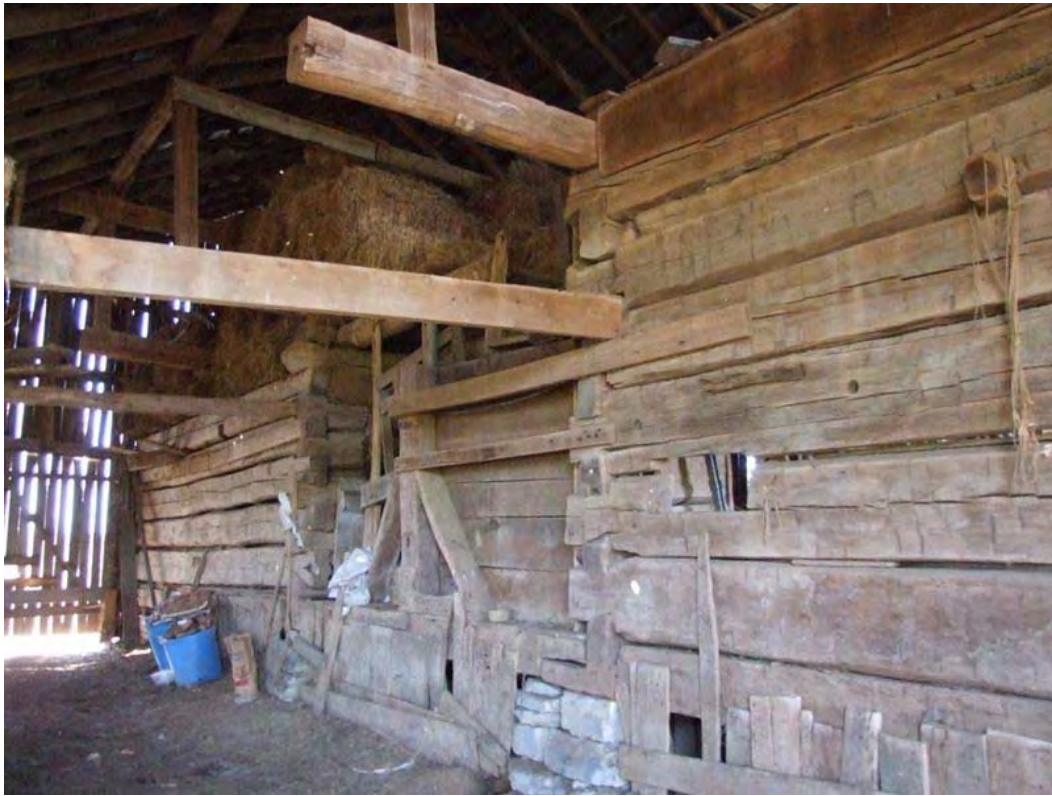
Figure 245: *WS 423, Early-mid nineteenth century Log Barn, Mooresville Vicinity.*

Larger log barns sometimes have two or more interior cribs: in the current survey, WS 423 is the only multi-crib barn documented, having two log cribs (Figure 245). The two cribs may not have been built at the same time, and there is some chance that one crib was a house, but the building needs to be inspected more closely. Although log barns were largely replaced by frame structures by the late 19th century, log barn construction continued well into the 20th century, as at MN 509 (Figure 246, exterior, and Figure 247, interior). In later construction, the logs are more typically round than hewn.

The earliest multi-purpose barns in the region were most likely log barns such as WS 423 (Figure 245) and frame English type barns. Log barns and English barns survive late in some instances, such as the modified English barn at WS 315 (Figure 237), or at MN 687 (Figure 257), which includes a corn crib along one side of the cross aisle. Transverse frame multi-purpose barns are more typical in the region. We have already seen an example of a transverse frame multi-purpose barn at MN 685 (Figure 240). Other examples include MN 189 (Figure 258) and WS 98 (Figure 259), which includes stables for stock, corncribs, loft storage for hay and grain, and feeding troughs and hay racks for the animals (Figure 261). Late examples such as the multi-purpose barn at WS 476 are often used for both tobacco and stock (Figure 260), and in many cases are often indistinguishable from a standard tobacco barn without interior inspection.

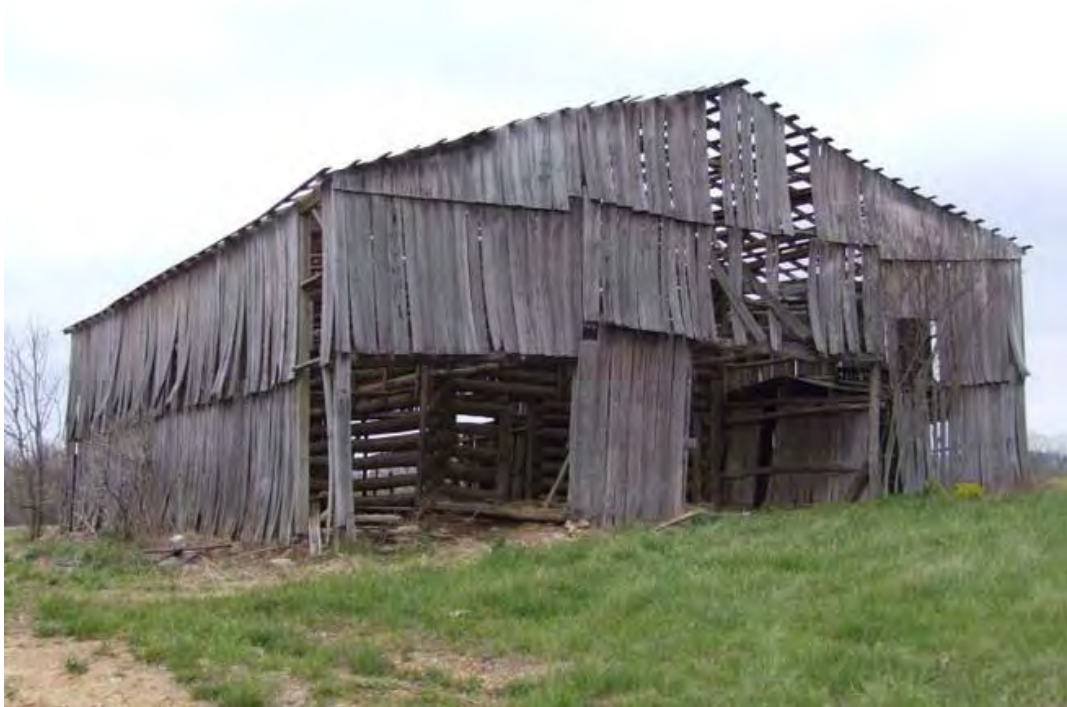
Figure 246: *MN 509, Log crib barn, early twentieth century, Raywick vicinity, exterior. See also Figure 247.*

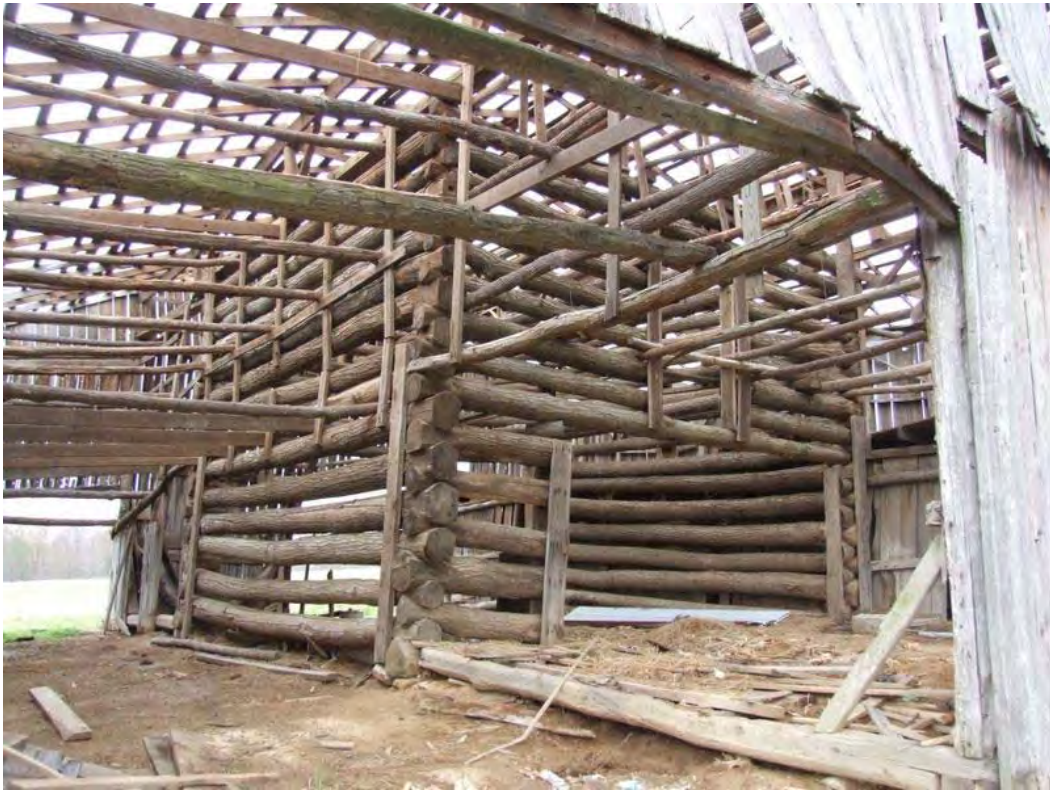
Figure 247: MN 509, interior. See also Figure 246.

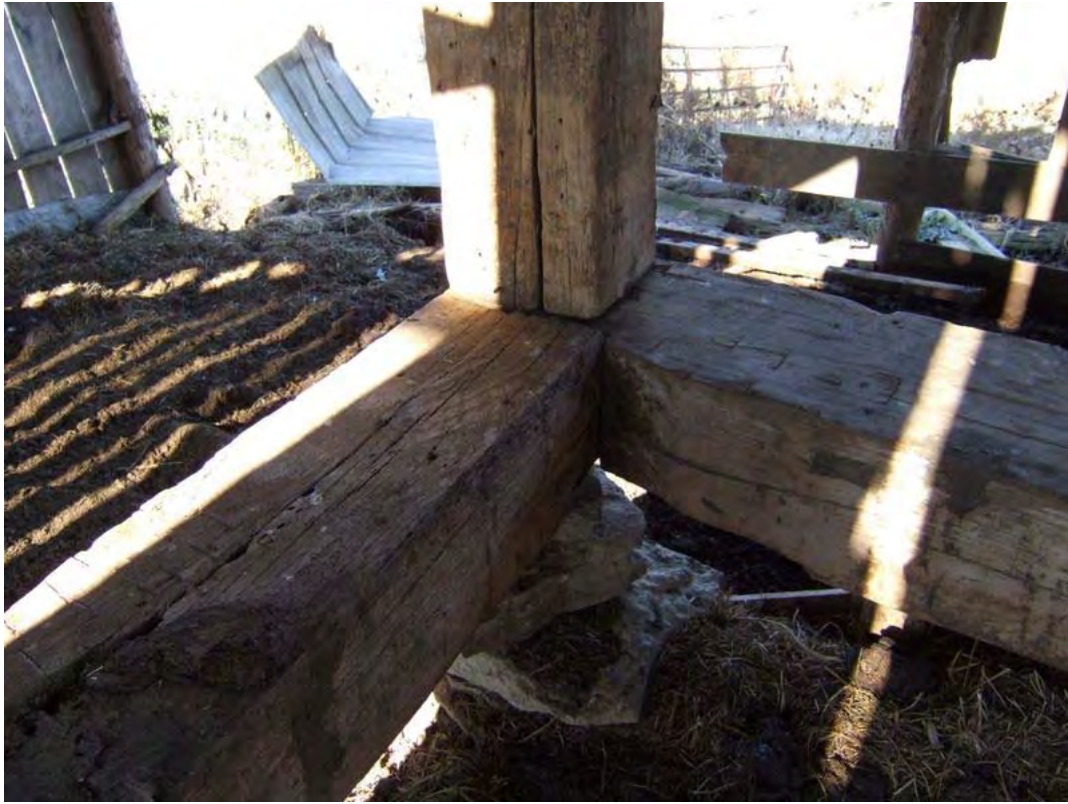
Figure 248: *WS 451, Timber Frame Barn, nineteenth century, Polin vicinity, detail of sills and post. See also Figure 250.*

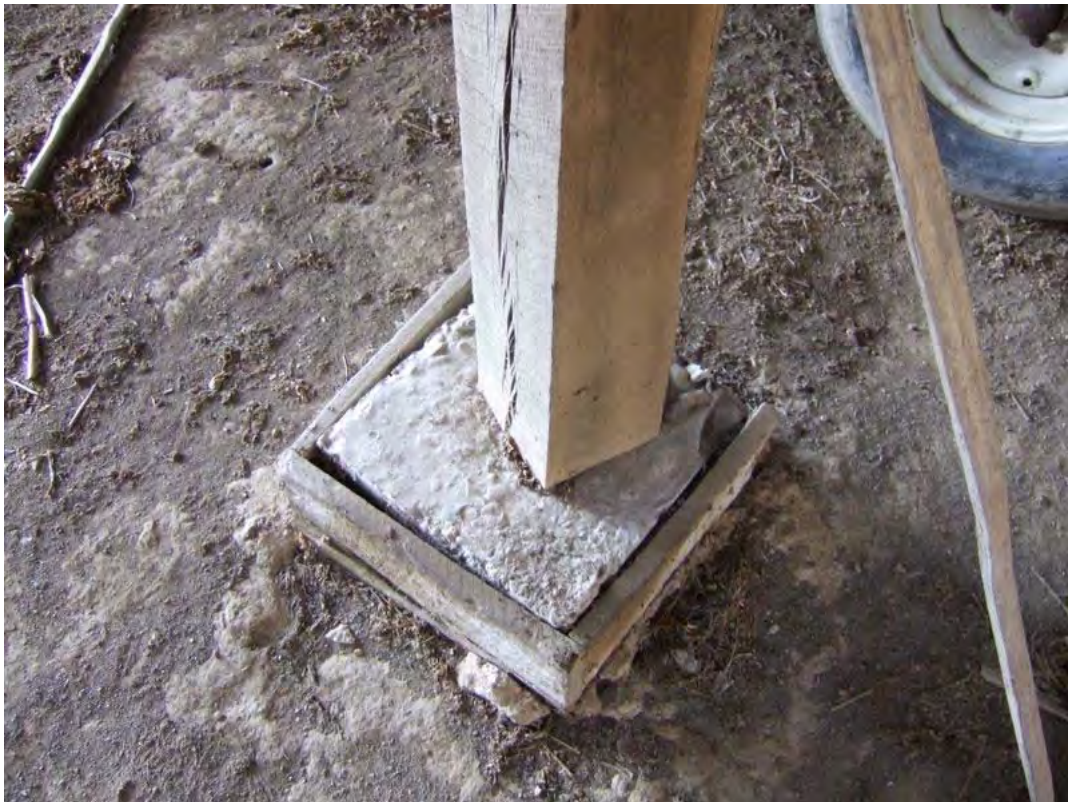
Figure 249: *MN 602, Multi-purpose Transverse Frame Barn, late twentieth century, Bradfordsville vicinity: detail of post on cement foundation block. See also Figure 251.*

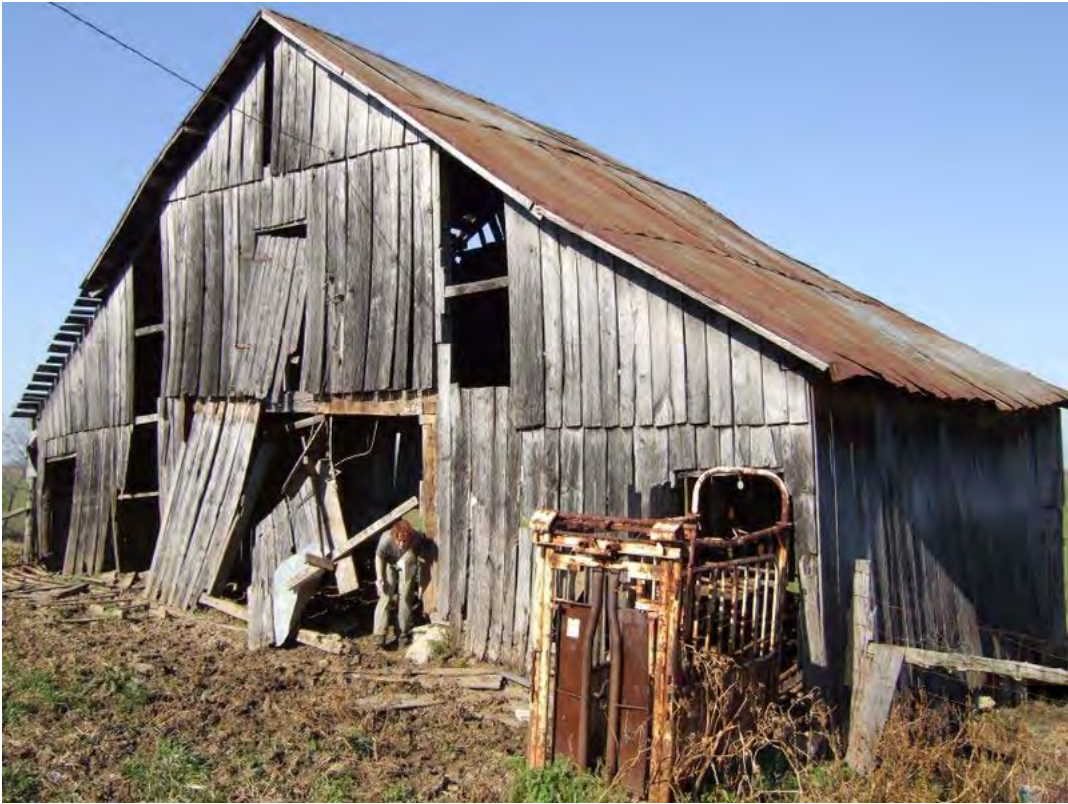
Figure 250: *WS 451, exterior. See also Figure 248.*
