A Survey of Historic Sites in Rural Marion and Washington Counties, Kentucky

A Report on the Findings of the *Rural Heritage Development Initiative Survey*
A project funded by a National Park Service Preserve America Grant

Kentucky Heritage Council

The State Historic Preservation Office, 2009

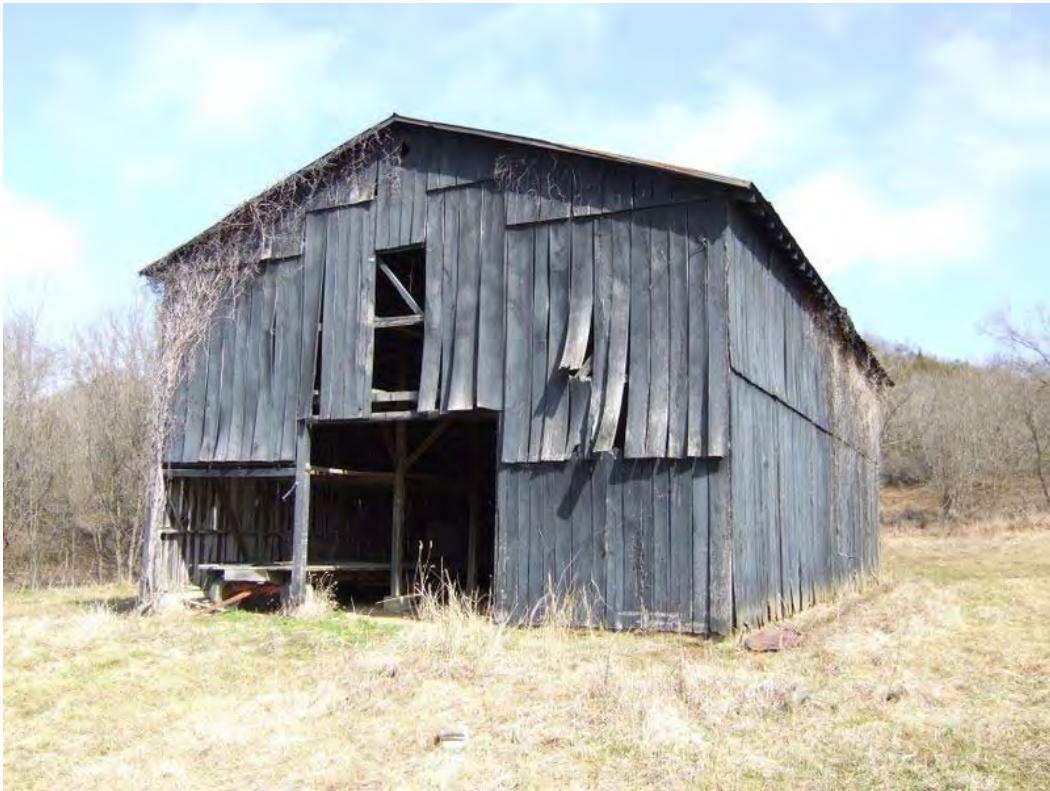
Figure 251: *MN 602, exterior. See also Figure 249.*

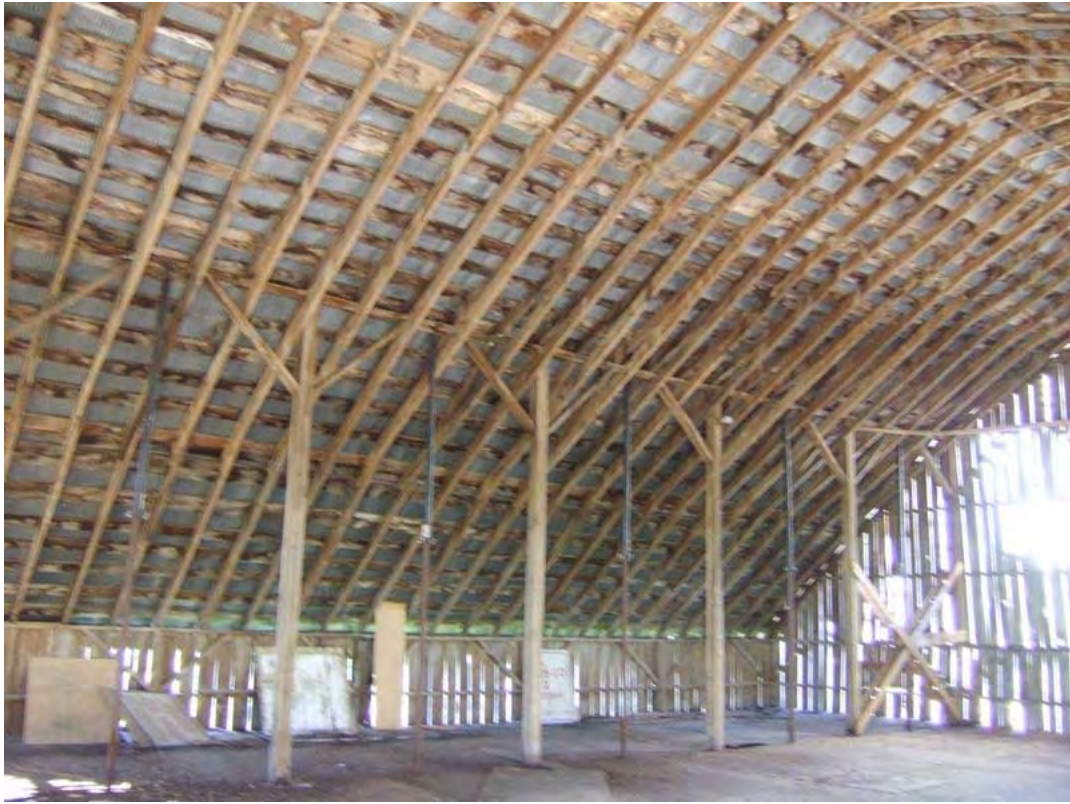
Figure 252: *WS 314, Dairy Barn, early twentieth century, interior view of loft, Fredericktown vicinity. See also Figure 277.*

were engineered that allowed the load of the roof to be carried down to the foundation without the intervening posts and braces. In stock and dairy barns with hay loft storage, this trend toward more open space with fewer interruptions from posts (WS 324, Figure 252), ultimately led to lattice or laminated truss examples with no posts interrupting the loft at all (MN 188, Figure 253). Tobacco barns, however large they became, are at the opposite extreme internally, with the interior space tightly crisscrossed with posts and rails upon which to hang the tobacco (WS 403, Figure 254).

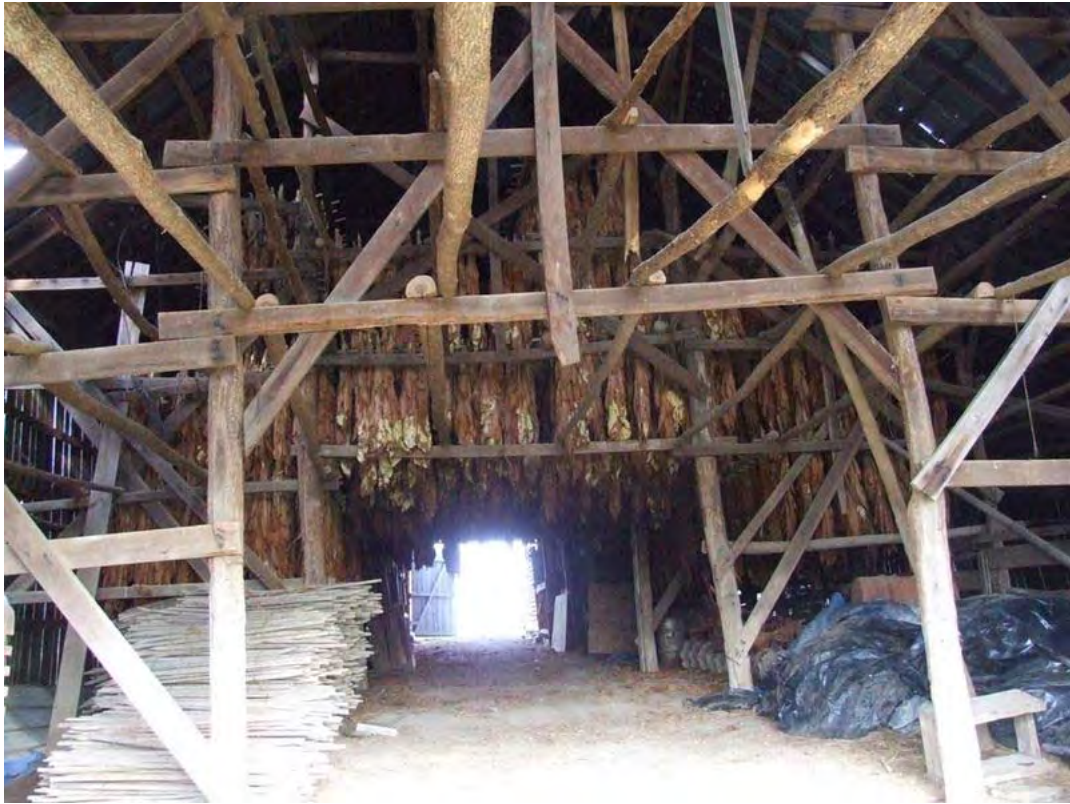
Figure 254: *WS 403, Tobacco Barn, early-mid twentieth century, Mooresville vicinity.*

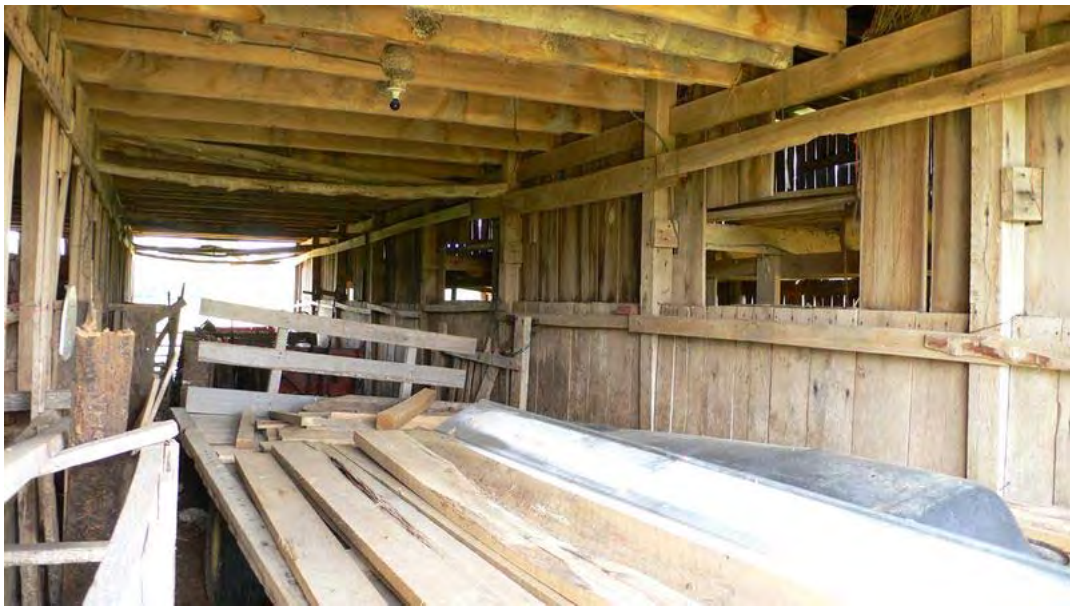
Figure 255: *MN 685, Multi-purpose Barn, interior of aisle. See also Figure 240.*

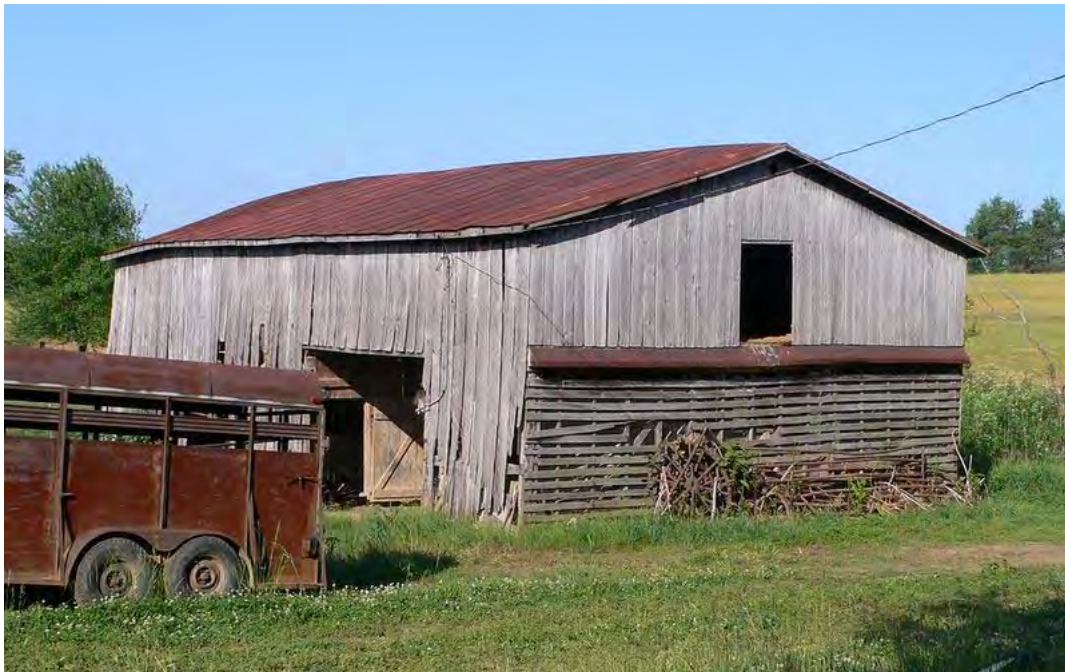
Figure 257: *MN 687, Multi-purpose Barn, early-mid twentieth century, Riley vicinity.*

The earliest multi-purpose barns in the region were most likely log barns such as WS 423 (Figure 245) and frame English type barns. Log barns and English barns survive late in some instances, such as the modified English barn at WS 315 (Figure 237), or at MN 687 (Figure 257), which includes a corn crib along one side of the cross aisle. Transverse frame multi-purpose barns are more typical in the region. We have already seen an example of a transverse frame multi-purpose barn at MN 685 (Figure 240). Other examples include MN 189 (Figure 258) and WS 98 (Figure 259), which includes stables for stock, corncribs, loft storage for hay and grain, and feeding troughs and hay racks for the animals (Figure 261). Late examples such as the multi-purpose barn at WS 476 are often used for both tobacco and stock (Figure 260), and in many cases are often indistinguishable from a standard tobacco barn without interior inspection.

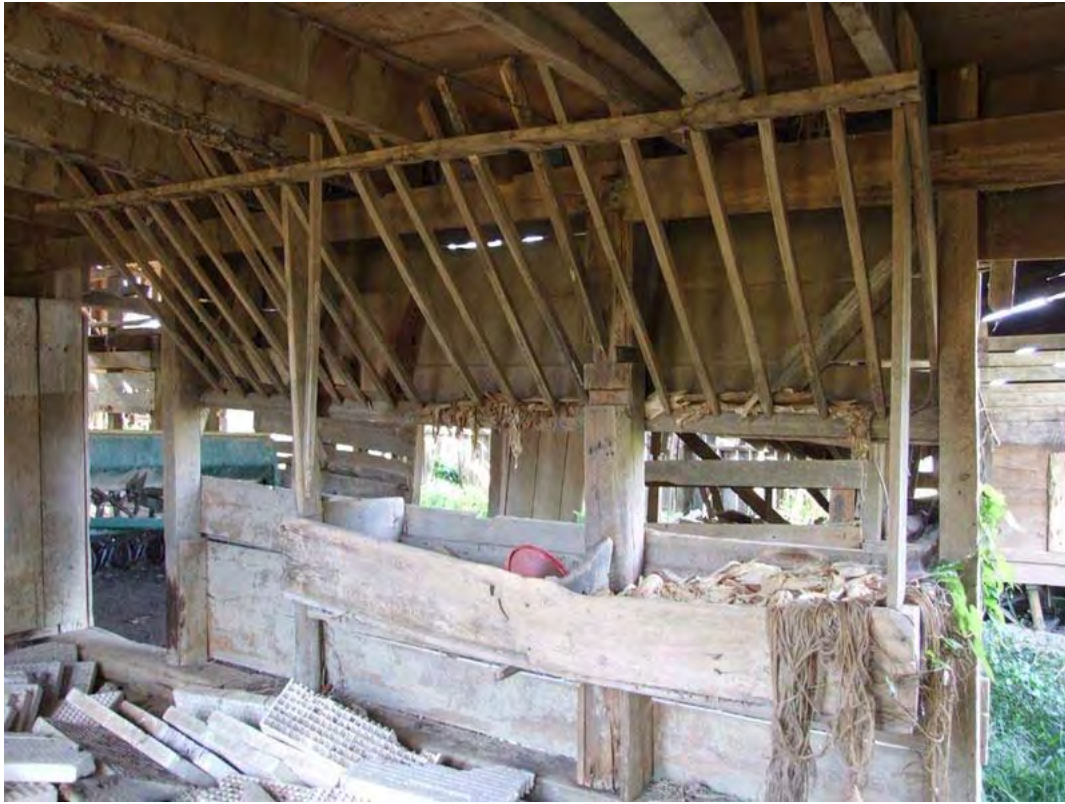
Figure 261: WS 98, *Feeding Rack and Manger*. See also *Figure 259*.

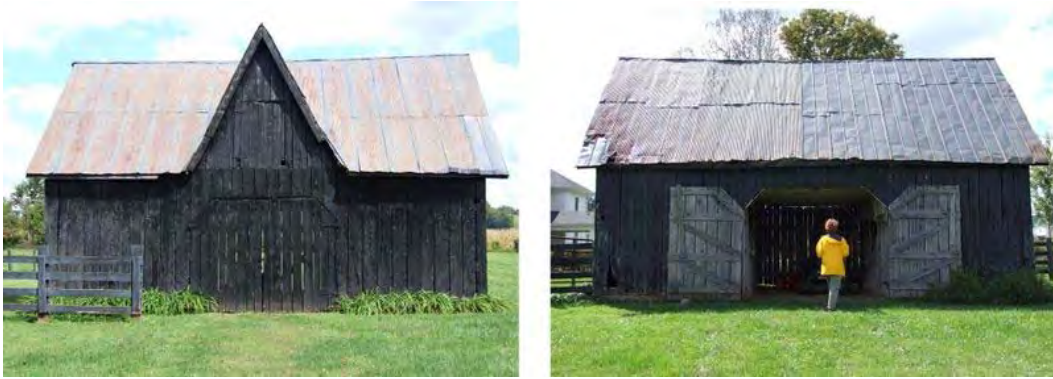
Figure 262: WS 33, Stock Barn, with stables, hay, and grain storage inside, late nineteenth century, Maud. Front of barn at left, back at right. An English barn type with a Gothic cross gable.

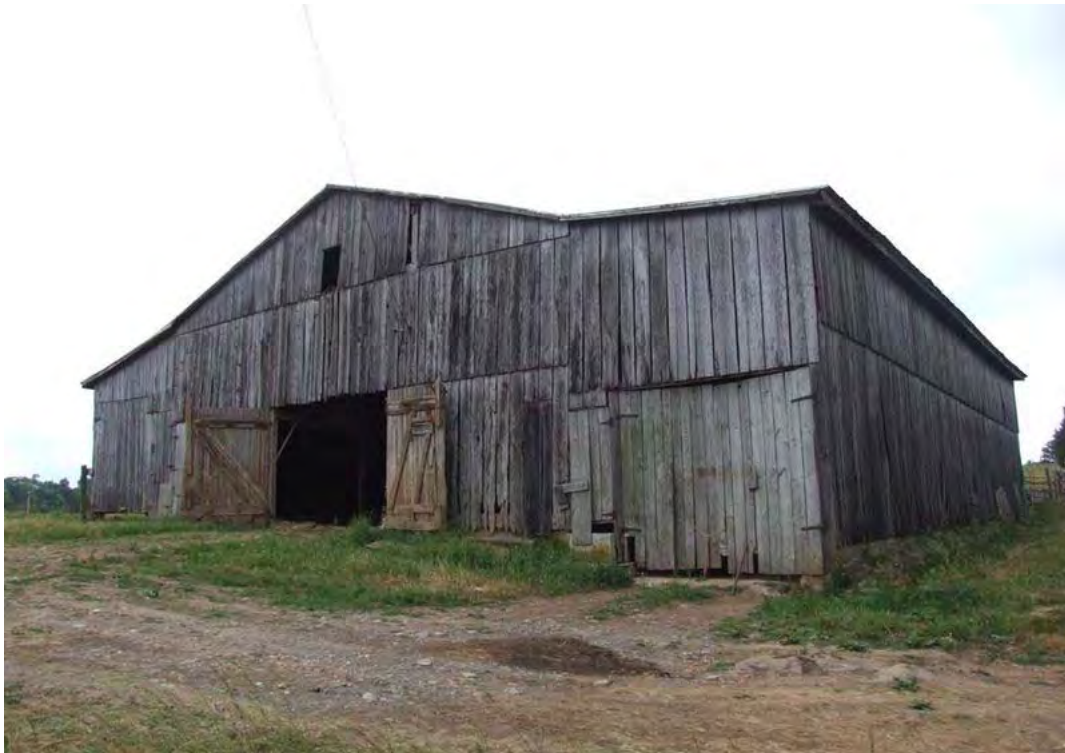
Figure 263: MN 749, Stock or Multi-purpose Barn, 1917, with later additions, Lebanon vicinity. See also Figure 264.

A good portion of a multi-purpose barn is typically dedicated to the shelter and feeding of larger farm animals, as we find at MN 749 (Figure 263), where there are several dedicated stable areas on the ground floor (Figure 264). The distinction between a multi-purpose barn and a stock barn isn't always clear, but in short, stock barns are almost completely dedicated to that purpose on the ground floor, although they typically have loft storage overhead. 144 barns were identified as stock barns in the survey. A quite interesting example is found at WS 33 (Figure 262). This is an English barn type with a shutter that opens for hay loading in the steep cross-gable. It is one of the few barns with an identifiable style with its gothic profile. Impressive for its size is the stock barn at MN 917, which has two parallel aisles on the ground floor, each lined with stables (Figure 239).

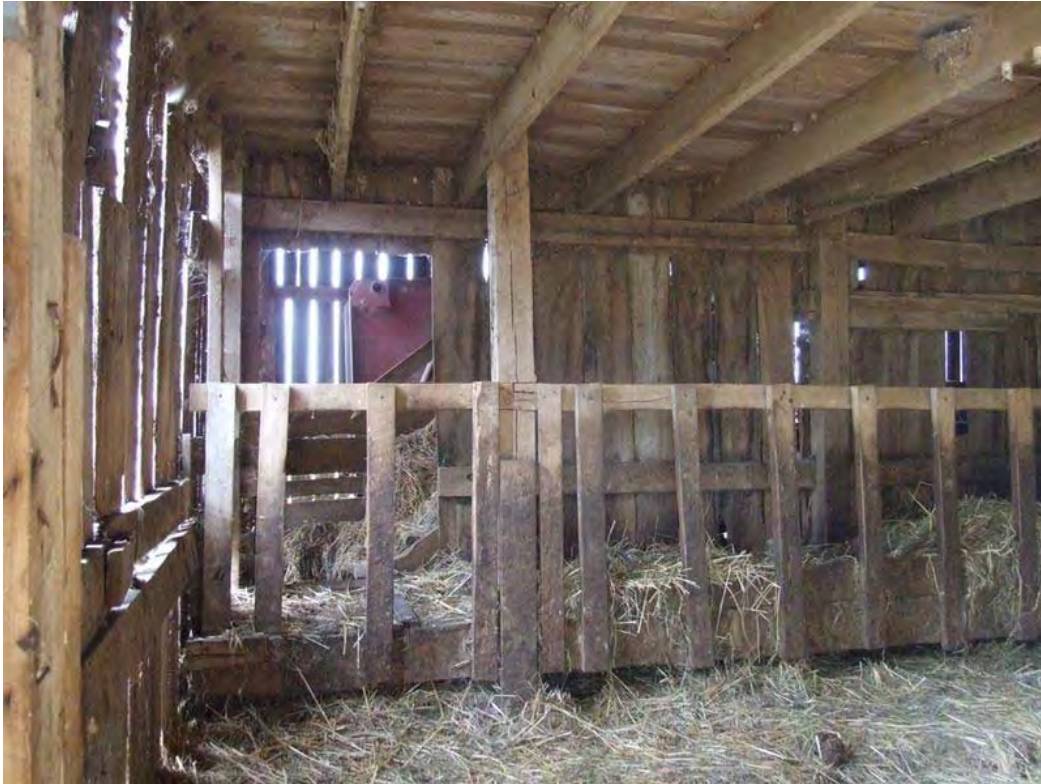
Figure 264: *MN 749, Stables, Lebanon vicinity, interior. See also Figure 263.*

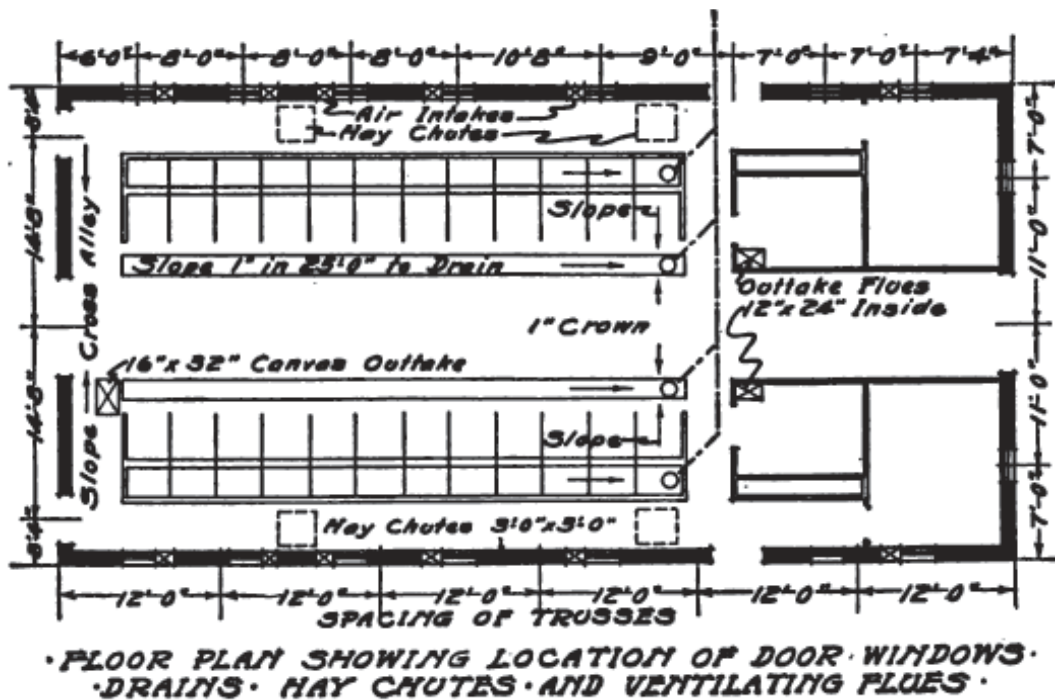
FIG. 11.—A floor plan of a dairy barn indicating location of hay chutes, ventilating flues, windows, etc.

Figure 270: Floor plan of a Dairy Barn, from W.A. Foster & Deane G. Carter, *Farm Buildings* (New York: John Wiley & Sons, 1922), 14.

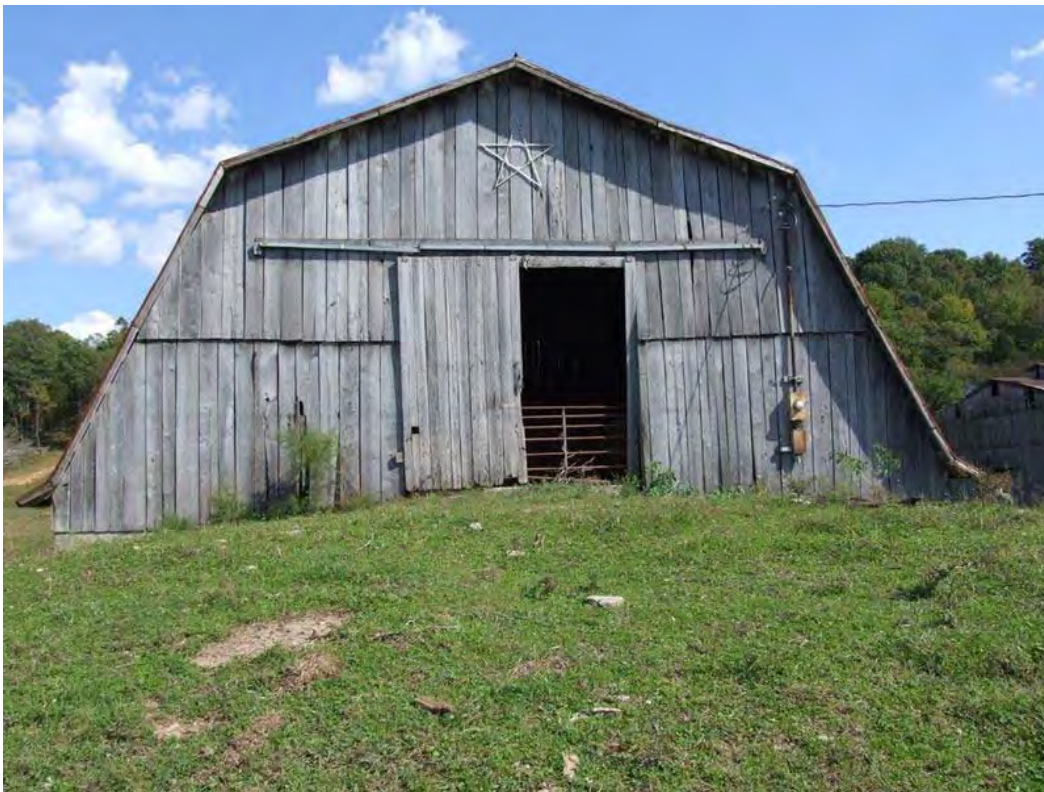
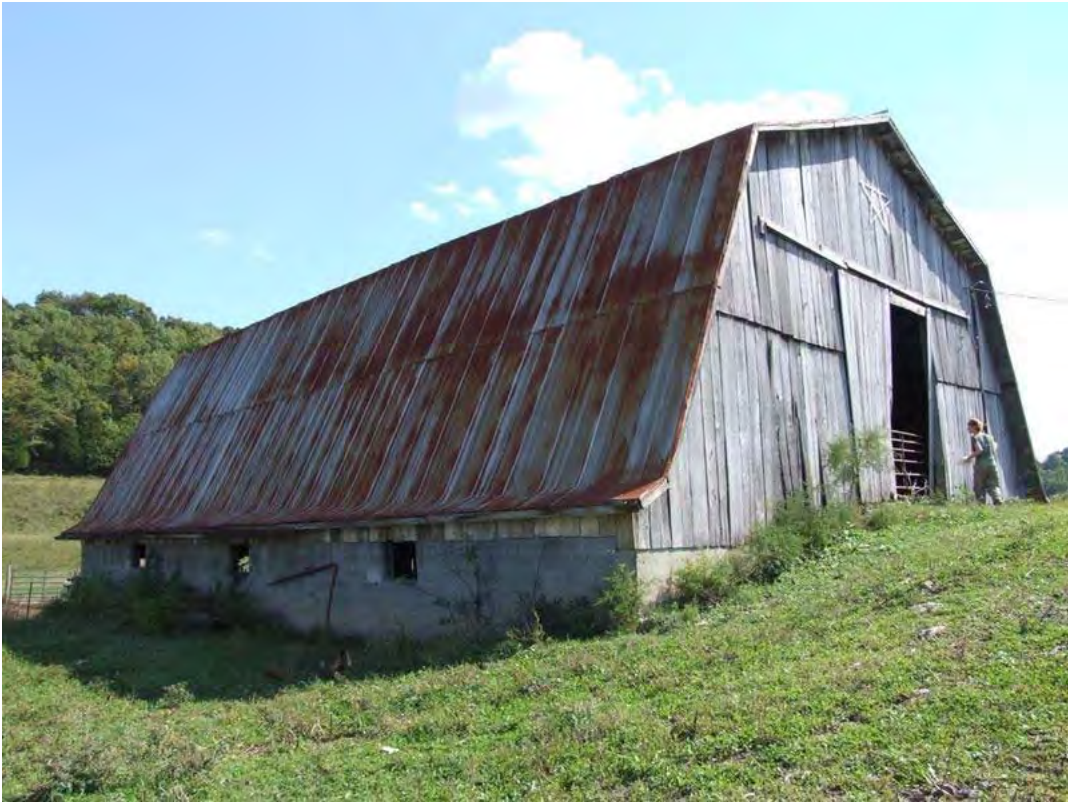
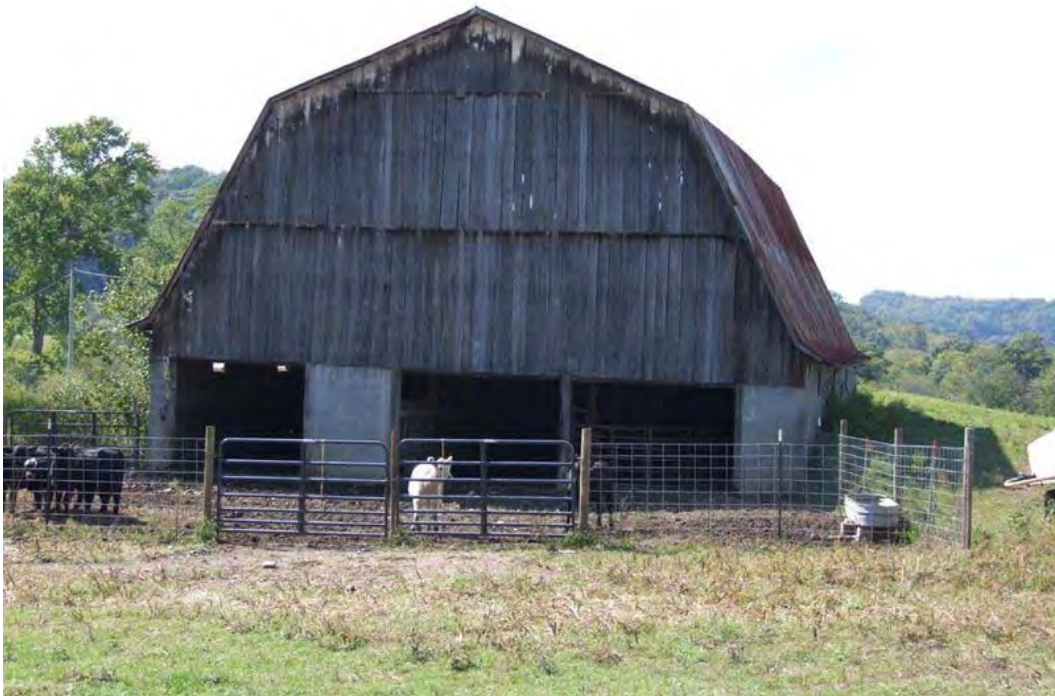
Figure 271: WS 98, Banked Dairy Barn, early-mid twentieth century, Fredericktown vicinity, uphill façade. See also Figure 272 and Figure 273.

Figure 272: *WS 98 Dairy Barn, 3/4 view. See also Figure 271 and Figure 273.*

Figure 273: *WS 98 Dairy Barn, downhill façade. See also Figure 271 and Figure 272.*

Another type of barn sometimes found in the region (at least two documented examples) is a bank barn, which may be transverse frame or English or some variant in plan. The distinguishing feature of the bank barn is that it is set into the side of a hill, so that access can be gained on two levels. The lower level, being partly under ground, has some measure of relief from hot or cold weather for sheltering farm animals. A good example is found at WS 633 and which has an open entry on the down hill end (Figure 241) flanked by massive stone foundations, and an English barn type cross aisle on the uphill side (Figure 242). A 20th century example can be found at WS 98 (Figure 271 - Figure 273).

In the nineteenth and early twentieth century, bank barns lent themselves well to dairy farming, allowing ground level access to both the upper level for hay storage and the lower level for stabling and milking (Figure 271 - Figure 273). However, the development of hay bailers and

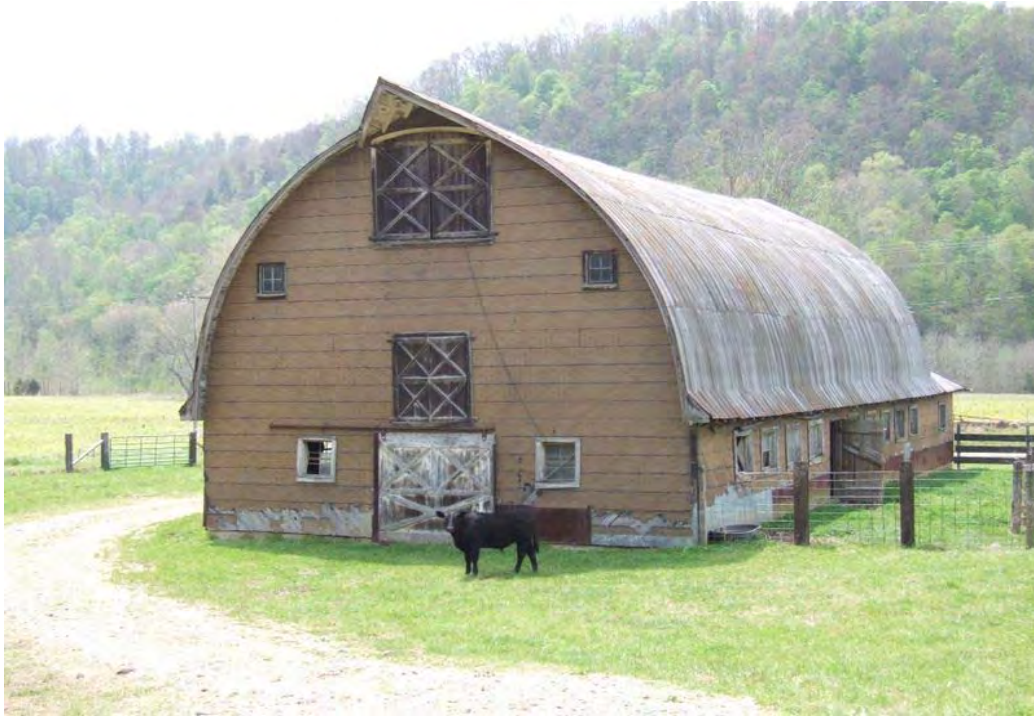
Figure 274: MN 518, Dairy Barn, early twentieth century, Raywick vicinity. Compare to Figure 275.

pulley loading systems made this convenience unnecessary in the early twentieth century. At the same time, developments in framing technology such as laminated or latticed rafter trusses allowed for the introduction of barns with large hay storage lofts uninterrupted by posts, such as the barn at MN 518 (Figure 274). Barns such as this were prefabricated and made available by mail order (Figure 275).

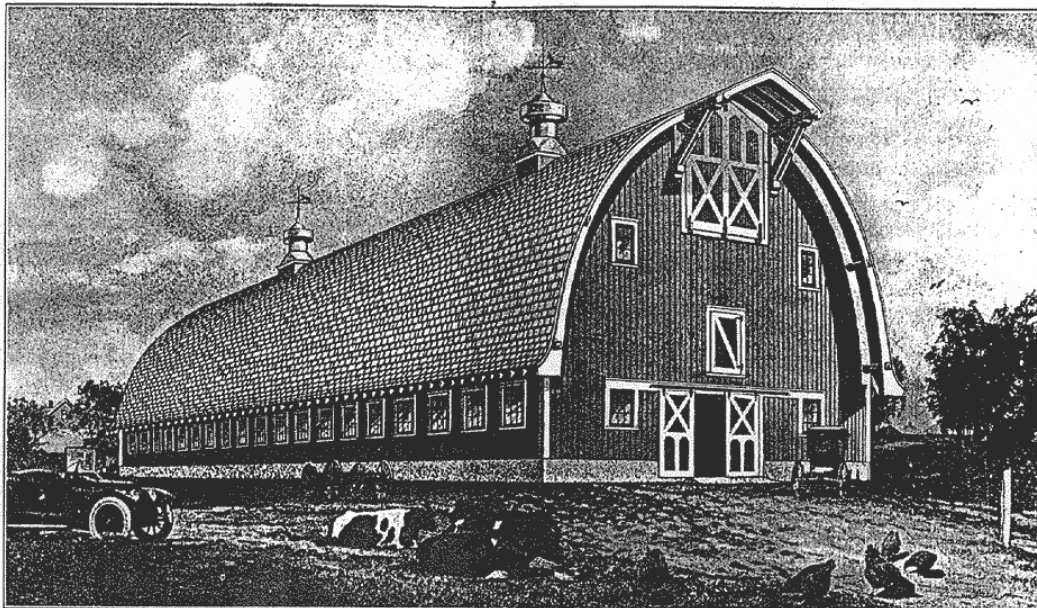
Figure 275: Sears, Roebuck & Co "Cyclone" barn, 1918.

It can be very difficult to accurately date frame barns. Most dating clues such as nail types or tool marks give you a rough idea of a date the building could not be older than, but are of less clear help in defining just how much later the building might be. It's not uncommon to find hand-hewn sills or posts in late 19th century barns. The circular sawn framing of a late 19th century barn such as the one at MN 685 (Figure 255, see also Figure 240) is often not far different from that of a half century later (WS 1123, Figure 256). Clues to dating later barns often come more readily from researching more contextual information and from oral history. Interior fittings such as feeding apparatus or hay pulleys may be datable by researching the manufacturer, or the building design might compare closely with dated examples from agricultural catalogs (Figure 275).

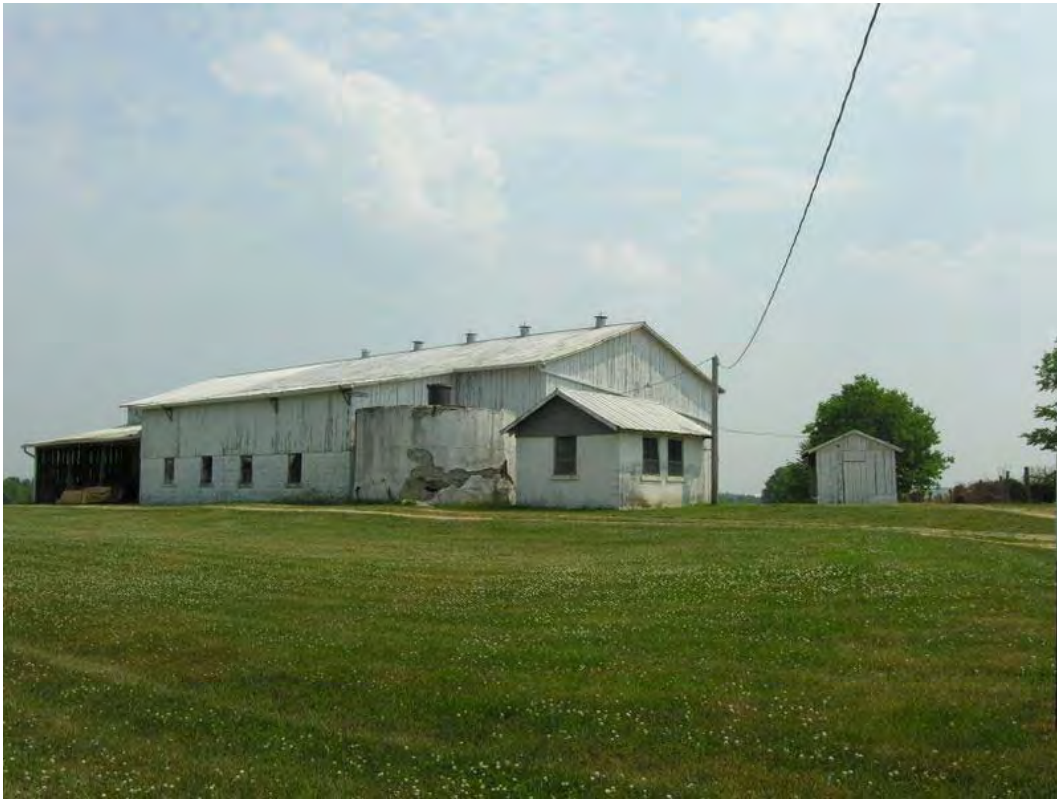
Figure 276: *WS 974, Cheser Dairy/Tobacco Barn, Water Tank, and Dairy, late 1940s, Willisburg*

In the early-mid twentieth century, milk handling rooms become common. These are typically of concrete block masonry construction, either free-standing as at WS 974 (Figure 276) and MN 292 (Figure 278), or attached to the barn much like a stripping shed, as at WS 317 (Figure 277). Early examples were used for handling large cans of milk, while late examples have large tanks (Figure 279) and refrigeration. At the same time, the milking parlor becomes increasingly automated, allowing for greater efficiency and sanitation in the handling of the milk product.

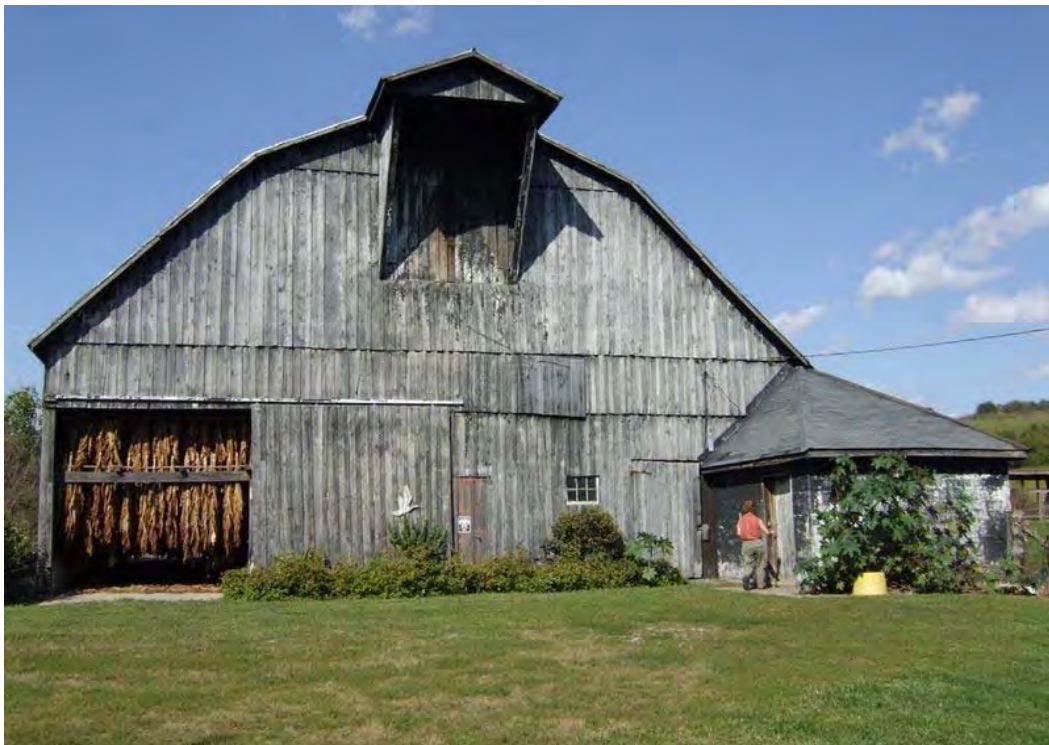
Figure 277: *WS 317, Transverse Frame Gambrel Roof Dairy Barn, now used for tobacco; early twentieth century, Fredericktown vicinity. The interior has stalls, milking, and feeding areas with a concrete trough, with a hay loft overhead. The extension at front right is a concrete block milk room. The barn is connected, via a board and batten section, to a concrete stave silo not visible here.*

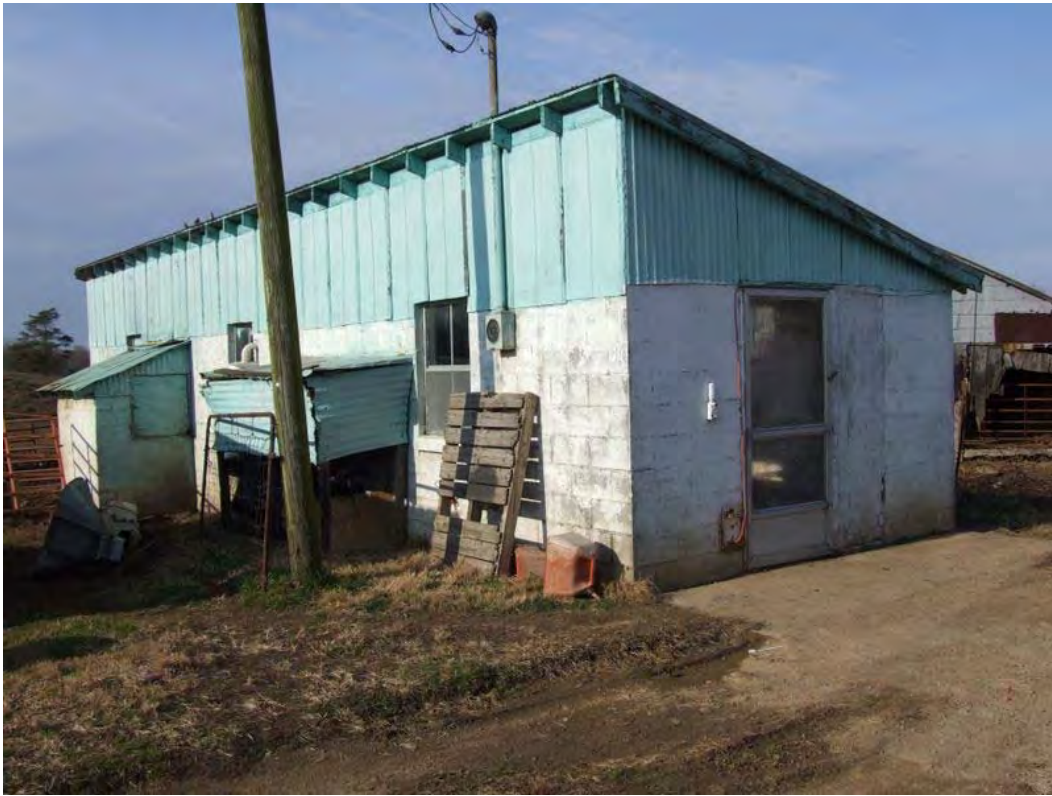
Figure 278: MN 292, Milkhouse, 1960s, Loretto vicinity.

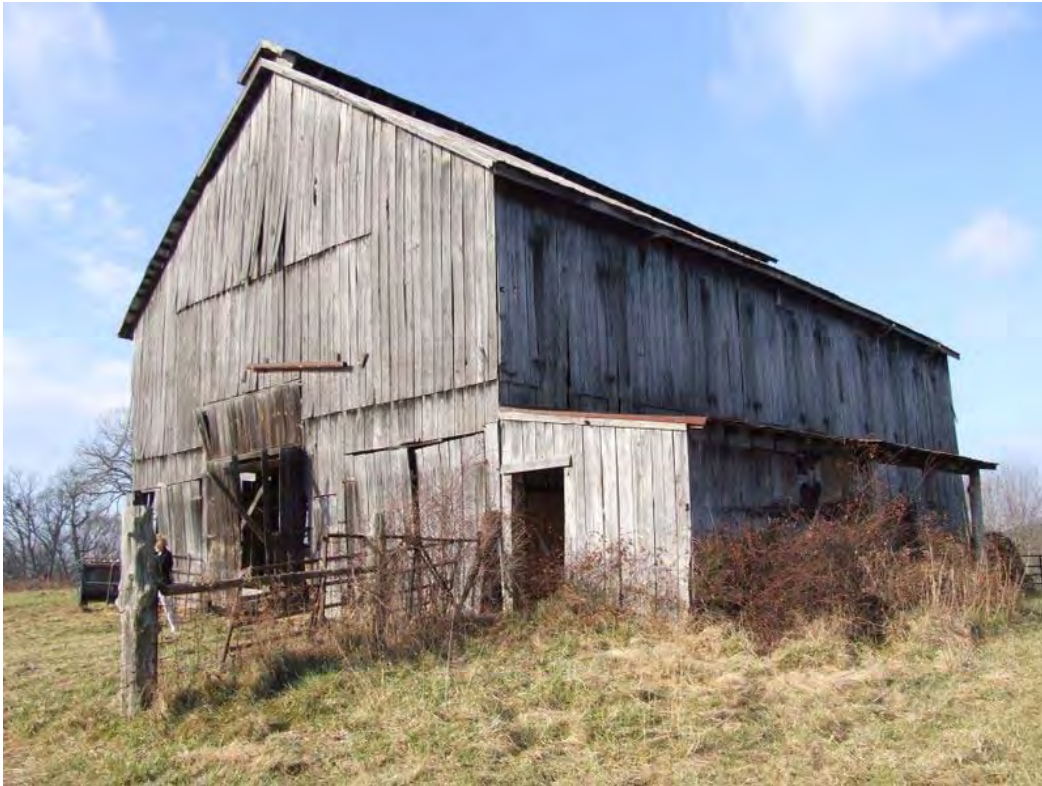
Figure 281: MN 273, Caleb Ballard Farm, Frame Tobacco Barn with roof ventilator, 1939, Holy Cross.

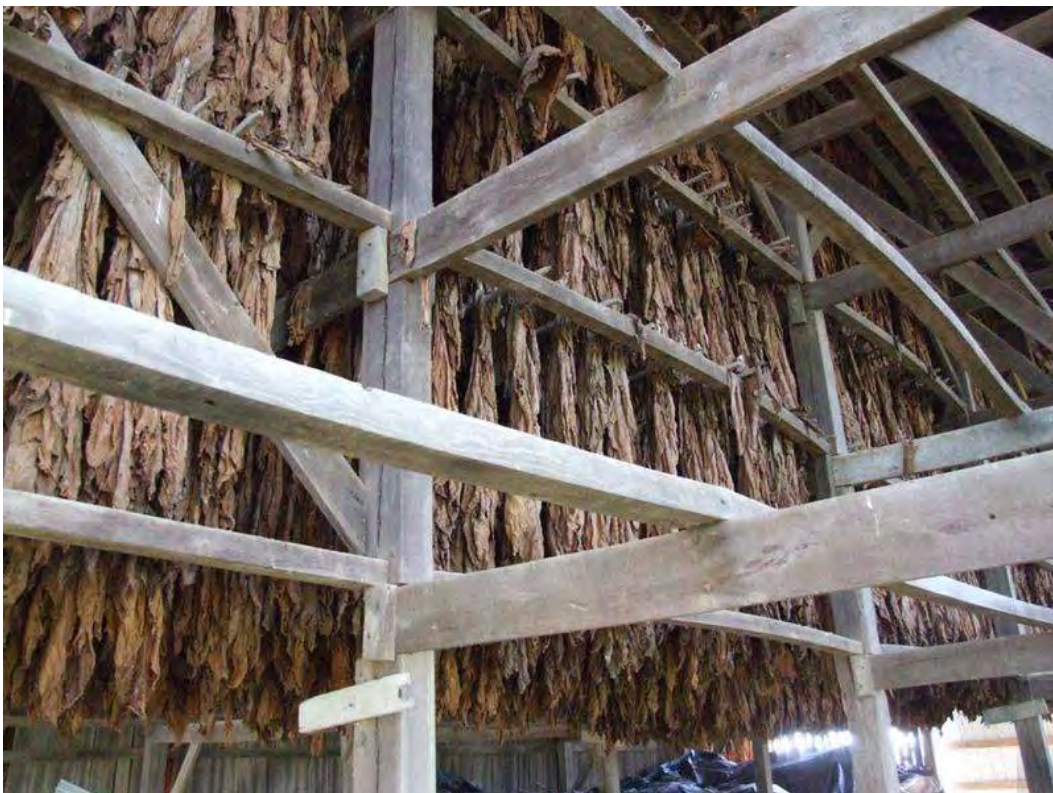
Figure 282: *WS 357, Mid-twentieth century Tobacco Barn, Mooresville vicinity. Interior view, with tobacco hanging.*

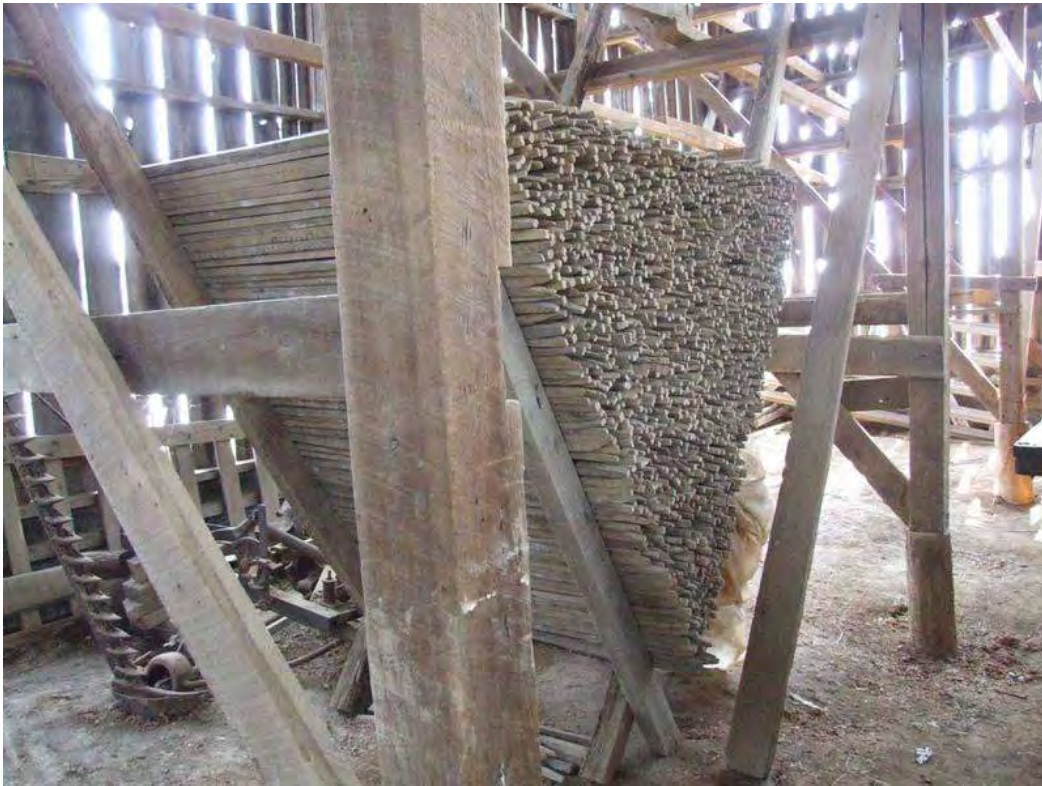
Figure 283: *WS 860, Tobacco Barn, circa 1940, Springfield vicinity. Interior detail showing a cradle of tobacco sticks stored in the off-season.*

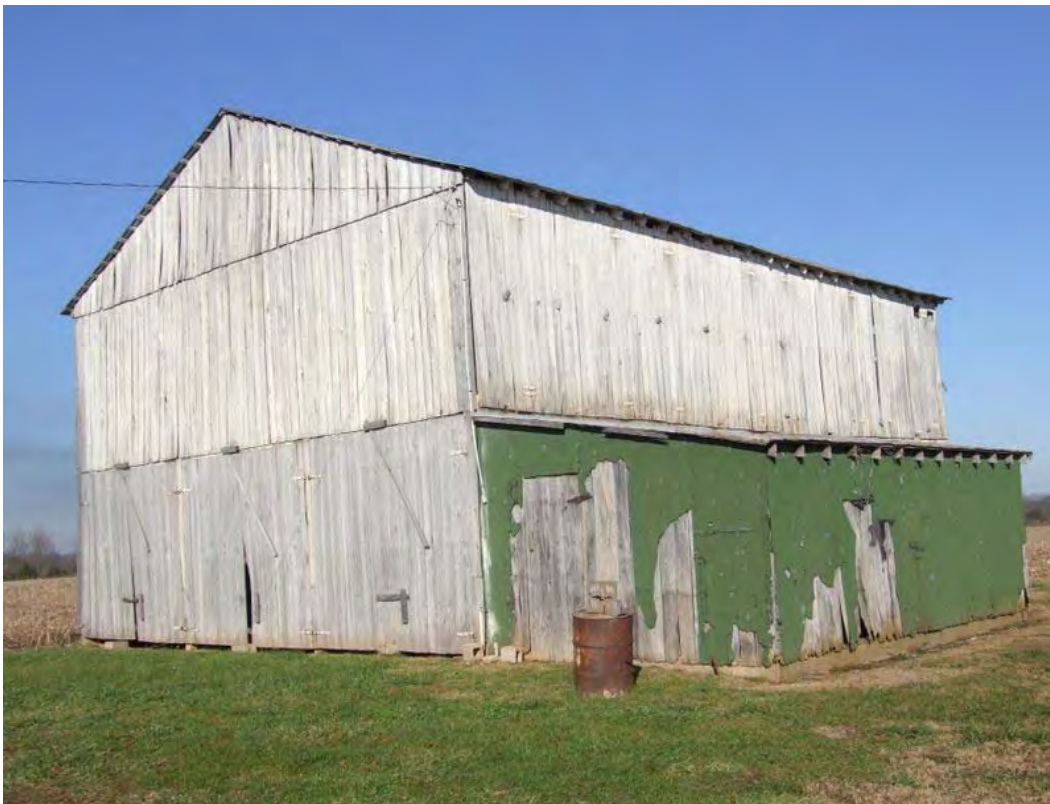
Figure 284: *MN 193, Tobacco Barn with attached Stripping Shed, mid twentieth century, Holy Cross vicinity.*

The typical form for an air-cured tobacco barn in Kentucky is a large, transverse frame barn (MN 273, for example, Figure 281). Large doors at each gable end open into an aisle that runs down the center. There are typically vented louvers along the sides of the building (these are visibly open at MN 515, Figure 285). The interior frame is crisscrossed with poles from which to hang the tobacco, which is attached to tobacco sticks (WS 403, Figure 254, and WS 357, Figure 282). Tobacco barns are usually accompanied by stripping rooms where the tobacco leaves are removed from the stalks and tied to tobacco sticks for drying. The tobacco sticks are riven or sawn sticks approximately four feet long (WS 860, Figure 283). Stripping rooms are typically small shed roof appendages to the front or side of the barn, accessible either from within the barn or from an exterior door (MN 273, Figure 281; MN 193, Figure 284; and WS 476, Figure 286). Detached stripping sheds have also been documented in the region (WS 590, Figure 287). In some cases, the stripping room may be of masonry construction in contrast to the frame of the

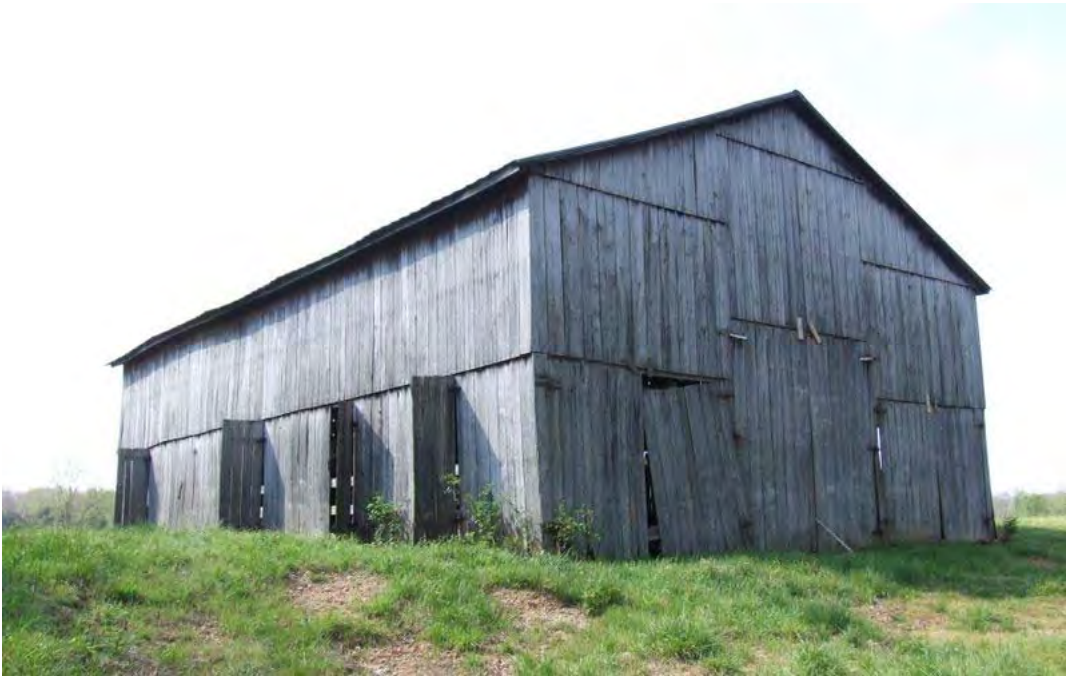
Figure 285: *MN 515, Frame Tobacco Barn, mid-late twentieth century, Raywick vicinity.*

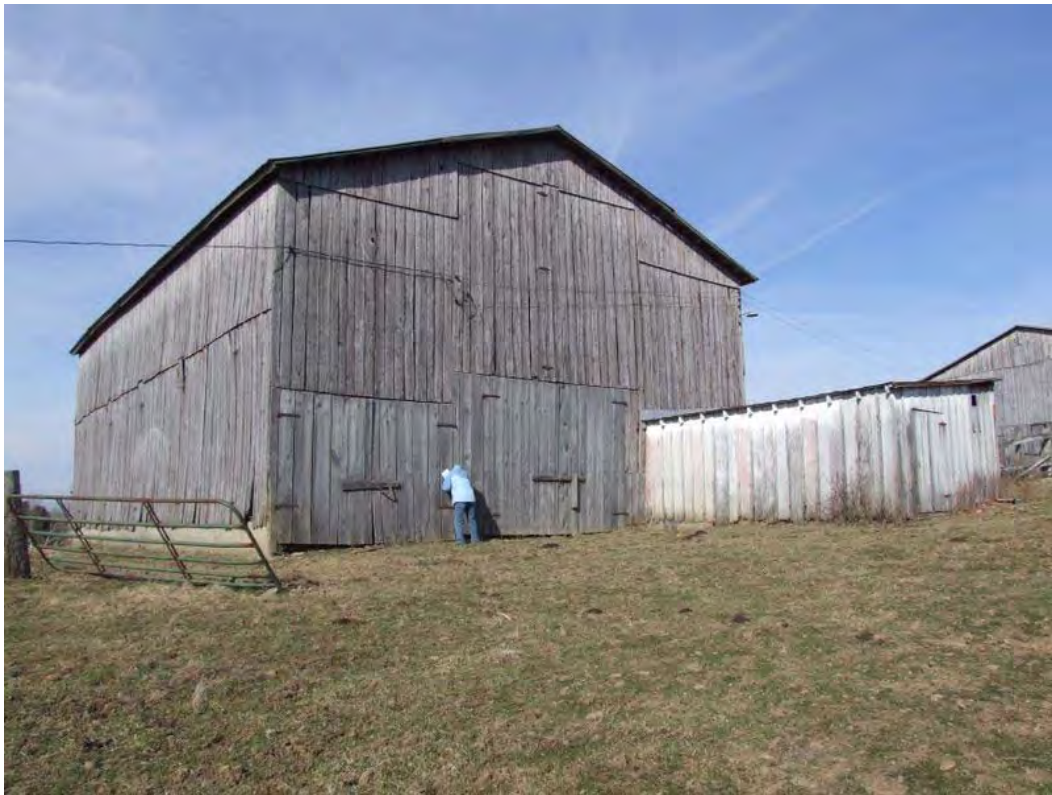
Figure 286: *WS 476, Tobacco Barn with attached Stripping Shed, 1950-70, Mackville vicinity.*

Tobacco barns are frequently located well away from the house, in the agricultural area, grouped with other barns (WS 476, Figure 3). It is also pretty typical to find tobacco barns in isolated locations well away from a house or agricultural complex, in close proximity to tobacco fields and situated on rises to take advantage of winds for drying (see MN 217, Figure 235 and WS 798, Figure 288). In some cases, they are situated near rural roads to facilitate loading tobacco from multiple locations.

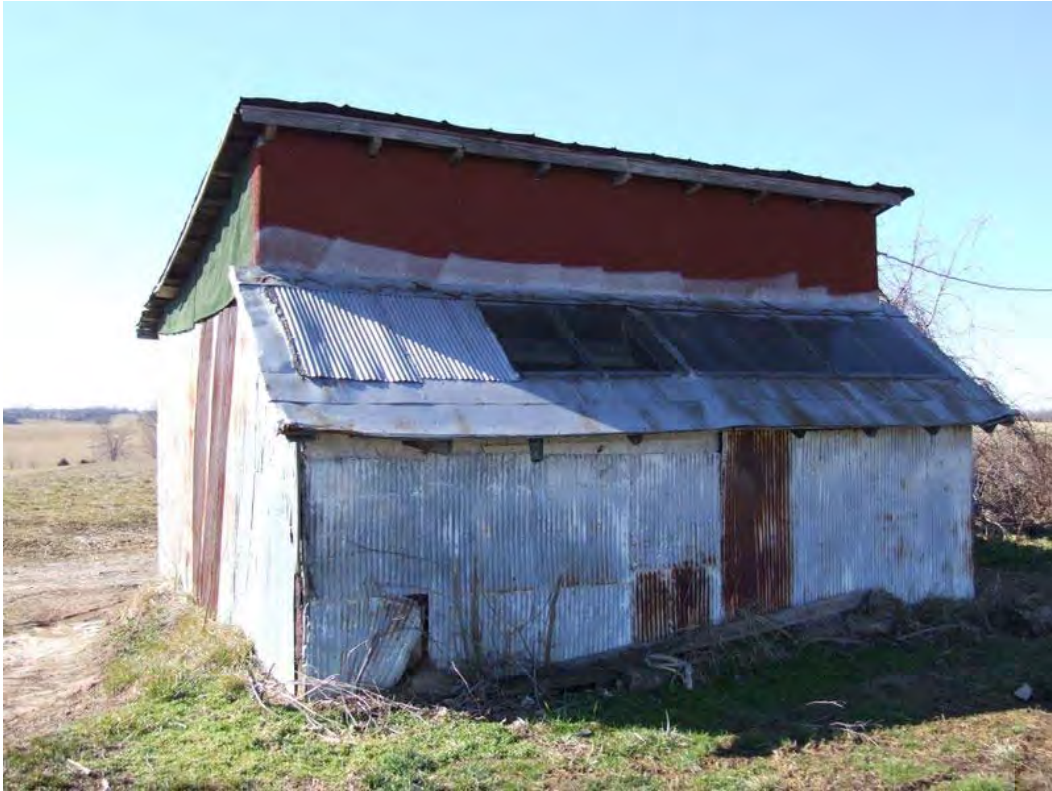
Figure 287: *WS 590, Detached Stripping Shed, mid twentieth century, Jenkinsville vicinity.*

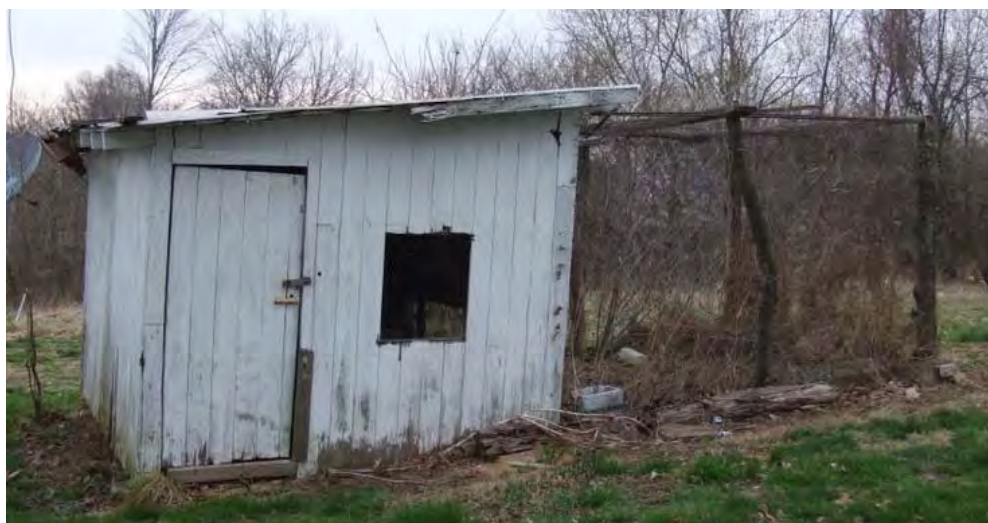
Figure 289: WS 706, *Poultry House*, mid twentieth century, Texas vicinity.
