A Survey of Historic Sites in Rural Marion and Washington Counties, Kentucky

A Report on the Findings of the *Rural Heritage Development Initiative Survey*
A project funded by a National Park Service Preserve America Grant

Kentucky Heritage Council

The State Historic Preservation Office, 2009

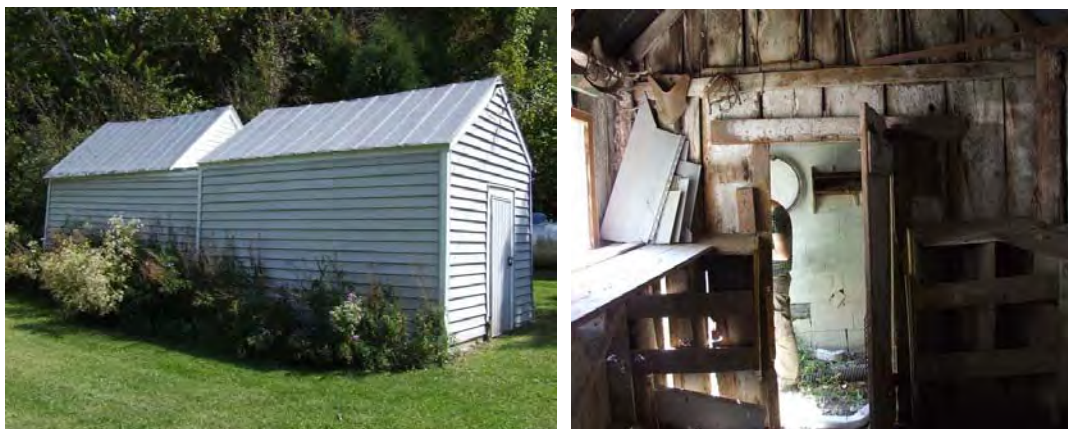
Figure 290: *WS 307, Exterior, left, and interior, right. Early-mid twentieth century vertical plank frame Chicken House adjacent to a Well House behind. Laying boxes are visible in the interior, right.*

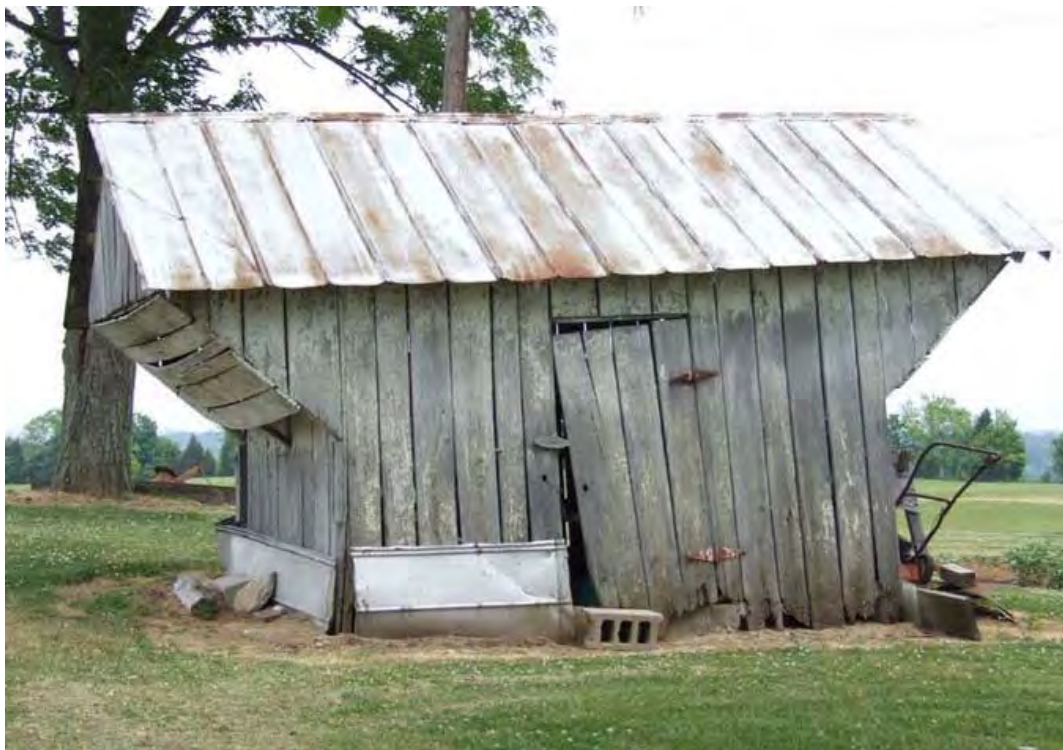
Figure 291: WS 931, *Frame Chicken House*, early twentieth century, Willisburg. This type of chicken house with cantilevered bays is a standard form in the twentieth century. The undersides of the bays are slatted to allow manure to sift through so that it could be collected underneath.

Other chicken houses such as the one at MN 193 (Figure 296), with its shed roof ventilation dormers, or the cantilevered type already discussed above (WS 931, Figure 291) appear to have probable origins in published designs. MN 193 is large enough to indicate that chickens must have a significant commercial aspect of this farm. Further research on the subject would help us to separate local improvised vernacular poultry house forms from published designs. Some later chicken houses grew much, much larger, as poultry production began to move toward the current industrial model of buildings with thousands of birds, as at WS 679 (Figure 297). At the same time, the chicken business became much more centralized in other parts of the country, so very large poultry houses like WS 679 are not common in Marion and Washington counties, and smaller houses continue to be constructed up to the present day.

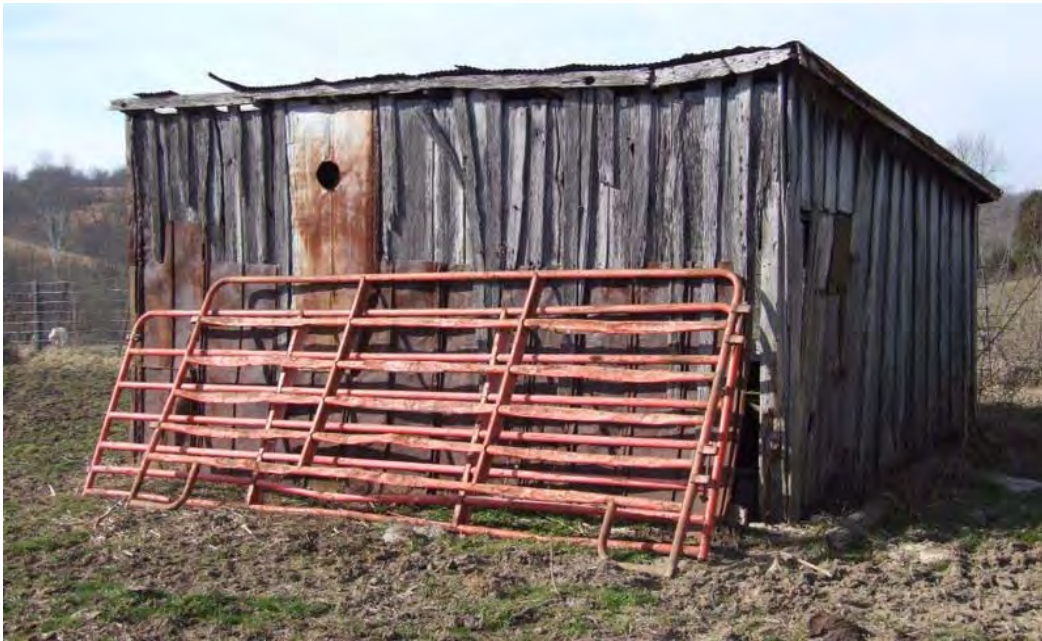
Figure 292: WS 476, Poultry House, 1930s-40s, Mackville vicinity. In contrast to the Brooder House at this site shown in Figure 4, this structure is located further away from the house, between the Tobacco Barn and the Stock Barn.

At WS 476, there is a second, larger poultry house (Figure 292), which must have been used for egg layers or raising mature chickens for meat. Interestingly, the brooder house is located near the edge of the domestic yard, while the larger poultry house is out in the agricultural yard near the larger barns, suggesting a division of labor in the care of poultry at this site.

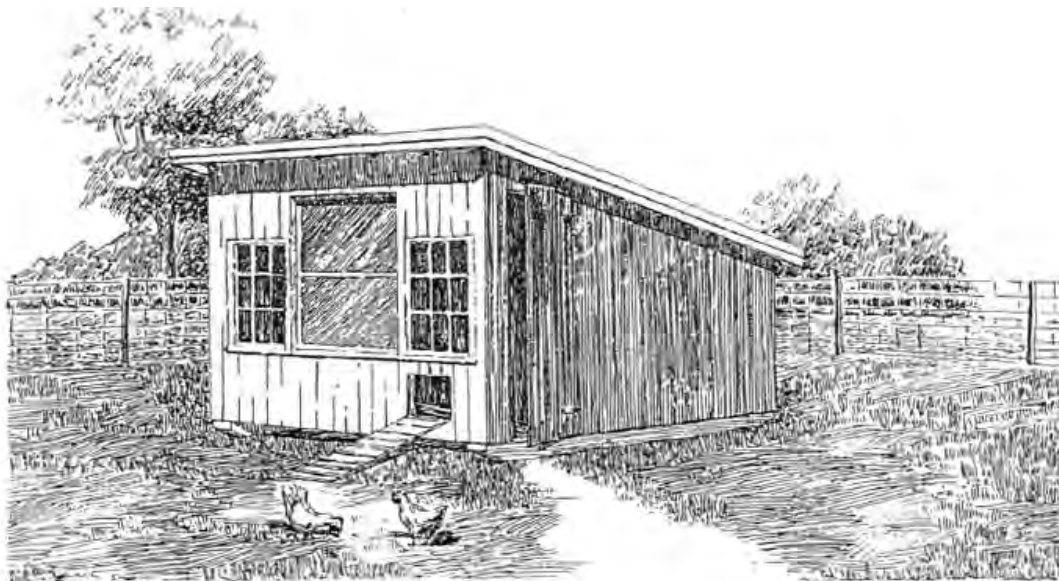
Portable brooder house, plan Ky. 11.727-3 (20 cents).

This 300- to 350-chick colony brooder house, under proper management, provides, at a reasonable cost, the fundamental housing requirements for the successful brooding of chicks: (1) ventilation thru windows, the muslin-covered opening and by rear wall-vents; (2) sunlight thru windows and open front (if house is faced South, East, or Southeast); (3) dryness; (4) freedom from drafts by proper management of ventilation and by having tight walls and floors; (5) durability, if materials are selected wisely; (6) sanitary conditions by proper cleaning, management of ventilation, and by following a range rotation or moving the house each year to clean ground. The plan also provides the necessary details for constructing a sun porch. For further information on housing and brooding chicks see Kentucky Extension Circular No. 157.

The Poultry house at WS 476 (Figure 4) is similar enough to the University of Kentucky’s “Portable Brooder house” (Figure 293) to suggest that while it probably was not built from those plans, it probably can be identified as a brooder house, a poultry house dedicated to raising chicks. It was important for these buildings to be well ventilated, warm, clean, and dry. Many of them have a small stove for heat (Figure 299). They often have large glazed windows facing south and louvers for ventilation, as well as a small door for the chickens to have access.

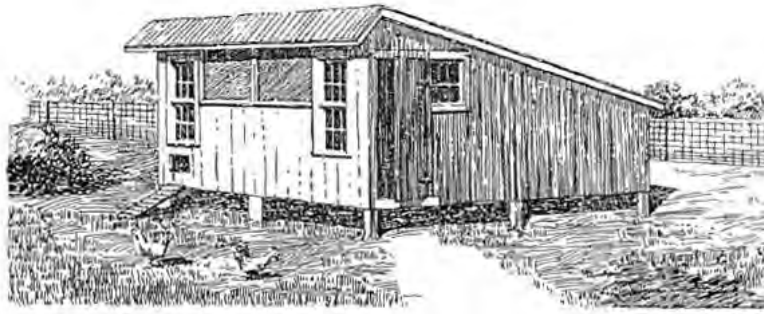
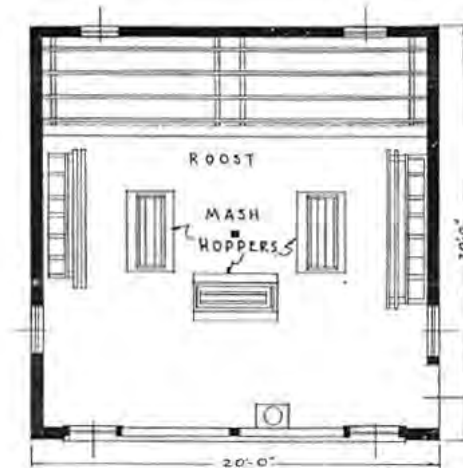
Laying house, plan Ky. 11.727-2 (20 cents).

The standard 20' x 20' Kentucky shed-roof house was designed for Kentucky conditions to provide sanitary, comfortable, well-lighted quarters for 100 laying hens, allowing 4 square feet of floor space and 8 to 10 inches of roosting space per bird. One nest is provided for each four hens. Multiple units for larger flocks can be provided by building several of the 20-foot units. Kentucky Extension Circular No. 107 gives additional information on housing farm poultry.

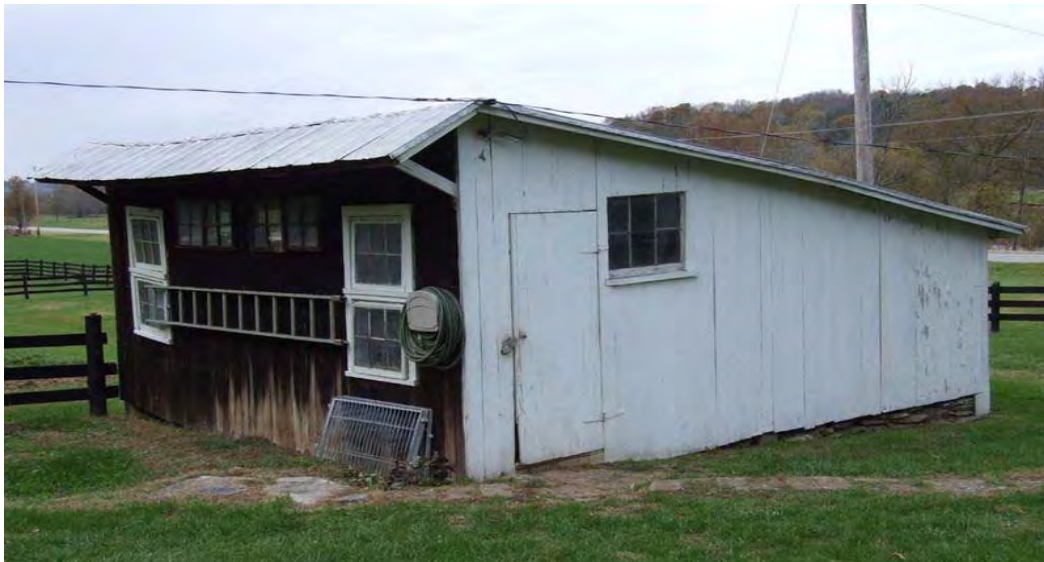
Figure 295: *WS 416 Eugene Mudd's Chicken House, 1939, Fredericktown vicinity. According to the current owner, Mr. Mudd's son, Tom, the house was built from plans obtained from the Agricultural Extension Agency, compare to the "Laying House Plan" in Figure 294.*

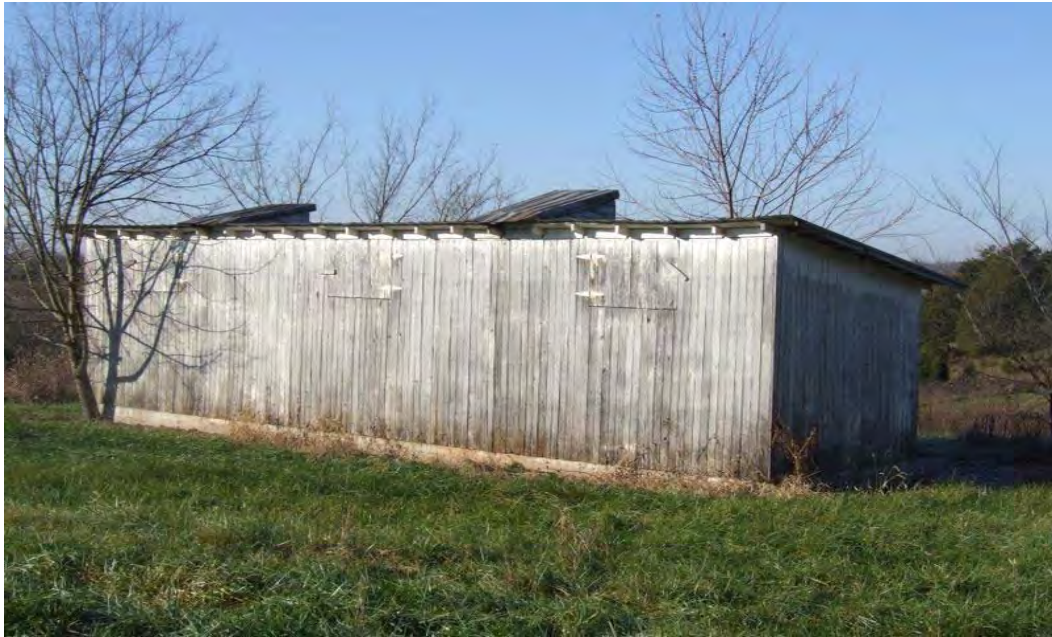
Figure 296: MN 193, Poultry House, 1930s-40s, near Terrapin Run. The roof has two dormer vents.

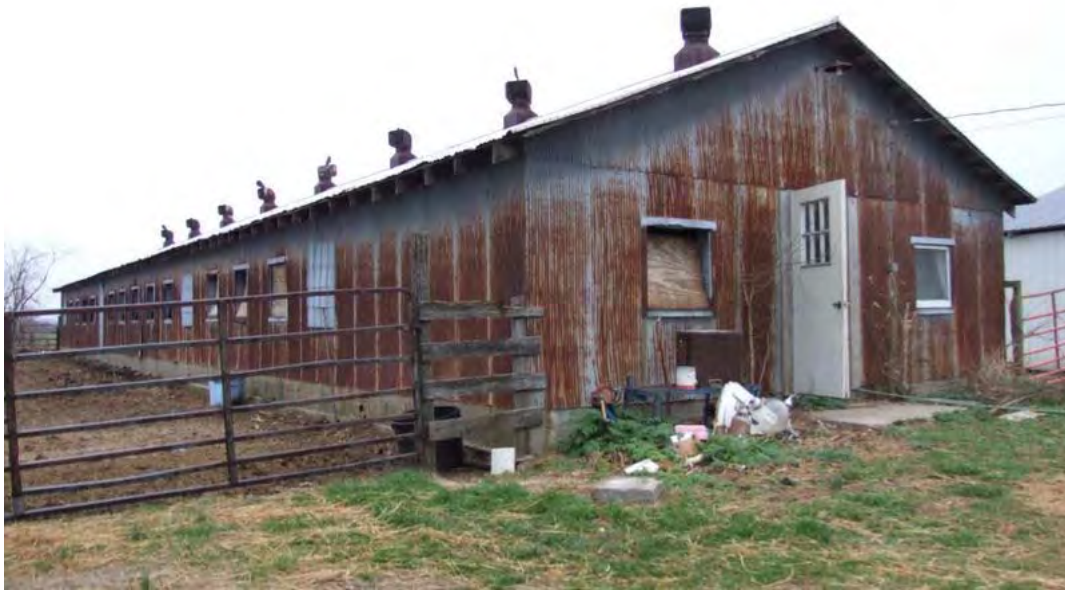
Figure 297: WS 679, 1950s-1960s Chicken House, near Pottsville. A larger chicken house for a commercial operation.

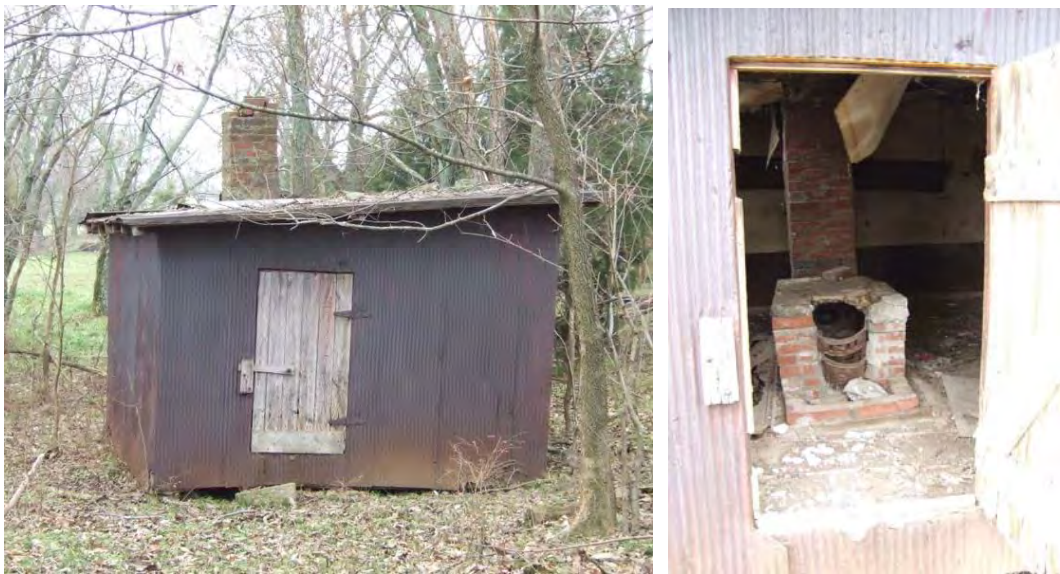
Figure 299: WS 436, *Joe Rine's Brooding house, 1930s-1940s, Springfield vicinity: exterior, left, and interior, right, showing warming stove.*

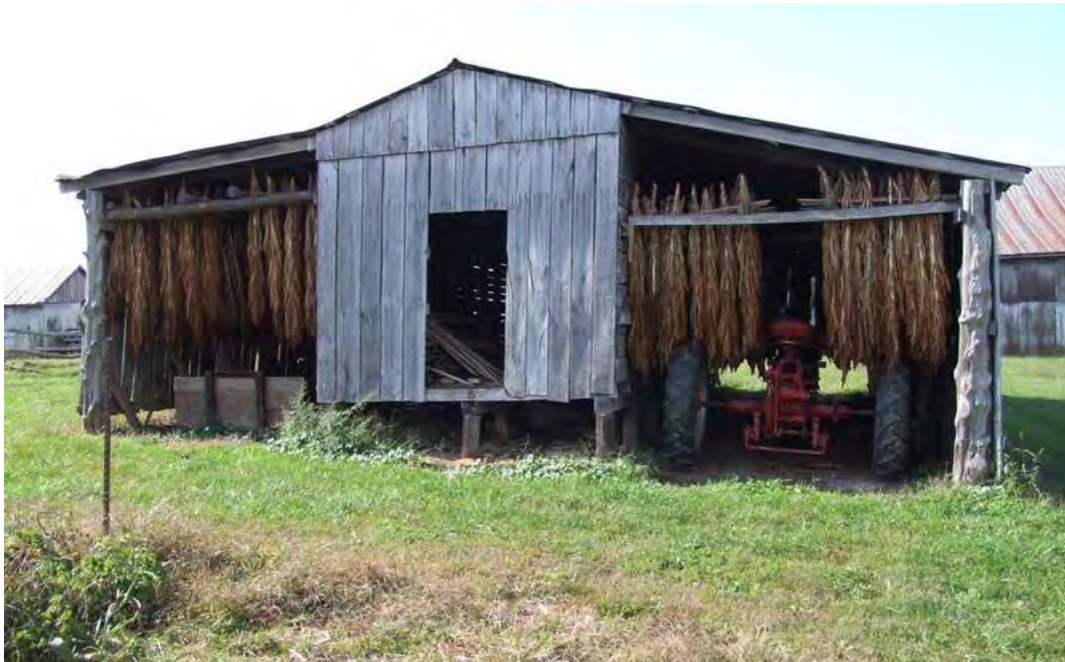
Figure 300: *WS 85, Frame Corn Crib, early-mid twentieth century, with side sheds being used to hang tobacco and shelter farm machinery, Mooresville vicinity.*

85, Figure 300). At the same time, many multi-purpose barns were designed to cure tobacco and simultaneously serve one or more other purposes.

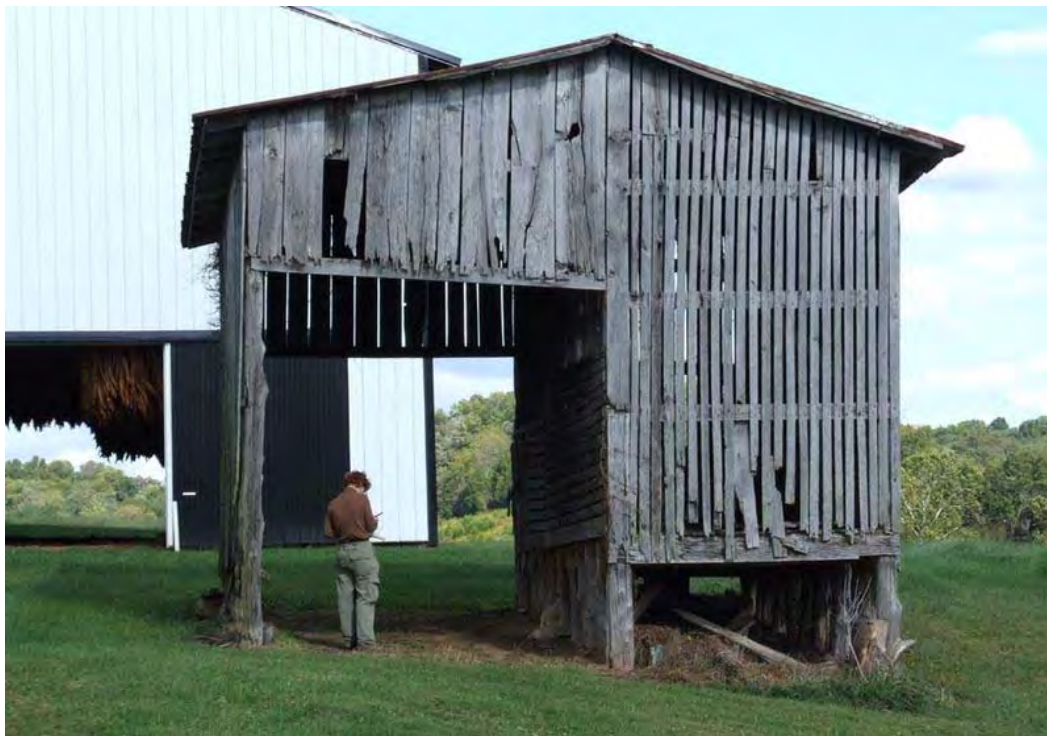
Figure 301: *WS 278, Side Drive Corn Crib, early-mid twentieth century, Maud vicinity.*

Cribs built of log, including temporary structures of light poles, are common even after log construction fell out of use for most other structures, perhaps because log construction lends itself well to creating ventilated structures (see WS 333, Figure 305, and WS 290, Figure 306). Frame corn cribs are enclosed with tightly spaced horizontal, vertical, or diagonal slats siding the walls with gaps between them allowing air to flow (see WS 278, Figure 301, and MN 655,

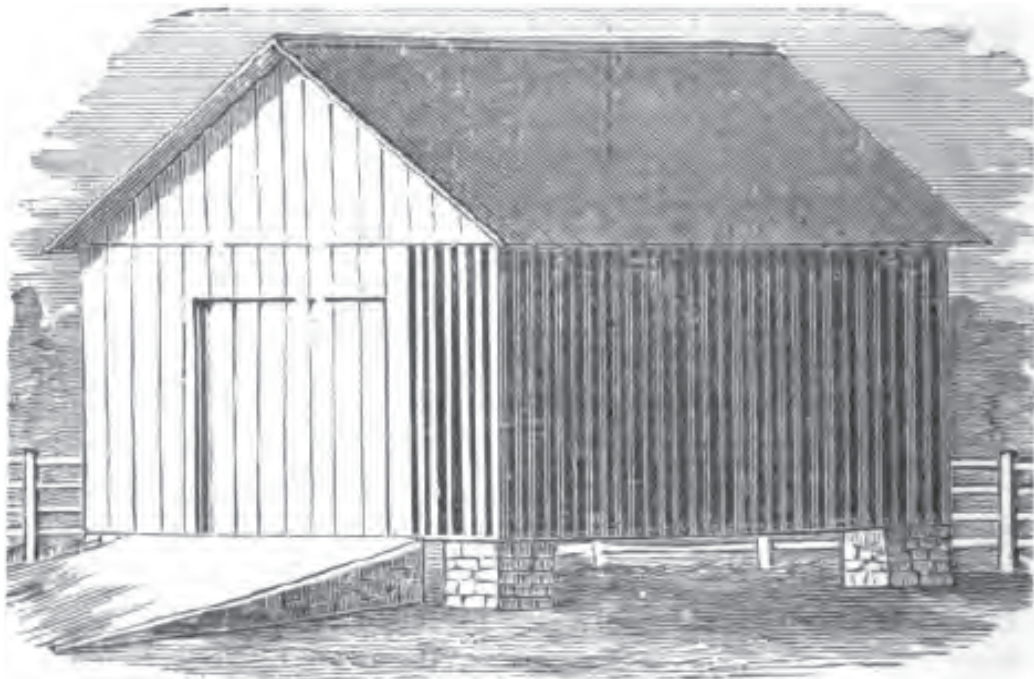
Fig. 188.—VIEW OF CORN CRIB AND GRANARY.

Figure 303: *Corn Crib/Granary, from Byron D. Halsted, Barn Plans and Outbuildings (New York: Orange Judd Co, 1898), 184.*

Corn cribs are structures used to store and dry corn still on the cob. Corn cribs are designed to keep the crop dry, above ground, and well ventilated. They are common structures: 96 were located in the survey area. The location of the building may vary, but it typically convenient to the agricultural yard. The crib is typically long and narrow, and often augmented with one or more side sheds, as in the crib at WS 85 (Figure 300), or placed under one roof with a sheltered wagon or carriage bay (WS 278, Figure 301). A common form has two cribs paired side by side under one roof with a space between wide enough to accommodate a carriage or a tractor (see WS 674, Figure 302), or the center area may be enclosed for a granary or some other purpose. Cribs are also incorporated into multi-purpose barns, frequently sharing a roof with grain storage (Figure 303), or taking up some of the floor space in a hay/stock barn (see WS 294, Figure 304).

Granaries are buildings suited for the storage of grains such as shucked corn, wheat, or rye. In the nineteenth century, grain was stored in buildings designed for the purpose, sometimes in one side or upstairs in a combined corn crib/granary (Figure 303). Twenty-eight granaries were documented in the survey area. Typical examples are small shed-roof buildings fairly similar to some poultry houses or corn cribs, but differing in detail (WS 476, Figure 310). An earlier and more elaborate example is found at MN 467 (Figure 311). Much like the corn crib at WS 85 (Figure 300), it has attached sheds for storage of vehicles or implements. Its function as a granary is revealed by the board walls lining the interior space (Figure 312). The higher than normal foundation is designed to help protect the grain from rats. Larger granary buildings are known in the state, but very few examples of this were located in the survey area. One exceptional example was found at MN 923 (Figure 313). The small numbers of larger granaries may be attributed to the rise in the first half of the twentieth century of alternatives for grain storage in the form of silos and bunkers.

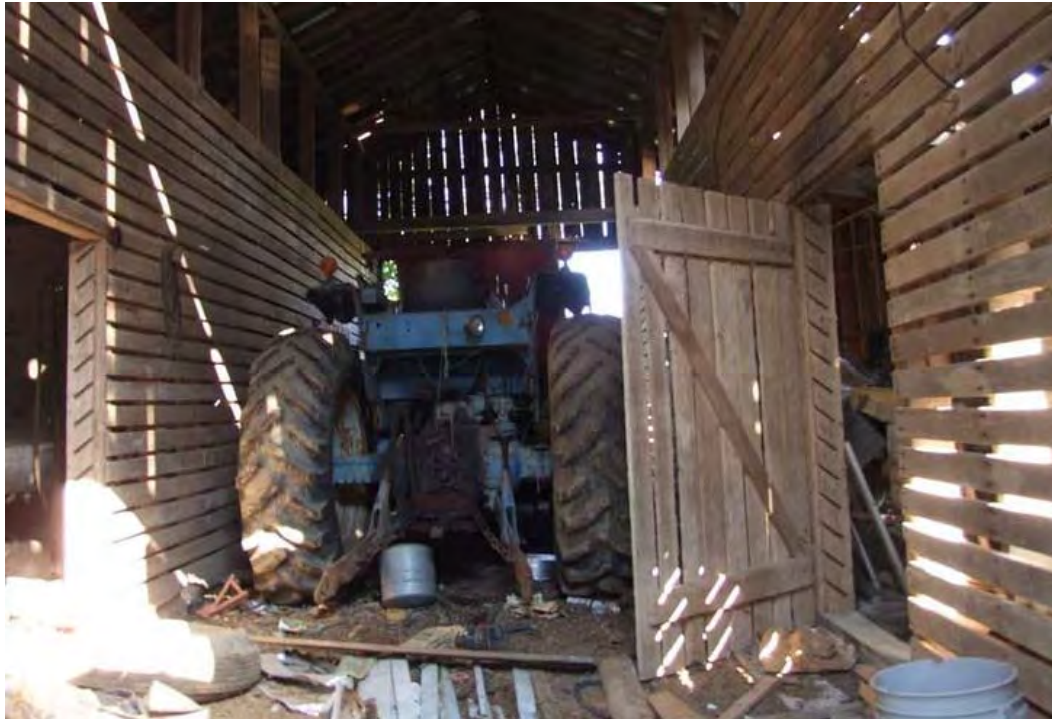
Figure 304: *WS 294, Multi-purpose Barn 1920s-30s, Booker vicinity, interior. Part of the interior is taken up by paired Corncribs with a central aisle inside. Note the diagonal openings in the door jambs – slats could be inserted here to control the height of the opening.*

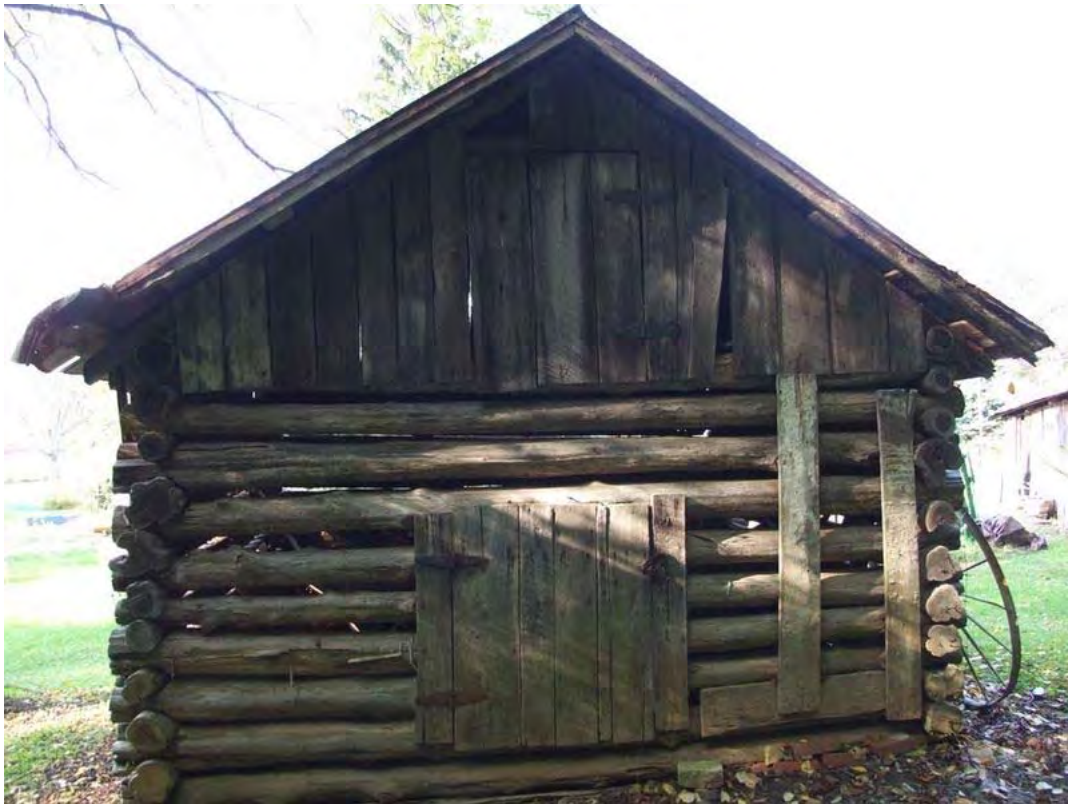
Figure 305: *WS 333, Cecil/Mudd farm, log corn crib, late nineteenth century, Fredericktown vicinity*

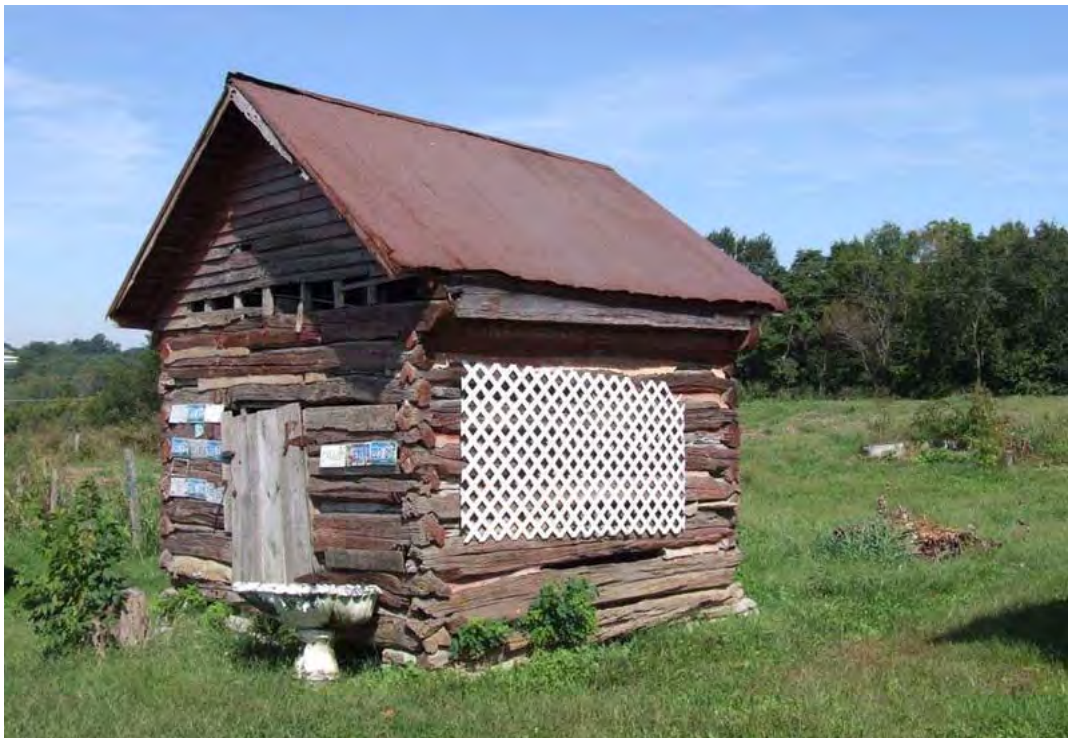
Figure 306: *WS 290, Log single pen Corn Crib, mid-late nineteenth century, later converted to a meat house, Mooresville vicinity.*

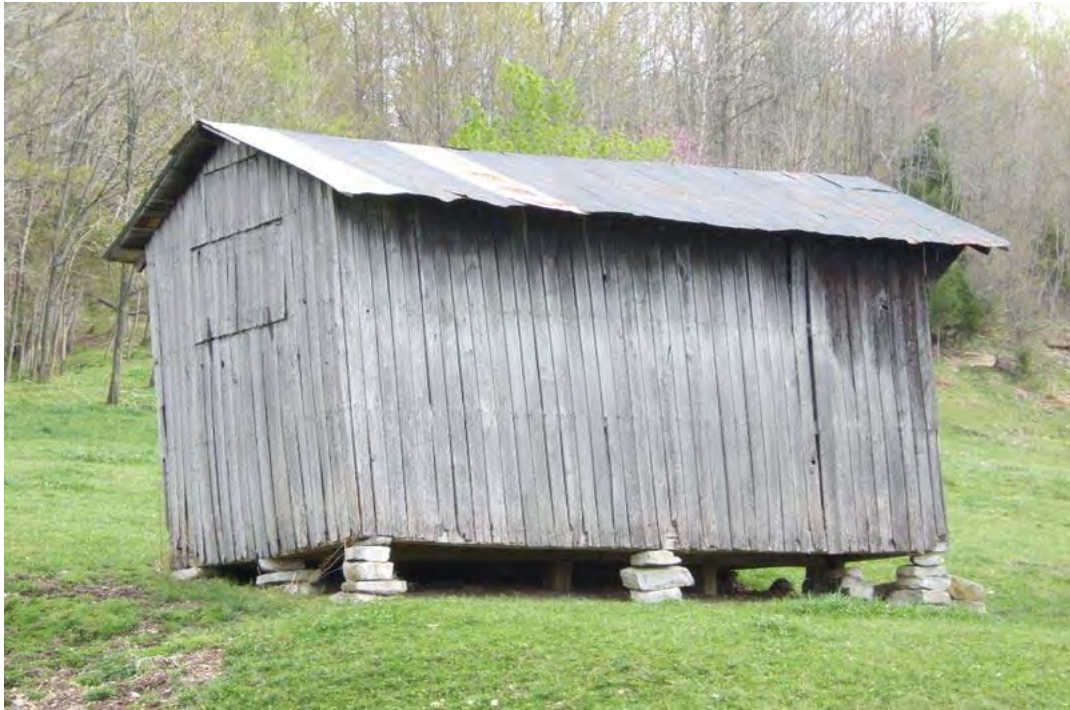
Figure 307: MN 655, Ellis Farm: frame, single pen Corn Crib, late nineteenth-early twentieth century, Bradfordsville vicinity.

Figure 307). The forms of corn cribs changed only slowly over the 19th-early 20th century, so construction dates must be estimated based upon technology such as nails and tool marks. In the early-mid 20th century, however, you begin to see prefabricated metal corn cribs in round or oval shapes (see MN 320, Figure 308).

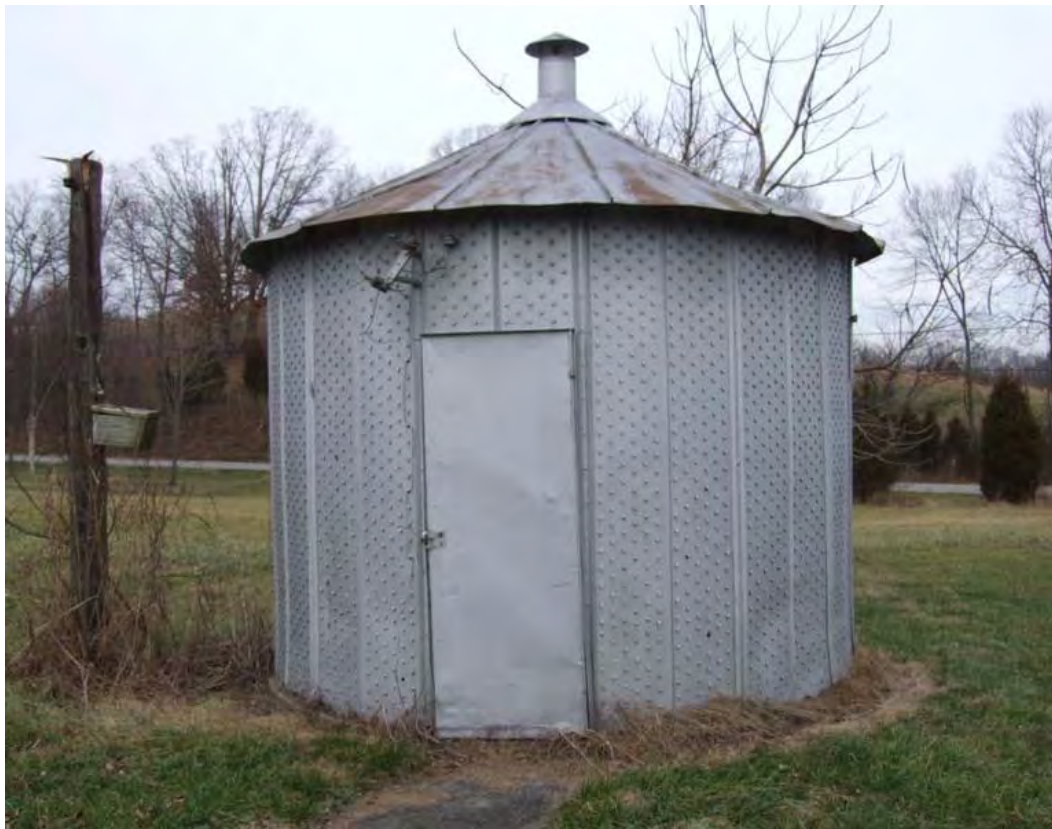
Figure 308: MN 320, Peterson Farm: mid twentieth century prefabricated metal Corn Crib, Dant vicinity.

Bunkers are prefabricated metal structures for the storage of grains, somewhat resembling silos, but shorter and wider, as at MN 45 (Figure 318). Similar structures of varying size and design are also found for the storage of corn (MN 320, Figure 308) and other agricultural products such as fertilizer and seed.

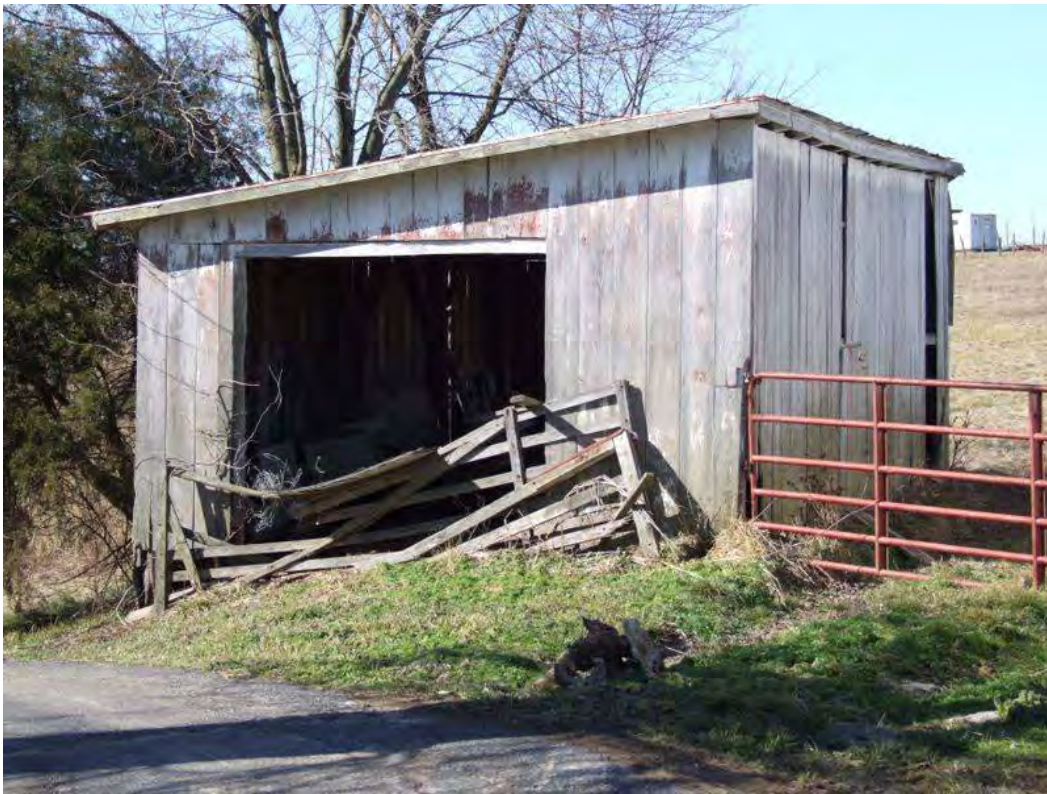
Figure 309: *WS 590: Scale House, twentieth century, Mackville vicinity.*

Scale houses superficially resemble garages or worksheds. They house a large scale for weighing cattle, grain, or other products for market. They have two areas inside. One is the drive-through bay for the load platform, suitable for wagons, farm animals, or trucks. Beside that is a narrow aisle where the scale is set and read. The scale has sliding weights like an old-fashioned doctor's scale. One example of a scale house was identified in the RHDI survey, a shed roof building at WS 590 (Figure 309).

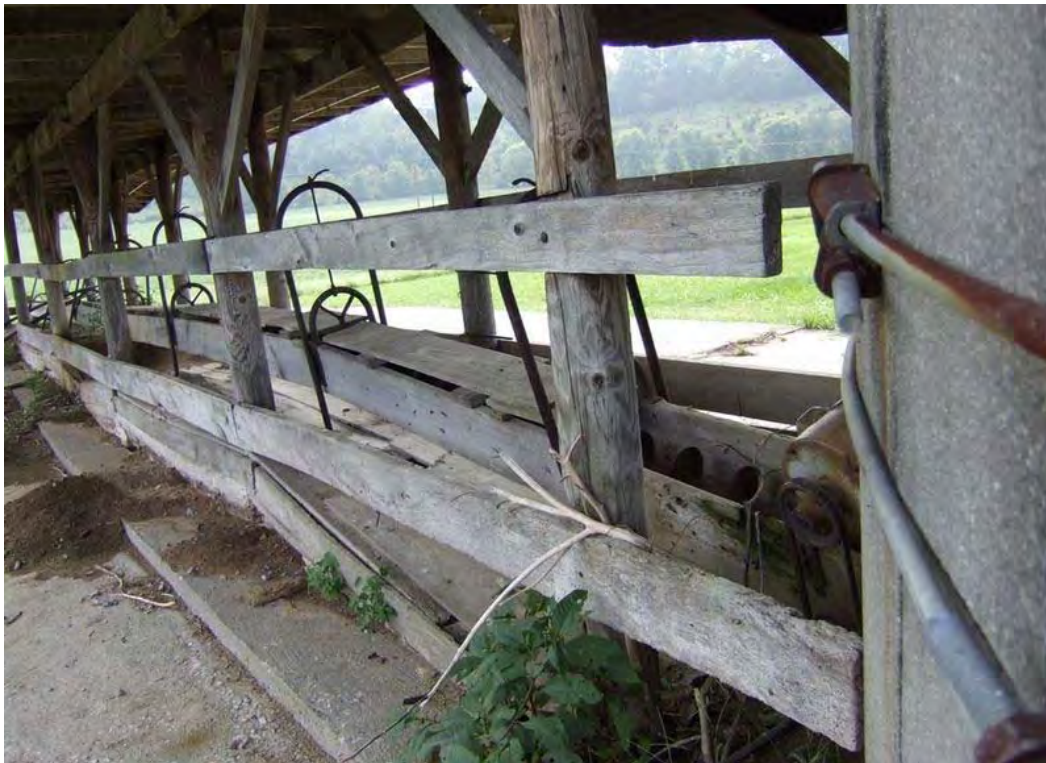
Figure 317: WS 27 Feed Carrying Mechanism and Feed Shed attached to Silo, mid twentieth century, Maud vicinity.

Silos are not limited to grain storage, as they were used to store feed corn and silage such as fodder – the green leaves of corn plants, alfalfa, clover, and the like. Prior to the development of silos in the late 19th century, silage was stored in pits or covered stacks. Silos were observed in large numbers in the survey area. The typical example is of concrete stave construction bound with metal straps as at WS 287 (Figure 314). Poured concrete (WS 580, Figure 315) and metal silos (MN 558, Figure 316) were also observed. Early silos were unloaded by hand, but later examples are joined to barns or covered feeding sheds and a long mechanical screw to distribute the feed from the silo into a long trough along the feed alley (WS 27, Figure 317).

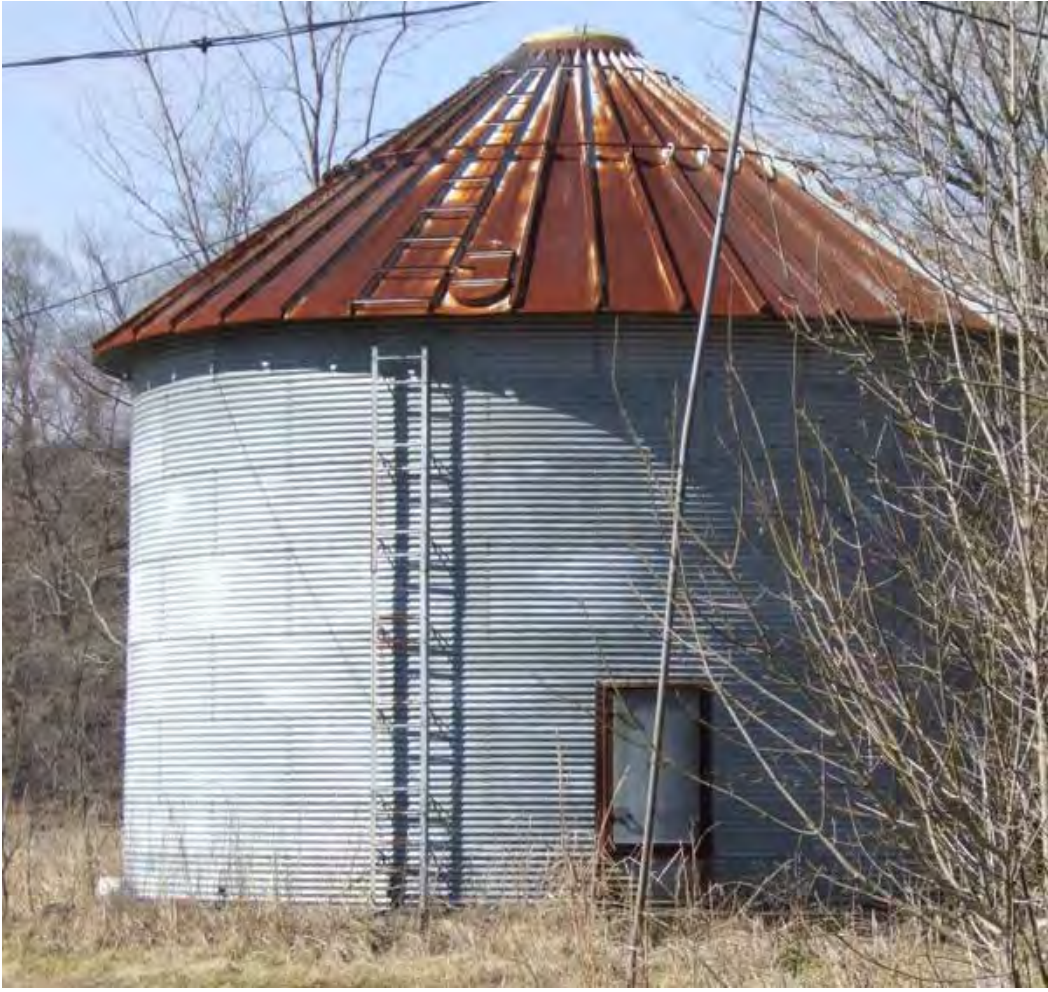
Figure 318: *MN 45, Prefabricated metal Grain Bunker, mid-late twentieth century, Bradfordsville vicinity.*

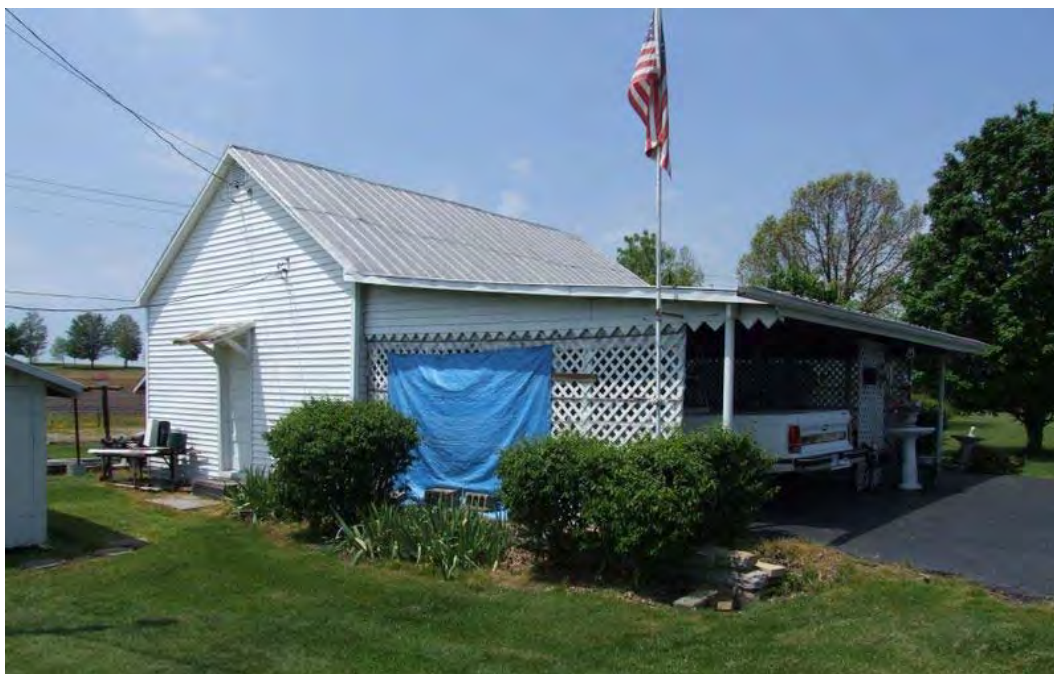
Figure 320: MN 549, African-American School House, early twentieth century, Belltown vicinity.

Of the fewer than 20 schools surveyed in this project, we have one African-American schoolhouse, several with religious affiliations, some one and two-room examples from the early twentieth century, and some more modern multi-room schools. The African-American school, MN 549 (Figure 320) has been moved twice according to its present owner. It was originally near present-day Saint Charles School (Figure 323), was moved near the present location, and then later moved a short distance to where it stands now. Its history is a little unclear, it was said to have been active in the 1950s, so it is possible that it became an African American school after the first move, depending on when that happened. It currently has an attached carport and is used

as a shop or utility building. It still has a bank of standard school windows under the later carport.

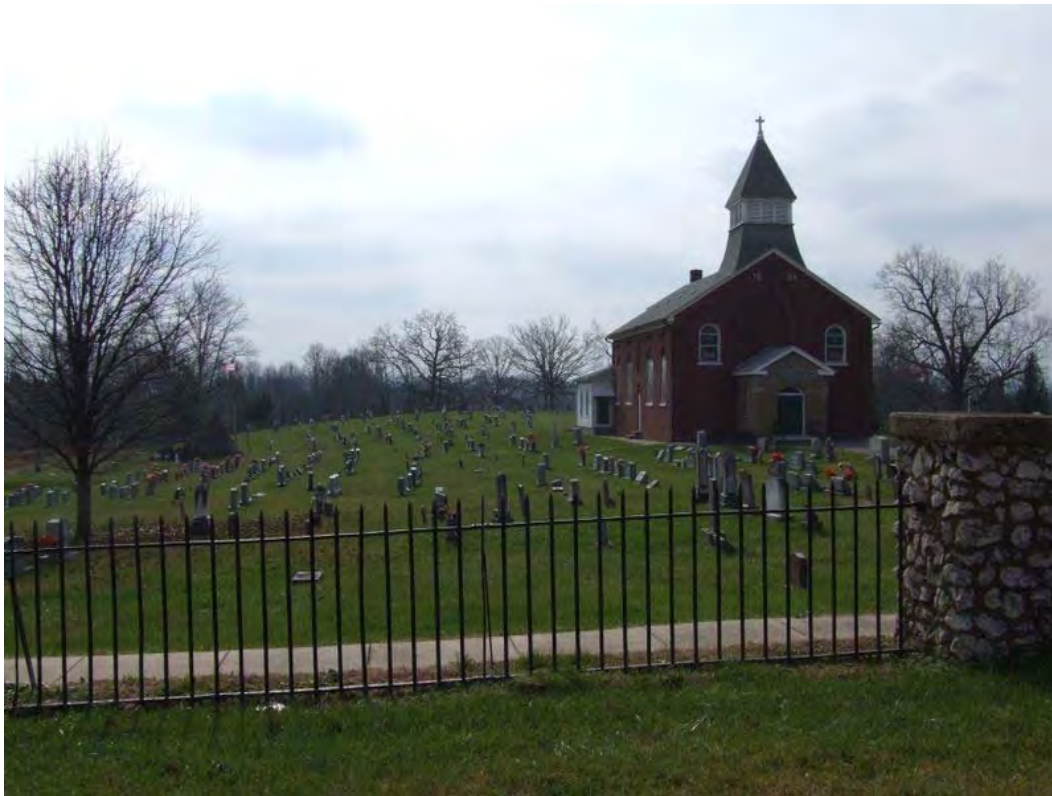
Figure 330: MN 13, *Holy Cross Catholic Church, 1824.*

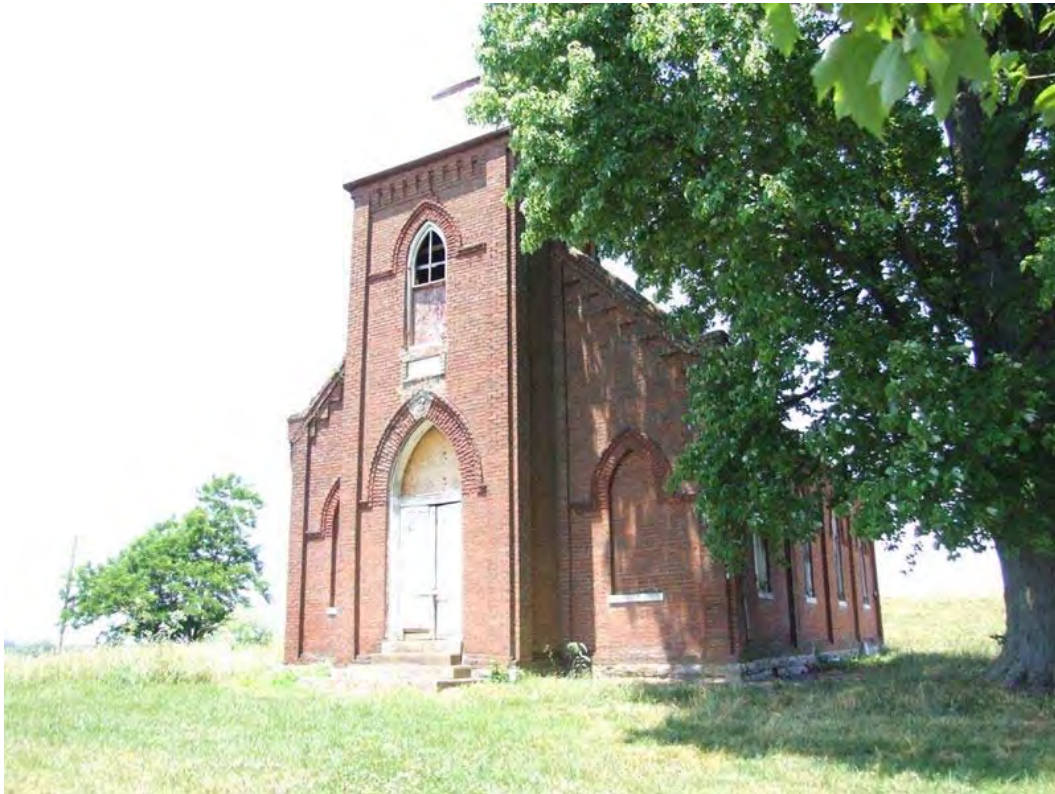
Figure 331: MN 95, *Pleasant Run Methodist Church, 1898.*

Like other historic resources, churches are often endangered, most typically when they fall into disuse. Substantial brick churches such as Pleasant Methodist Church (Figure 331) may stand for some time, but the plainer frame churches tend not to fair so well. For example, the Ealy Chapel

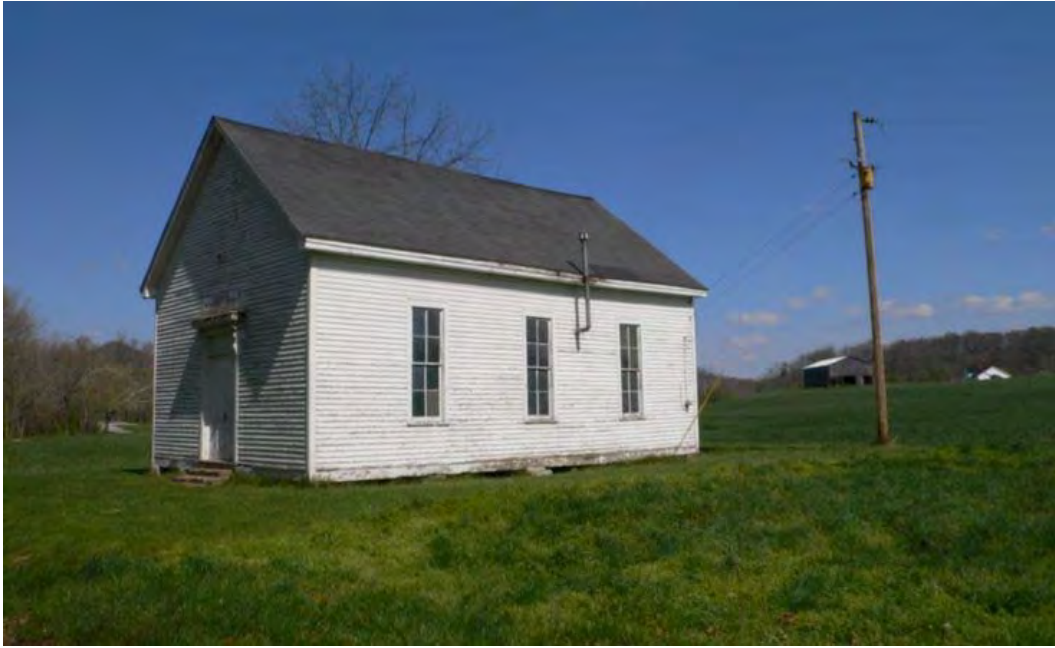
Figure 332: MN 663, *Kedron Methodist Church, late nineteenth century.*

The churches newly added to the inventory in the RHDI survey are mainly the smaller and plainer rural examples, and twentieth century town churches. Many of the rural examples are simple frame buildings with gable entries, and not a lot of architectural detail, such as Kedron Methodist Church, near Gravel Switch (Figure 332). One of the major variations on this form is

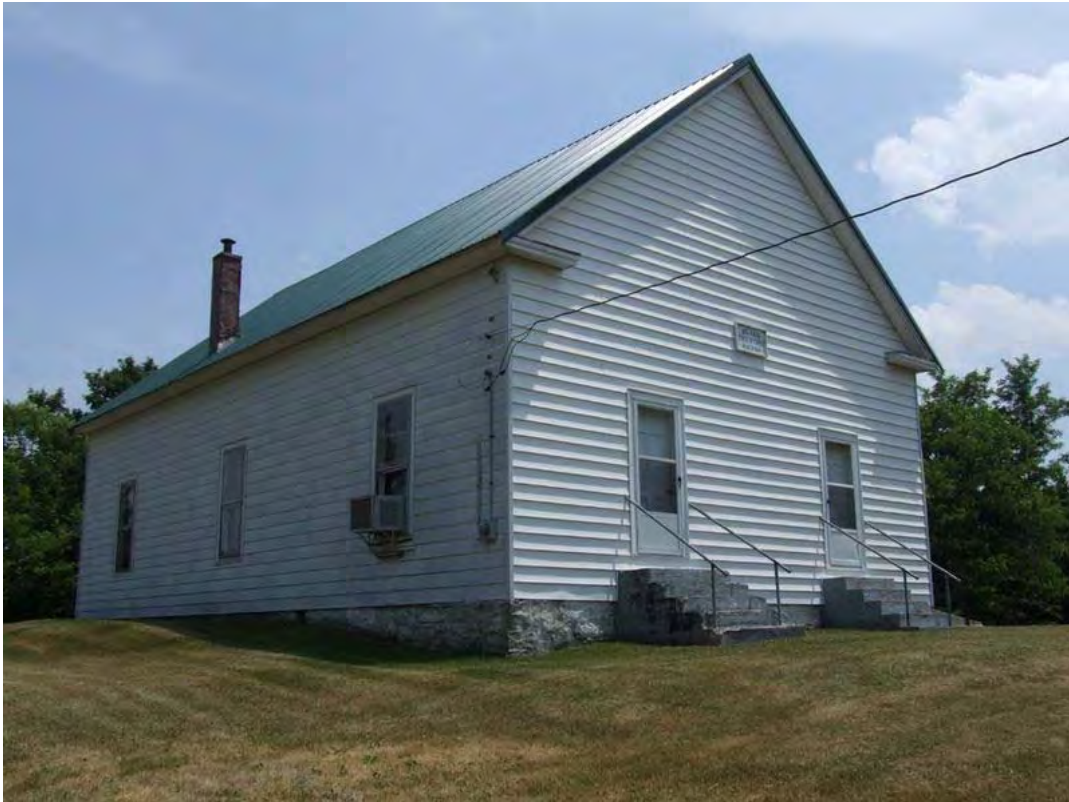
Figure 333: WS 912, *Mount Zion Church of Christ, 1914, Battle Vicinity.*

that some have two entrances, which often, but not always reflects the presence of two aisles inside, such as Mount Zion Church of Christ (Figure 333). Where these plainer churches tend to have more elaboration is through the addition of a steeple, as we see at the Battle Baptist Church (Figure 334). The tradition of the small rural church continues well into the recent past, as at Arbuckle Baptist Church (Figure 335), which replaced an earlier building in 1967. Larger rural churches do exist of course, as at Bethlehem Baptist church (Figure 336).
