A Survey of Historic Sites in Rural Marion and Washington Counties, Kentucky

A Report on the Findings of the *Rural Heritage Development Initiative Survey*
A project funded by a National Park Service Preserve America Grant

Kentucky Heritage Council

The State Historic Preservation Office, 2009

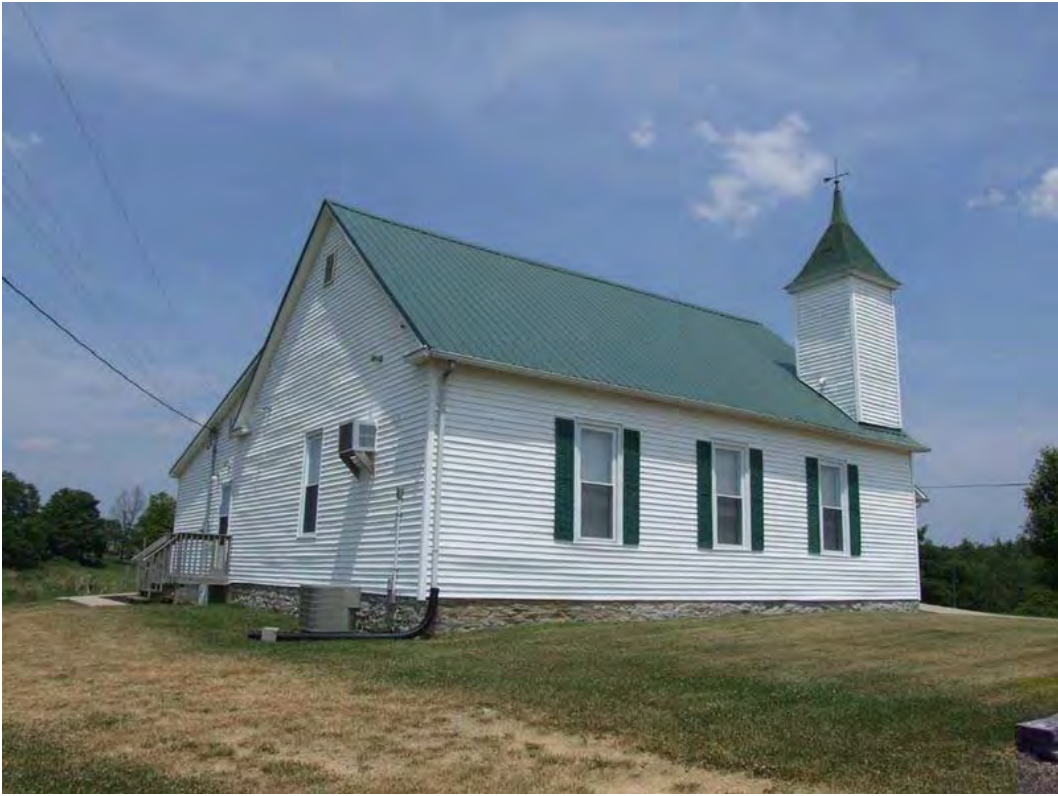
Figure 334: *WS 913, Battle Baptist Church, 1904.*

that some have two entrances, which often, but not always reflects the presence of two aisles inside, such as Mount Zion Church of Christ (Figure 333). Where these plainer churches tend to have more elaboration is through the addition of a steeple, as we see at the Battle Baptist Church (Figure 334). The tradition of the small rural church continues well into the recent past, as at Arbuckle Baptist Church (Figure 335), which replaced an earlier building in 1967. Larger rural churches do exist of course, as at Bethlehem Baptist church (Figure 336).

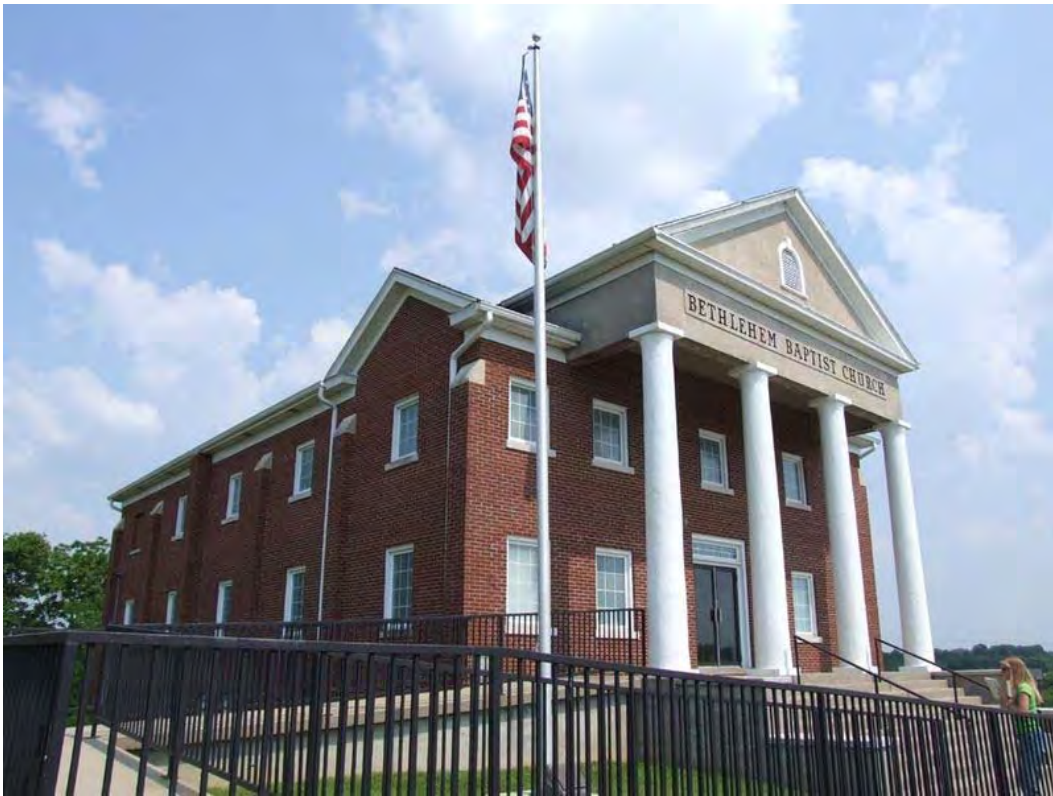
Figure 336: WS 880, *Bethlehem Baptist Church, 1940, Texas vicinity.*

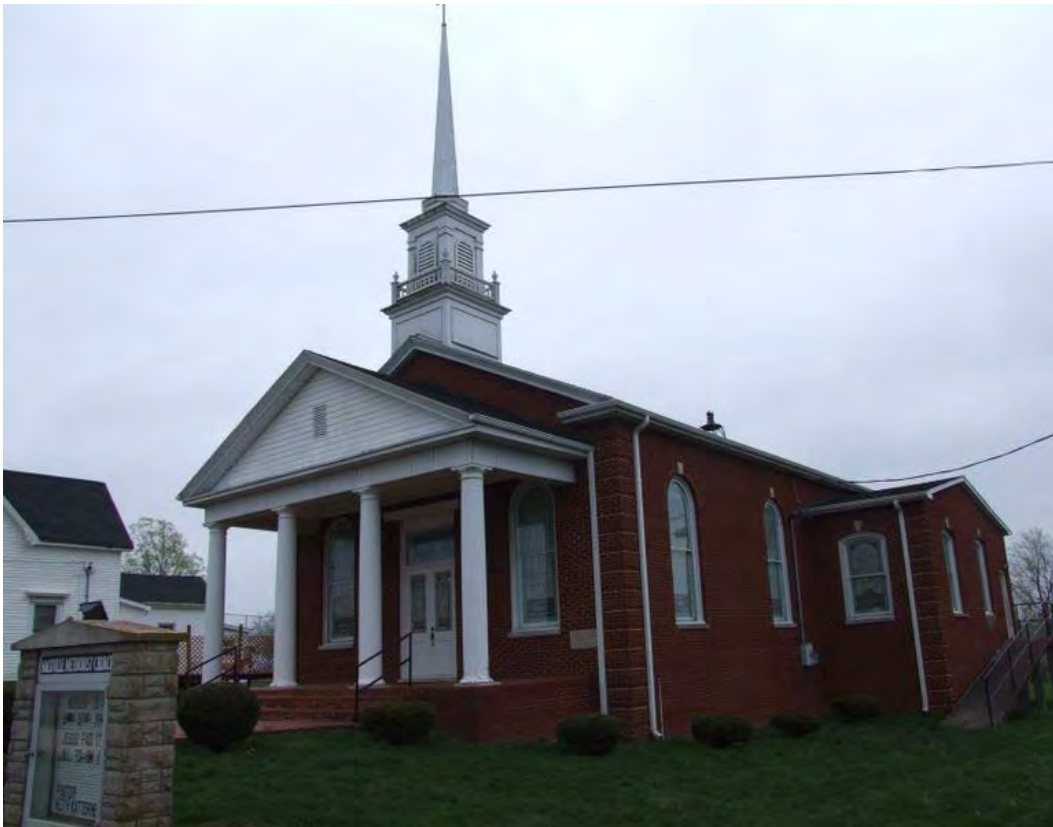
Figure 337: WS 53, *Mackville Methodist Episcopal Church, 1920.*

Churches in towns tend to serve larger congregations and thus tend to be larger and more elaborate architecturally. The Mackville Methodist Episcopal Church is a good example of this (Figure 337). In some cases, we find town churches to be simple in form, but quite large in size, as at the United Methodist Church of Gravel Switch (Figure 338), a good example of stone-faced concrete block construction. Gravel Switch is a small town, but is also home to another fairly large church, the Gravel Switch Baptist Church of 1952 (Figure 120).

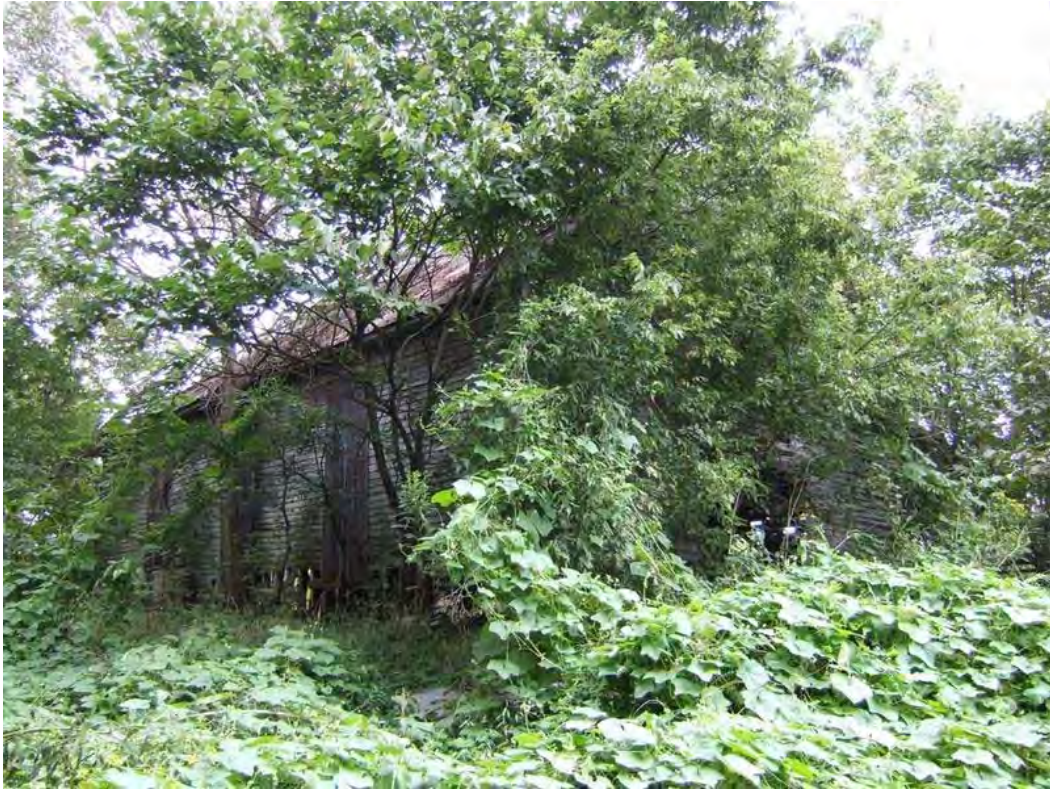
Figure 339: WS 263, *Maud Methodist Church, late nineteenth-early twentieth century.*

African Methodist Episcopal Zion Church in the Litsey/Poortown area, which the author documented in the early 1990s, was sadly found to be a fallen ruin in the current survey. In some cases, rural churches are reused as agricultural buildings, as at the former Methodist Church in Maud (Figure 339), which was used for a time as a tobacco barn, but which now faces an uncertain future. A happier story is the Bradfordsville Christian Church, which has been converted to a performing arts center for the community (Figure 340).

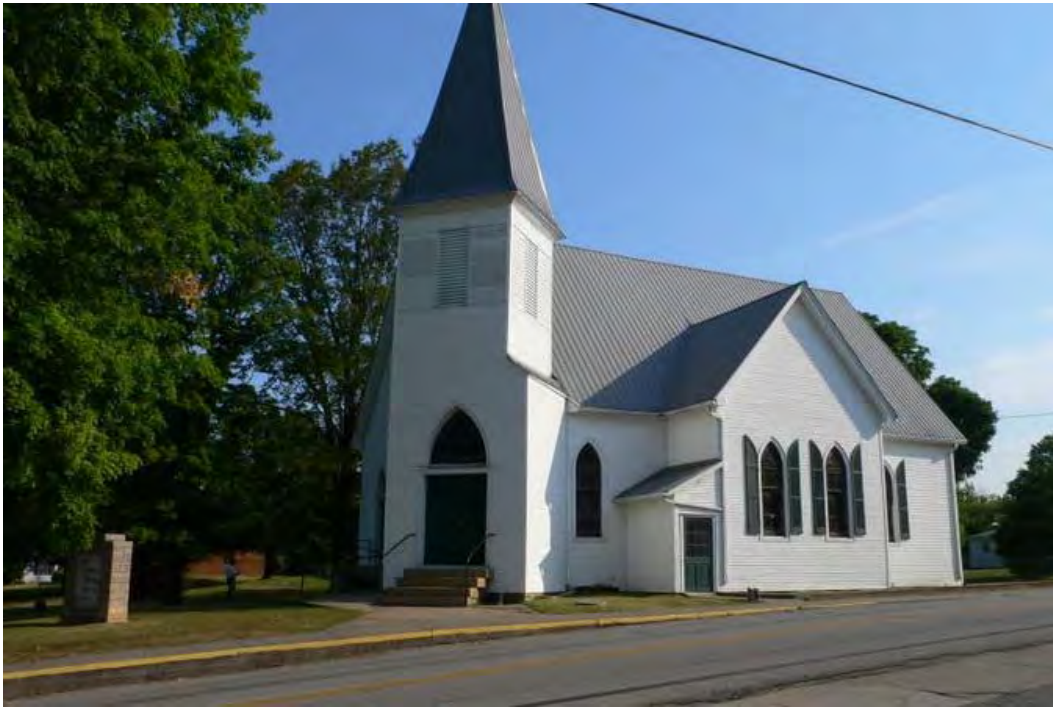
Figure 340: MN 926, Bradfordsville Christian Church (now Bradfordsville Performing Arts center), late nineteenth century.

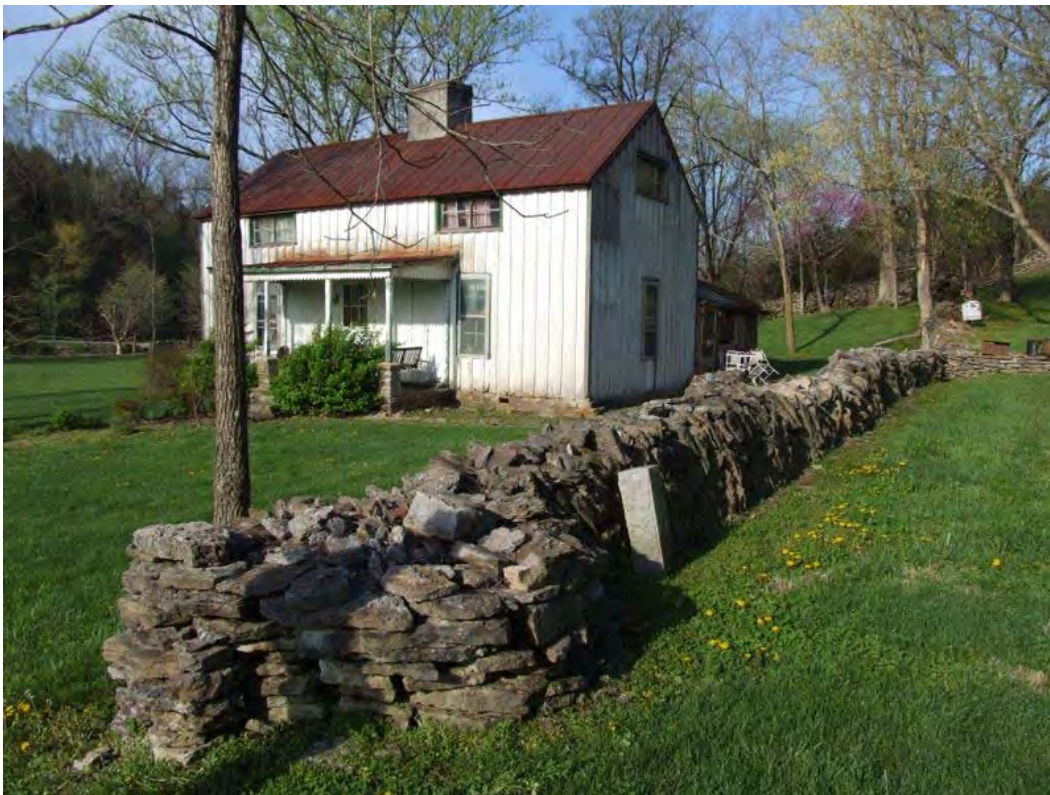
Figure 344: WS 720. Center chimney double pen House with board and batten siding, early-mid nineteenth century, Manton vicinity. Extensive stone fencing separates domestic and agricultural spaces. See also Figure 345 and Figure 346.

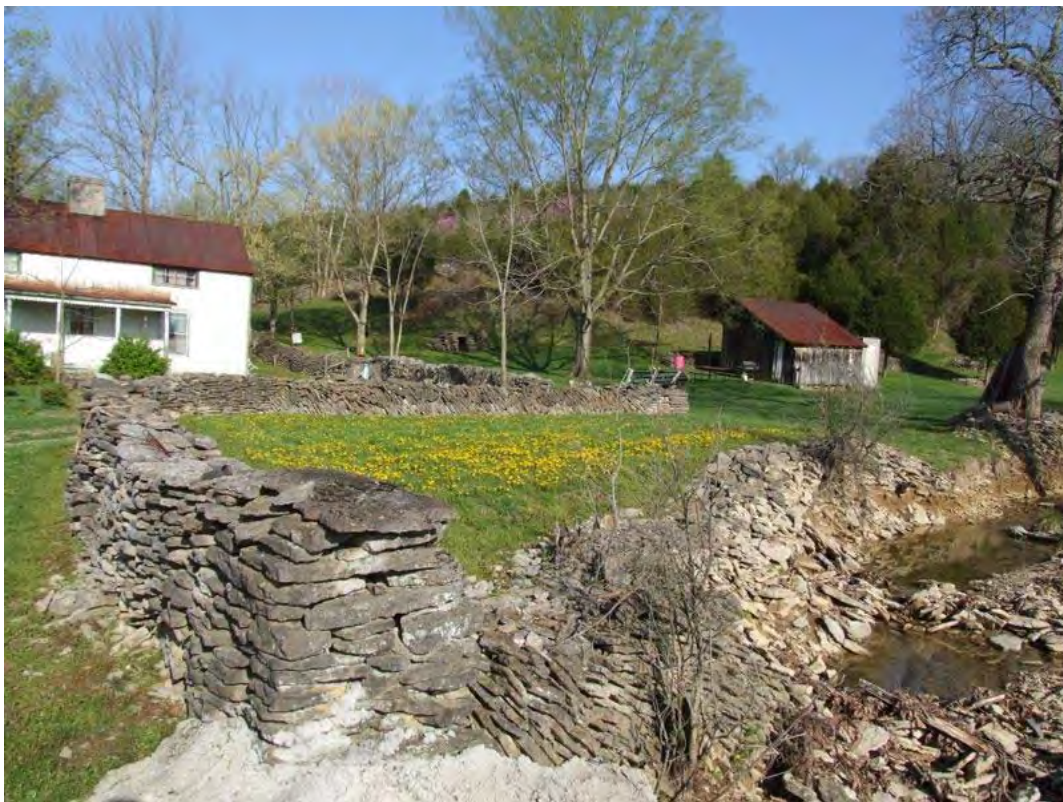
Figure 345: *WS 720, Stone Fencing surrounding house. See also Figure 344 and Figure 346.*

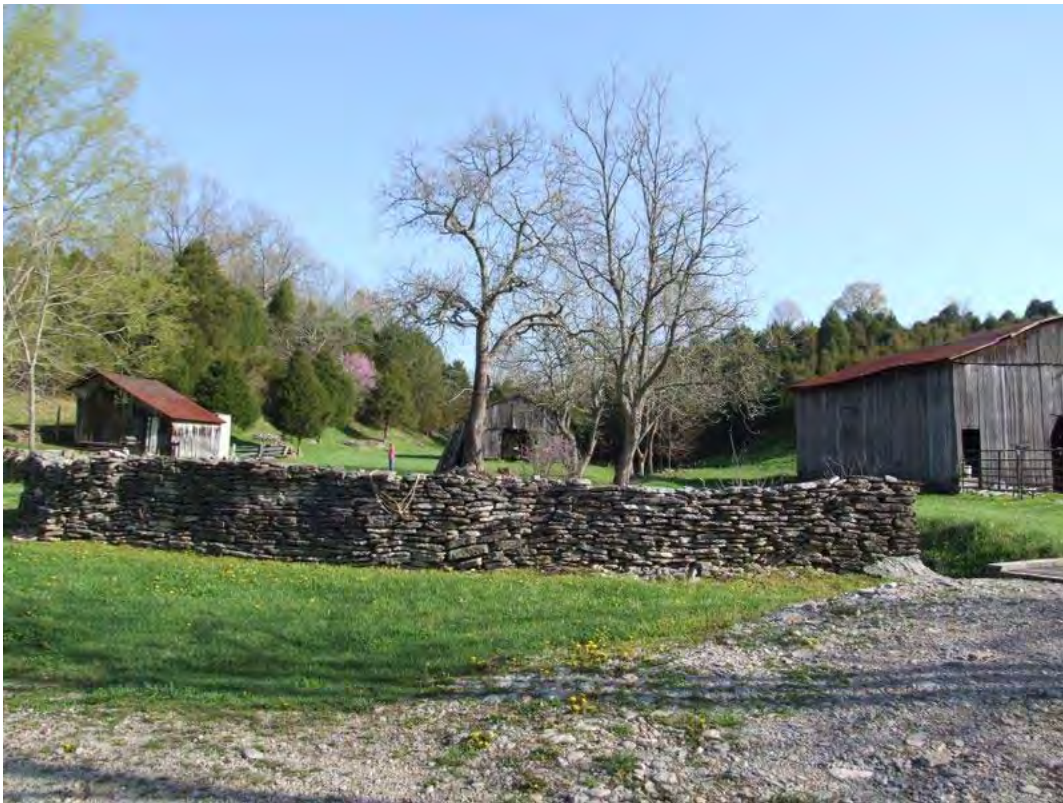
Figure 346: *WS 720 View from the House toward the Agricultural Yard and Outbuildings beyond. See also Figure 344 and Figure 345.*

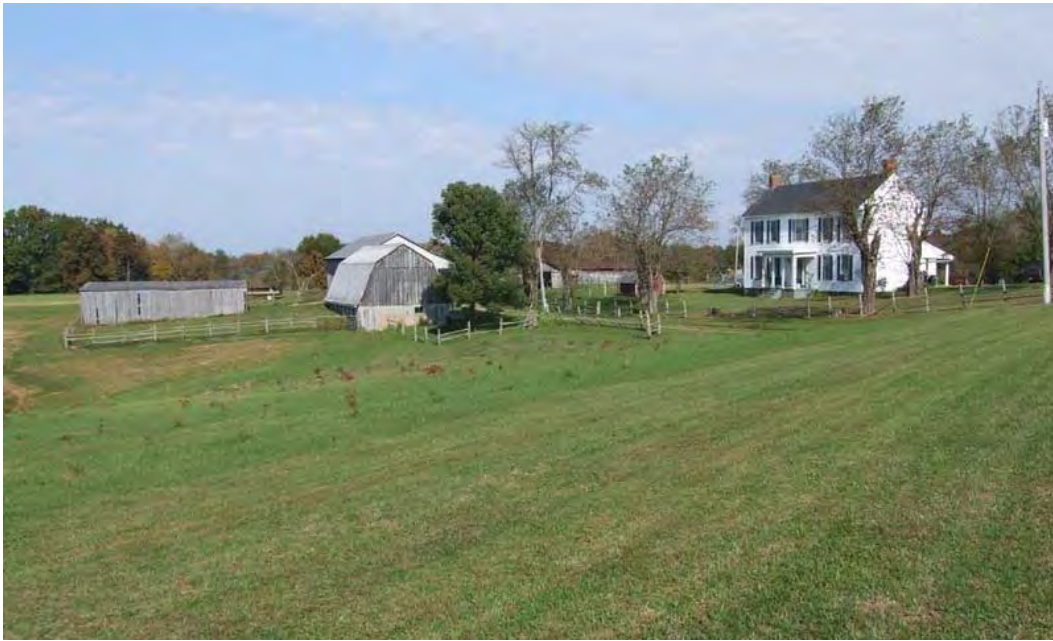
Figure 347: *WS 85, James Grigsby farm, Mooresville vicinity. The oldest part of the house is an early nineteenth century log section located in the ell behind the frame front section seen here. The gambrel roof barn left center is a banked dairy barn with a milking parlor and milk room on the ground level and hay storage above. Other outbuildings include a tobacco/multi-purpose barn, corn crib, smokehouse, machine shed, and garage.*

Early farms often have little resemblance to their original configuration, having evolved in a later period. With the end of slavery, the growth of automobiles and farm machinery, and changes in agricultural production, such evolution was inevitable. At WS 85 (Figure 347), for example, we see no evidence of rock fences, and all the agricultural outbuildings date to an early twentieth century period that concentrated on dairy, tobacco, and other commodities. The house, however, has a log portion dating back to the early nineteenth century, with the front main portion of the house built in frame by the mid nineteenth century. Farms such as these reflect changing historic forces over a long period of time.

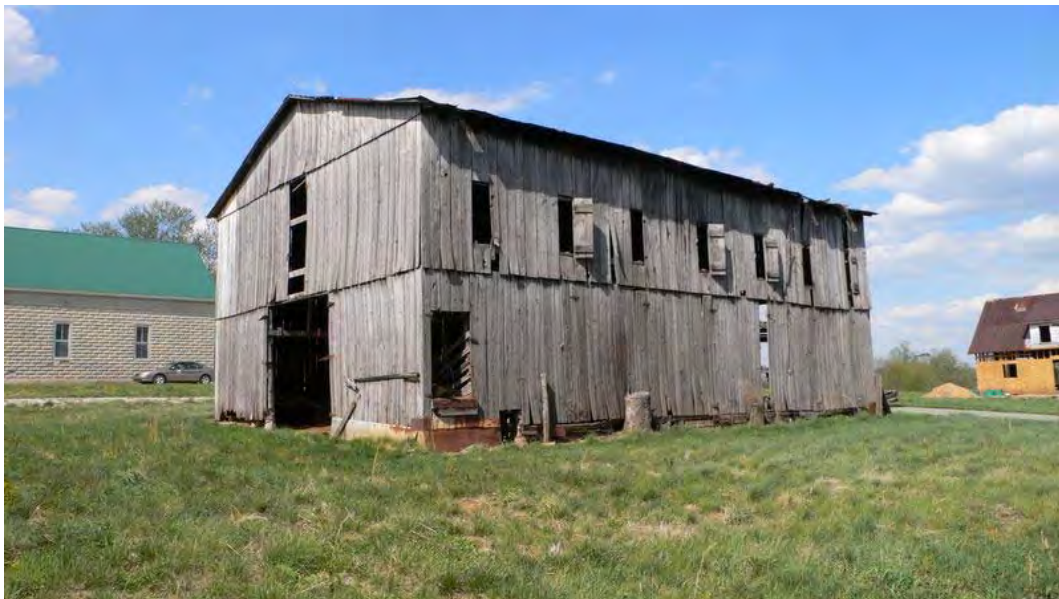
Figure 348: *MN 669, multi-purpose barn, early twentieth century, Gravel Switch. The stone-faced concrete block building in the background is MN 668, the United Methodist Church.*

For example, many Kentucky's small towns have a significant agricultural presence within their borders. The placement of barns on urban lots (Figure 348) is one noted practice, where crops harvested from surrounding fields could be stored convenient to markets and transportation. The barn alone in town does not constitute a farm, but we do sometimes find small farmsteads in

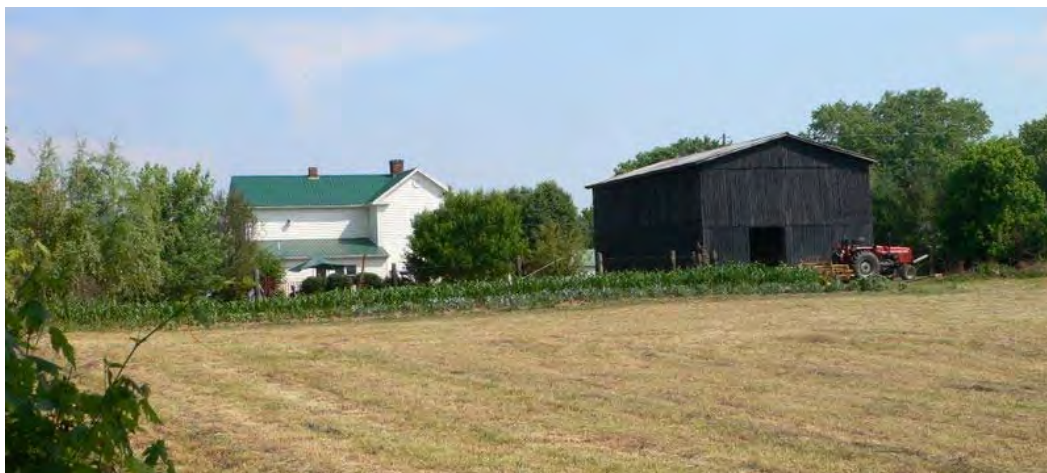
Figure 349: MN 937, farm, late nineteenth, early twentieth century, Bradfordsville. This picture is taken from the back of the lot: the house faces East Main Street.

towns (Figure 349). In many small towns, such as Bradfordsville or Willisburg, deep lots face the main thoroughfare with a house near the front and long fields behind. These “urban farms” often have the domestic and agricultural yards compressed tightly together to maximize the field space. Convenient to markets and transportation routes, these smaller farms may have been more heavily invested in crops such as tomatoes, orchard crops, and vegetables than their more rural counterparts, and may have an increasing role to play with the recent growth of interest in local production and farmer’s markets.
