**The Restoration of Burton's Store
Perryville, KY**

May 1, 2010 to February 1, 2011

**Report Prepared by Bill Faulconer
Photos by Linda Faulconer, Timothy Wilkinson and Vicki Goode**

**Chaplin Hills
Timberwrights**

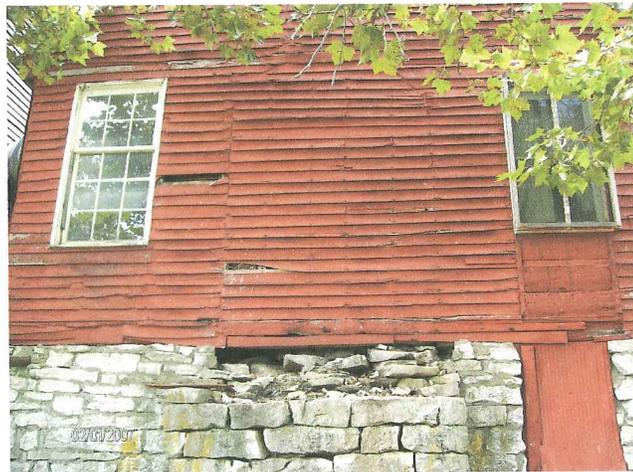
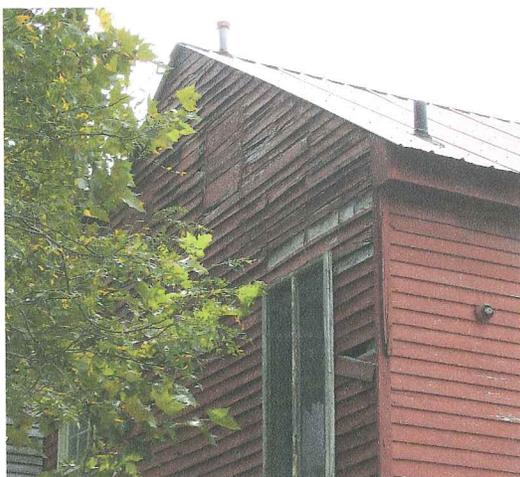
The hand hewn timber frame is erected upon a dry laid stone foundation that is nearly 8 feet high at the rear of the building. The framing method is scribe rule, and the design is a late example of English derivation as exhibited by the "English tying joint" used at the top of each corner post. In this system, the top of each corner post has two tenons. The lower tenon is parallel to, and receives, the top plate of the side walls, while the upper tenon, the "teazle tenon", receives the tie beam, which in turn passes over the top plate and clasps it in place.

The sill plates, top plates, and corner posts are white oak, and all other framing members are tulip or yellow poplar (*Liriodendron tulipifera*). The poplar floor and ceiling joists, wall studs, and rafters were hewn first, then transported to a sash mill for further reduction to 3"x 8" floor and ceiling joists, and 3"x 4" studs and rafters. It is not unusual to find timbers in this building with one or more hewn surfaces, and the rest sawn. The 8"x 8" oak sill plates are 34 feet long down the sides and each is a single piece of wood. The top plates on the sidewalls are 4"x 6"x 34 feet and

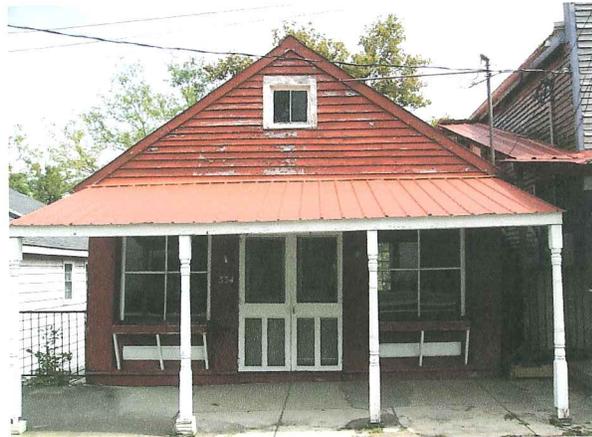
Originally, an 8"x 8" cross beam at the center of the building connected the two long sill plates to prevent spread. It was tenoned and pegged at each end into mortises in the sills. Diagonal braces descended from the center stud in each side wall to this beam, and the braces, in turn, became part of a partition wall that once separated the front public part of the store from the private section in the rear, where the proprietor lived with his family.

Behind this partition, there also once existed a stairway leading to the two attic rooms. These rooms are fully plastered and trimmed to the same extent as downstairs, and were additional living space for the proprietor. At some point, the tie beam, braces, partition wall and stairway were all removed, and with them went a great deal of the stability of the building. The original flooring, upstairs and down had been tongue & grooved poplar. Both floors were removed in the past and only the downstairs was replaced with pine.
