Kurfees Paint Co.
Name of Property

The Kurfees Paint Co. Building (JF-CD-239) is a 4-story brick, concrete and limestone building fronting on Market Street, in Louisville, Kentucky's largest city. The rectangular building is approximately 107 feet wide (east-west) and 204 feet deep (north-south). The formal façade faces Market Street and presents restrained Beaux-Arts detailing along this façade. The west, north and east elevations are primarily utilitarian elevations with rectangular steel windows and very little decoration except at the corners, parapet, and elevator shaft. Seventeen years after the company's founding, Joseph and Joseph Architects was commissioned to design the first of two phases for a production facility at the corner of Brook and Market Street. The original structure, constructed in 1915, was the first 3 structural bays, approximately 45 feet along Market Street. The second phase, constructed in 1928, comprised the rest of what exists of the building today, an additional 62 feet along Market Street.

The Kurfees Paint Company Building is a four story brick building with stone base and accents. The main decorative facade is oriented to the south along Market S

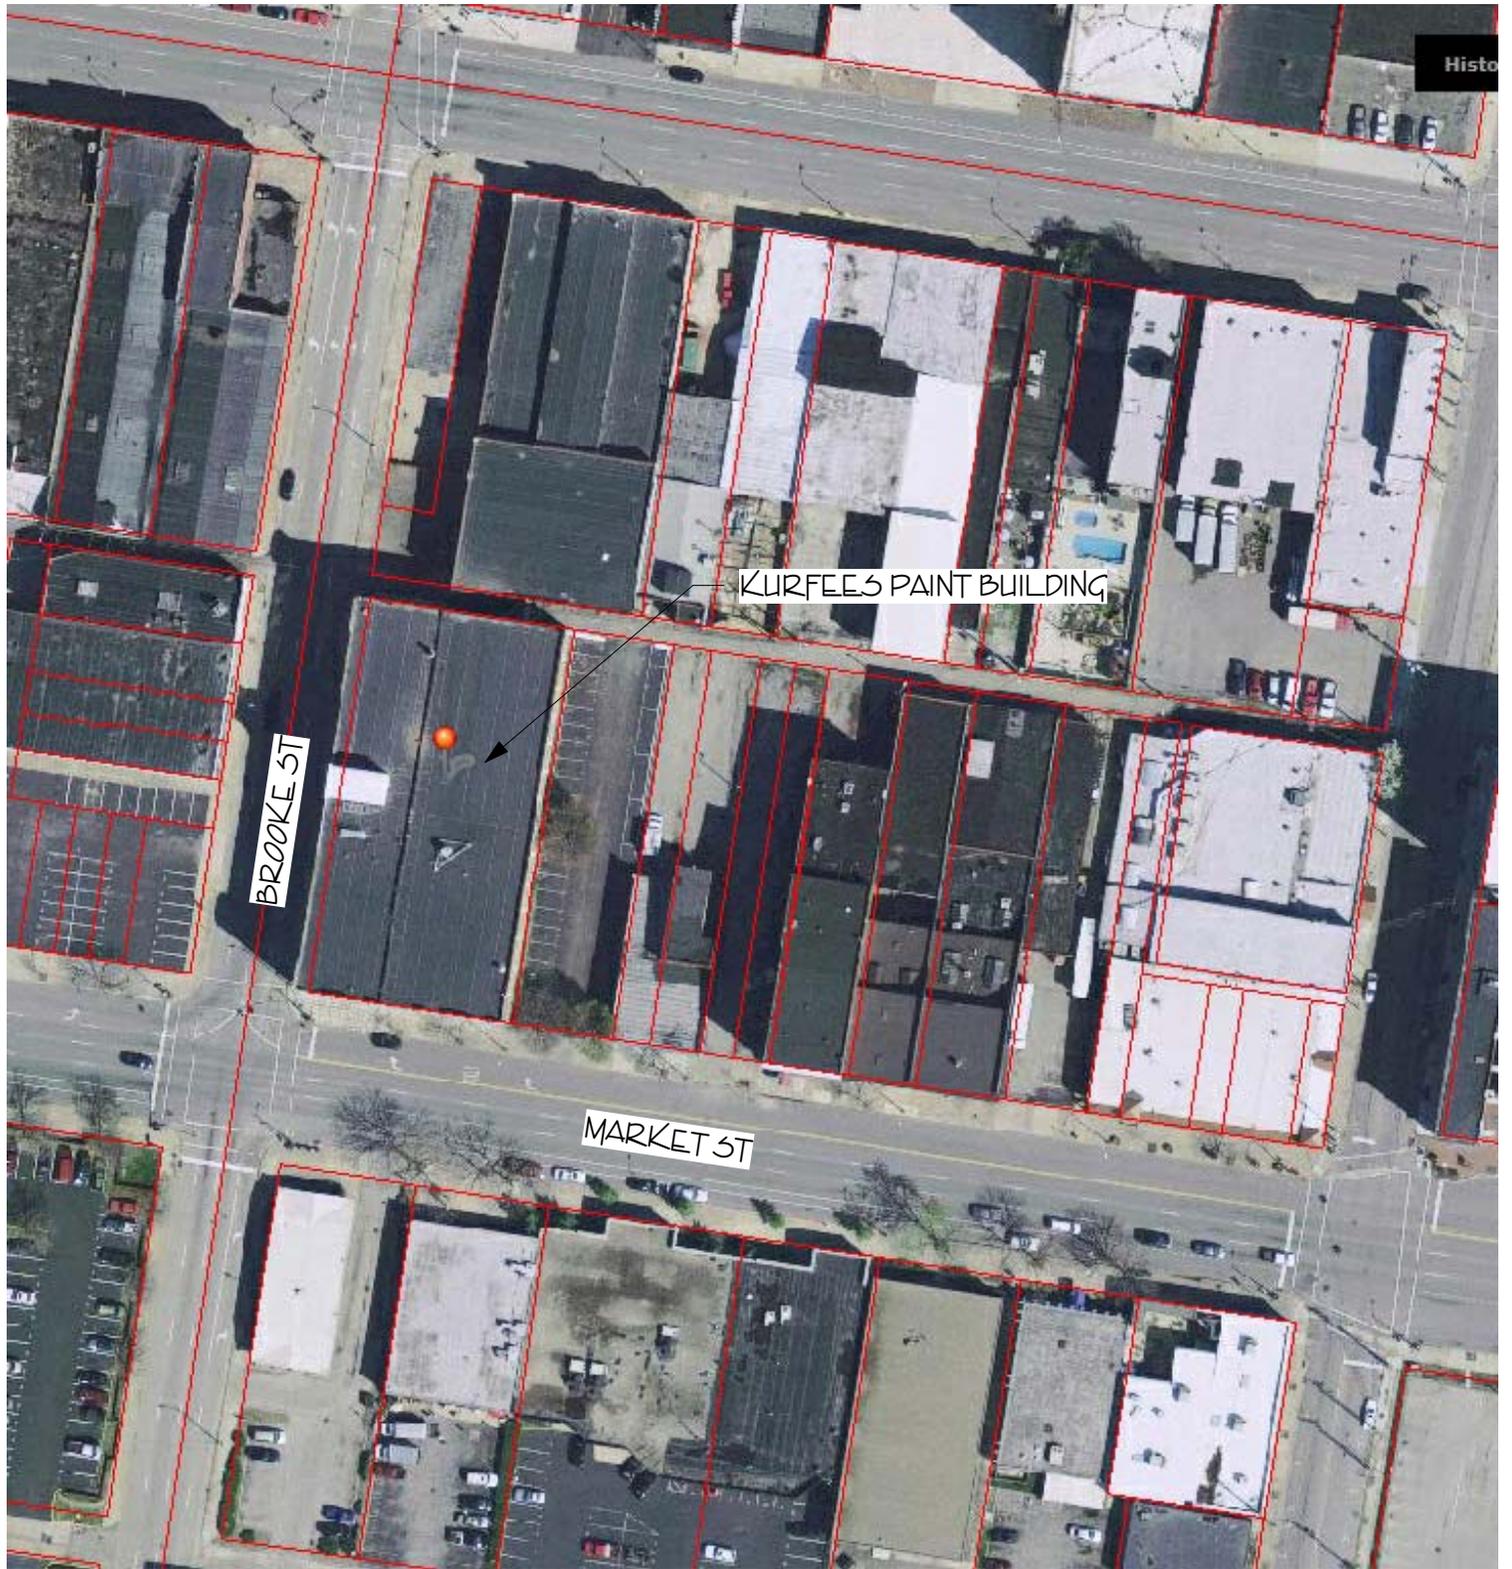
A106
SHT
02/28/13

SITE PLAN

The property proposed for this listing corresponds to the Jefferson County Property Valuation Administrator (PVA) parcel 017B01820000, which is a rectangular shaped lot approximately 107 ft wide (east-west) by 204 ft deep (north-south) corresponding to the address 201 East Market St.

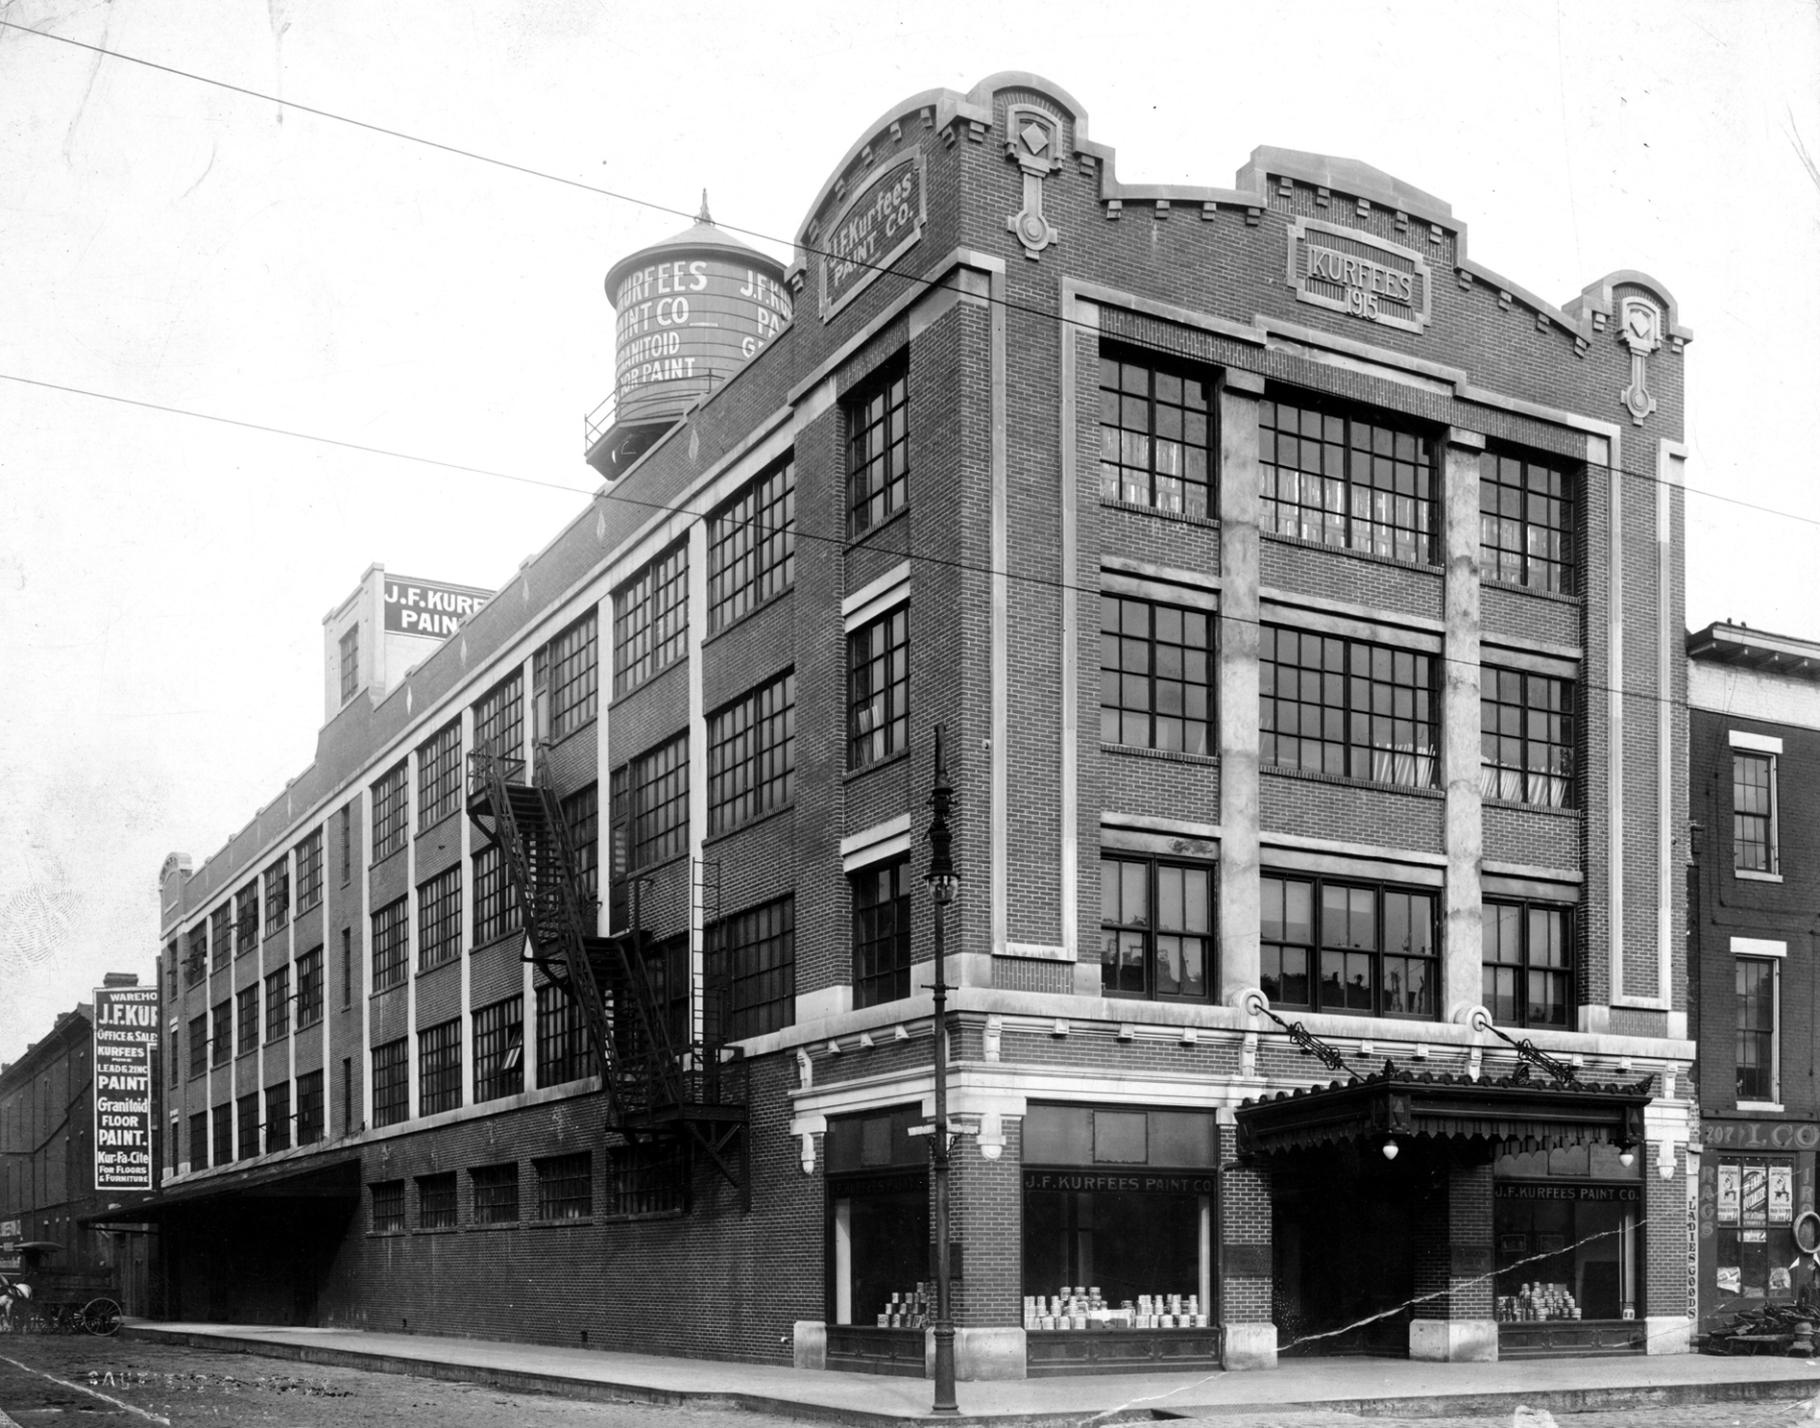
KY_Jefferson County_Kurfees Paint Building_0001
Southwest corner historic photograph, approximate date 1915

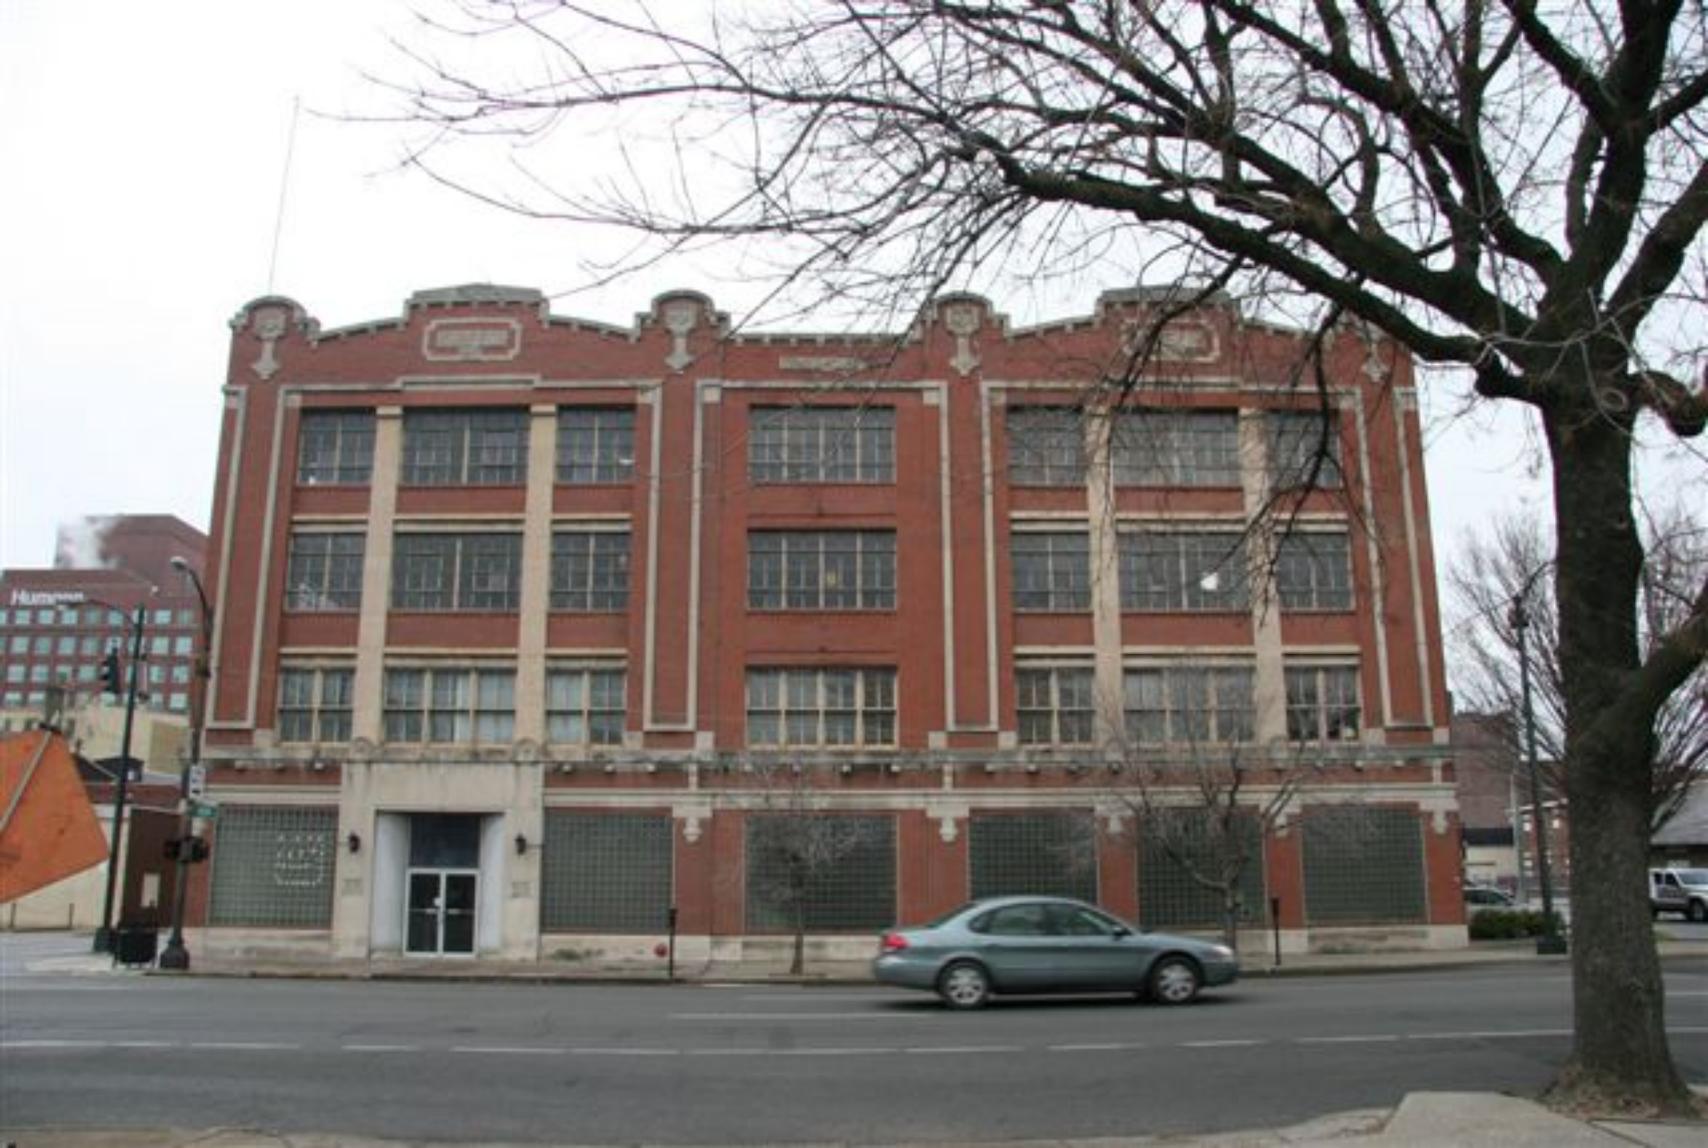
KY_Jefferson County_Kurfees Paint Building_0003
South façade parapet of original 1915 building, showing date stone

The façade is capped with an entablature of a stone which tops the arch parapet. The arches correspond to the rhythm set up by the 3-1-3 pattern of floors 2-4. In Beaux Arts style each pilaster terminates in a decorative element. In this case, the pilasters terminate in a distinctive cut stone medallion which is a more decorative version of the first-floor pilaster capitals.

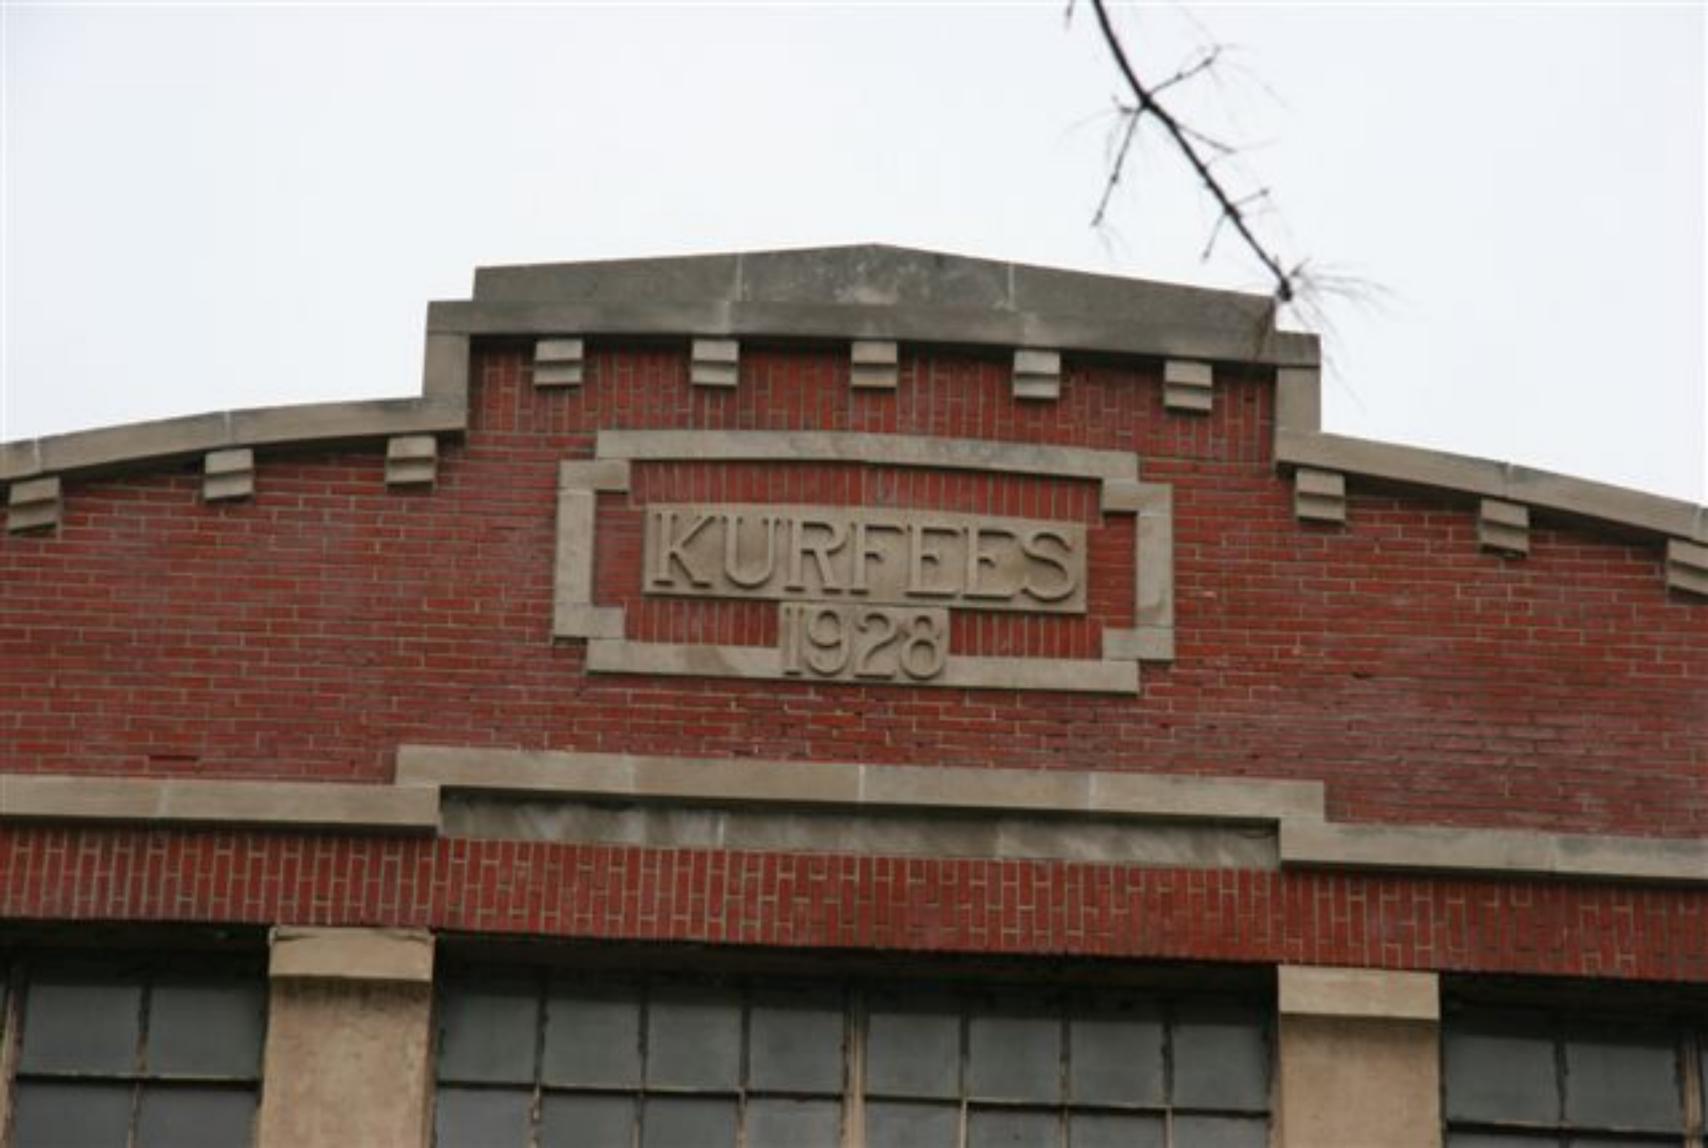
KY_Jefferson County_Kurfees Paint Building_0004
South façade parapet of 1928 addition, showing date stone
