National Register of Historic Places Registration Form

historic name Maple Grove
other names/site number WS-20; Hardin House; Old Settles Place

street & number 3216 Perryville Road NA not for publication
city or town Springfield vicinity
state Kentucky code KY county Washington code 229 zip code 40069

Maple Grove (WS-20) is a nineteenth-century brick I-house with central hall plan in the Federal style. It is located at 3216 Perryville Road, at the southeast edge of in Springfield, seat of Washington County, Kentucky. The house faces south toward US Highway 150. It sits off the road but is visible, surrounded by fields on all sides. The area proposed for listing is a 120' x 250' rectangle within a 15.46-acre property, which is a portion of a once-larger historic farm. The property proposed for listing contains only the house and a small amount of land around it. The larger parcel, outside of the area proposed for listing, contains agricultural work buildings like others found on area farms. The nominated property is being described and interpreted for its architectural values. The house contains fine wood work and contains interior features that are typical of Federal era constru

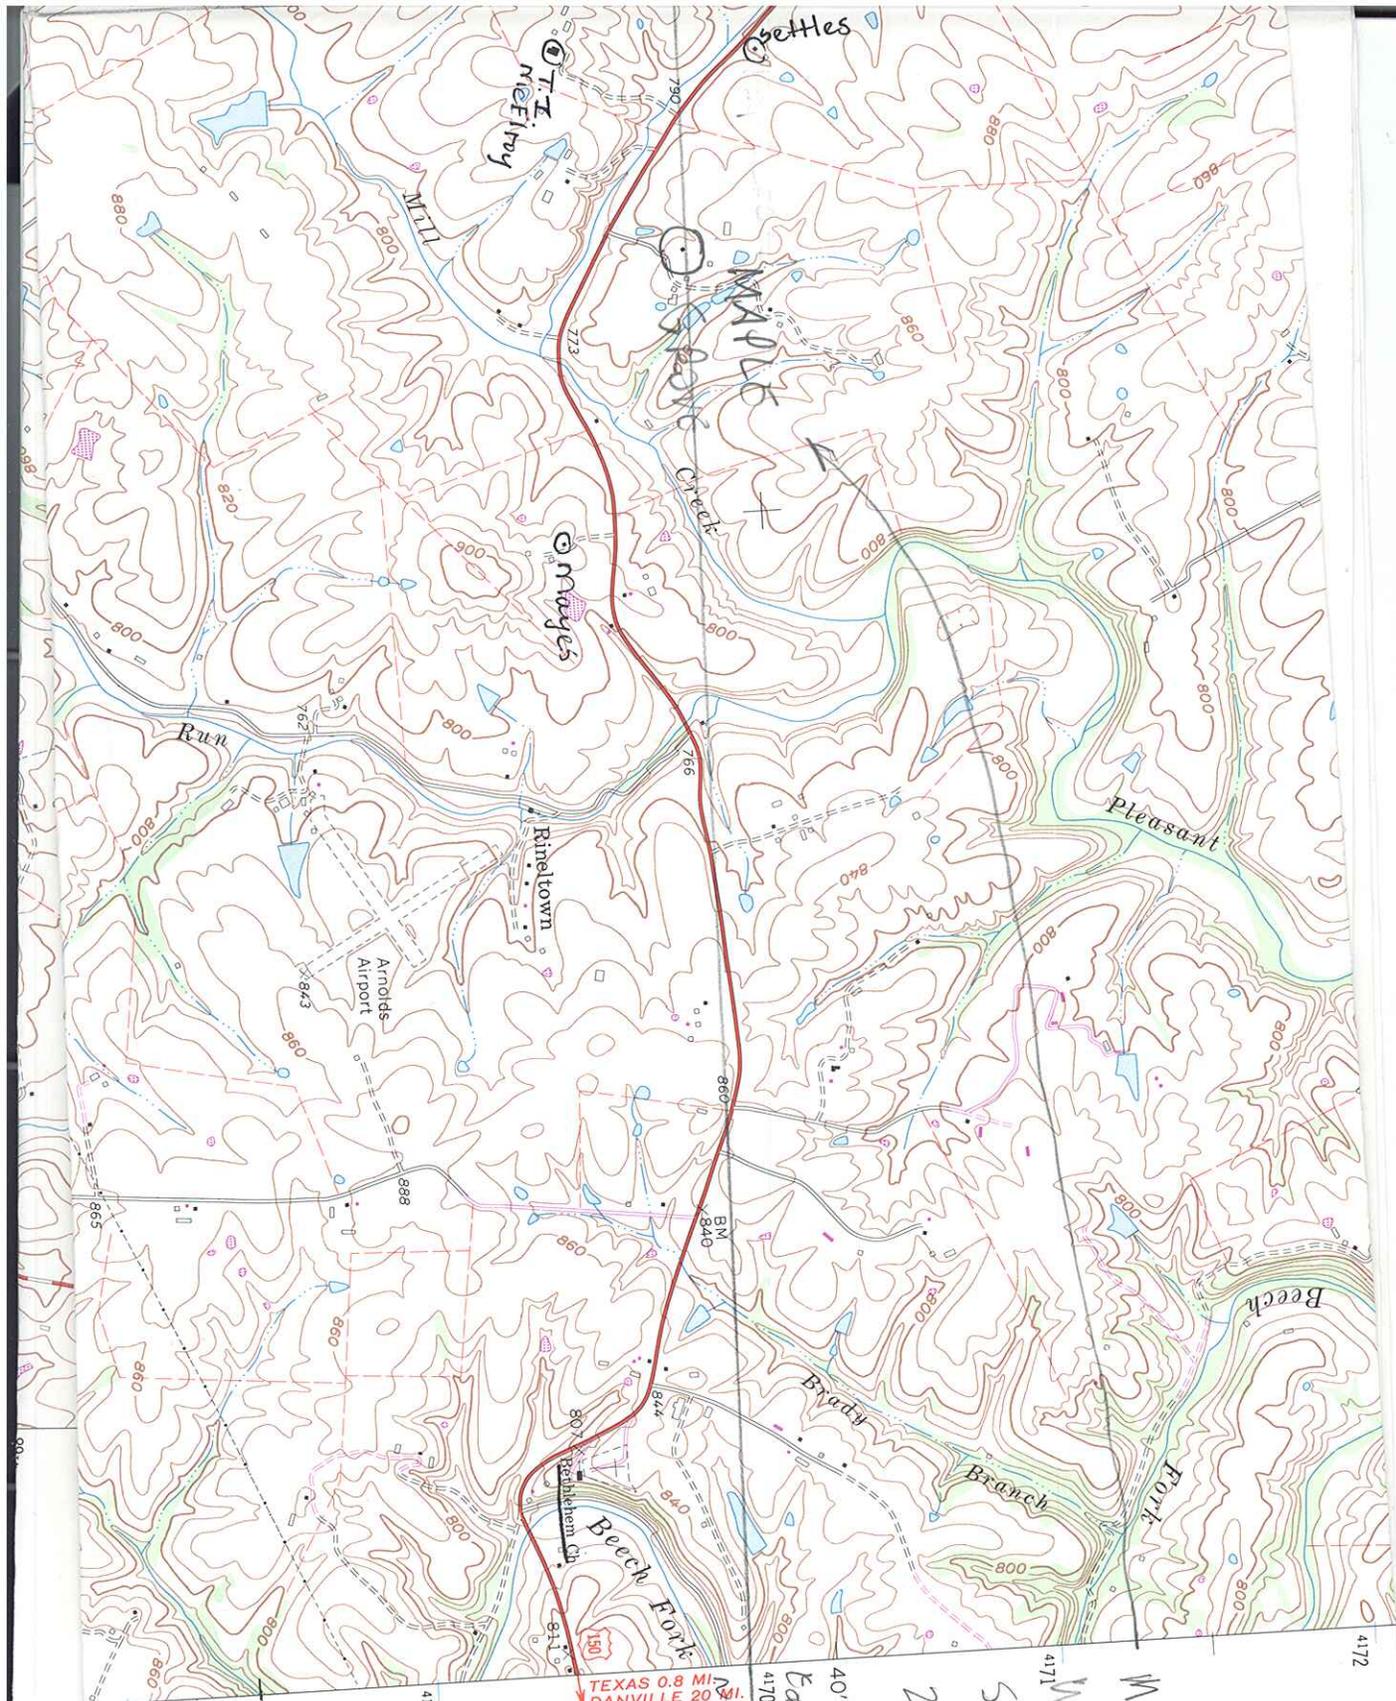
Coanoughter,
 Goods
 off map

40' 1927 NAD
 Easting 660 857.53
 Northing 4170001.61

Maple Grove
 Washington Co. KY
 Springfield quad
 Zone 16

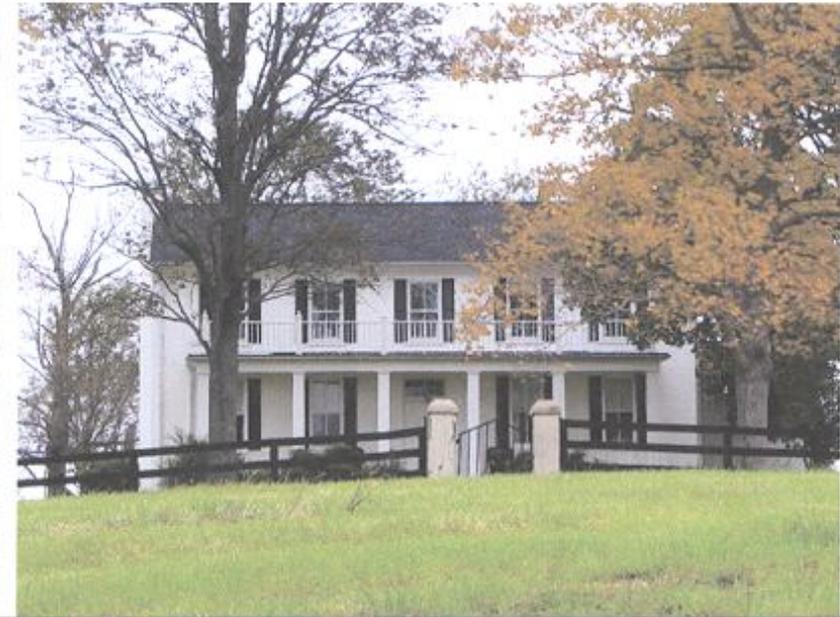
Map 25-060

PROPERTY CARD

Location **PERRYVILLE RD 03216**

Building 1 Residence

Descr HOUSE & 15.46 ACRES

Year Const 1900

The Boundary is found within a property in Washington County, Kentucky, located on the property maps of the Washington County Property Valuation Office and identified as property 060 on Map 25. Property 060, which has the address 3216 Perryville Road, is a 15.46-acre parcel. The area proposed for listing is a rectangle within that property. The rectangle is described as beginning at A on the west side of the drive approximately 200' south of the principal (south) façade of the house, north 250' along west side of the drive to B, then west 120' along a fence to the rear of the house to C, then south 250' along a fence to D, then east 120' along the fence to the point of origin. **See the site map within the nomination for a depiction of this.**

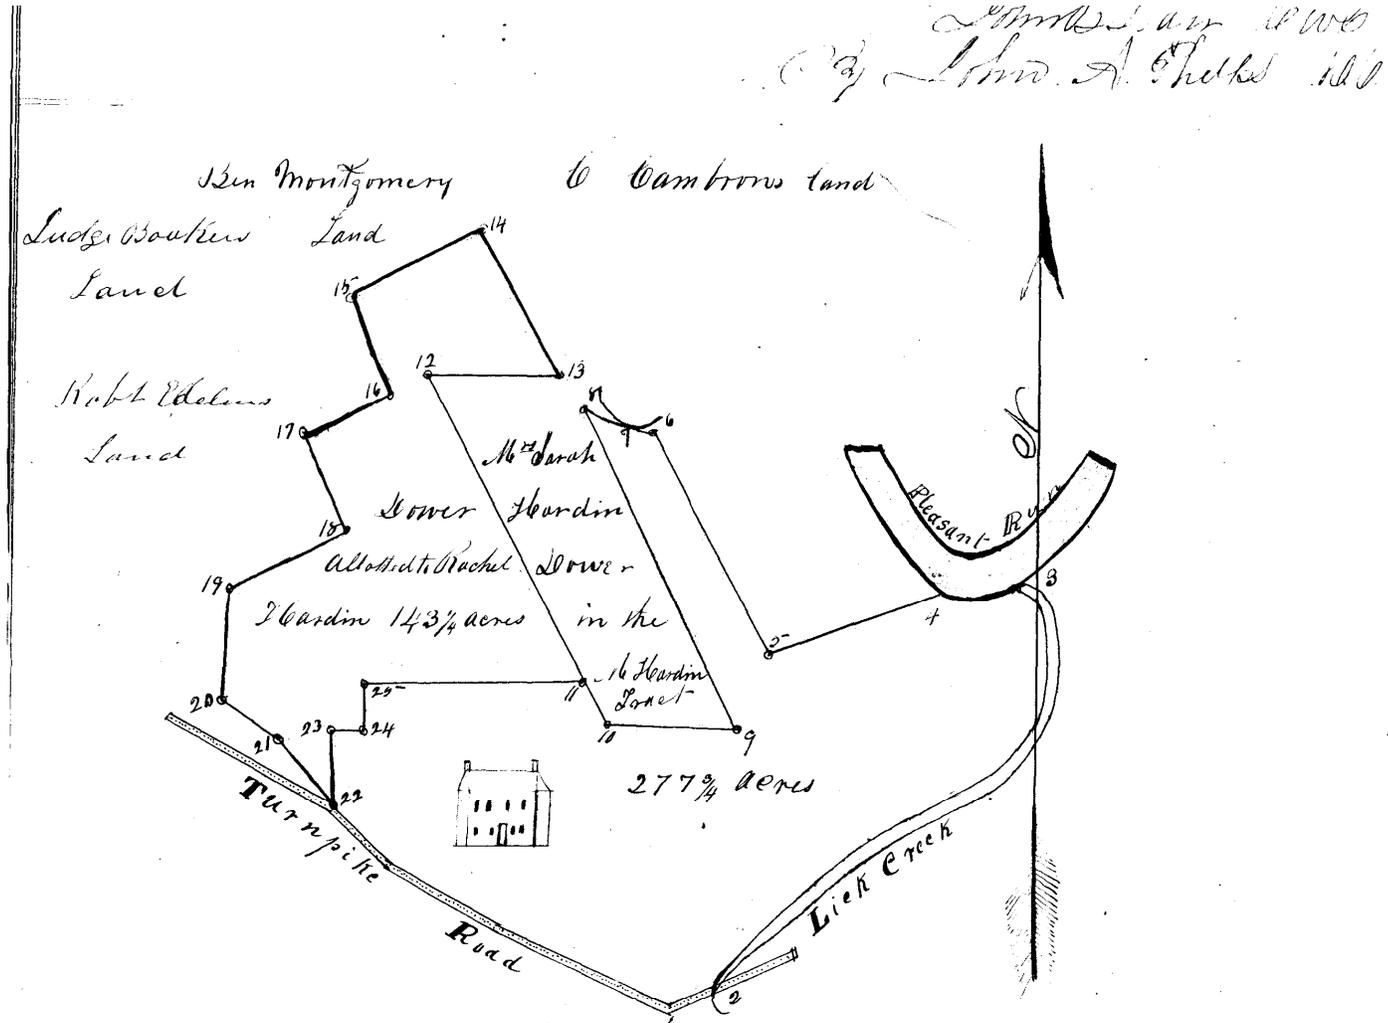
Figure 2: : A historic map of the Hardin property, ca. 1836. Found in Washington County Deed Book "U."

The earliest records of the land holding are from 1836, the year in which a survey of Benoni Hardin's 1000-acre property was completed in preparation for a division of the land between Hardin's descendents (Figure 2, from Washington County Deed Book "U" 1836: 308-310). In the deed's land survey, the house is already present on the property. Hardin's property was divided into seven parcels, with the parcel containing the house going to Francis McElroy, daughter of Benoni and Rachel Hardin.

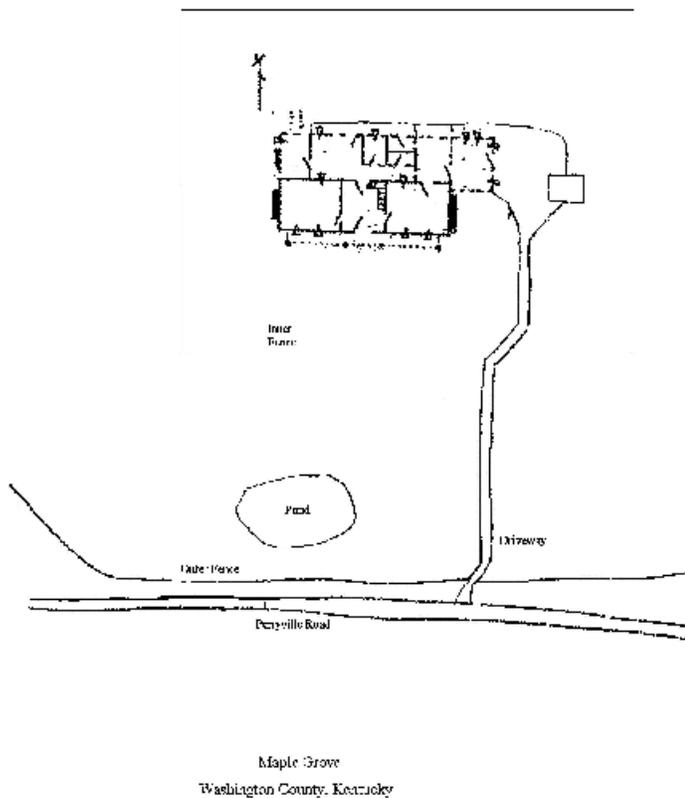
Figure 3: Site Plan of Maple Grove

The 15.46-acre property is situated between large tracts of farm land that were a part of the Hardin land holding. The current land holding includes the house, three barns, an old silo and a shed (see Figure 3, site plan). The fences to the east, north, and south mark boundaries of the current property. One barn is located close to the north boundary of the property north east of the house. The other two barns are due east of the house, facing each other roughly 70 yards apart, in a fenced-in area about one-half an acre against the eastern boundary of the property. The silo is just east of the southernmost barn.

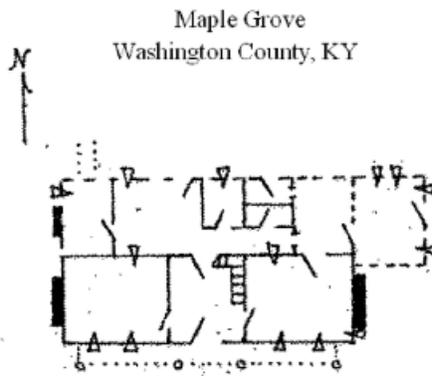
Figure 4: Floor Plan of Maple Grove

The house is a two-story, five-bay brick I-House with two additions on its back (north) side. The first addition came in 1982, and stands directly behind the house. It is two stories tall and has a shed roof. Attached to the south side of the 1982 addition is a shed-roofed carport. A second addition was placed on the rear in the mid-1980s with a kitchen. The kitchen addition is one story, projecting eastward from the two-story addition; both additions' north faces align (see Figure 4, floor plan).
