National Register of Historic Places Registration Form

historic name Chalybeate Springs Hotel Springhouse
 other names/site number ED-117
 Related Multiple Property NA

Chalybeate Springs Hotel Springhouse
Name of Property

Edmonson County, Kentucky
County and State

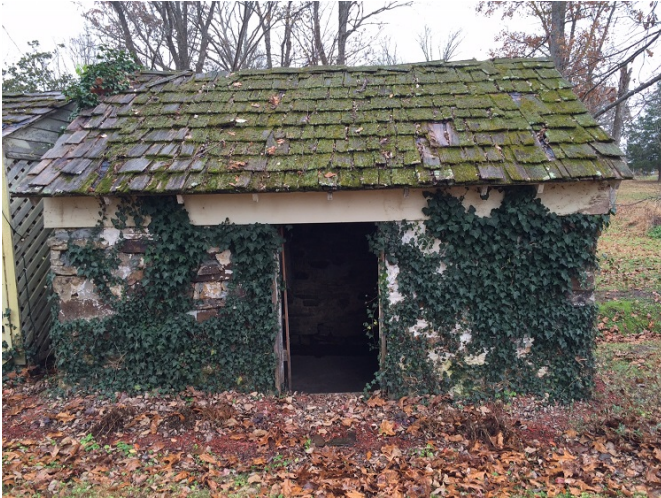
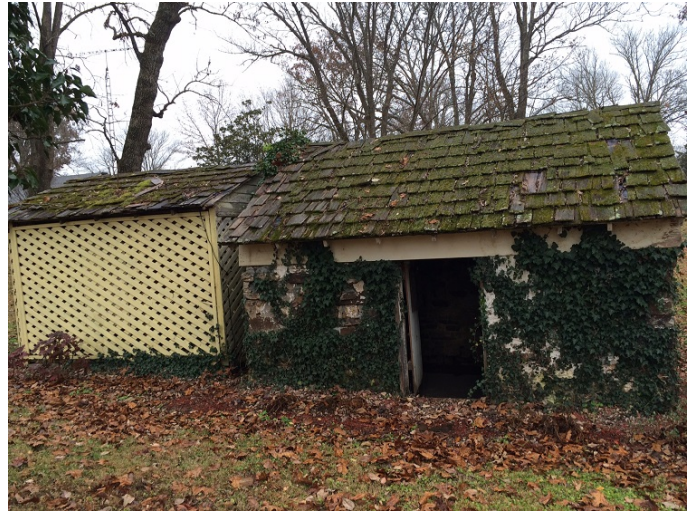
Views of the West side of the Springhouse

The entrance to the springhouse is on the west wall. There is about a foot of space between the north wall of the springhouse and the south wall of a second springhouse, reconstructed of frame and lattice on the nineteenth-century stone foundation of a similar frame springhouse.

The stone springhouse is constructed of fieldstones and mortar. A wood door, painted white, is in the center of the west wall, providing the only opening into the building that has not been sealed. A wooden plate runs the length of the west and east walls, over which is constructed the wood-shingled roof. The south and north sides are gabled with wood planks. The south end has evidence of a walled-up doorway, which the current property owner believes led to a third building, possibly a grist mill, which was also over the spring. The east wall has two small rectangular windows covered with horizontal wooden bars. Chalybeate Spring enters the springhouse in the northeast corner and exits in the southeast corner.

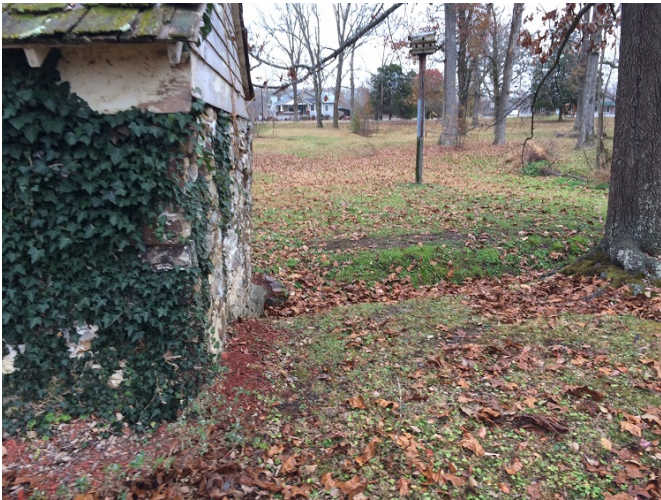
Southwest corner of Springhouse

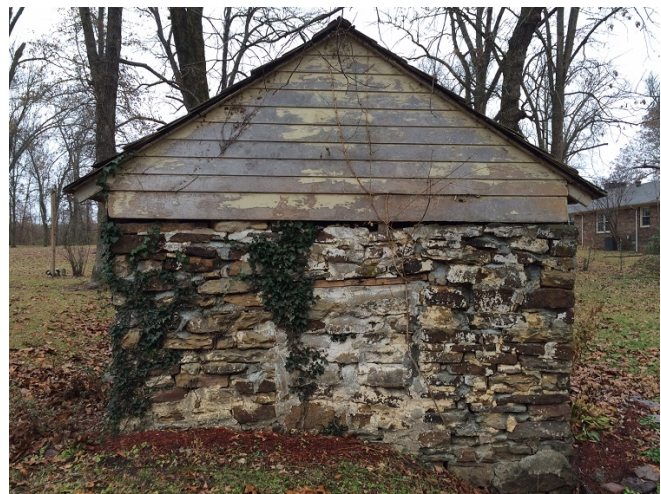
South side of Springhouse

The springhouse also possesses integrity of **design** and of **materials**. With the exception of the sealed south door, its exterior appearance has not been significantly altered. The stone construction and interior flooring are original. While the shingle roof is likely a replacement, the shake shingles used are in keeping with the period in which the springhouse was built and used by the hotel. The retention of design and material integrity give the feature its authenticity.

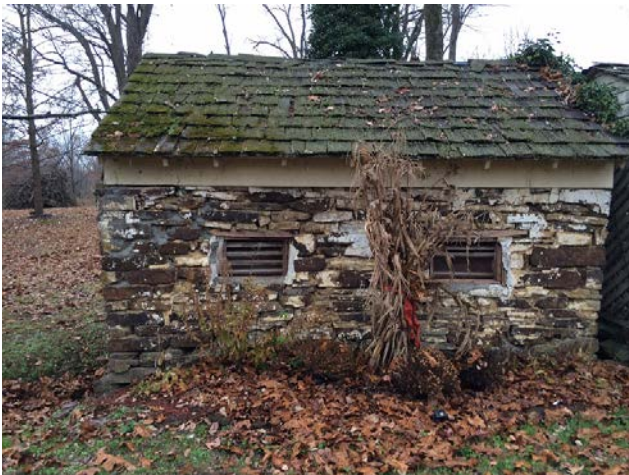
East side of the Springhouse

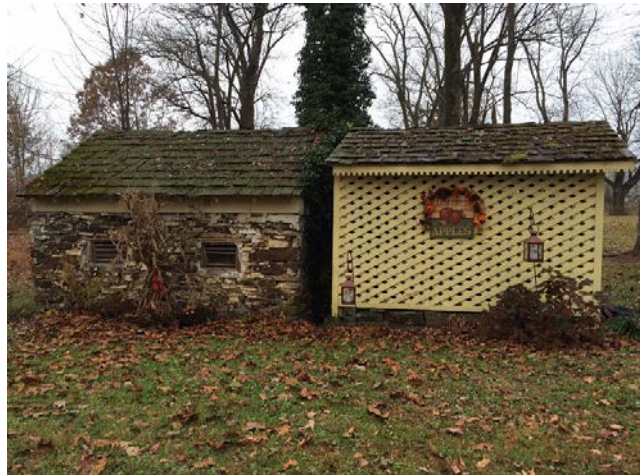
East side of Historic Springhouse and Frame Springhouse

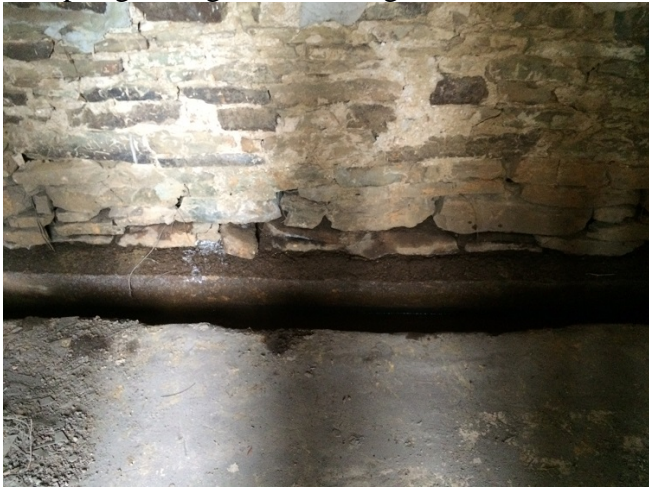
The interior of the springhouse is one room. The stone walls are left uncovered, and the wooden rafters and roof are left exposed. The floor is concrete and elevated in the southwest corner. The two windows in the east wall, evident from the exterior, are sealed on the interior with rock and concrete, though their upper wooden sills are still visible. The doorway in the south wall is sealed with fieldstones, and the upper sill is also visible, supported by three vertical planks that rest on stones. A concrete trough runs north-south next to the east wall, directing the spring through the building.

Interior view of Springhouse

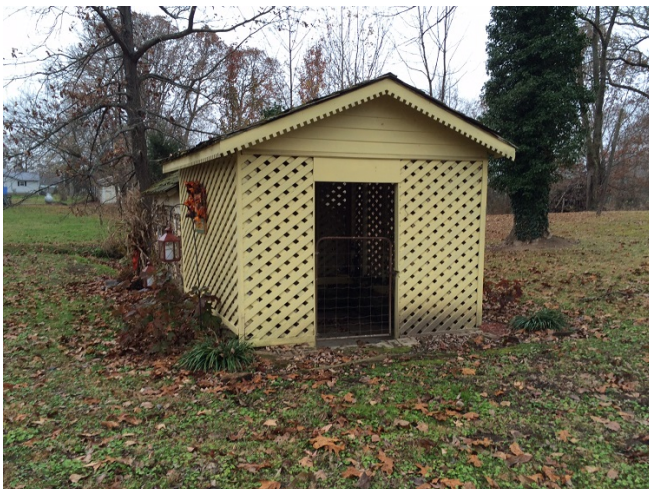
The frame springhouse is located immediately to the north of the stone springhouse, separated by about a foot of space. Its stone foundation is original, while the walls and roof are a reconstruction done by former property owner Dr. Dale Gray in the 1960s. This reconstruction is a wood frame covered on the outside with wood latticework. There are gables on the north and south ends, covered with planks. The roof is of shake shingles, with dental trim on all four sides. There is a single opening, on the north side of the springhouse, consisting of a slightly off-center doorway with a wire gate. The interior floor is concrete. The Chalybeate Spring issues up through a circular hole in the northeast corner of the floor and flows to the south and between the springhouses, staining the concrete floor red.

Frame Springhouse

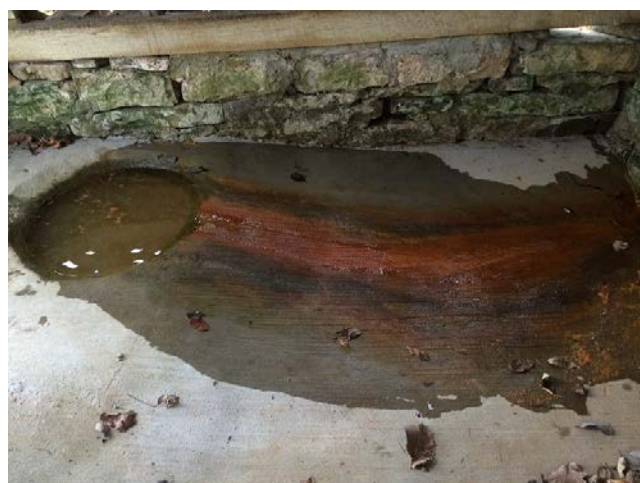
Interior of Frame Springhouse

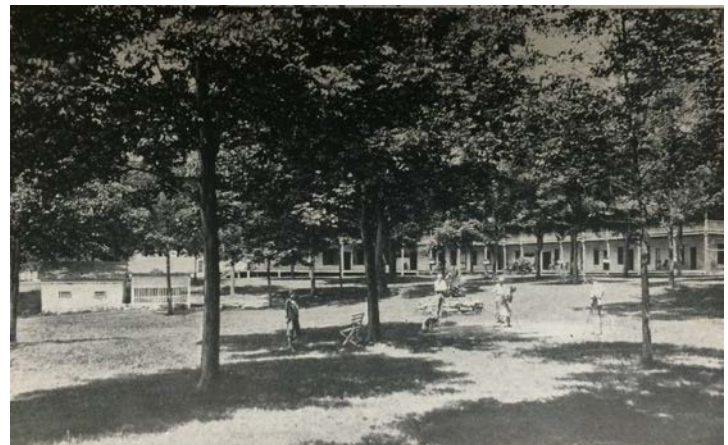
Undated postcard of the Chalybeate Springs Hotel yard, including the springhouses, left hand area of shot (courtesy of WKU Special Collections).
